## NPDES Tribal Wastewater Lagoon Inspection Report – Non-Discharging

| National Database Information | |
|---|---|
| Inspection Date: July 25, 2024 | Inspection Type: CEI-Lagoon General Permit |

| Facility Location Information | |
|---|---|
| Site/Facility Name & Location:<br><b>Brockton Wastewater Treatment Facility</b><br><b>Town of Brockton</b><br><b>Fort Peck Reservation, Montana</b><br><b>48.149290°N, 104.909018°W</b> | Email Report to:<br><b>Douglas Marottek, County Commissioner</b><br><b>Town of Brockton</b><br><a href="mailto:commissioner@rooseveltcountry.org">commissioner@rooseveltcountry.org</a> |

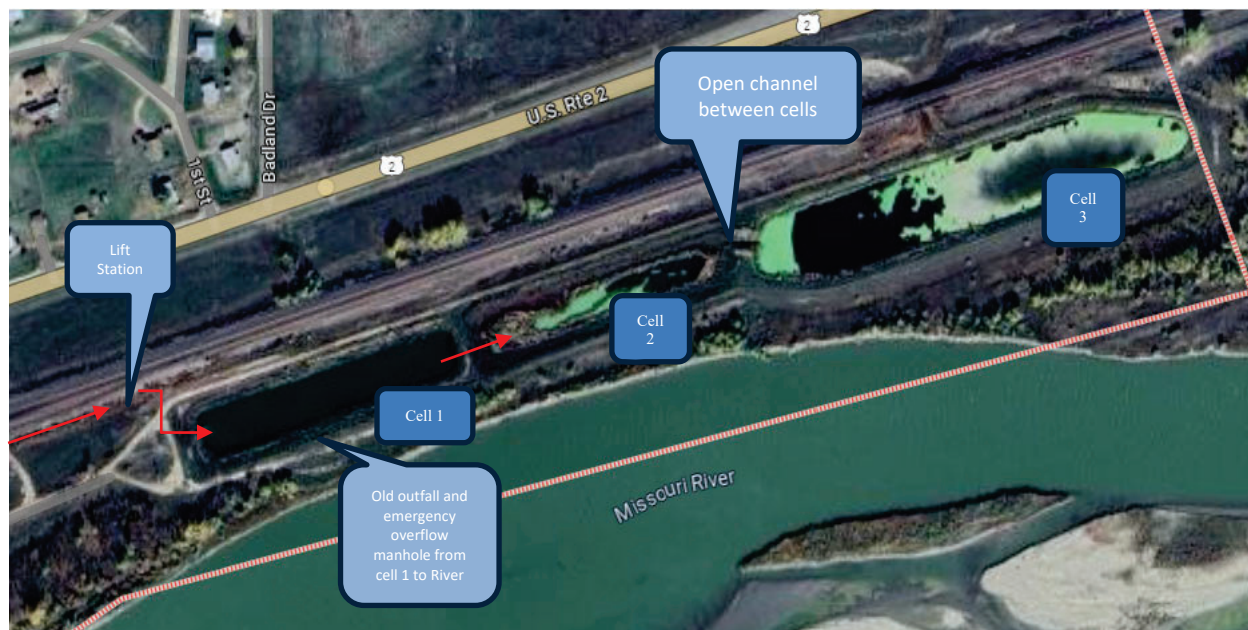
Facility map:

The facility was originally constructed in 1950 as a one-cell lagoon. Mr. Boyd was not sure when the other two cells were constructed. The facility consists of a collection system with one lift station and three facultative lagoon cells serving a population of approximately 260 (2020 census). The three cells typically run in series by gravity with no pumps for aeration or flow. Cell 1 is approximately 2 acres, cell 2 is approximately 2.18 acres, and cell 3 is approximately 5.12 acres. The lift station is located just outside the entrance to the lagoon cells and is designed to move all influent into cell 1. Effluent discharge from cell 3 would be through a valved pipe located in the southeastern end of cell 3 and exiting in the Missouri River. Mr. Boyd stated the valve is rusted shut and could not discharge. See the facility map below.
