## **Appendix B Photograph Log**

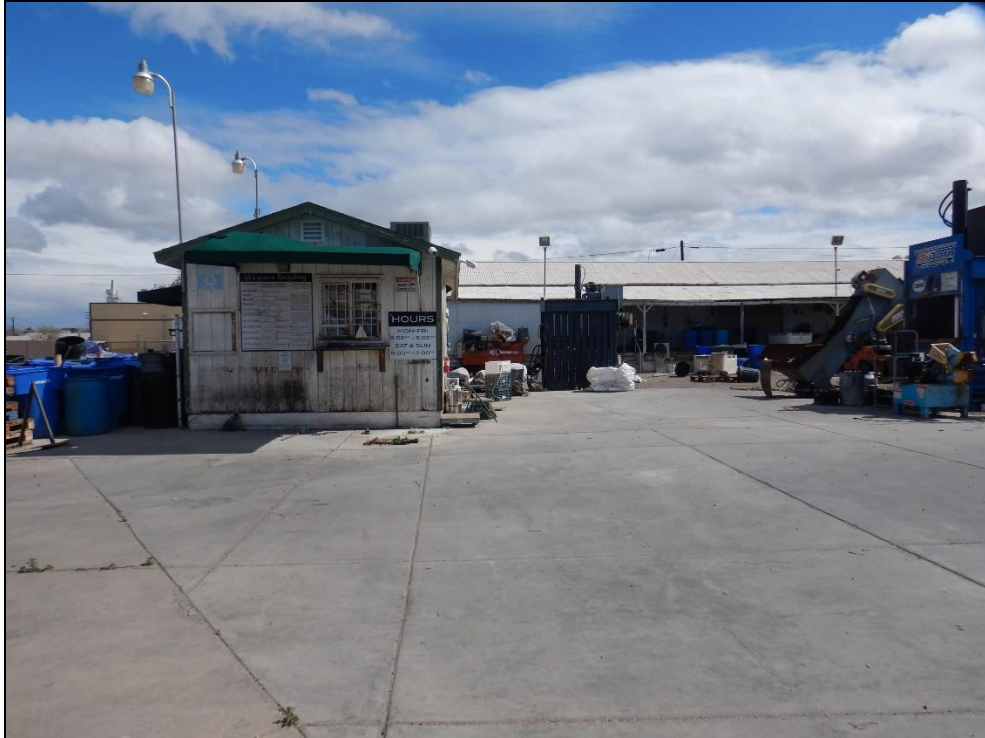
**Photograph 1.** View, facing east, of the Facility's office building from the entrance at South 3<sup>rd</sup> Street.

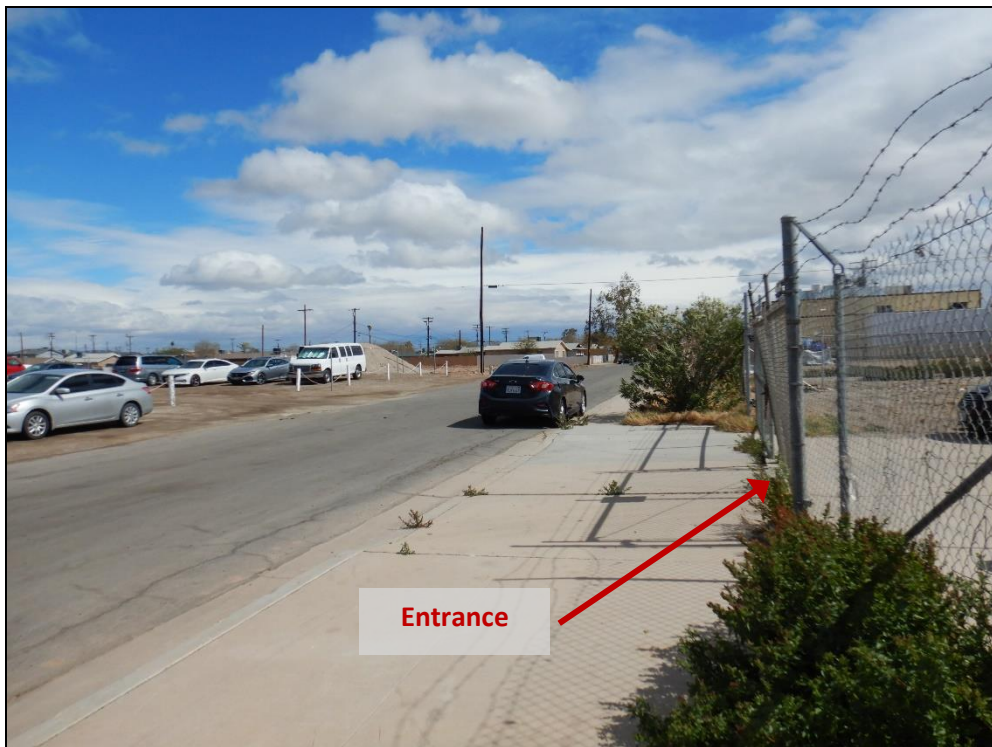
**Photograph 2.** View, facing east, of the Facility's entrance from West Brighton Avenue.

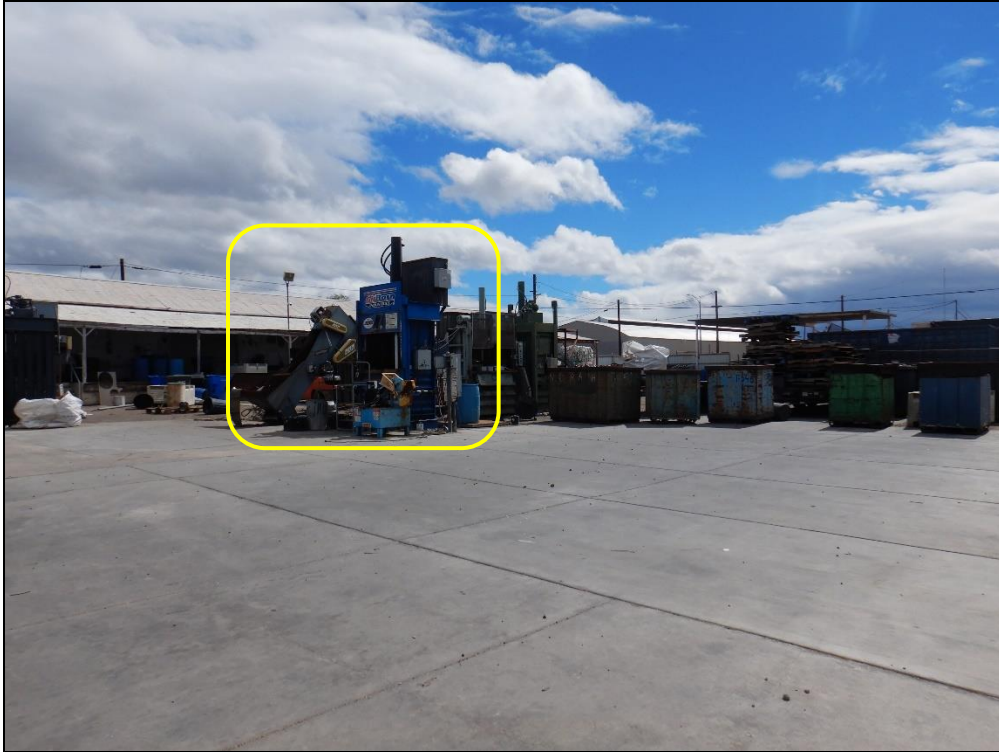
**Photograph 3.** View, facing southeast, of the Facility's machine to process materials.

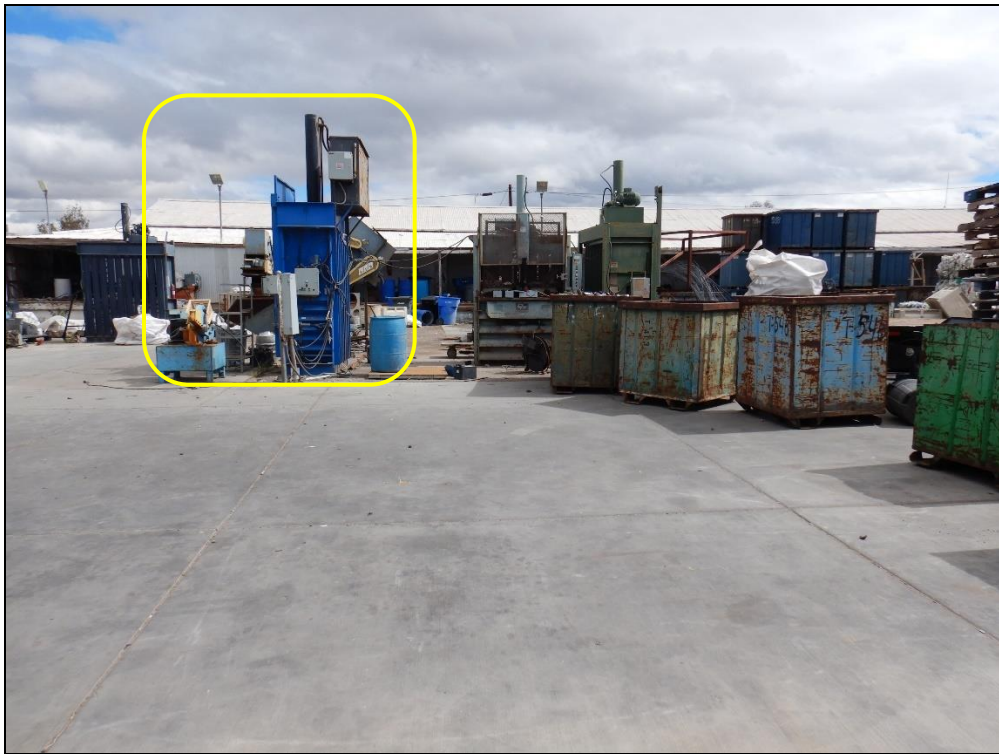
**Photograph 4.** View, facing east, of the Facility's machine to process materials and materials storage.

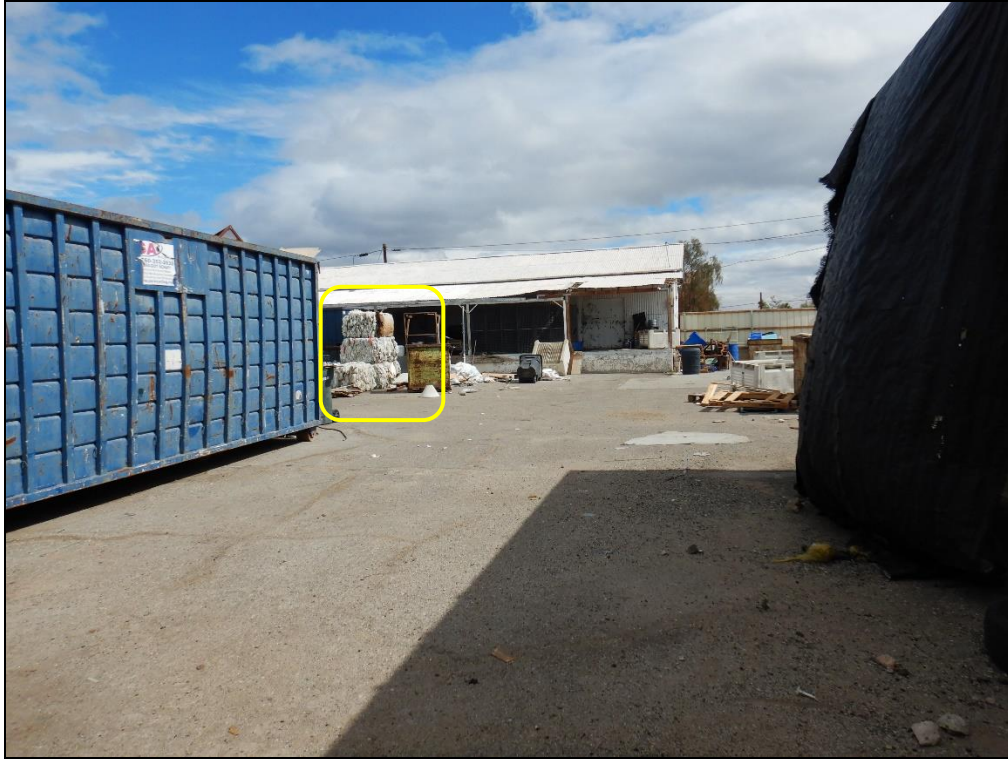
**Photograph 5.** View, facing northeast, of materials at the Facility which appear to have been compacted and bound.

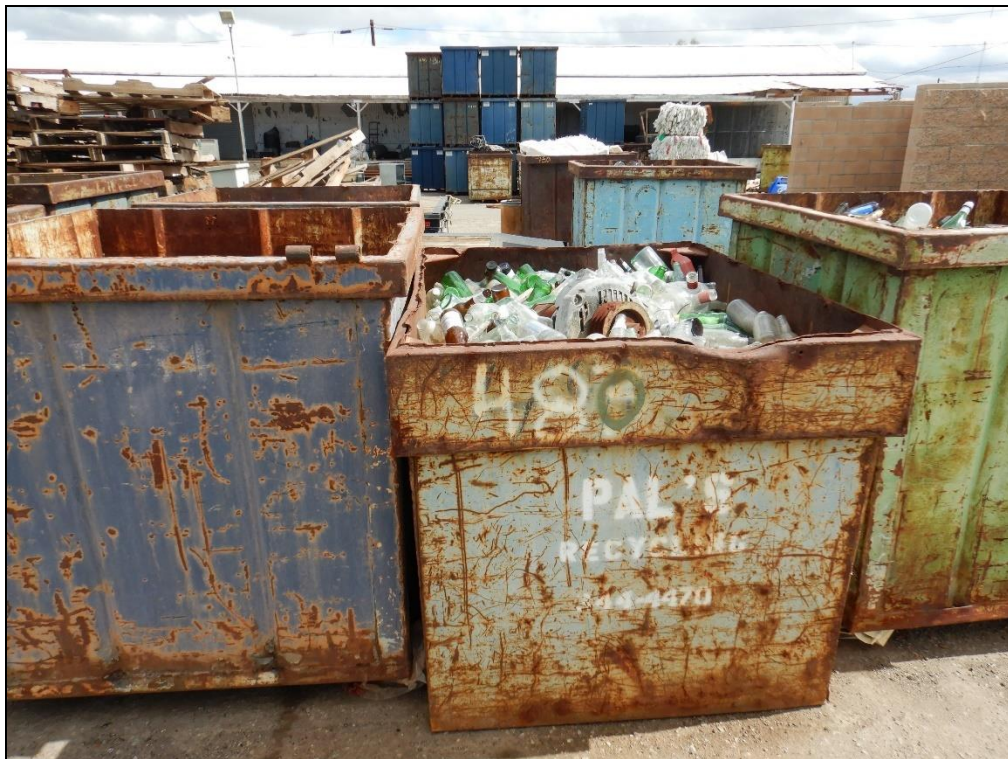
**Photograph 6.** View, facing east, of recyclable materials stored at the Facility.

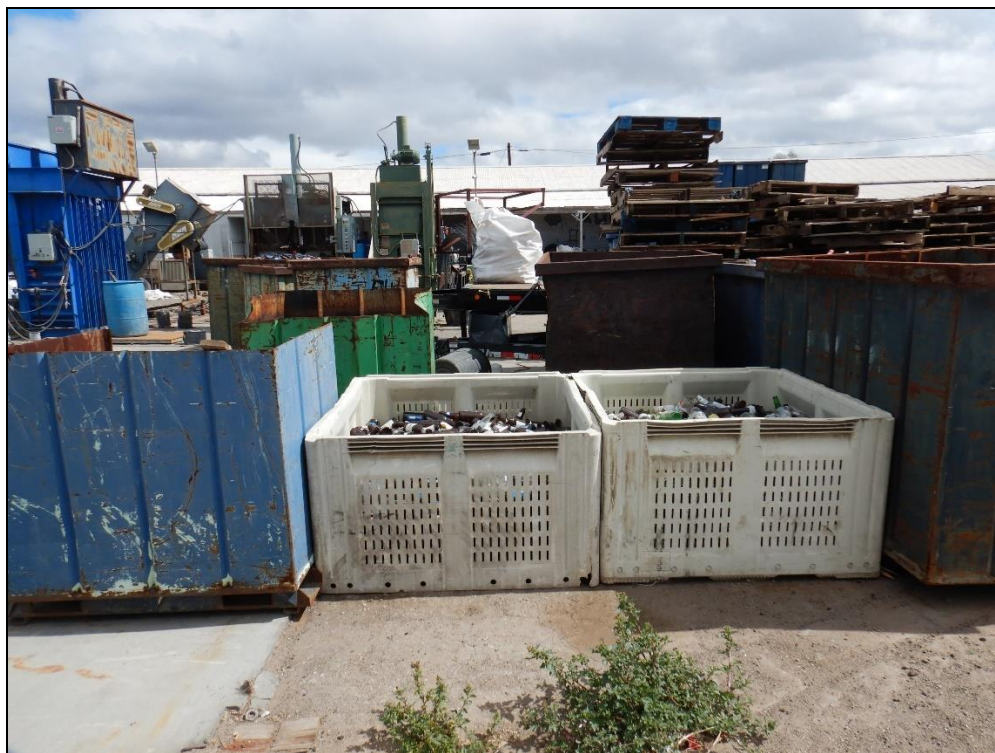
**Photograph 7.** View, facing east, of recyclable materials stored at the Facility.

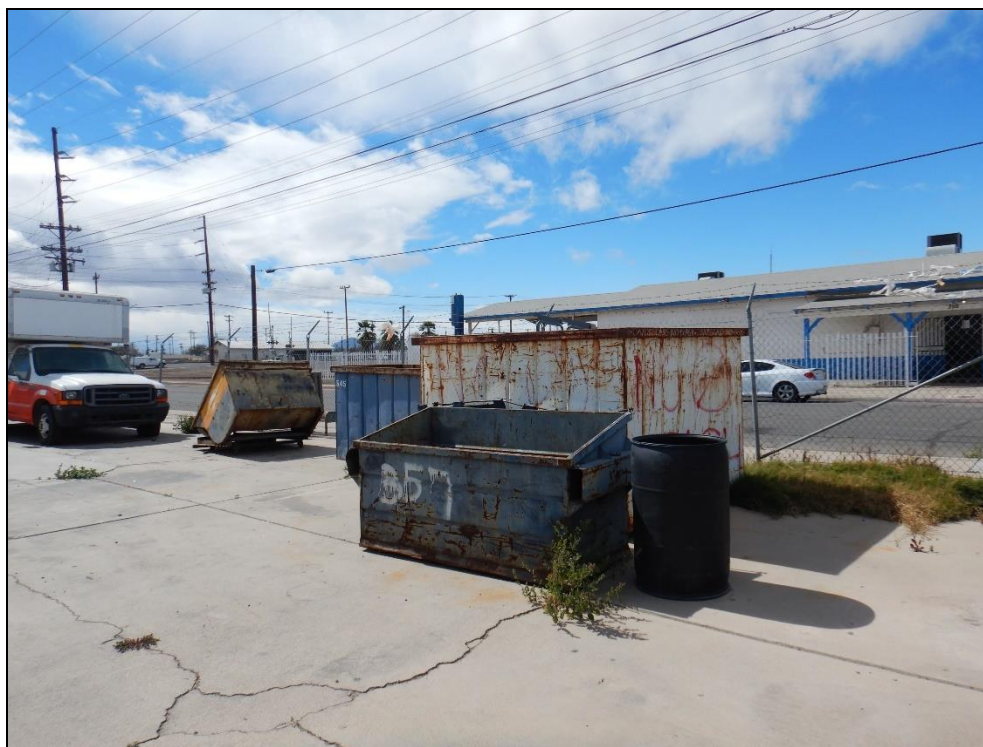
**Photograph 8.** View, facing southwest, of waste containers in the northwest corner of the Facility.

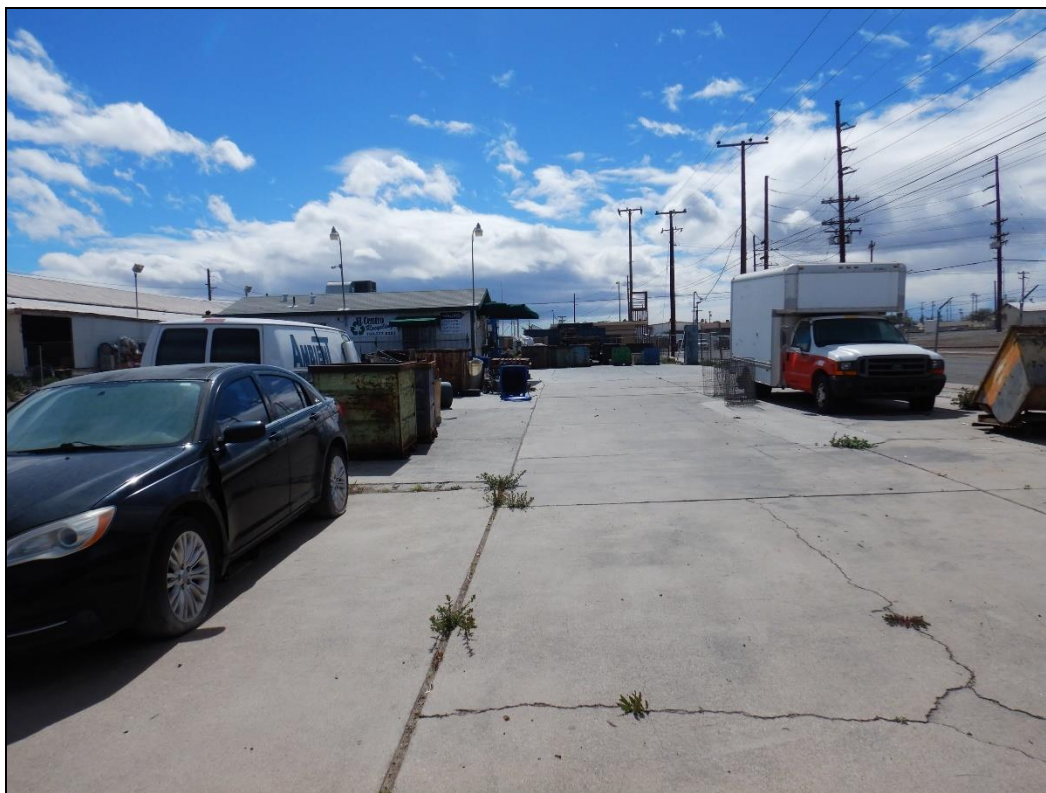
**Photograph 9.** View, facing south, of the Facility's impervious surface.
