**Region 6 - Enforcement & Compliance Assurance Division**  
**INSPECTION REPORT**

| Inspection Date(s): | 03/09/2022 | |
| Media Program: | Water | |
| Company Name: | Mustang SUD | |

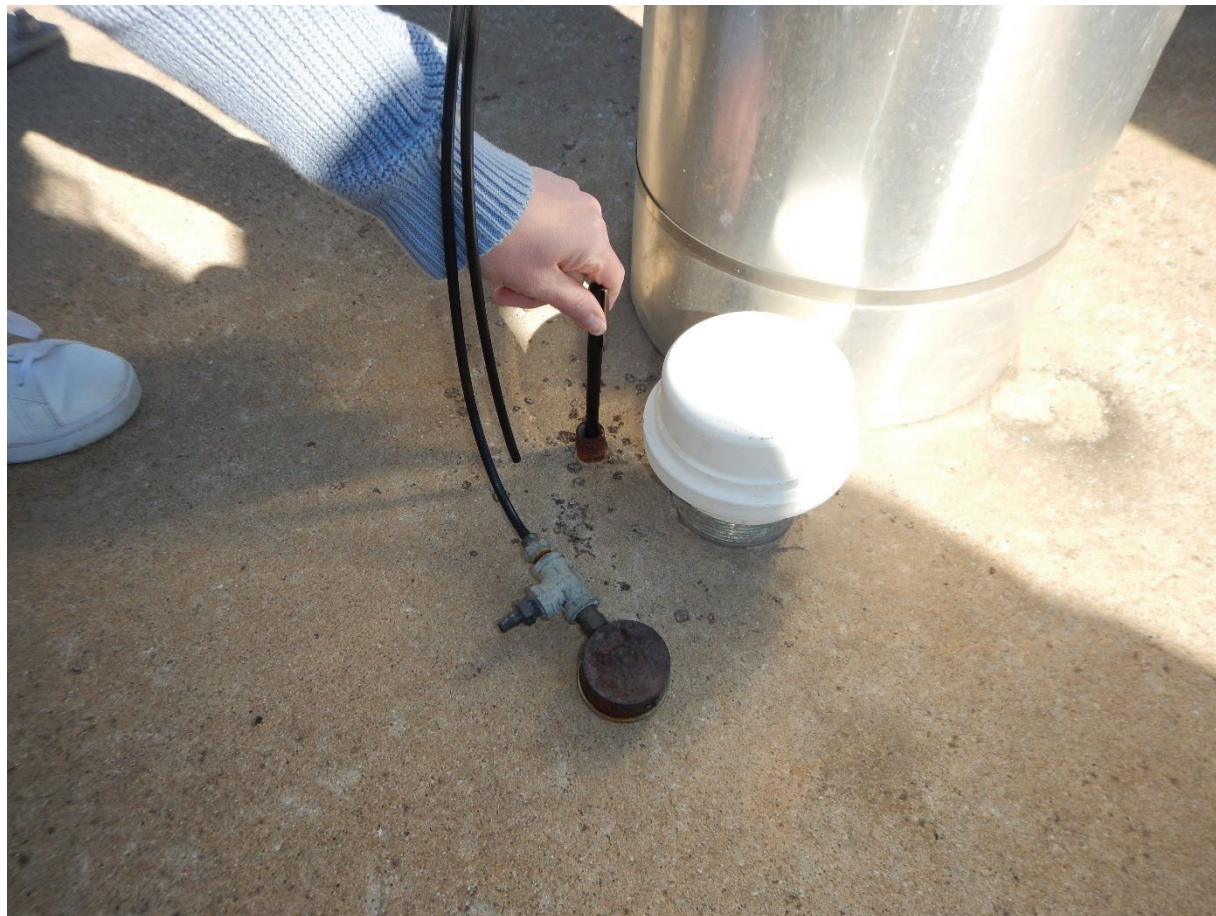
Photo No. 1

- Well on Mustang SUD property, served by gated entrance
- 2019 expansion
- Well 1 winterized (Photo 2)
- Open hole of unknown use in well pad (Photo 1)
- Caulk missing around electrical conduit (Photo 3)
- Moisture observed around base of ground storage tank (Photo 4)
- Unknown pipe without cover (Photo 5)

- Open hole of unknown use in well pad could be open to ground and potential pathway for contamination (Photo 1)
- Caulk missing around electrical conduit could be potential pathway for contamination (Photo 3)
- Moisture observed around base of ground storage (Photo 4)
- Unknown pipe without cover could be trip hazard or potential pathway for contamination (Photo 5)
- Lid on drainage outside of chlorine injection room has unknown pipe terminating in drain, could be possible cross connection (Photo 6)

Description: Open hole in concrete on well pad

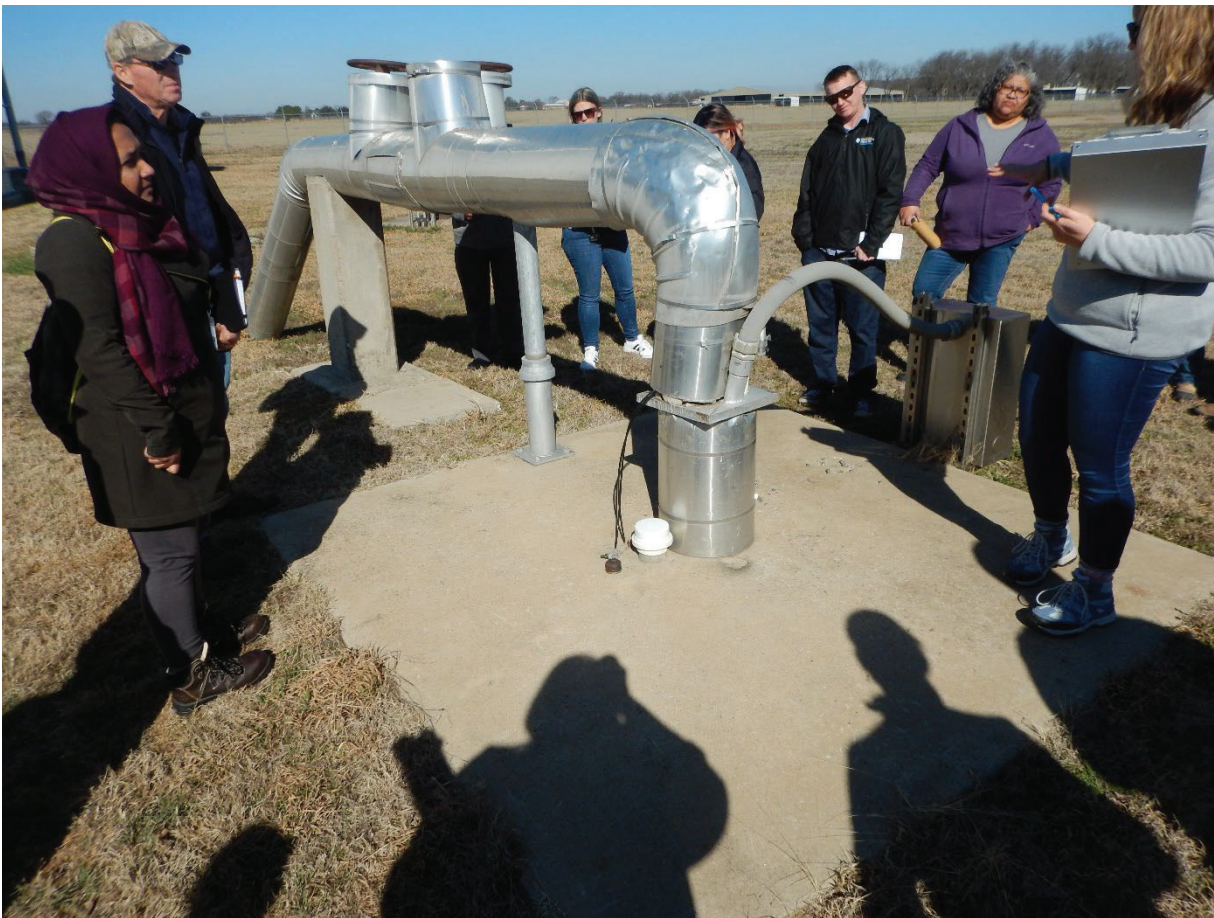
Photo No. 2

Description: Well 10. Well near Mustang SUD office

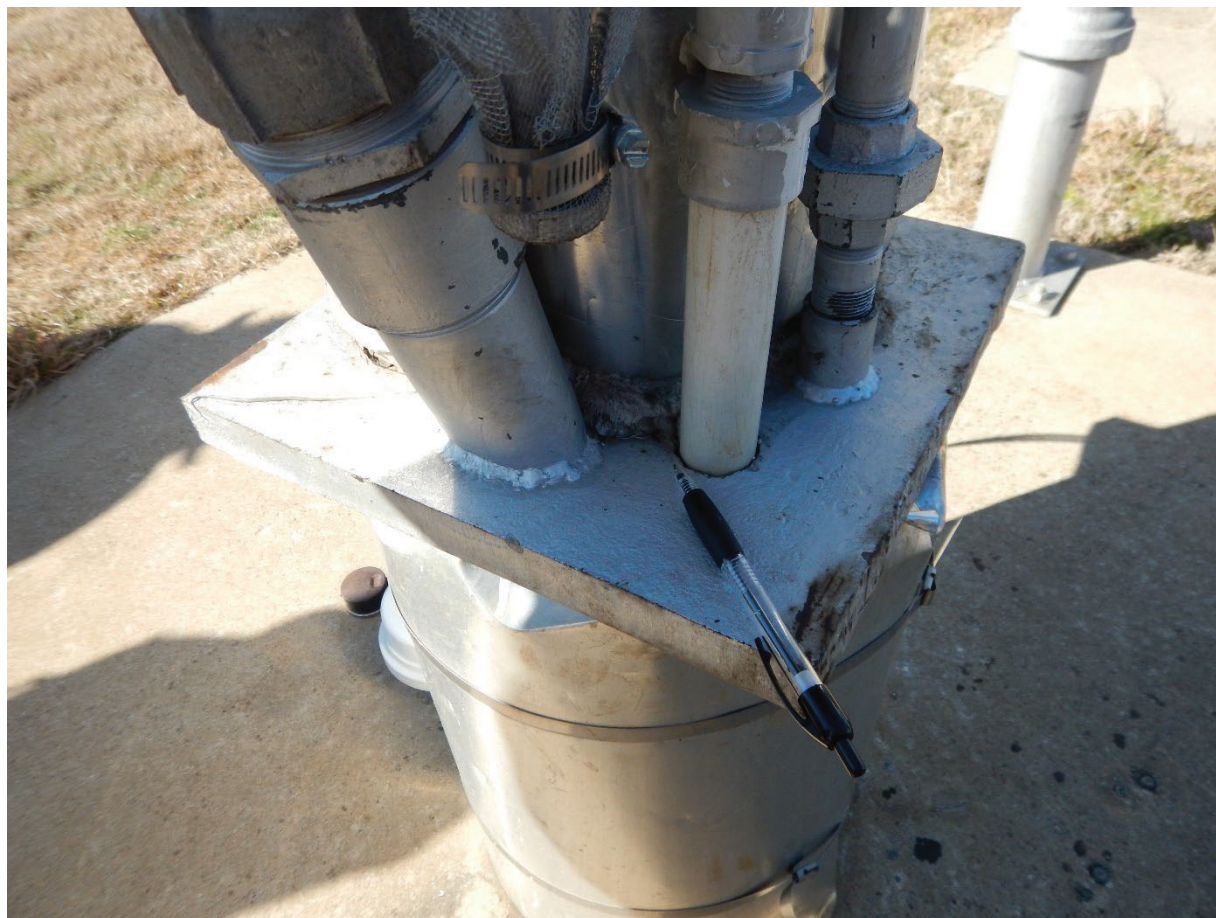
Photo No. 3

Description: Caulk missing around PVC pipe on wellhead

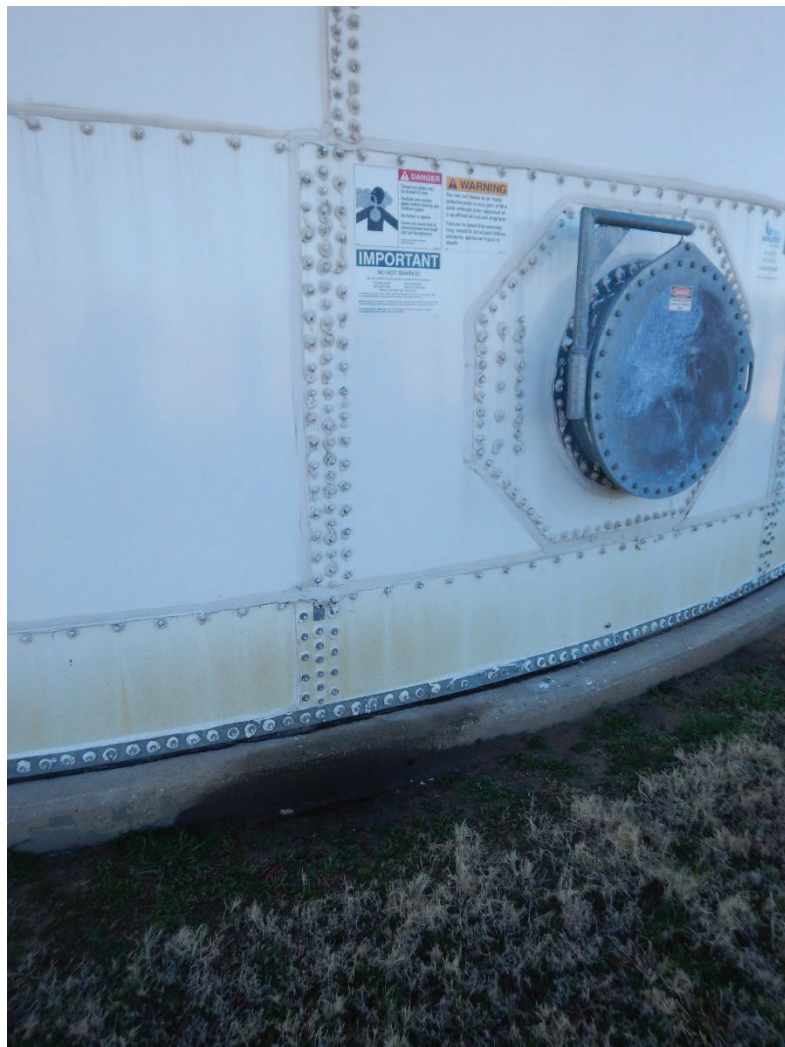
Photo No. 4

Description: Standing water at base of storage tank at Aubrey site

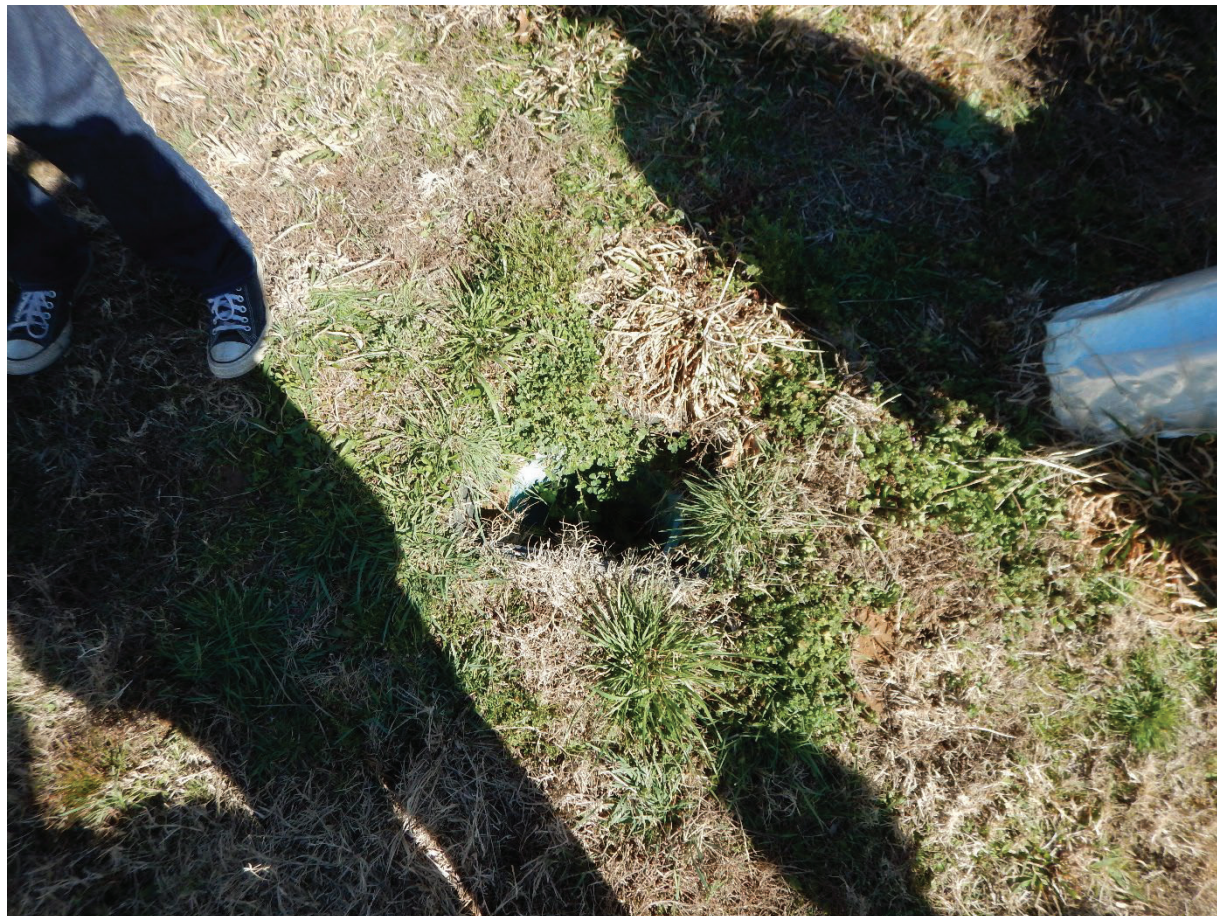
Photo No. 5

Description: Unknown pipe without cover at Aubrey site.

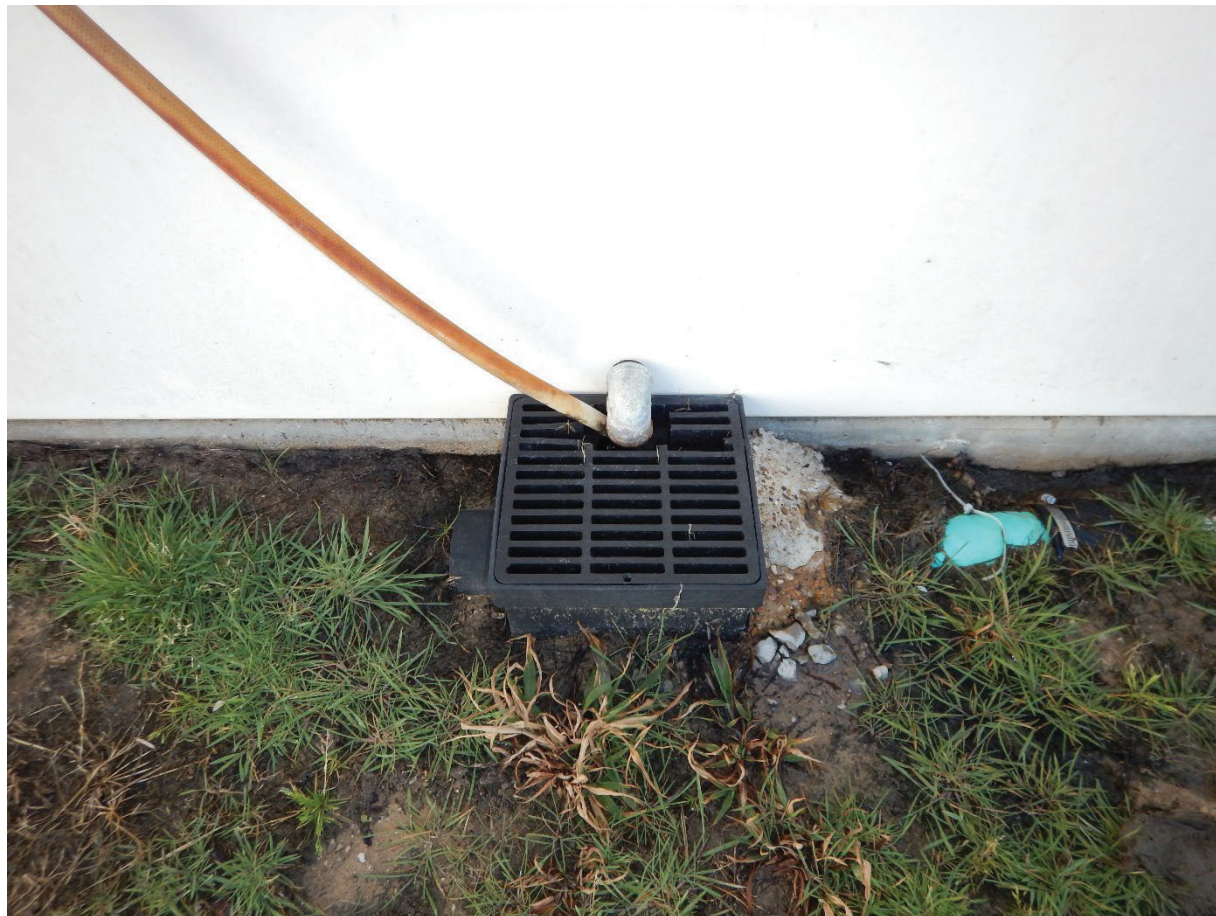
Photo No. 6

- Lid on drainage outside of chlorine injection room has unknown pipe terminating in drain (Photo 6)

Description: Multiple pipes terminating in runoff drain from

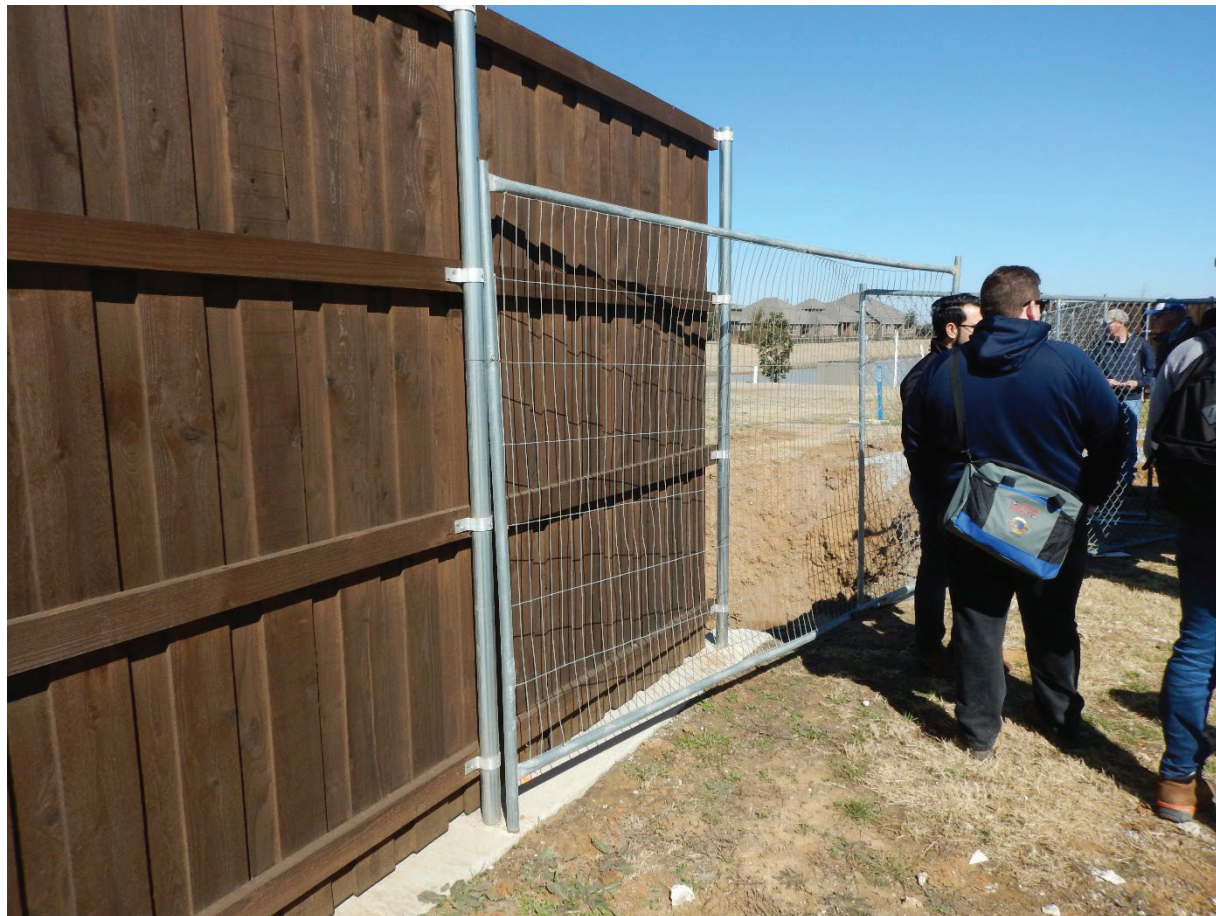
Photo No. 7

- Temporary line from well No 12 Hathaway filling storage tanks
- Well not in use
- UTRWD constructing vault outside of fence of Well 11
- Temporary fencing due to construction at Well 11 (Photo 7 & 8)
- Pump room serving as storage for hoses and other equipment (Photo 10)

- Temporary fencing due to construction at Well 11 does not meet TCEQ security requirements (Photo 7 & 8)
- Pump room serving as storage for hoses and other equipment could be trip hazard when needing to service equipment (Photo 10)

Description: Temporary fencing at Well 11.

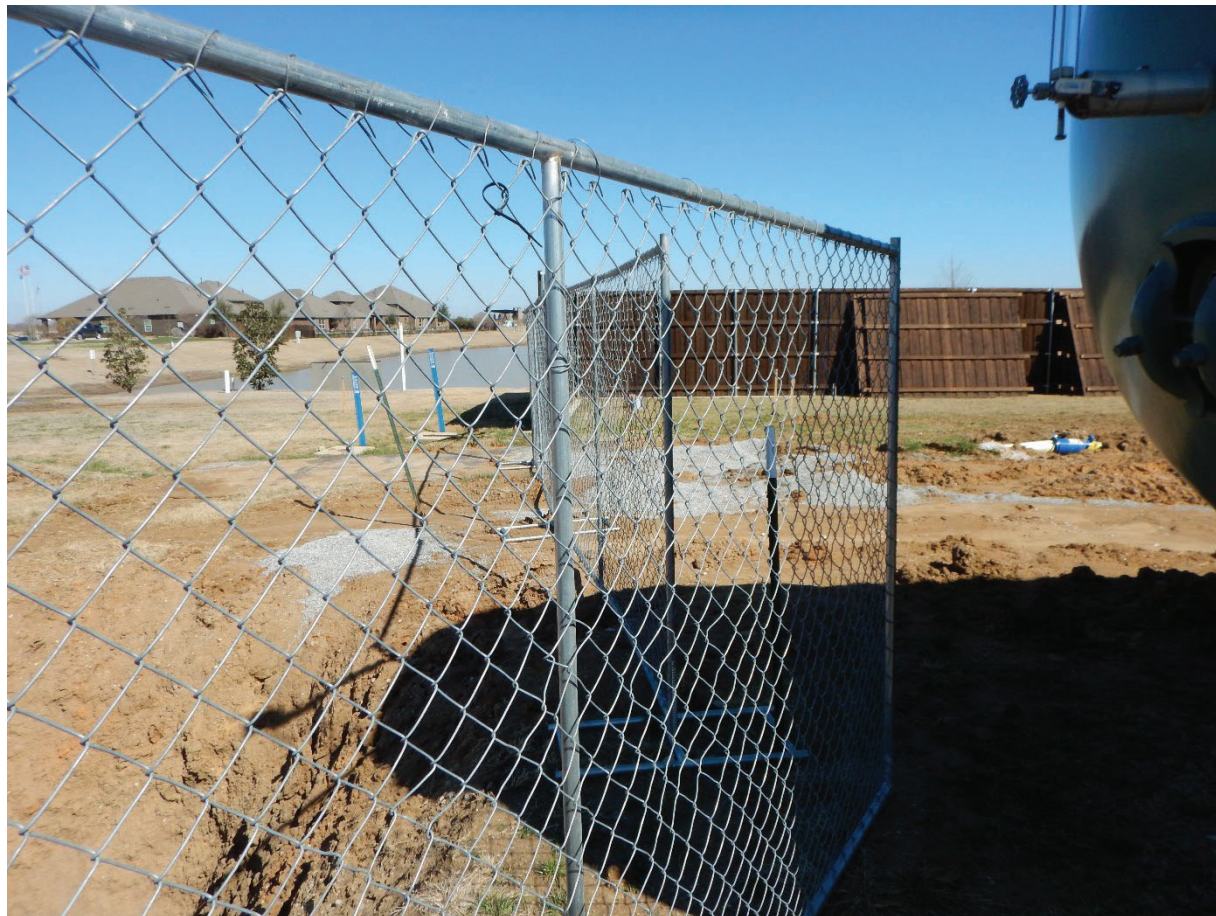
Photo No. 8

Description: Open temporary fencing at Well 11

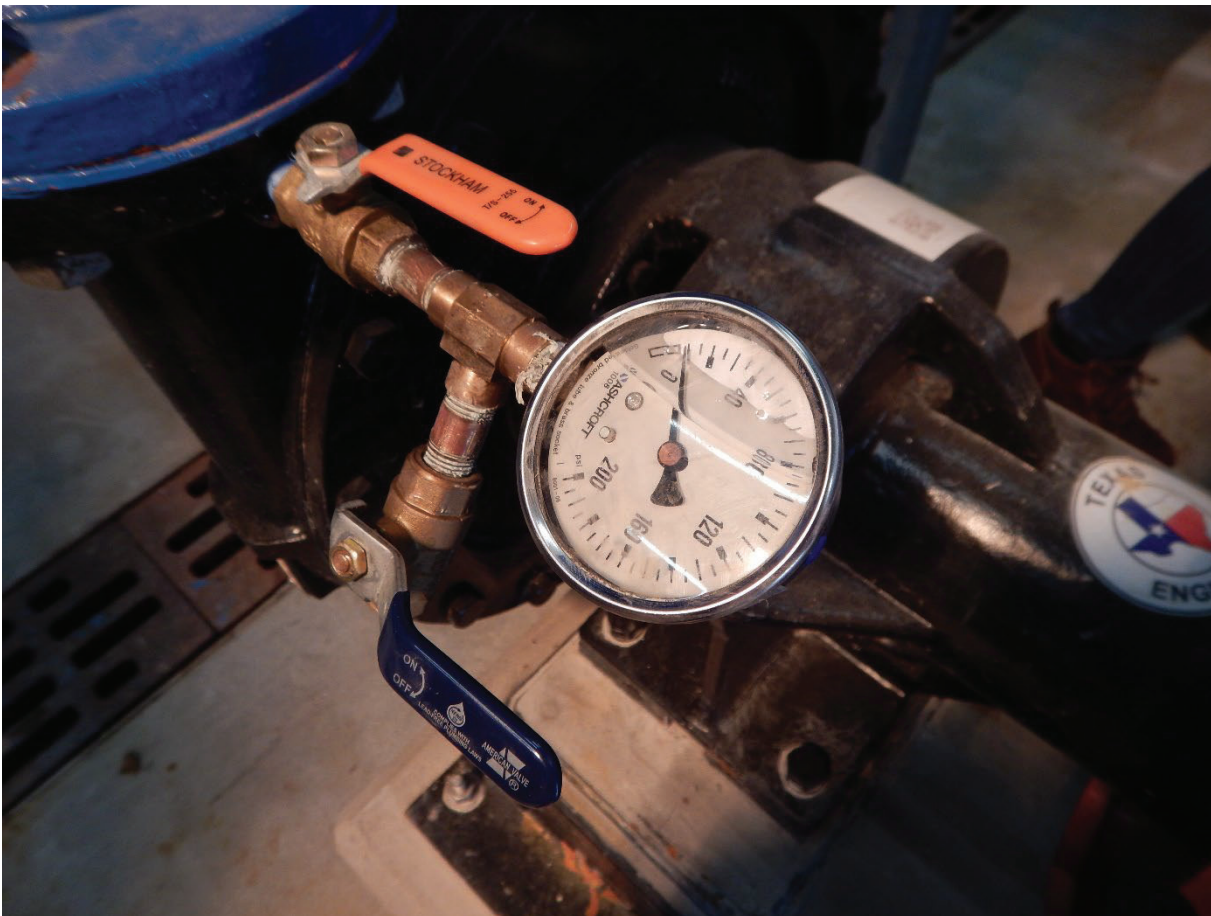
Photo No. 9

Description: Pressure gage at Well site 11

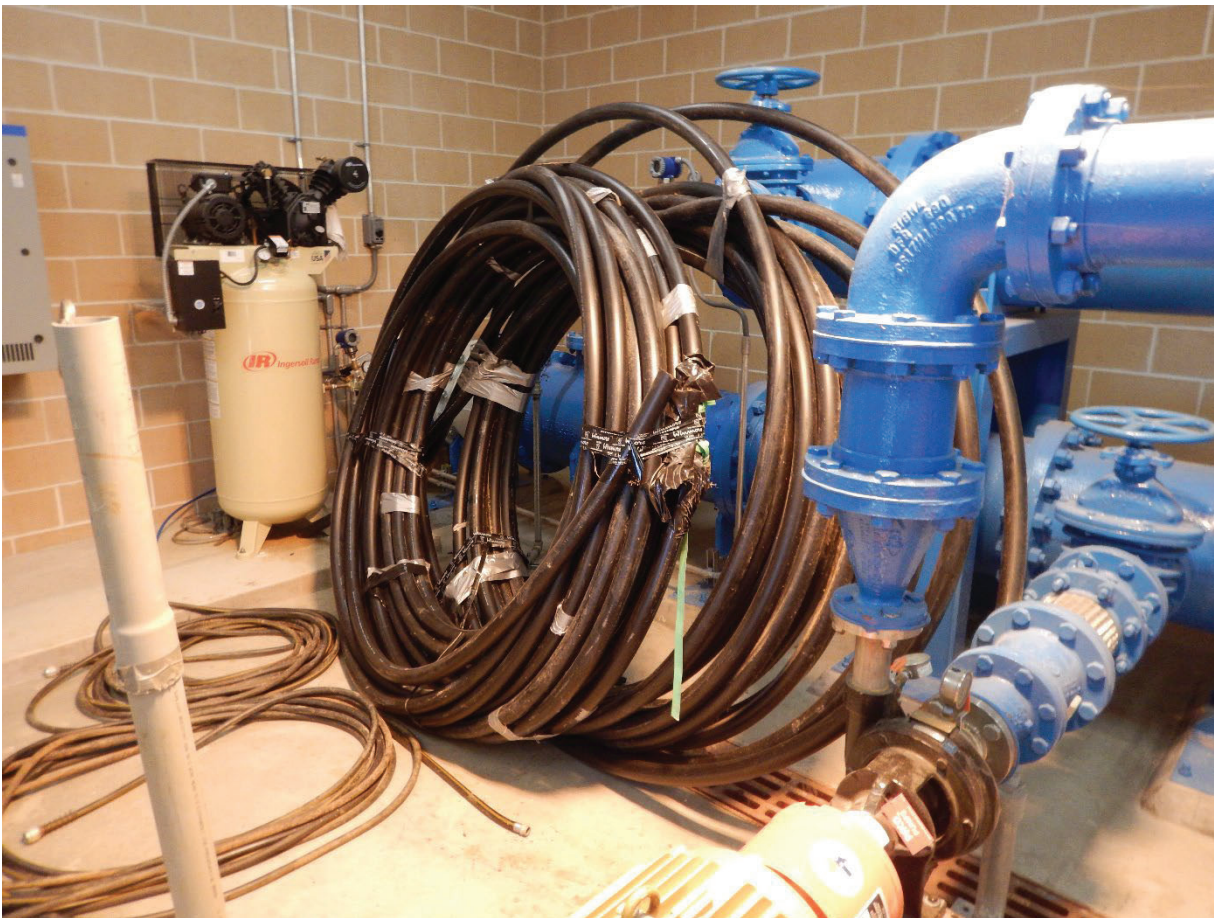
Photo No. 10

Description: Hoses stored in pump room at Well 11

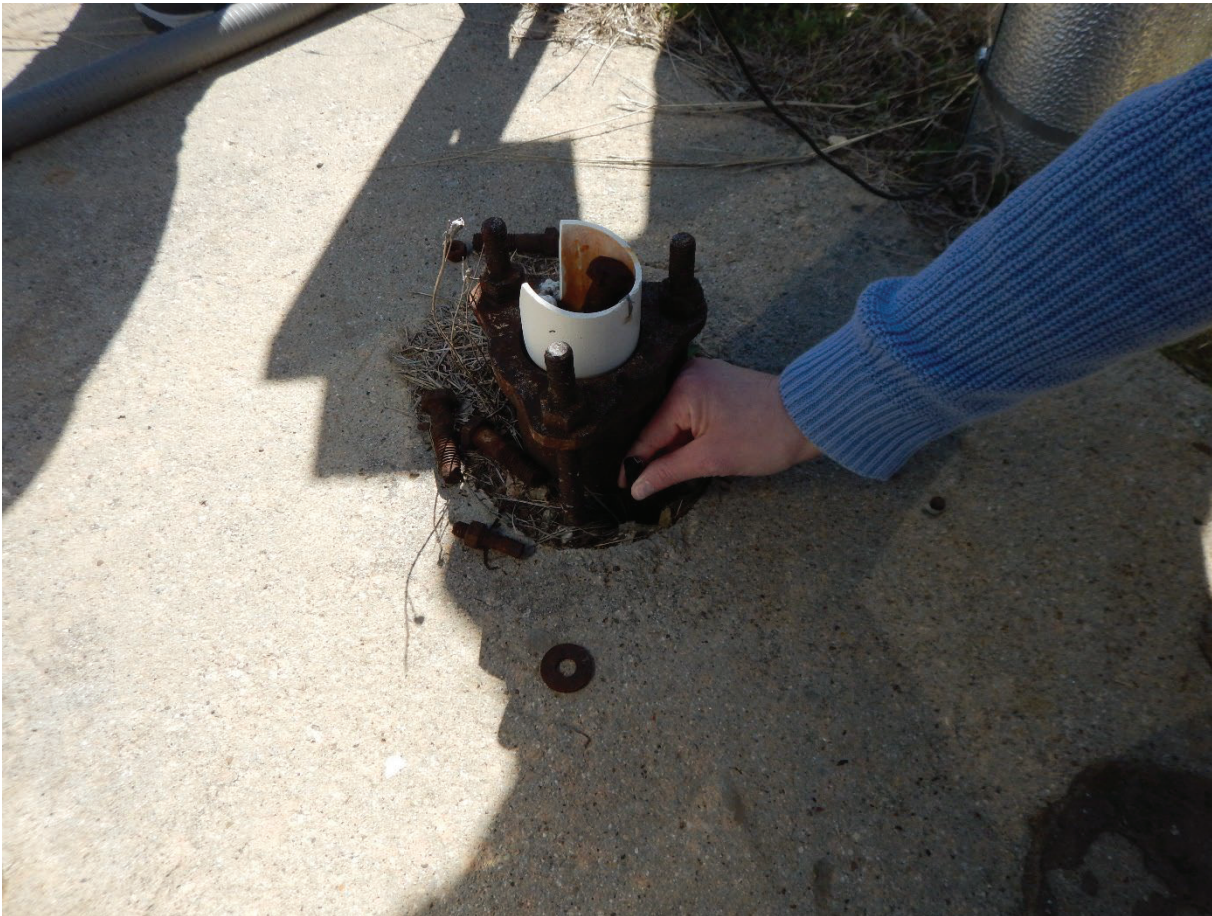
Photo No. 11

- Livestock in close proximity to the well
- Open hole, looks to be old well present (Photo 11)
- Open hole casing is open to the surface (Photo 12)
- Ground storage tank on gravel pad originally. Pad overgrown with vegetation or completely covered with mud (Photo 13 and 14)

- Livestock on other side of fence, setback requirement for livestock from public water supply well not met, check with TCEQ to see if variance received
- Open hole, looks to be old well present that is not properly plugged and abandoned, could be source of potential contamination (Photo 11 & 12)
- Ground storage tank on gravel pad originally. Pad overgrown with vegetation or completely covered with mud, view to do outside visual inspection impaired and could cause additional wear from soil/tank contact (Photo 13 and 14)

Description: Abandoned well open to ground surface at Well 2

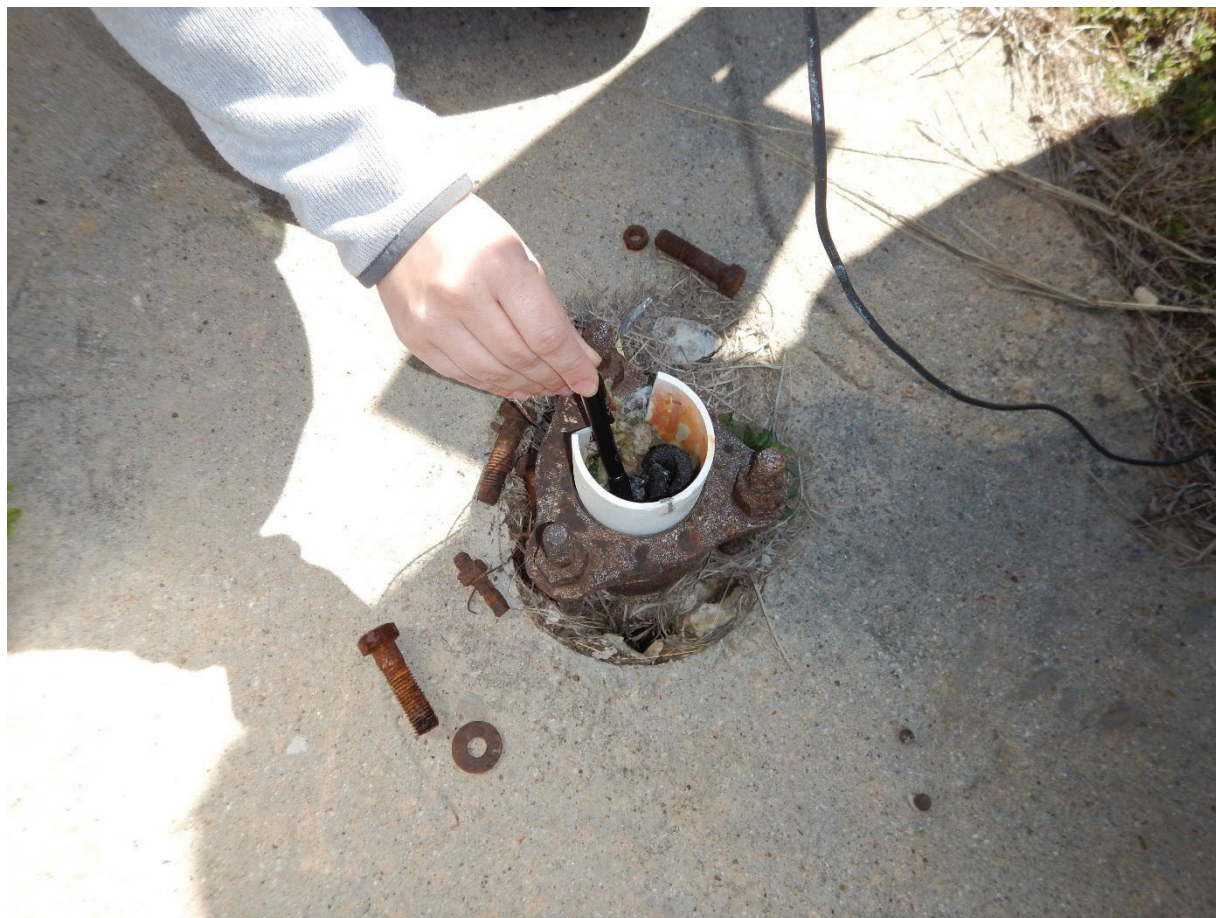
Photo No. 12

Description: Abandoned well open to ground surface at Well 2

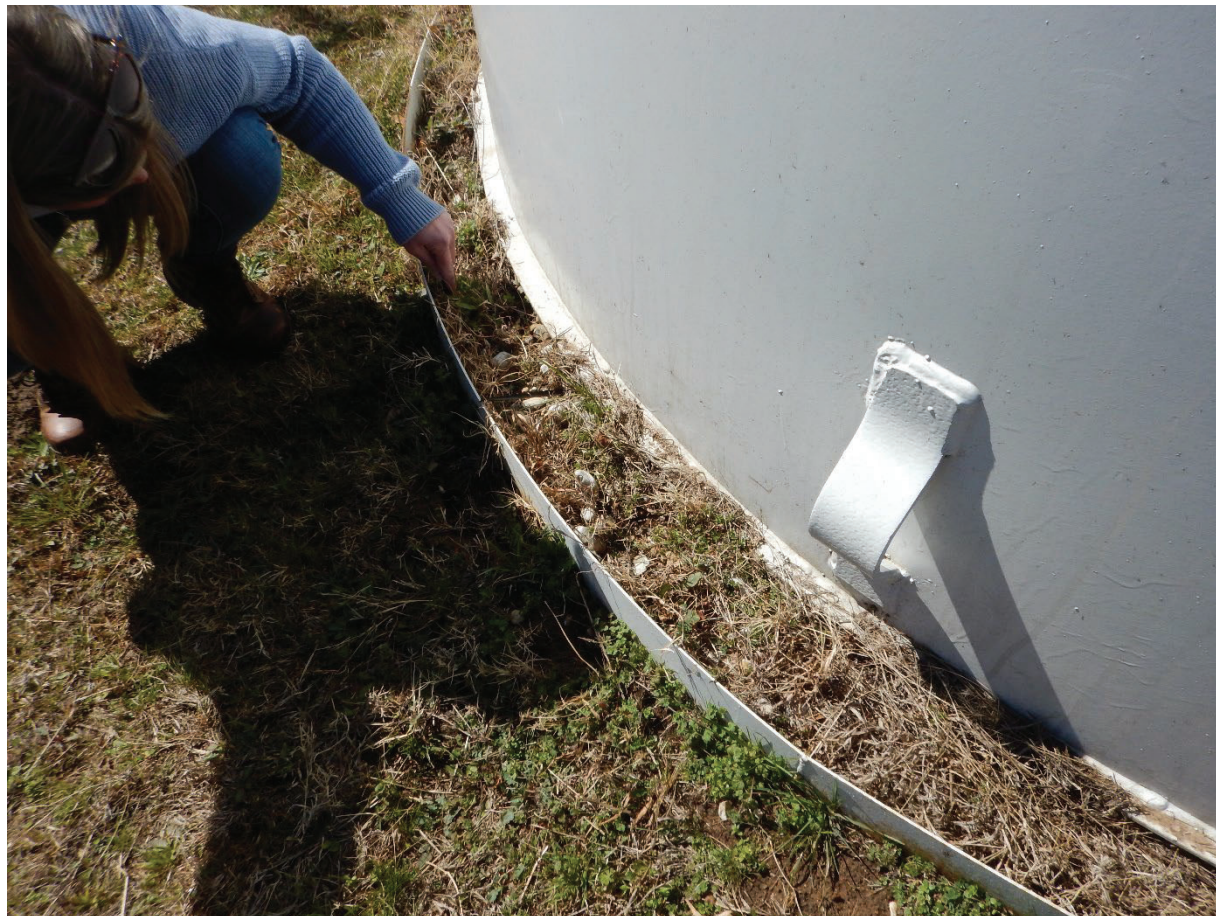
Photo No. 13

Description: Ground storage tank pad overgrown with vegetation, gravel under vegetation at Well 2

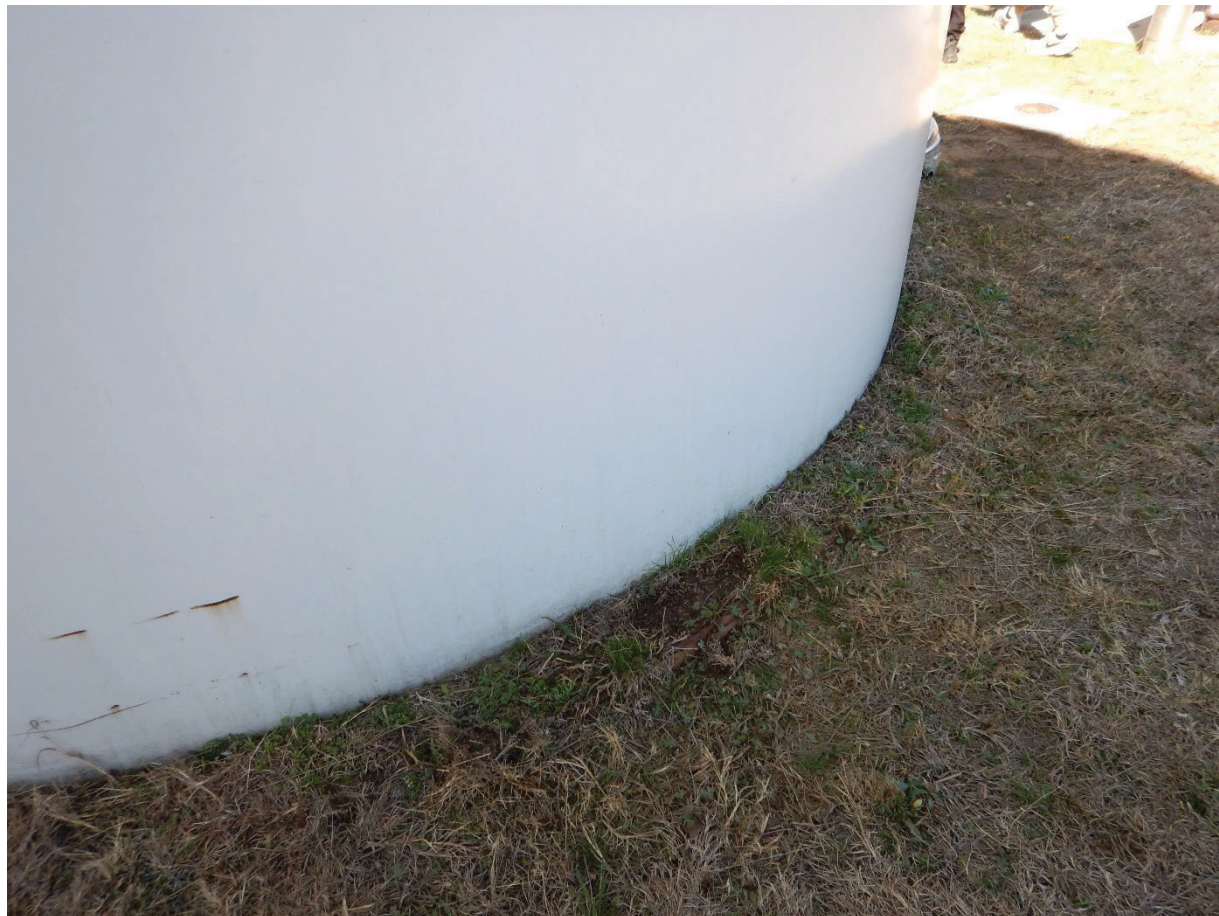
Photo No. 14

Description: Ground storage tank pad covered by vegetation completely at Well 2

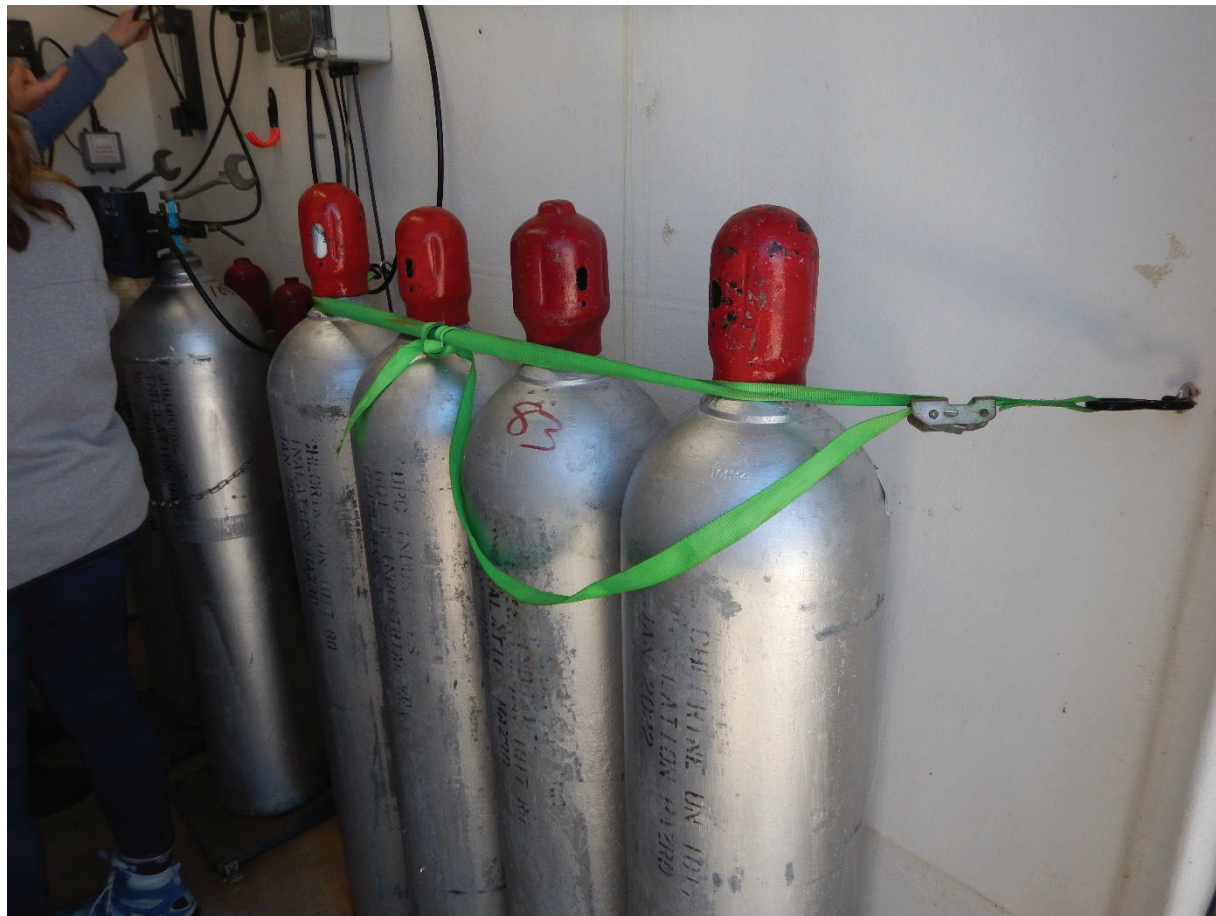
Photo No. 15

- Chlorine cylinders secured with strap in chlorine room (Photo 15)
- Well is missing sanitary seal (Photo 16 & 17)
- Open conduit around electrical on well (Photo 18)
- Flexible screen on vent (Photo 19)
- Disconnected sample tap on well (Photo 20)
- Electrical conduit detached from electrical box (Photo 21)

Description: Chlorine cylinders secured with strap at Hathaway Well Site

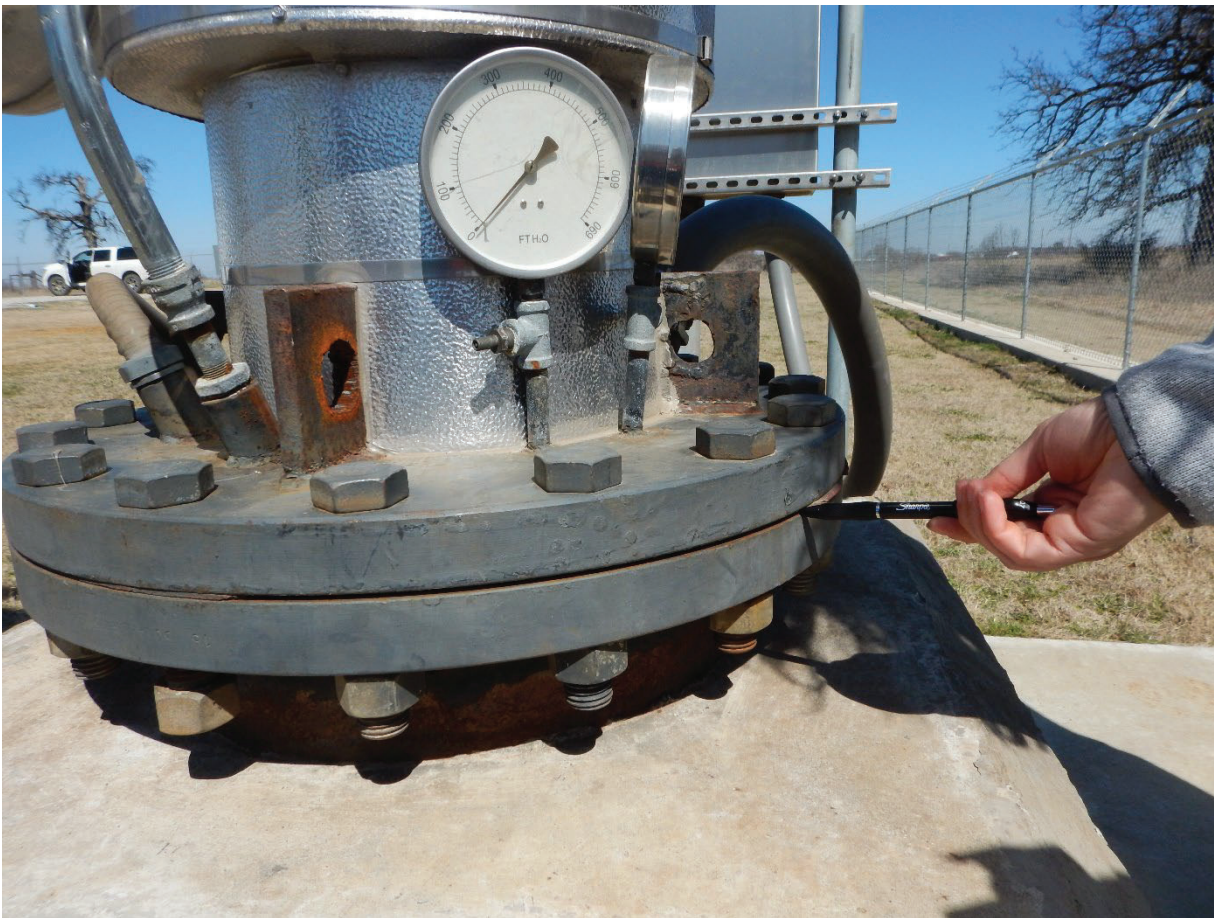
Photo No. 16

- Missing sanitary seal on wellhead, could be source of potential contamination (Photo 16 & 17)
- Open conduit around electrical on well could be source of potential contamination (Photo 18)
- Flexible screen on vent may not meet TCEQ requirements for screen- ensure screen meets TCEQ requirements (Photo 19)
- Electrical conduit detached from electrical box could provide source of potential contamination (Photo 21)

Description: Missing sanitary seal at Hathaway Well Site

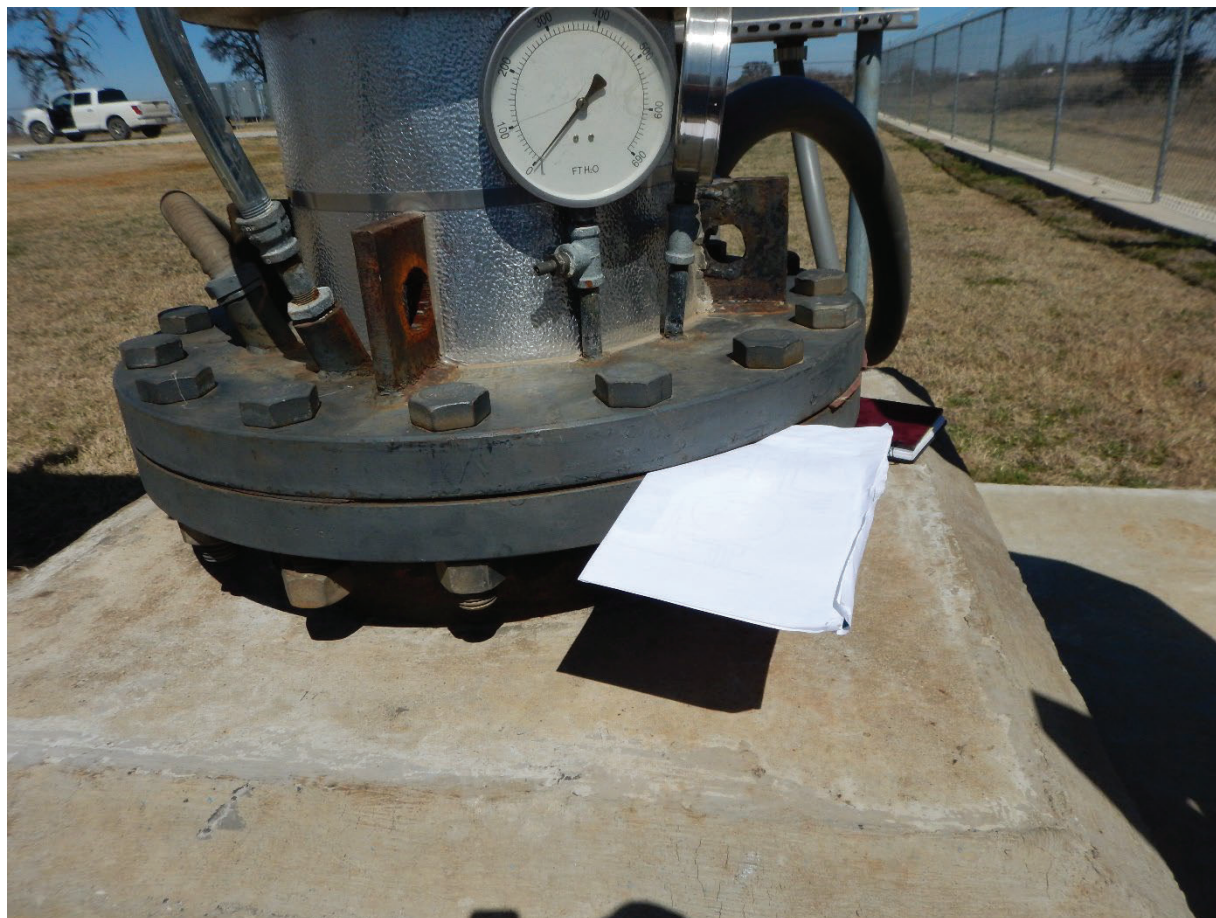
Photo No. 17

Description: Missing sanitary seal at Hathaway Well Site

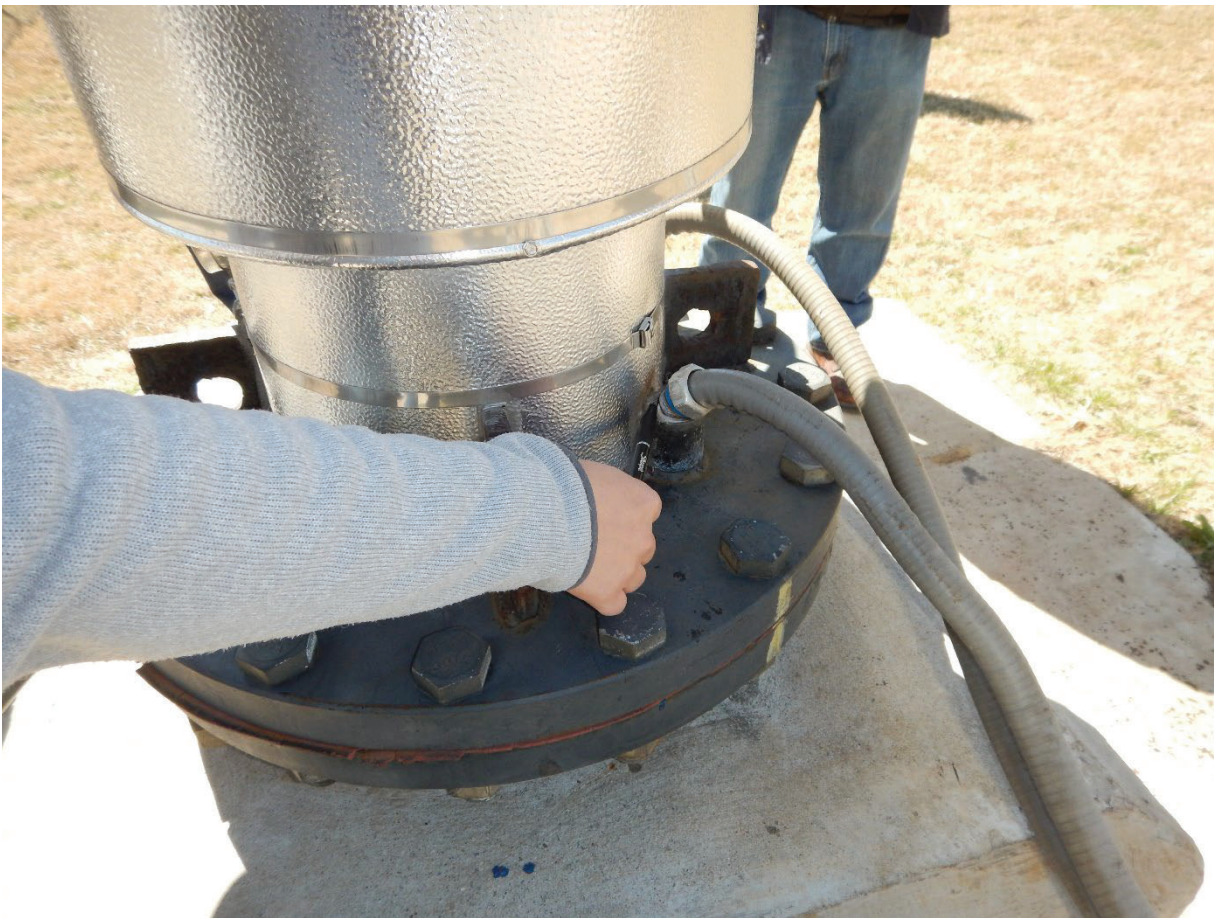
Photo No. 18

Description: Open casing around electrical conduit at Hathaway Well Site

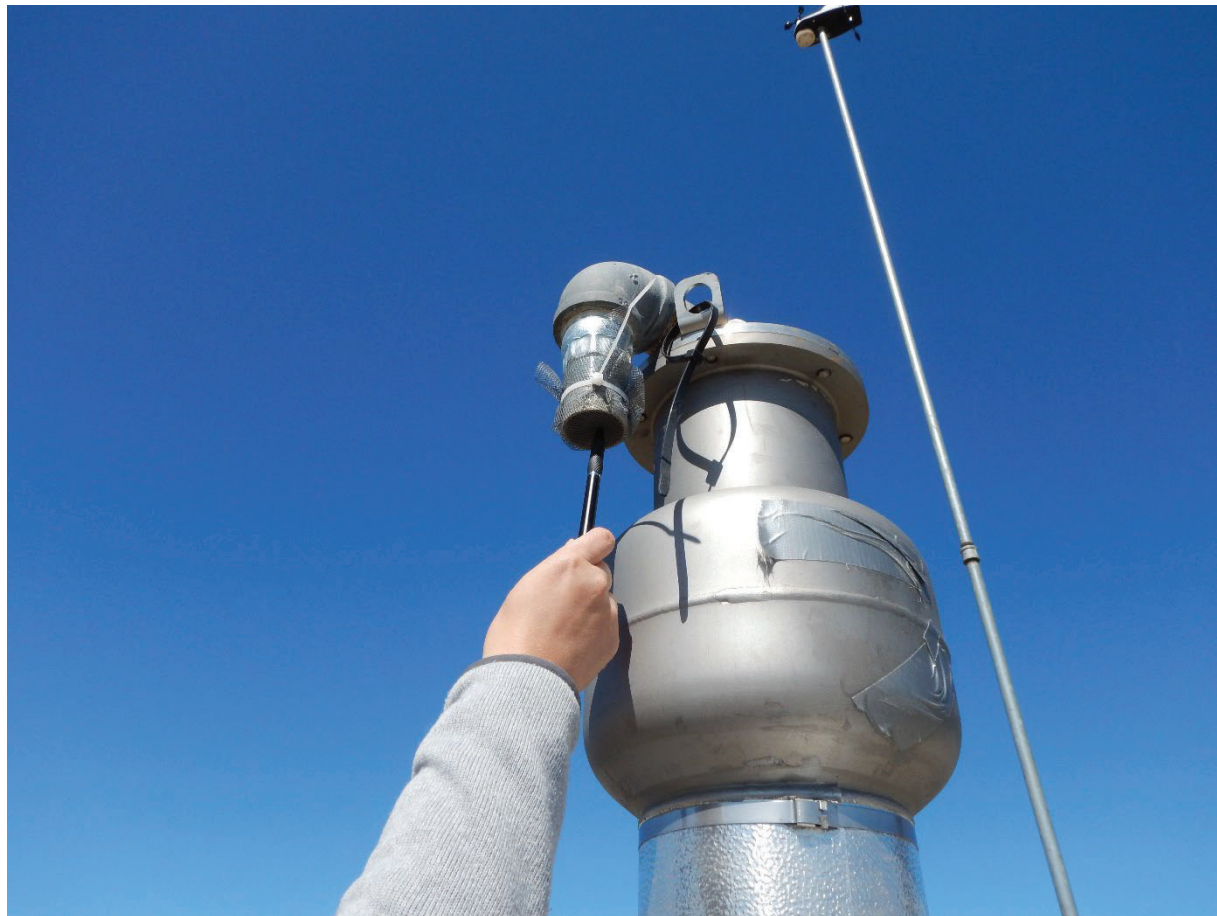
Photo No. 19

Description: Flexible screen, plastic, at Hathaway Well Site
