**Region 6 - Enforcement & Compliance Assurance Division**  
**INSPECTION REPORT**

| Inspection Date(s): | 03/09/2022 | |
| Media Program: | Water | |
| Company Name: | Mustang SUD | |

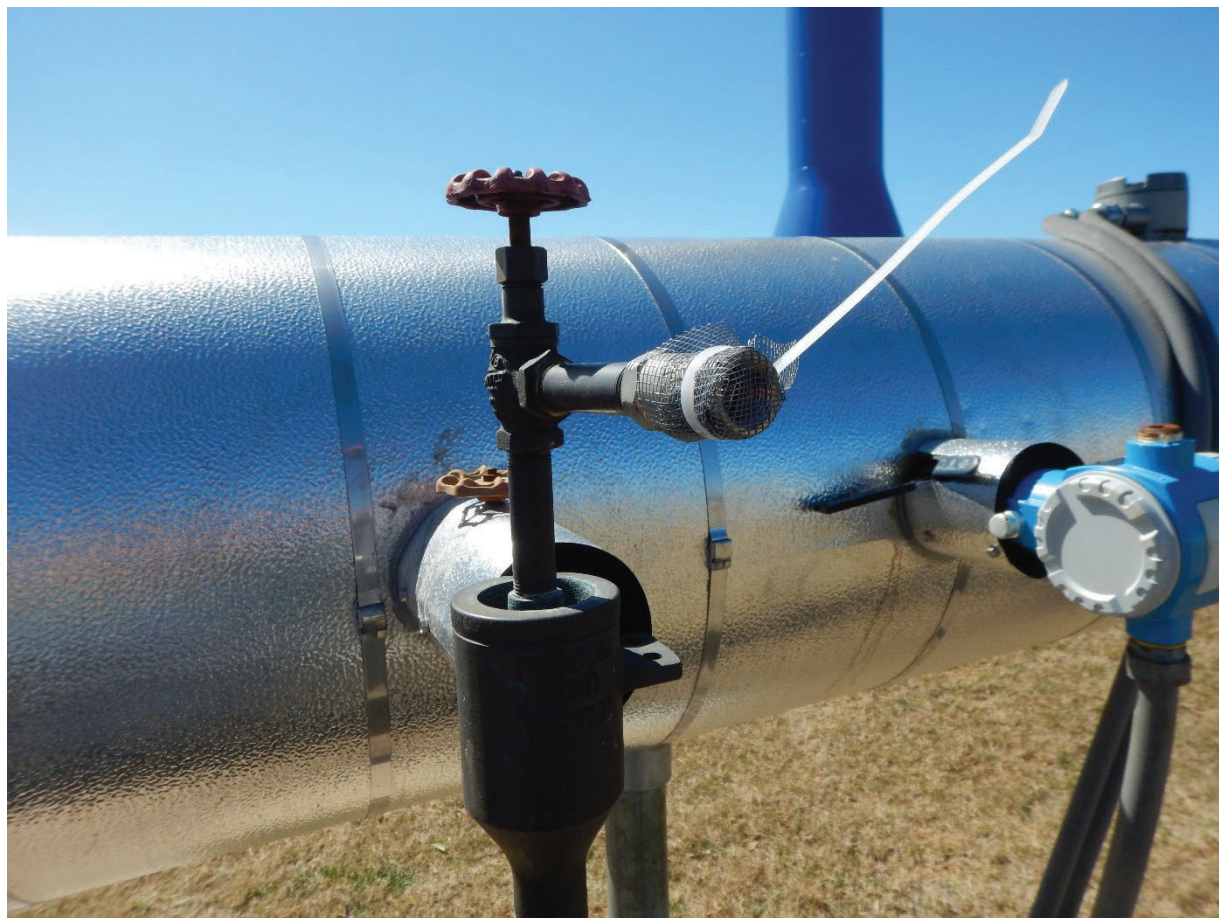
Photo No. 20

- Chlorine cylinders secured with strap in chlorine room (Photo 15)
- Well is missing sanitary seal (Photo 16 & 17)
- Open conduit around electrical on well (Photo 18)
- Flexible screen on vent (Photo 19)
- Disconnected sample tap on well (Photo 20)
- Electrical conduit detached from electrical box (Photo 21)

- Missing sanitary seal on wellhead, could be source of potential contamination (Photo 16 & 17)
- Open conduit around electrical on well could be source of potential contamination (Photo 18)
- Flexible screen on vent may not meet TCEQ requirements for screen- ensure screen meets TCEQ requirements (Photo 19)
- Electrical conduit detached from electrical box could provide source of potential contamination (Photo 21)

Description: Disconnected sample tap with open conduit Hathaway Well Site

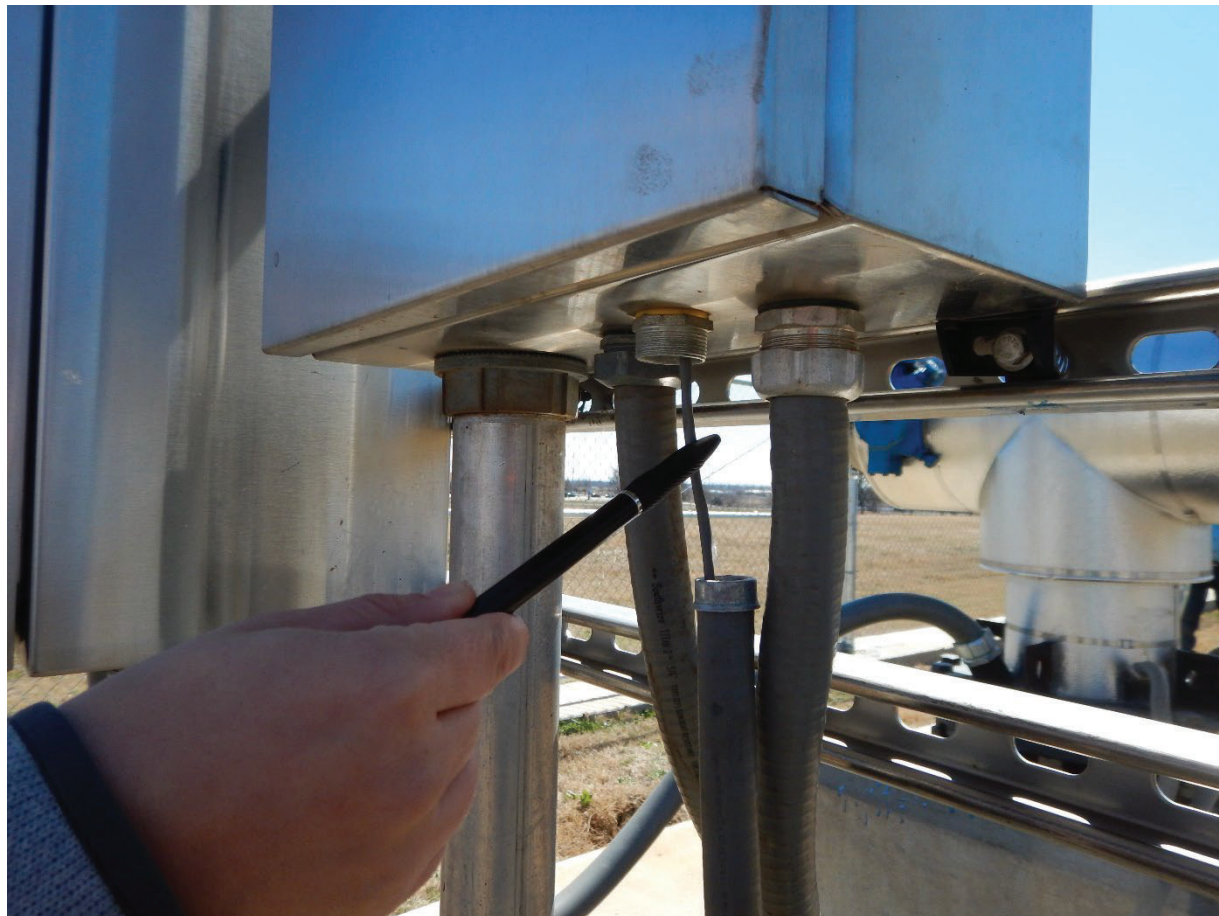
Photo No. 21

Description: Exposed wiring and open conduit (other end connects to well) at Hathaway Well Site

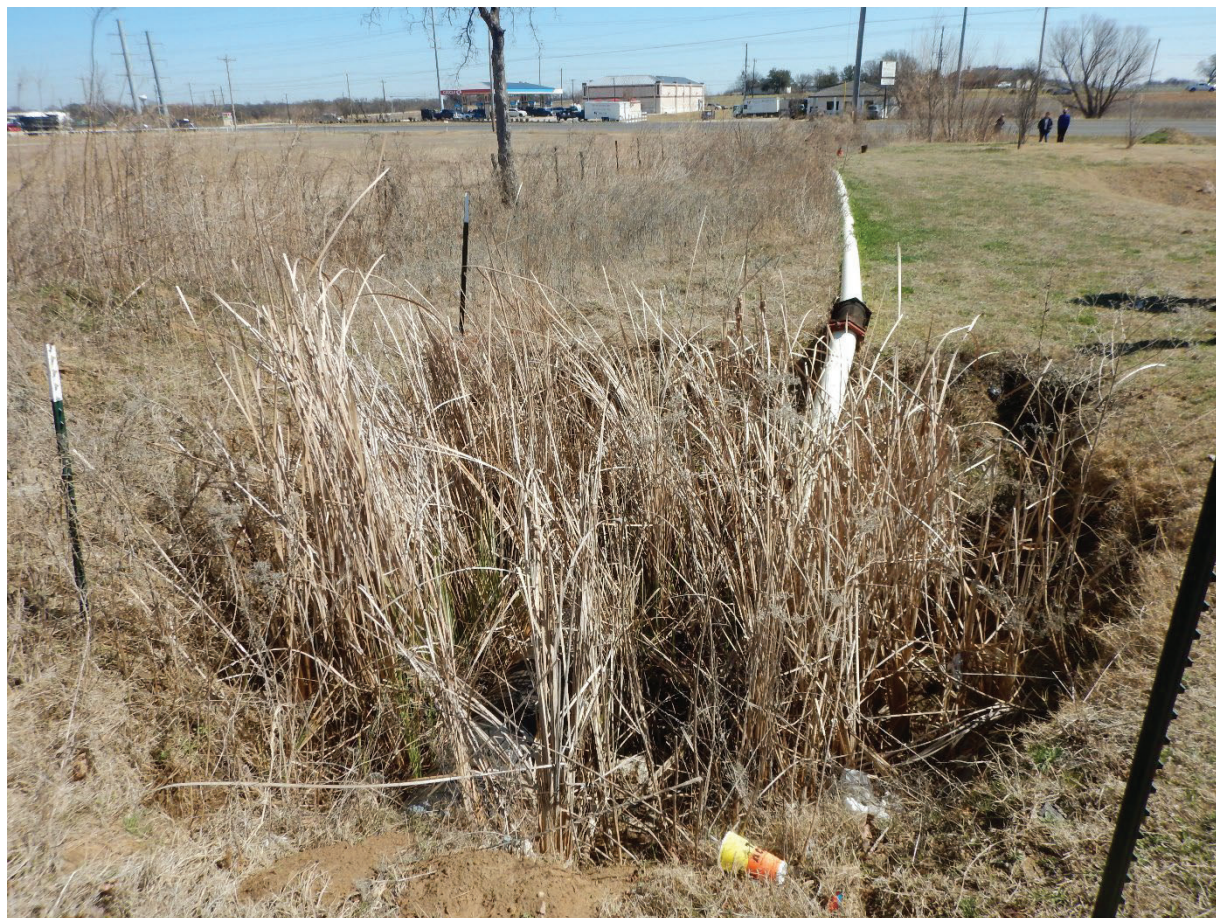
Photo No. 22

- Temporary line installed from well 12 (Hathaway) to service WTP 11 which is offline from a well failure (Photo 22)
- Temporary line is installed along busy road and has sample taps installed (Photo 23)
- The sample tap is near the busy road and has tire tracks near it (Photo 24)
- Large amount of standing water was observed at the storage site (Photo 25)

Description: Temporary Water Line due to well failure

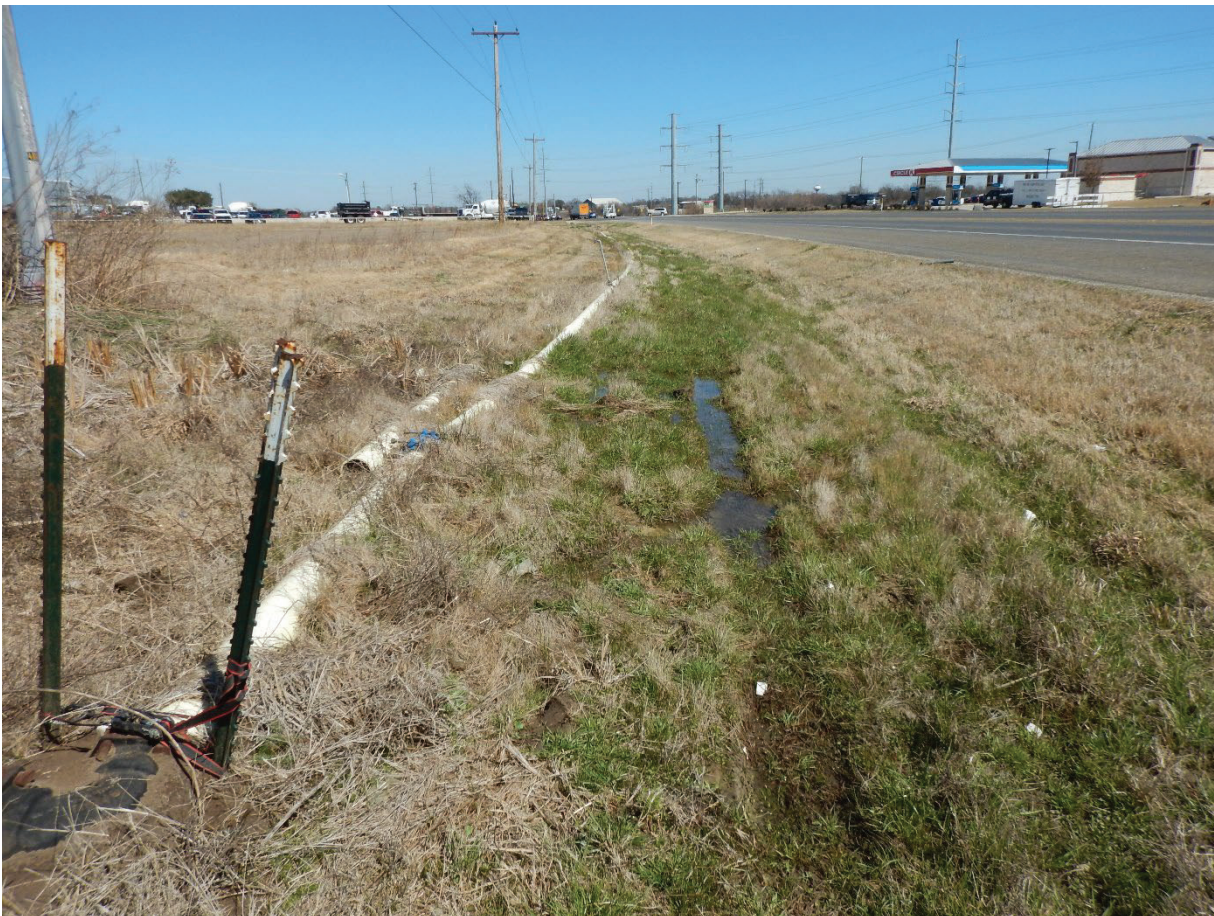
Photo No. 23

Description: Temporary line due to well failure with sample tap near road and standing water

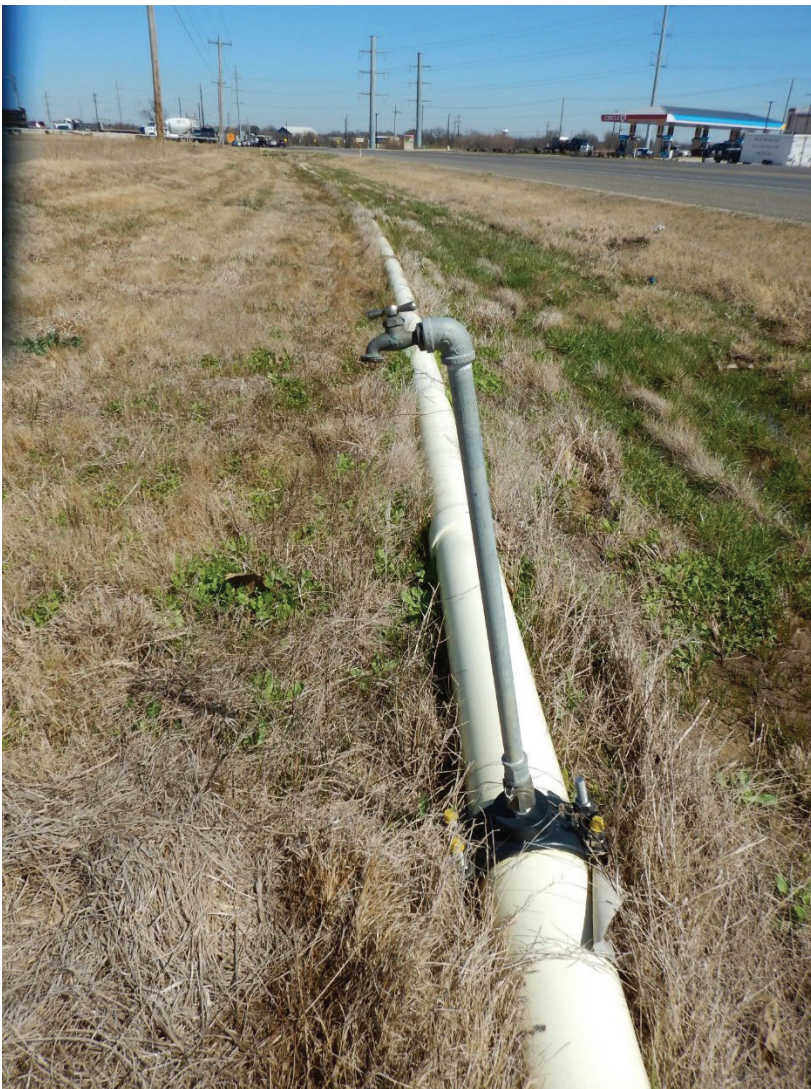
Photo No. 24

- System unsure if temporary line received TCEQ approval, discussed submitting necessary paperwork if temporary authorization cannot be located
- The sample tap is near the busy road and has tire tracks near it. Sample tap accessible by any person and tire tracks show that cars have been close. Could also lead to possible cross connection if a hose was connected by someone driving by (Photo 24)

Description: Temporary line with sample tap near road with tire tracks and standing water

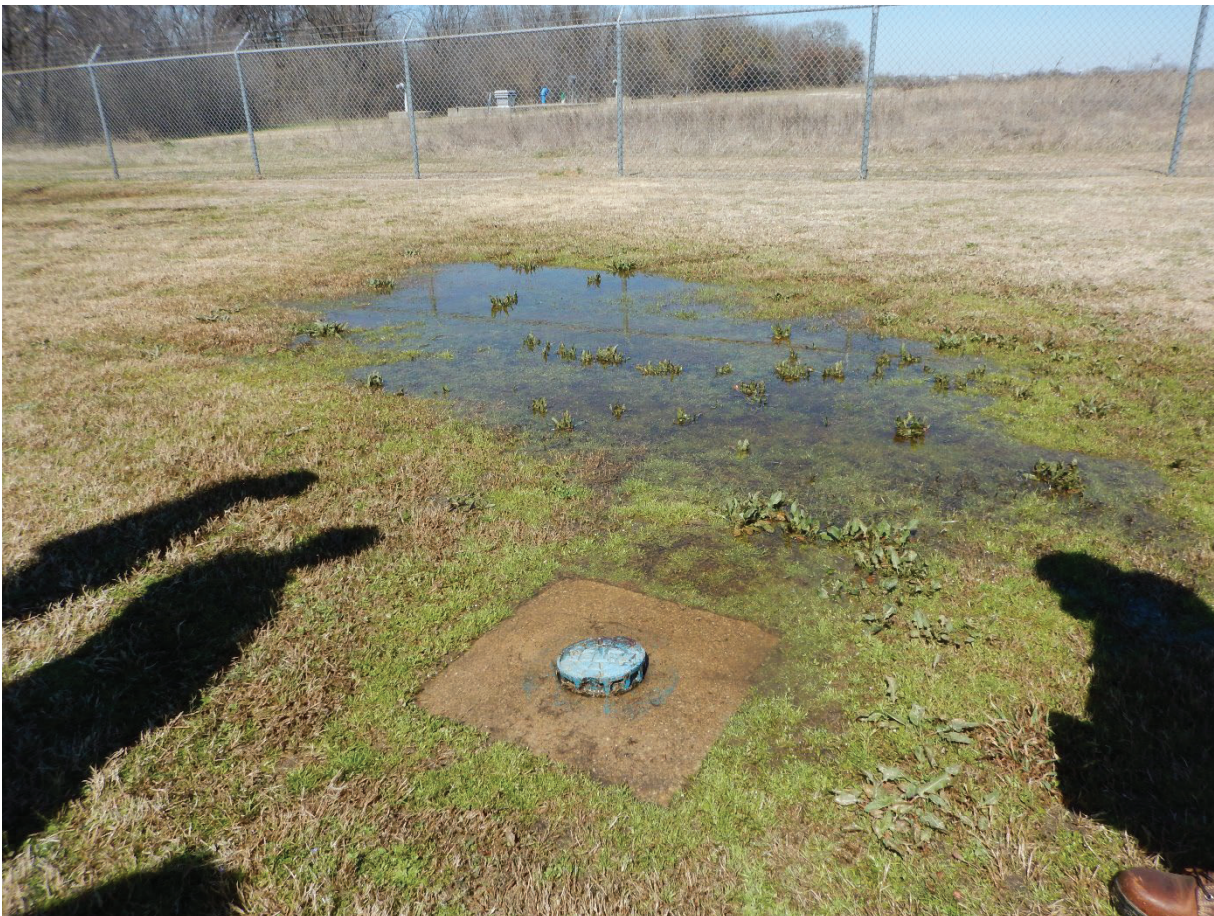
Photo No. 25

Description: Standing water at storage site

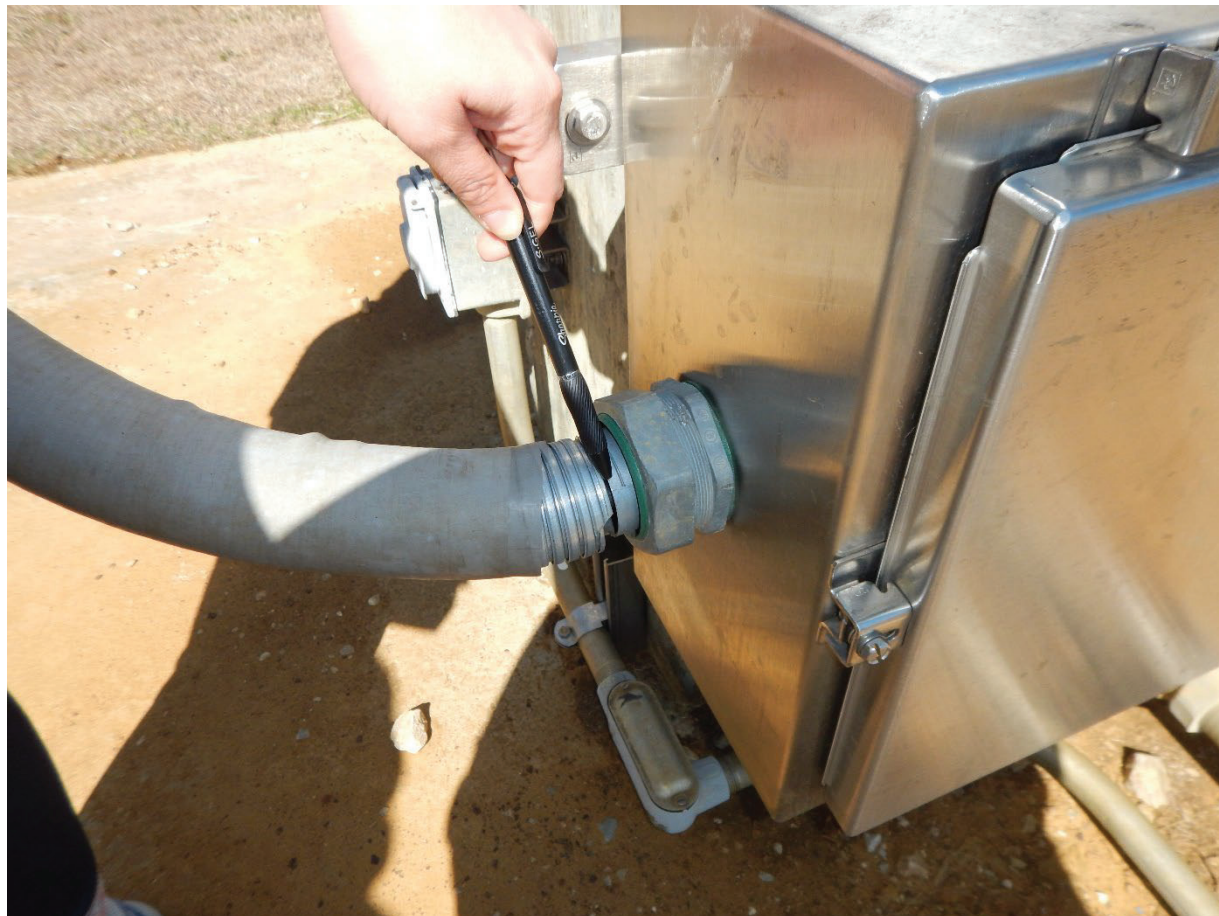
Photo No. 26

- Conduit on electrical box has separated (Photo 26)
- Well pad is downgrade and has evidence of previous flooding on electrical equipment (Photo 27)
- Various wires were also present at well. Disconnected but still connected at well (Photo 28)
- Unscreened and possibly unused connection on well 5 (Photo 29)
- Elevated storage tank at well 5 had ladder that was not secured (Photo 30)
- Seal around ground storage tank is pulling away from tank (Photo 31)
- Discoloring observed on ground storage water tank (Photo 32)
- Gasket around bottom of storage tank cracking and pulling away (Photo 33)

- Conduit on electrical box has separated, could be path for potential contamination (Photo 26)
- Elevated storage tank at well 5 had ladder that was not secured which does not meet security requirements (Photo 30)
- Seal around ground storage tank is pulling away from tank, TCEQ requirement for gasket or screen for overflows not met (Photo 31)
- Gasket around bottom of storage tank cracking and pulling away which could cause tank to not perform as intended (Photo 33)

Description: Open space on electrical conduit at Pilot Point (Well 5)

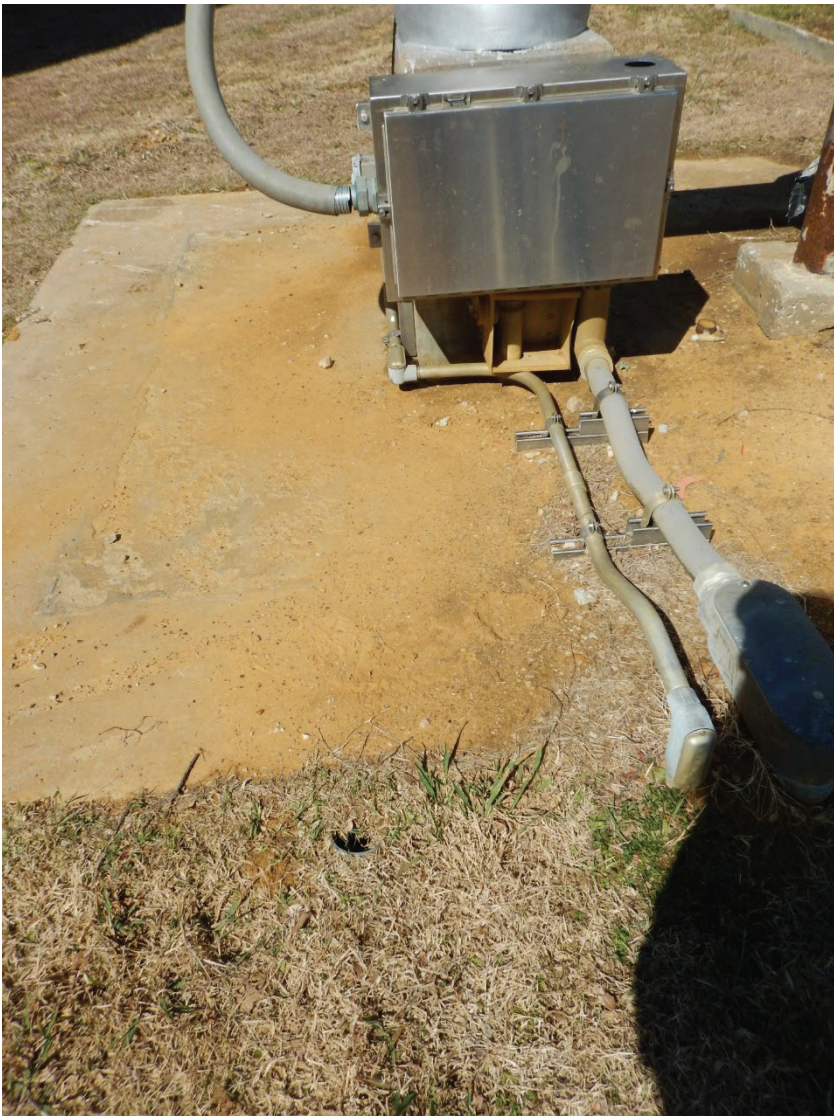
Photo No. 27

Description: Well pad showing signs of previous flooding at Well 5

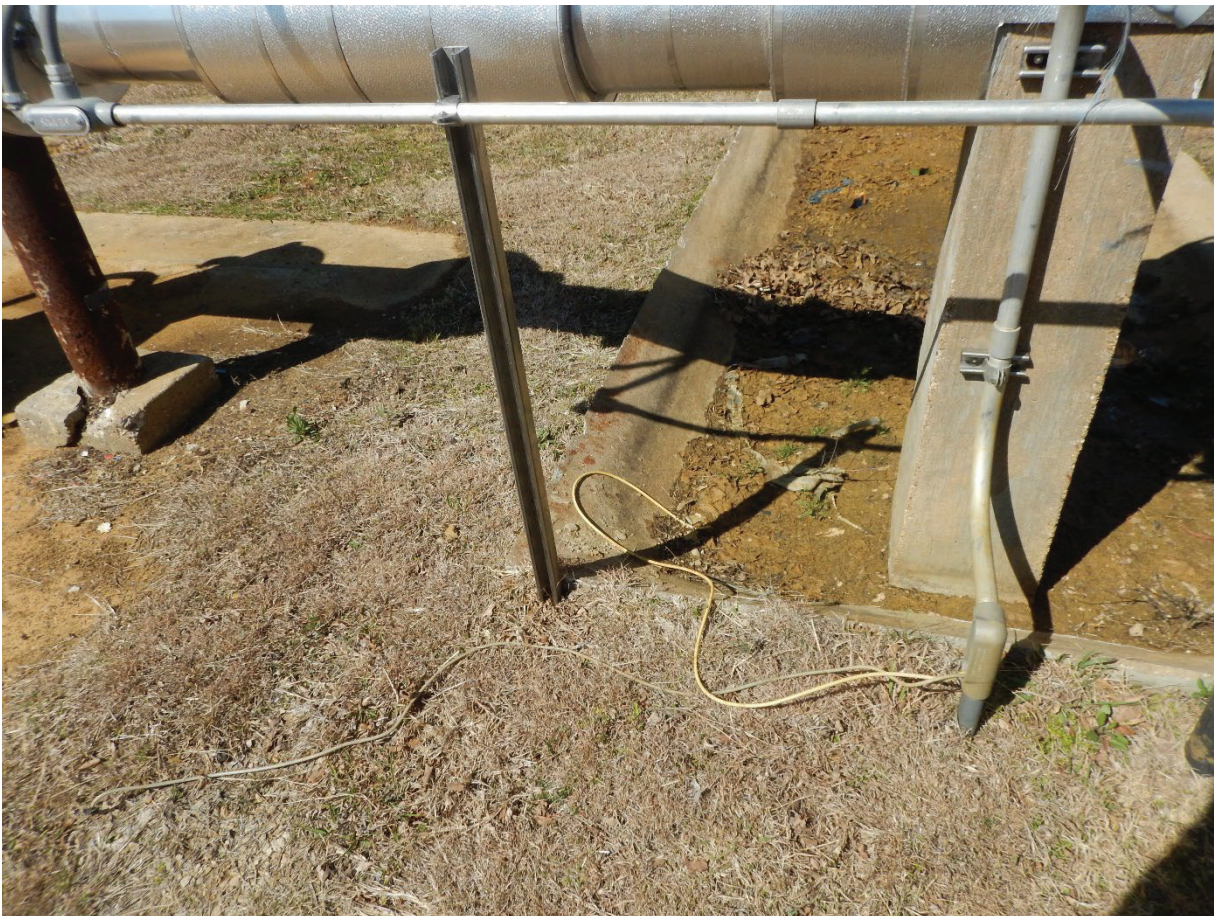
Photo No. 28

Description: Disconnected but present wires at Well 5

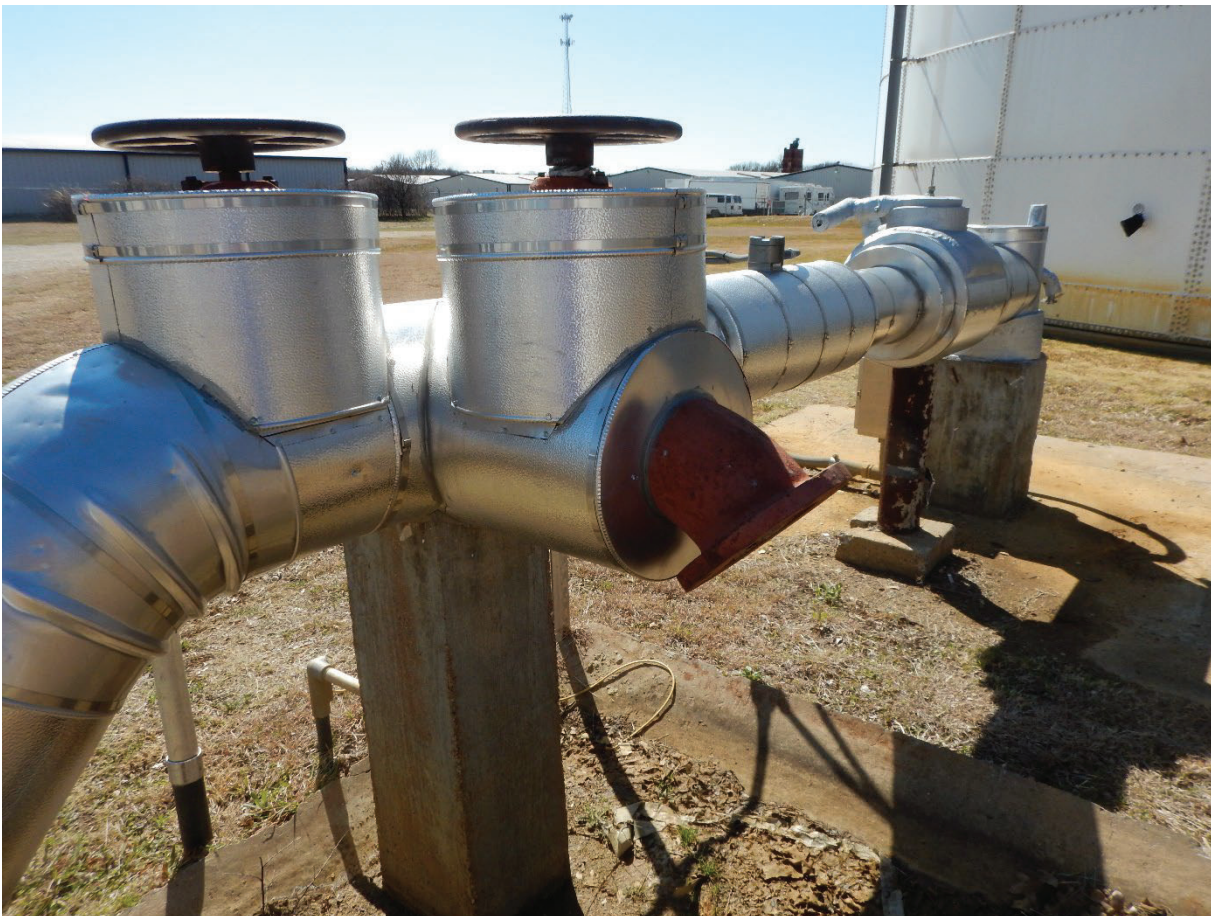
Photo No. 29

Description: Unscreened possible valve on Well 5

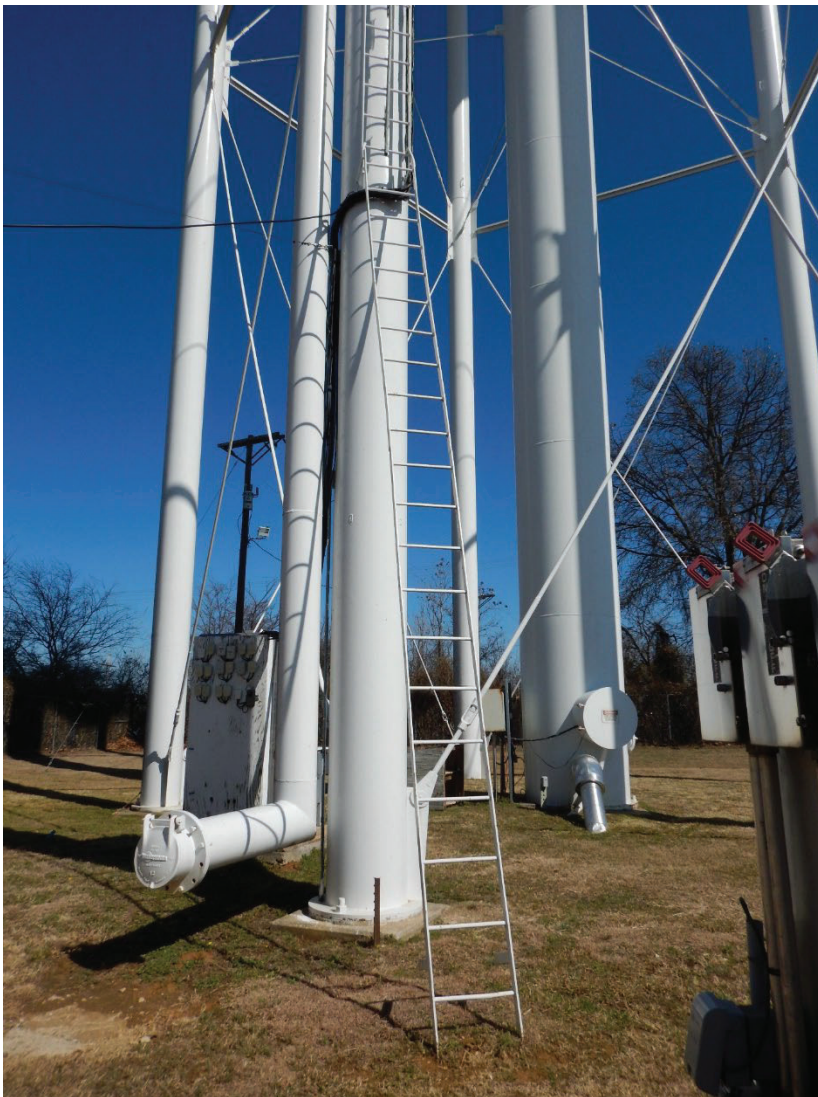
Photo No. 30

Description: Ladder unsecured for elevated storage tank at Well 5

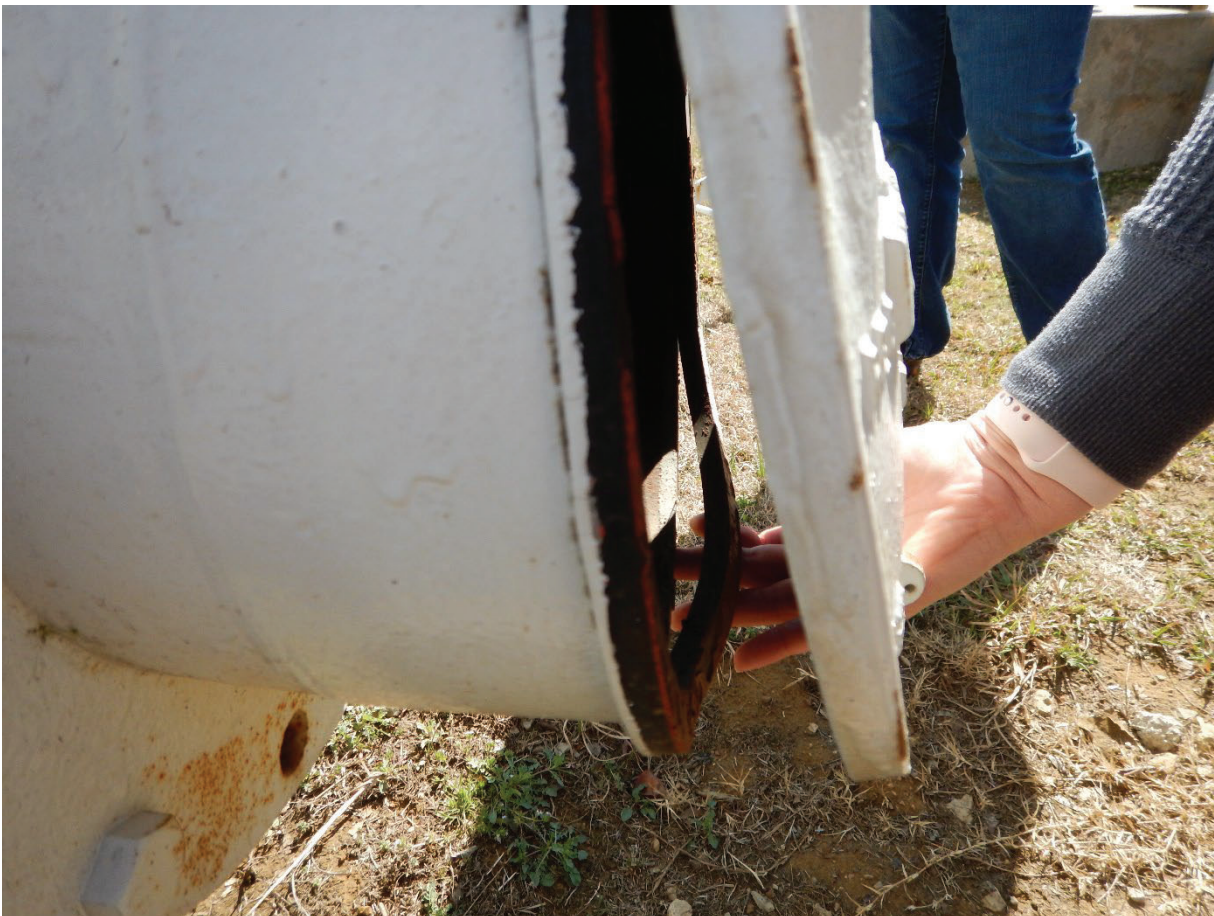
Photo No. 31

Description: Storage tank gasket detaching from tank at Well 5 at ground storage tank

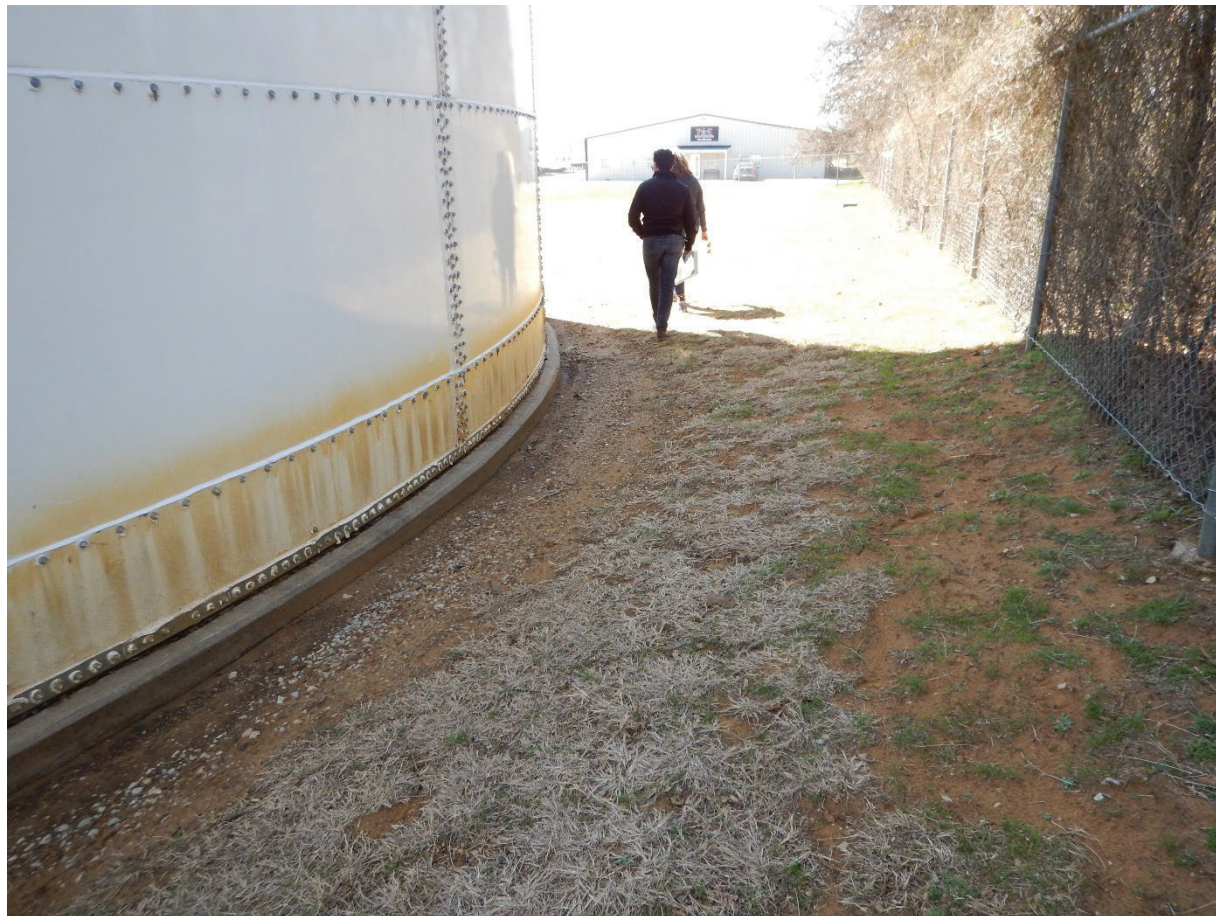
Photo No. 32

Description: Staining on Ground storage tank

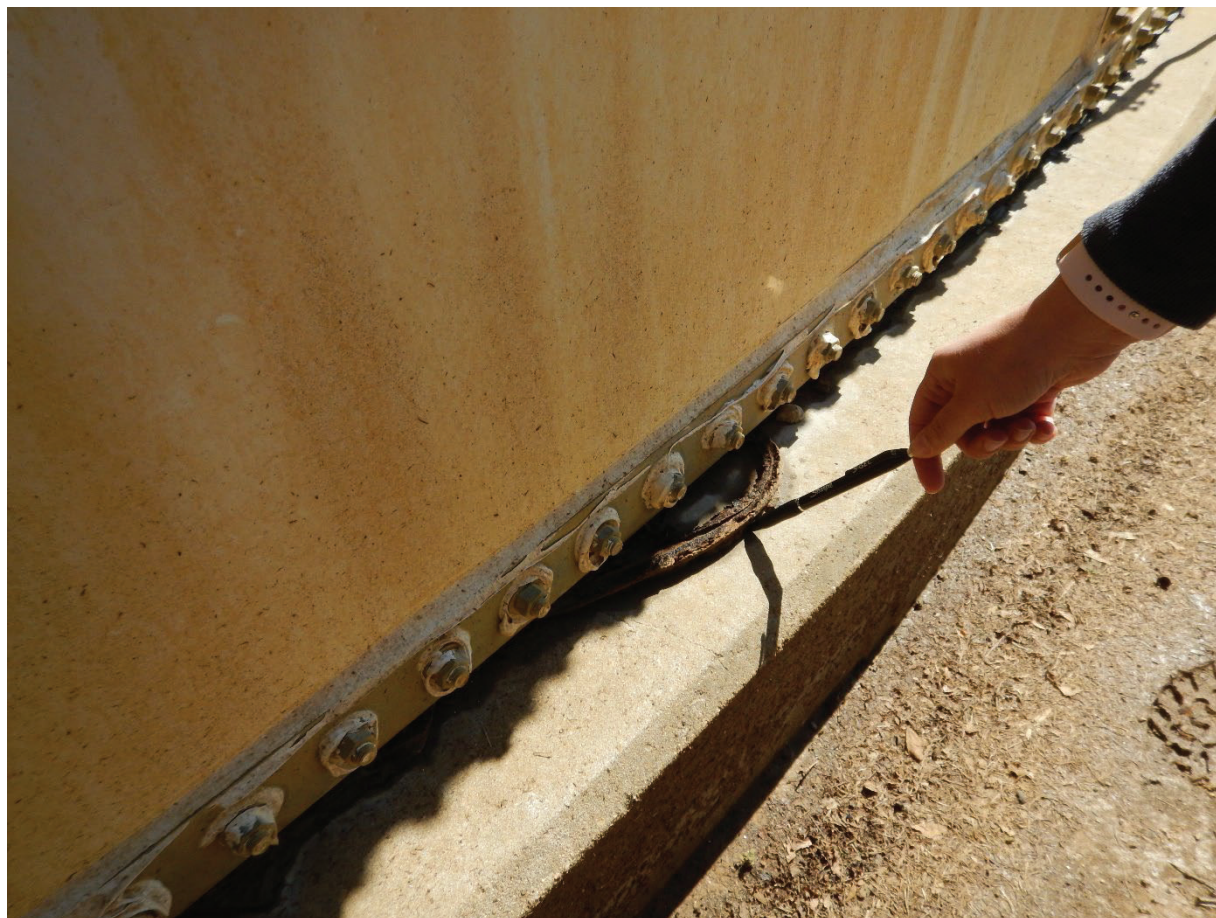
Photo No. 33

Description: Gasket around bottom of ground storage tank missing and/or crumbling
