**Region 6 - Enforcement & Compliance Assurance Division**  
**INSPECTION REPORT**

| Company Name: | <b>Vinland Energy, LLC</b> | |
| Facility Name: | <b>Bickley Lease</b> | |
| Identification/Permit Number: | TXU011246 | |

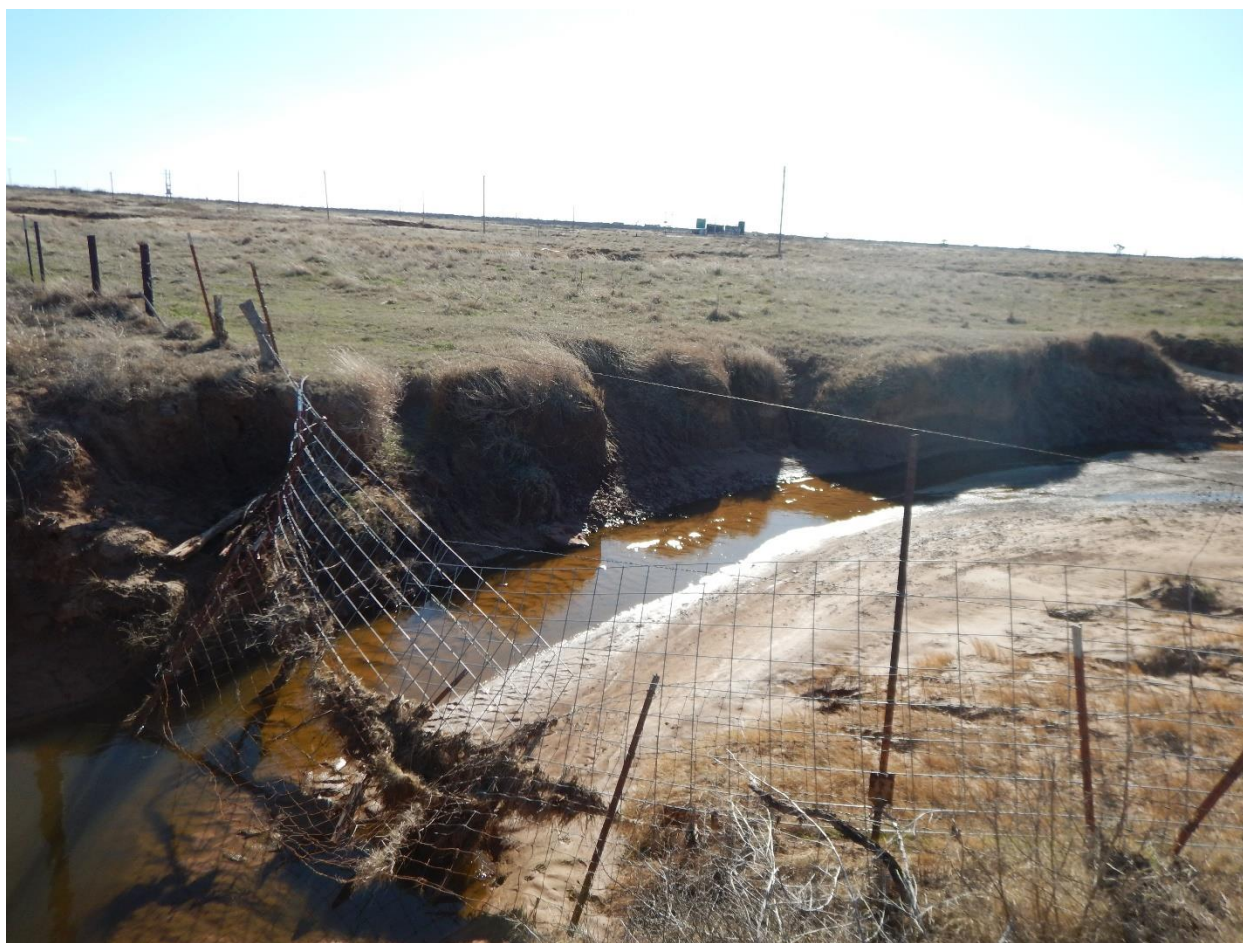
Photo No. 1

Description: This was an overview of Long Creek downstream from the facility in the distance. I observed erosion along the channel indicative of constant flow in the area.

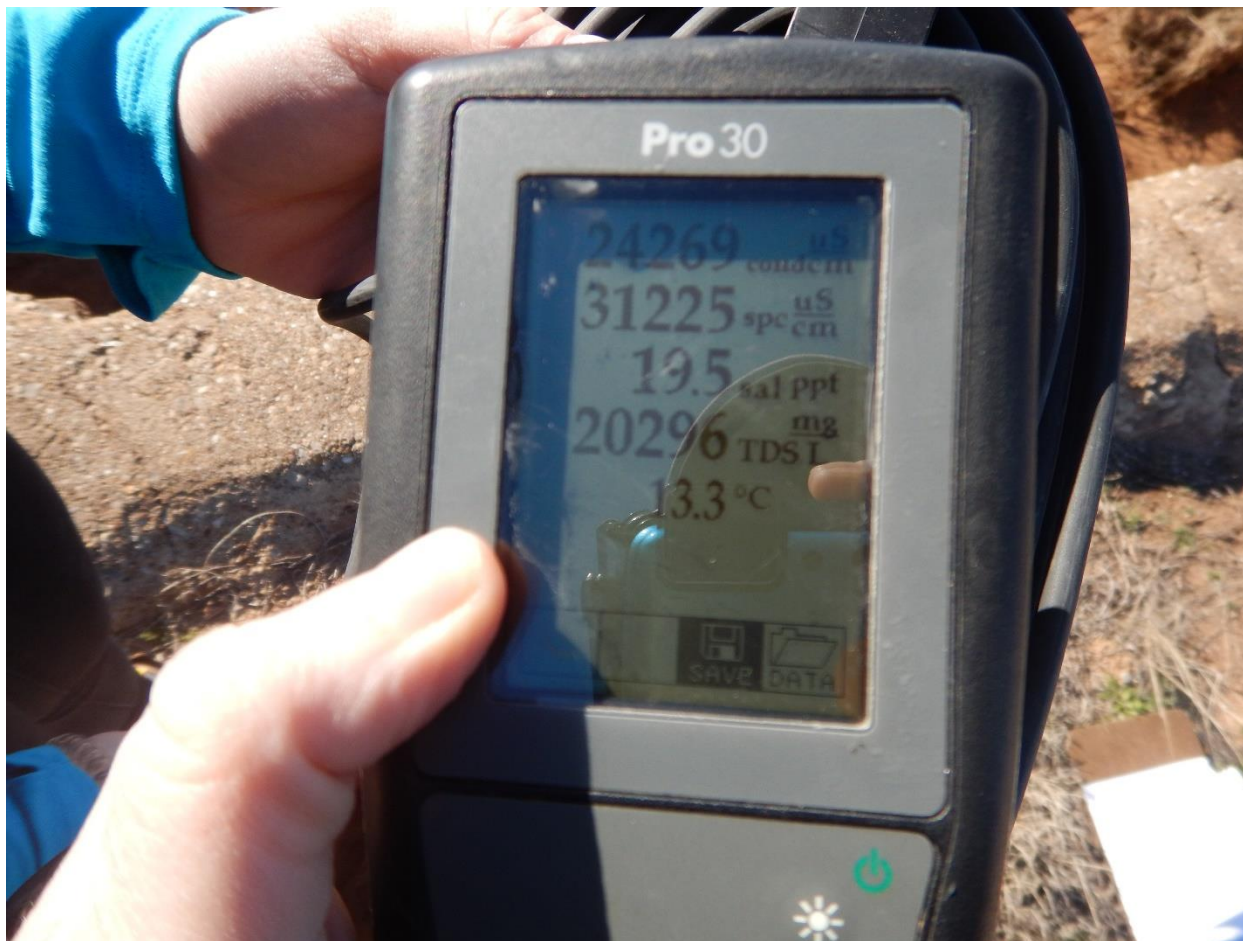
Photo No. 2

Description: The YSI Pro 30 conductivity meter showed elevated TDS levels of 20,296 mg/L.

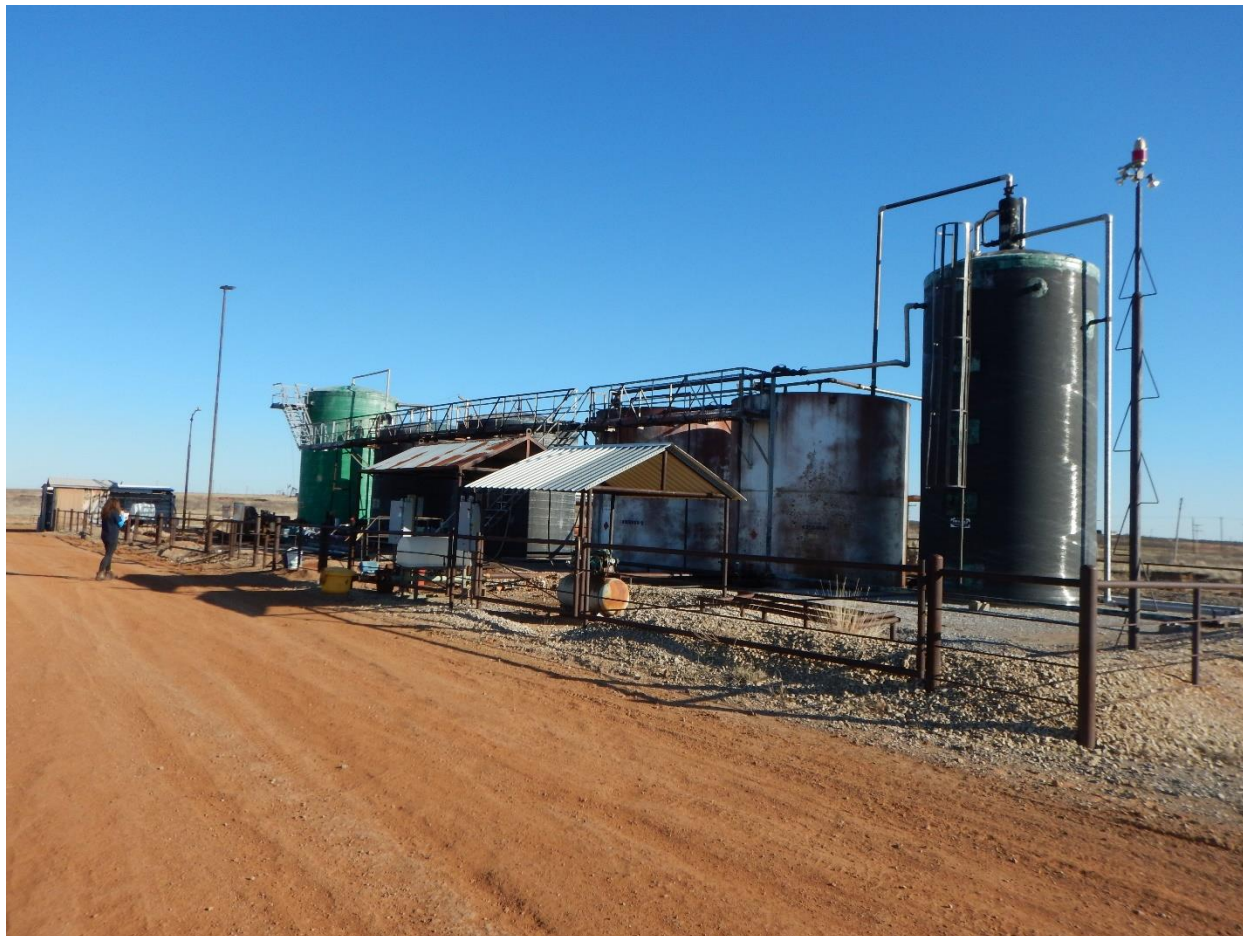
Photo No. 4

Description: In Photo 4, showed an overview of an active tank battery at the facility with four oil storage tanks and two produced water storage tanks on site. I observed that there was not adequate secondary containment surrounding the tank batteries, along with the berm wall surrounding the facility is low.

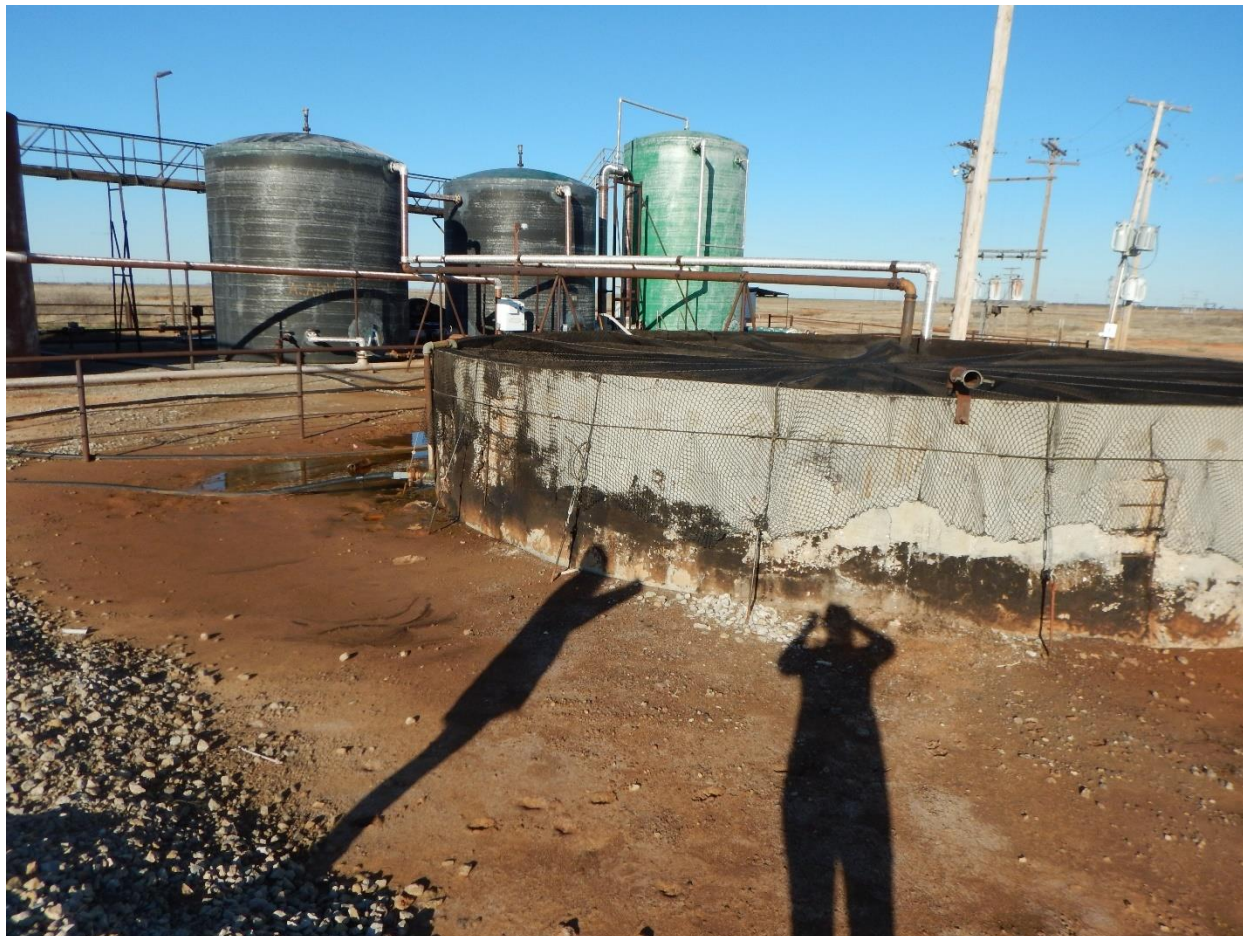
Photo No. 5

In Photos 5 and 6 an open produced water storage tank was observed behind the main tank battery area and showed fluids, including oil sludge on top in the tank. The concrete containment was deteriorated and there was visible staining and salt crystallization all around this open storage tank. In Photo 7, the berm wall surrounding the open produced water storage tank was low in height and inadequate. One of four separators conducting chemical processes were identified in Photo 8. Photo 9 identifies one point of discharge of fluids from a piping juncture. A previous eroded flow path was observed from this area to Long Creek. There was not an active leak occurring from this point at the time of the inspection. Historic salt crystals were identified, along with crystalized hard salts on four out of the five flowlines located north of the main tank battery. A downstream contaminated flow path was observed from the flow lines in Photo 10. The conductivity meter exhibited elevated levels of TDS

There are expressed areas of concern which included the open produced water storage tank with its deteriorated and stained concrete containment with visible oil sludge seen at the top (Photos 5, 6, and 7). Additionally, this site had no secondary containment surrounding the tank batteries, with low berm walls (Photos 5, 6, and 7). There were two instances of two elevated levels of Total Dissolved Solids (TDS) over 100,000 mg/L (Photos 13 and 22), particularly in Photo 13 and 14 which showed the point of entry. There was not an active discharge at this time. EPA Region 6 inspectors Kayla Woods and Jeanne Eckhart conducted a mid-inspection conference at Vinland Energy, LLC at 5:22pm on 2/24/2020 for the inspection with Chris Vestal, the Production Superintendent, who noticed EPA inspectors on site as he was driving in towards the facility. During the conference, Kayla Woods and Jeanne Eckhart reviewed the areas of concern related to the Clean Water Act that they had identified up to that point with Chris Vestal. A final closing conference was not conducted, as Mr. Vestal was not present.

Description: An open produced water storage tank was located behind the main tank battery and had fluids in it, including oil sludge on top. The concrete containment was falling apart which showed staining and salt crystallization outside of the containment area and flowing towards Long Creek.

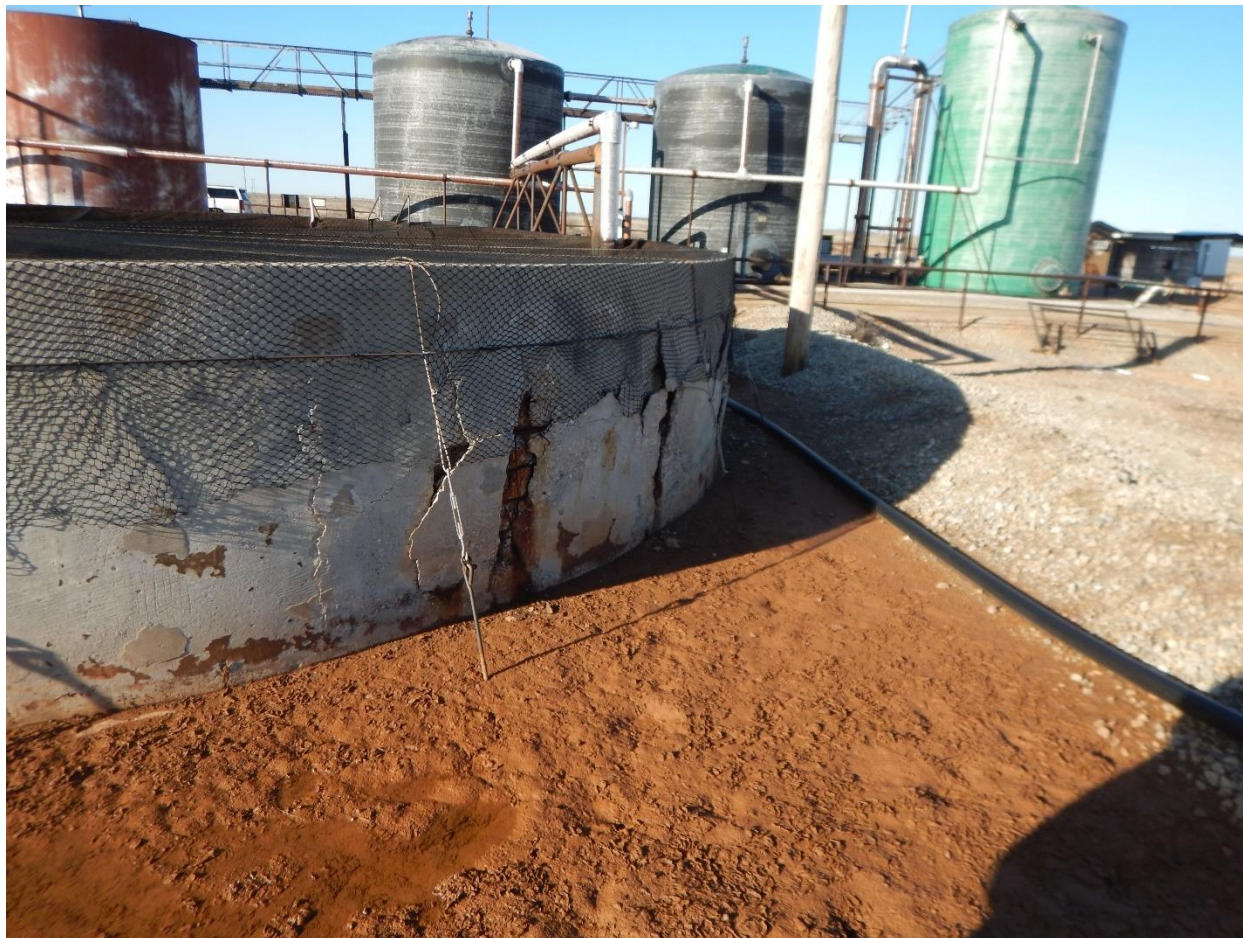
Photo No. 6

Description: Another photo showing the damage and staining of this open storage tank from the other side.

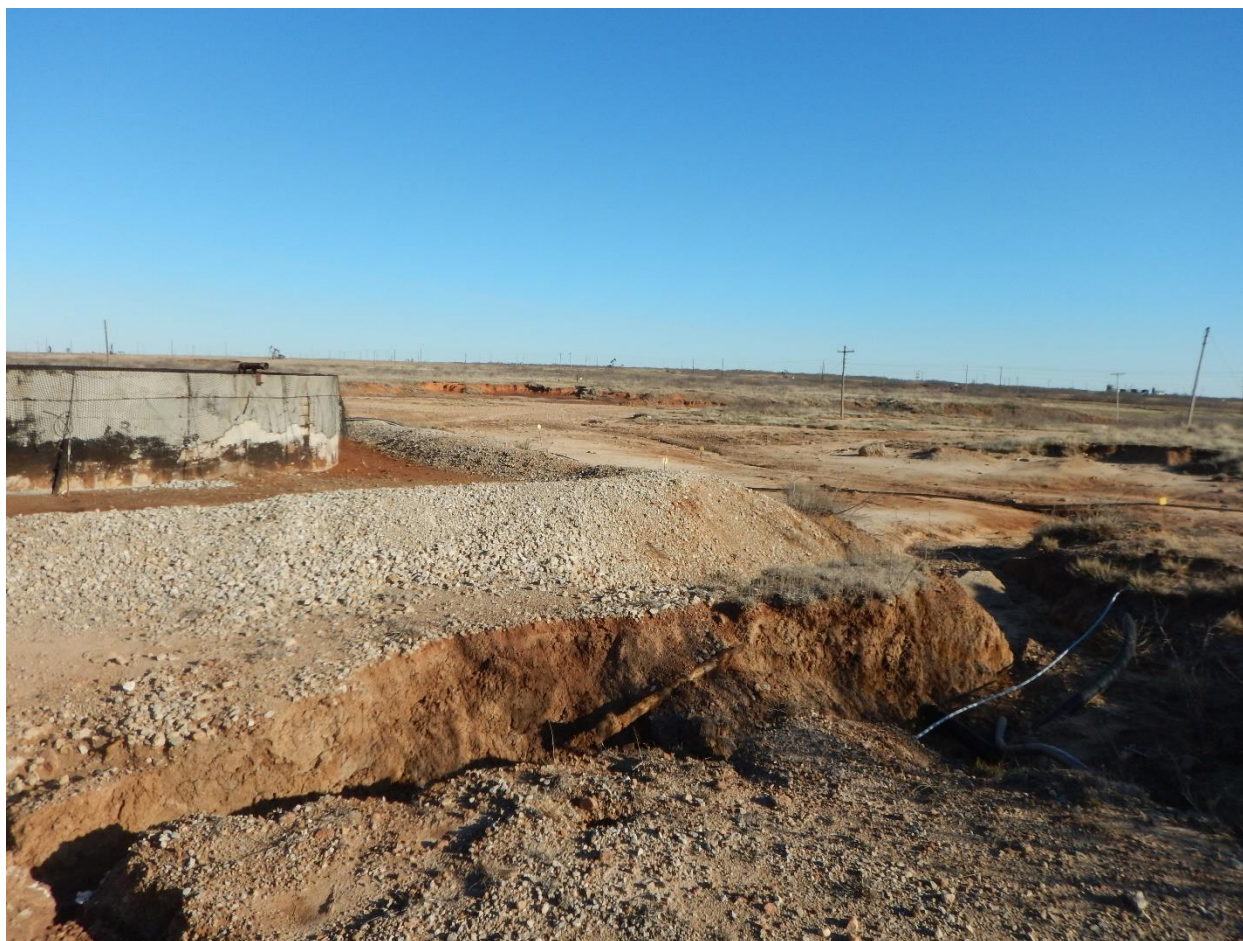
Photo No. 7

Description: This open produced water storage tank was inadequate and deteriorating at the tank walls. The berm wall surrounding the open produced water storage tank was low in height and inadequate as well. There was surface damage outside of the secondary containment, including salt crystallization and eroded flow paths indicating previous flow towards Long Creek.

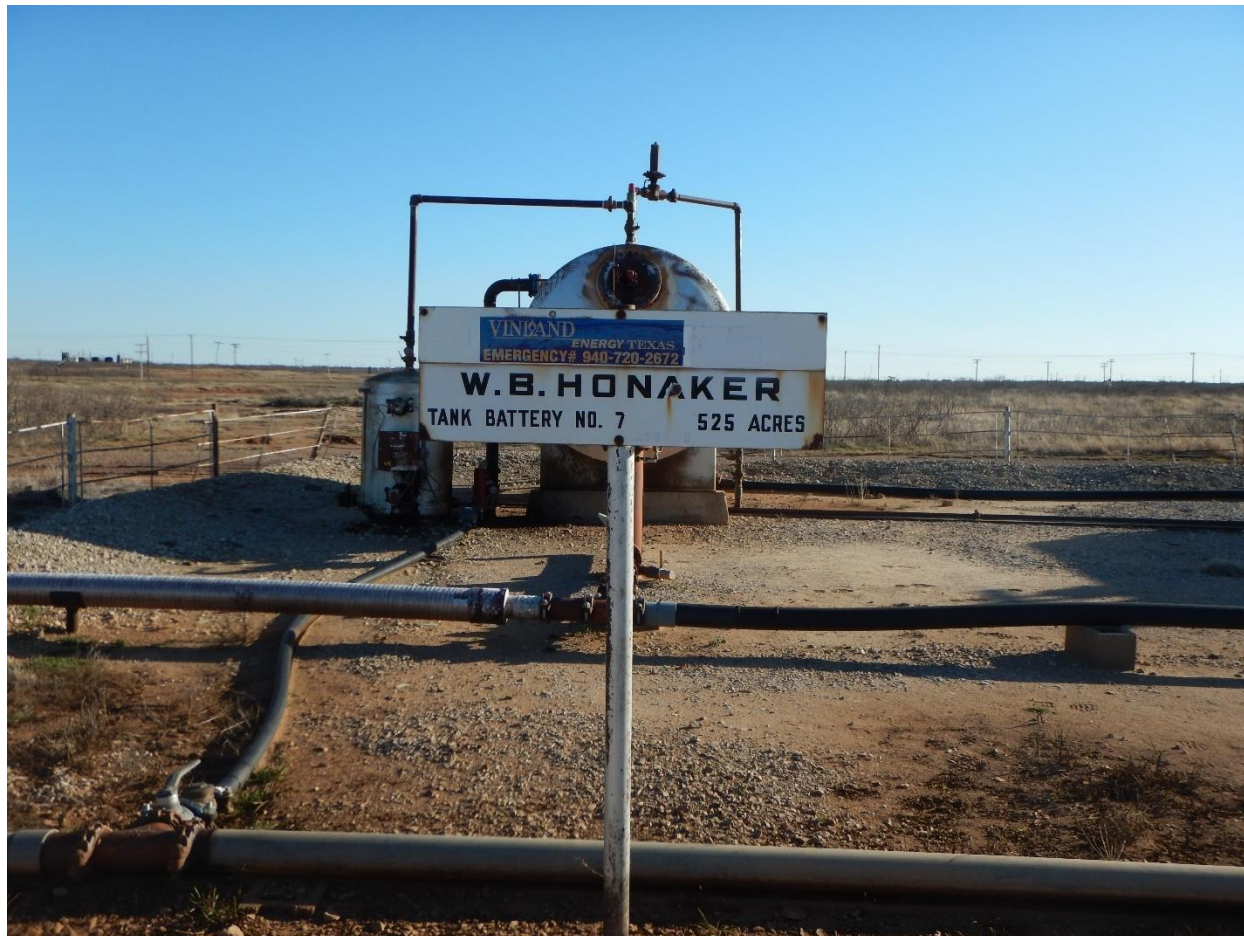
Photo No. 8

Description: This image shows Vinland Energy, LLC W.B. Honaker Tank Battery sign located on the Bickley Lease. This image shows 1 of the 4 separators on site that were connected to the main tank battery with flow lines.

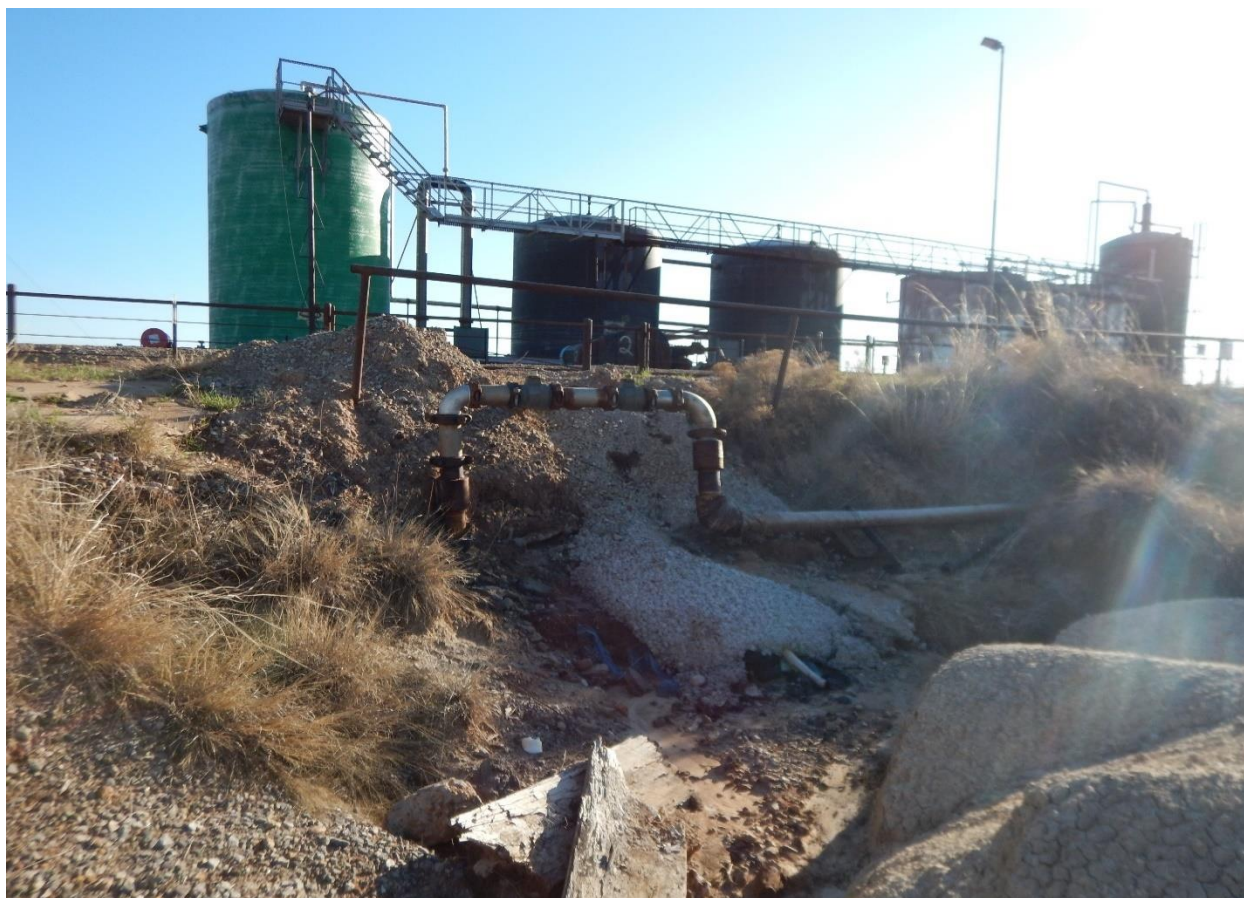
Photo No. 9

Description: This image identifies one point of discharge of fluids from a piping juncture. A previous eroded flow path was observed from this area to Long Creek. There was not an active leak occurring from this point at the time of the inspection. Historic salt crystals were identified, along with crystalized hard salts on four out of the five flowlines located north of the main tank battery.

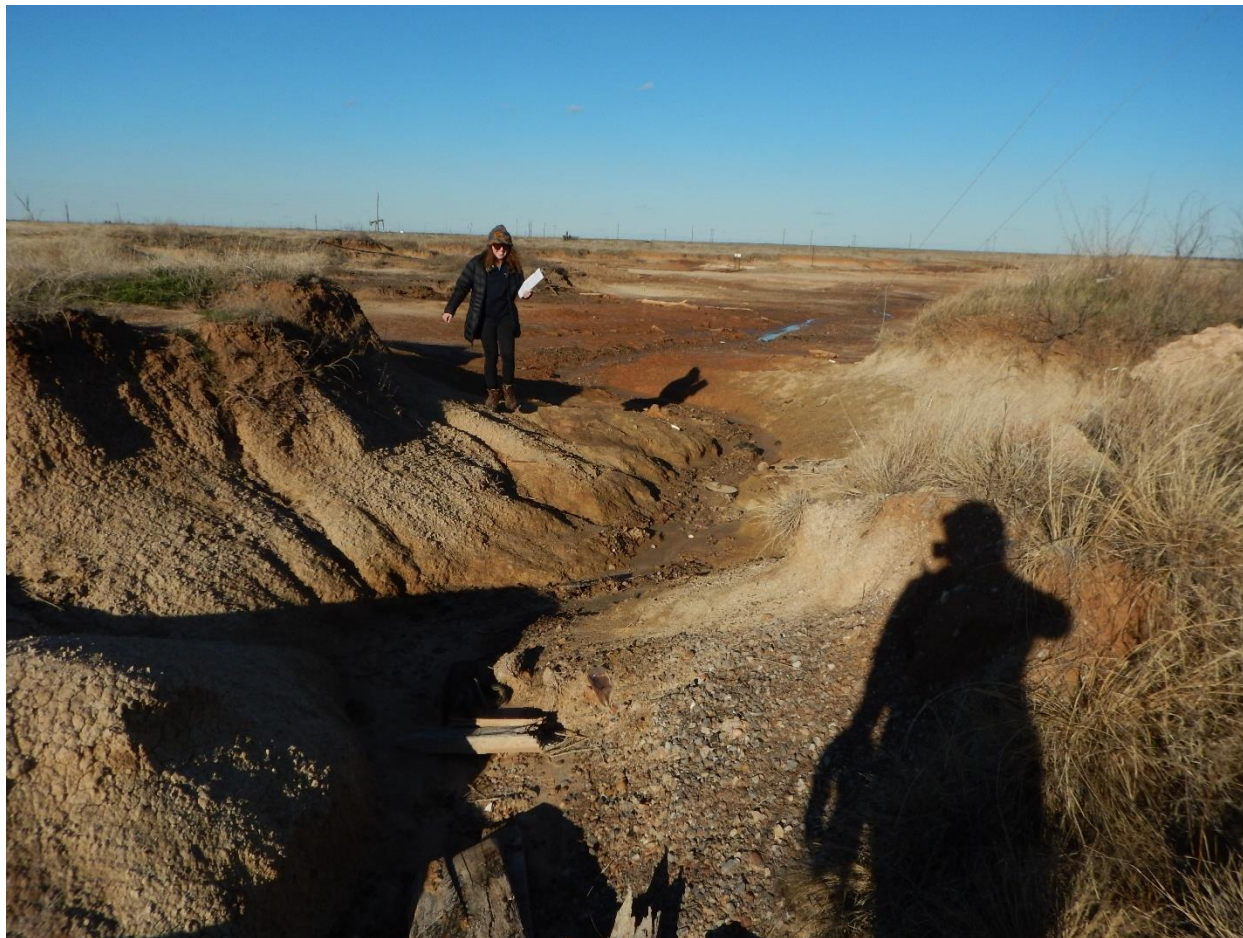
Photo No. 10

Description: This photo shows the beginning of the contaminated flow path downstream towards Long Creek.

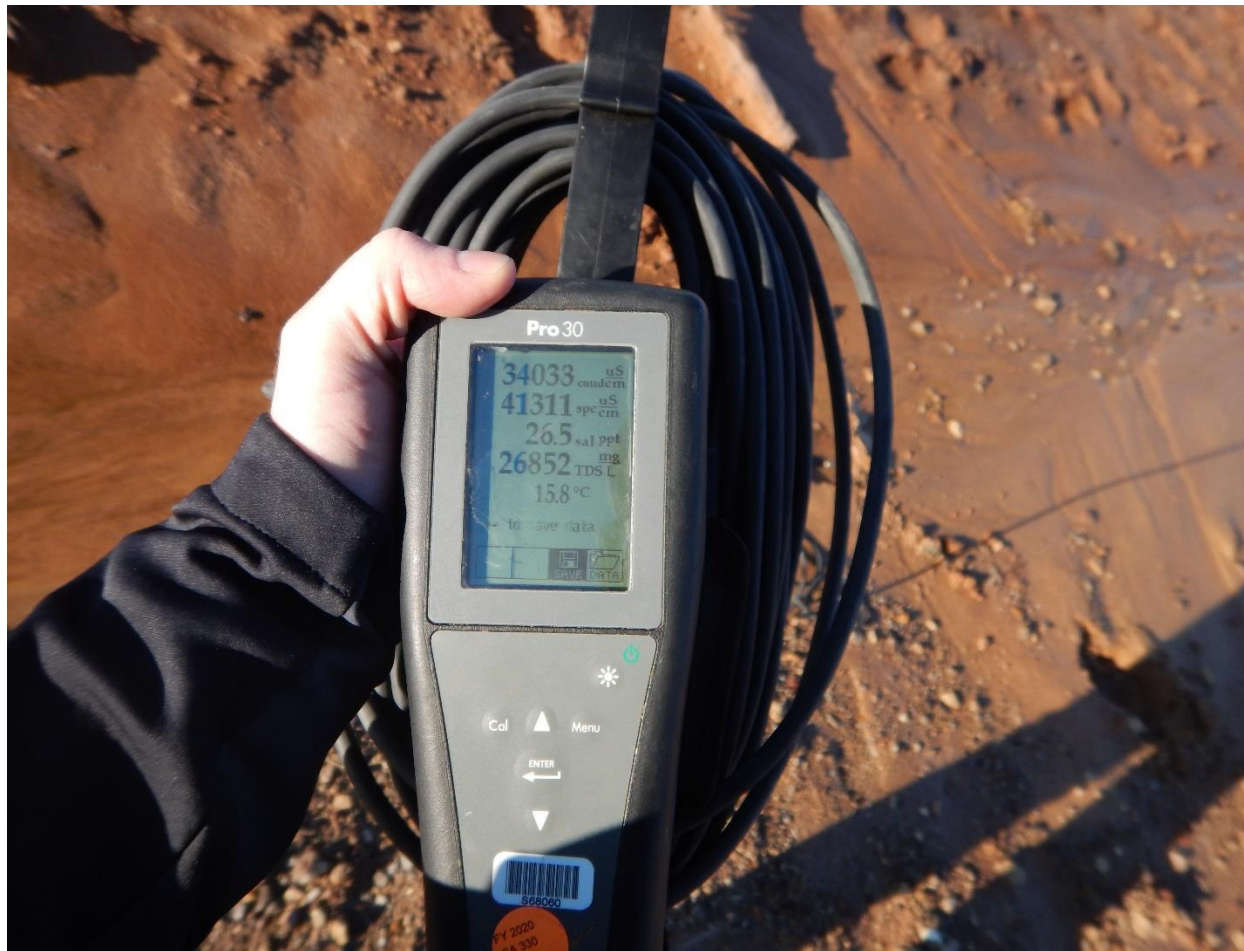
Photo No. 11

measured at 26,852 mg/L in Photo 11. Photo 12 displayed a polluted downstream flow path along the surface towards Long Creek.

Description: The YSI Pro 30 conductivity meter showed elevated levels of TDS in the contaminated flow path that measured 26,852 mg/L.

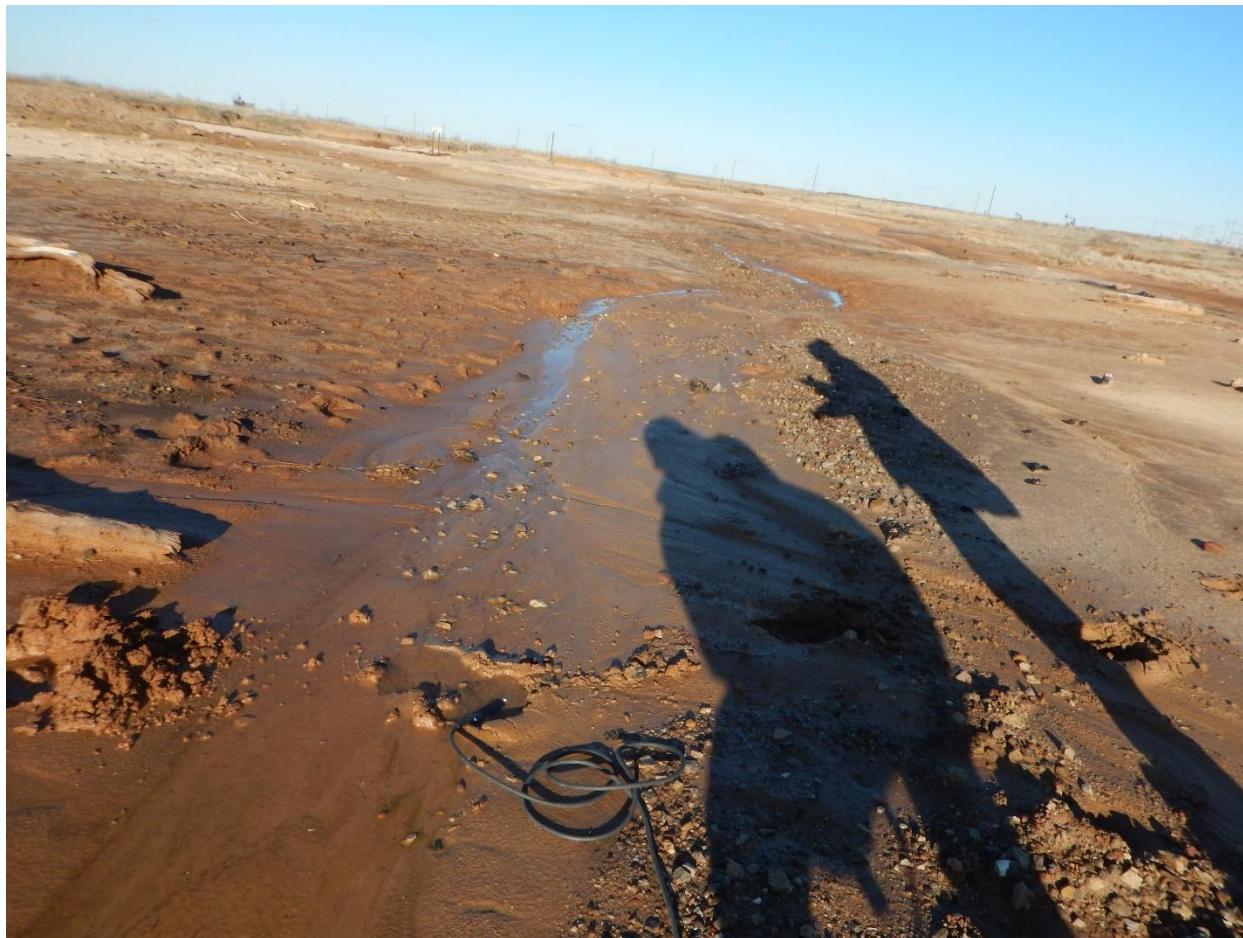
Photo No. 12

Description: A photo of the polluted downstream flow path along the surface towards Long Creek.

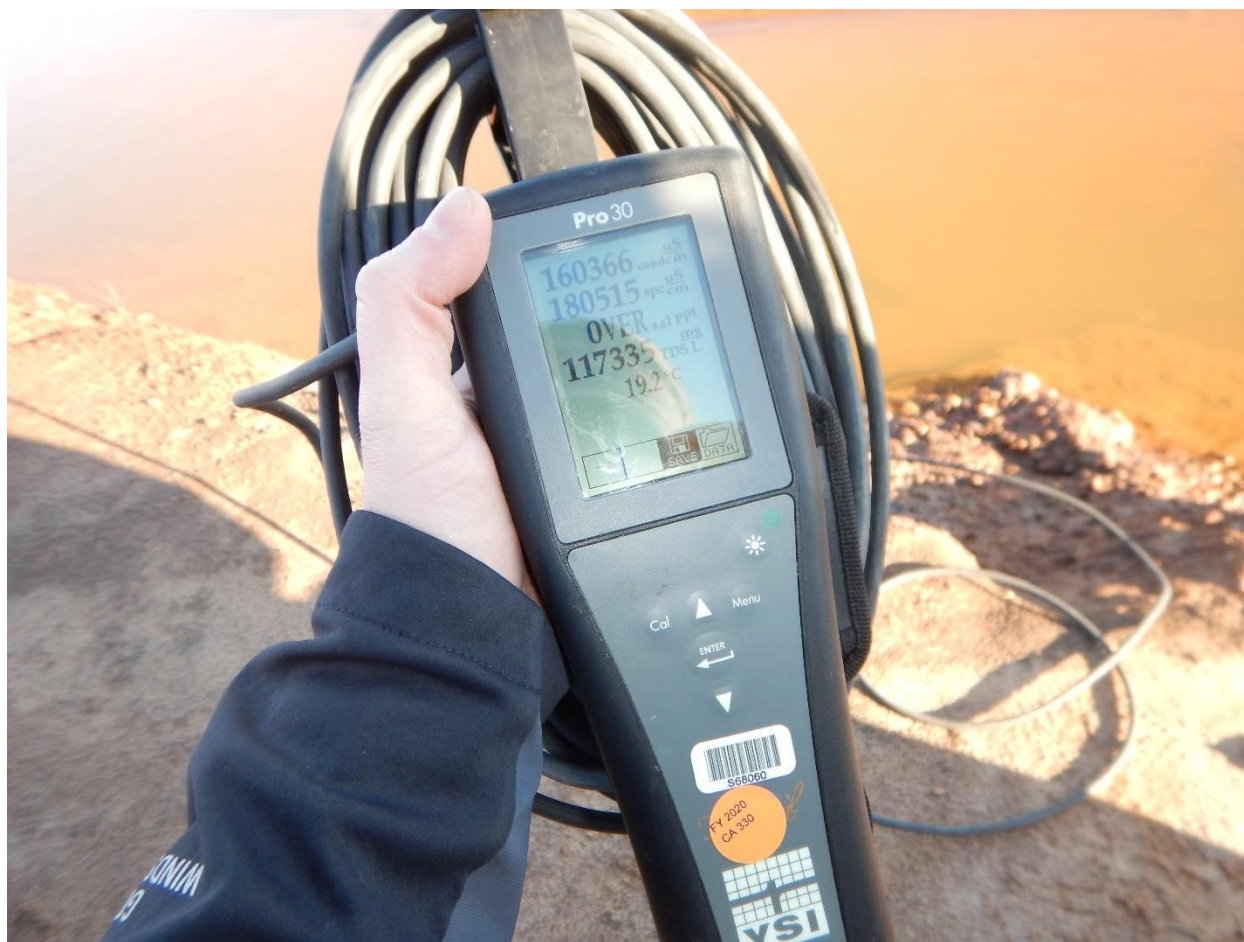
Photo No. 13

Photo 13 presented extremely elevated TDS levels at the point of entry (Photo 14) into Long Creek downstream at 117,335mg/L on the YSI Pro 30 conductivity meter. There was not an active discharge identified going into Long Creek during the inspection. I observed upstream of the facility on Long Creek that the vegetation was dead and salt crystallization was seen. Photo 15 shows Long Creek split approximately 100' downstream from the point of entry, and then re-merge. Photos 16 and 17 show another overview of the contaminant flow path from the facility toward the point of entry on Long Creek. After these photos were taken and our observations were documented we walked back upstream on Long Creek toward the facility, past the open storage tank. From Photo 18, The YSI Pro 30 conductivity meter measured elevated TDS levels of 56,311 mg/L upstream on Long Creek from the facility and observed point of entry. At this time, we began packing equipment to leave the facility and continue the inspection the next day. As we were driving towards the gate, we met Chris Vestal, Production Supervisor for Vinland Energy. We briefly advised Mr. Vestal of our observations before leaving the facility.

Description: The YSI Pro 30 conductivity meter showed elevated TDS levels of 117,335 mg/L at the point of entry of the contaminants into Long Creek.

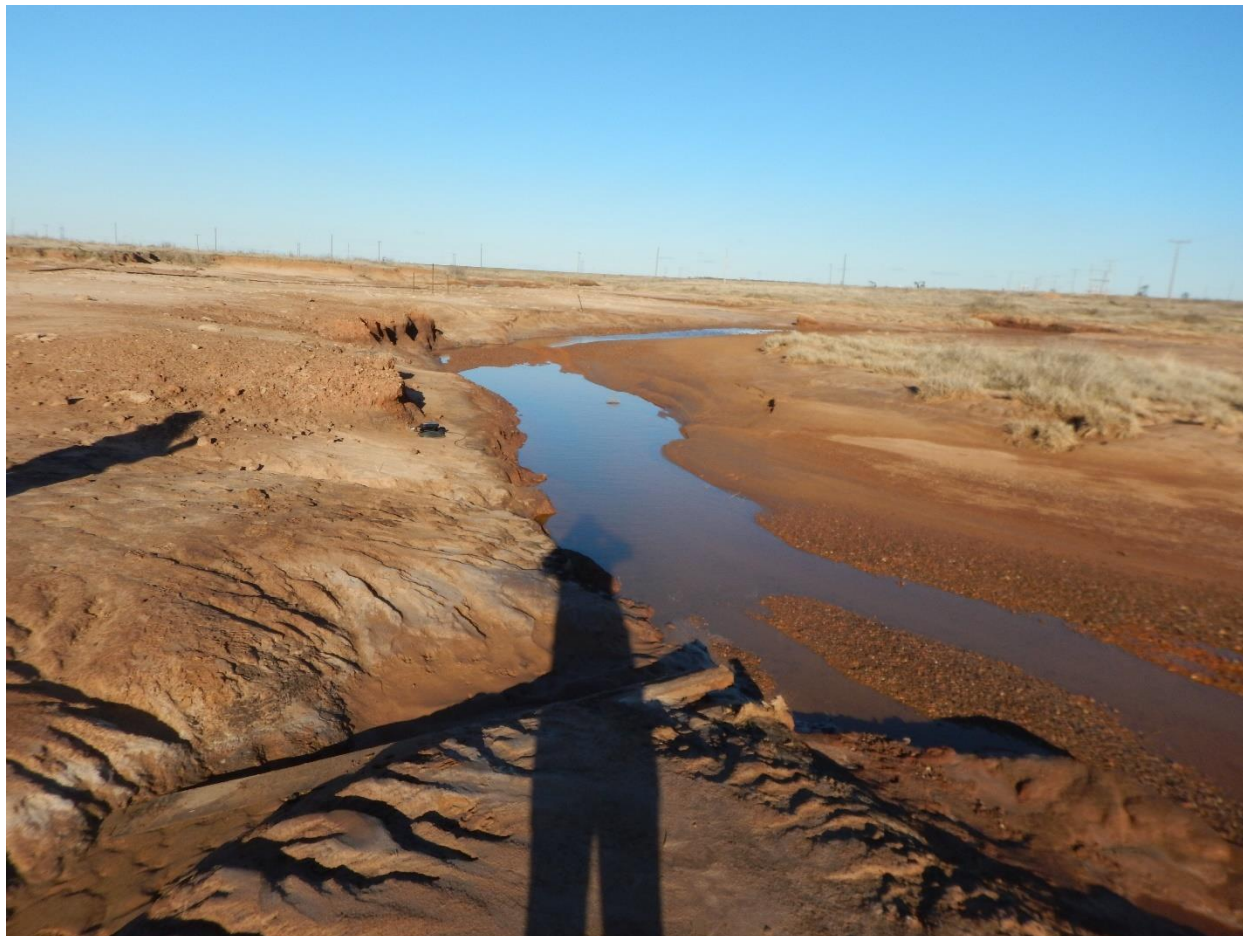
Photo No. 14

Description: This image shows the downstream point of entry on Long Creek. There was not an active discharge identified going into Long Creek during the inspection. I observed upstream of the facility on Long Creek that the vegetation was dead and salt crystallization was seen.

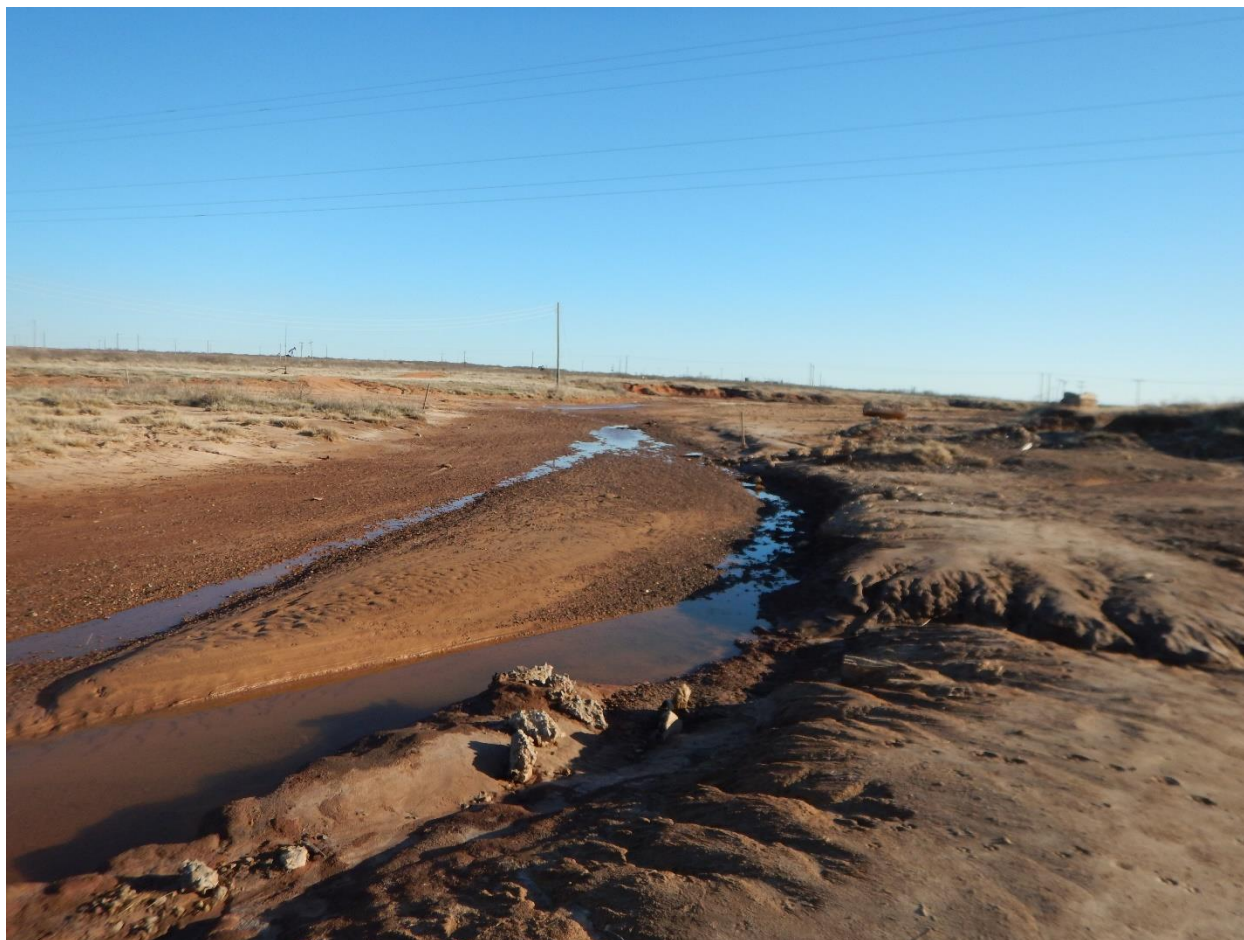
Photo No. 15

Description: Photo 15 shows Long Creek split approximately 100' downstream from the point of entry, and then re-merge.

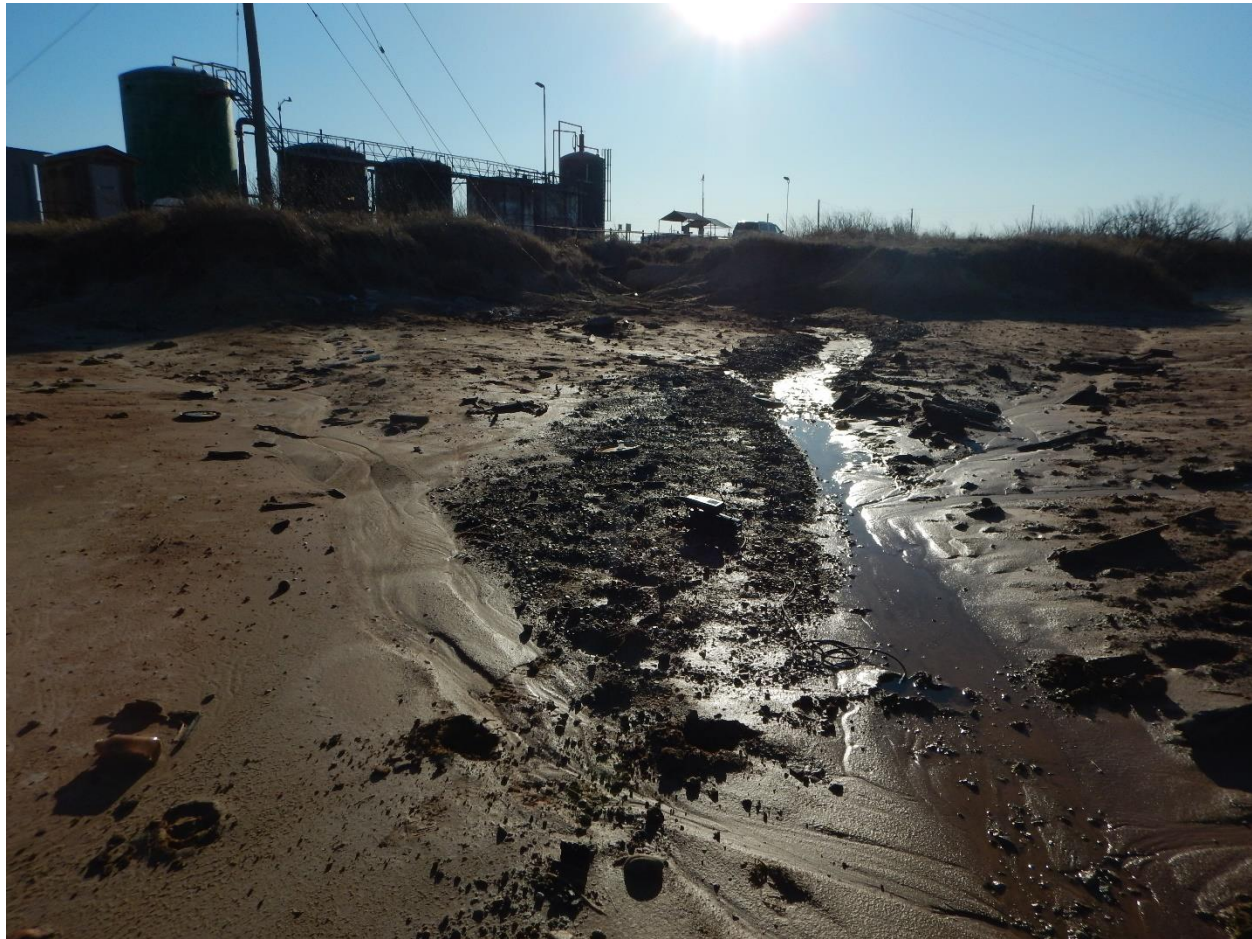
Photo No. 16

Description: This image shows an overview of the contaminated flow path from the facility toward the point of entry on Long Creek.

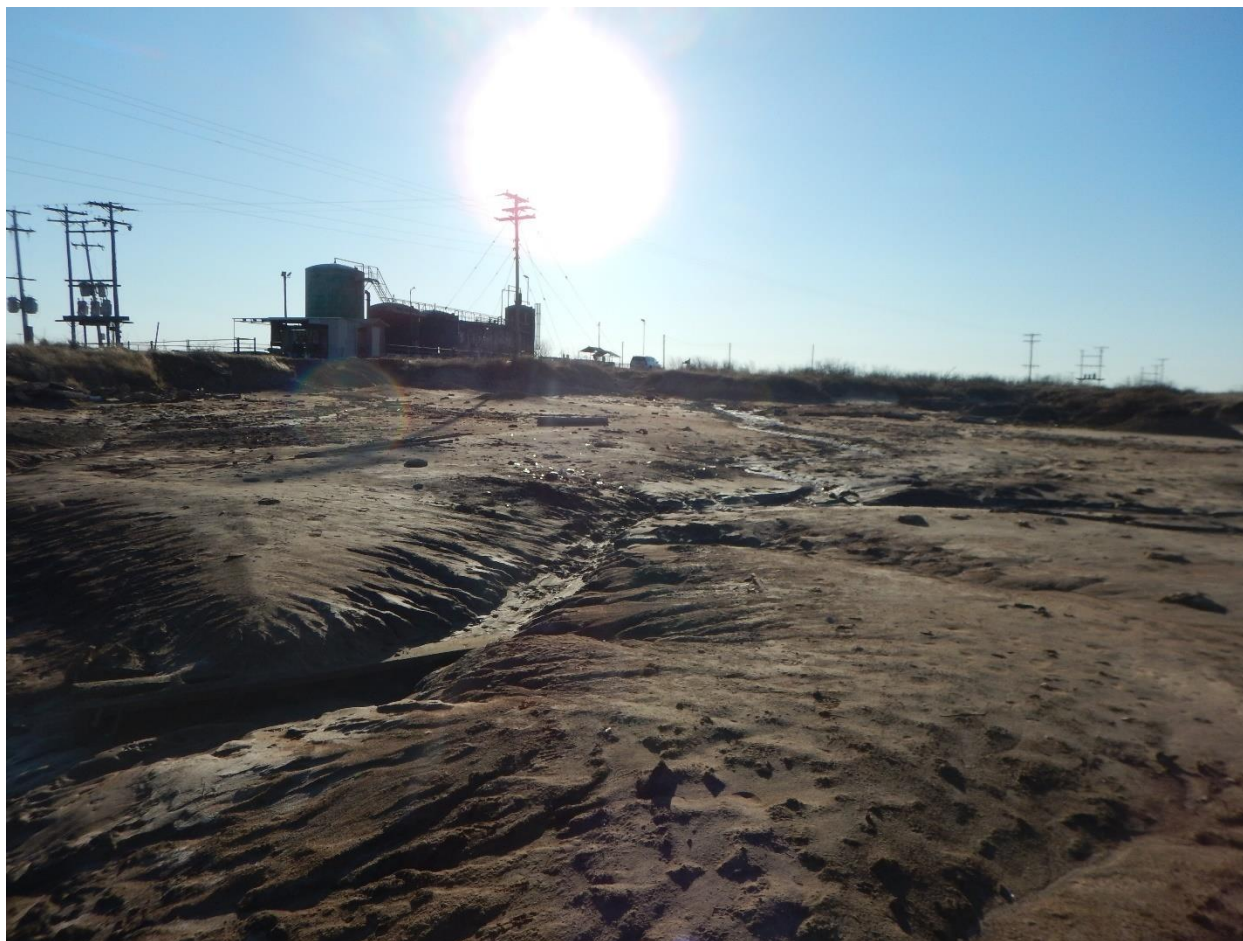
Photo No. 17

Description: This image shows another overview of the contaminant flow path from the facility toward the point of entry on Long Creek.

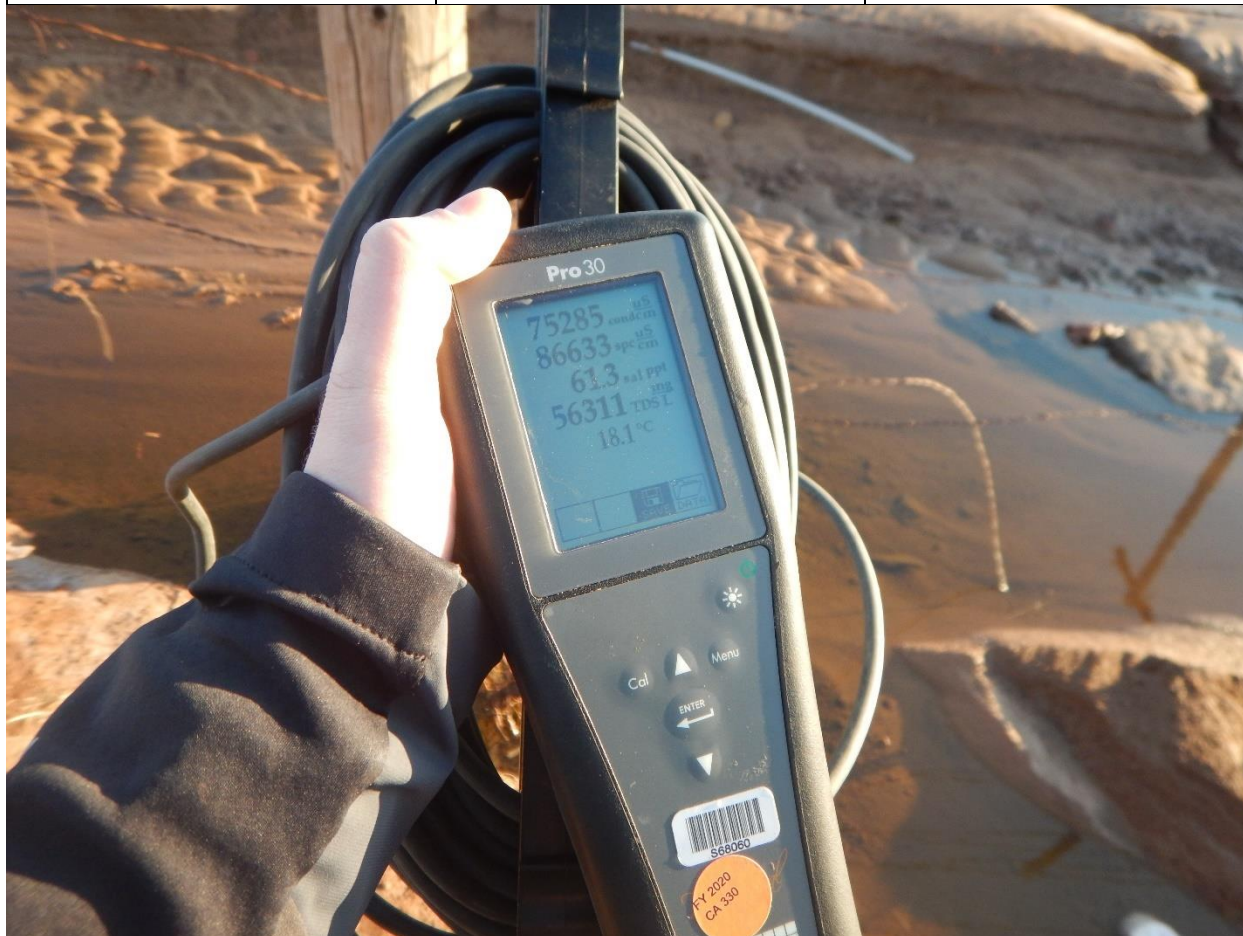
Photo No. 18

Description: The YSI Pro 30 conductivity meter measured elevated TDS levels of 56,311 mg/L upstream on Long Creek from the facility and observed point of entry.
