**Region 6 - Enforcement & Compliance Assurance Division**  
**INSPECTION REPORT**

| Company Name: | <b>Vinland Energy, LLC</b> | |
| Facility Name: | <b>Bickley Lease</b> | |
| Identification/Permit Number: | TXU011246 | |

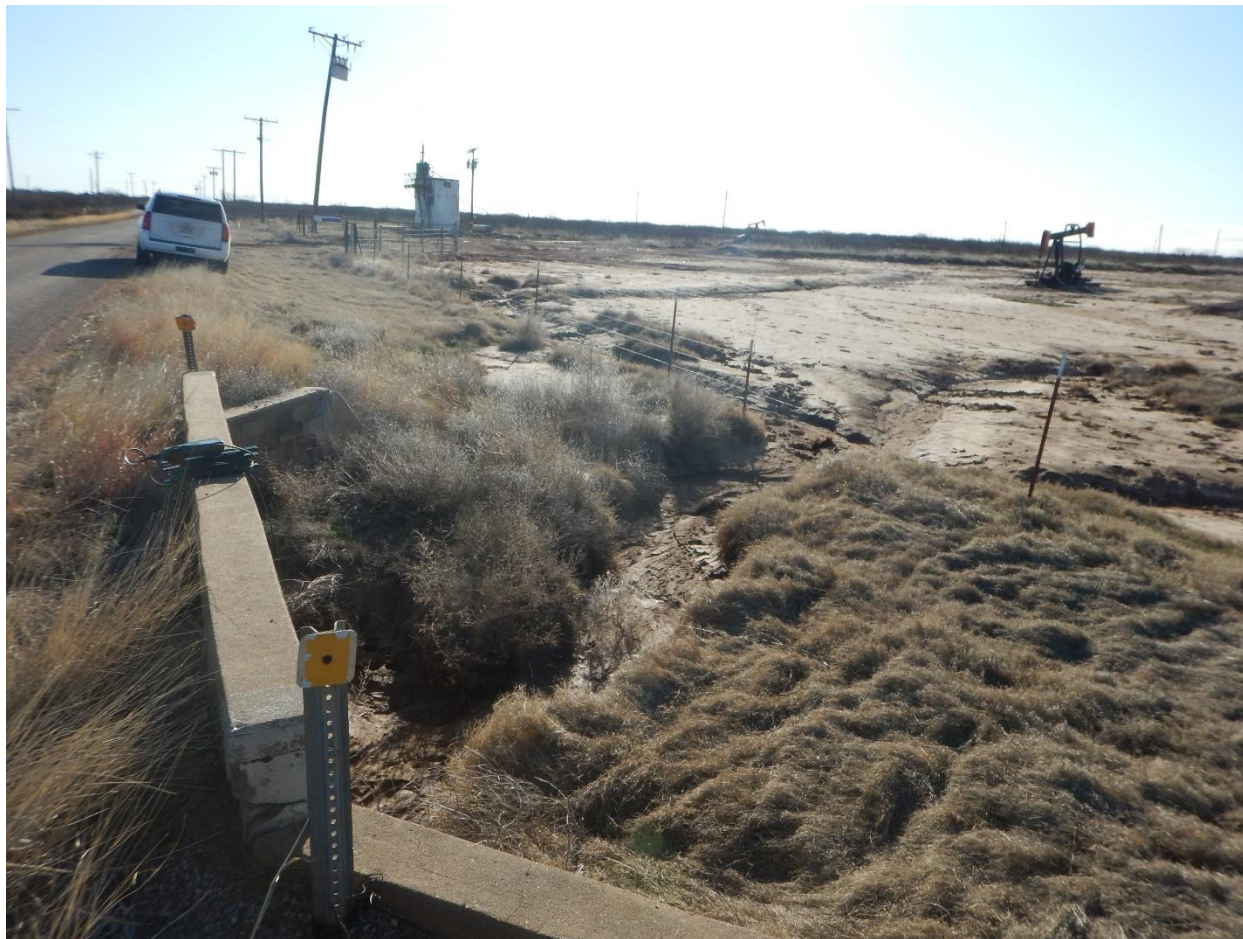
Photo No. 19

At 8:00 am on 2/25/20, we restarted the inspection. In Photos 19, I observed at this location upstream on Long Creek from the Bickley Lease: no flow in the stream observed, no active identified discharge, and no vegetation. There was an active lease very close to this upstream channel. In Photo 20, the YSI Pro 30 conductivity meter showed elevated TDS levels of 1,359 mg/L upstream from the point of entry. This is the furthest point upstream that we measured. Inspectors Jeanne Eckhart and Kayla Woods walked across the road to go back downstream of Long Creek to find elevated levels of TDS again at 101,432 mg/L in Photos 21 and 22. I observed channel definition in Long Creek and dead vegetation at this location. Continuing upstream again, the YSI Pro 30 conductivity meter showed elevated TDS levels of 48,744 mg/L upstream in photo 23. There were animal tracks nearby the pooled-up area in Long Creek where 48,744 mg/L TDS levels were found. Water flow at this location was not connected to downstream surface flow in Long Creek. We observed two other operators in the area near where these elevated TDS levels were identified.

Description: I observed at this location upstream on Long Creek from the Bickley Lease: no flow in the stream observed, no active identified discharge, and no vegetation. There was an active lease very close to this upstream channel.

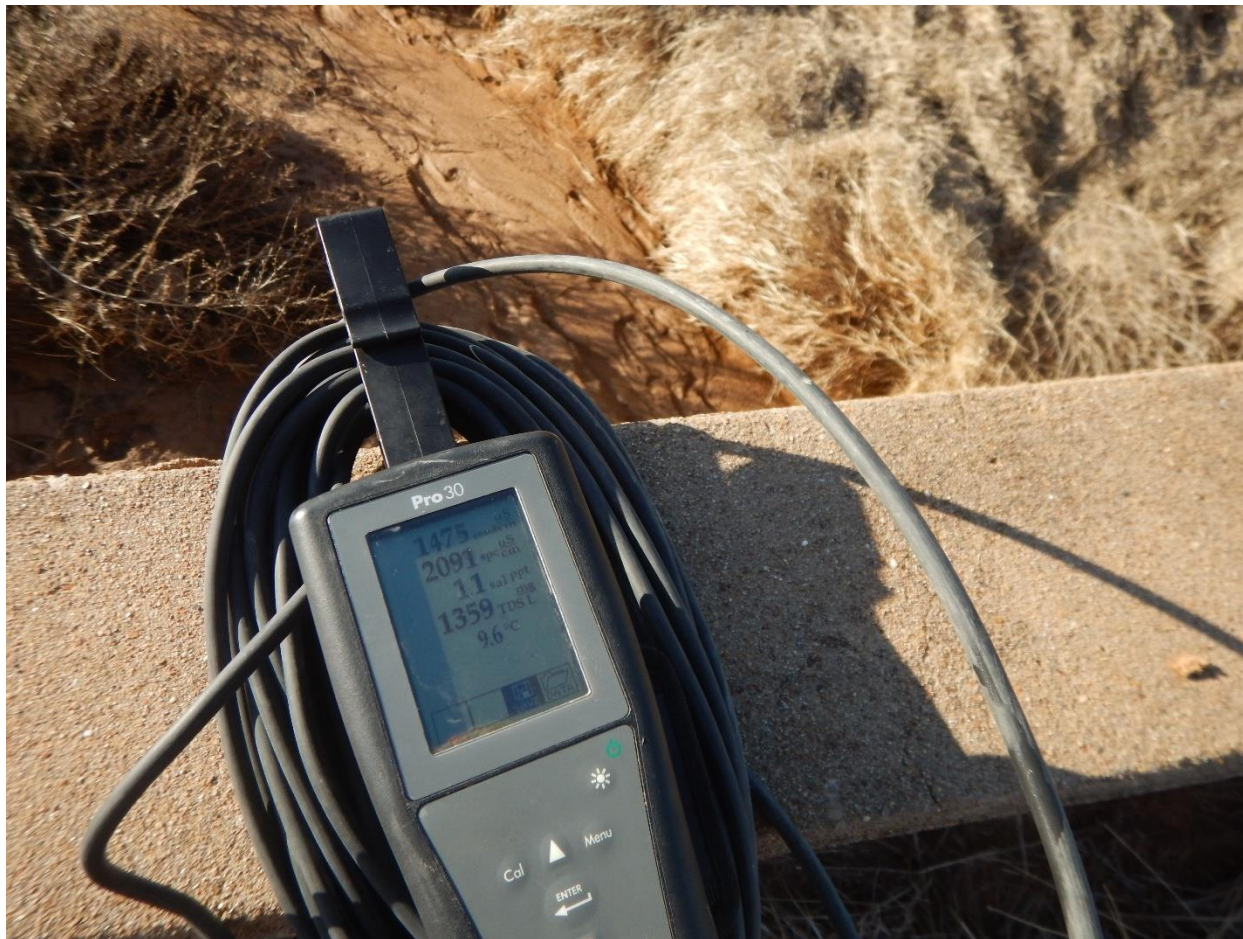
Photo No. 20

Description: The YSI Pro 30 conductivity meter showed elevated TDS levels of 1,359 mg/L upstream from the point of entry. This is the furthest point upstream that we measured.

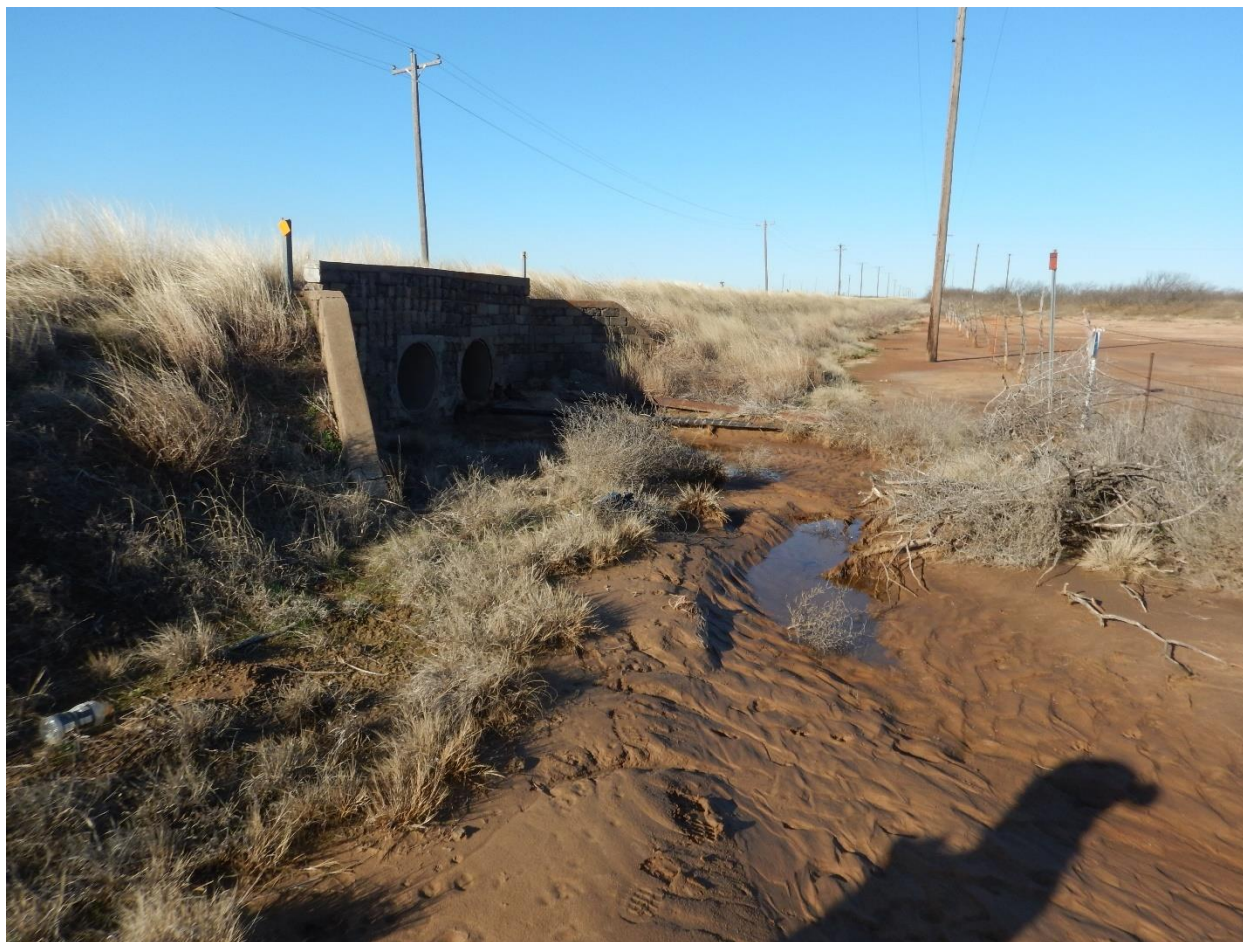
Photo No. 21

Description: This photo was taken upstream of the point of entry and downstream from the 1,359 mg/L TDS reading. I observed channel definition in Long Creek and dead vegetation at this location.

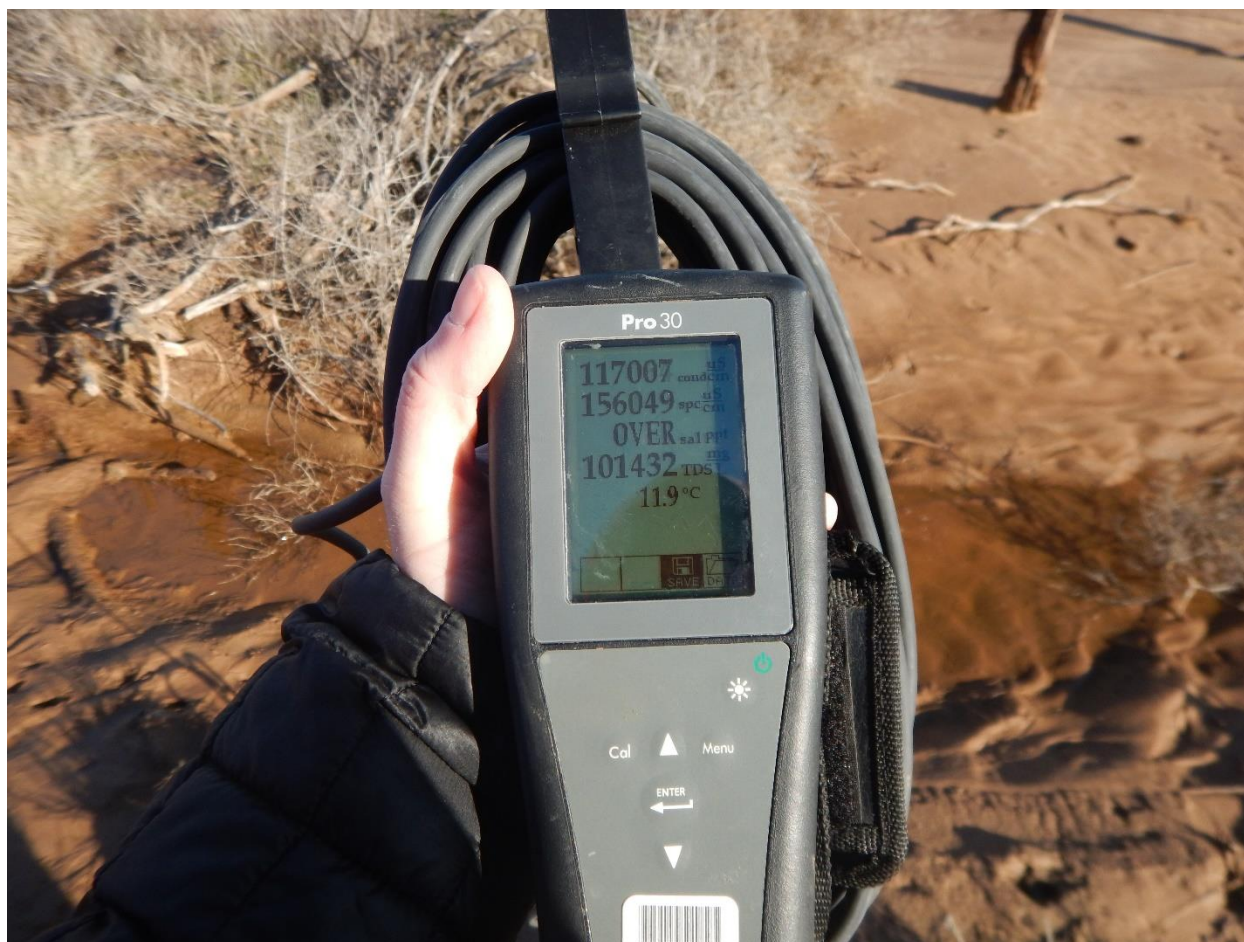
Photo No. 22

Description: A YSI Pro 30 conductivity meter measured elevated TDS of 101,432 mg/L from Photo 21's location.

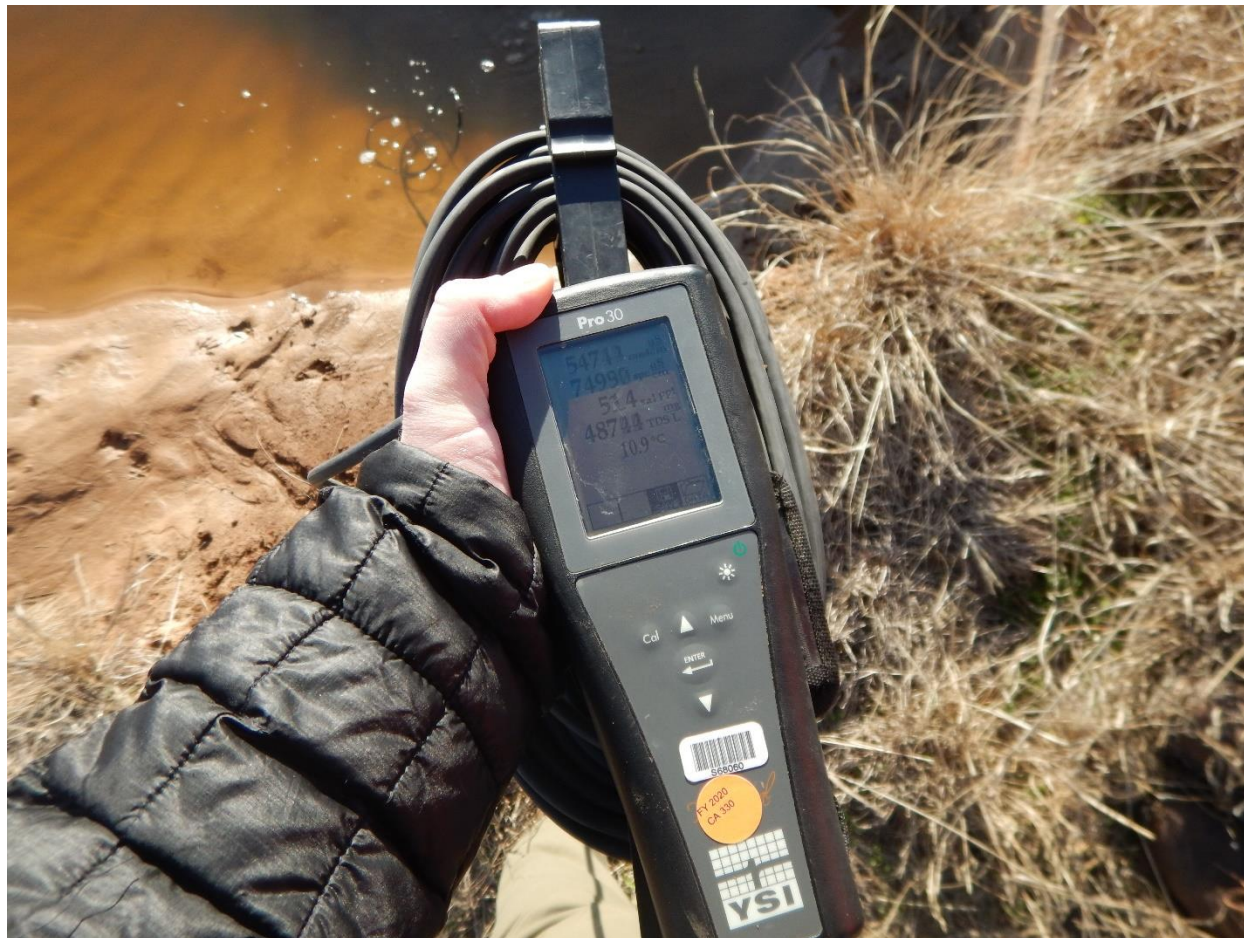
Photo No. 23

Description: The YSI Pro 30 conductivity meter showed elevated TDS levels of 48,744 mg/L upstream.

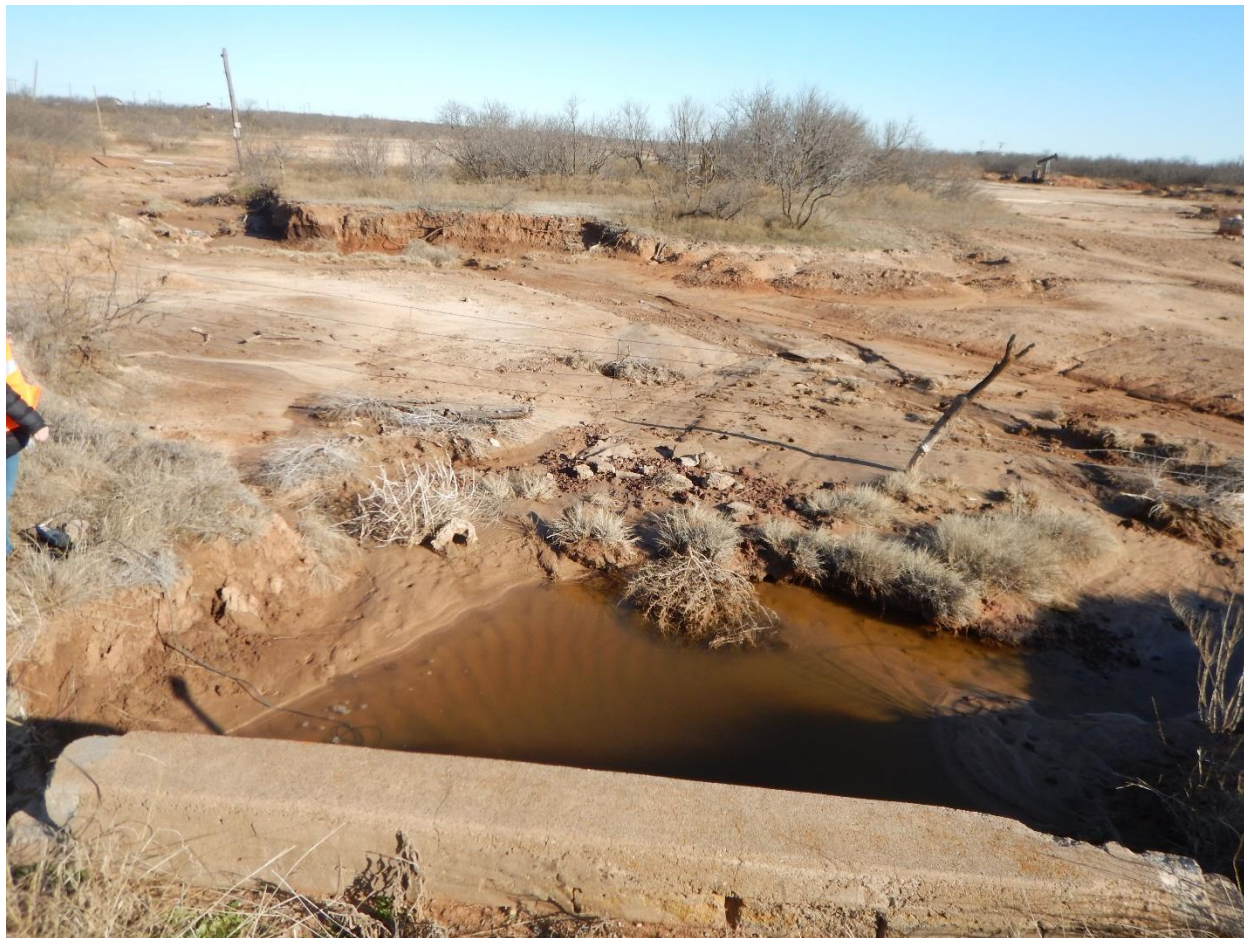
Photo No. 24

Description: There were animal tracks nearby the pooled-up area in Long Creek where 48,744 mg/L TDS levels were found. Water flow at this location was not connected to downstream surface flow in Long Creek. We observed two other operators in the area near where these elevated TDS levels were identified.

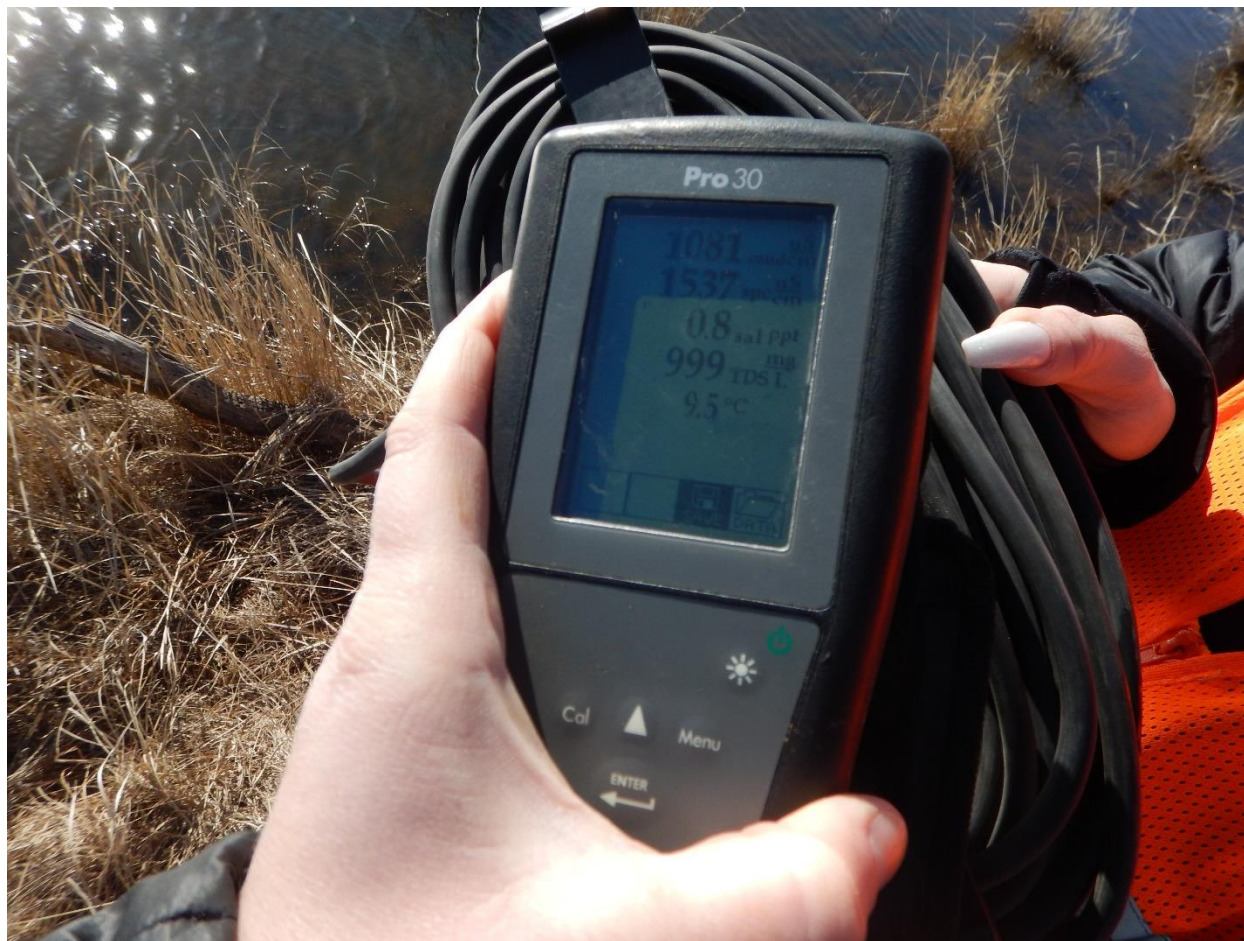
Photo No. 25

Photo 25 was taken further upstream of Long Creek and southwest of 1,359 mg/L TDS. The TDS levels were 999 mg/L. We observed livestock grazing in this area and no aquatic life in the pond. We drove downstream along Long Creek past the Bickley lease and the 117,388 mg/L TDS measurement. The TDS levels Northeast of the Bickley Lease were 11,604 mg/L in Photo 26. At this location, Photo 27 exposed well-defined channel banks and bed rock observed in the stream. There were animal tracks observed again, however I did not observe any aquatic life in Long Creek during the inspection. The creek was flowing downstream, or northward, during the inspection. TDS levels were 11,513 mg/L in Photo 28. I noticed some high watermarks downstream in Photo 29. I observed large culverts in place on Long Creek at the road crossing indicating the creek had consistently been flowing over time. After this measurement, this concluded our CWA inspection at the Bickley Lease on 2/25/2020 at 10:08AM.

Description: There was a small pond at side of Long Creek that was not connected to the creek. This photo was taken further upstream of the creek at this pond. The TDS levels measured 999 mg/L. We observed livestock grazing in this area and no aquatic life in the pond.

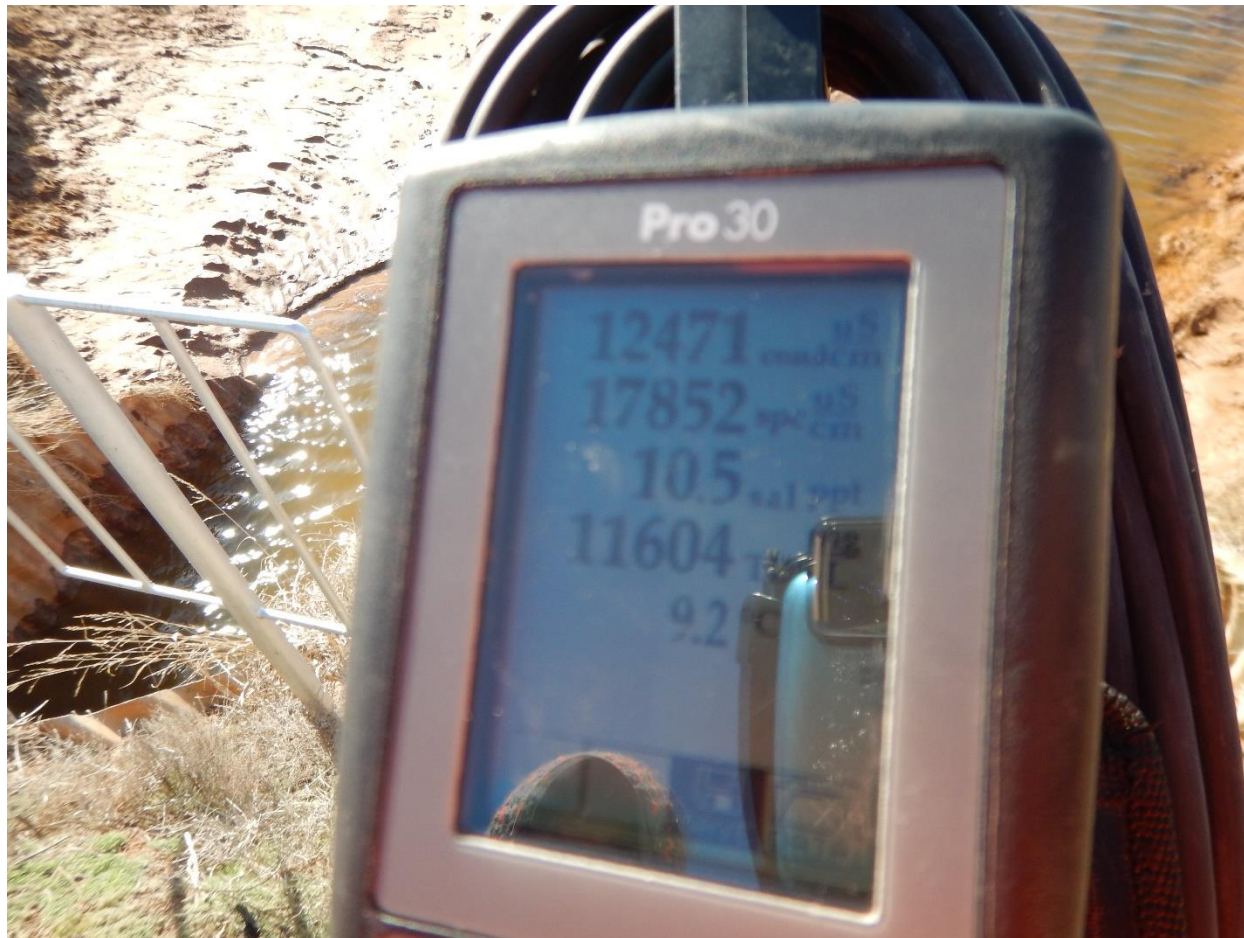
Photo No. 26

Description: We arrived downstream along Long Creek past the Bickley lease and the 117,388 mg/L TDS measurement. The TDS levels were 11,604 mg/L. There were well-defined channel banks and bed rock observed in the stream. I observed large culverts in place on Long Creek at the road crossing indicating the creek had consistent flow over time.

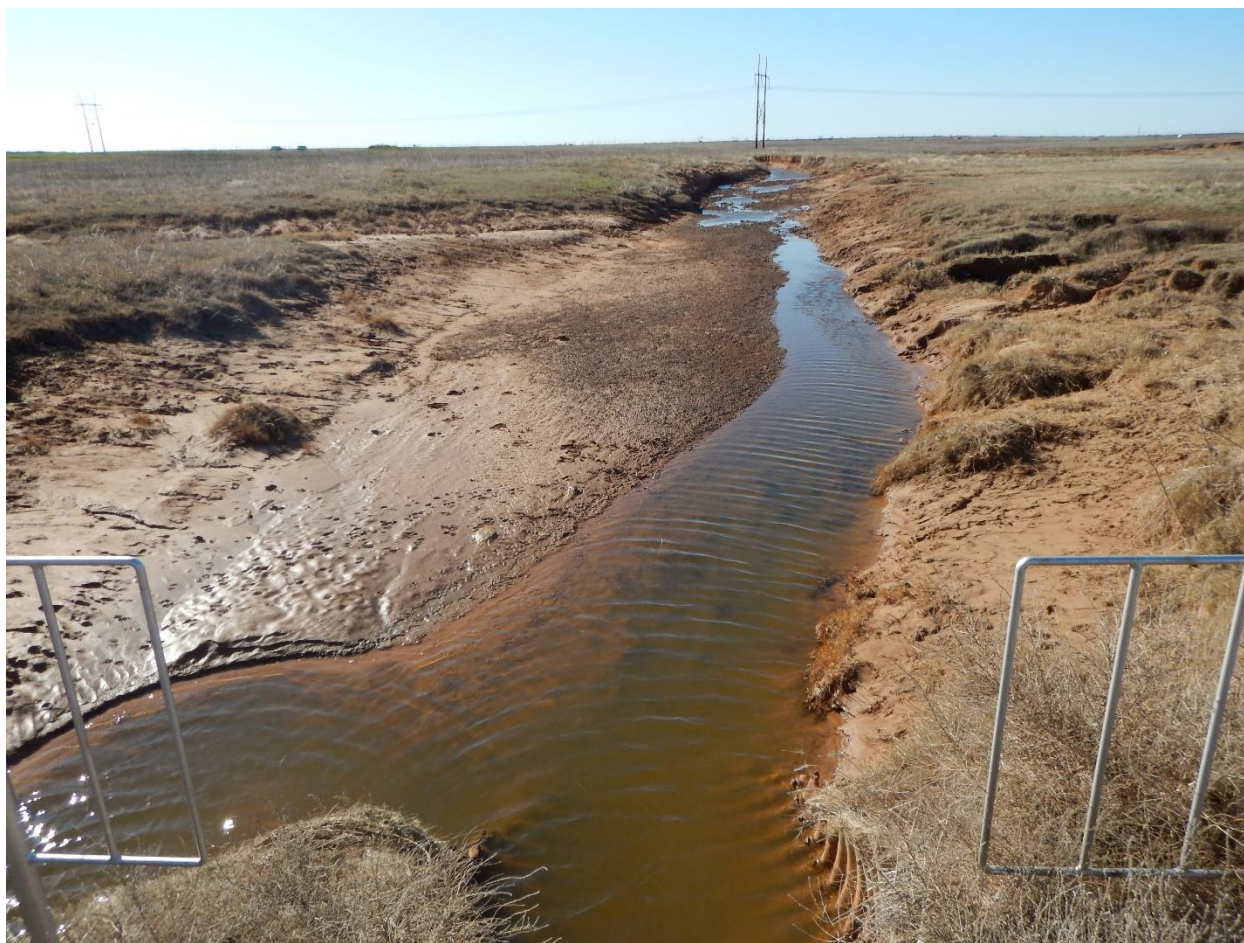
Photo No. 27

Description: The creek was steadily flowing. There was a well-defined channel a bed/bank observed. There were animal tracks observed on creek channel side.

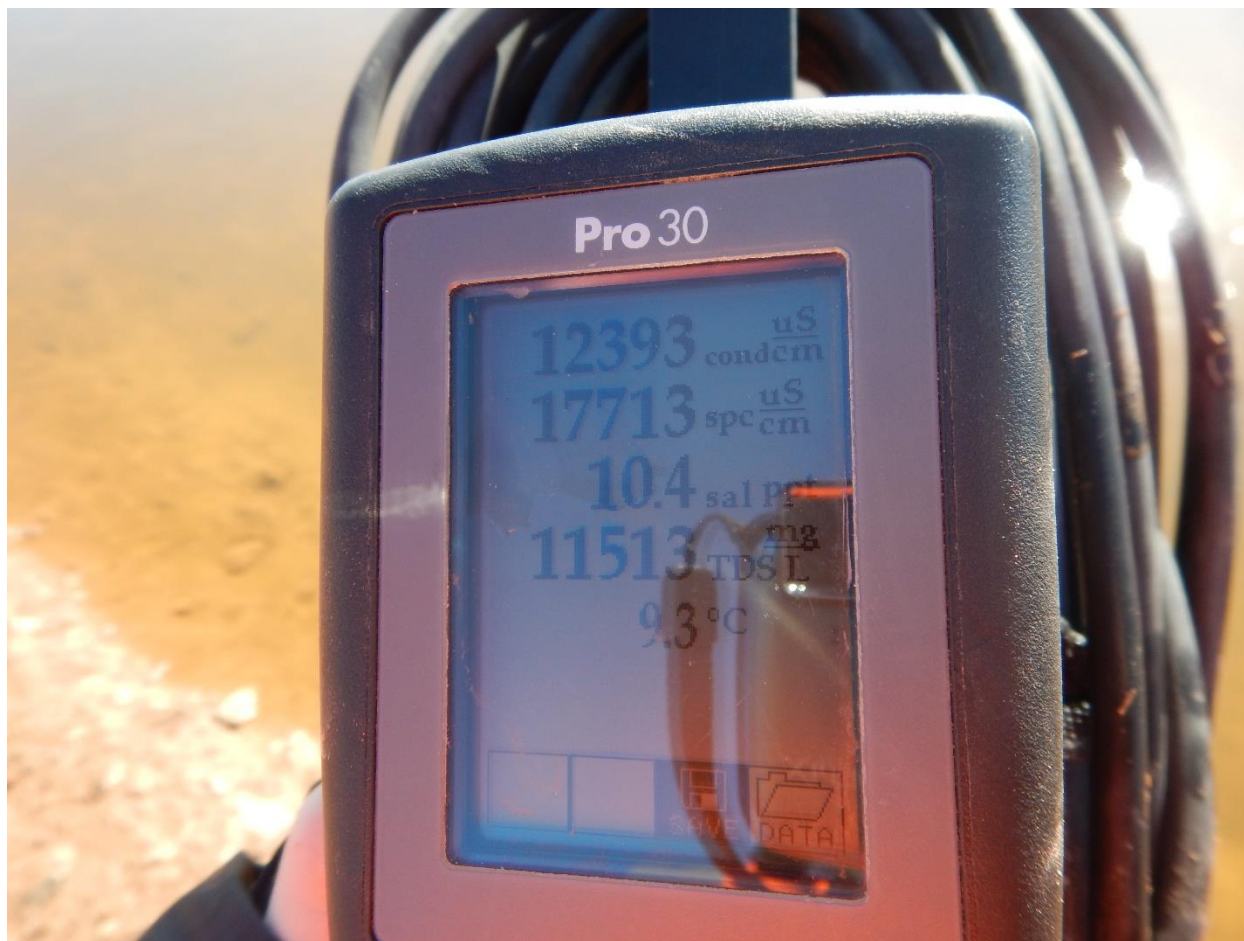
Photo No. 28

Description: The creek was flowing downstream during the inspection. TDS levels were 11,513 mg/L.

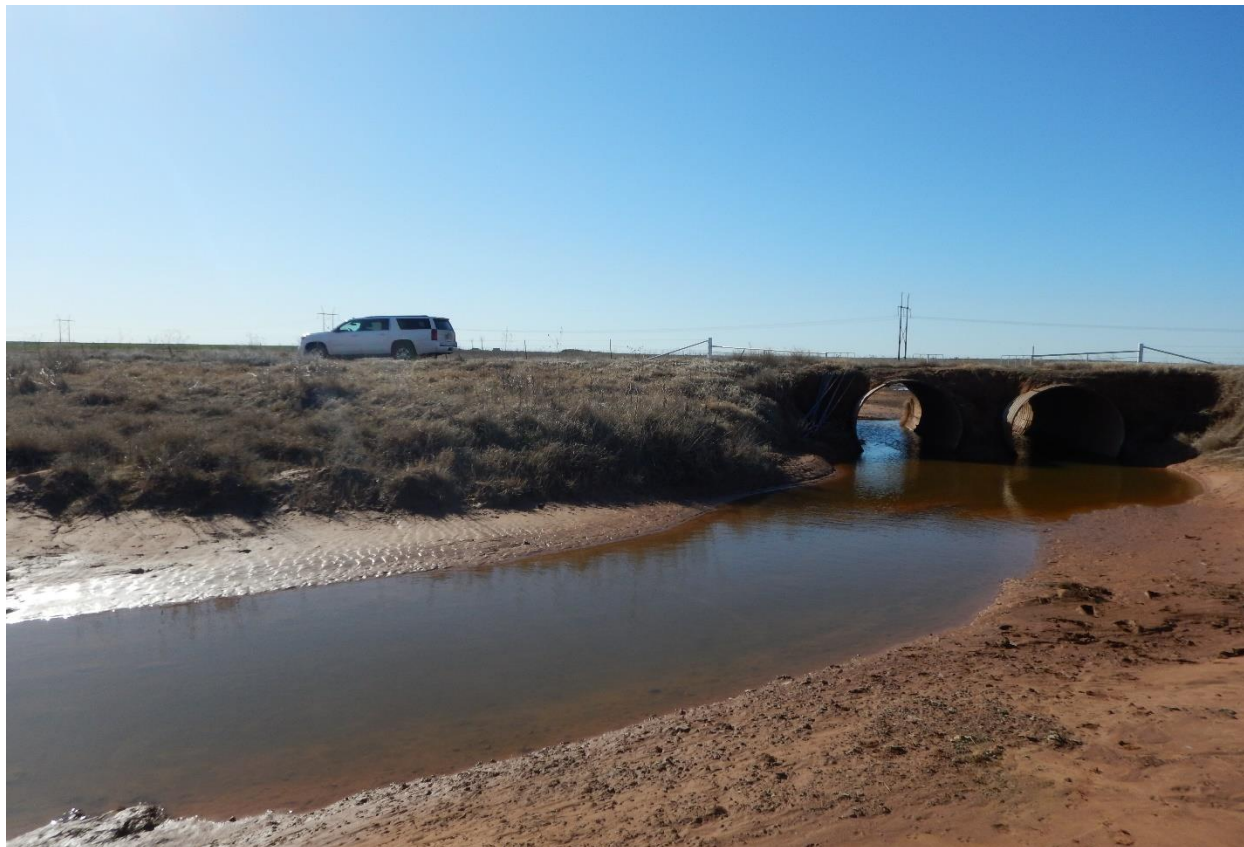
Photo No. 29

Description: There was a well-defined channel a banks and bed rocks in the stream. Large culverts in place on creek at the road crossing. Some high watermarks downstream were observed.
