**Well Inspection**  
**Osage DNR / Environmental Protection Agency**  
**1201 Elm Street, Suite 500**  
**Dallas, Texas 75270**

| | | <b>Lease Name</b> | TO I | | |
| | | <b>Well ID</b> | 1-13 | | |

### Photograph Log 2 Photos

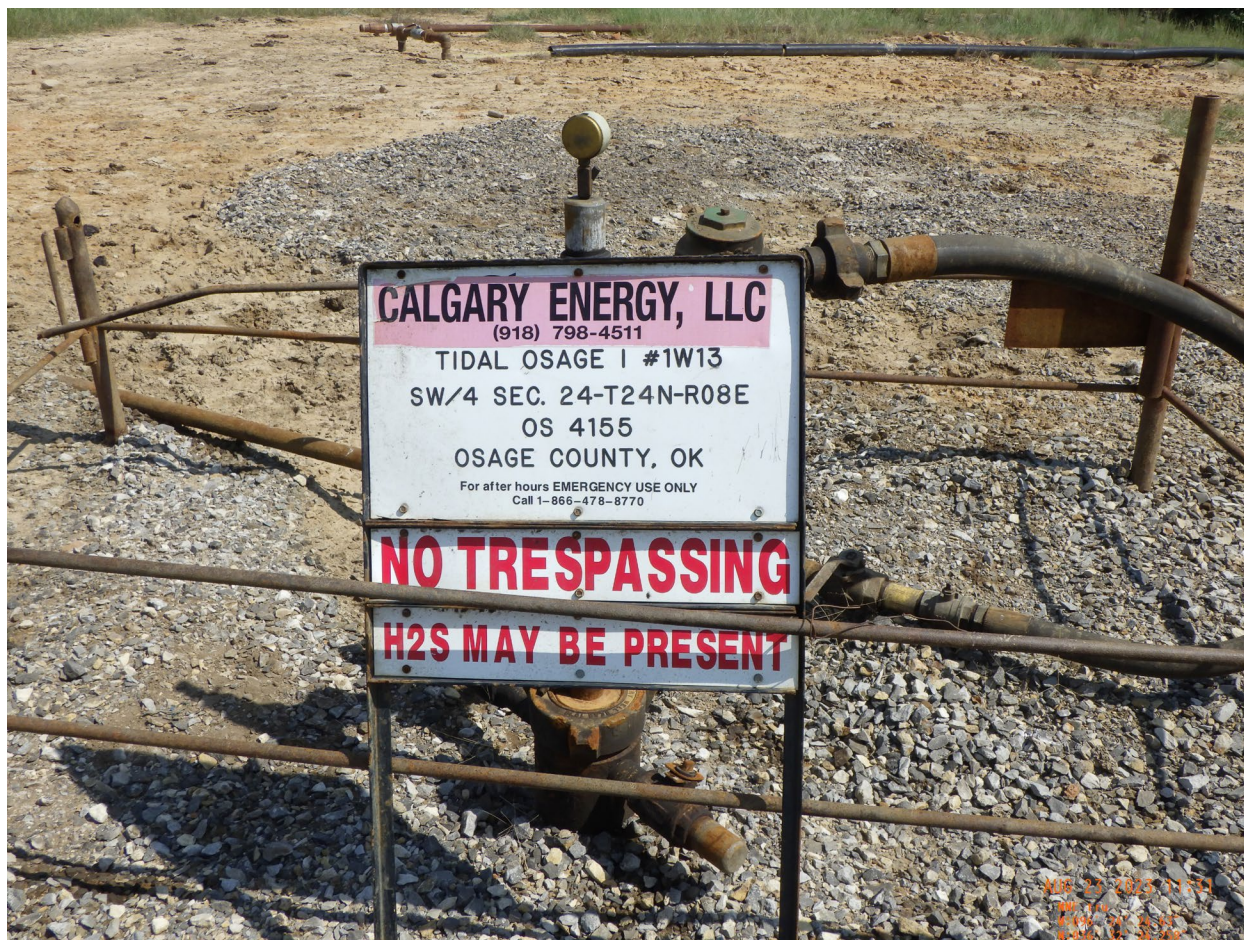
Photo No. 1

**Description:** OS6519000 well sign and well at the time of the inspection. Well sign was inaccurate at the time of the inspection.

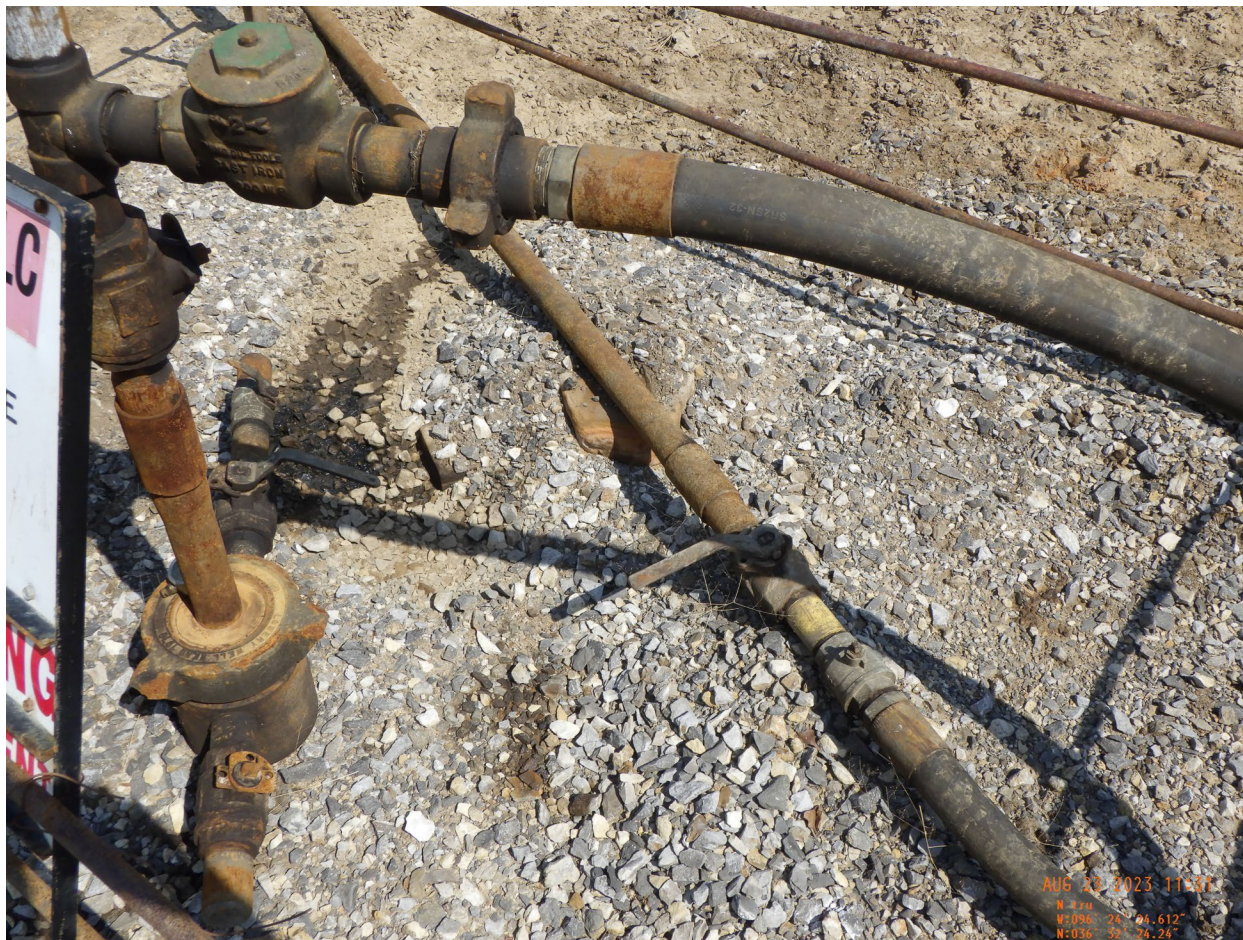
Photo No. 2

**Description:** Flowline connected to OS6519000 with valve closed, preventing injection. Closed valve was leaking fluid by at the time of the inspection.
