B.F.GOODRICH CHEMICAL COMPANY  
Avon Lake General Chemical Plant

DATE: March 8, 1972

SUBJECT: Near Miss - Repetitive Accident Type #10 - Fill Building or Area with Explosive Mixture

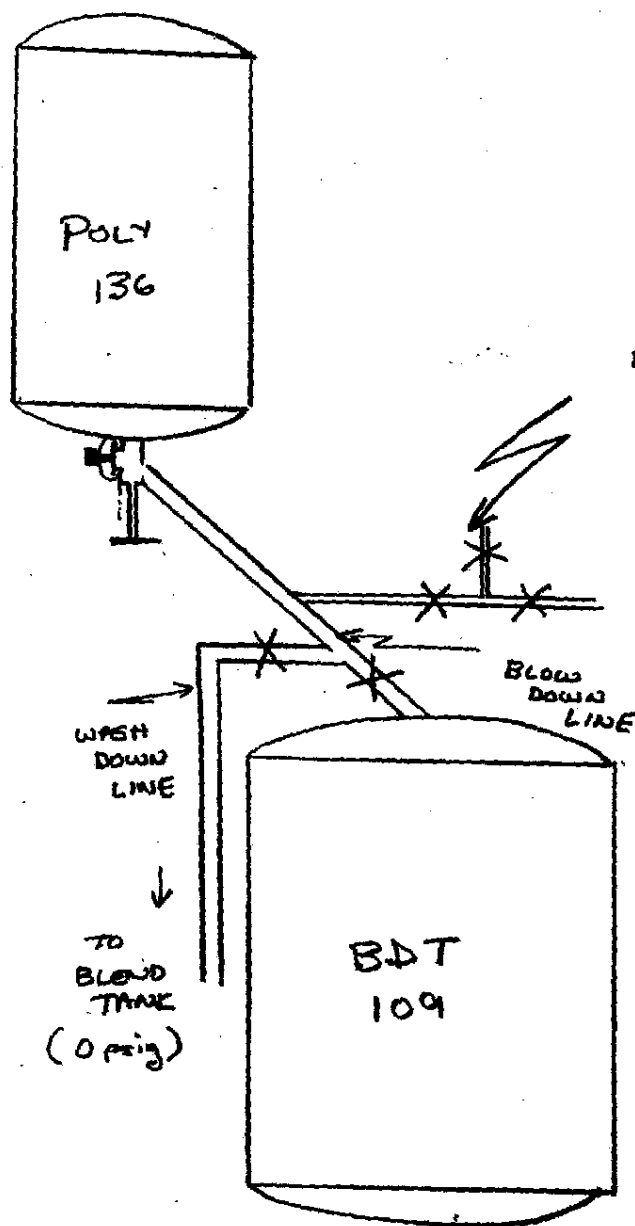
The attached sketch is used to explain what occurred. ( B/461 Blowdown Operator stated that he closed the valve on the blowdown line and the bottom Powell valve on the Poly. He opened the wash line to bleed off any pressure and then removed the inspection plate on the Powell valve. As he removed the inspection plate he found that the bottom valve was completely plugged with polymer. He hooked up a steam hose to the block and bleed system and blew out the plug. After the plug was blown out, slurry (102-F5) and vinyl chloride started coming out the inspection plate opening. Garofolo and another man tried to close the bottom valve on Poly #136 more tightly, but they could not stop the VCl flow. The gas alarm was then sounded and the area was subsequently under an alarm condition for 40 minutes. The poly was quickly put on recovery from the top and the unreacted vinyl chloride monomer was removed from the poly, although slurry continued to run out of the inspection plate and onto the second floor.

As the steam was used to remove the visible plug in the bottom valve, apparently a plugged condition in the bottom Powell valve inside the poly also broke loose. The valve was improperly seated when the poly was charged. This permitted polymer to form in the bottom valve during reaction and prohibited closing the valve completely after monomer started leaking out of the inspection plate opening.

- ① The steaming method is felt to be a safe approach to unplugging blowdown lines. However when unplugging lines in the future, the poly will be recovered prior to removal of the inspection plate to prevent gas escape.
- ② The bottom valves and blowdown lines will be pressured with water prior to charging the poly. The water will be left in the lines during reaction. This procedure will detect leaky valves ahead of time and the leaky valves will be changed.
- ③ A long term aspect of this problem involves conversion of the bottom valves to ball valves. This is necessary to enable HRC cleaning of the Polys.
