## Region 6 - Enforcement & Compliance Assurance Division

### INSPECTION REPORT

| Company Name: | <b>EOL Water Supply Corporation</b> | |
| Identification/Permit Number: | TX1550025 | |

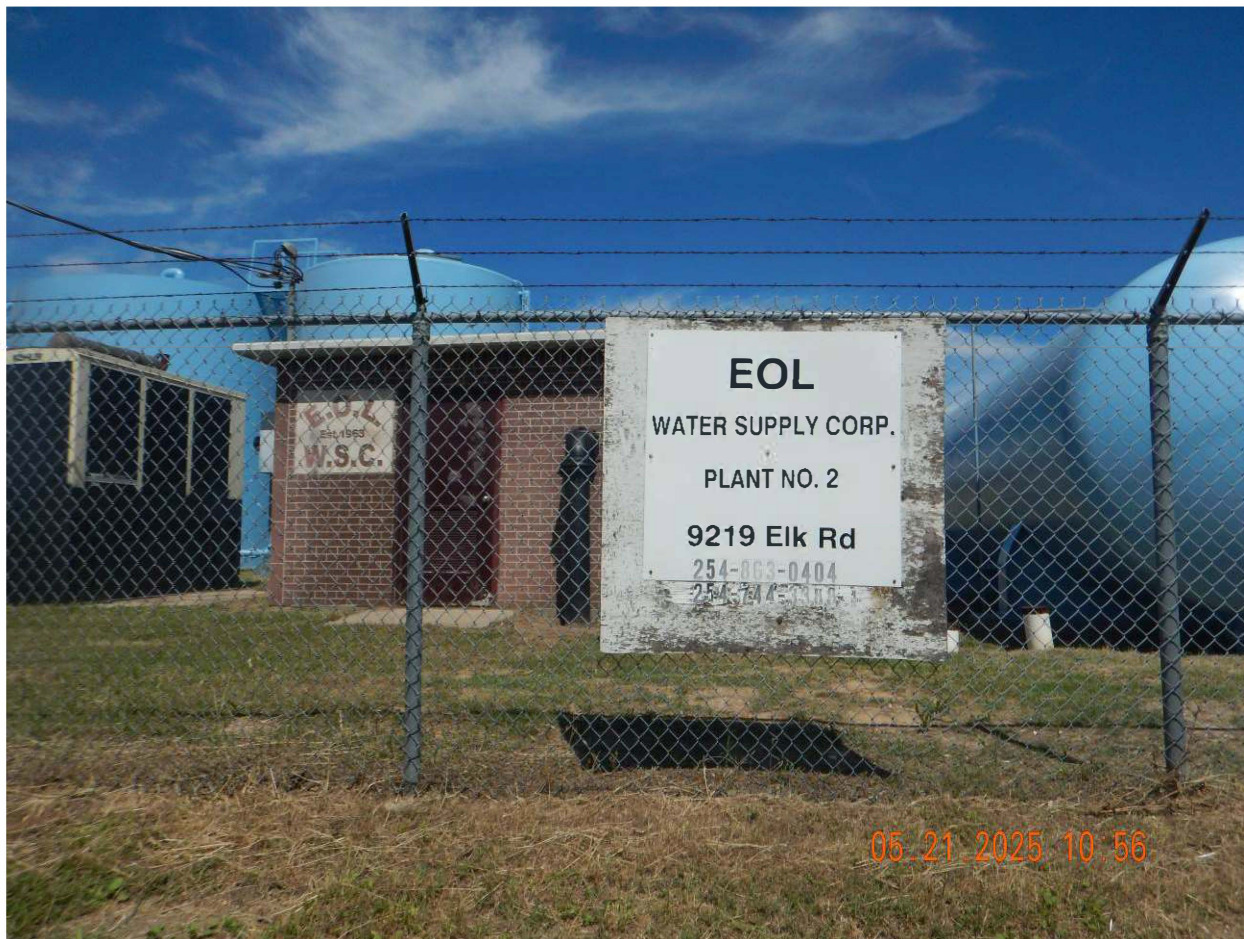
Photo No. 1

1. The chlorine room at Plants 2 and 1 did not have a viewing window, crash bar, alarm, or chlorine sensor (Photos 6,14)
2. The chlorine room ventilation at Plants 2 and 1 was not tied to automatic switches
3. The entrance of Plants 2 and 1 did not contain signage warning of chlorine gas storage (Photos 1, 13)
4. Spent chlorine gas tanks were unchained at Plants 2 and 1 (Photos 5, 7,14)
5. Ground storage tanks at Plants 2 and 1 were missing adequate climb protection (Photos 9, 15, 18)
6. A ground storage tank at Plant 2 housed a wasp's nest in the overflow valve (Photo 10)
7. Well 3 at Plant 3 was missing a 24-mesh screen on the air relief valve (Photo 20)
8. There were exposed openings in the wellhead at Plant 3 (Photo 12)
9. A flapper valve at Plant 1 would not self-close once opened (Photo 16)

Description: Signage on entrance to Plant 2 with no warning of chlorine gas storage on site

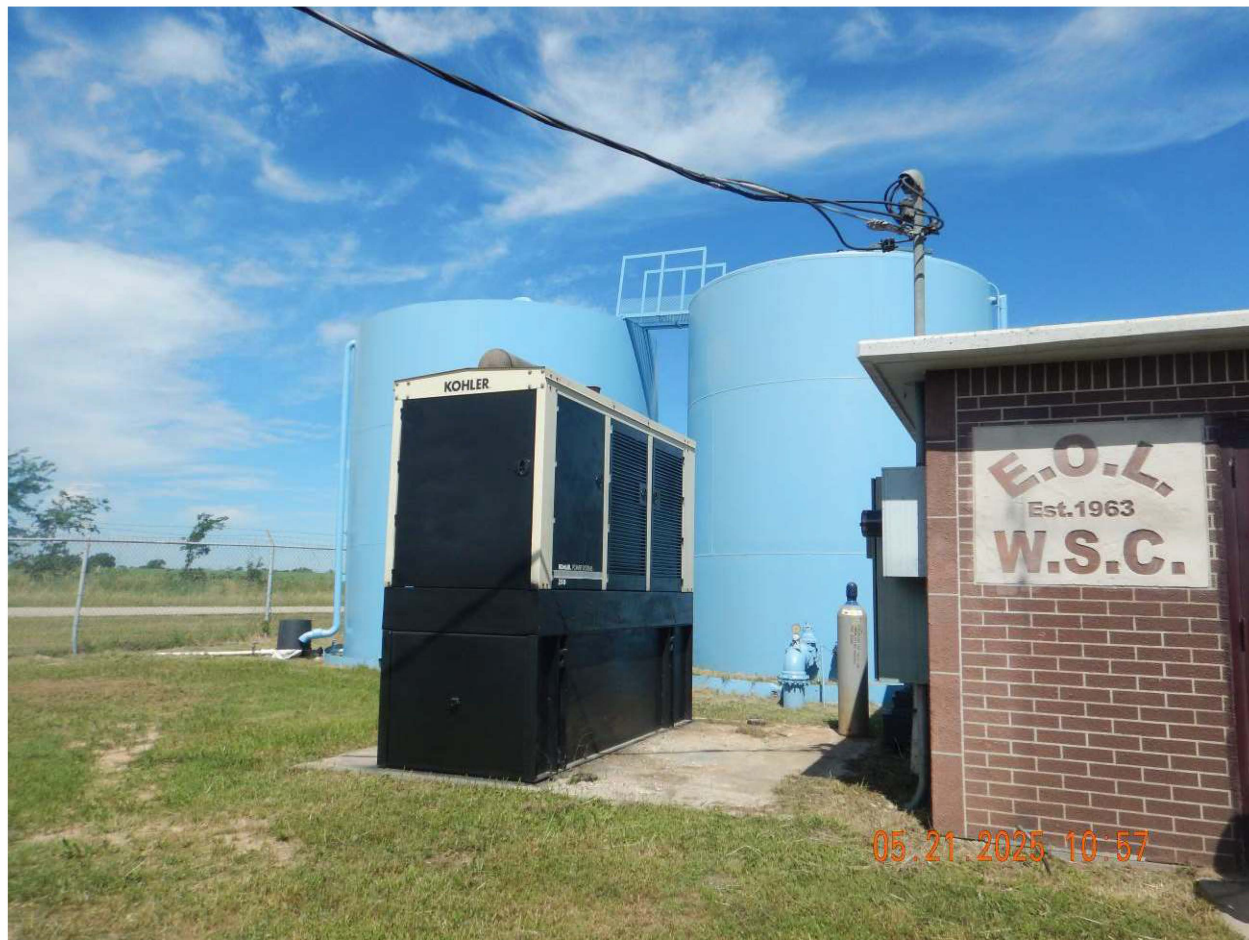
Photo No. 2

Description: Emergency generator located at Plant 2

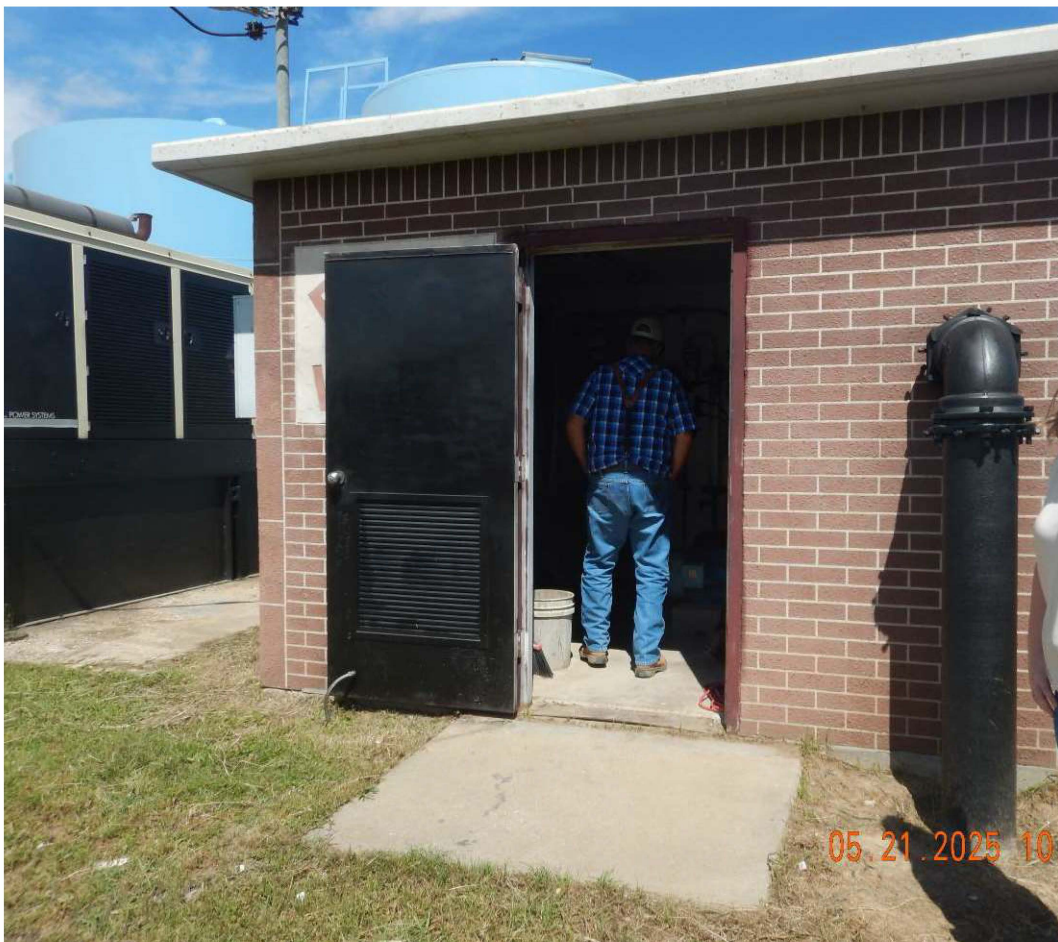
Photo No. 3

Description: Chlorine injection and pump room

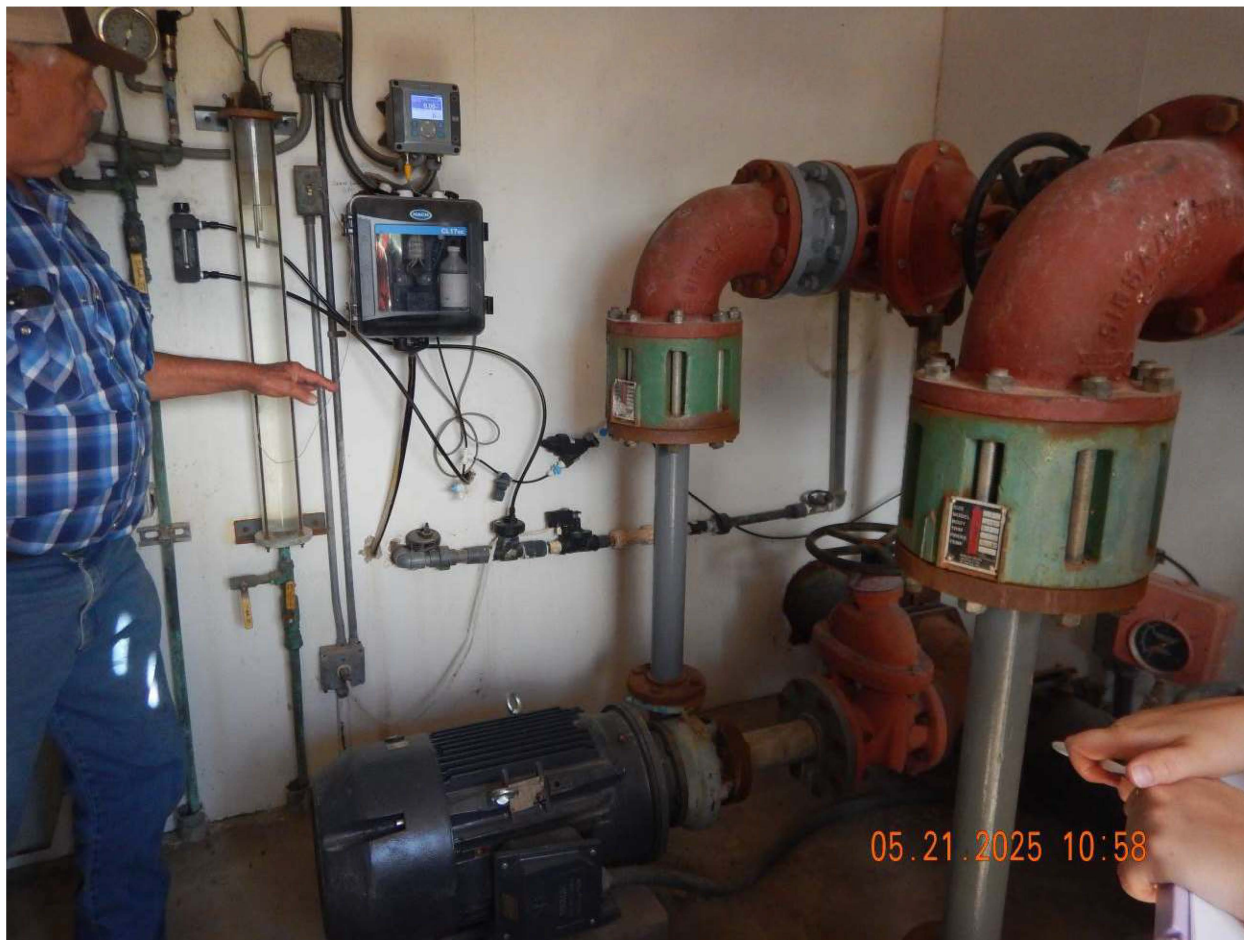
Photo No. 4

Description: Chlorine injection and service pumps

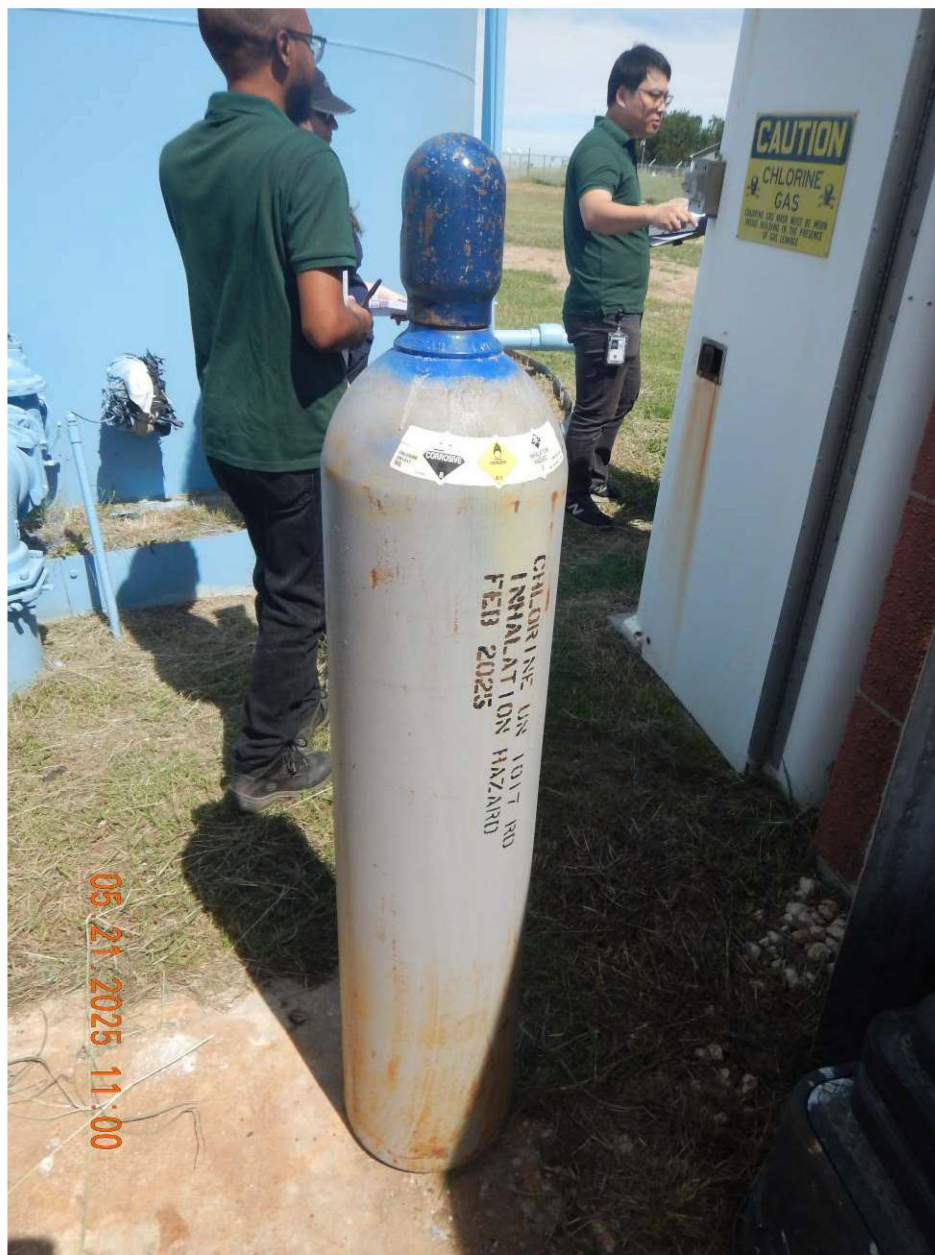
Photo No. 5

Description: Unchained spent chlorine gas cylinder

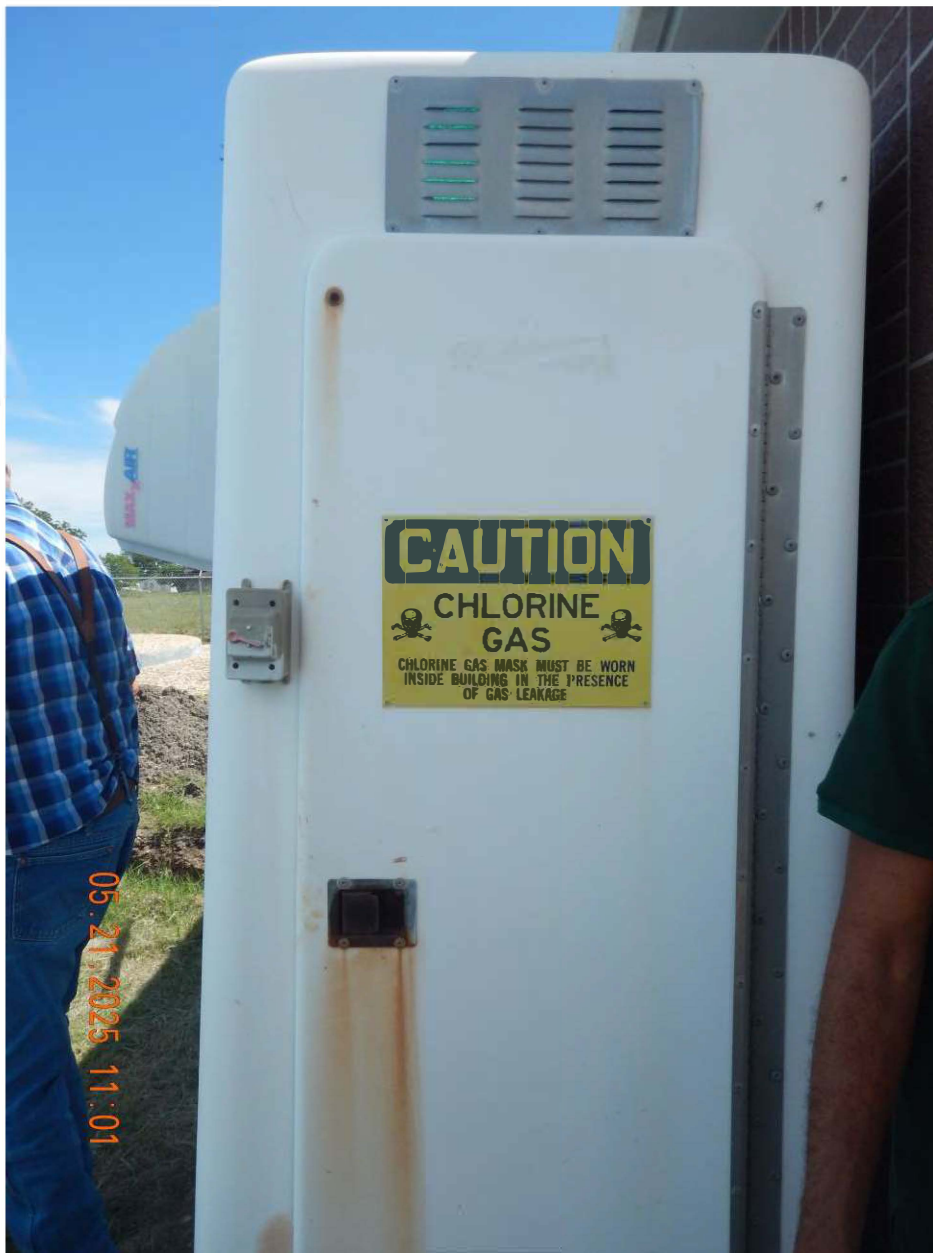
Photo No. 6

Description: Door of chlorine gas room missing viewing window

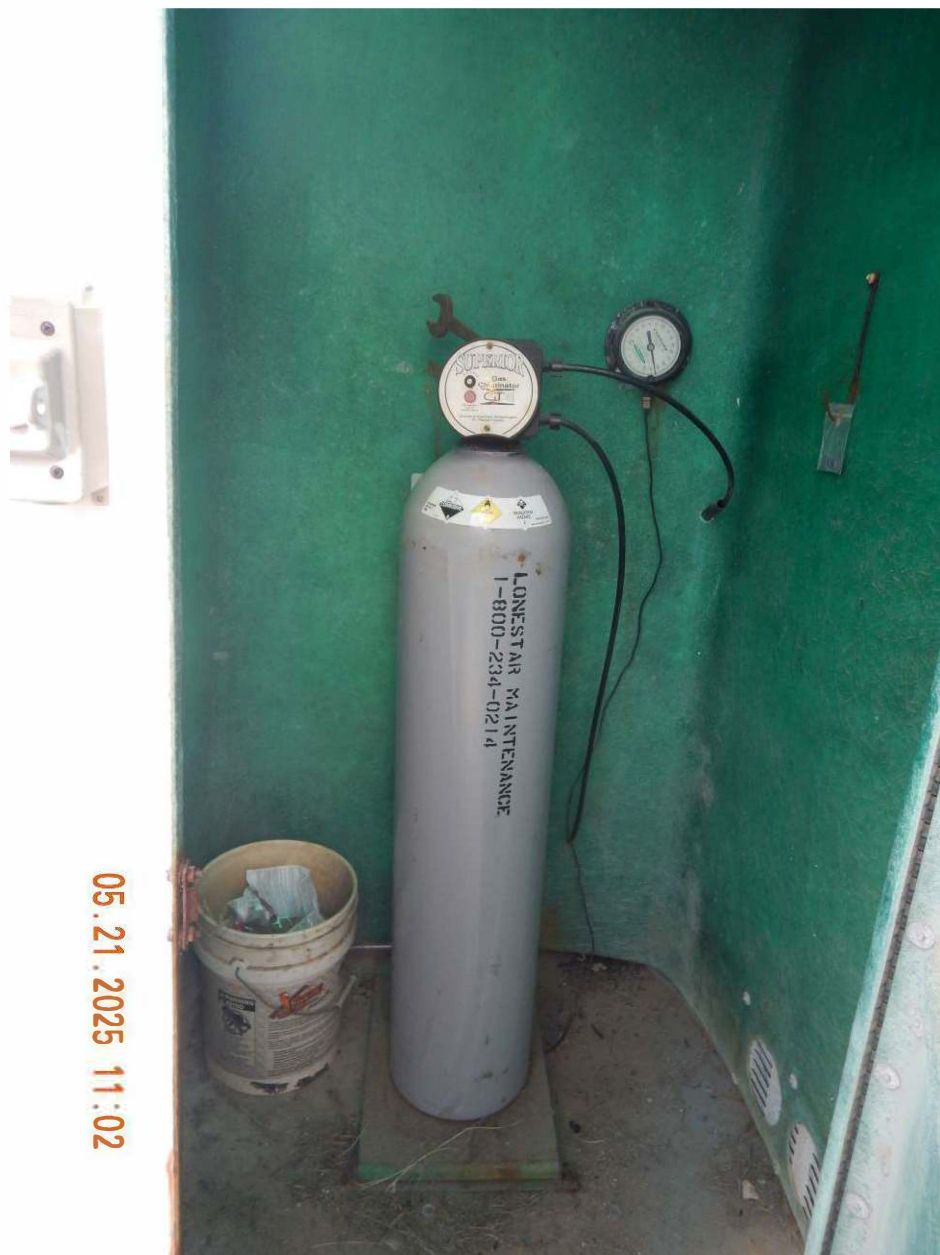
Photo No. 7

Description: Chlorine gas room missing alarm and chlorine gas sensor

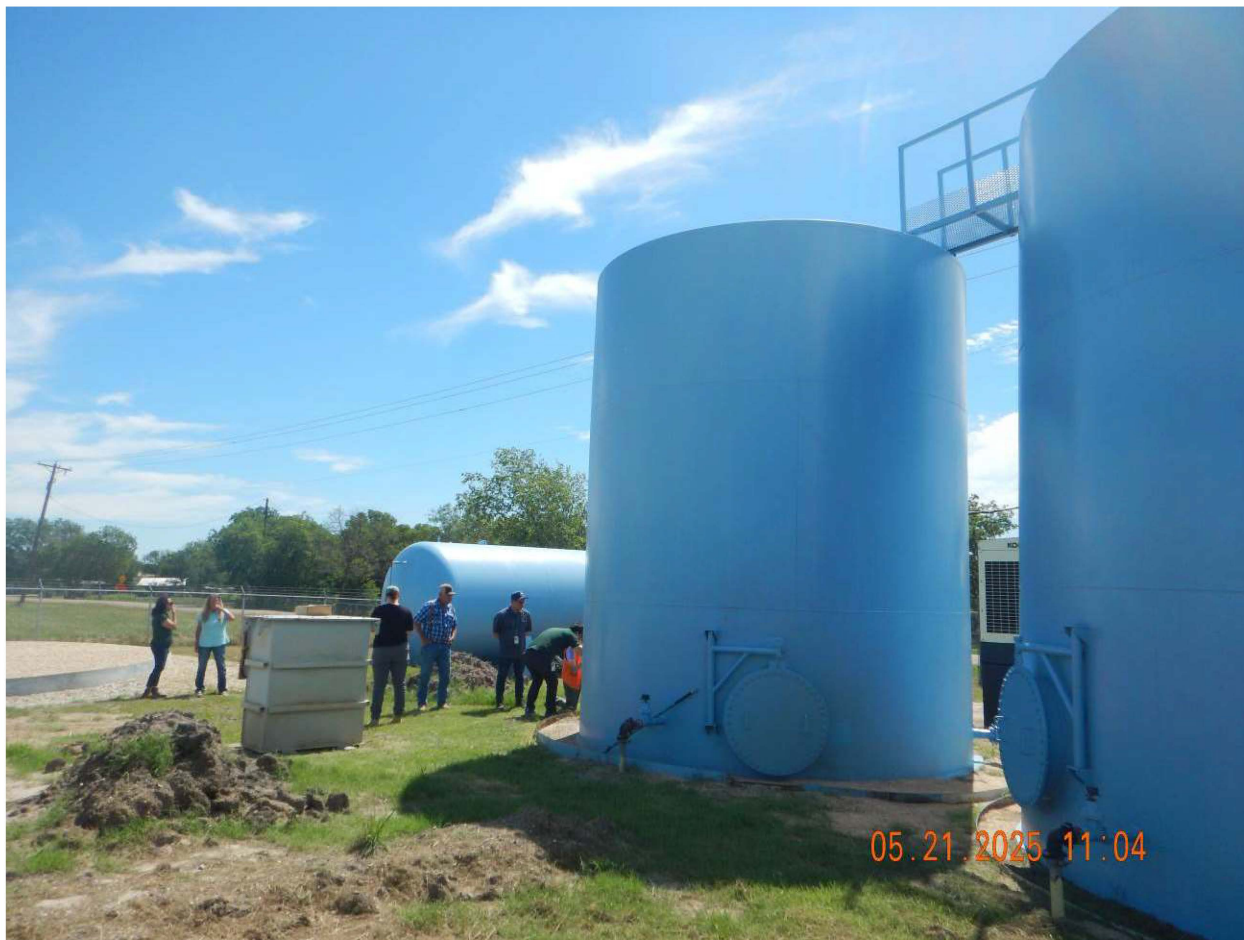
Photo No. 8

Description: Ground storage tanks and hydrostatic pressure tank at Plant 2

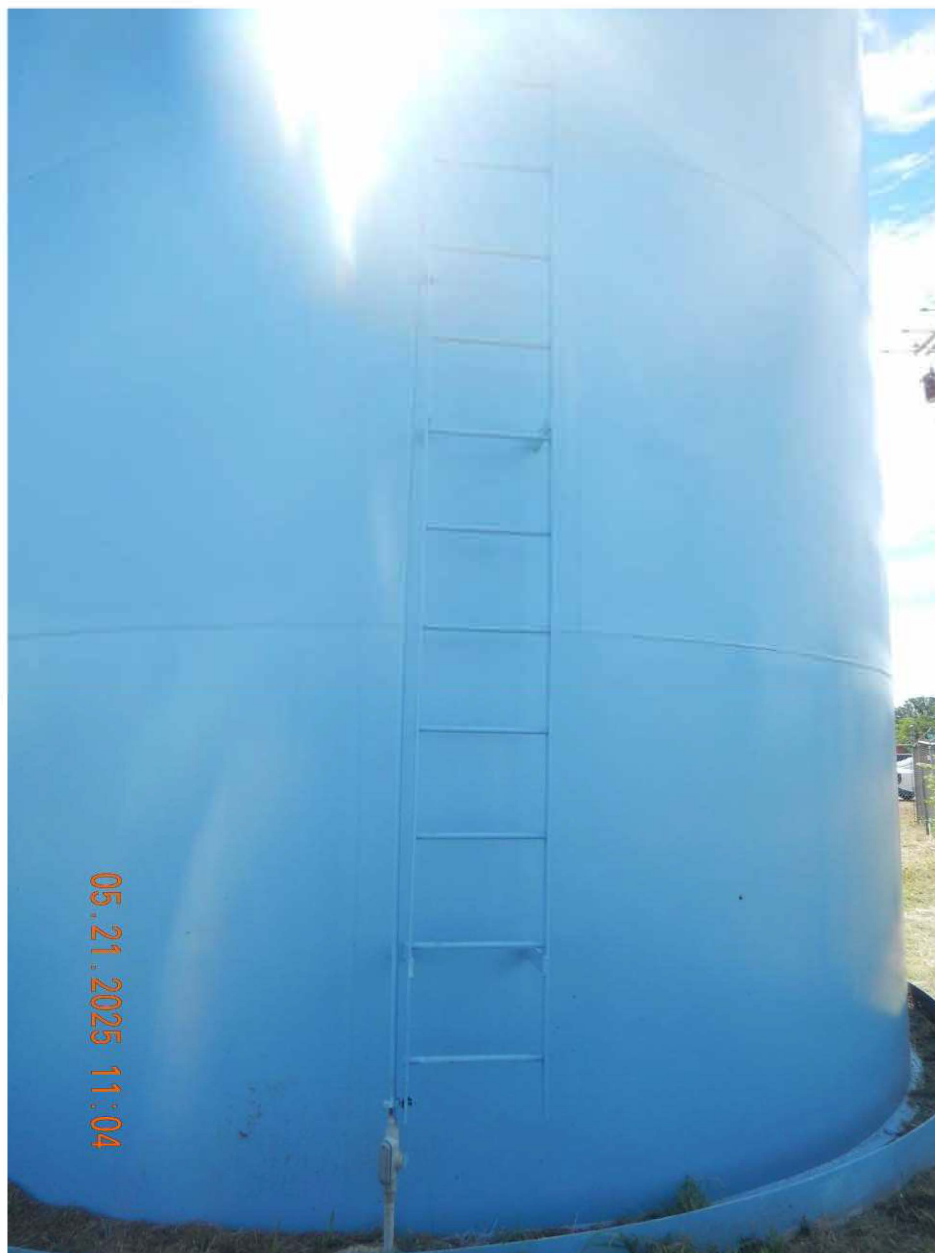
Photo No. 9

Description: Ground storage tank at Plant 2 missing adequate climb protection

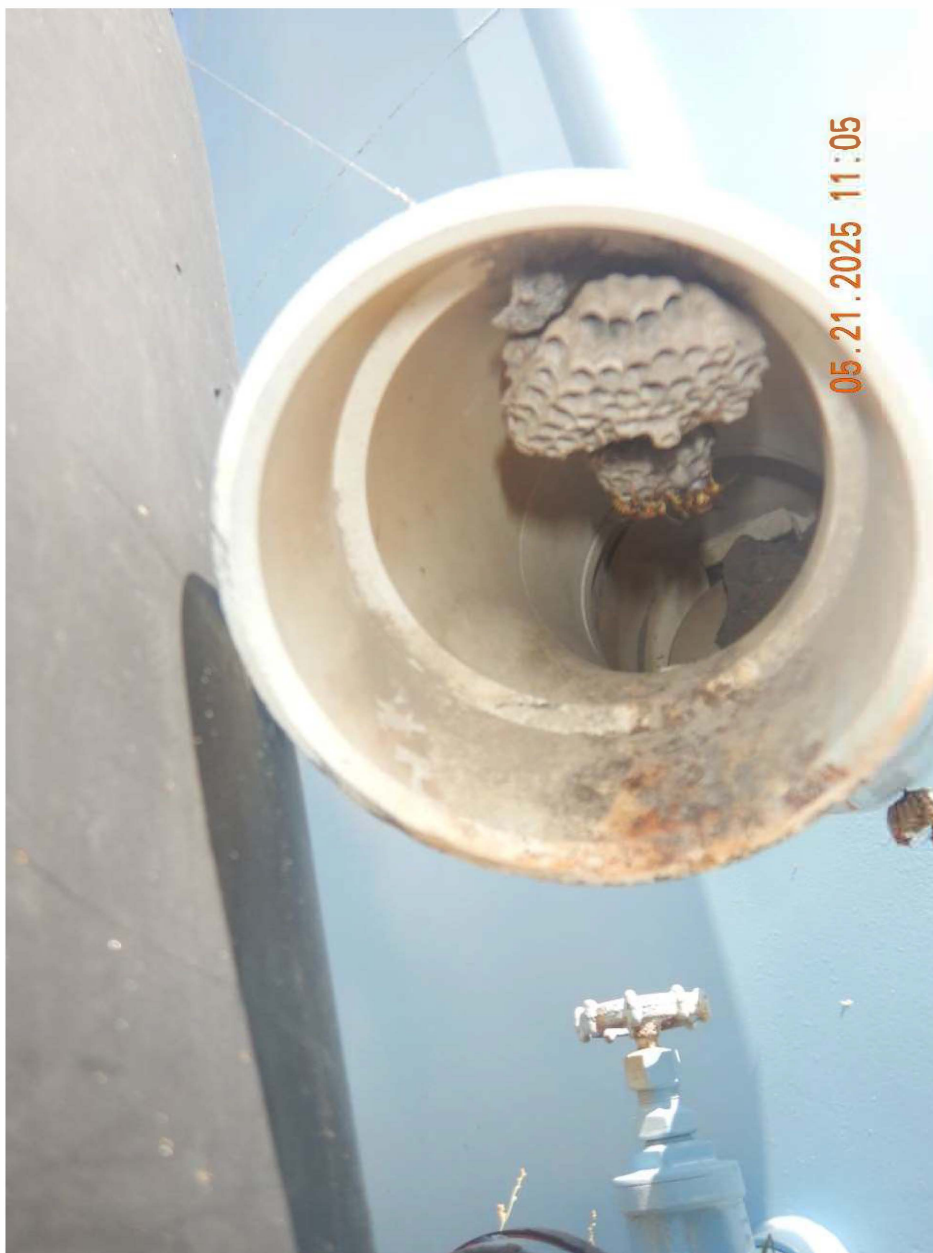
Photo No. 10

Description: Wasp's nest discovered in ground storage tank overflow

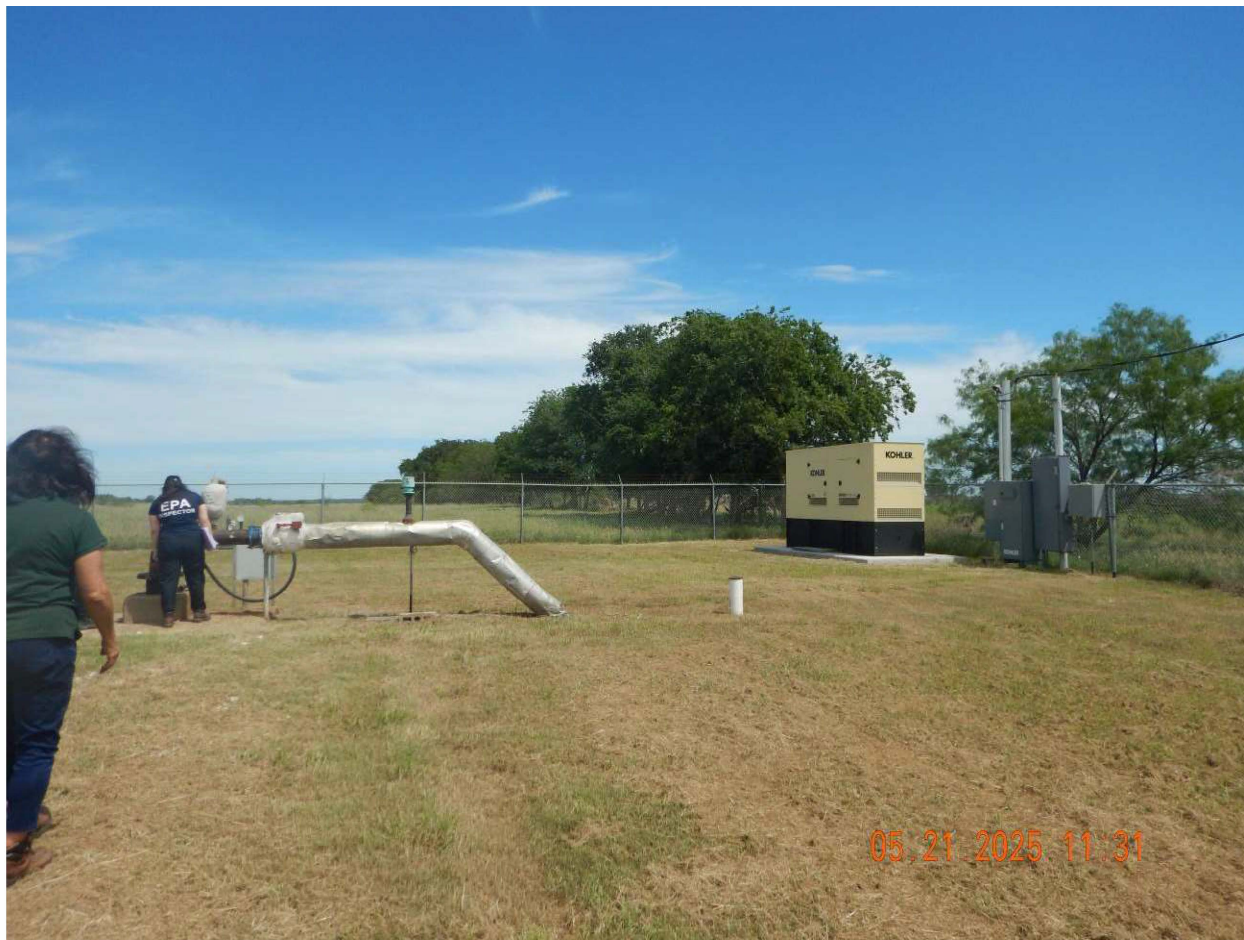
Photo No. 11

Description: Well 3 and accompanying emergency generator

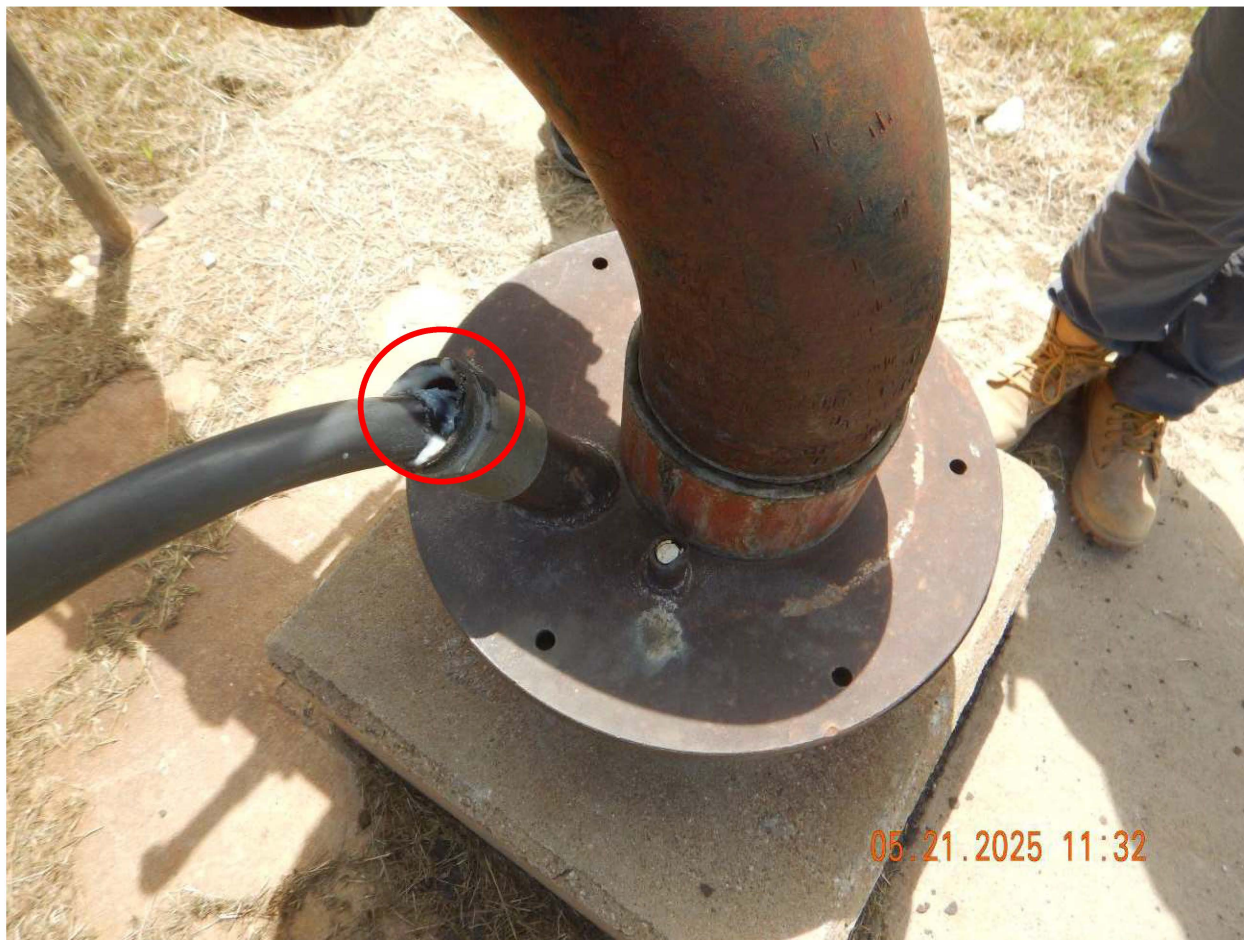
Photo No. 12

Description: Well head of Well 3 with openings for exposure

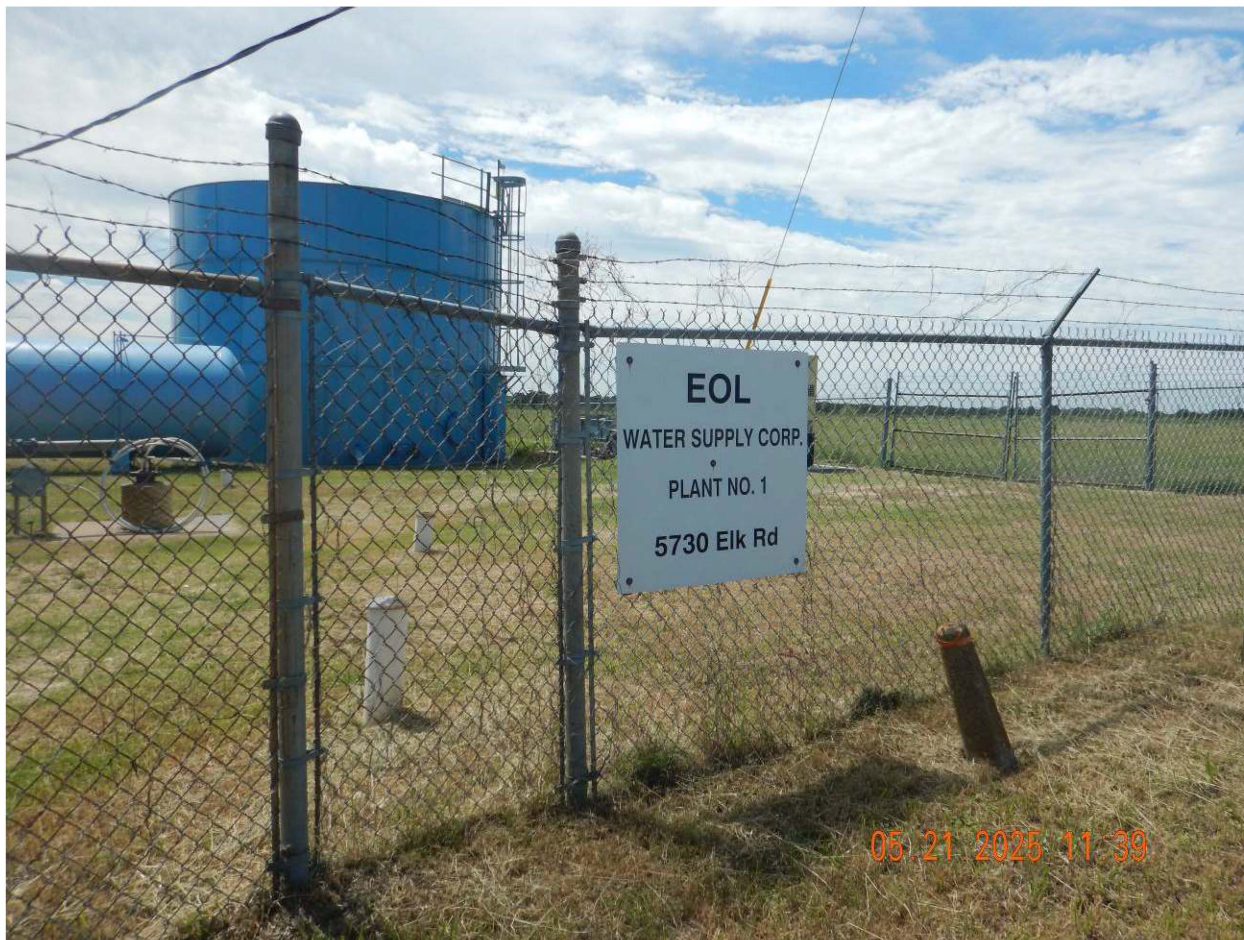
Photo No. 13

Description: Signage on entrance to Plant 1 with no warning of chlorine gas storage on site

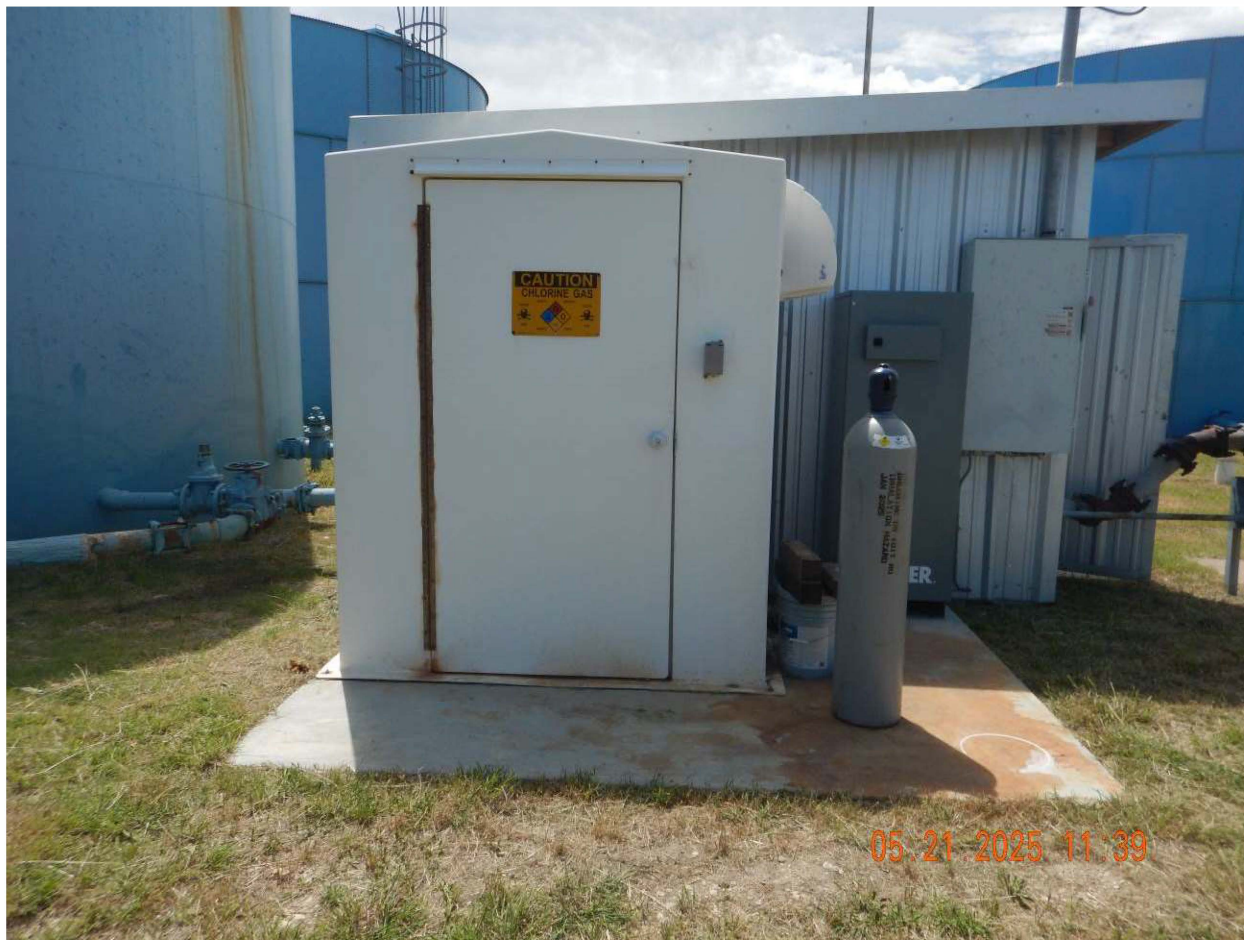
Photo No. 14

Description: Door of chlorine gas room missing viewing window and unchained spent chlorine gas cylinder

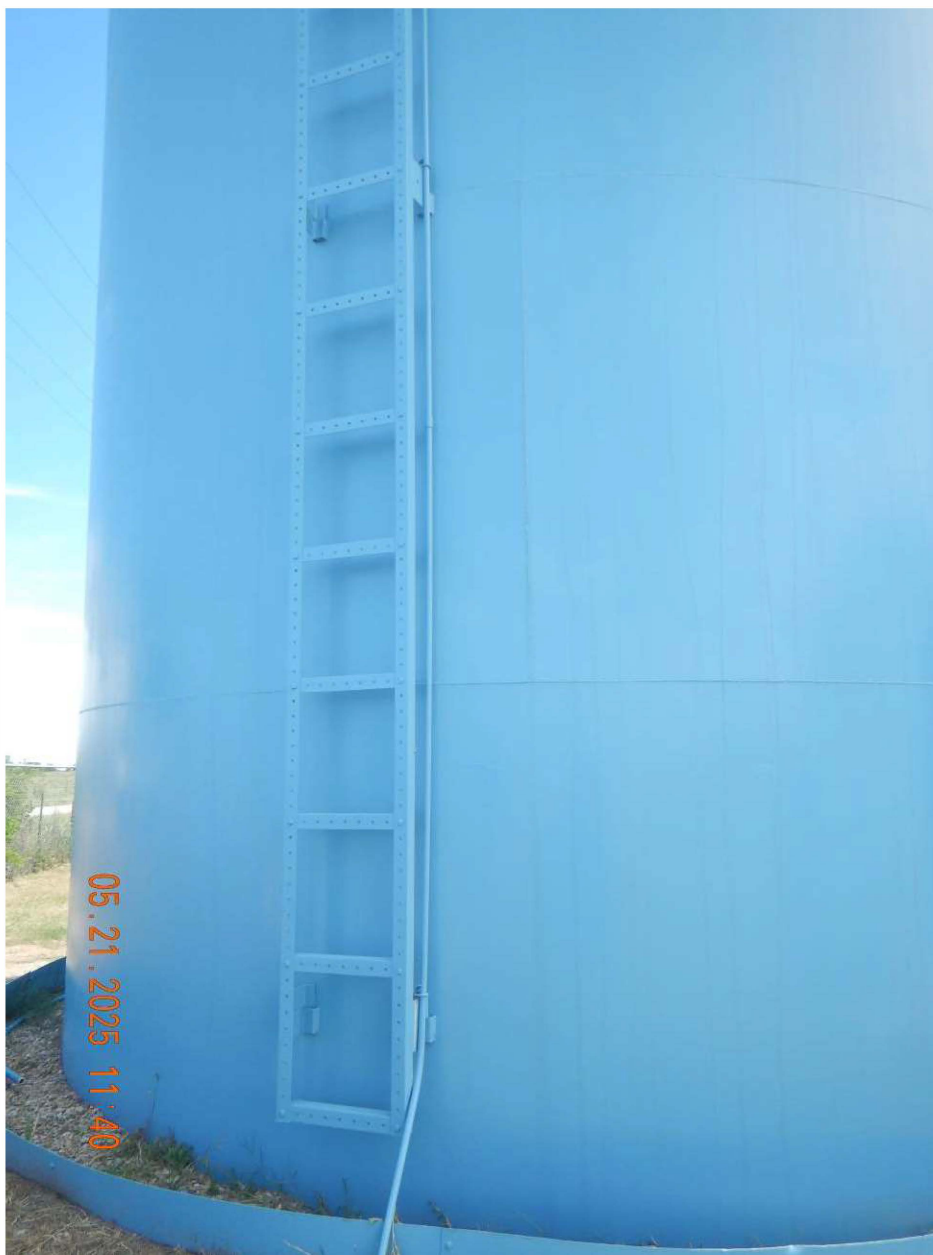
Photo No. 15

Description: Ground storage tank at Plant 1 missing adequate climb protection

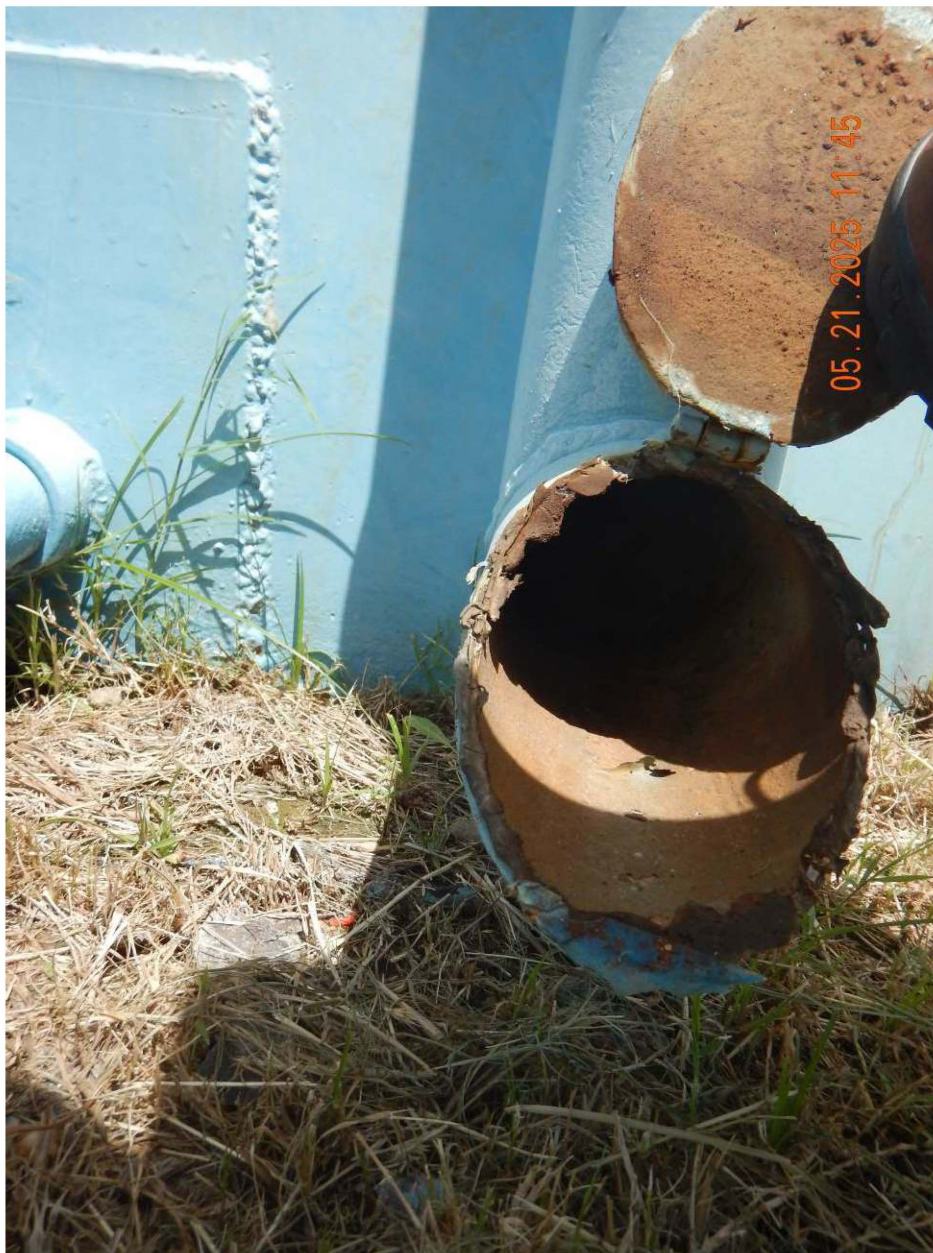
Photo No. 16

Description: Flapper on overflow valve of ground storage tank would not self-close once opened

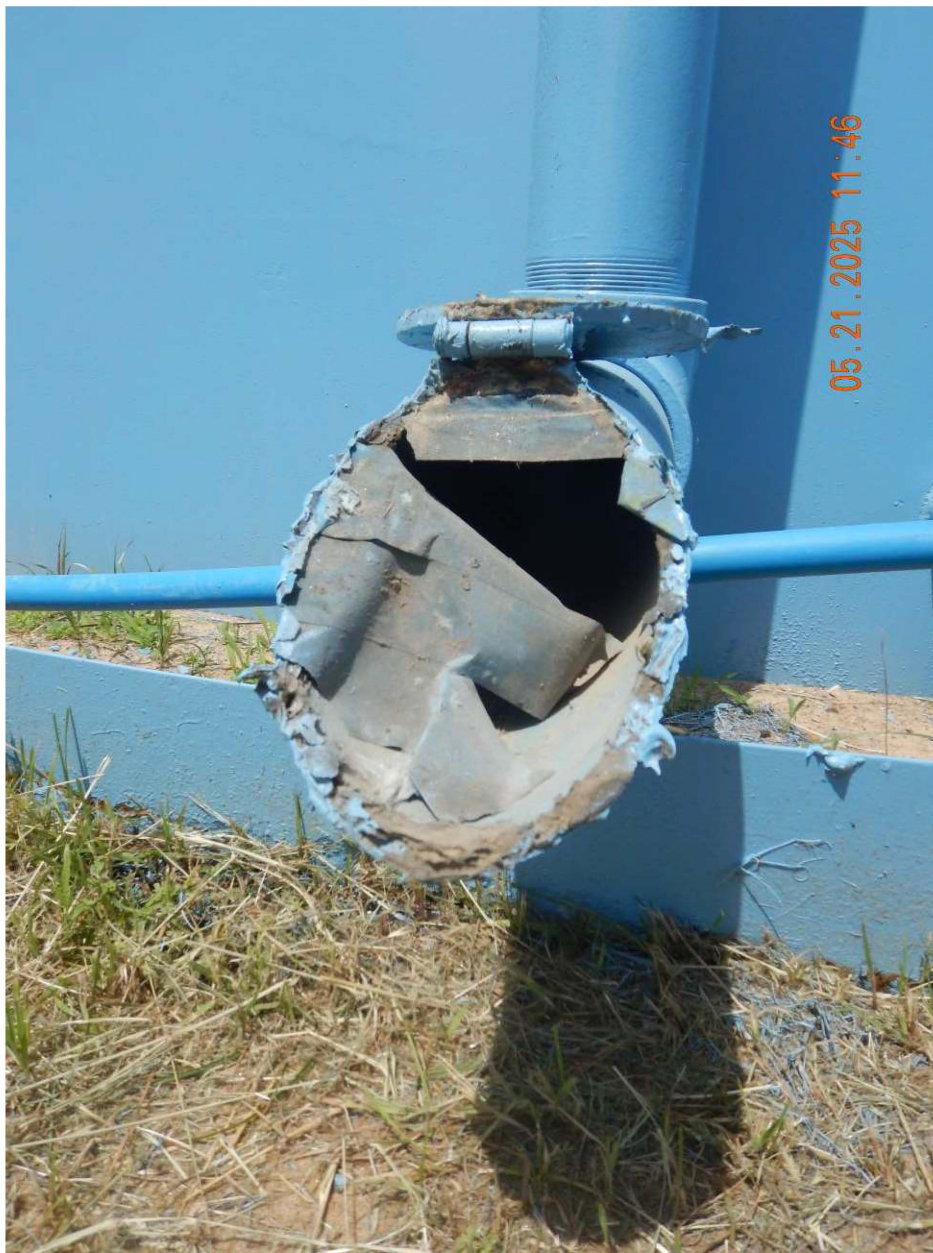
Photo No. 17

10. An overflow flapper valve contained painter's tape that prevented the valve from fully closing at Plant 1 (Photo 17)
11. There was a heavy leak at the cooling tower of Plant 1 (Photo 19)

Description: Flapper on overflow valve of ground storage tank covered in painters tape preventing proper sealing

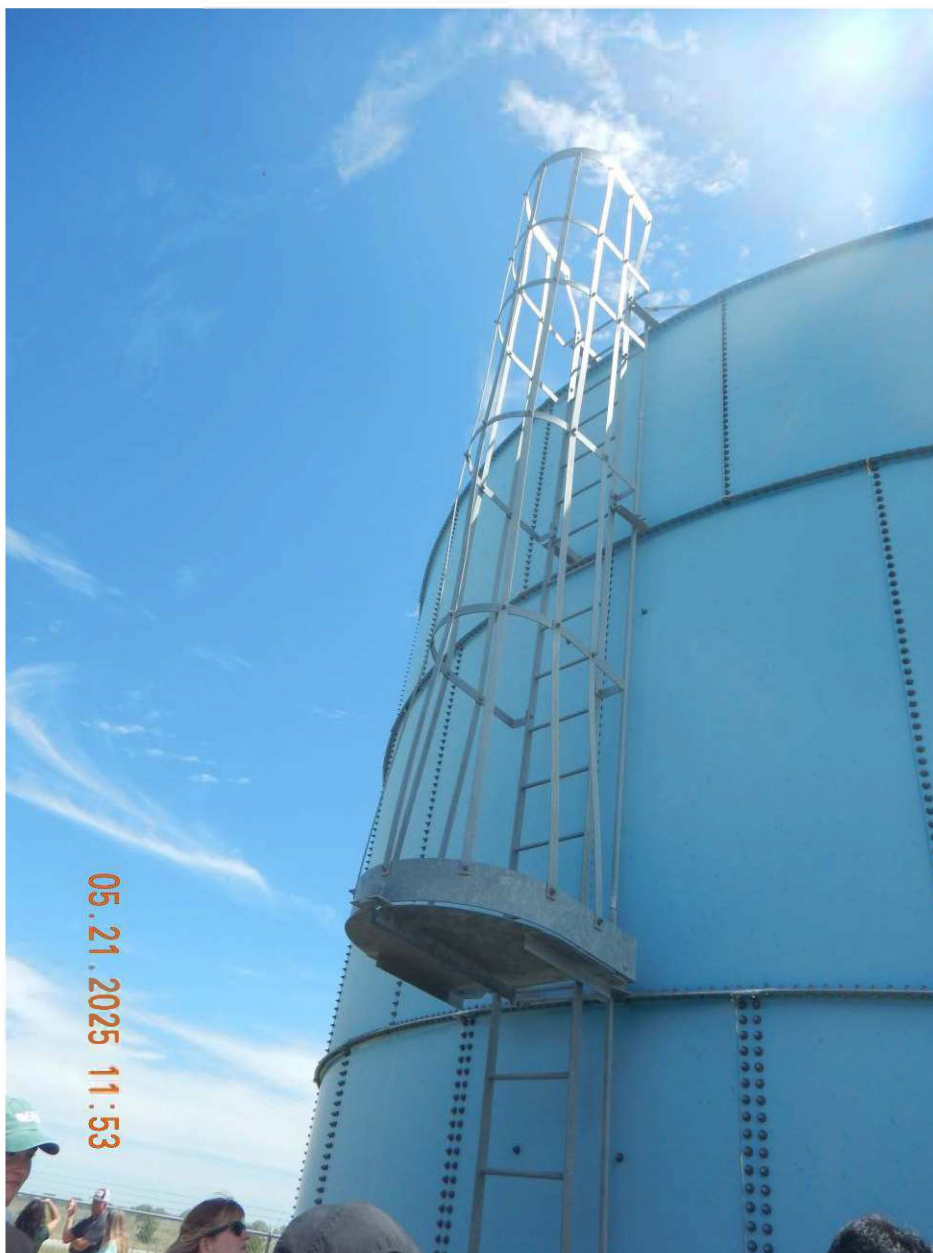
Photo No. 18

Description: Climb protection at ground storage tank at Plant 1 missing lock

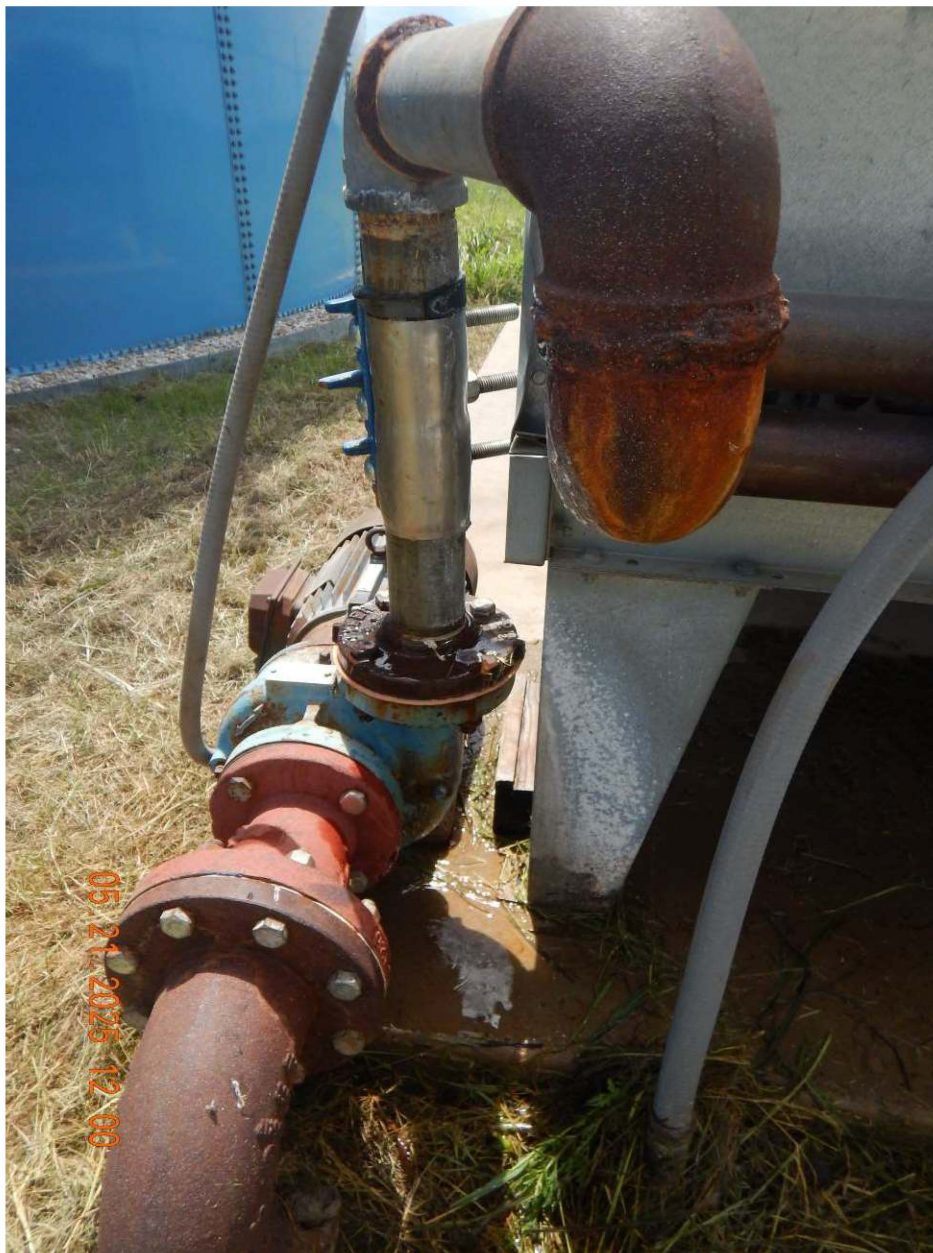
Photo No. 19

Description: Leak at the cooling tower at Plant 1
