## Region 6 - Enforcement & Compliance Assurance Division

### INSPECTION REPORT

| Company Name: | <b>EOL Water Supply Corporation</b> | |
| Identification/Permit Number: | TX1550025 | |

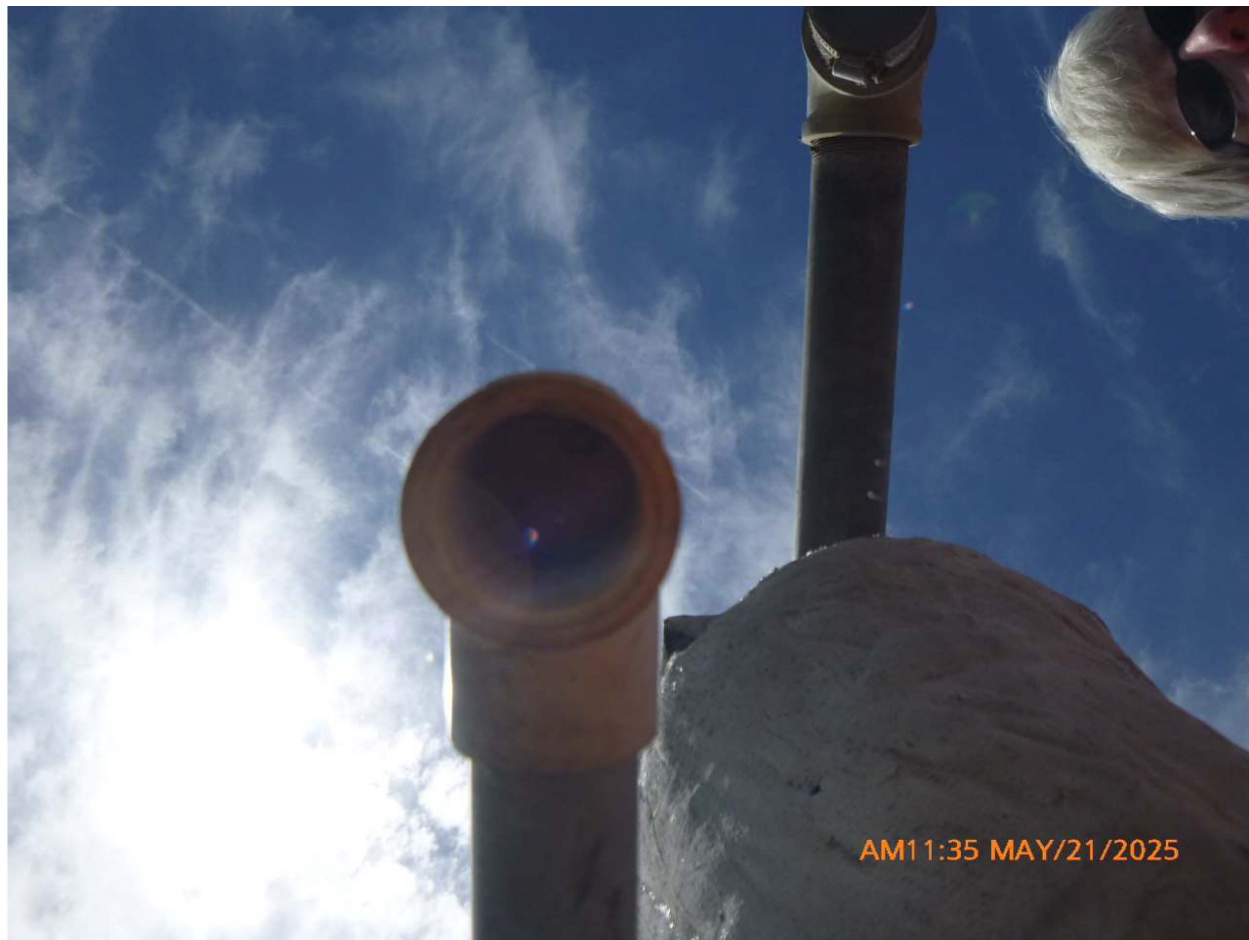
Photo No. 20

Description: Air relief valve at Well 3 missing a 24-mesh screen
