**Region 6 - Enforcement & Compliance Assurance Division**  
**INSPECTION REPORT**

| Inspection Date(s): | 03/03/2025 | |
| Company Name: | <b>Dumas Feedyard LLC</b> | |
| Facility Name: | <b>Dumas Feedyard</b> | |

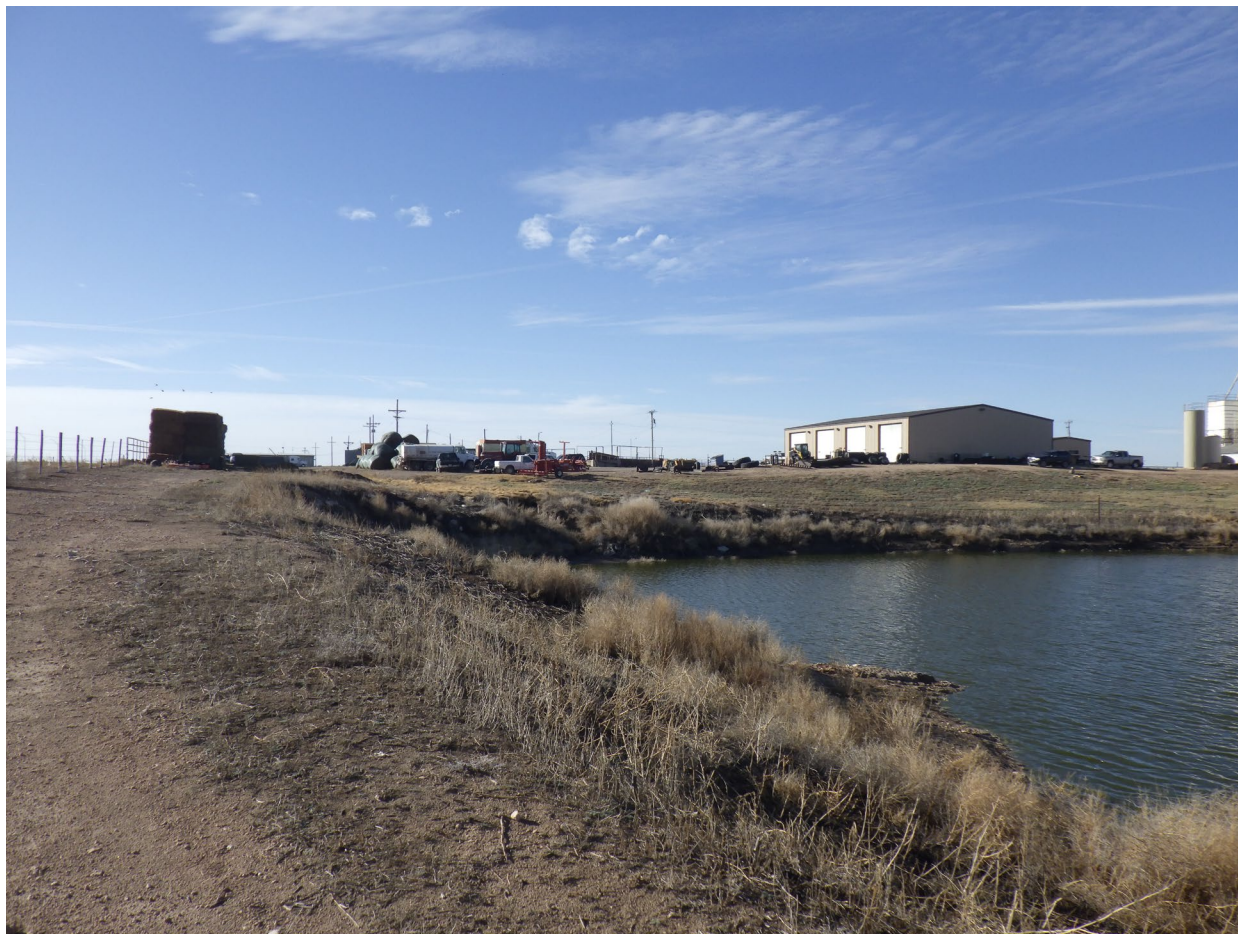
Photo No. 1

Description: View to the south. Shows feed within the drainage of the RCS and adequate freeboard on berm. Pole marker present.

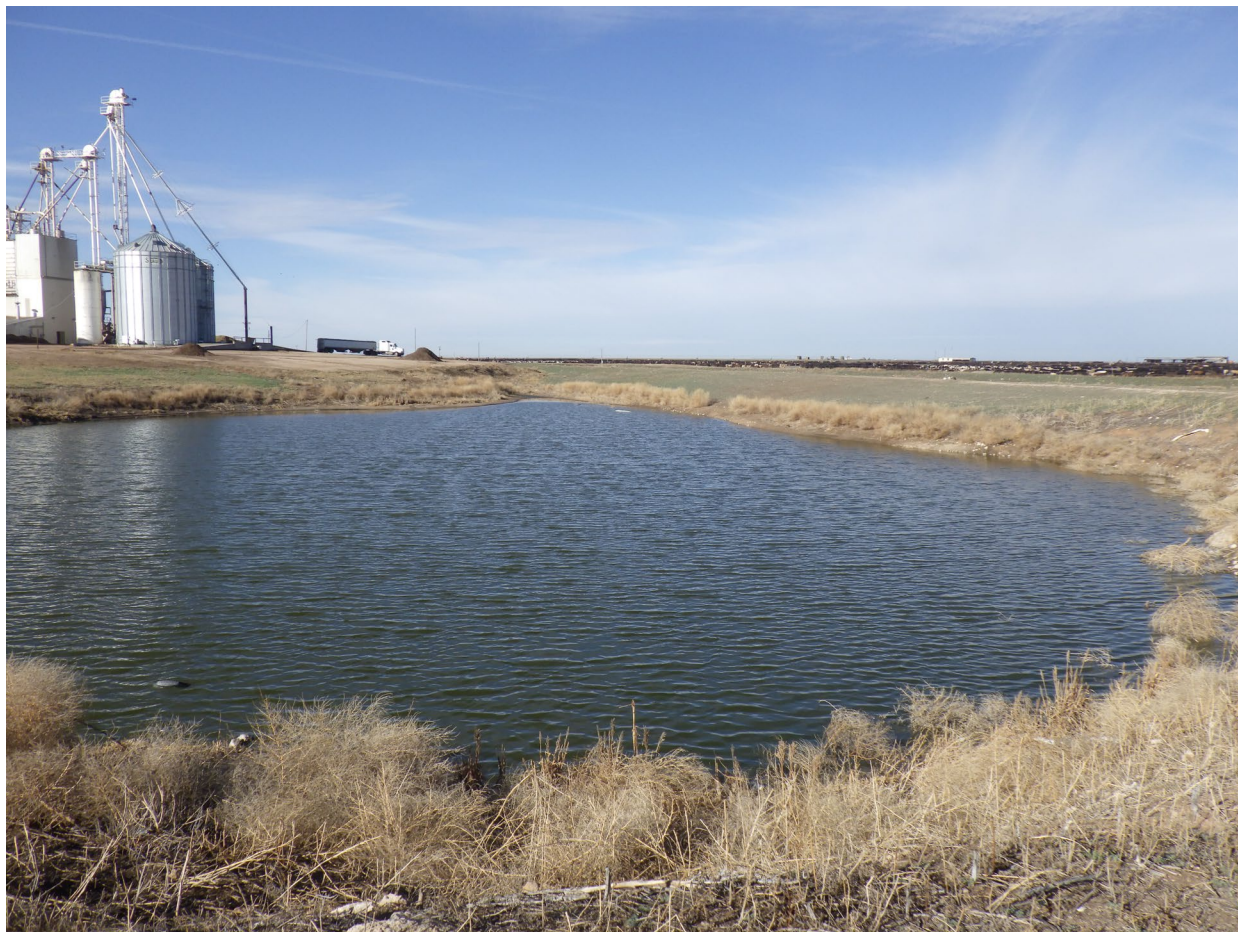
Photo No. 2

Description: View to the west. Commodity storage in background along with drainage channel entering the RCS.

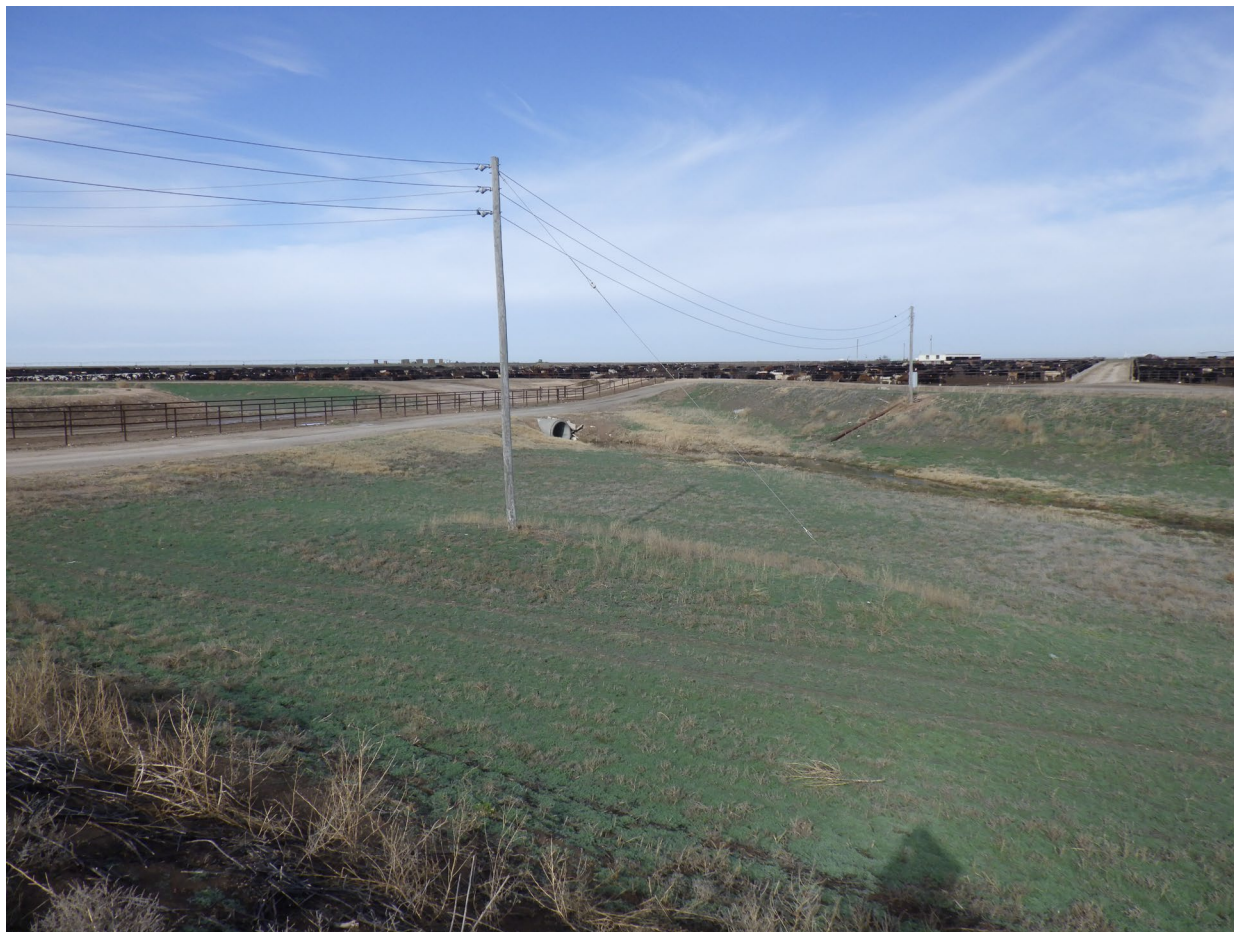
Photo No. 3

The facility has berms on either side of the Palo Duro Creek to prevent wastewater runoff from entering the waterway (Appendix 1, Photos 3, 4, 11, 12, 14 & 15). The berms are in good condition and seemed adequate to prevent a discharge at the time of the inspection.

Description: View to the north. Culvert for Palo Duro Creek path that runs between berms.

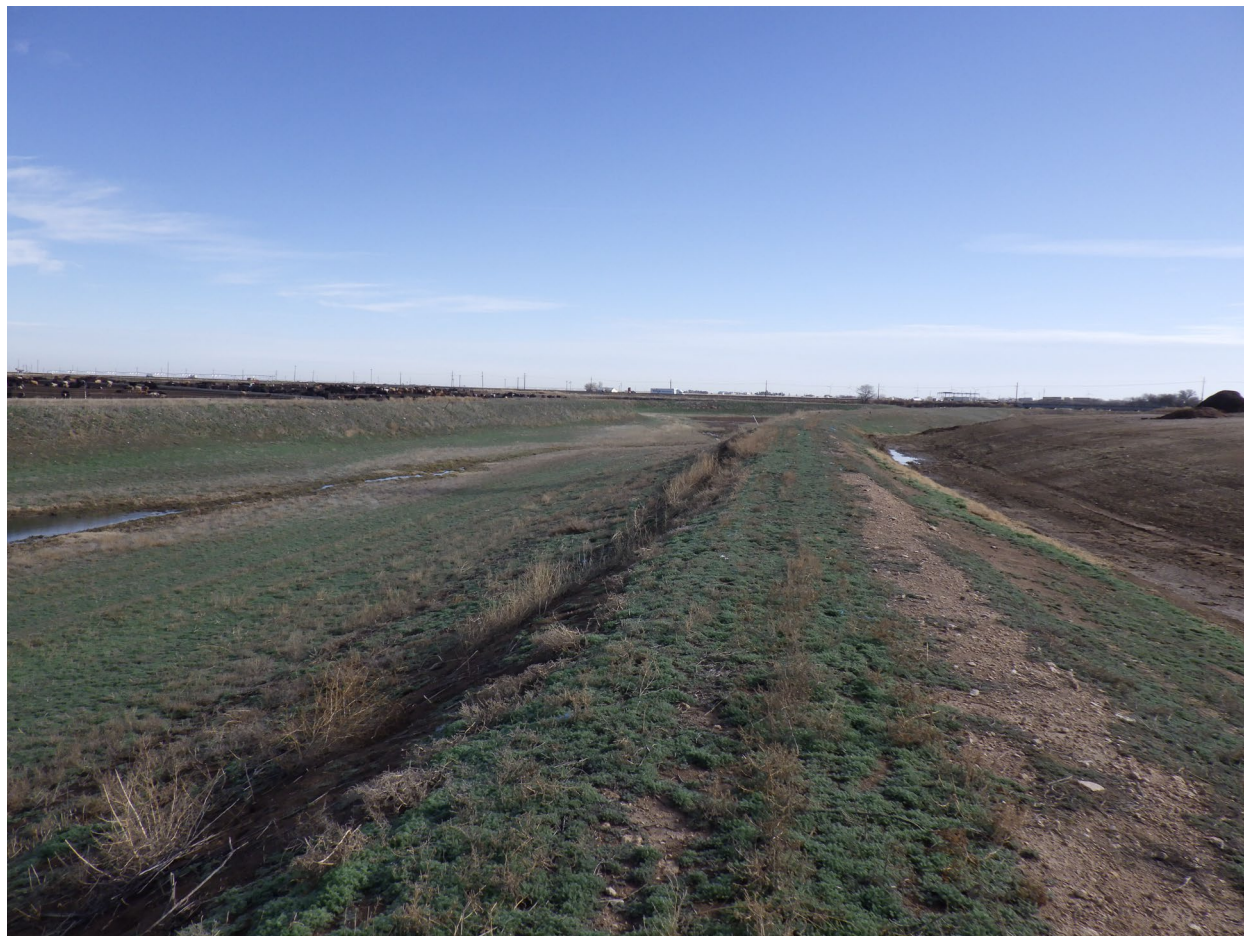
Photo No. 4

Description: View to the east. Standing on berm between Palo Duro Creek and commodity storage area.

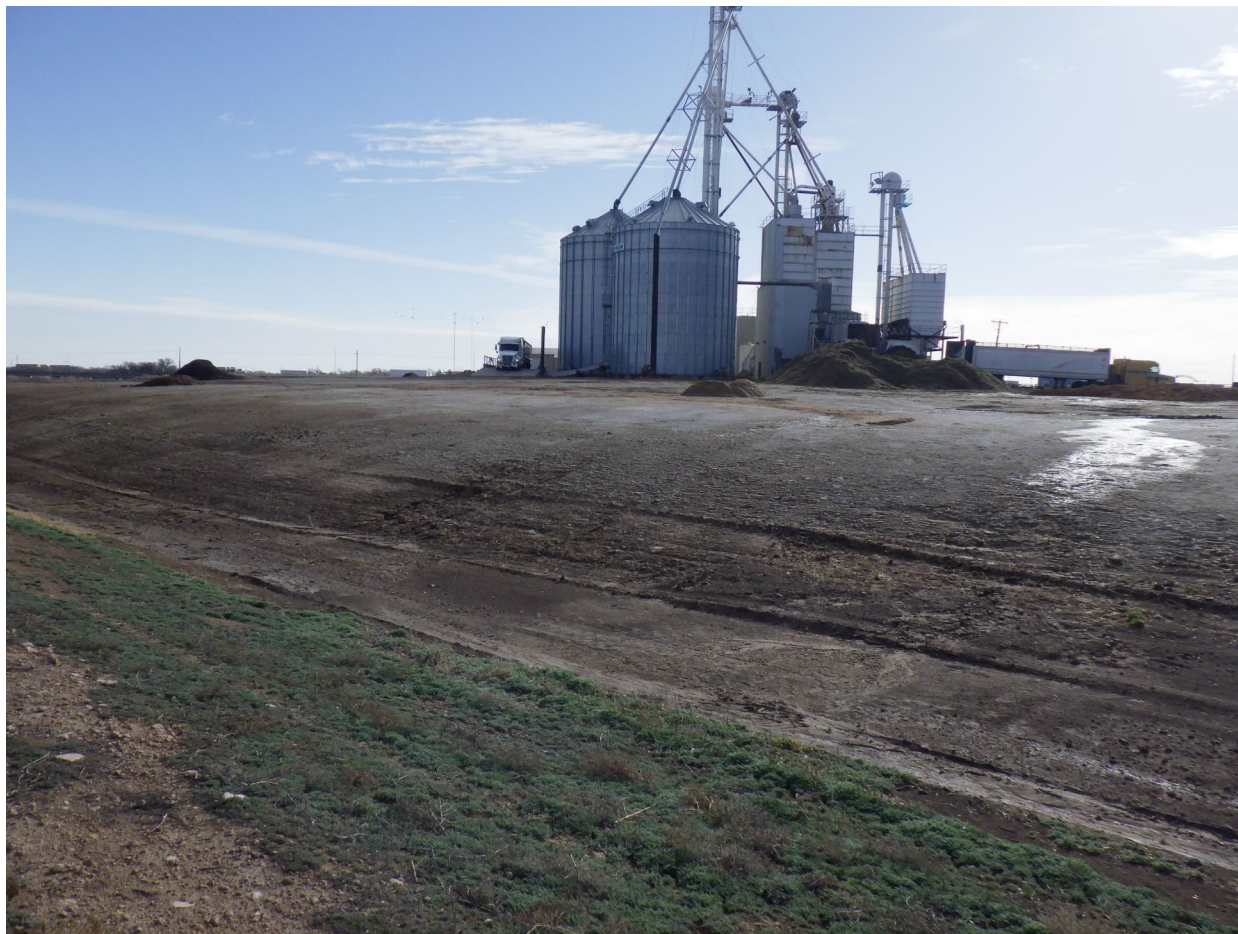
Photo No. 5

Description: View to the southeast. Standing on berm. Shot of commodity storage area showing slope.

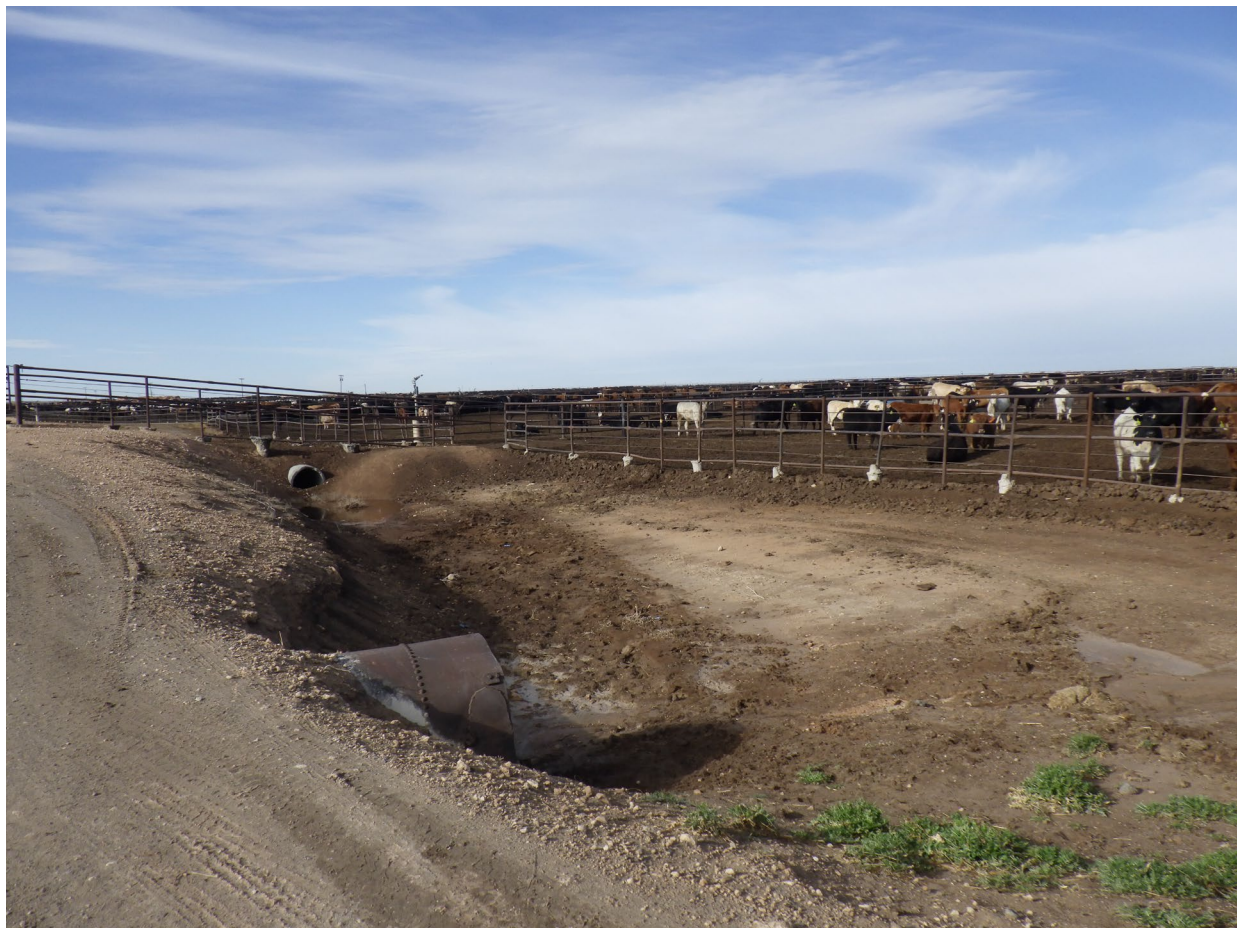
Photo No. 6

Description: View to the northwest. Drainage channel next to open lot pens that directs runoff to RCS.

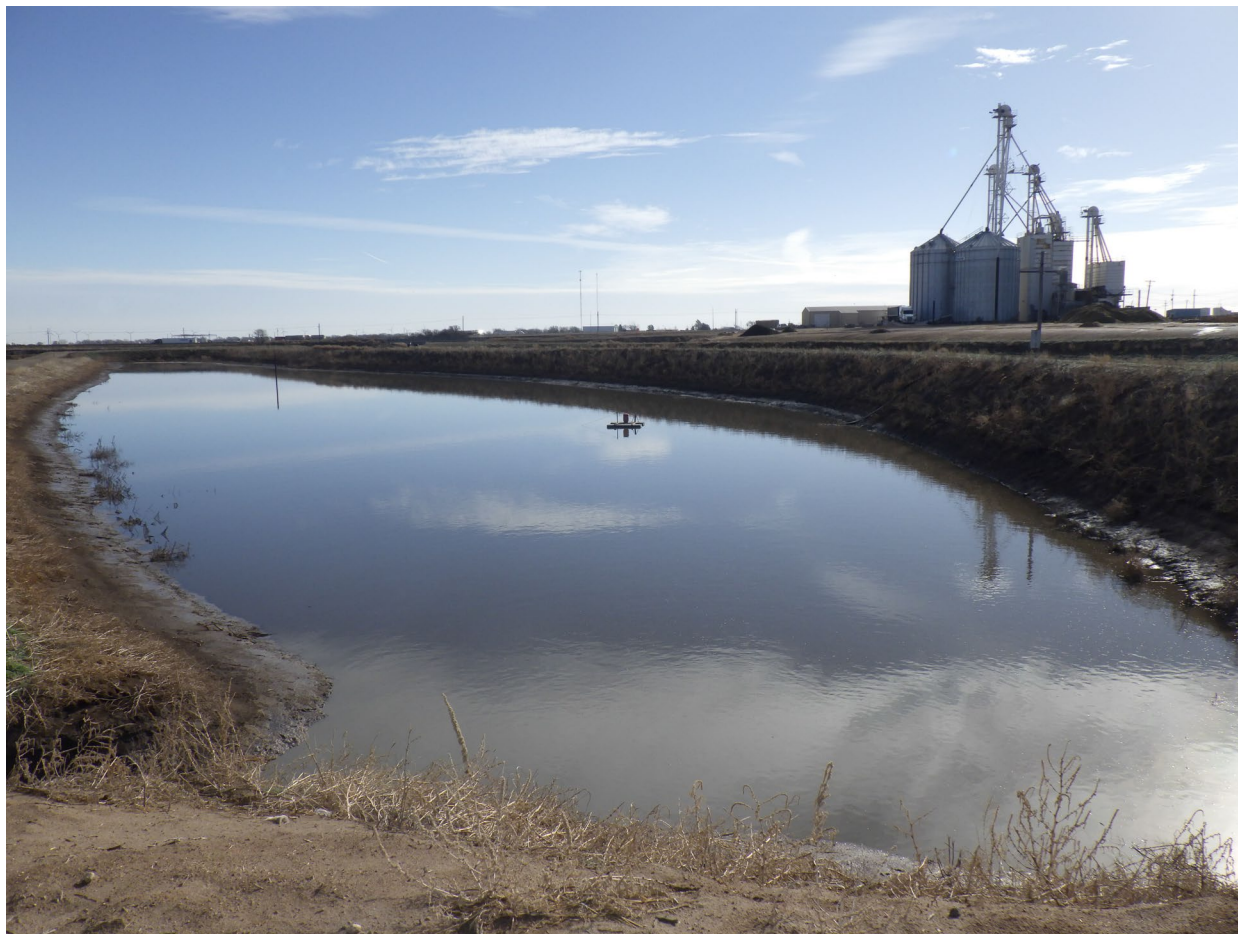
Photo No. 7

Description: View to the southeast. Outfall from drainage channel shown in Photo 6. Pump and pole marker visible along with commodity storage in background.

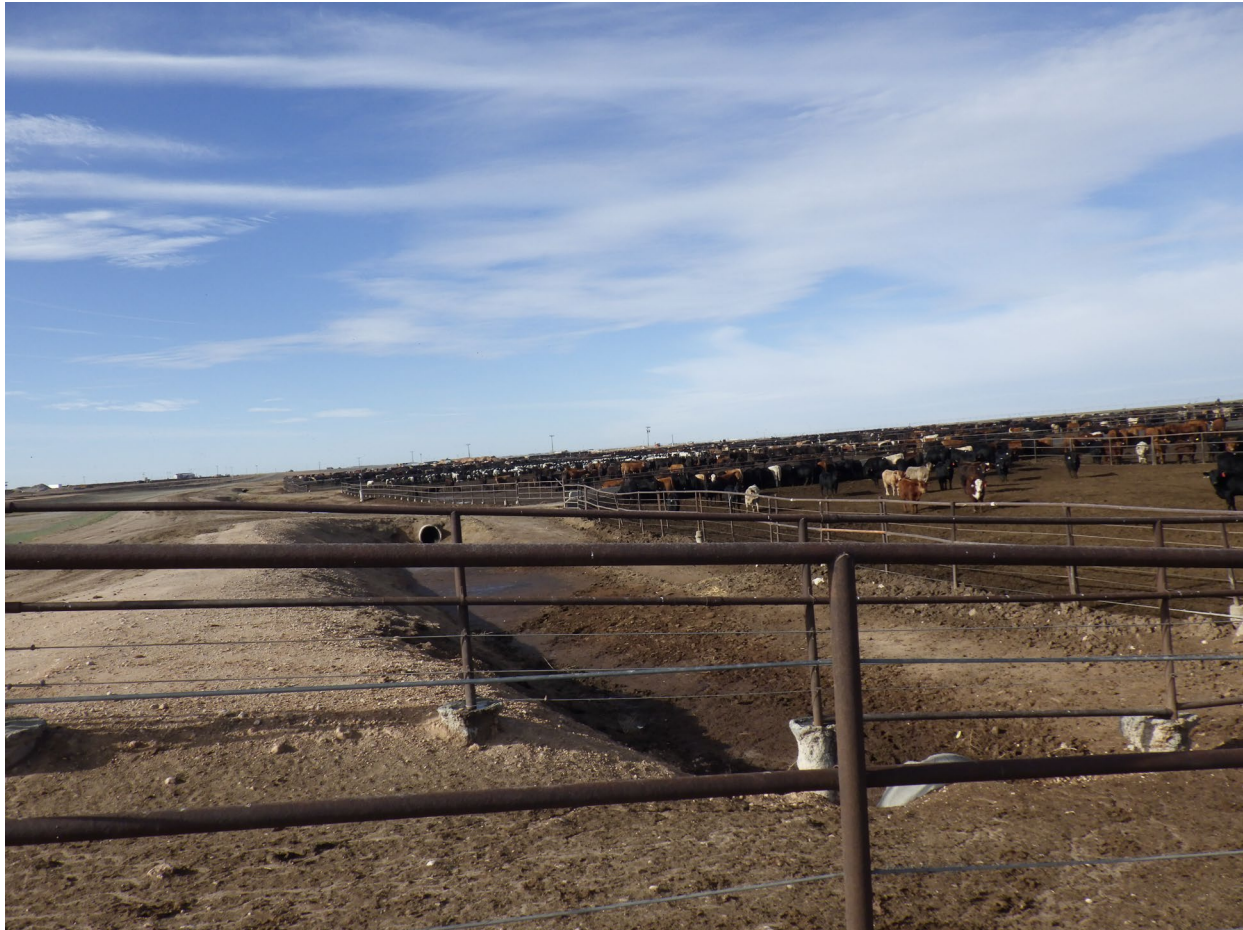
Photo No. 8

Description: View to the southwest. Drainage channel next to open lot pens.

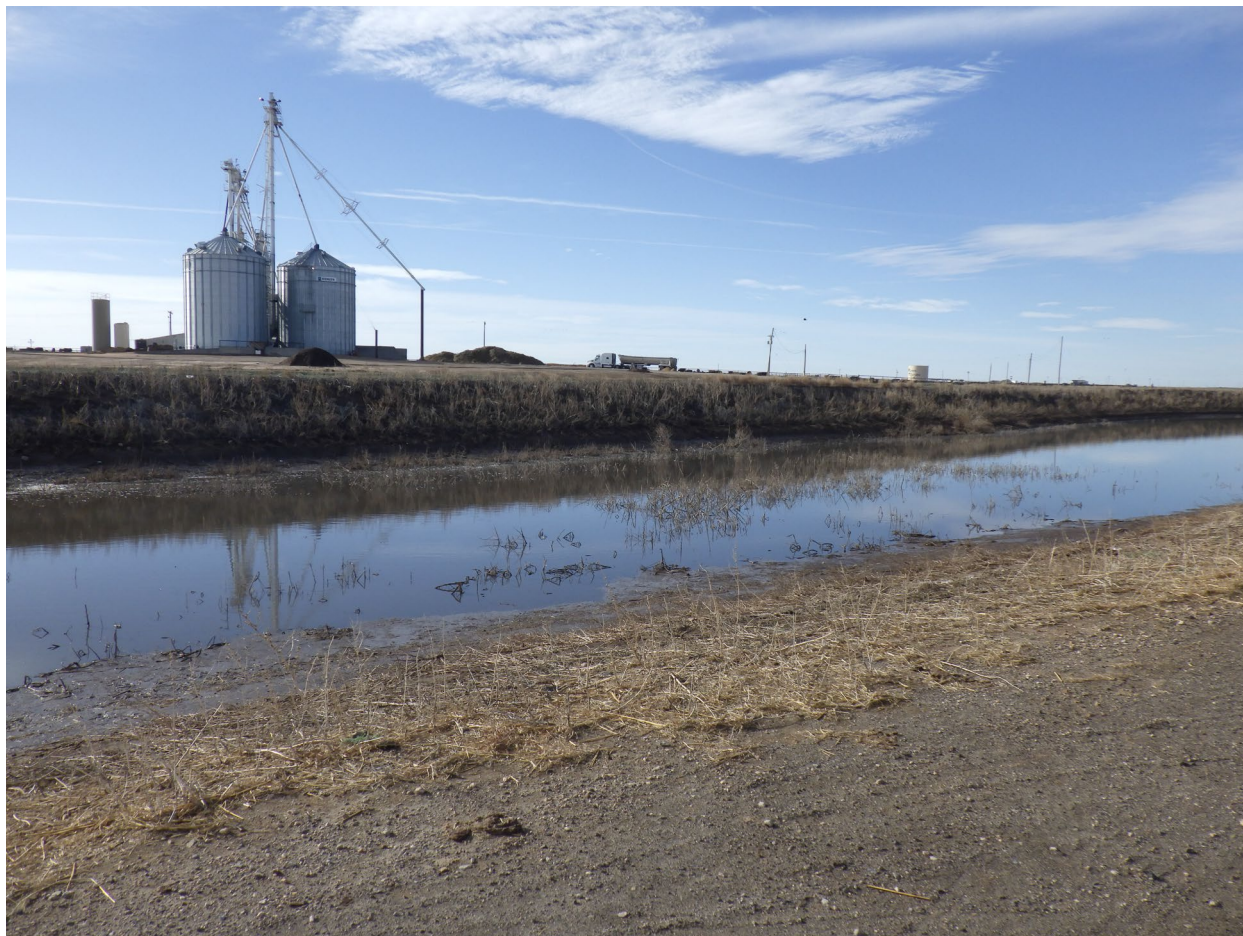
Photo No. 9

A check of the lagoon designs and as-builts showed adequate storage for the production area and 25-year/24-hour rain event. The lagoons are all clay lined and certified. Infiltration tests were all shown to be above the minimum requirement of hydraulic conductivities no greater than  $1 \times 10^{-7}$  centimeters per second. The most recent 5-year evaluation of the RCSs was conducted on 09/21/20 by Benjamin Weinheimer of TCFA. A visual check of the lagoons was conducted and there was adequate freeboard, pole markers, lack of erosion, no solids overloading, and no evidence of unauthorized discharge. However, there were no lagoon fences present (Appendix 1, Photos 1, 2, 7, 9, 10, 13, 16 & 20) (see Areas of Concern 2). There was also some vegetation growing in the RCS 1A (Appendix 1, Photos 9 & 10) (see Areas of Concern 2).

- 1) There is vegetation growth inside RCS 2. Part III.A.10. (f)(3) of the TPDES CAFO General Permit requires “No tree shall be allowed to grow such that the root zone would intrude or compromise the structure of the liner or embankment.”
- 2) There is a lack of fencing for RCSs. Part III.A.10. (f)(2) of the TPDES CAFO General Permit requires “Liners must be protected from animals by fences or other protective devices.”

Description: View to south. RCS below commodity storage. Vegetation present in RCS.

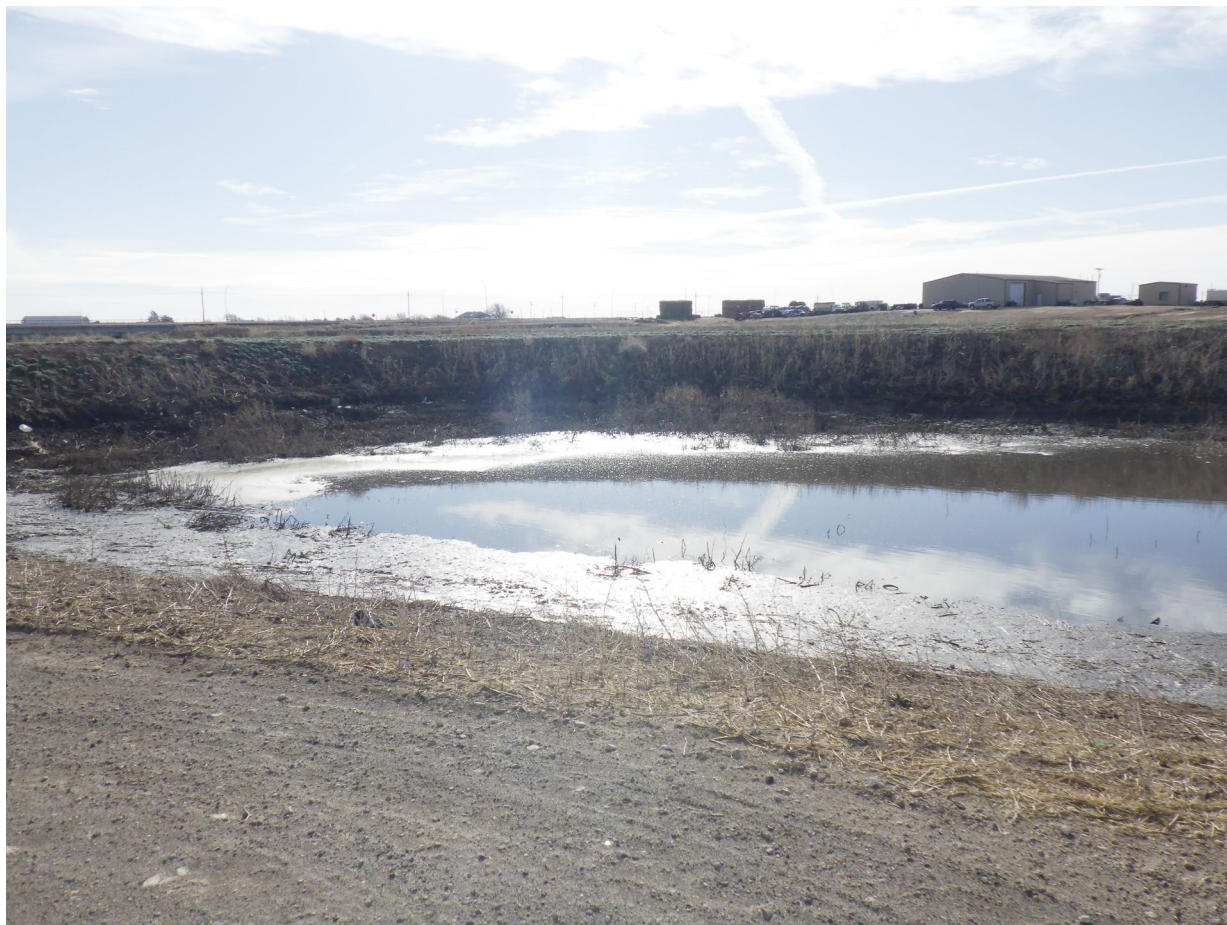
Photo No. 10

Description: View to southeast. Corner of RCS in Photo 9. Shows vegetation growth inside RCS.

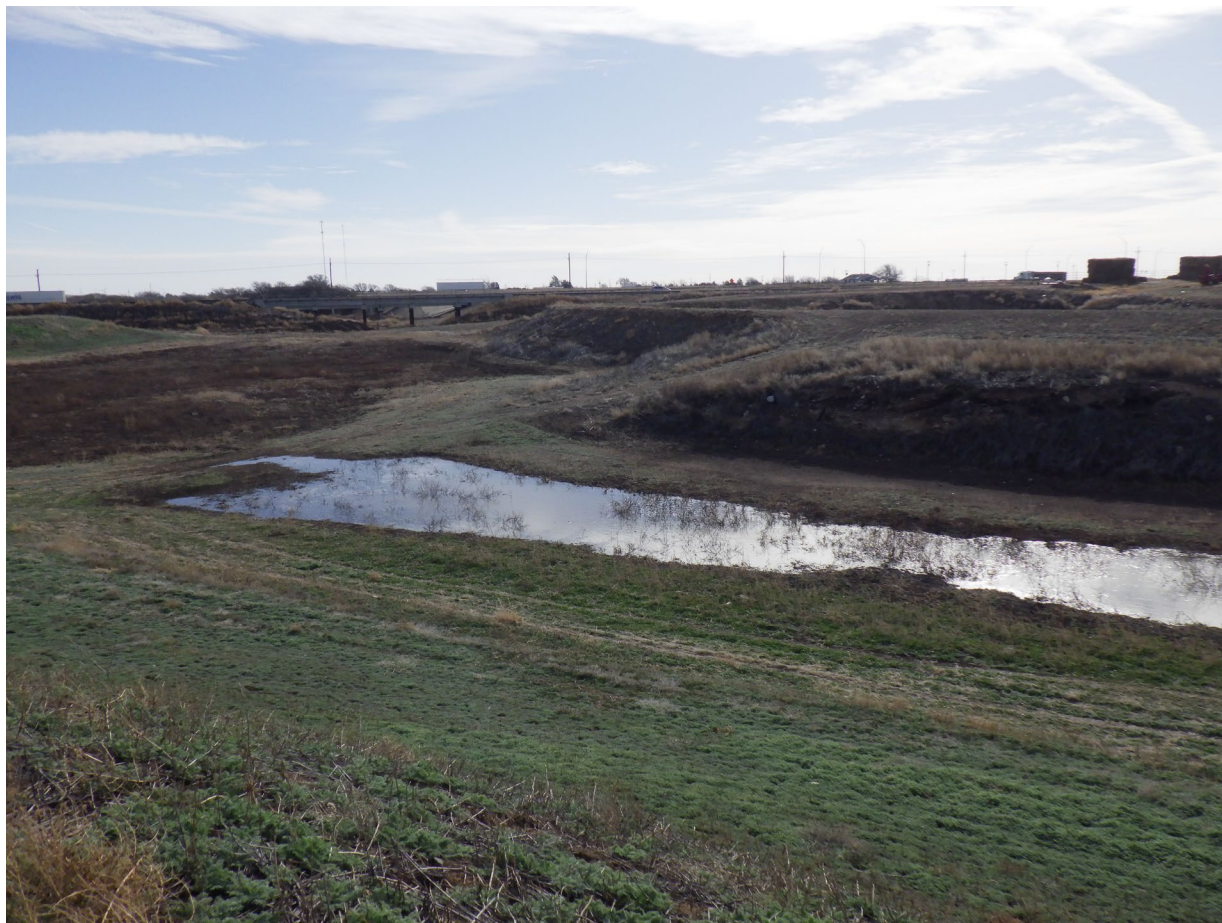
Photo No. 11

Description: View to the east. Palo Duro Creek.

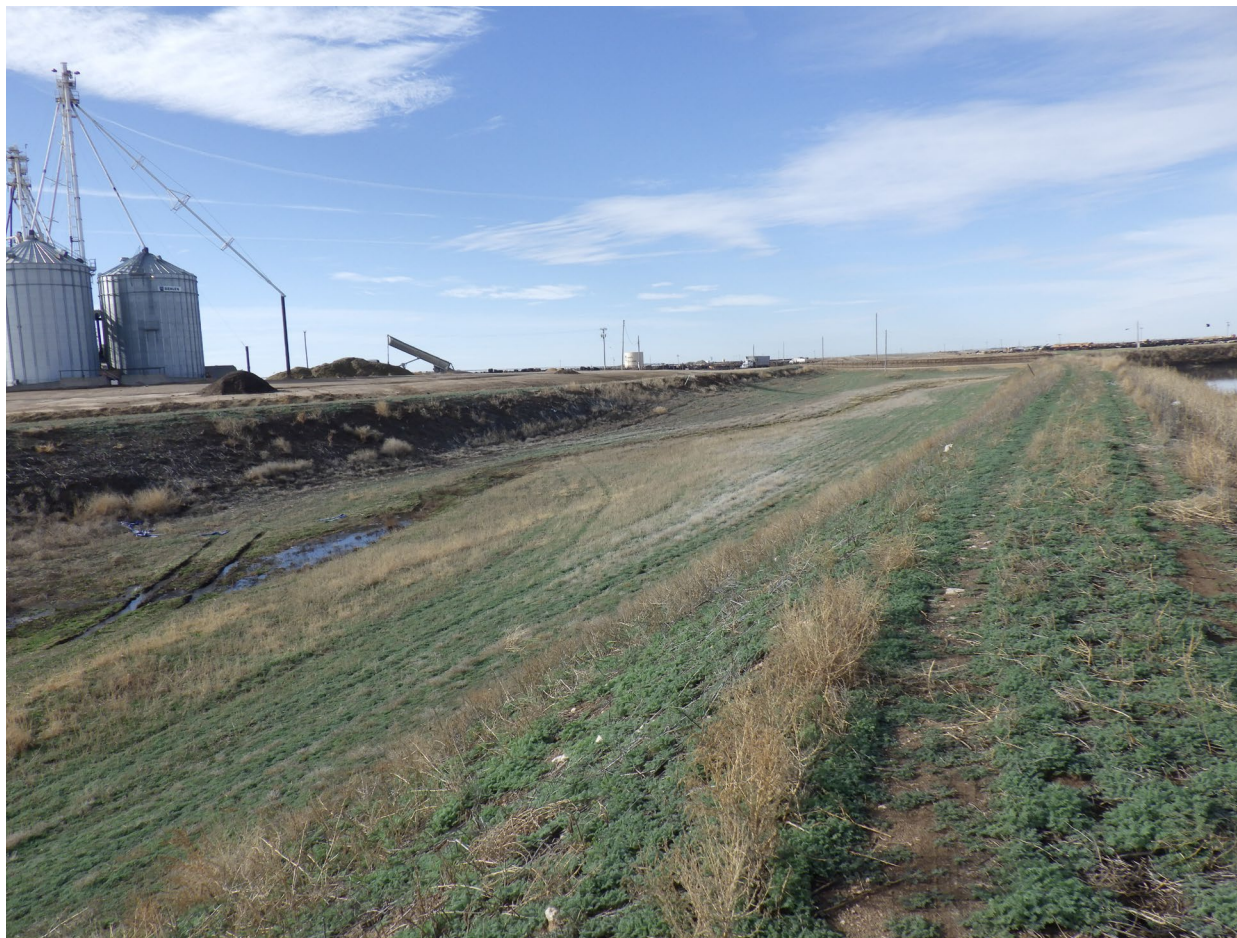
Photo No. 12

Description: View to the west. Palo Duro Creek between berms.

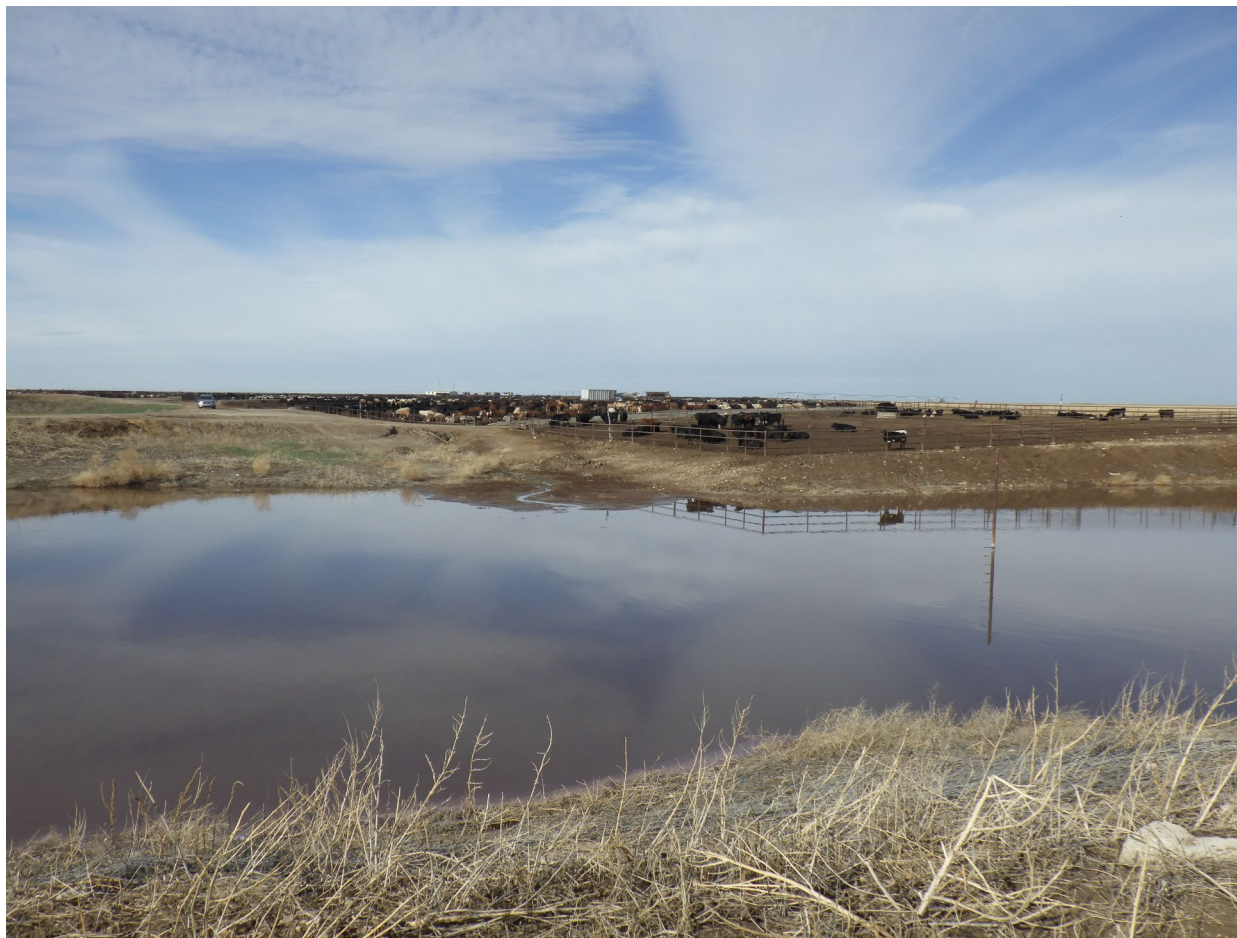
Photo No. 13

Description: View to the north. RCS with drainage channel outfall from pens.

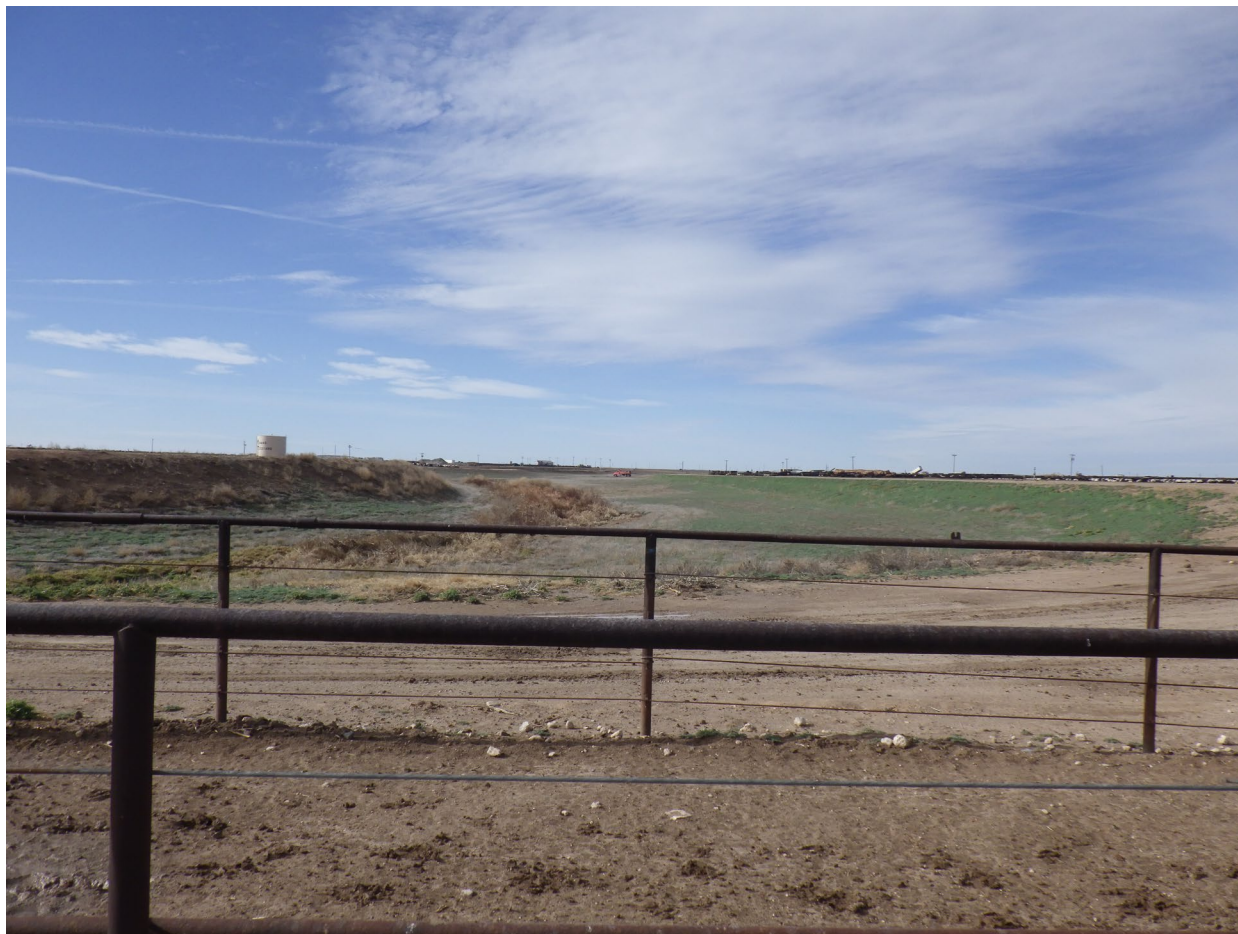
Photo No. 14

Description: View to the west. Palo Duro Creek before it goes under road through culvert. Shows berms.

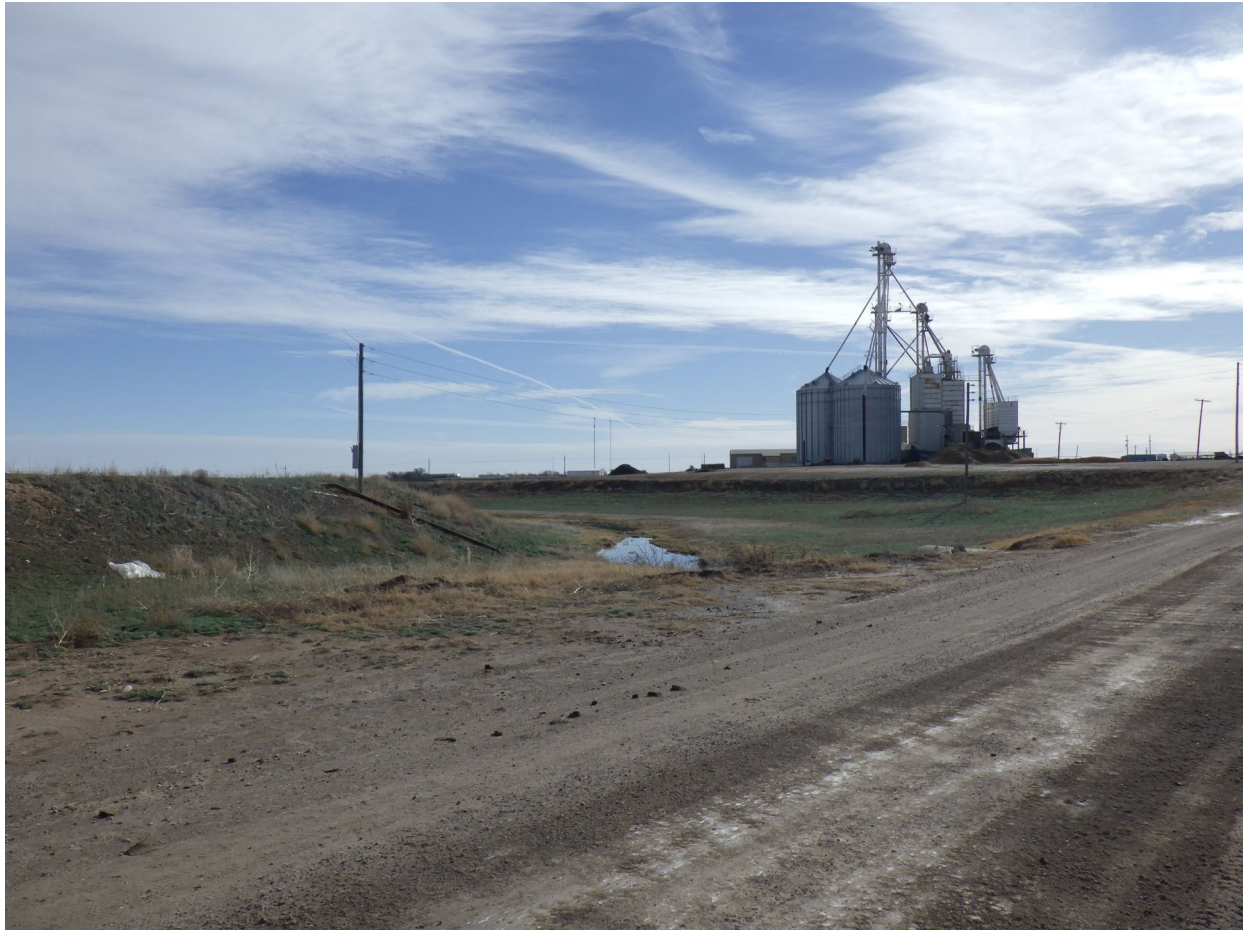
Photo No. 15

Description: View to the southeast. Palo Duro Creek.

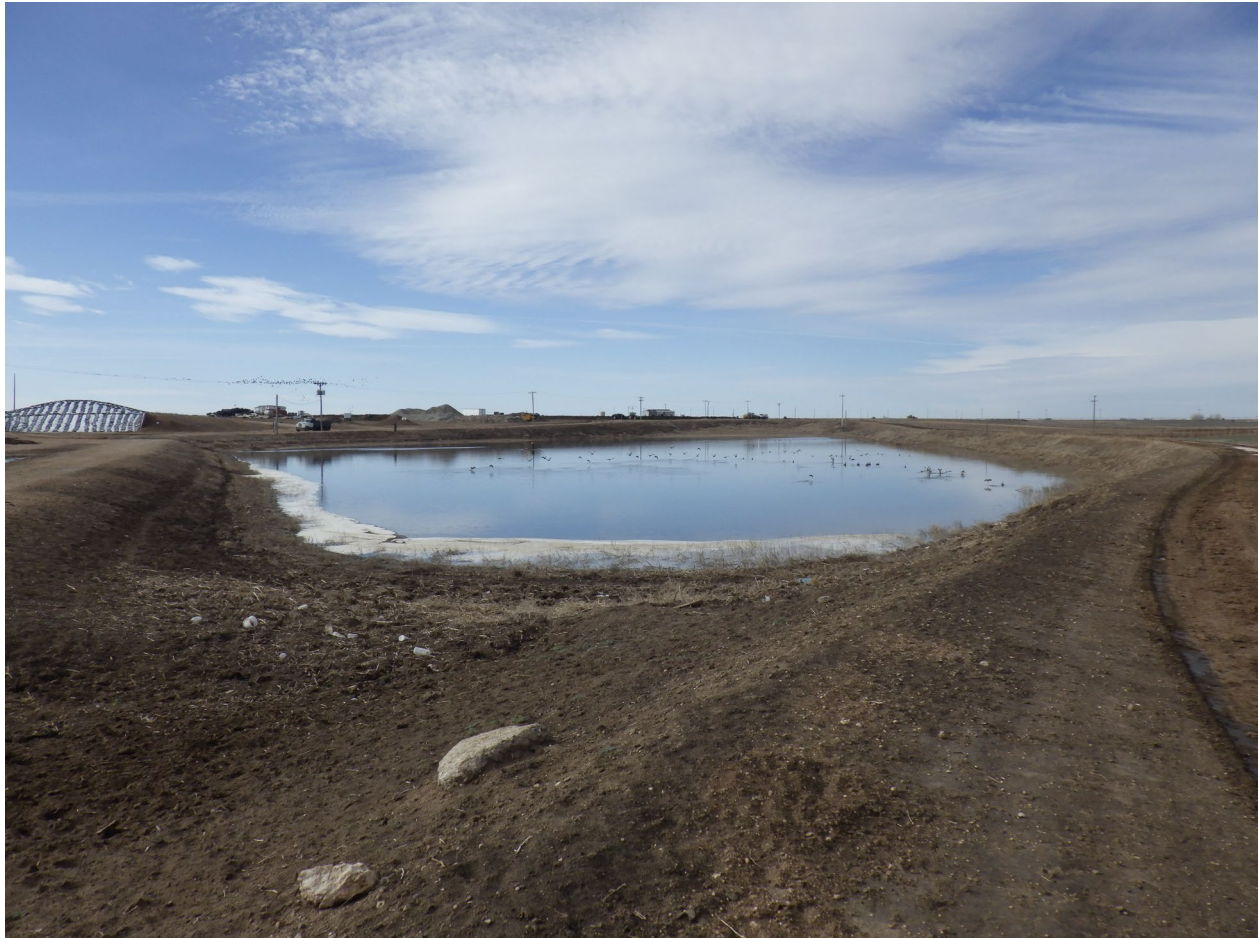
Photo No. 16

Description: View to the northwest. RCS with silage bunkers and composting in background.

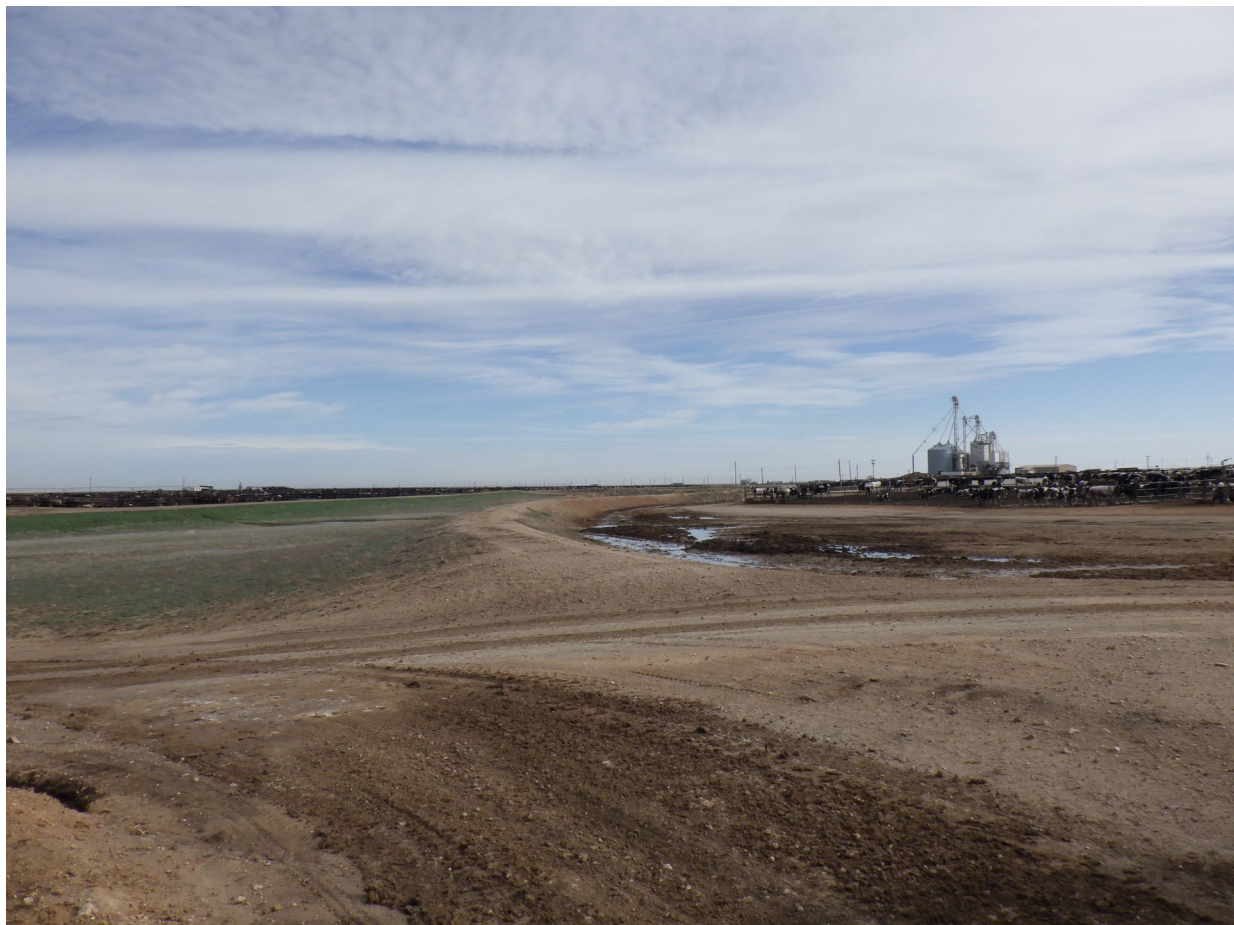
Photo No. 17

Description: View to the east. Drainage channel from pens. Shows berms.

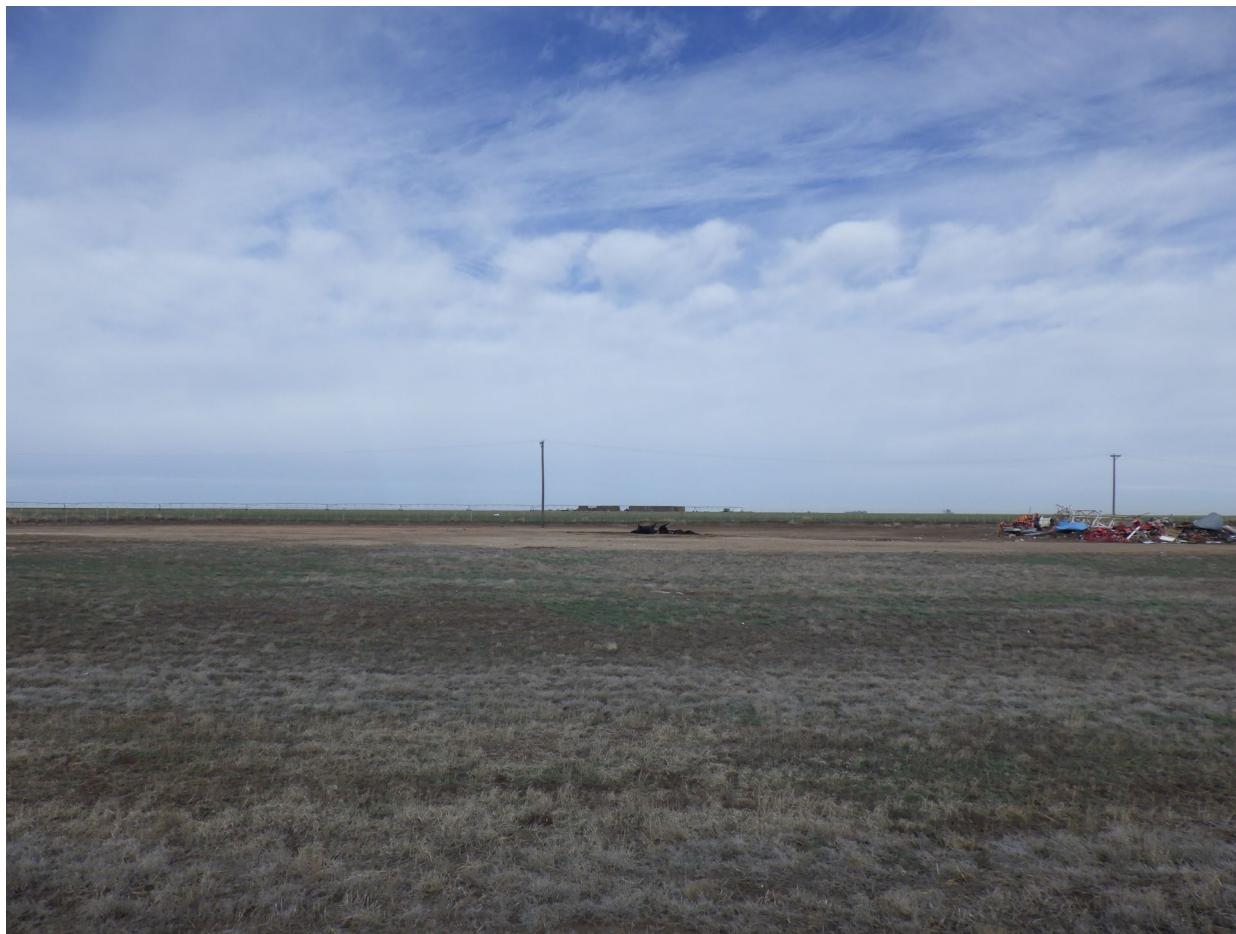
Photo No. 18

There was a single mortality that was set aside for pickup at the time of the inspection (Appendix 1, Photo 18).

Description: View to the northwest. Mortality on site waiting for pickup.

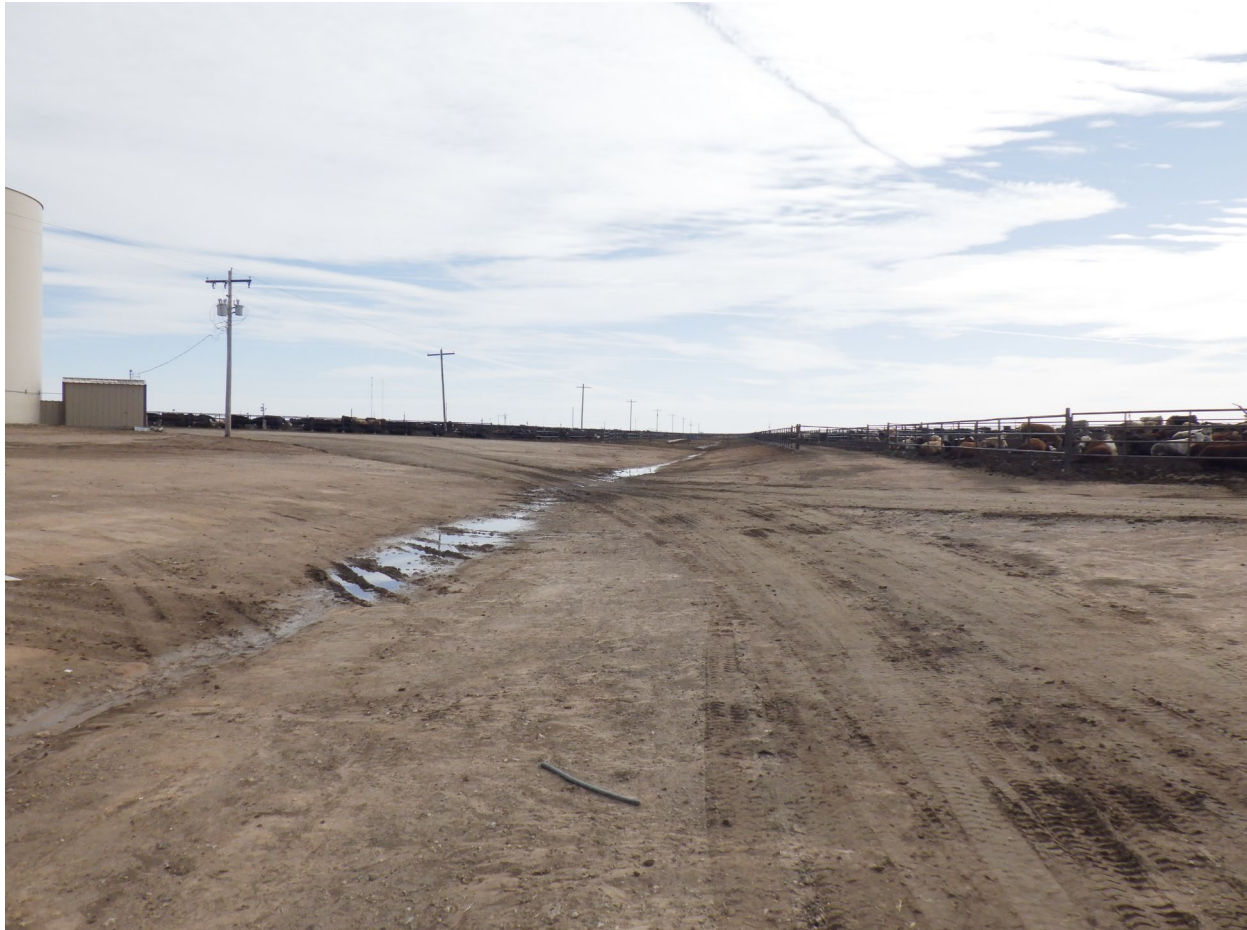
Photo No. 19

Description: View to the south. Drainage channel from open lot pens.
