**Region 6 - Enforcement & Compliance Assurance Division**  
**INSPECTION REPORT**

| Inspection Date(s): | 03/03/2025 | |
| Company Name: | <b>Dumas Feedyard LLC</b> | |
| Facility Name: | <b>Dumas Feedyard</b> | |

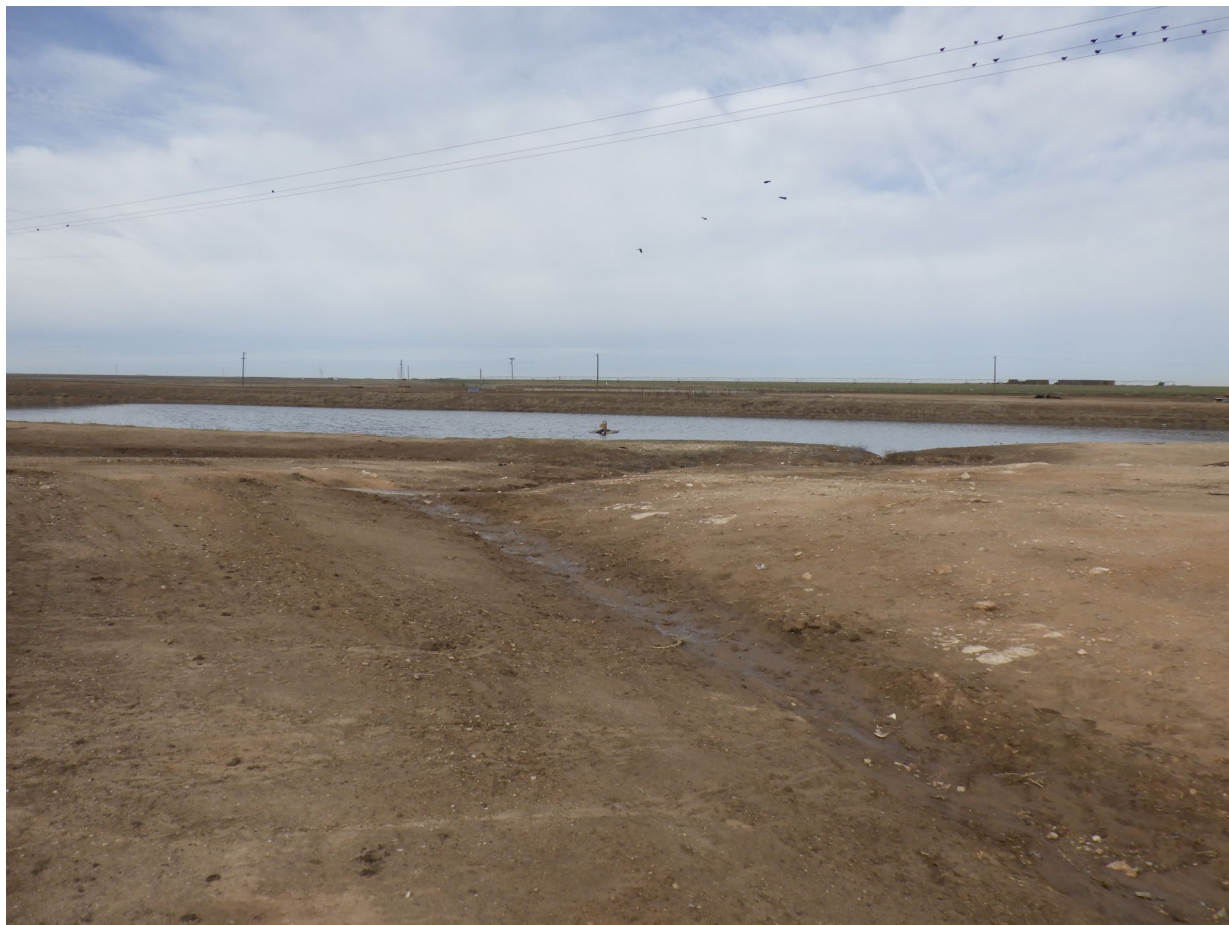
Photo No. 20

Description: View to the north. Drainage channel outfall to RCS.

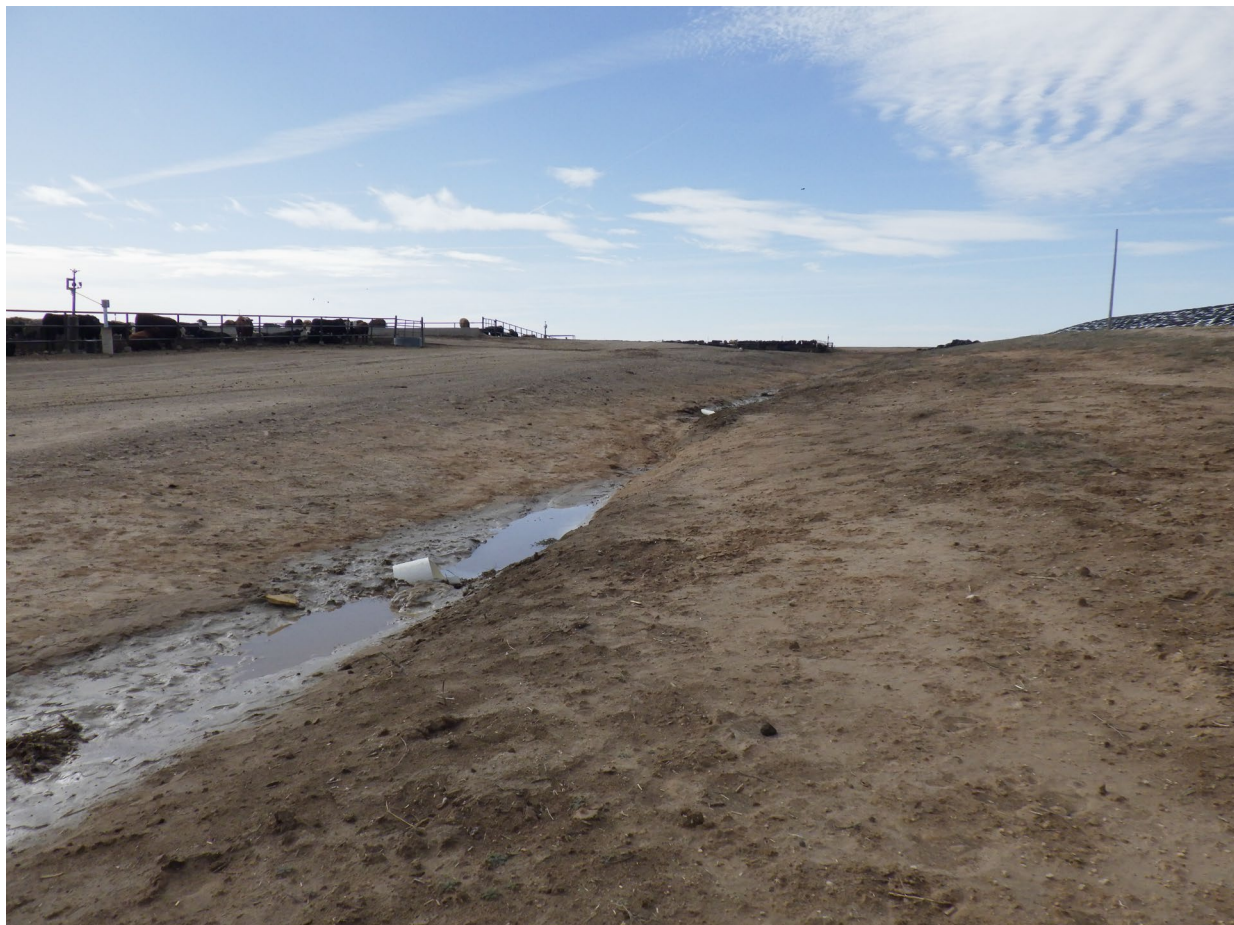
Photo No. 21

Description: View to the west. Drainage channel between open lot pens and silage bunker.

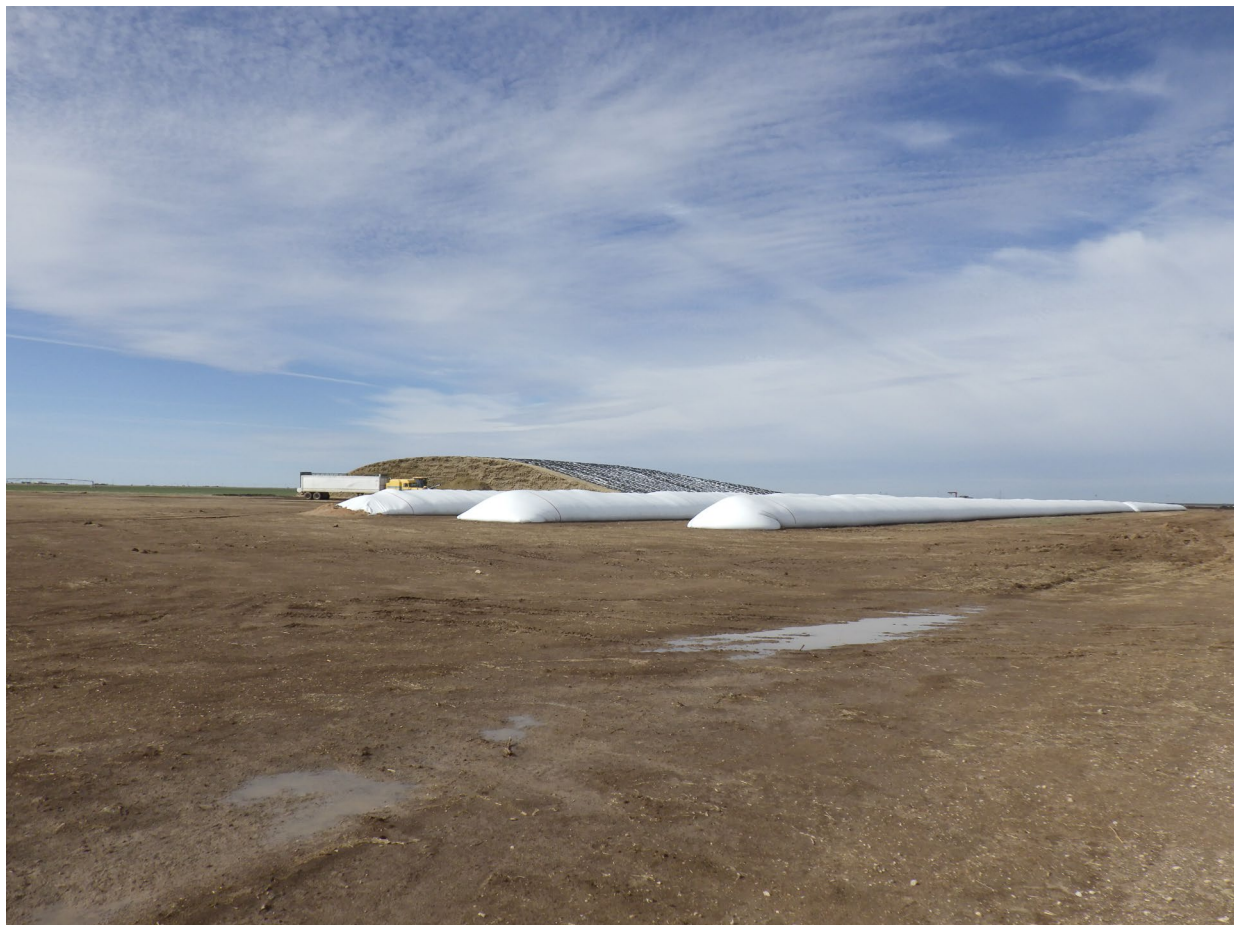
Photo No. 22

Description: View to the southwest. Covered silage.

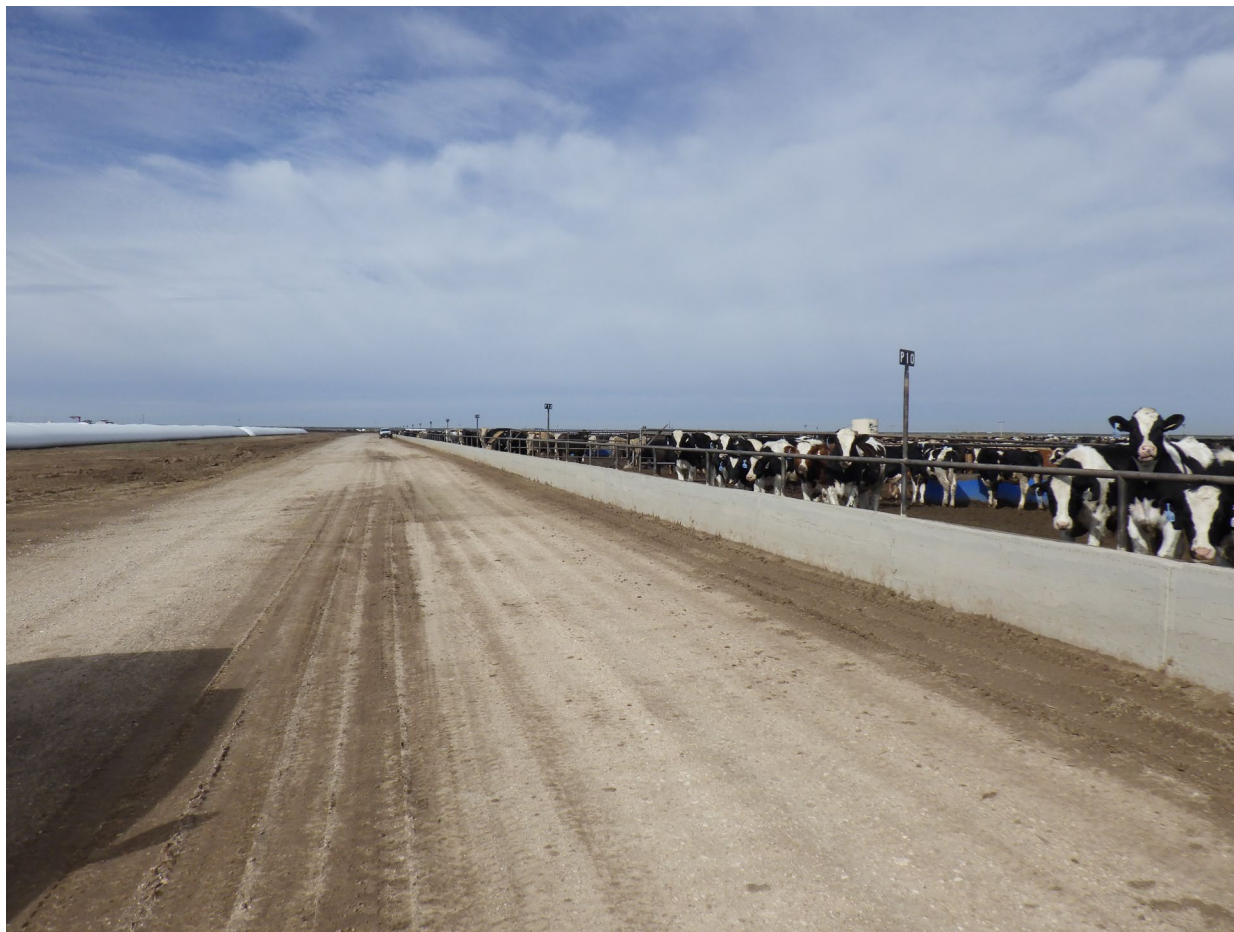
Photo No. 23

Description: View to the west. Southern perimeter of pens showing concrete barrier.

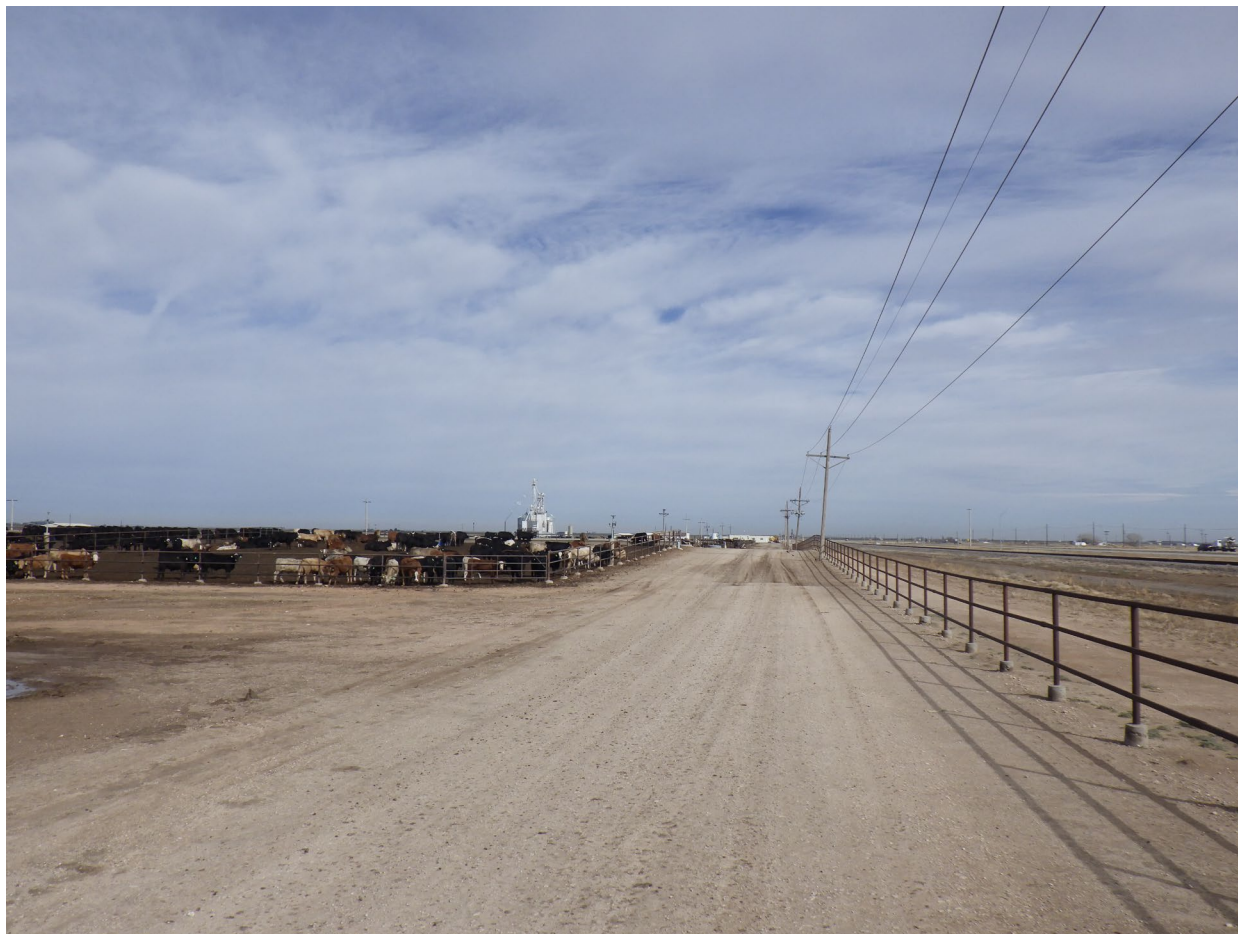
Photo No. 24

Description: View to the north. Southeastern corner of pens showing eastern perimeter.
