**Region 6 - Enforcement & Compliance Assurance Division**  
**INSPECTION REPORT**

| Inspection Date(s): | 09/13/2022 | |
| Company Name: | <b>Laguna Development Corporation</b> | |
| Facility Name: | <b>Casa Blanca Wastewater Treatment Plant (WWTP)</b> | |

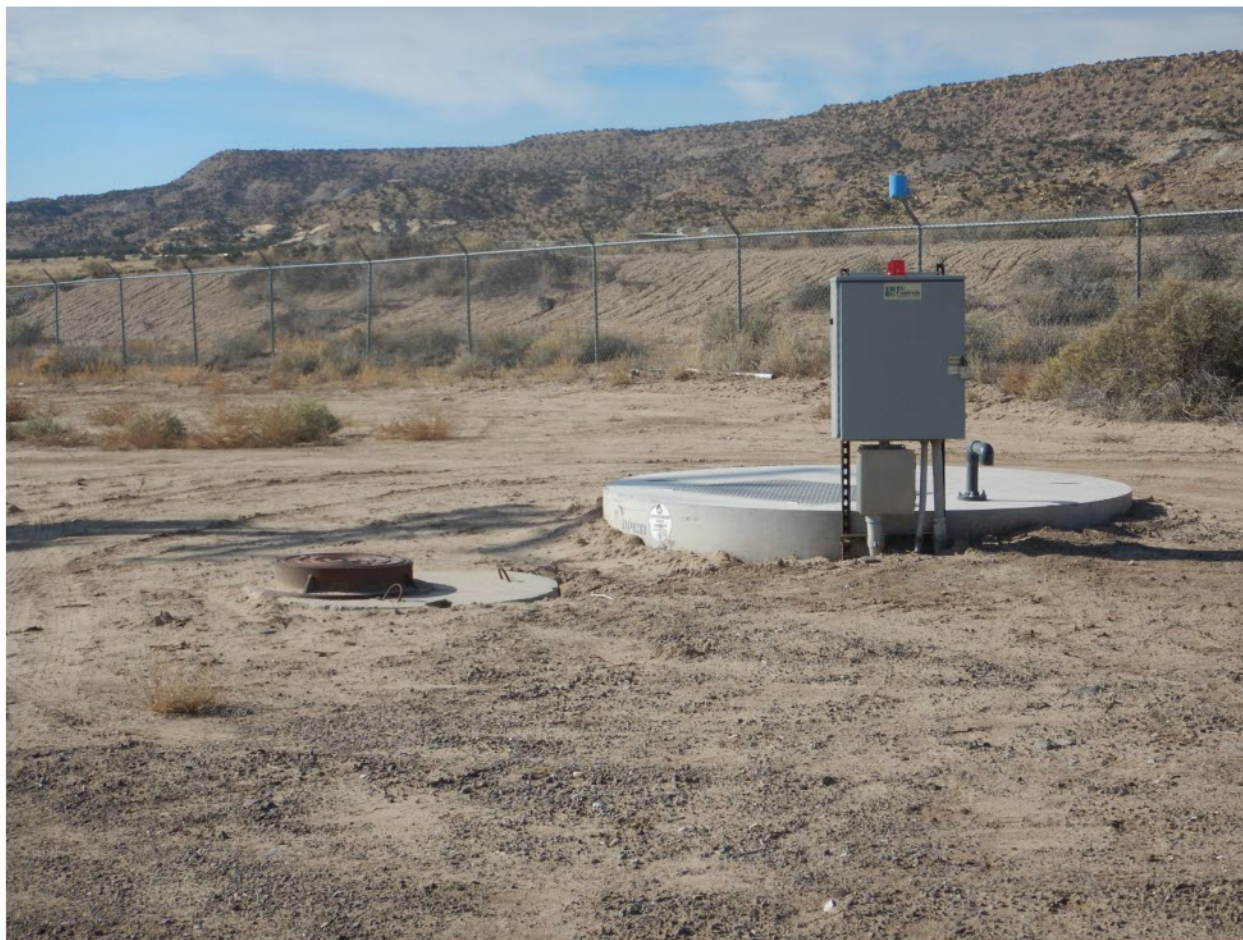
Photo No. 1

| Name | Location | Comment |
|---|---|---|
| WWTP #1 | Northwest corner inside WWTP fenced perimeter | Vault (concrete) was replaced, and LS was serviced circa early 2020. Locked hatchway w/ safety gate. |

View of Lift Station (LS) WWTP#1 located at the approximate Northwest corner inside WWTP fenced perimeter. (DSCN1653). September 13, 2022. Photographed by D. Esparza

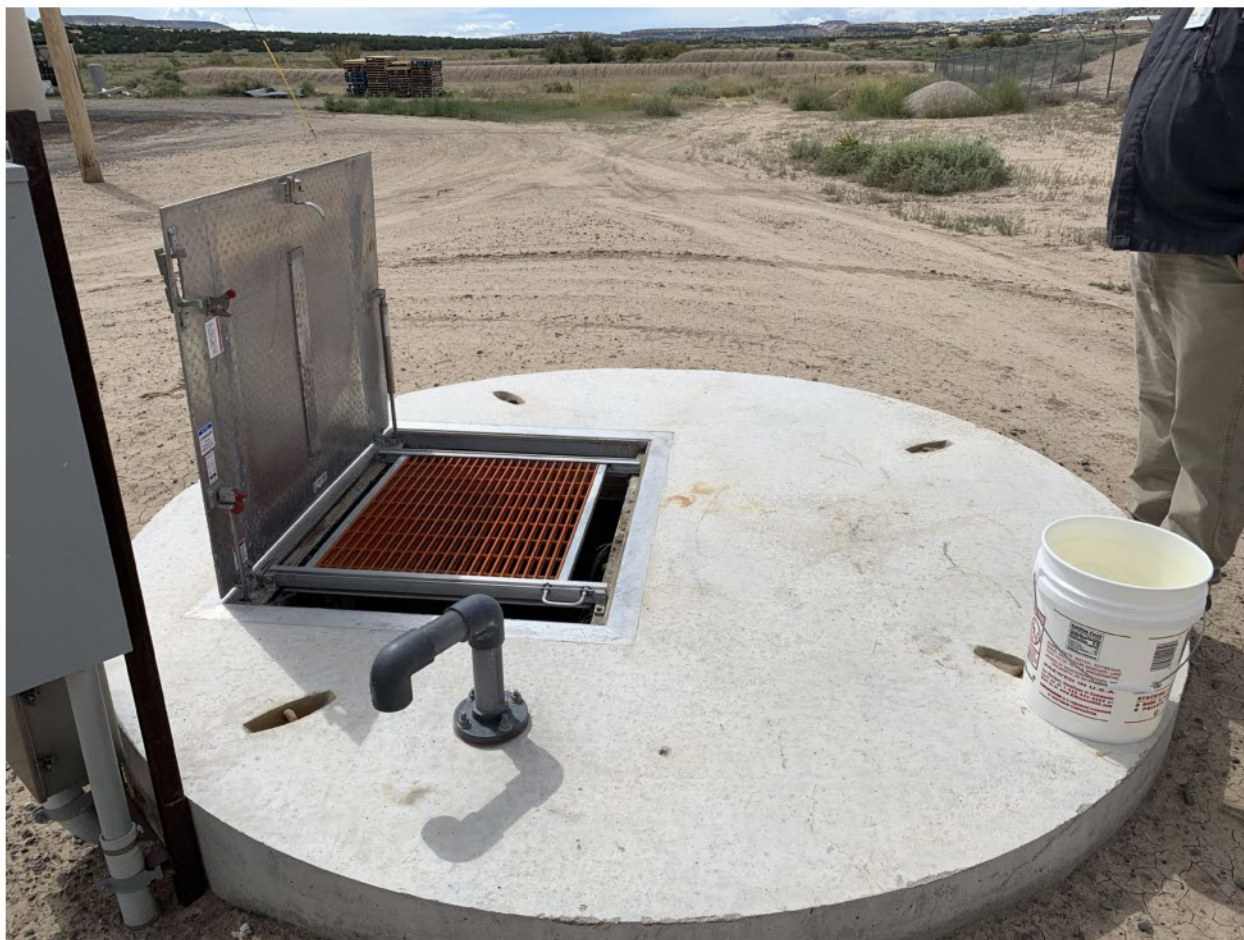
Photo No. 2

View of LS WWTP#1 with hatchway open and safety gate in-place. (IMG0138). September 13, 2022.  
Photographed by D. Esparza

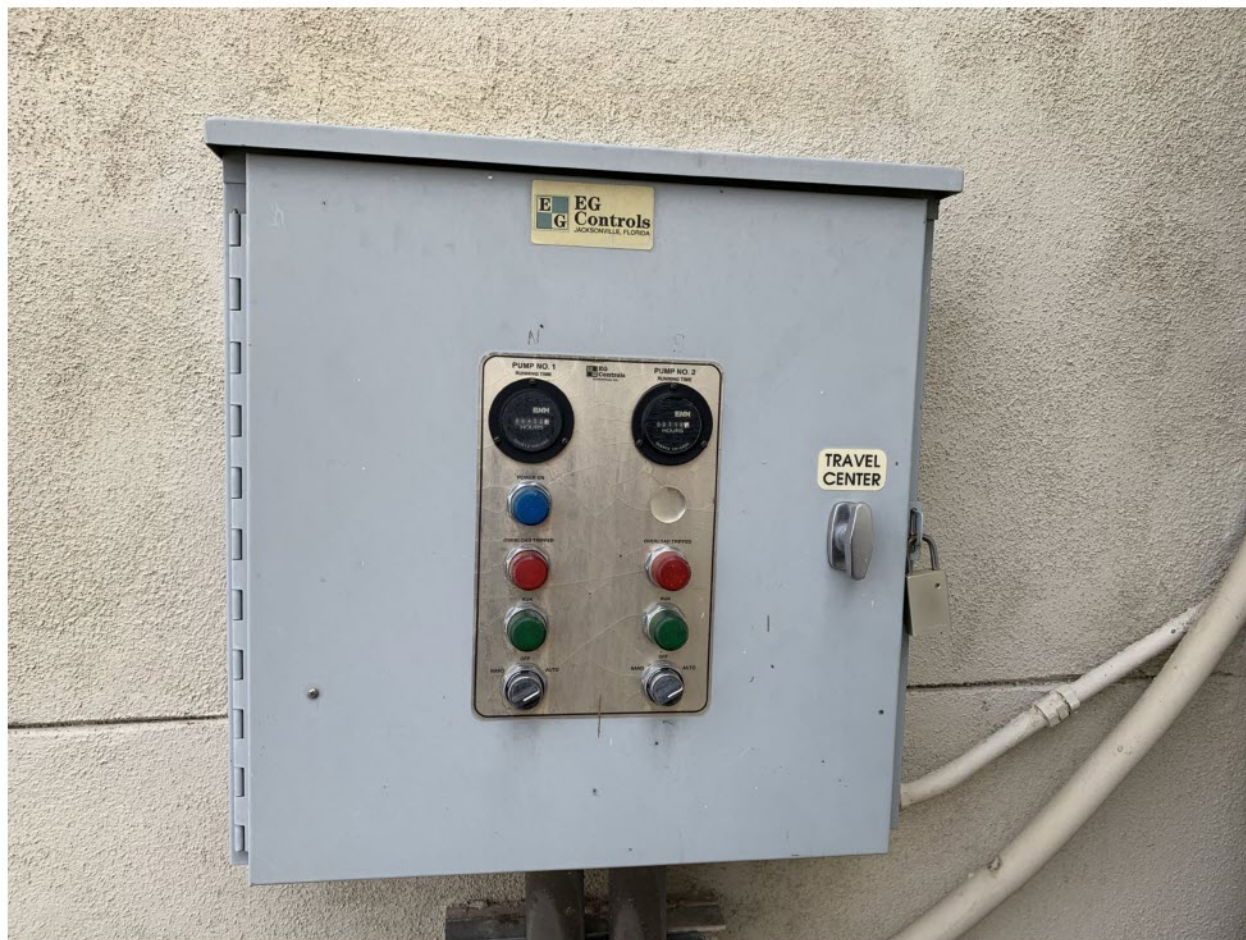
Photo No. 3

| Name | Location | Comment |
|---|---|---|
| Burger King | West side of drive-thru next to building | Vaults were cleaned, serviced and new pumps were installed circa early 2020. |

View of control panel of the Burger King Lift Station located along the West side of drive-thru next to the building. (IMG0140). September 13, 2022. Photographed by D. Esparza

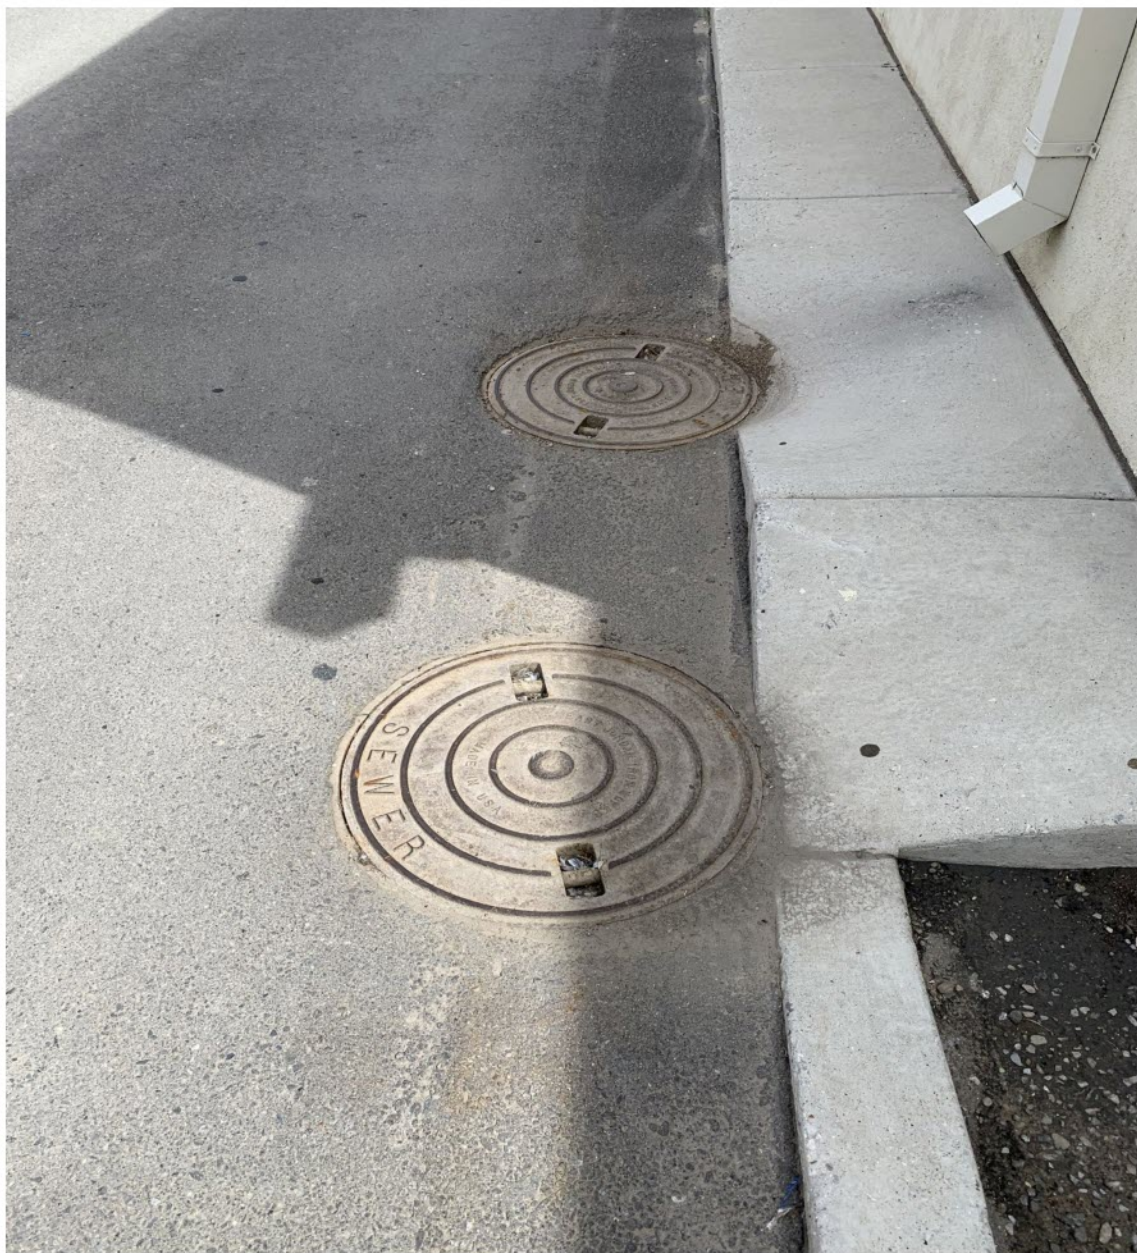
Photo No. 4

- The operator (Mr. Trotter) oversees this facility Casa Blanca WWTP (NM0030678) and Rio Puerco (NM0030686) on an individual employee basis full-time 24-hour per day 365 days per year.
- Additionally, he (Trotter) is responsible for sample collection and operation and maintenance (O&M) associated with both facilities.
- Lift Station WWTP#2 located approximately North and outside the fenced perimeter lacks secure perimeter fencing, alarms (either audible or flashing light) or signage.
- Lift Station-Burger King located within the restaurant drive-thru lacks ready access for servicing and/or routine maintenance.

View of the Burger King Lift station vaults located within the drive-thru next to the building. (IMG0142).  
September 13, 2022. Photographed by D. Esparza West side of drive-thru next to building

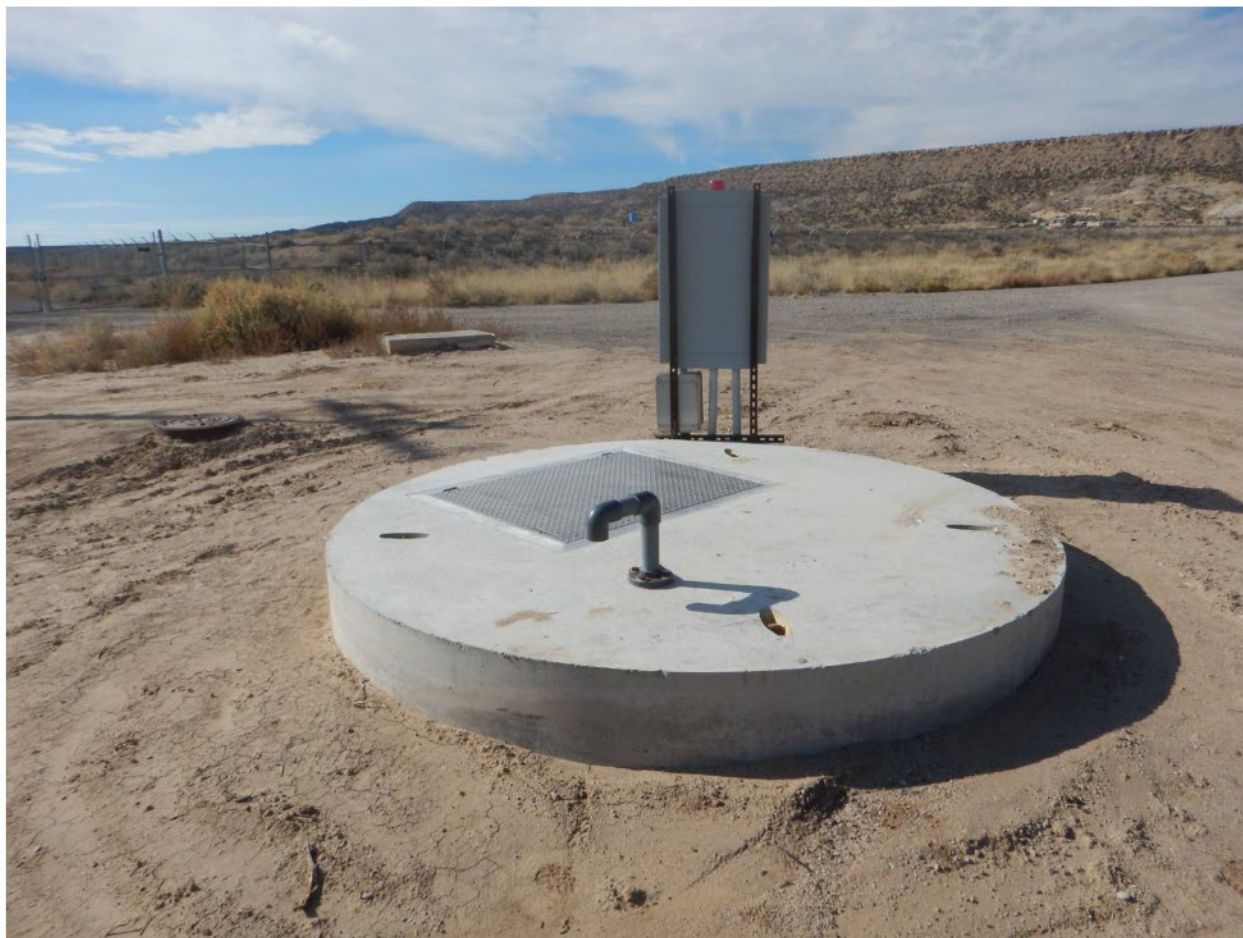
Photo No. 5

| Name | Location | Comment |
|---|---|---|
| WWTP #2 | North outside of WWTP fenced perimeter | Vault (concrete) was replaced, and LS was serviced circa early 2020. Locked hatchway w/ safety gate. Lacks secure perimeter fencing, alarms (either audible or flashing light) or signage. |

View of Lift Station (LS) WWTP#2 located approximately North and outside of WWTP fenced perimeter (DSCN1658). September 13, 2022. Photographed by D. Esparza
