## CAA112(r) INSPECTION REPORT

| <b>Name:</b> TOBA, Inc/Wald Family Foods, LLC (formerly TOBA, Inc/DI Manufacturing, LLC) | |
| <b>Address:</b> 1144 Bridger Court, McPherson, Kansas | <b>Date of Inspection:</b> January 23-25, 2024 |
| <b>Process:</b> 311412, Frozen Specialty Food Manufacturing | |

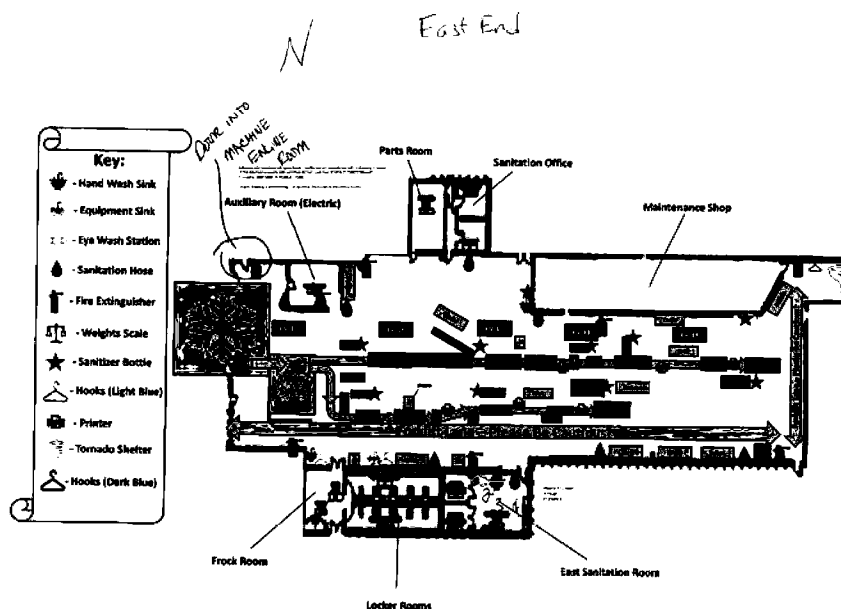
Before entering the main machinery/engine room, I was looking for an eyewash/safety shower outside of the machinery/engine room and did not see one in the area. I referred to the facility's color map of the area that also identifies safety systems including fire extinguishers and eyewash stations and observed that one was not identified on the map in the vicinity of the machinery/engine room door (see map labeled "East End" in Appendix 1). This is discussed below in the **PROCESS SAFETY INFORMATION (PSI)** section of this inspection report.

As described in the **FIELD TOUR** section of this report, I observed a shower inside the machinery/engine room, but no eyewash/safety shower was located outside of the machinery/engine room within 55 feet of the machinery room door as is described in IIAR 2-2021, 6.7.2. as shall be installed. After the field tour while covering the questions in the IIAR 2-2021 checklist, I stated that I had not observed an eyewash/safety shower in the vicinity outside of the machinery/engine room. Mr. Wilson stated that there was not one. Mr. Woosley asked what part of IIAR 2-2021 required an eyewash/safety shower outside of the machinery/emergency shower room.

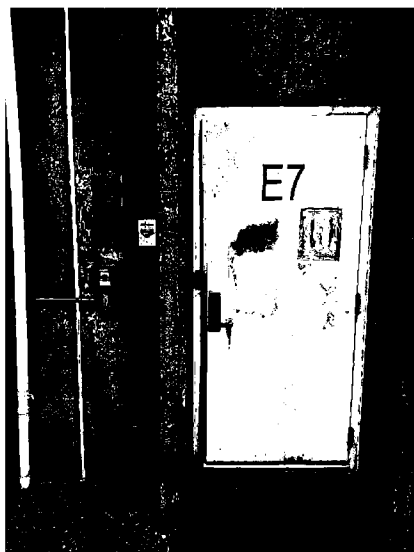
Image 121 (taken by facility personnel)

Due to weather conditions the previous week and at the time of the inspection, I was told that there was ice and snow on the roof making it a hazardous area. Mr. Klug volunteered to take photos of the King Valve on the roof and of the outside of door E7. I agreed that would be acceptable. Photolog digital image numbers 117 through 121 were emailed to me from Mr. Klug and do not contain file names or digital date and time stamps. The emails containing these images will be maintained as part of the official EPA file for the facility (Appendix 27).

As shown in the photos taken by Mr. Klug and emailed to me (photolog digital image numbers 120 and 121 in Appendix 1), Wald had signs for door E7 but because the door is planned to be replaced, Messrs. Wilson and Klug stated that they did not want to affix the signs to the outside of a door that would be removed soon because the signs could not be removed and re-affixed to the new door.

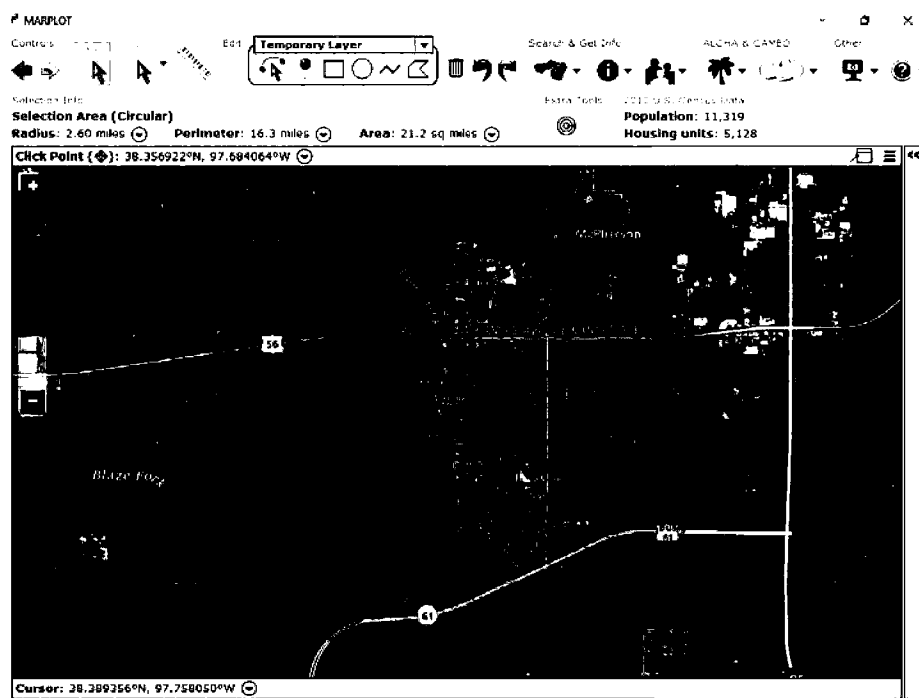
Using RMP\*Comp and MARPLOT, I obtained the following circular area for worst case scenario when the anhydrous ammonia release quantity is 18,395 pounds:

Using Missouri Census Data Center, I obtained a population of 12,063 persons within the 2.6-mile radius which differs by a population of 1,442 persons greater than the population of persons impacted by the calculation made by LoTemp.

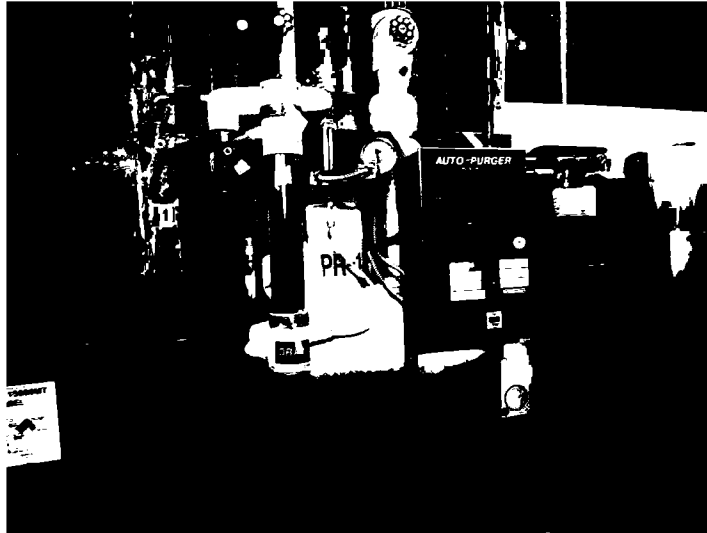
P1230032.JPG

We then entered the main machinery/engine room. Upon entry I noticed the refrigeration system purger labeled PR-1 and documented with photos the ice accumulation on the unit

(P1230032.JPG - P1230036.JPG). I observed and documented by photo equipment and pipe labeling (P1230037.JPG - P1230043.JPG). I asked if Wald had an ice management policy and was told by Mr. Klug that they did not.

Additionally, the **FIELD TOUR** section of the report and photo log documents icing on several units that need maintenance attention and defrosting, including the LAT-1 Pot (P1230083.JPG - P1230085.JPG), the oil pot under the high suction accumulator (P1230105), the EV-4 evaporation (P1230109.JPG - P1230113.JPG) and the PR-1 purger (P1230032.JPG – P1230036.JPG). These are like images in the MI report.
