Region 10 Enforcement and Compliance Assurance Division

**INSPECTION REPORT**

| <b>Regulatory Program:</b> | CWA NPDES/Industrial Stormwater | |
| <b>Facility Name:</b> | Maddens Facility | |

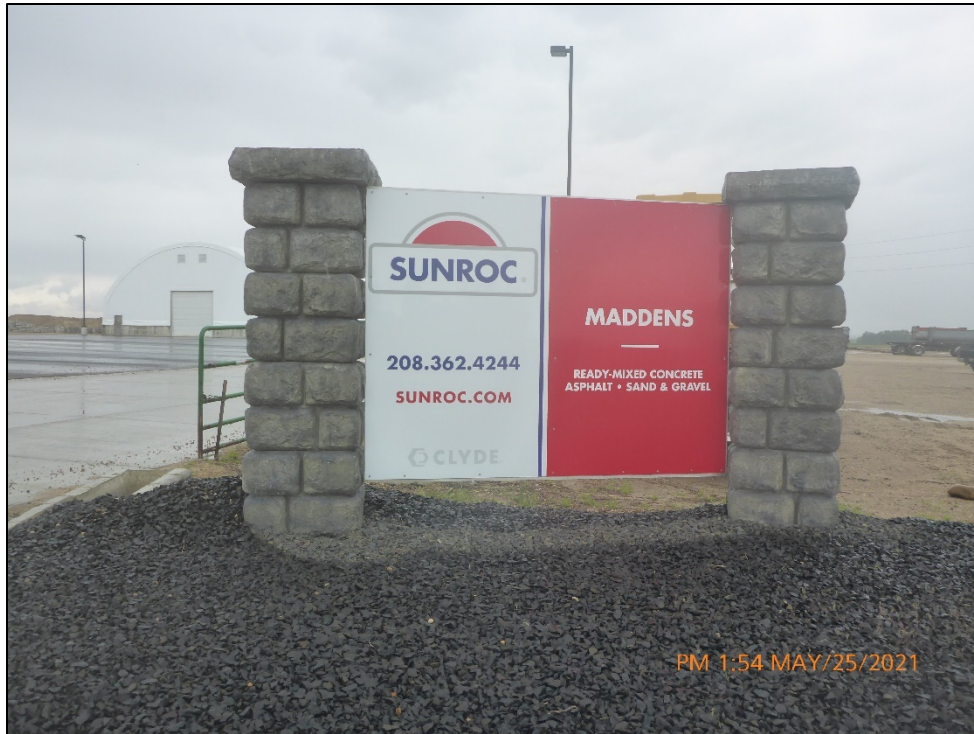
**Photograph 1.** View of the Facility sign.

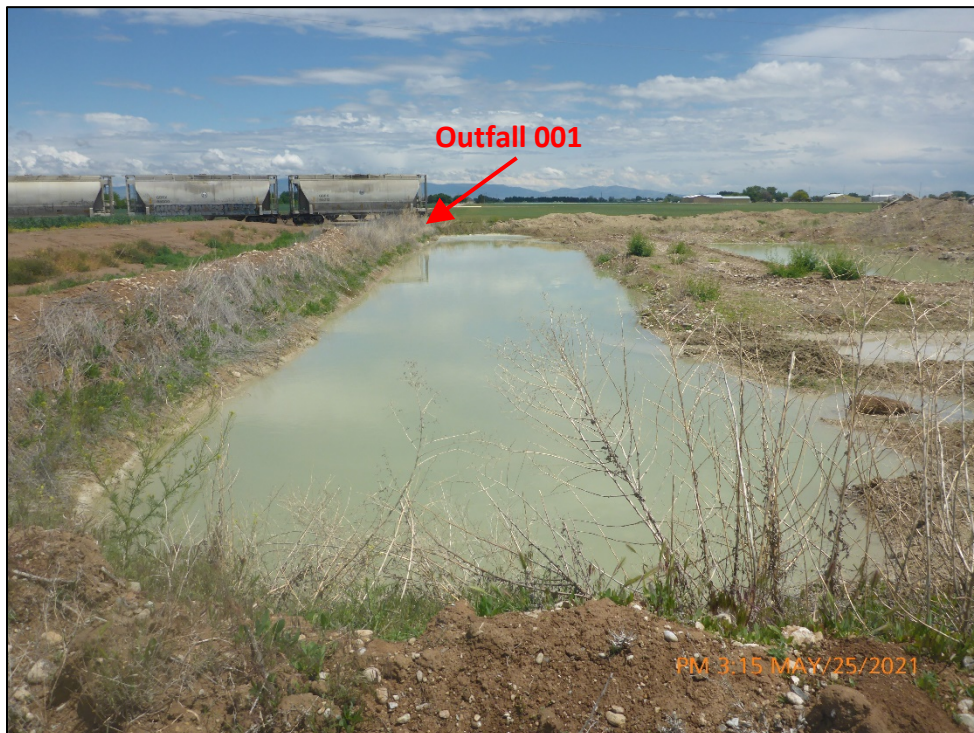
**Photograph 2.** View, facing east, of the stormwater retention basin in the northern corner of the Facility. Outfall 001 is located at the basin's spillway on the northeast corner.

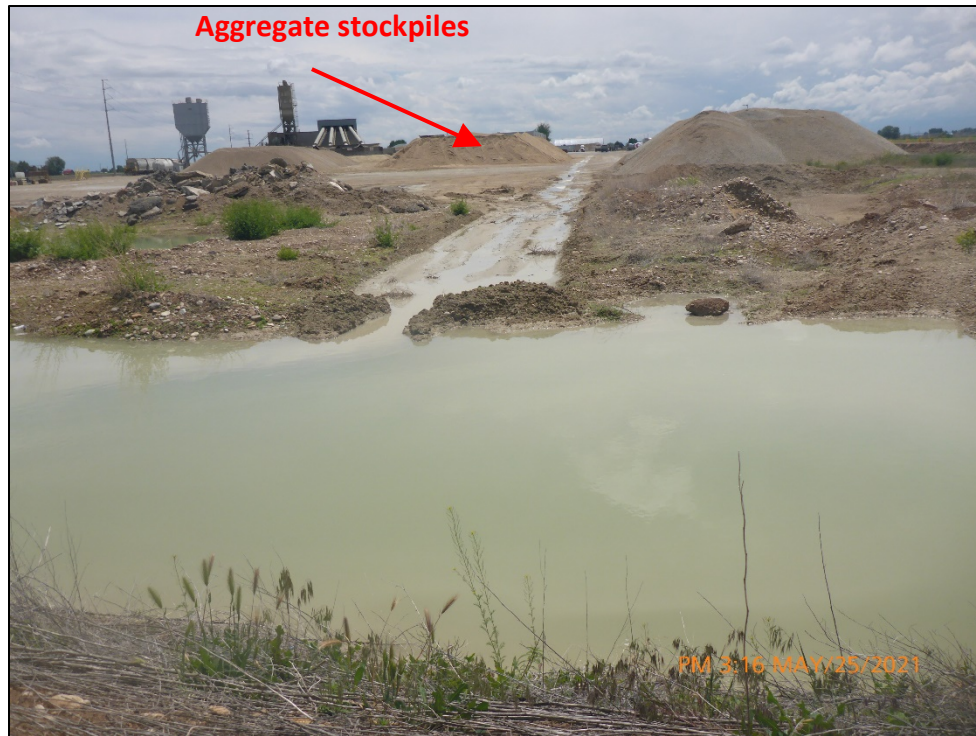
**Photograph 3.** View, facing south, of the inlet on the west side of the stormwater retention basin. A valley gutter that runs north between the concrete truck parking area and aggregate stockpiles enters the basin at this location.

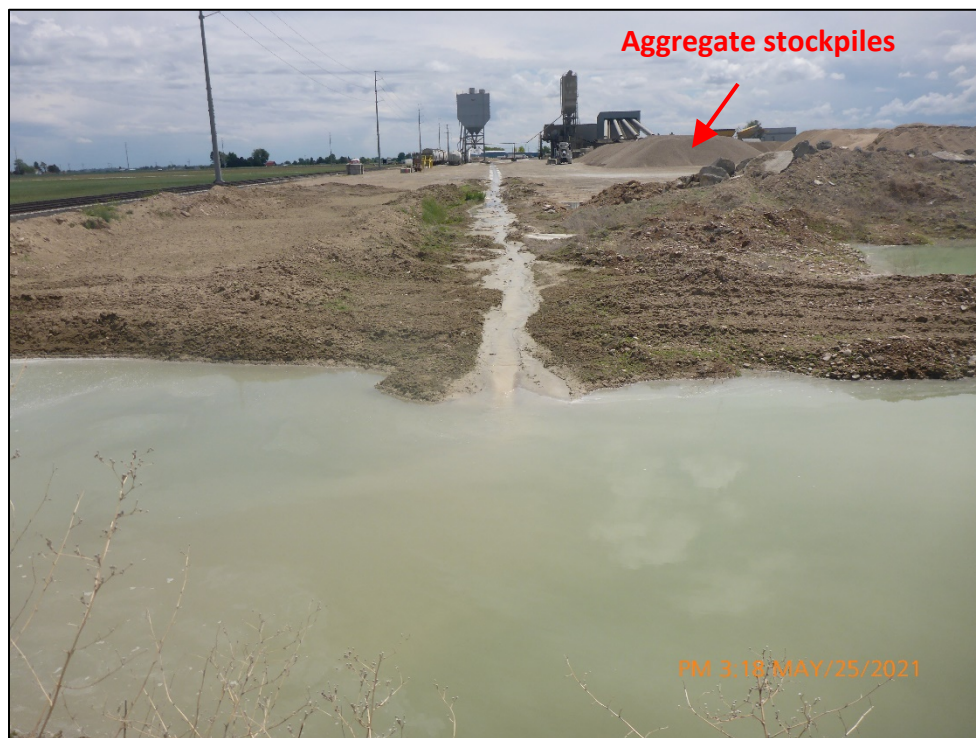
**Photograph 4.** View, facing south, of the inlet on the east side of the stormwater retention basin. A valley gutter that runs north between the aggregate stockpiles and the Facility's eastern perimeter enters the basin at this location.

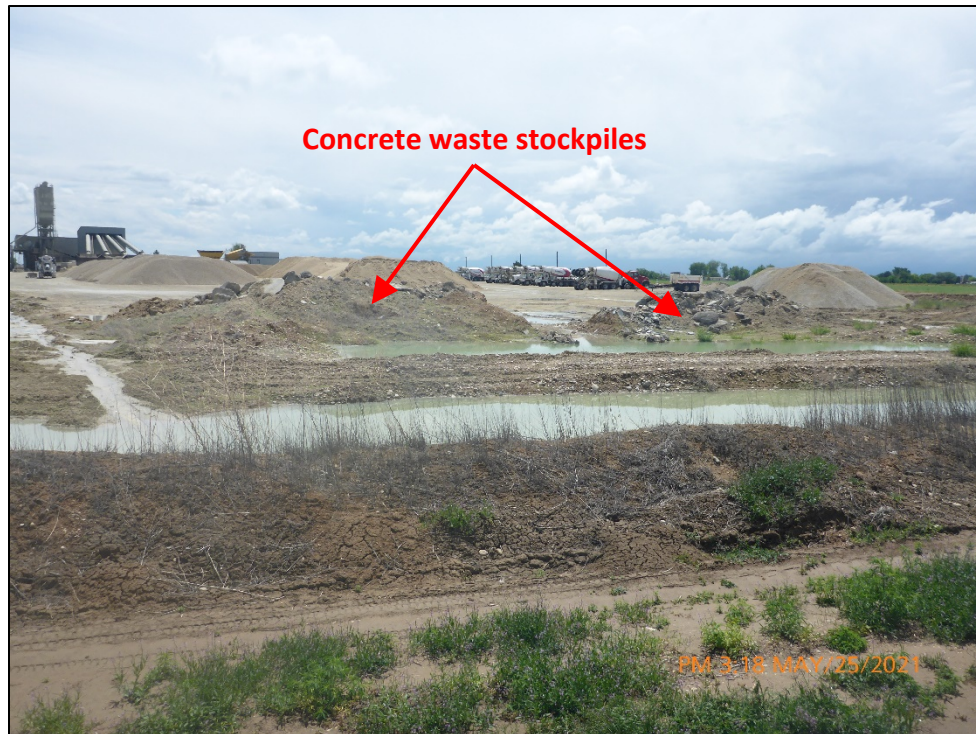
During the inspection, we observed waste concrete piles on the south side of the stormwater retention basin ([refer to Photograph 5](#)). It was unclear if the stockpiles were diminishing the capacity of the retention basin. Mr. Henderson stated that concrete waste that cannot be recycled and settled material excavated from the retention basin are stockpiled in this location until it is eventually hauled offsite for disposal. Section 3.1.5, Erosion and Sediment Controls, of the SWPPP states, “The retention pond at the northernmost end of the site is scheduled to be expanded. The addition will have the topsoil removed and placed as berms along the edges of the pond.” At the time of the inspection, the expansion of the basin had been completed and topsoil berms were in place.

- Hardened and excavated concrete waste piles located on the southern edge of the stormwater retention basin (refer to Photograph 5).
- Outdoor washing area on the north side of the maintenance building (refer to Photograph 9).

- Area of Concern 1a –We observed waste concrete piles on the south side of the stormwater retention basin that may have been diminishing the capacity of the basin.

**Photograph 5.** View, facing southwest, of concrete waste stockpiles on the south side of the stormwater retention basin (between the two inlets to the basin) shown in Photographs 3 and 4.

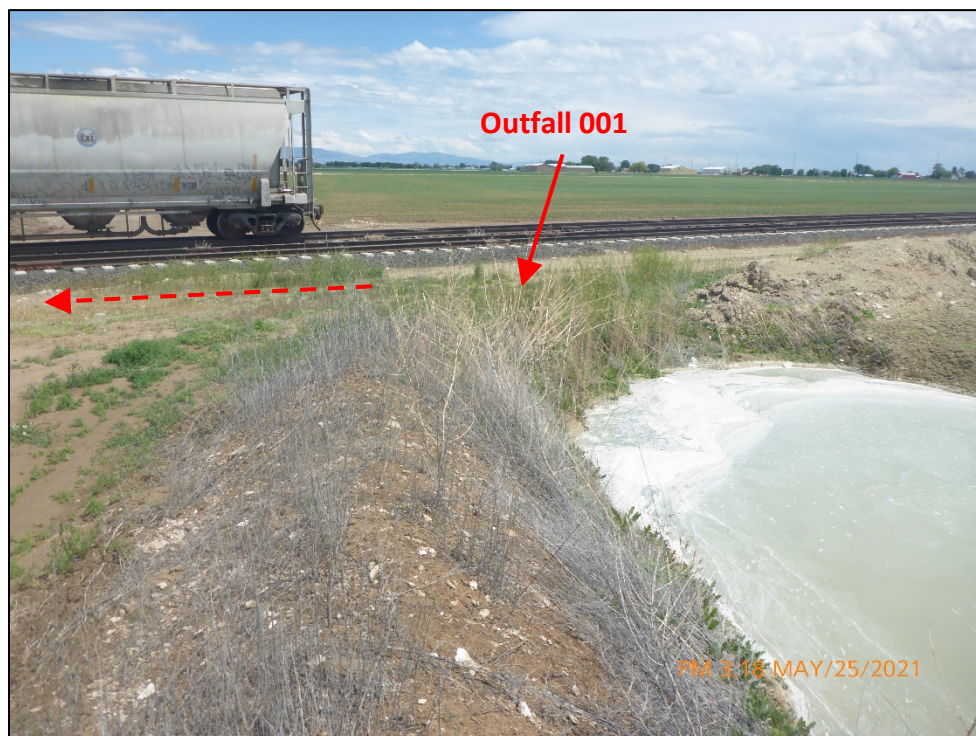
**Photograph 6.** View of the overflow point of the stormwater retention basin, noted as Outfall 001. Red dotted arrow indicates flow direction from Outfall 001 to the Lower Fivemile Drain.

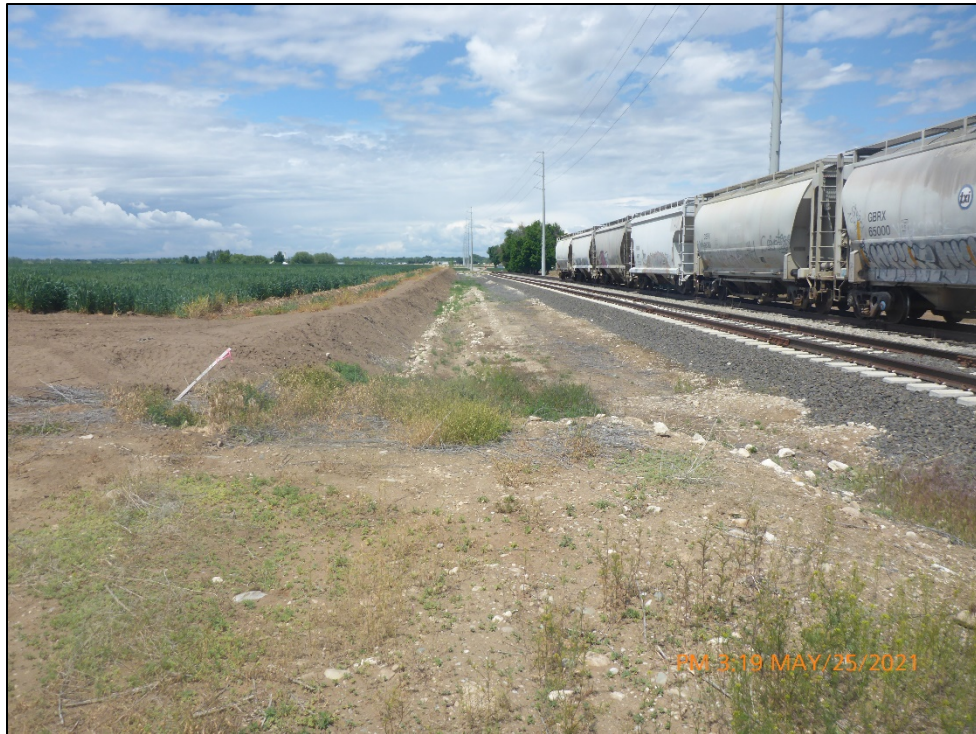
**Photograph 7.** View, facing north from Outfall 001, of the stormwater flow pathway along the railroad right-of-way from Outfall 001 toward the Lower Fivemile Drain.

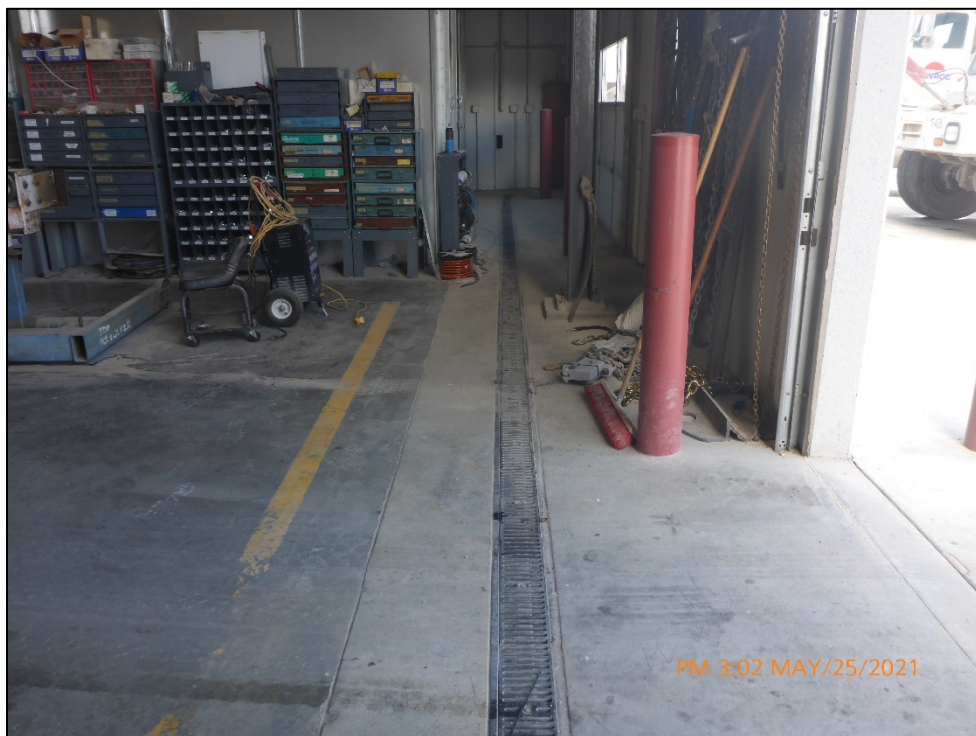
**Photograph 8.** View, facing north inside the maintenance building, of a trench drain that flows to an onsite subsurface infiltration structure located north of the maintenance building and adjacent fuel island.

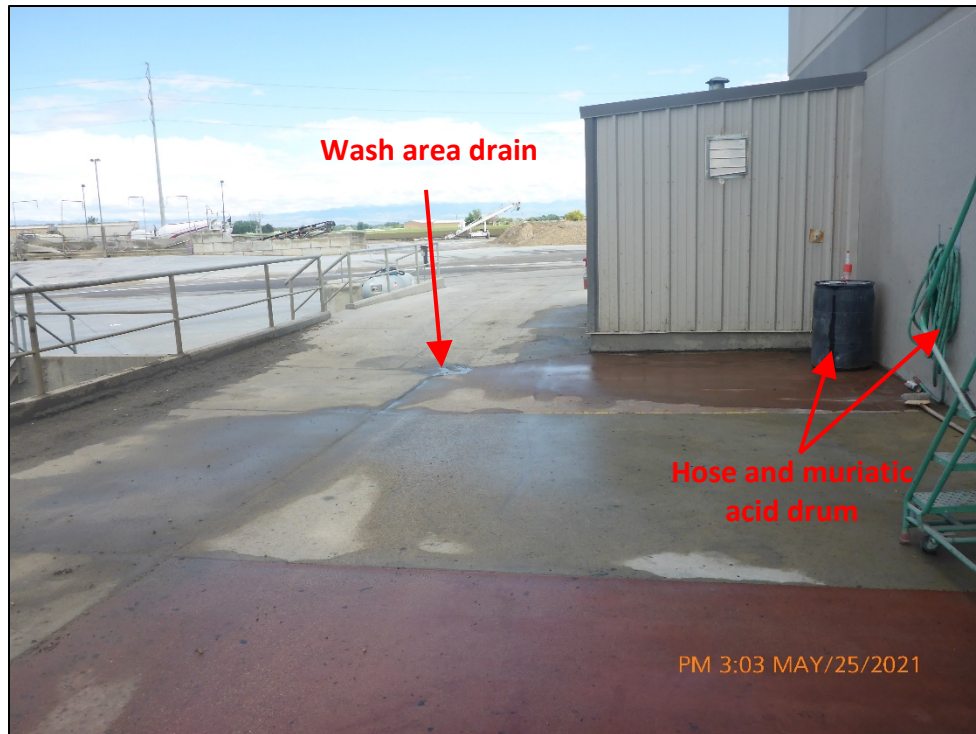
We observed an outdoor washing area located on the outside of the maintenance building’s northern wall. Mr. Henderson confirmed that this wash area also drains to the subsurface infiltration structure located to the north (refer to Photograph 9). Near the fuel island and subsurface infiltration structure, we observed a grated storm drain inlet with a casted message “Outfall to Stream. Dump No Pollution” (refer to Photographs 10 and 11). Mr. Henderson confirmed this storm drain also leads to the subsurface infiltration structure.

**Photograph 9.** View, facing east, of an outdoor wash area located north of the maintenance building. Note the hose and 55-gallon drum of muriatic acid. This wash drain flows to the onsite subsurface infiltration structure located north of the maintenance building.

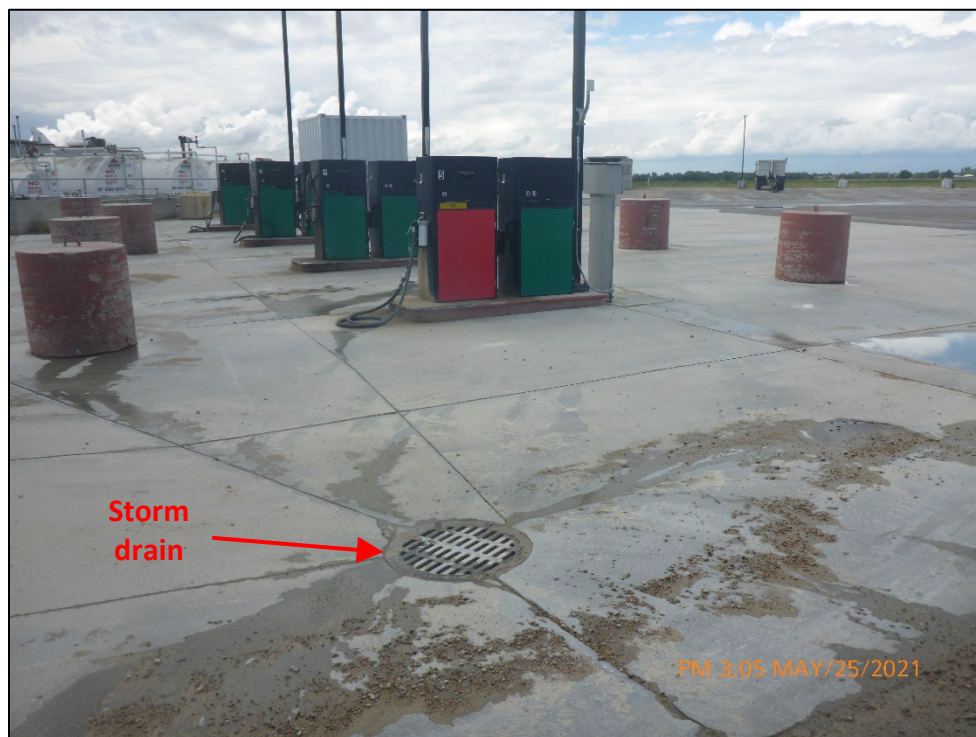
- Storm drain inlet and associated onsite subsurface infiltration structure described by Mr. Henderson (refer to Photographs 10 and 11).
- Impervious valley gutters that run north on both the east and west sides of the batch plant and aggregate stockpile that flow into the stormwater retention basin in the northern corner of the Facility (refer to Photographs 12, 13, and 15).

**Photograph 10.** View, facing west, of a storm drain near the fuel island that is north of the maintenance building and outdoor wash area shown in Photographs 8 and 9. Mr. Henderson confirmed that this storm drain is connected to the onsite subsurface infiltration structure.

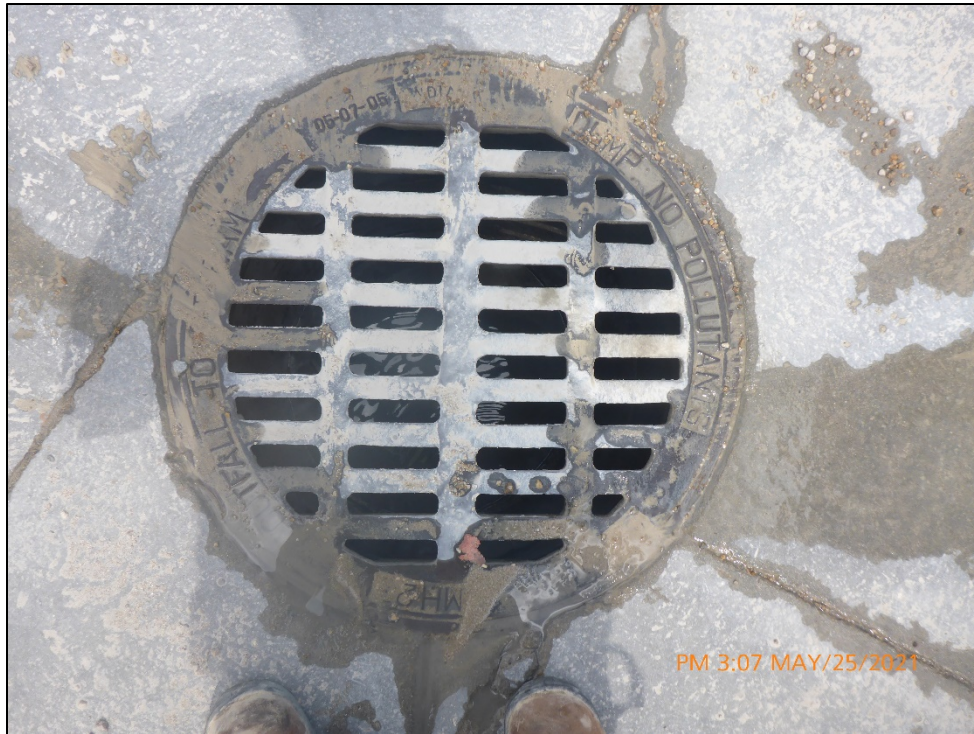
**Photograph 11.** Close-up view of the storm drain shown in Photograph 10. This grate is casted with the message "Outfall To Stream. Dump No Pollution".

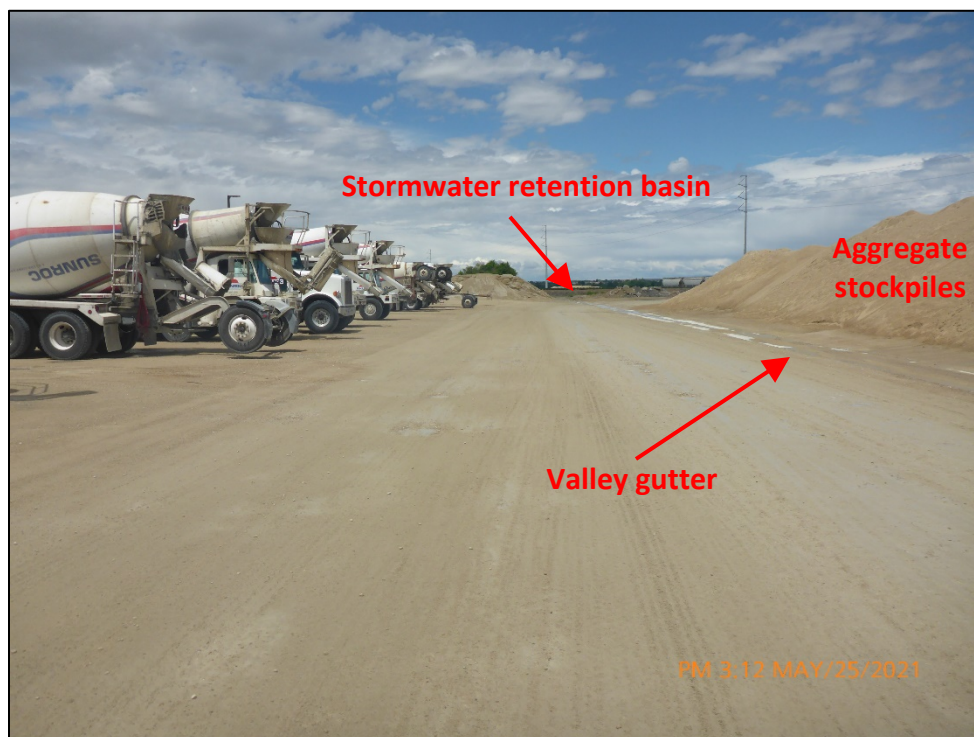
During the inspection, we observed evidence that sediment had mobilized from aggregate stockpiles into the valley gutter on the west side of the Facility that flows north into the northwestern side of the stormwater retention basin ([refer to Photographs 12 and 13](#)). Control measures were not in place to prevent sediment from mobilizing into this valley gutter. Section 3.1.5, Erosion and Sediment Controls, BMP #7 of the SWPPP states, “Stockpile management procedures and practices are designed to reduce or eliminate air and stormwater pollution from stockpiles of soil, aggregates, paving materials such as Portland Cement Concrete rubble, asphalt concrete, asphalt concrete rubble, aggregate base, aggregate sub-base or pre-mixed aggregate. The stockpiles should be placed in an area where sediment from precipitation will not be discharged to waters of the US.”

**Photograph 12.** View, facing north, of the valley gutter that flows north to the stormwater retention basin, located along the west side of the Facility between the concrete truck parking area and aggregate stockpiles.

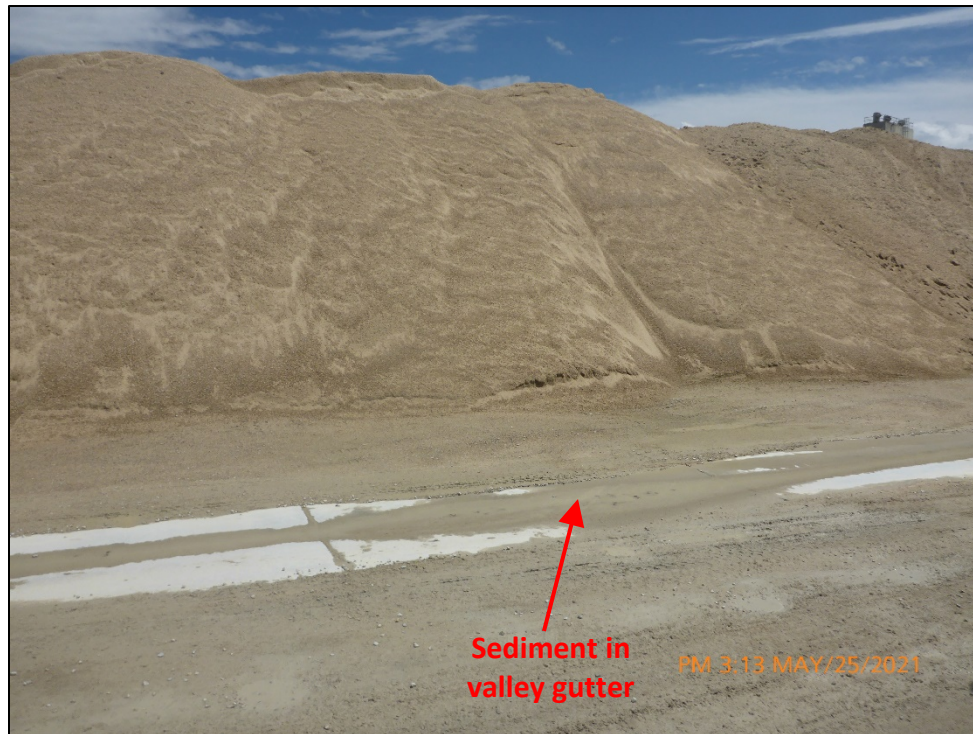
- Area of Concern 1b –We observed sediment that had mobilized from aggregate stockpiles into the valley gutter that flows north into the northwestern side of the stormwater retention basin.

**Photograph 13.** View, facing east, of sediment in the valley gutter adjacent to the aggregate stockpiles shown in Photograph 12. Control measures were not in place to prevent sediment from the aggregate stockpiles from entering this valley gutter.

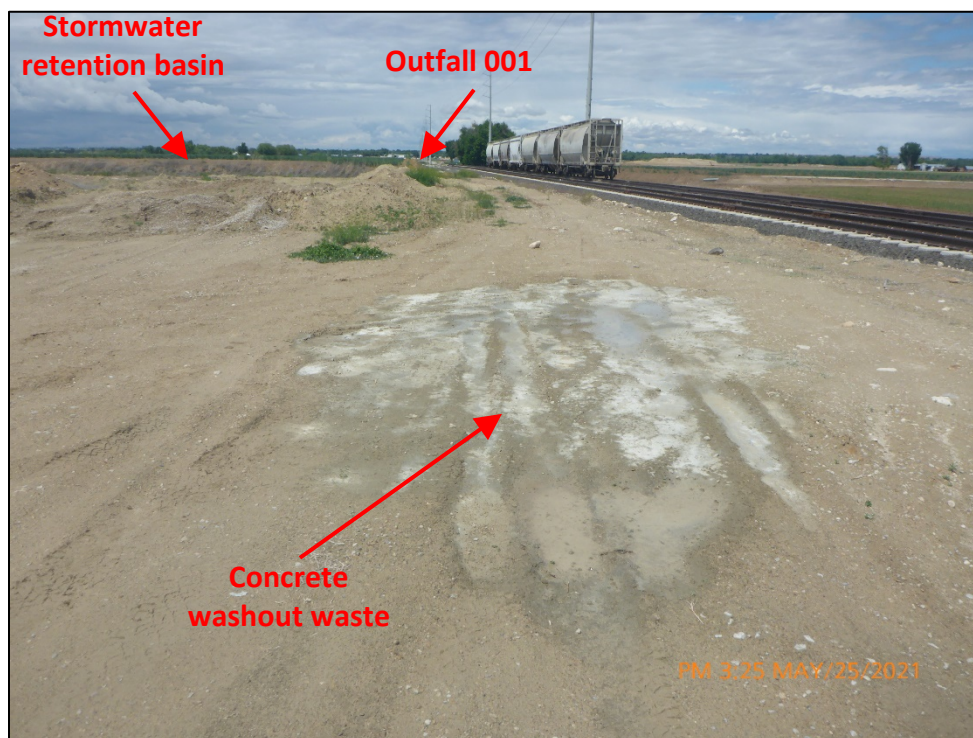
We observed uncontained concrete washout waste on the ground surface along the northeastern perimeter, upgradient of the stormwater retention basin and Outfall 001 (refer to Photograph 14). Mr. Henderson stated this was not an approved washout location and that concrete truck drivers are educated to only wash out in authorized locations.

- Area of Concern 2a – We observed uncontained concrete washout waste on the ground surface along the northeastern perimeter, upgradient of the stormwater retention basin and Outfall 001.

**Photograph 14.** View, facing north, of the concrete washout waste on the ground surface in the northeastern portion of the Facility, upgradient of the stormwater retention basin and Outfall 001.

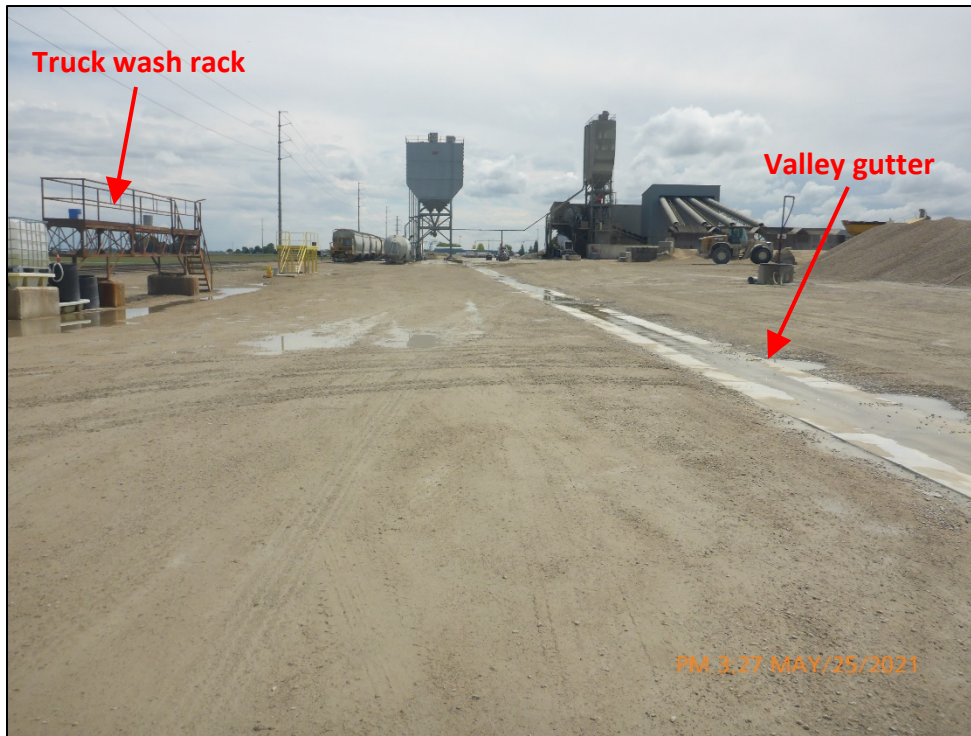
We observed an uncovered truck wash rack area on the northeast side of the Facility that drains to the stormwater retention basin (refer to Photograph 15). Wash water from the wash rack falls onto the surrounding gravel surface. Any runoff from the operation would collect in a downgradient valley gutter and be conveyed north to the northeastern side of the stormwater retention basin, upgradient of Outfall 001. We also observed the storage of concrete stripping chemicals at this wash rack. Due to recent precipitation experienced at the Facility, the secondary containment units for chemicals in this area were full of stormwater (refer to Photograph 16). The SWPPP does not identify this particular vehicle wash rack or concrete stripper storage area (refer to Exhibit 3). The SWPPP also does not identify a wash water contribution to the stormwater retention basin.

- Area of Concern 2b – We observed an uncovered truck wash rack area and associated concrete stripper storage area on the northeast side of the Facility that appears to drain to the stormwater retention basin.

**Photograph 15.** View, facing south, of an uncovered truck wash rack located in the northeastern portion of the Facility. Wash water from this wash rack would appear to flow over the gravel surface, into the valley gutter, and subsequently into the stormwater retention basin.

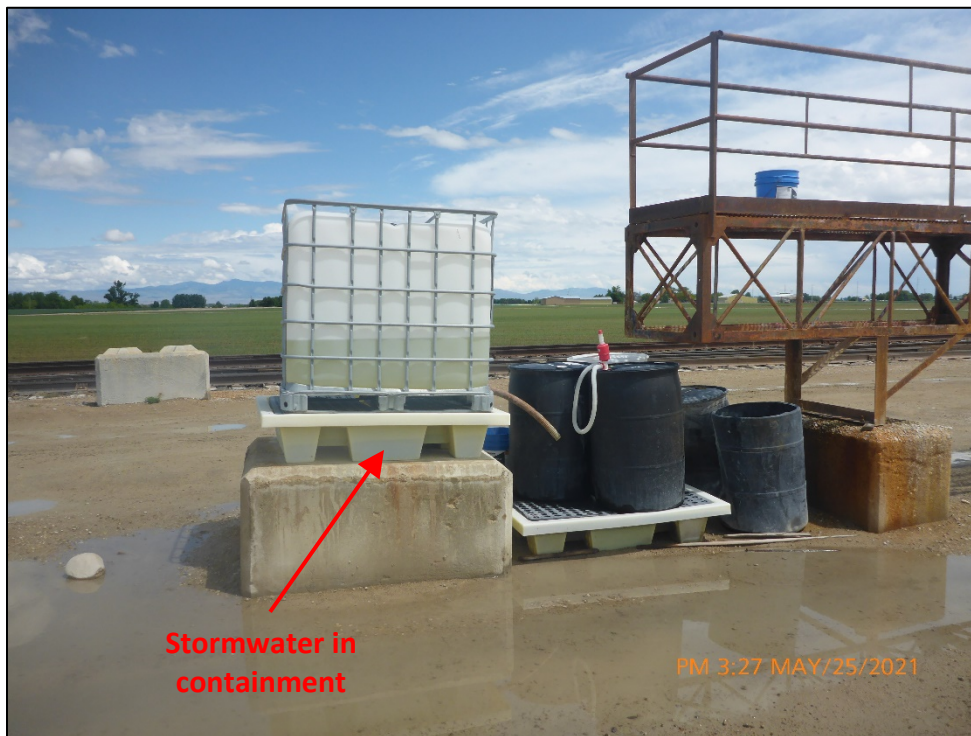
- Uncovered truck wash rack and associated concrete stripper storage area on the northeast side of the Facility (refer to Photographs 15 and 16).
- Bulk chemical storage tanks of calcium chloride, phosphoric acid, and concrete additives at the batch plant (refer to Photograph 17).

**Photograph 16.** View, facing east, of concrete stripping chemicals stored at the truck wash rack shown in Photograph 15. Note this wash rack is not identified on the SWPPP site map. Due to recent heavy precipitation, the secondary containment units were full of stormwater.

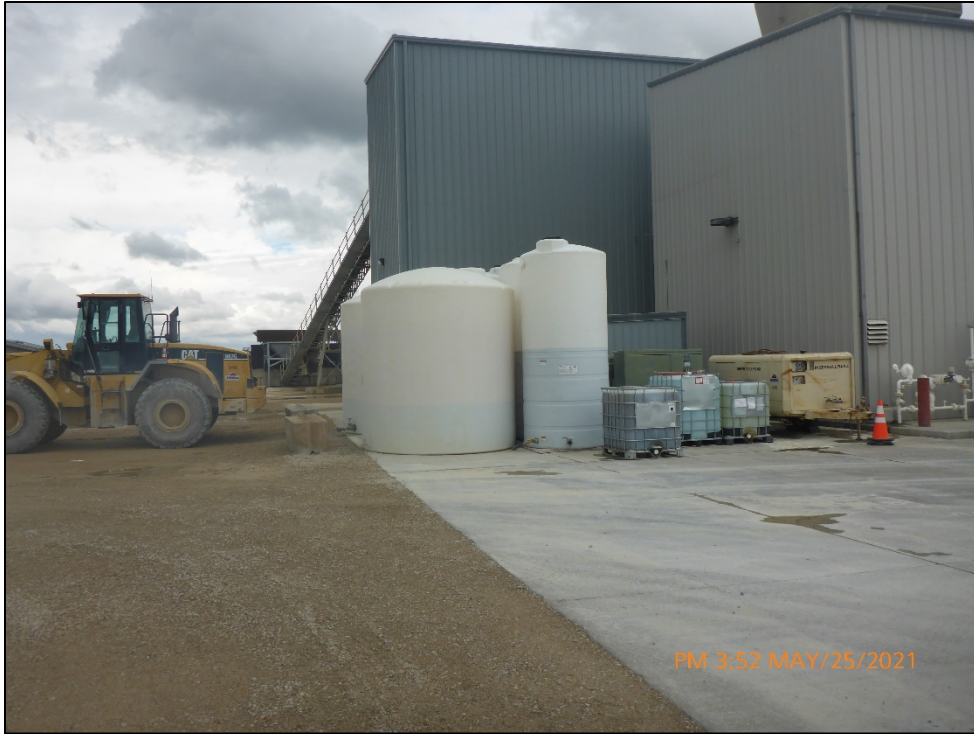
**Photograph 17.** View, facing north, of the bulk chemical storage area at the batch plant. This chemical storage area is not identified on the SWPPP site map.

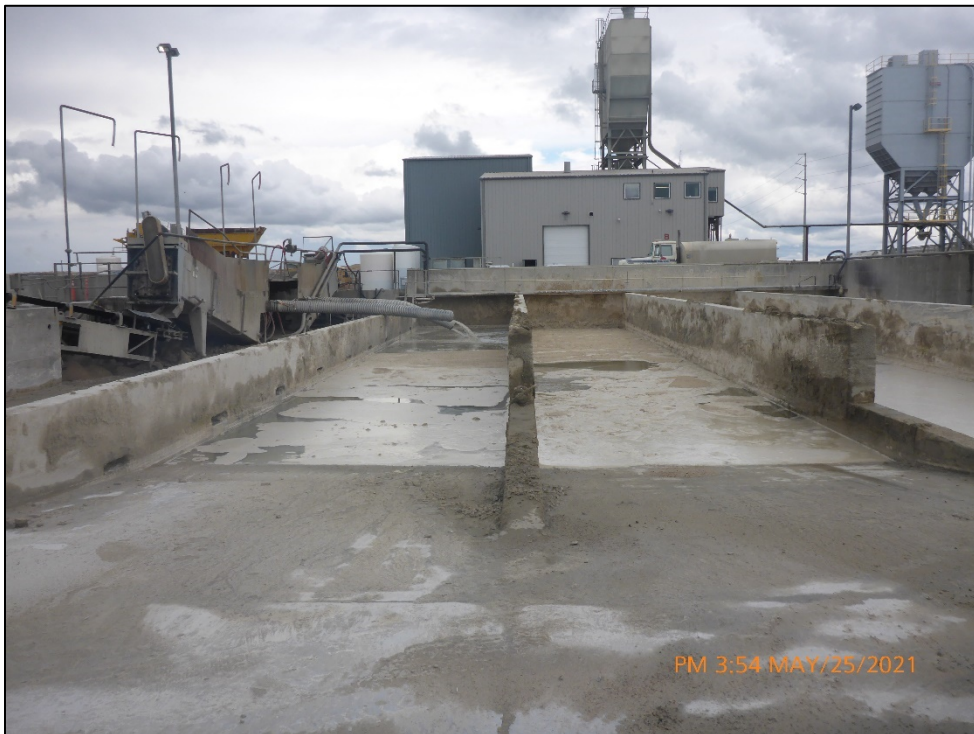
**Photograph 18.** View of the wash water recycling system, which was operational at the time of the inspection.

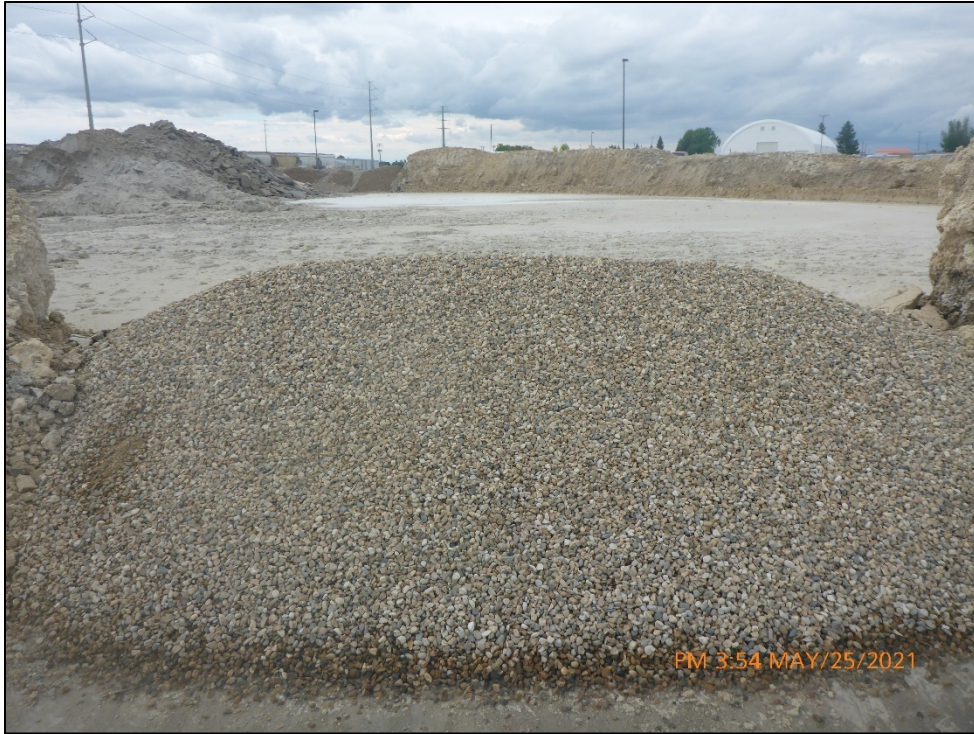
**Photograph 19.** View, facing south, of the aggregate and waste concrete drying basin south of the wash water recycling system shown in Photograph 18. Settled solids from the wash water recycling system settling bays, as well as other wet concrete waste, is allowed to dry and harden in this basin.

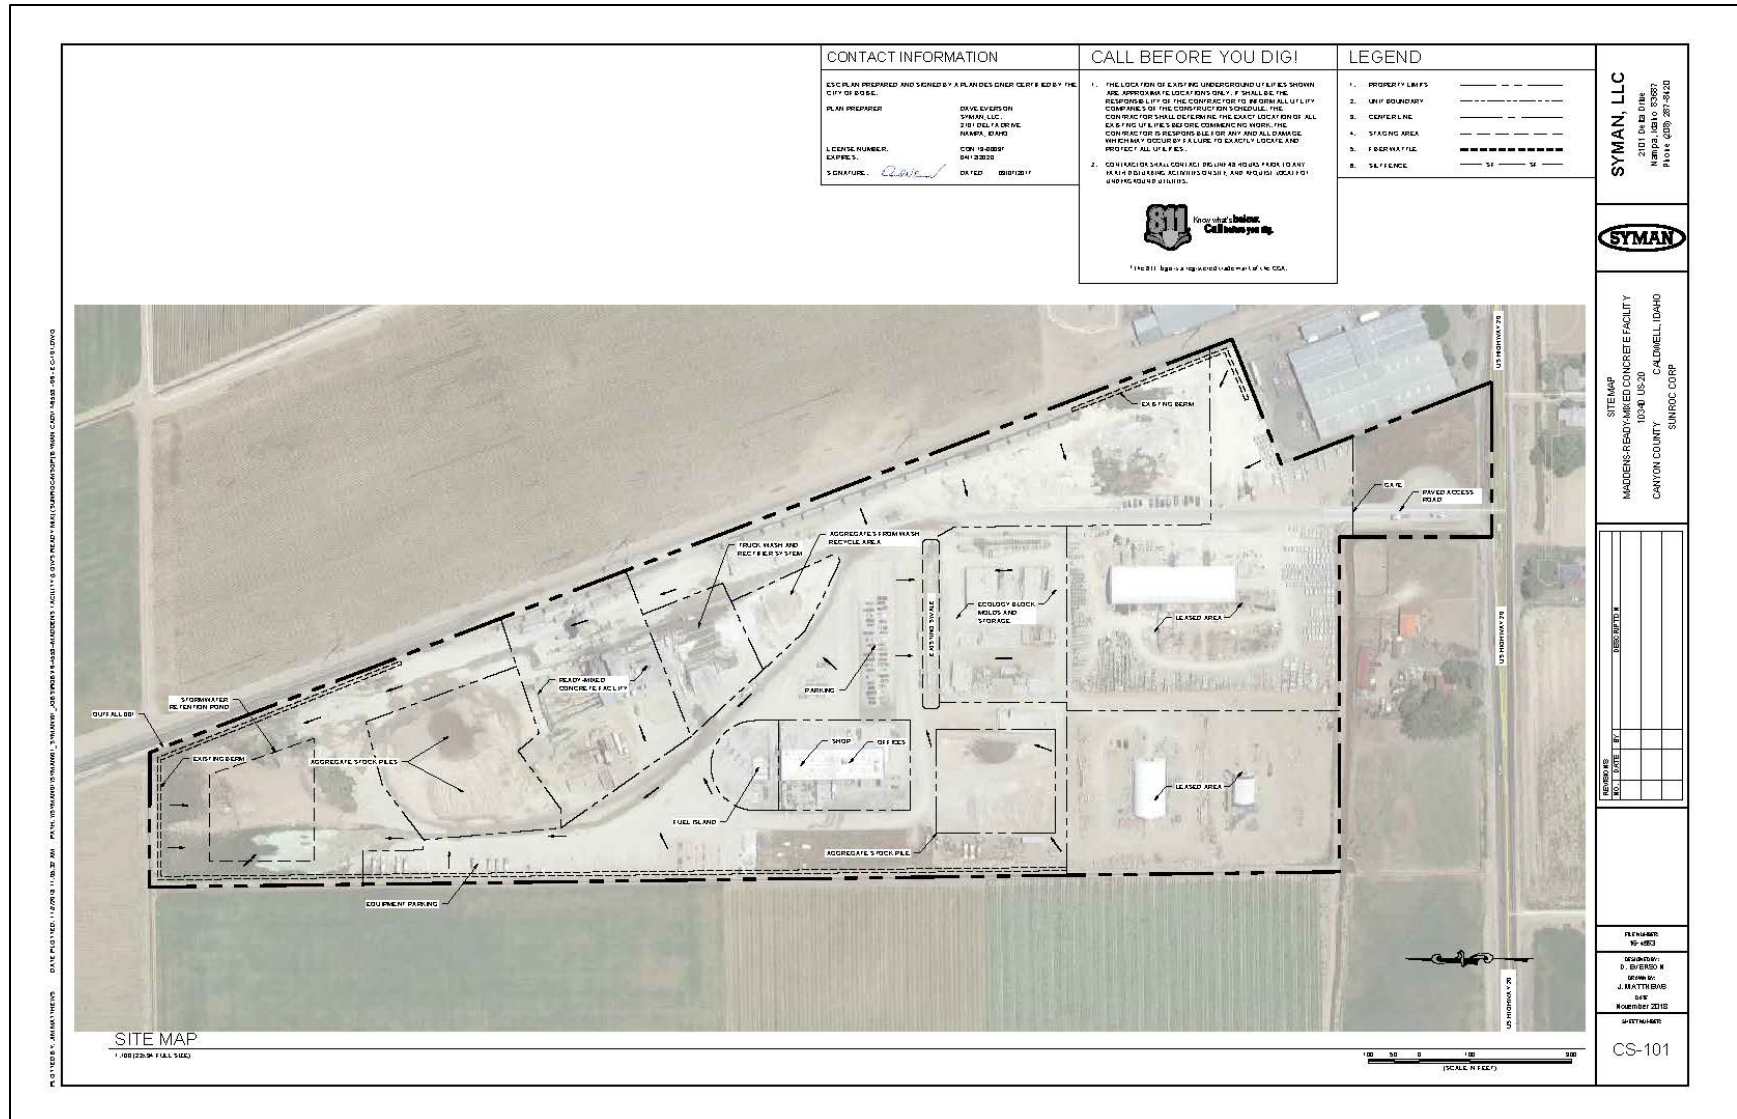
The SWPPP site map was not reflective of Facility conditions at the time of the inspection. During the inspection, I observed the following areas and features at the Facility that were not identified on the SWPPP site map:

**Exhibit 3.** SWPPP Site Map (map dated November 2018). The SWPPP Site Map was missing several elements required by the Permit (see Section III – Areas of Concern).
