**CWA COMPLIANCE EVALUATION INSPECTION REPORT  
U.S. ENVIRONMENTAL PROTECTION AGENCY, REGION 5**

**Purpose:** Compliance Evaluation Inspection

Heusinkveld Farms, LLP.  
17526 County 5  
Spring Valley, Minnesota 55975  
Fillmore County  
43.60994321103799, -92.28757527146949

**Date of Inspection:** 04/28/2025

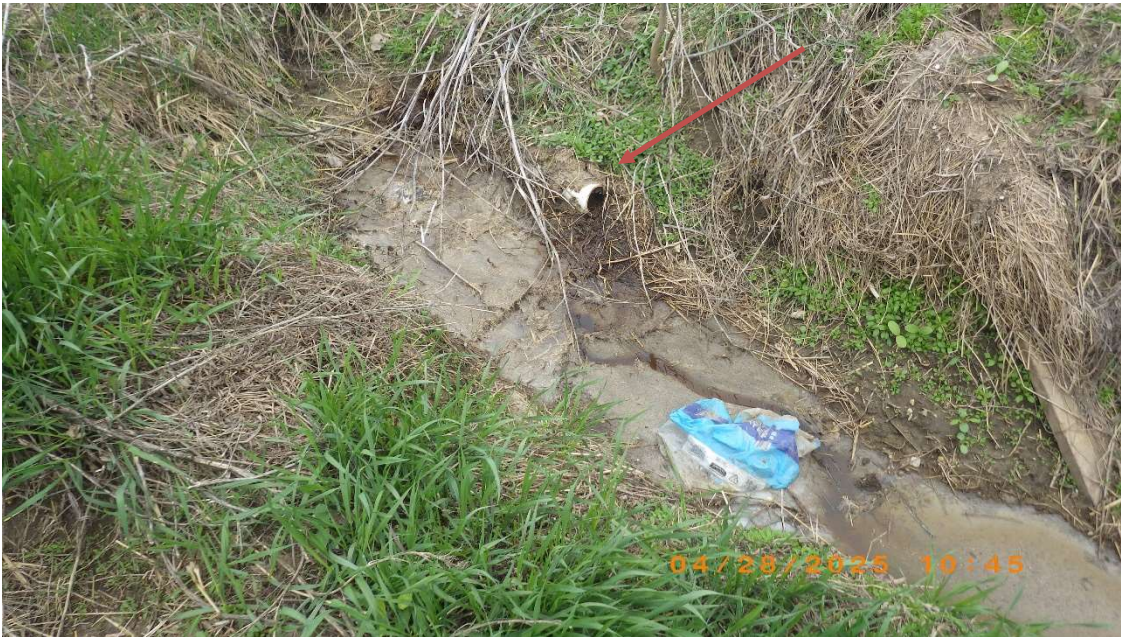
7: RIMG0007

The Inspectors then walked east and observed a white pipe protruding from the hillslope northeast of Calf Barn 2 (photos 7 and 8). The Operator identified the pipe as coming from calf milk room in Calf Barn 2. The Inspectors walked east along the north side of the Feed Bunker and observed a flow path with white colored liquid originating from the pipe from Calf Barn 2 (photo 9). The Inspectors observed that there was no liquid in the flow path approximately 130 feet from the source (photo 10). The Inspectors walked east to the northeast corner of the Feed Bunker and observed holes and erosional flow paths in the soil at the base of the northeast corner of the Feed Bunker with a dark color liquid and staining present (photos 11-13).

3. The white pipe from Calf Barn 2 may convey process wastewater.
4. The northeast corner of the Feed Bunker may be leaking leachate.
5. The erosional flow path east of the Big Pit may convey process wastewater toward the unnamed intermittent waterway to the east.

Description: White PVC pipe (red arrow) identified by the Operator as coming from Calf Barn 2 where calf milk is prepared.

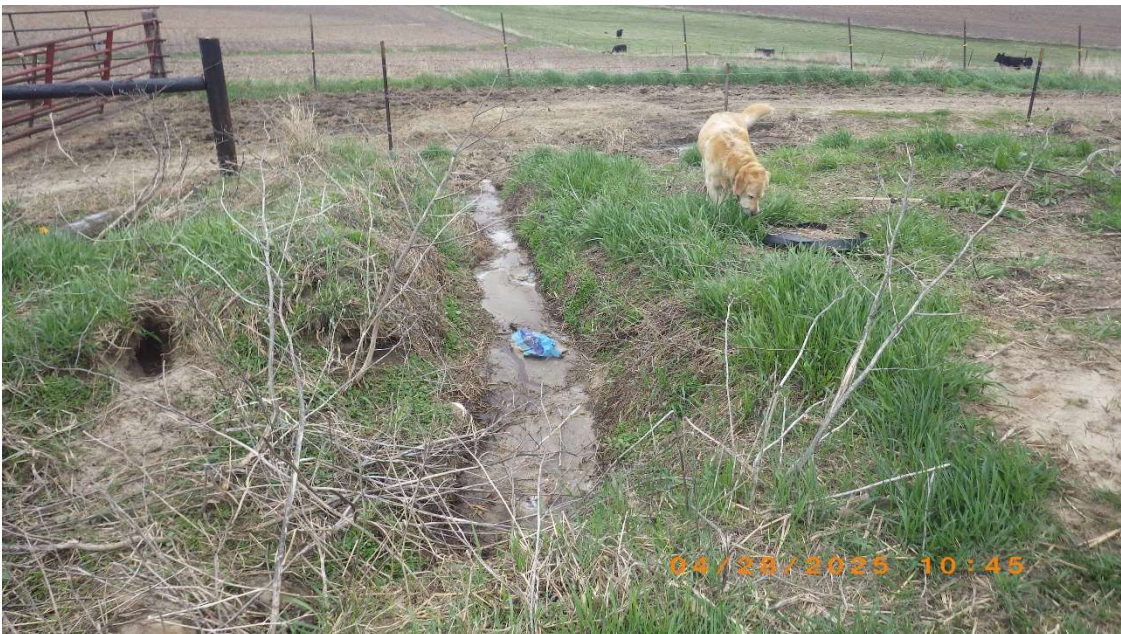
8: RIMG0008

Description: Looking north along flowpath from the white PVC pipe noted in Photo 7.

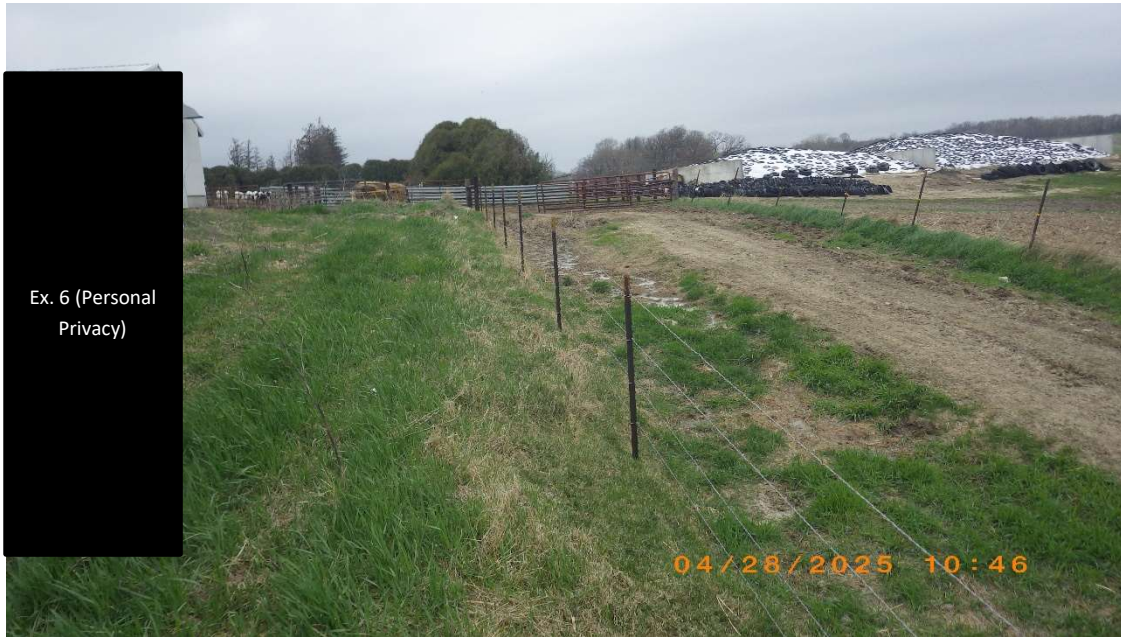
9: RIMG0009

Description: Looking west uphill along the flowpath from the pipe noted in photo 7.

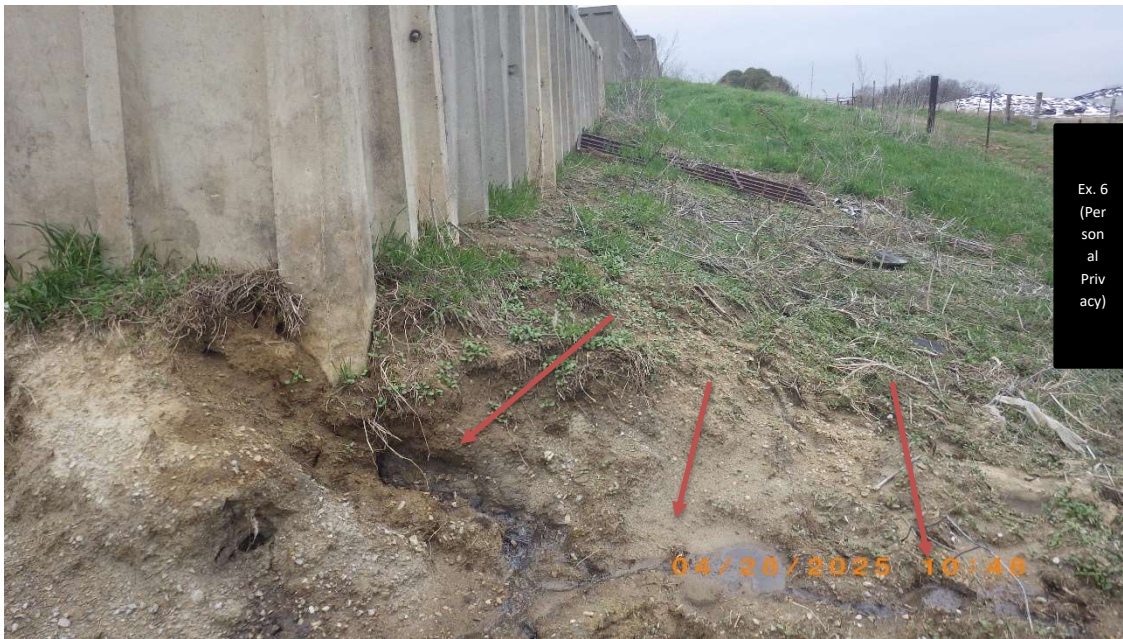
11: RIMG0011

Description: Looking west along the north side exterior of the Feed Bunker. Note erosional flowpath with dark colored liquid originating at the northeast corner of the Feed Bunker (red arrows).

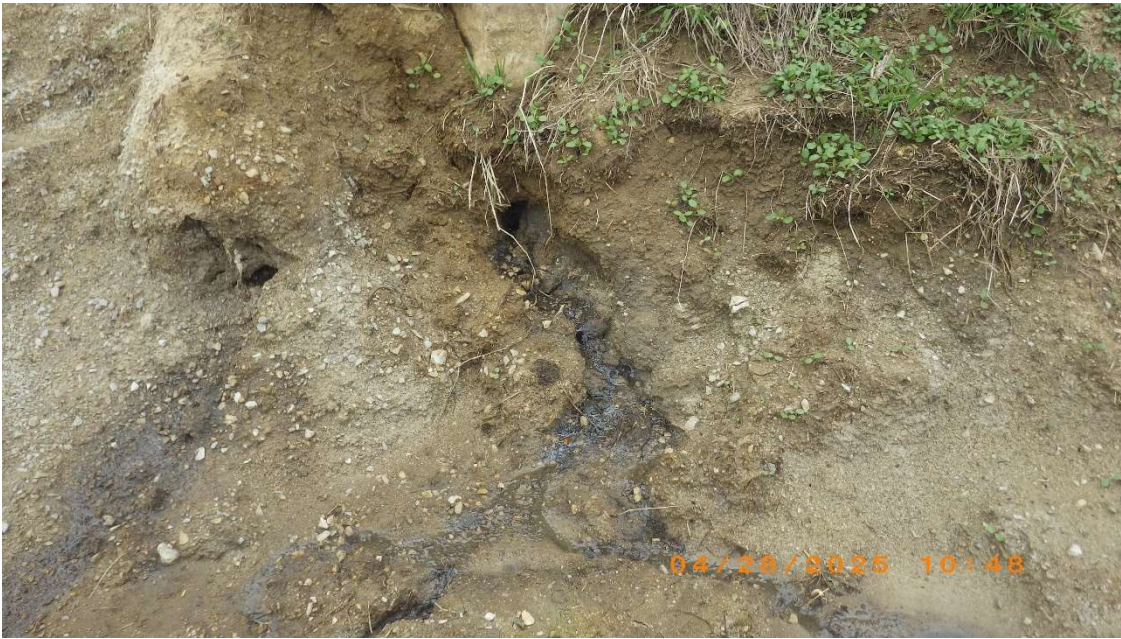
13: RIMG0013

Description: Close up of the holes at the base of the northeast corner of the Feed Bunker with dark color liquid.

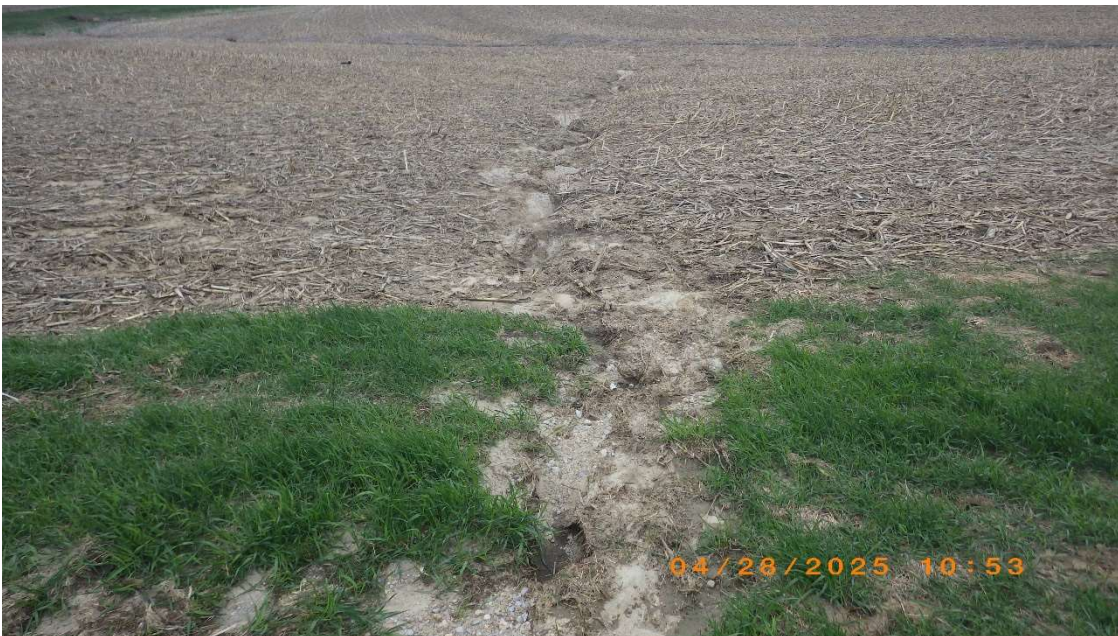
18: RIMG0018

The Inspectors walked southeast to the northeast corner of the Big Pit (photos 16 and 17). The Inspectors observed an erosional flow path from the access road east of the Big Pit into the crop field east of the Big Pit (photos 18 and 19).

Description: Erosional flowpath through crop field on the east side of the Big Pit.

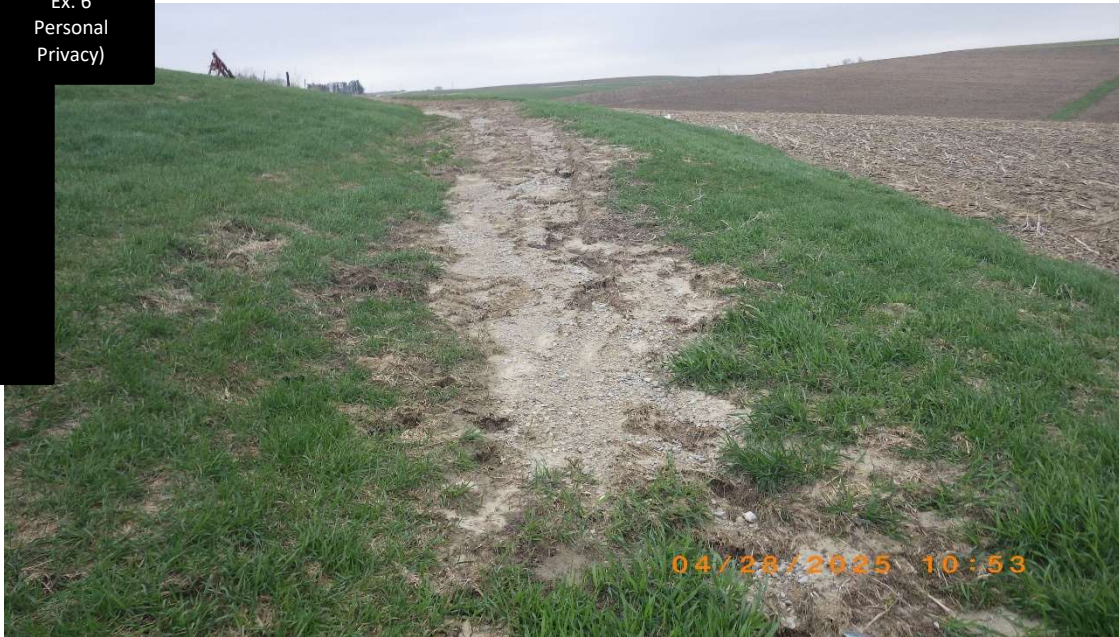
19: RIMG0019

Description: Looking north along erosional flowpath on the east side of the Big Pit.

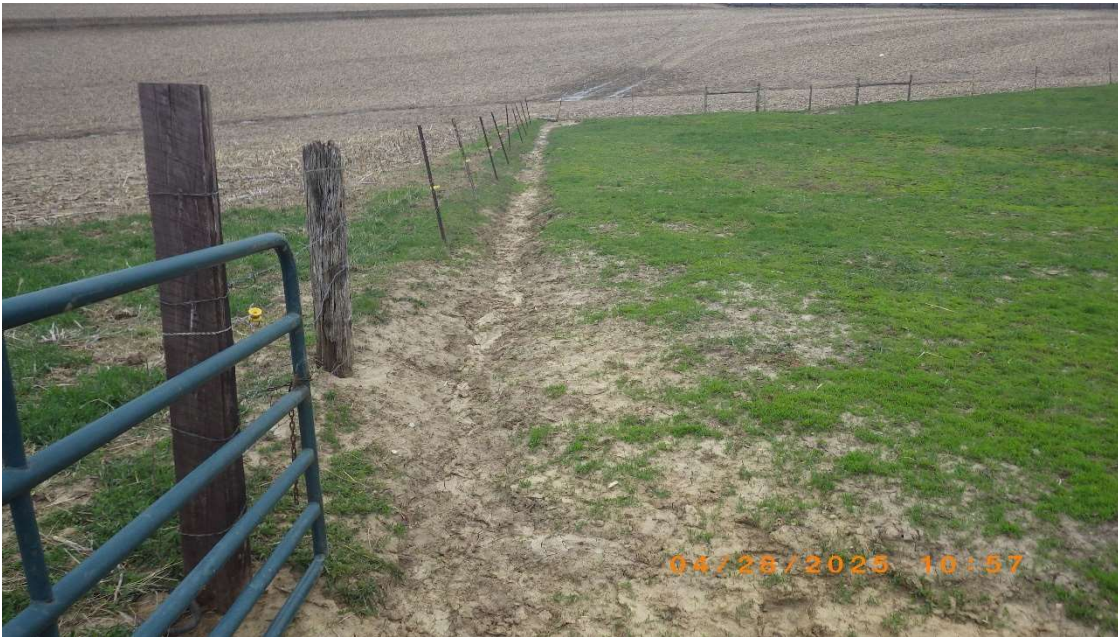
21: RIMG0021

The Inspectors walked around the east side of the Big Pit and then west along the south side of the Big Pit (photo 20). The Inspectors observed an erosional flow path along the fence to the south (photo 21). The Inspectors walked west and observed manure solids on the top of the wall of the Big Pit and on the ground on the south side of the Big Pit (photo 22). The Inspectors observed an erosional flow path to the south (photo 23). The Inspectors continued west and observed manure solids on the top of the wall of the Sand Pit and on the ground south of the south wall of the Sand Pit (photo 24). The Inspectors

Description: Erosional flow channel to the south along the fence line on the south side of the Big Pit.

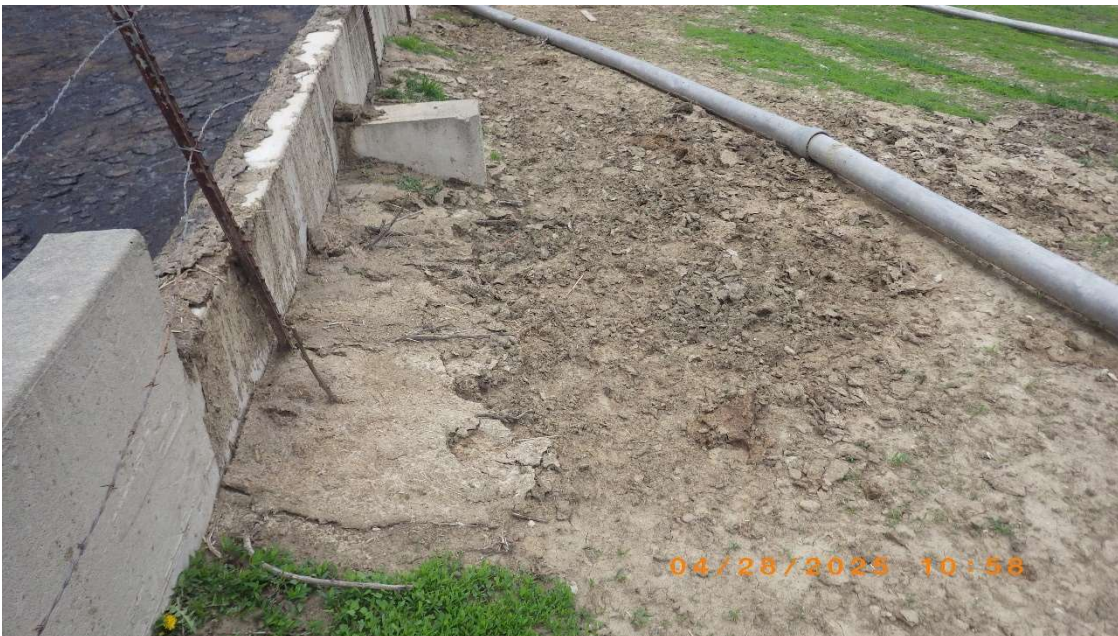
22: RIMG0022

Description: Manure solids pushed over the top of the south wall of the Big Pit.

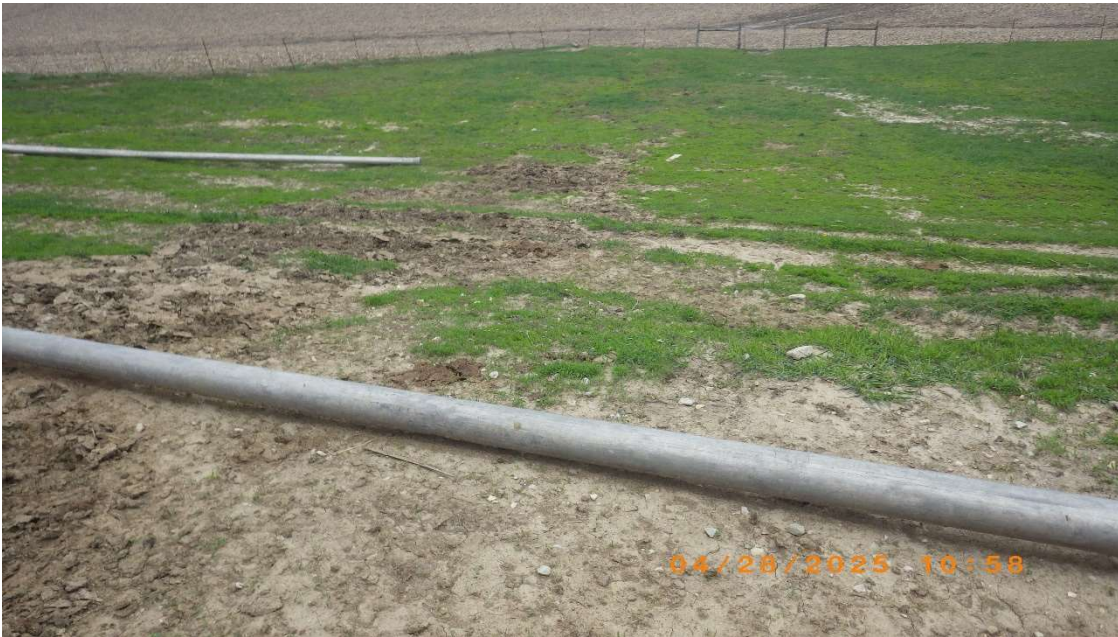
23: RIMG0023

Description: Erosional flowpath to the south on the south side of the Sand Pit.

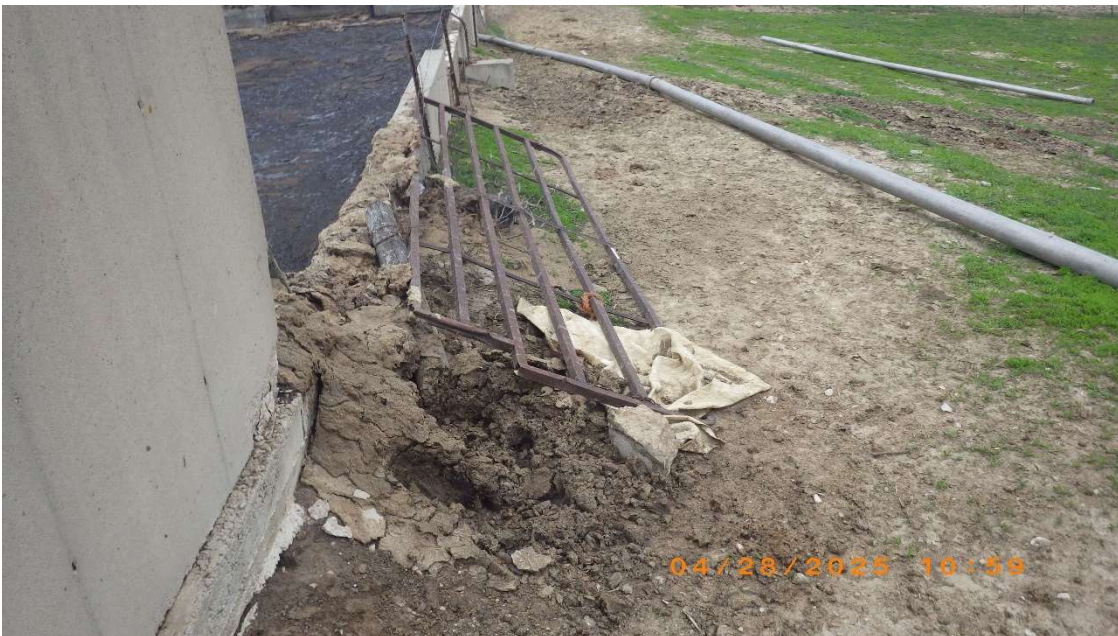
24: RIMG0024

Description: Manure solids pushed out of the southwest corner of the Sand Pit.

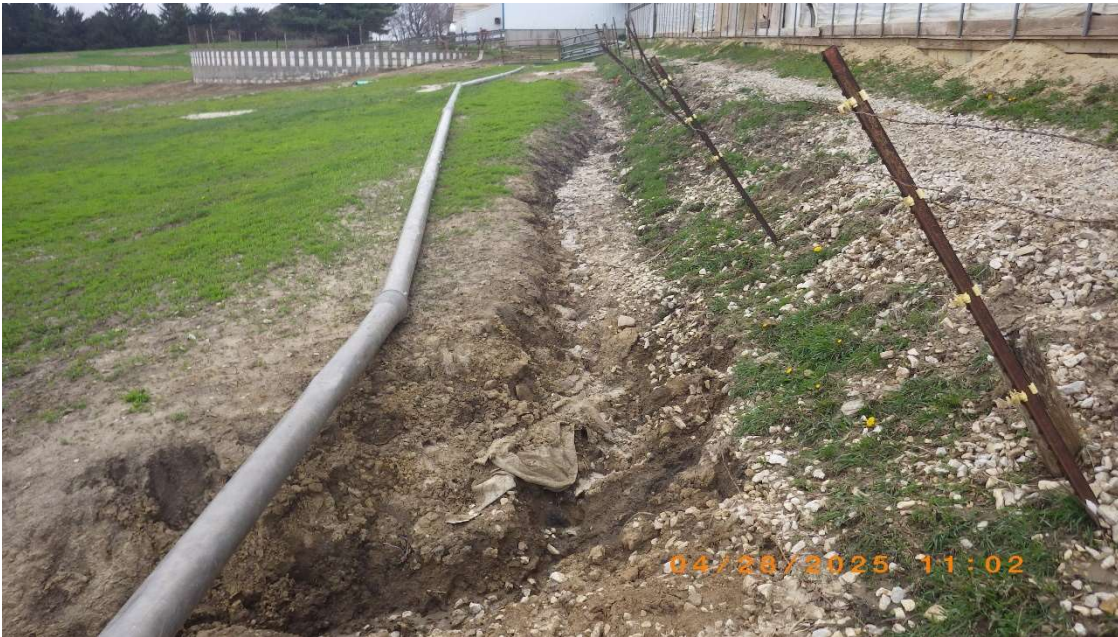
25: RIMG0025

observed an erosional flow path along the south side of the Dairy Barn parallel to the Dairy barn which then turned south (photos 25 and 26).

Description: Erosional flowpath on the south side of the Dairy Barn.

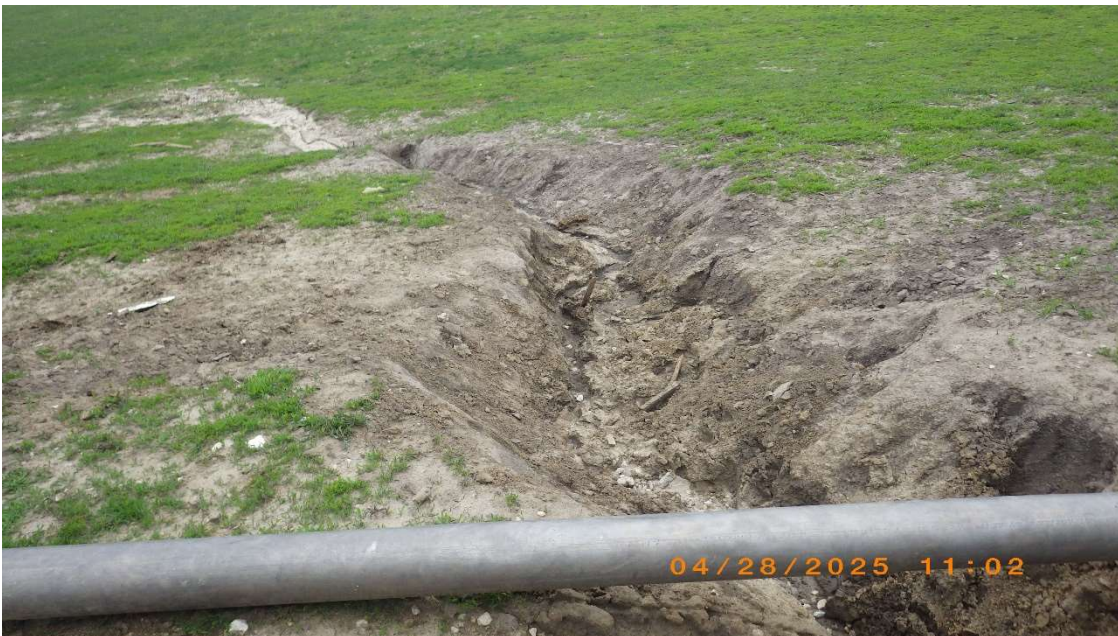
26: RIMG0026

Description: Continuation of the erosional flowpath from Photo 25 to south.

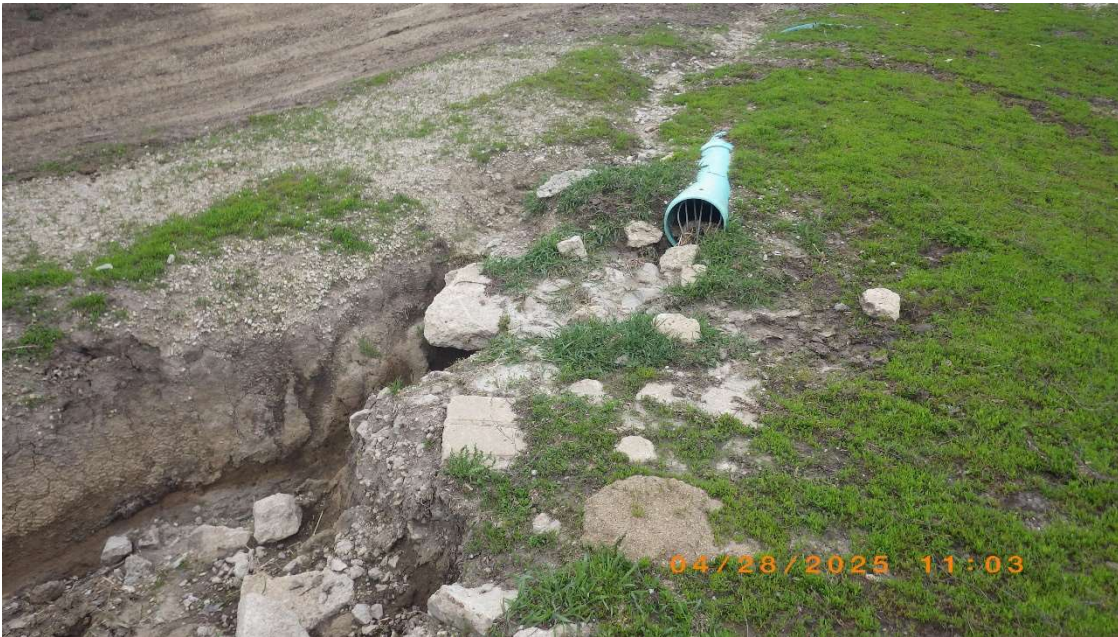
27: RIMG0027

The Inspectors walked west and observed a blue pipe protruding southeast out of the hillslope south of the Dairy Barn with an erosional flow path southeast (photos 27 - 29). The Operator stated that the pipe conveyed stormwater from the area north of the Parlor Water Pit. The Inspectors walked around the south side of the Parlor Water Pit and observed a white pipe on the west side of the Parlor Water Pit (photo 31). The Operator stated that this was an older now unused pipe that had conveyed stormwater from the area north of the Parlor Water Pit.

Description: Blue pipe identified by the Operator as stormwater from the north side of the Parlor Wash Water Pit.

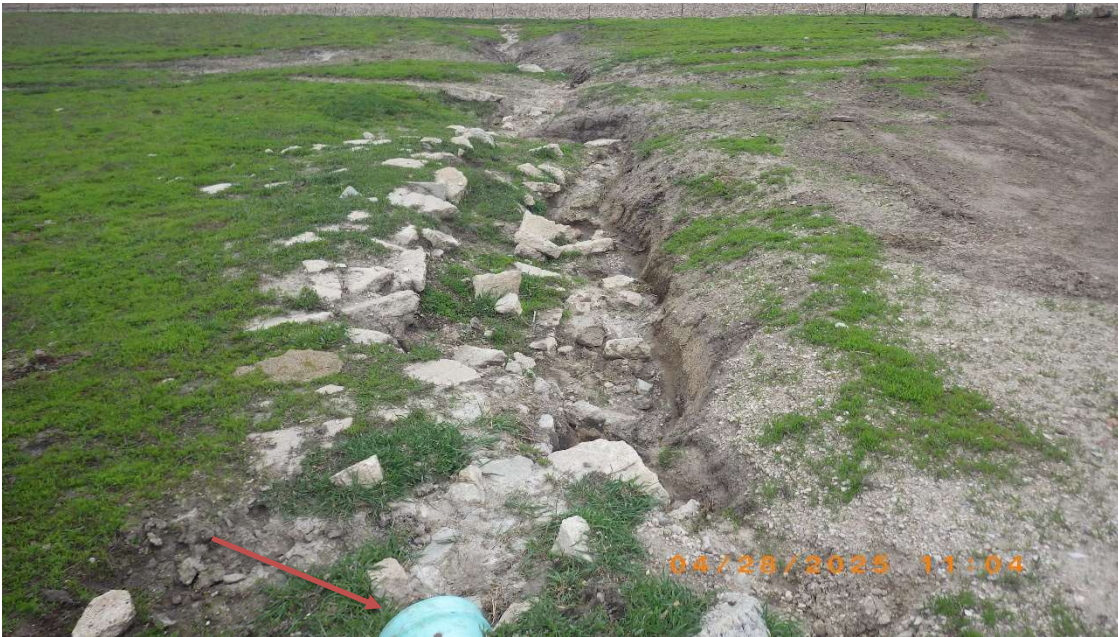
29: RIMG0029

Description: Erosional flowpath to the south. Outlet of the blue stormwater pipe seen in photo 28 (red arrow).

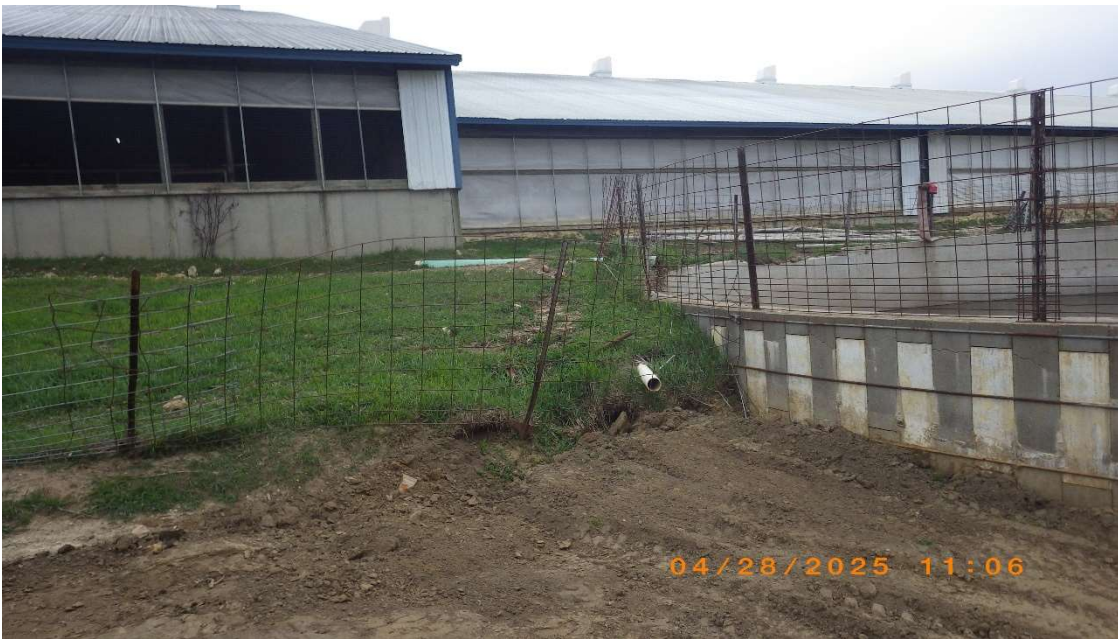
31: RIMG0031

Description: West side of the Parlor Wash Water Pit (right). The White pipe was identified by the Operator as an older pipe that had been used to convey stormwater from the north side of the Parlor Wash Water Pit.

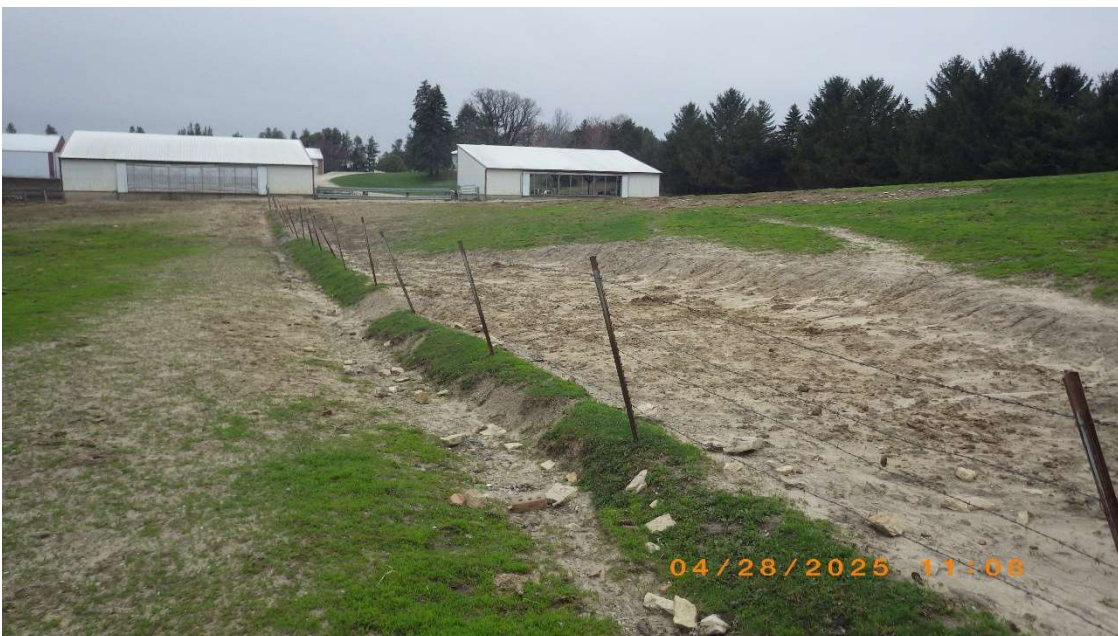
32: RIMG0032

The Inspectors walked southwest and observed the outdoor lots north of the Dry Cow Barns. The Inspectors observed that the outdoor lots were partially denuded with erosional flow paths south to the crop field south of the outdoor lots (photos 32-36). The Inspectors also observed an erosional flow path along the south fence of the outdoor lots (photo 37).

Description: Looking south across outdoor lots toward the Dry Cow Barns. Note denuded areas and erosional features.

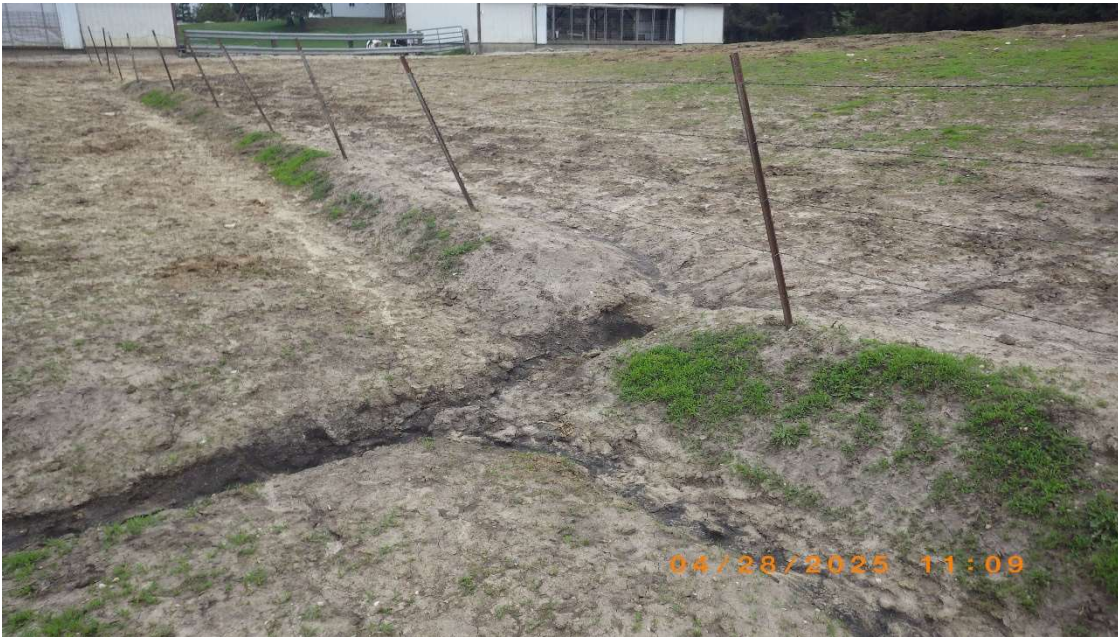
33: RIMG0033

Description: Erosional flowpaths converging into an erosional flowpath to the east.

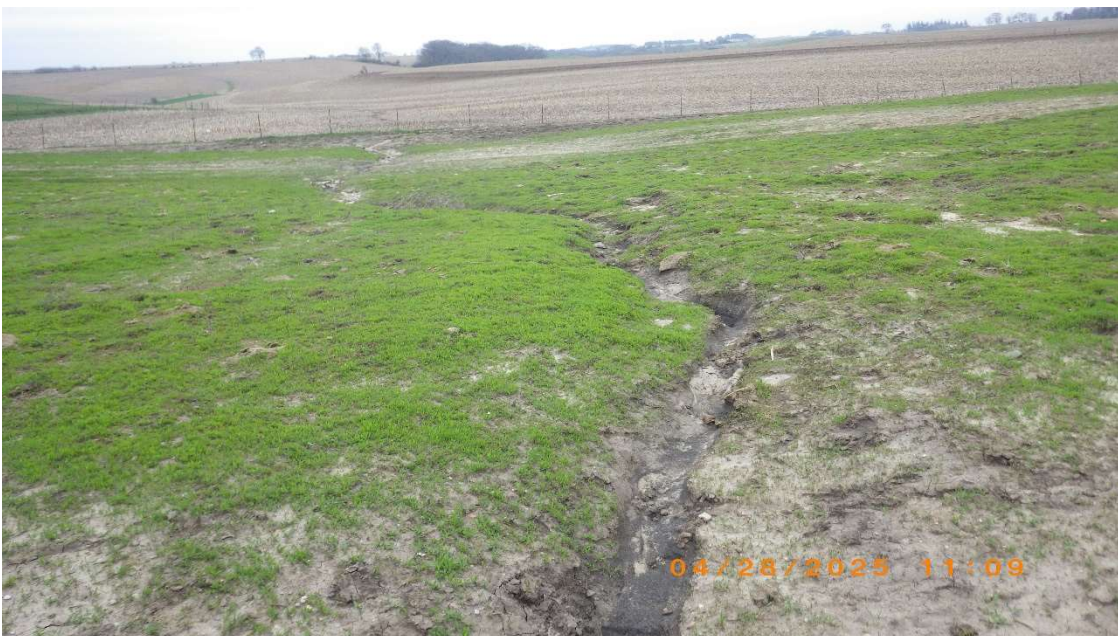
34: RIMG0034

Description: Erosional flowpath to the east through the outdoor lots between the Dry Cow Barns and Milk Parlor.

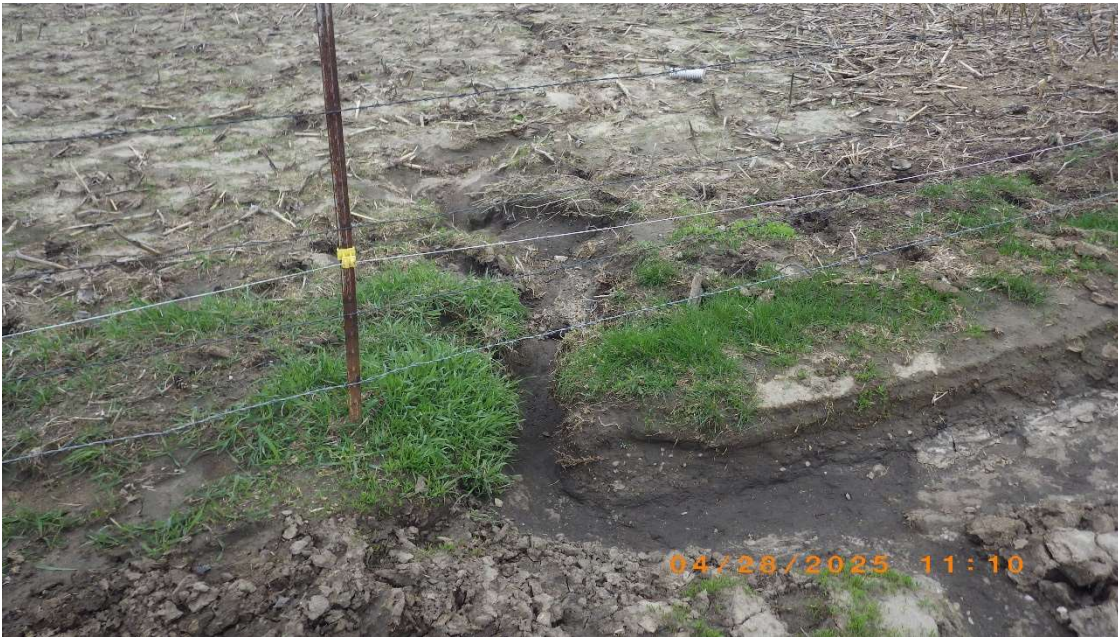
35: RIMG0035

Description: Erosional flowpath from the outdoor lots into the crop field east of the outdoor lots.

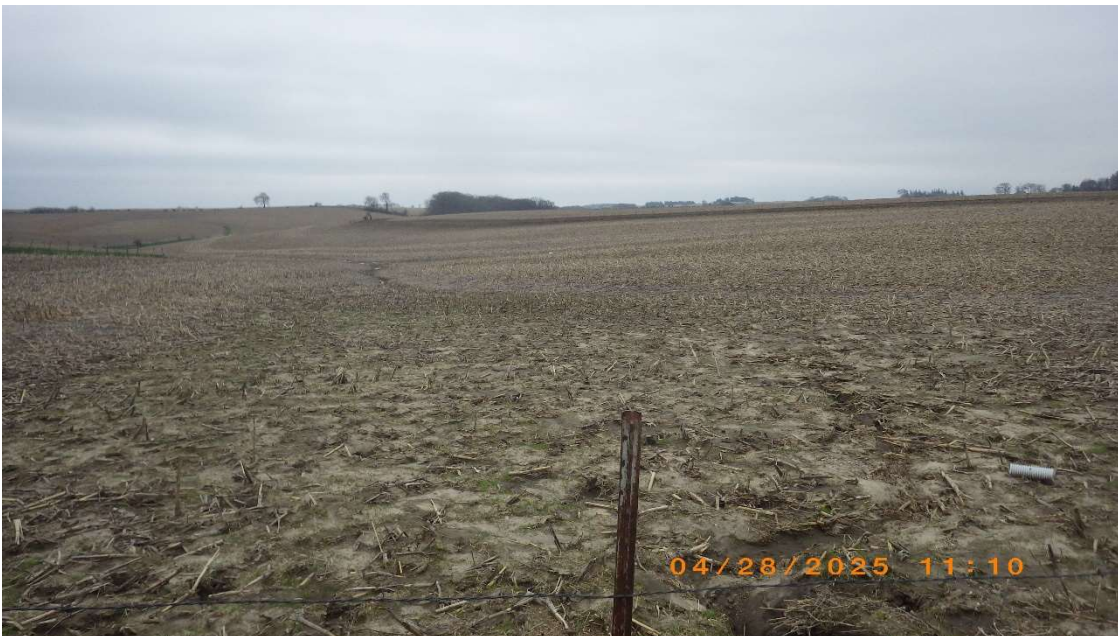
36: RIMG0036

Description: Erosional flowpath into the field east of the outdoor lots between the Dairy Barn and the Dry Cow Barns.

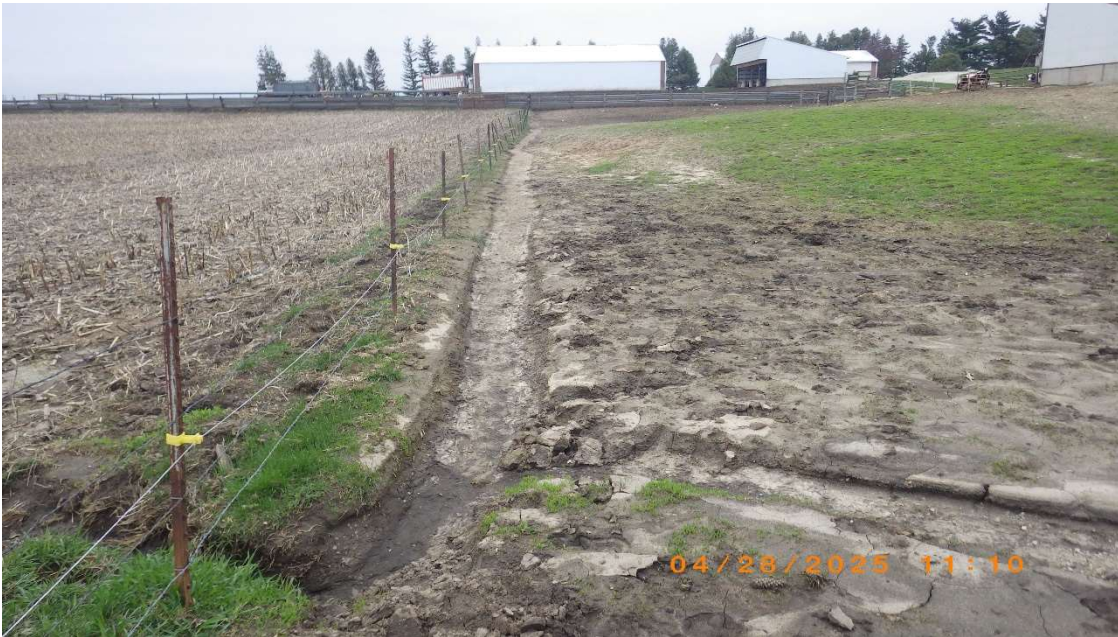
37: RIMG0037

Description: Erosional flowpath along the east edge of the outdoor lots between the Dairy Barn and the Dry Cow Barns.

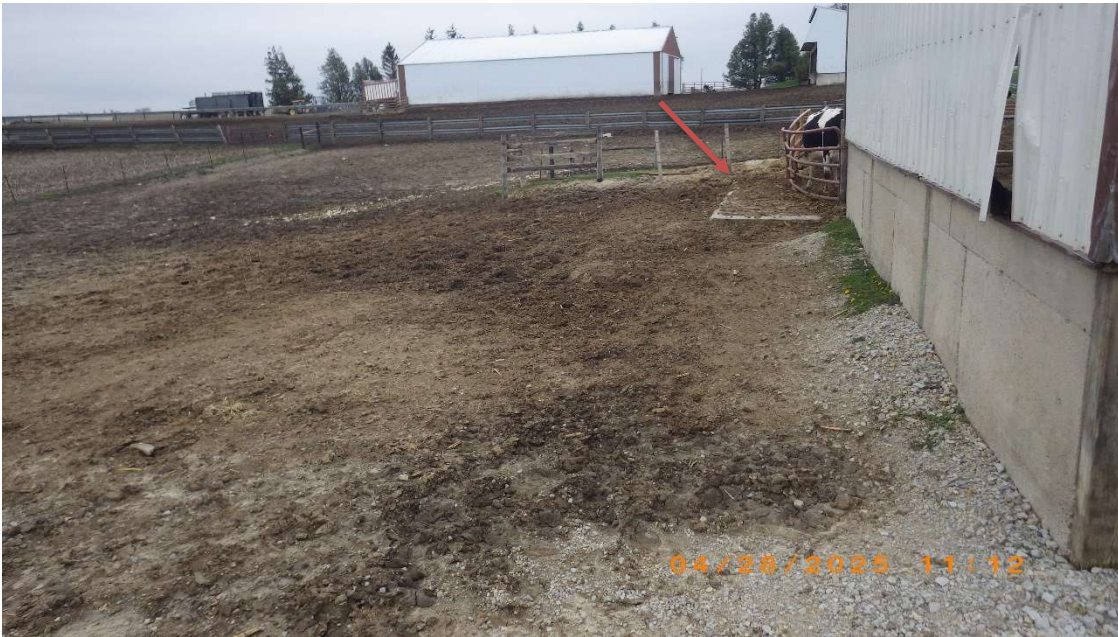
41: RIMG0041

The Inspectors walked south to the north side of the Dry Cow Barns (photos 38 and 39). The Inspectors walked southeast and observed the east side of the Dry Cow Barns and observed manure off the edge of the concrete pad south of the Dry Cow Barns (photos 41 and 42). The Inspectors then walked southwest and observed erosional flow paths from the denuded lot north of the Cattle Shed through the denuded lot south of the Dry Cow Barns to the crop field south of the outdoor lots (photos 43-46). The Inspectors also observed an erosional flow path from the area south of the Dry Cow Barns along the fence to the east (photos 47 and 48).

Description: Looking south along the east side of the Dry Cow Barns. Note the manure over the edge of the concrete pad of the outdoor lot on the south side of the Dry Cow Barns (red arrow).

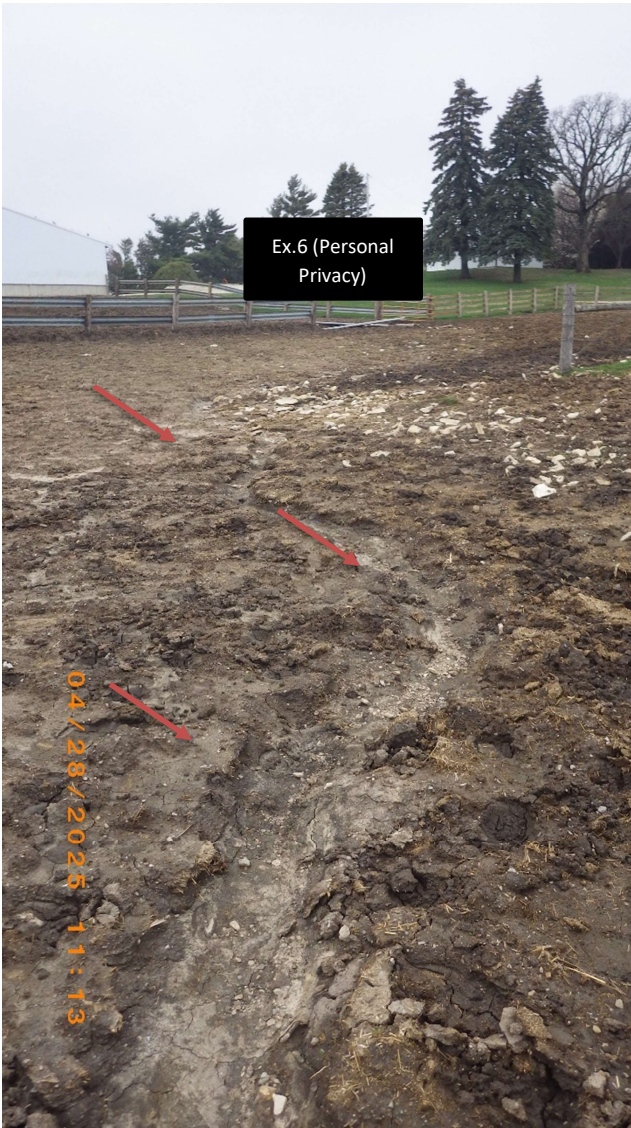
43: RIMG0043

Description: Looking southwest across outdoor lot on the south side of the Dry Cow Barns. Note erosional flowpath (red arrows).

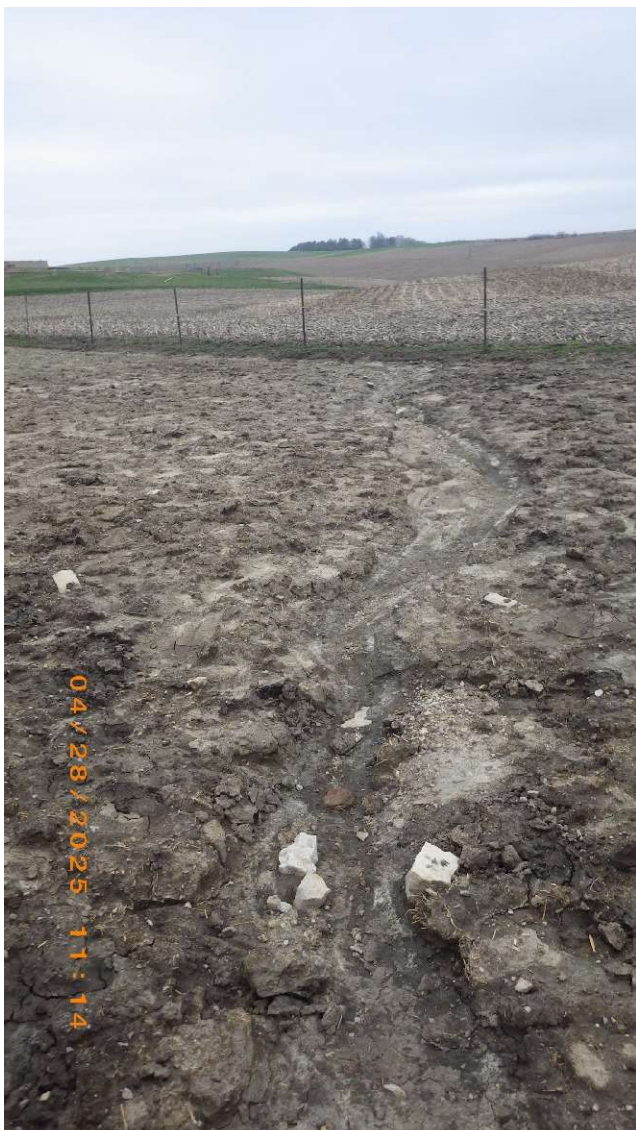
44: RIMG0044

Description: Looking northeast along erosional flowpath through the outdoor lot southeast of the Dry Cow Barns into the crop field east of the outdoor lot.

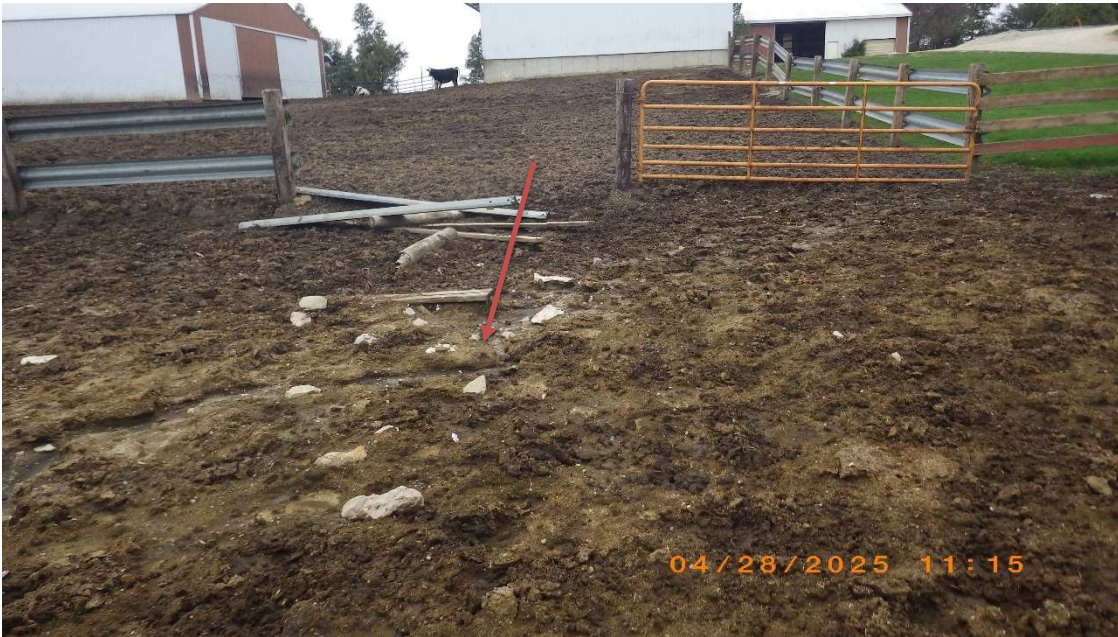
45: RIMG0045

Description: Erosional flowpath (red arrow) through the outdoor lot south of the Dry Cow Barns.

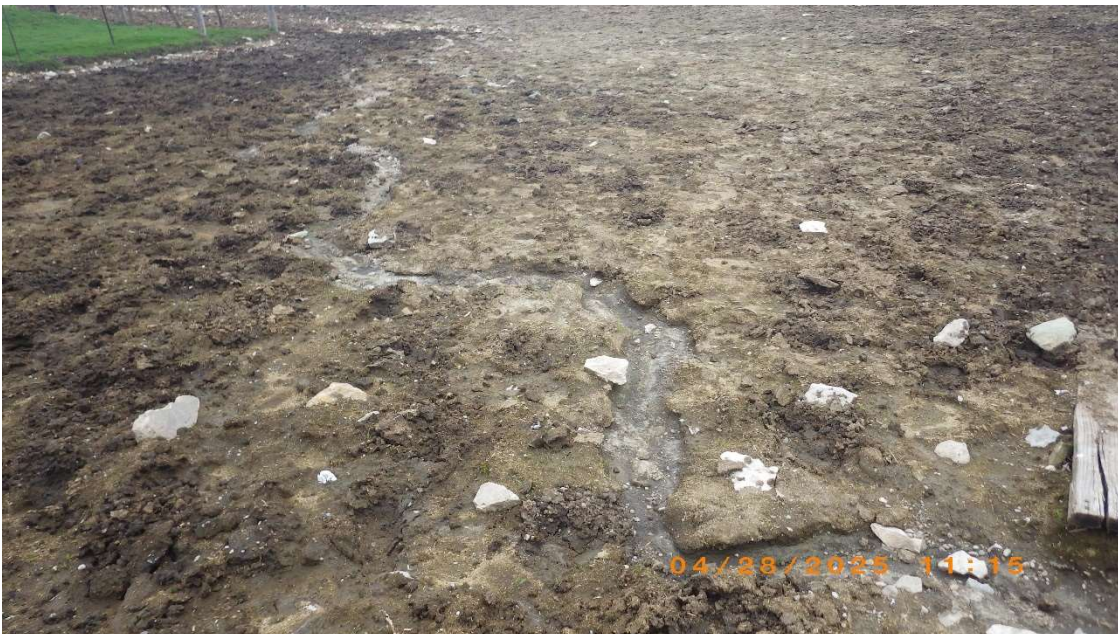
46: RIMG0046

Description: Continuation of the erosional flowpath observed in Photo 45 northeast to the erosional flowpath observed in Photo 43 and Photo 44.

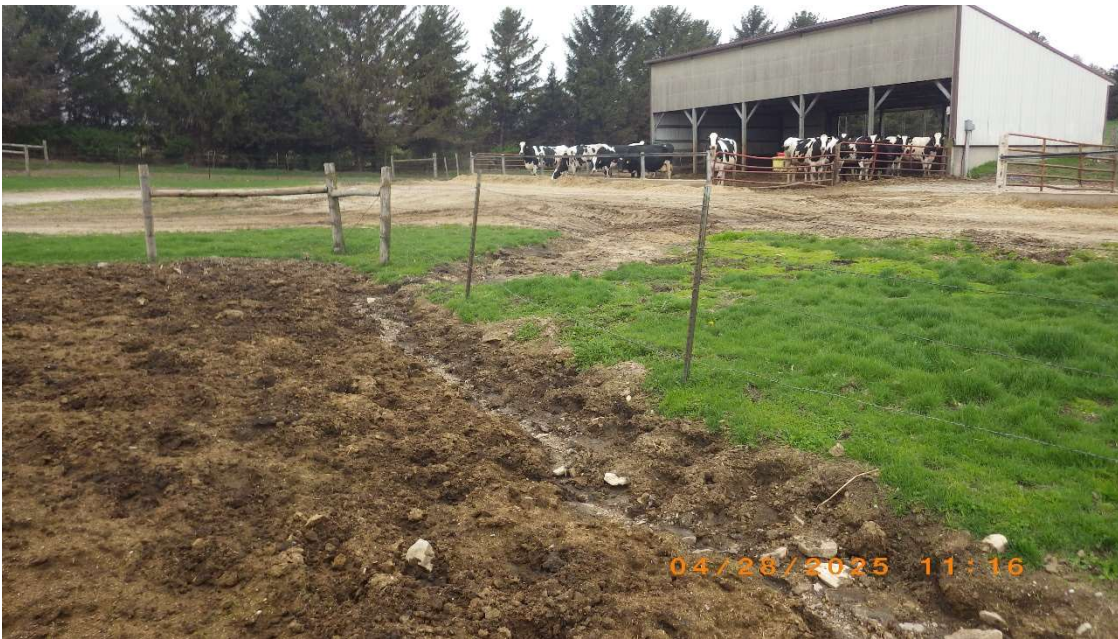
47: RIMG0047

Description: Erosional flowpath along the fence row of the outdoor lot south of the Dry Cow Barns and north of the Cattle Shed.

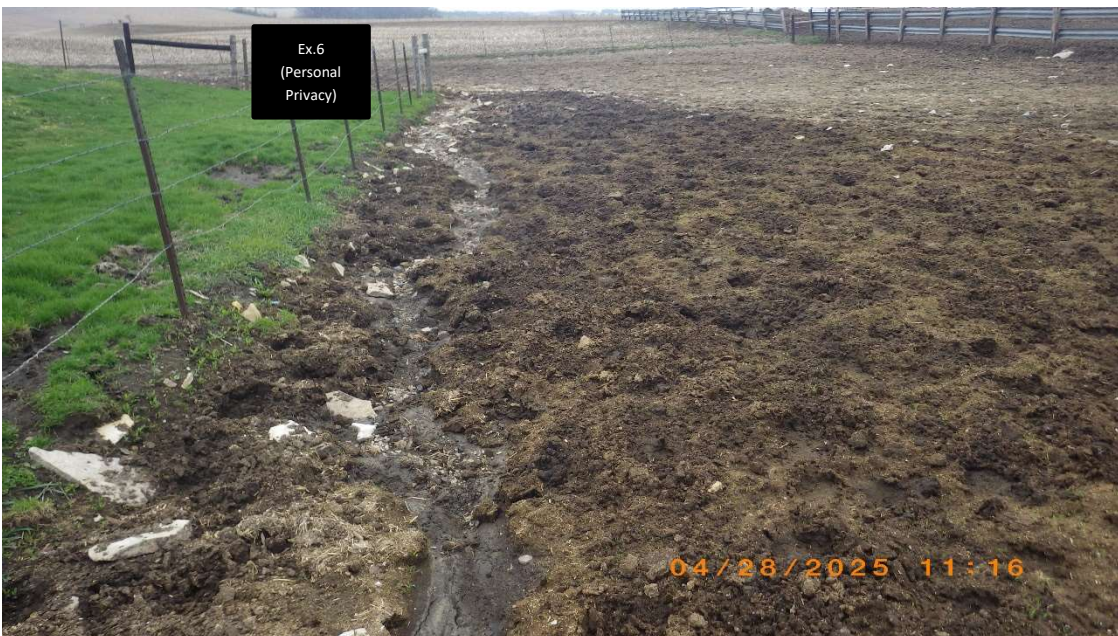
48: RIMG0048

Description: Continuation of the erosional flowpath along the fence row of the outdoor lot south of the Dry Cow Barns and north of the Cattle Shed.
