**CWA COMPLIANCE EVALUATION INSPECTION REPORT  
U.S. ENVIRONMENTAL PROTECTION AGENCY, REGION 5**

**Purpose:** Compliance Evaluation Inspection

Heusinkveld Farms, LLP.  
17526 County 5  
Spring Valley, Minnesota 55975  
Fillmore County  
43.60994321103799, -92.28757527146949

**Date of Inspection:** 04/28/2025

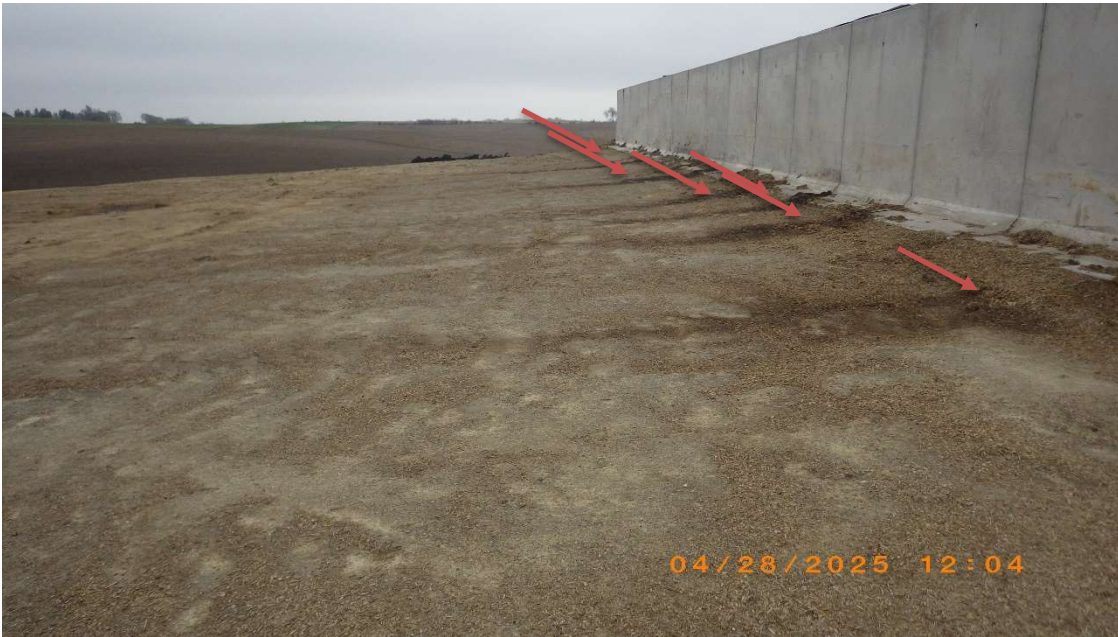
79: RIMG0079

Description: Looking east across the north side of the North Silage Pad. Note dark staining at seams of the concrete wall (red arrows).

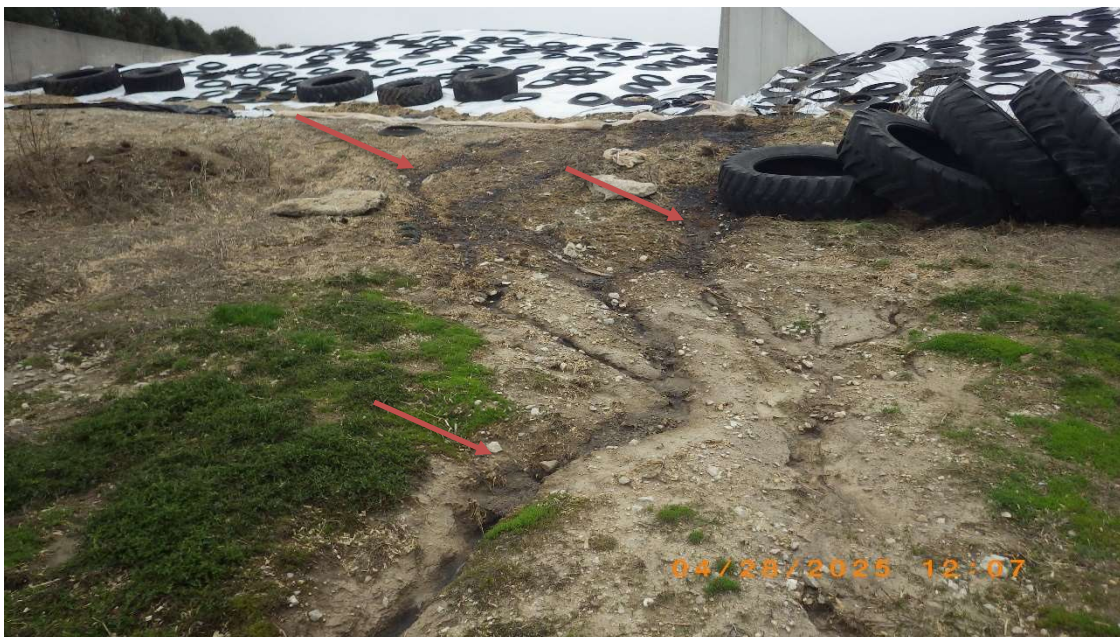
83: RIMG0083

The Inspectors then walked east to the east side of County 5 and north to the southwest corner of the North Silage Pad (photo 73). The Inspectors walked north along the west side of the North Silage Pad and observed erosional flow paths along the west side of the North Silage Pad to the crop field to the north (photos 75 and 75). The Inspectors then walked north to the north end of the silage mound north of the North Silage Pad (photos 76-78). Then Inspectors then walked south to the north side of the North Silage Pad. The Inspectors observed staining at the seams of the north wall of the North Silage Pad (photos 79-80). The Inspectors then walked south on the east side of the North Silage Pad and observed erosional flow path with dark staining from east side of the North Silage Pad to the crop field to the east (photos 81-84).

Description: Looking west at the east side of the North Silage Pad. Note erosional flowpaths and dark staining (red arrows).
