## **RCRA Inspection Report**

Allworth, LLC  
500 Medco Road  
Birmingham, Alabama 35217  
EPA ID No: ALD094476793  
NAICS: 325998 – All Other Miscellaneous Chemical Product and Preparation Manufacturing  
562112 – Hazardous Waste Collection  
562211 – Hazardous Waste Treatment and Disposal

June 17, 2021

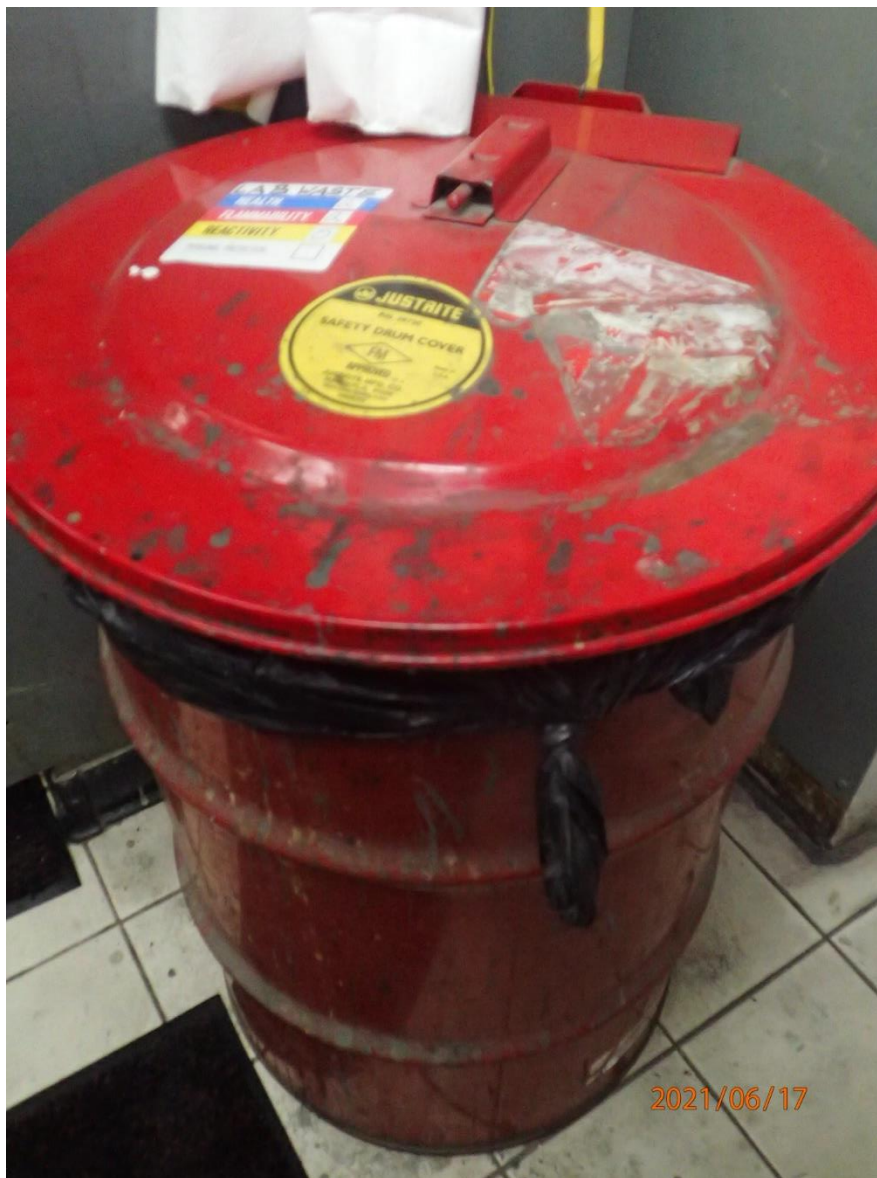
- One (1) 55-gallon drum labeled "Lab Waste", closed, with a hazard identification sticker marked for flammability (Photo #1). The drum was not marked "Hazardous Waste."
- One (1) pint-size glass jar of Sulfuric Acid under a fume hood labeled "Hazardous Waste," closed, and no indication of hazard (Photo #2)
- One (1) 5-gallon container of lab sample waste under a fume hood labeled "Hazardous Waste," closed, and with an indication of hazard for flammability (Photo #3)

**Photo 1:** 55-gallon drum labeled “Lab Waste”, closed, with a hazard identification sticker marked for flammability.

**Pursuant to ADEM Admin. Code r. 335-14-3-.01(5)(a)5. [40 C.F.R. § 262.15(a)(5)], which is a condition of the SAA Permit Exemption, a generator is required to mark or label its containers (i) with the words "Hazardous Waste" and (ii) with an indication of the hazards of the contents.**

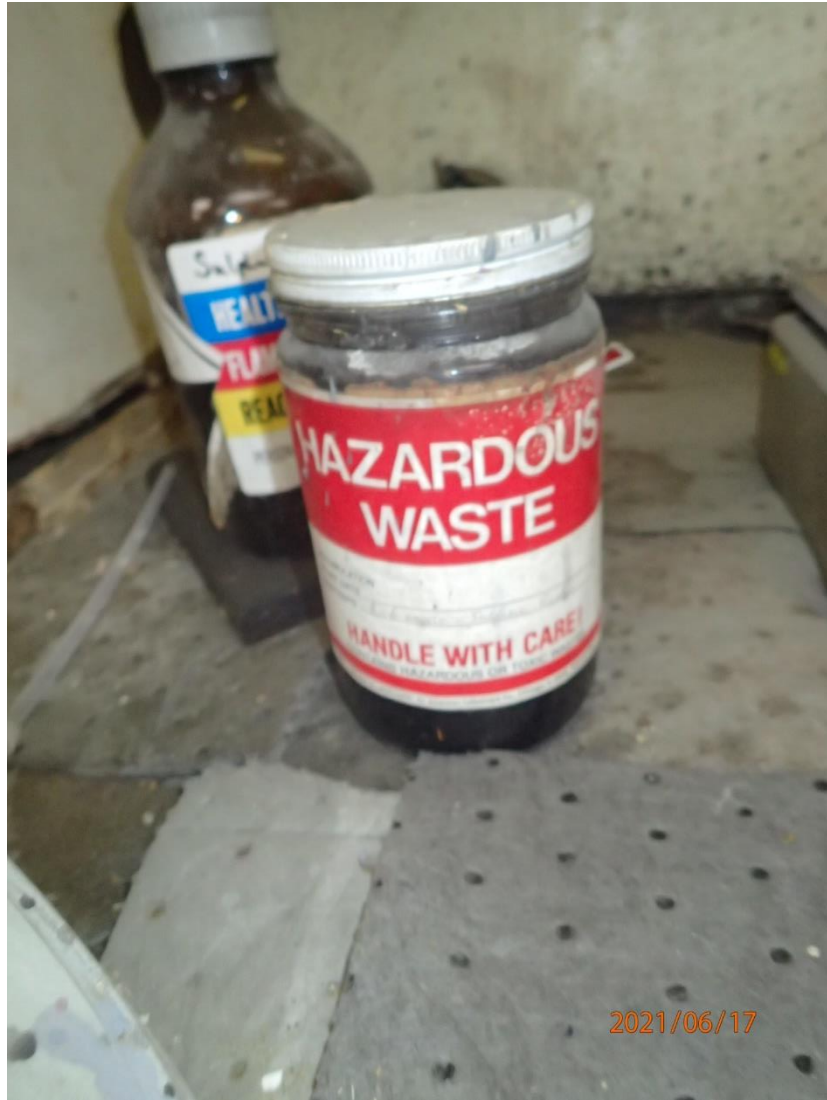
**Photo 2:** Pint-size glass jar of Sulfuric Acid under a fume hood labeled “Hazardous Waste”, closed, and no indication of hazard

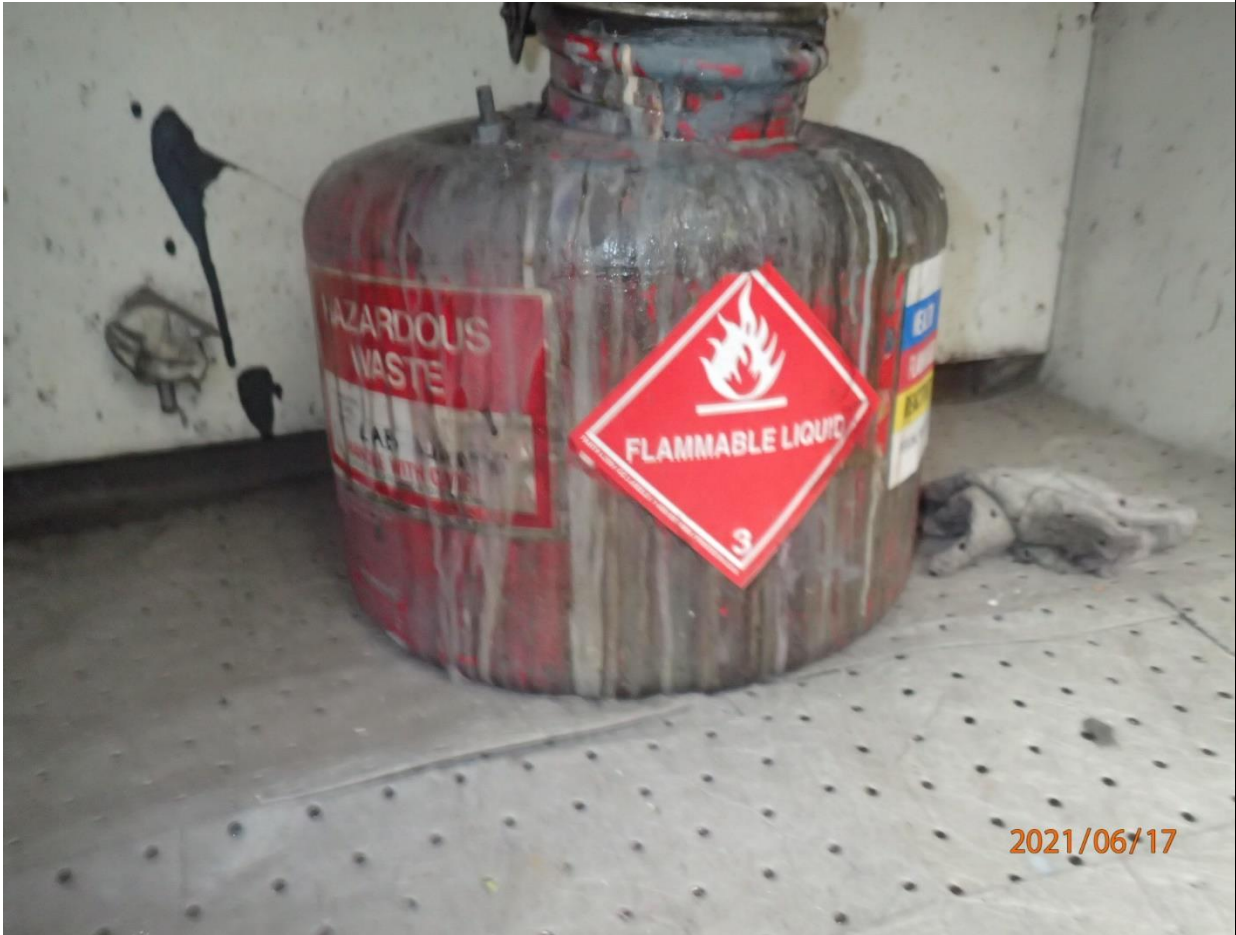
**Photo 3:** 5-gallon container of lab sample waste under a fume hood labeled “Hazardous Waste”, closed, and with an indication of hazard for flammability

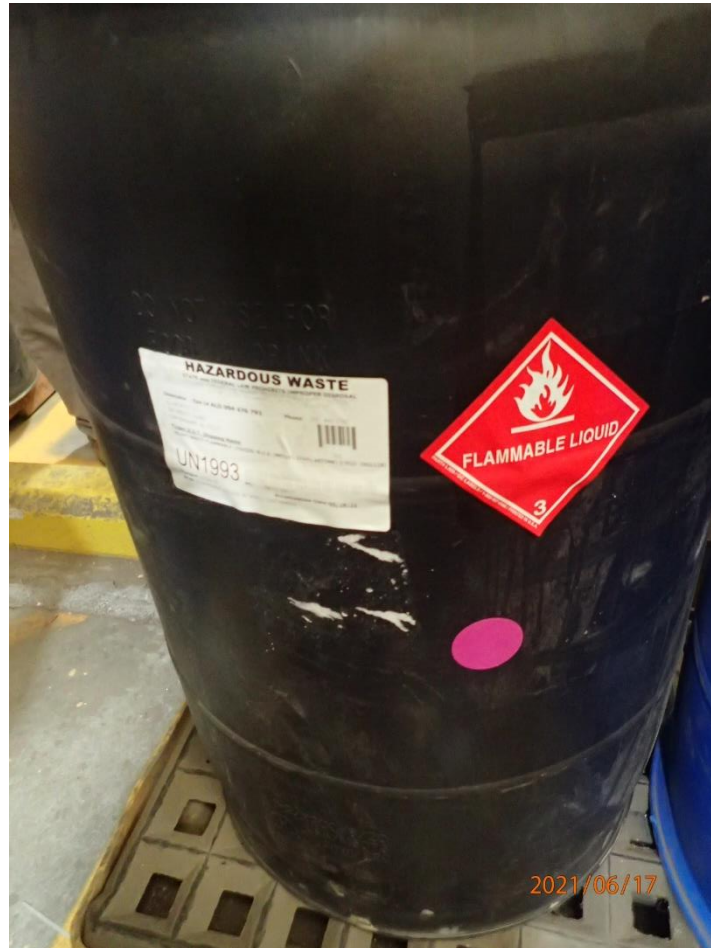
- Two (2) 55-gallon drums of laboratory waste on spill containment pallets labeled "Hazardous Waste", closed, dated, and with DOT placards to indicate the hazardous contents. (Photos #4 and #5)
- Approximately 71 additional pallets of hazardous waste containers were observed varying in size from 5-55 gallons and one (1) cubic yard box. All hazardous waste containers were properly labeled, placarded, dated, and closed.

**Photo 4:** 55-gallon drums of laboratory waste on spill containment pallet labeled “Hazardous Waste”, closed, dated, and with DOT placards to indicate the hazardous contents.

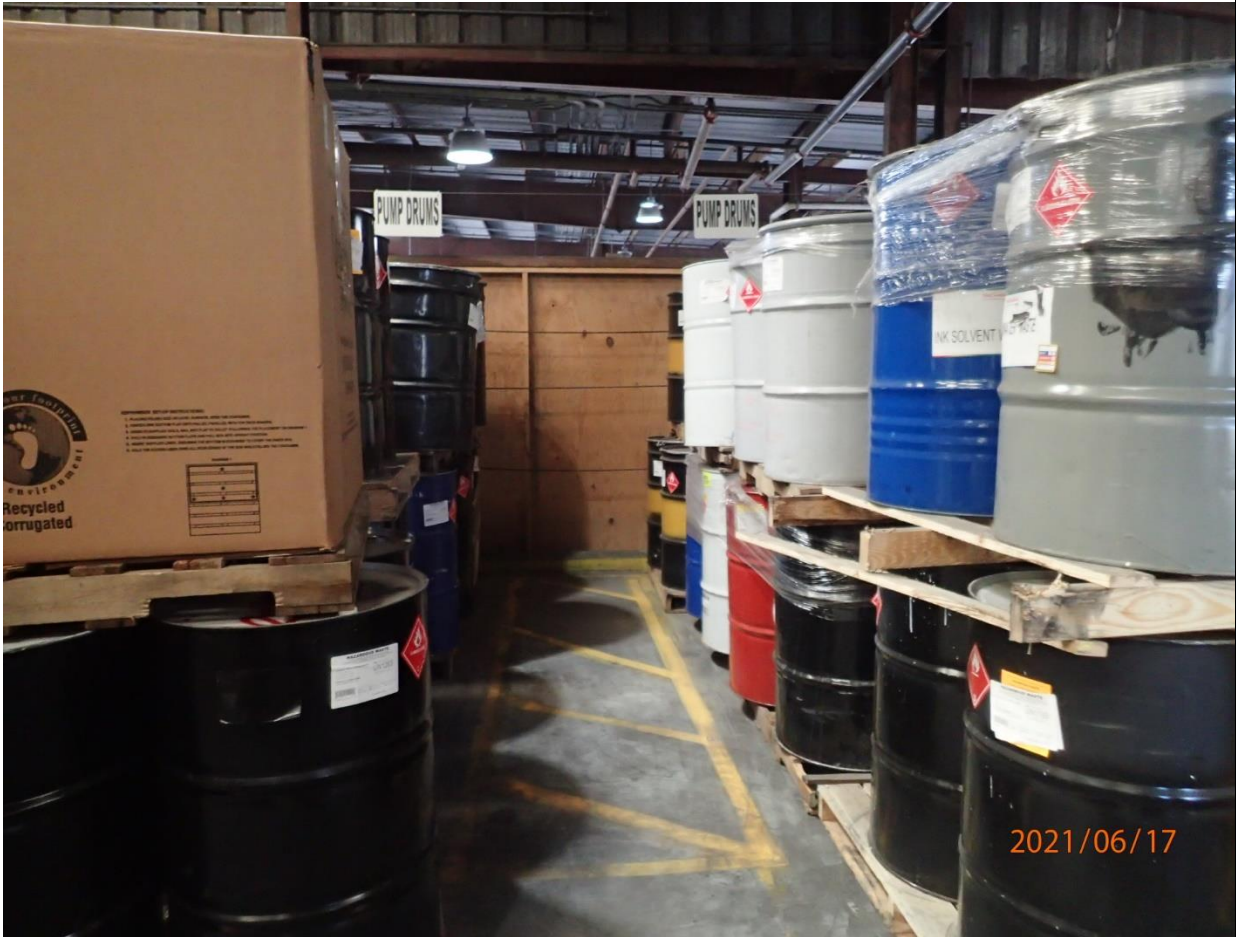
**Photo 6:** A portion of Container Storage Area-B

secondary containment in this area has a total capacity of 2,019 gallons. Secondary containment appeared to be in good condition. This area primarily stores outbound waste. Adequate aisle was observed while inspecting hazardous waste containers (Photo #6). The following hazardous wastes were observed, all containers were properly labeled, placarded, dated, and closed.

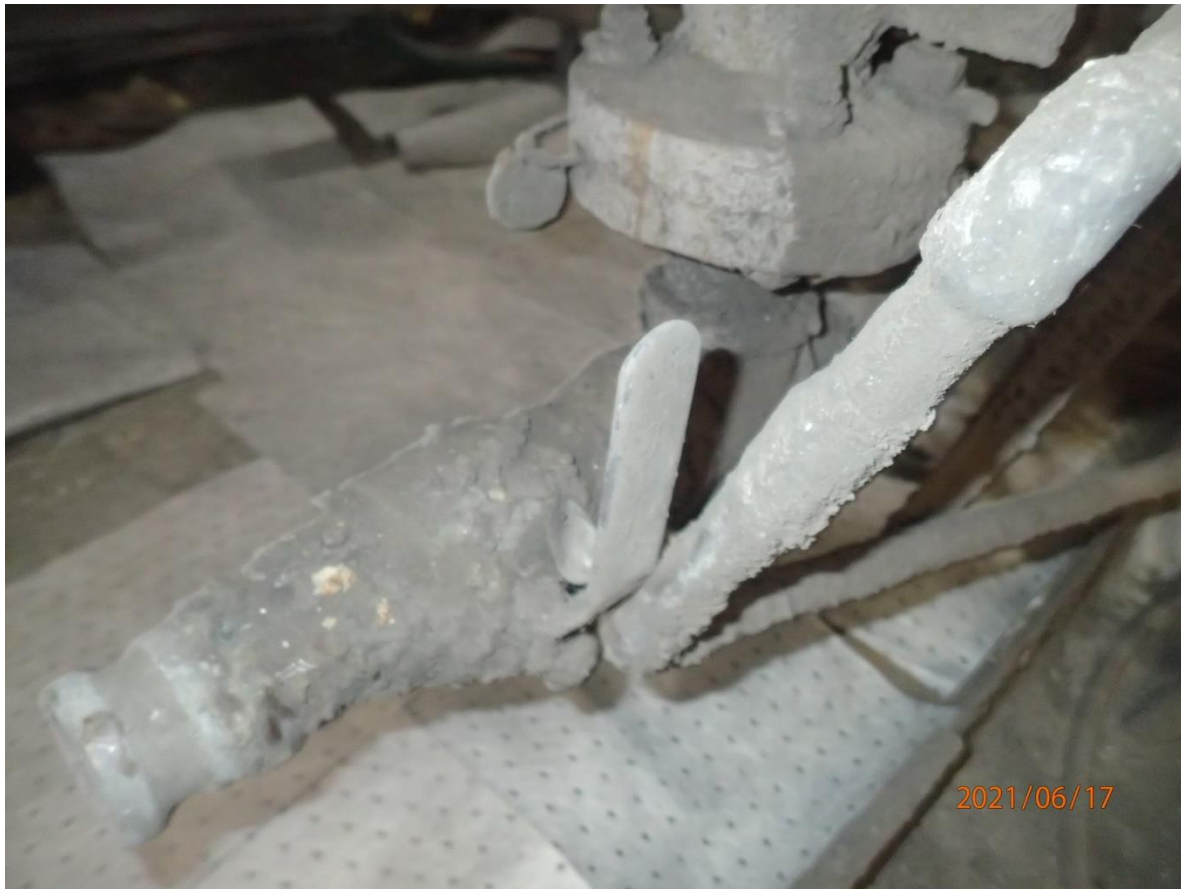
**Photo 7:** Luwa® Solvent Recovery Unit illegible tags for equipment.

**Pursuant to ADEM Admin. Code r. 335-14-6-.28 [40 C.F.R. § 264.1050(d)], Each piece of equipment to which this subpart applies shall be marked in such a manner that it can be distinguished readily from other pieces of equipment.**

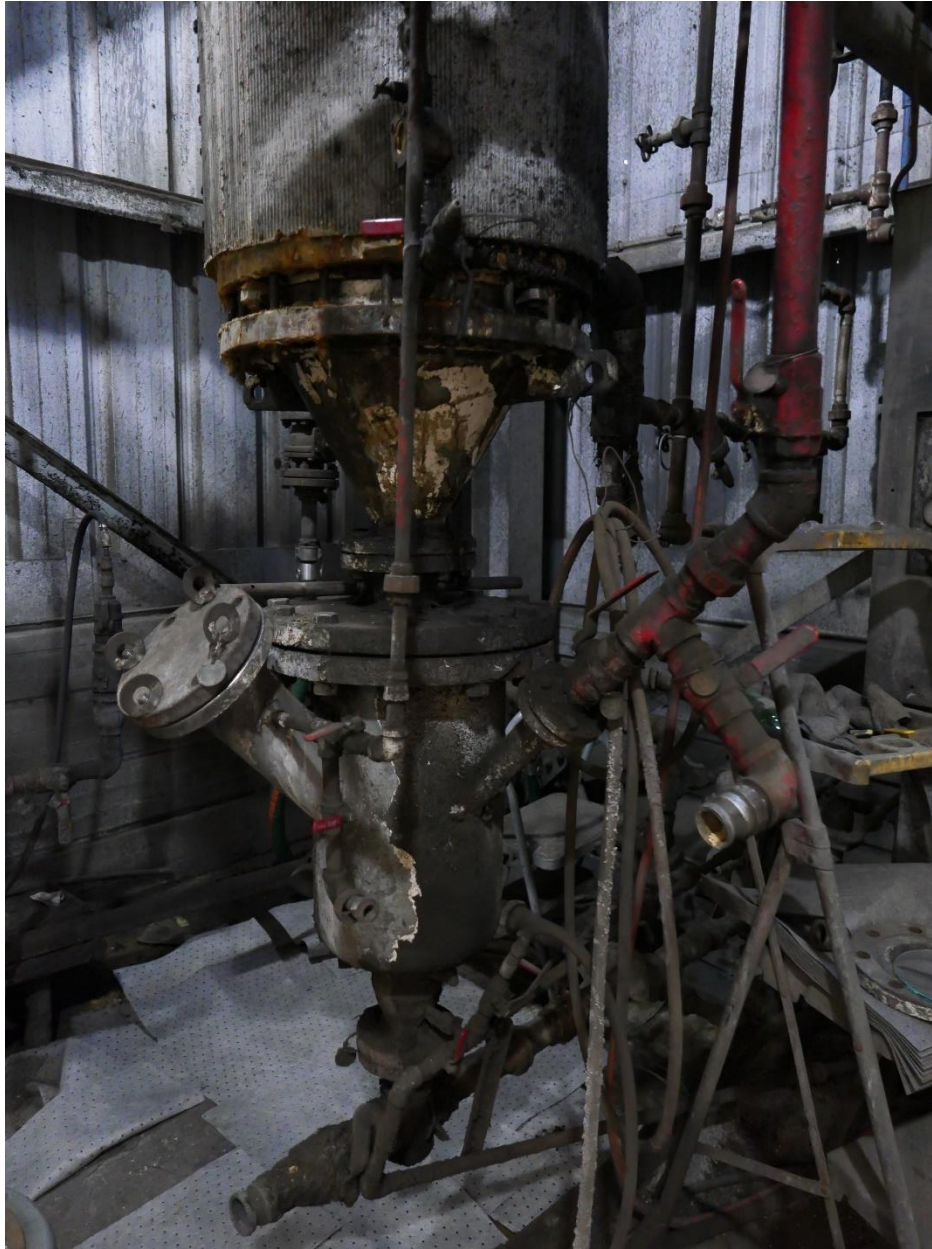
**Photo 8:** Luwa® Solvent Recovery Unit illegible tags for equipment.

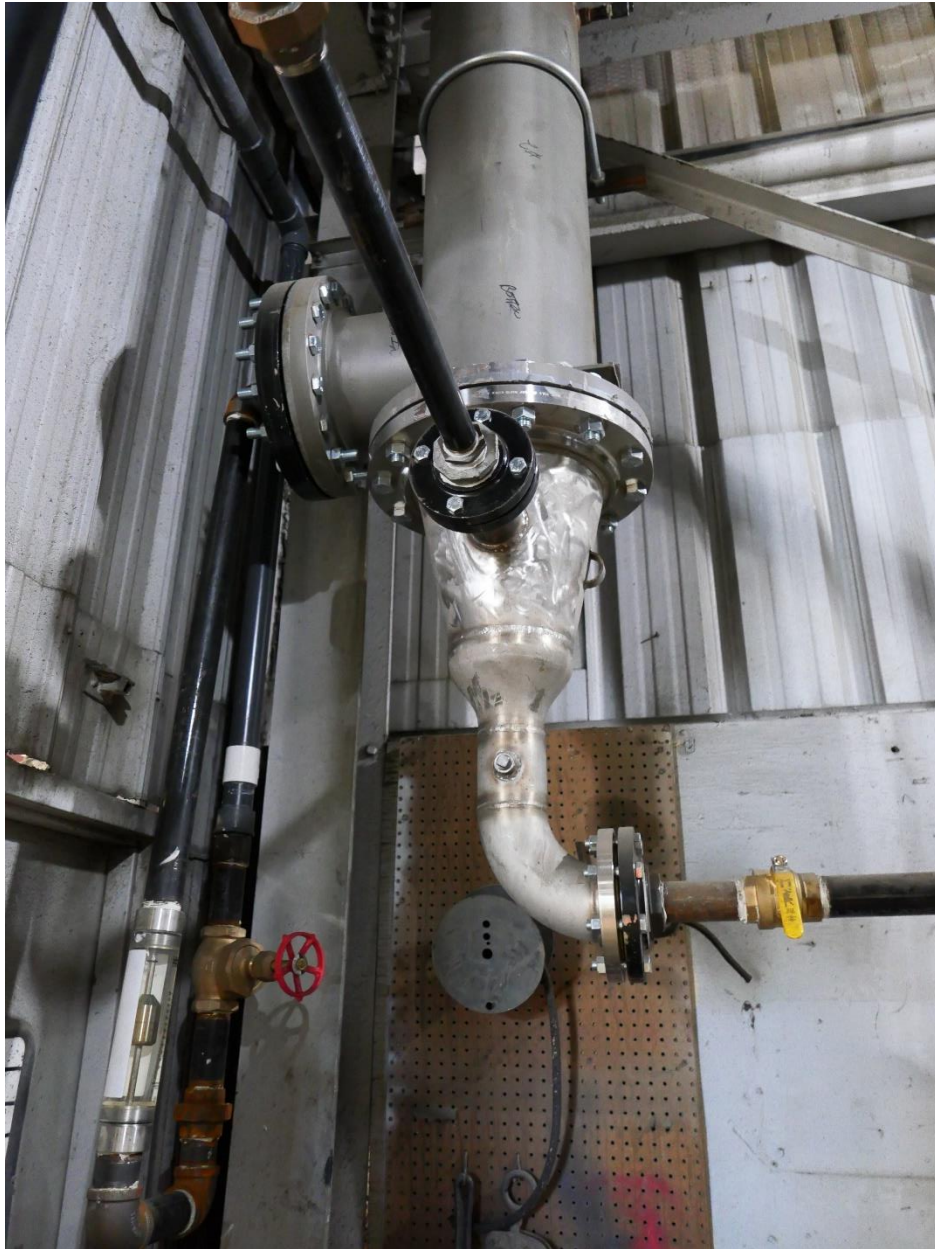
The Luwa® thin film solvent distillation unit (LTFSDU) is located in Allworth's main warehouse. It is used to reclaim spent solvent from acetone, MEK, and paint thinners. The LTFSDU can process 6,000 gallons of spent solvent which takes 6-7 hours to produce approximately 3,100 gallons of solvent product. At the time of the inspection, the inspection team observed the piping associated with the solvent recovery unit (valves, flanges, and pumps) were tagged; however, some of the tags were not legible (Photos #7 and #8). On some parts of the piping, it appeared that some valves, flanges, and pumps were not tagged (Photo #9).

**Photo 9:** Luwa® Solvent Recovery Unit, missing tagging of connections, flanges, etc tags for equipment.

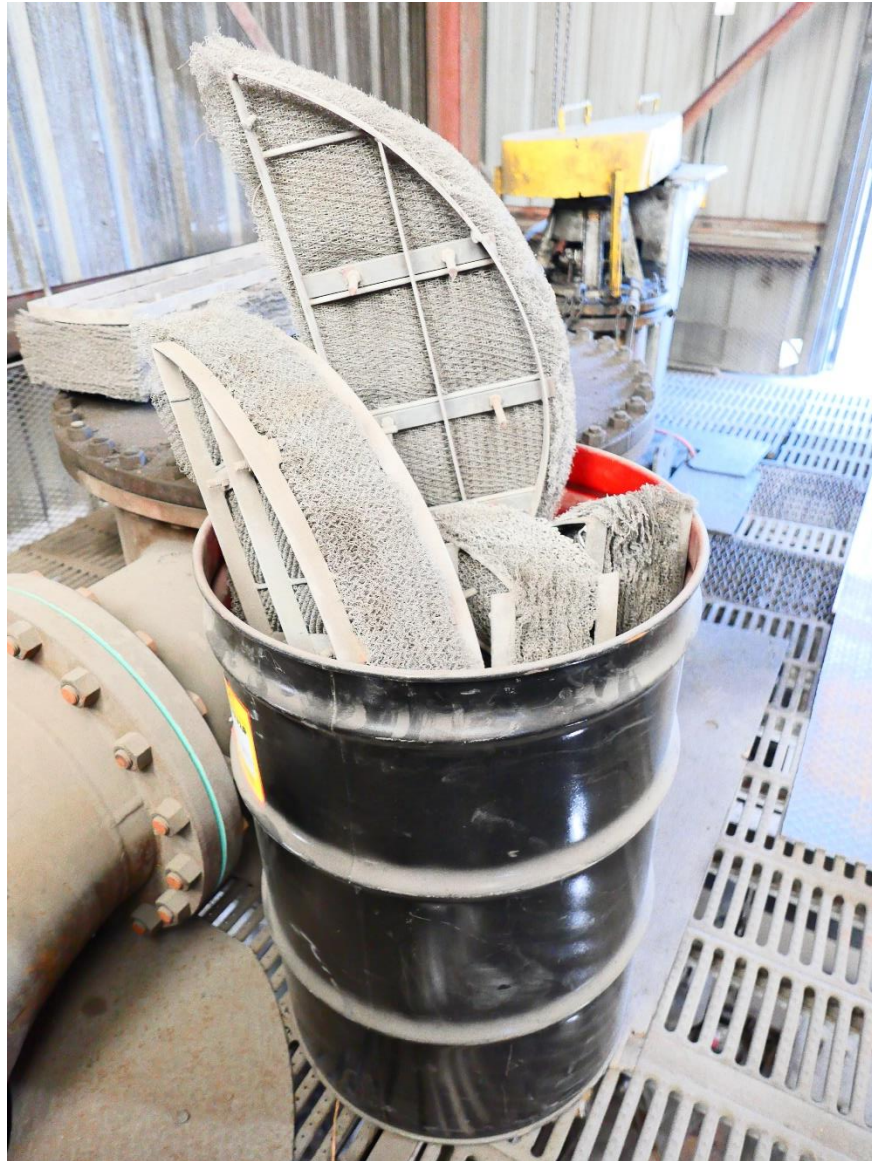
On the second floor just above the Solvent Recycling Area, one (1) 55-gallon drum labeled "Hazardous Waste – Empty Paint Cans" was observed open, containing spent air filters only. Mr. Williamson explained that the filters are not hazardous waste and do not come into contact with any hazardous waste or hazardous waste constituents. Mr. Williams further explained that the filters were placed inside the pre-labeled drum in error which would be relabeled (Photo #10).

**Photo 10:** One (1) 55-gallon drum labeled “Hazardous Waste – Empty Paint Cans” was observed open, containing spent air filters only.

**Pursuant to ADEM Admin. Code r. 335-14-3-.01(2) [40 C.F.R. § 262.11], A person who generates a solid waste, as defined in 335-14-2-.01(2), must make an accurate determination as to whether that waste is a hazardous waste in order to ensure wastes are properly managed according to applicable AHWMA regulations.**

An accurate waste determination should be performed on the spent air filters or the facility should provide a written response determining whether the waste is hazardous or non-hazardous based on generator knowledge. Acceptable knowledge that may be used in making an accurate determination as to whether the waste is listed may include waste origin, composition, the process producing the waste, feedstock, and other reliable and relevant information.

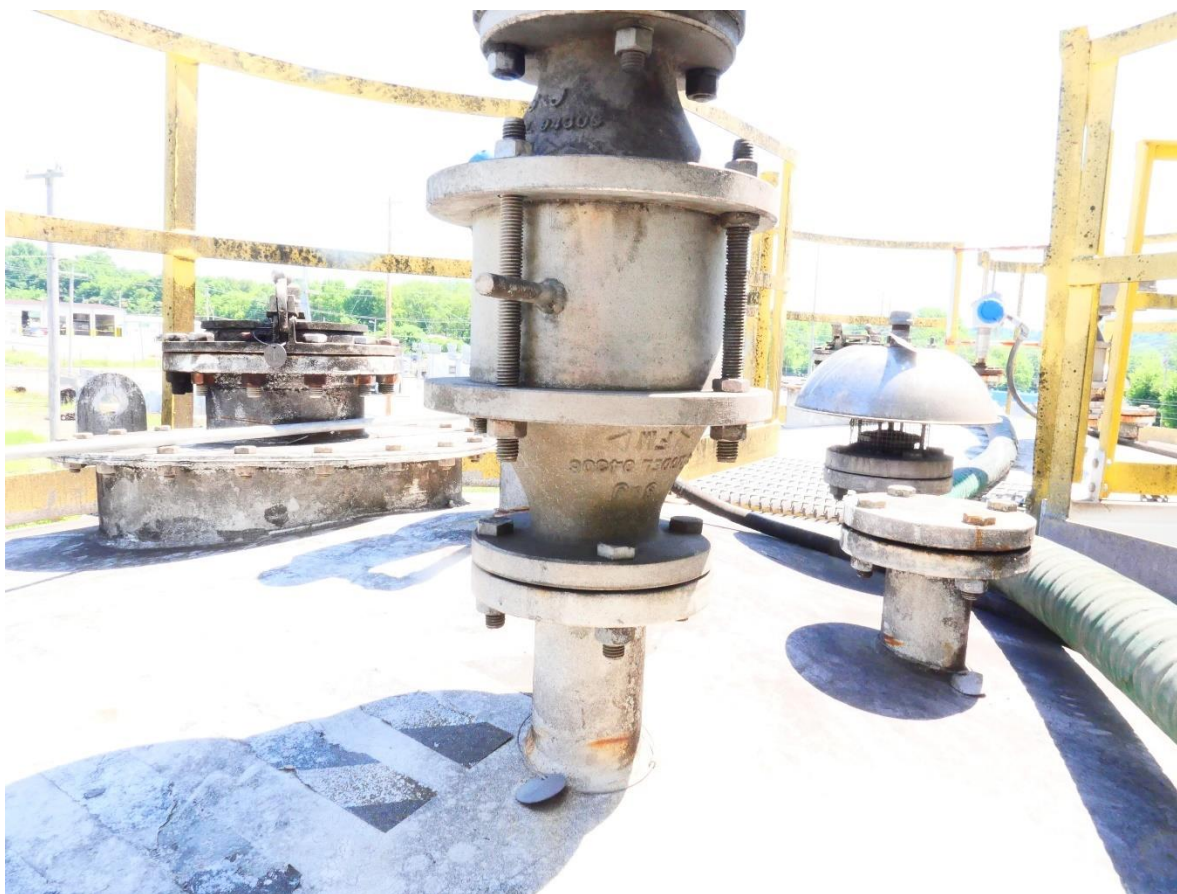
**Photo 12:** Tank System 2 – Roof Top

Tank System 2: Located outside of the warehouse next to the Maintenance Storage Area and near the Solvent Recycling Area. This area consists of six (6) fixed-roof above ground storage tanks (F-1, F-2, F-3, F-4, F-5, and F-6). Each tank has a permitted storage capacity of 6,000 gallons or 36,000 gallons in total. The tank farm is situated within a coated concrete secondary containment structure with a total containment capacity of 8,387 gallons. The tanks store spent solvent wastes prior to being introduced into the facility's solvent recovery unit. All tanks were labeled with the words "Hazardous Waste". Tanks lines and associated equipment (flanges/pumps/end caps) used when transferring the hazardous waste to the tank were tagged as required by Subpart BB (Photo #11). As required by Subpart CC, no visible cracks, holes, or gaps between each fixed roof's edge and tank walls were observed. All openings in the roof were secured in their closed positions. Tags were observed in place on latched manway hatch (Photo #12).

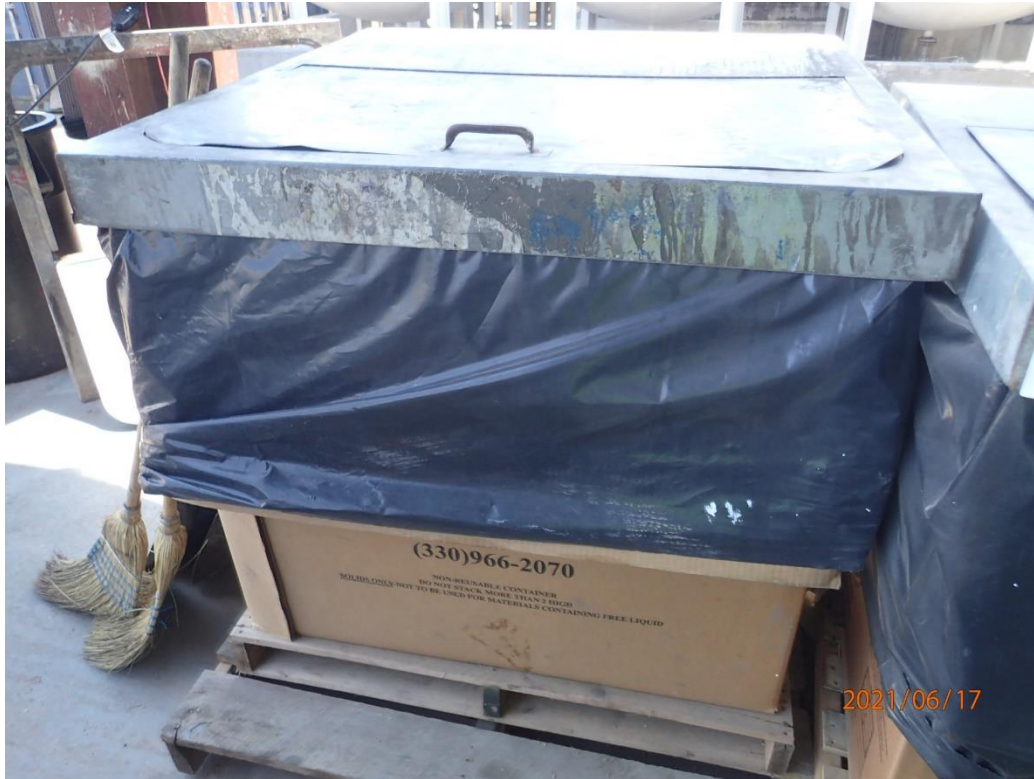
**Photo 13:** One (1) cubic yard box of hazardous waste was not labeled. Corrected onsite.

**Pursuant to ADEM Admin. Code r. 335-14-3-.01 (5)(i) [40 CFR 262.17(a)(5)(i)], A generator must mark or label its container with the following: (i) The words "Hazardous Waste" and (ii) An indication of the hazards of the contents.**

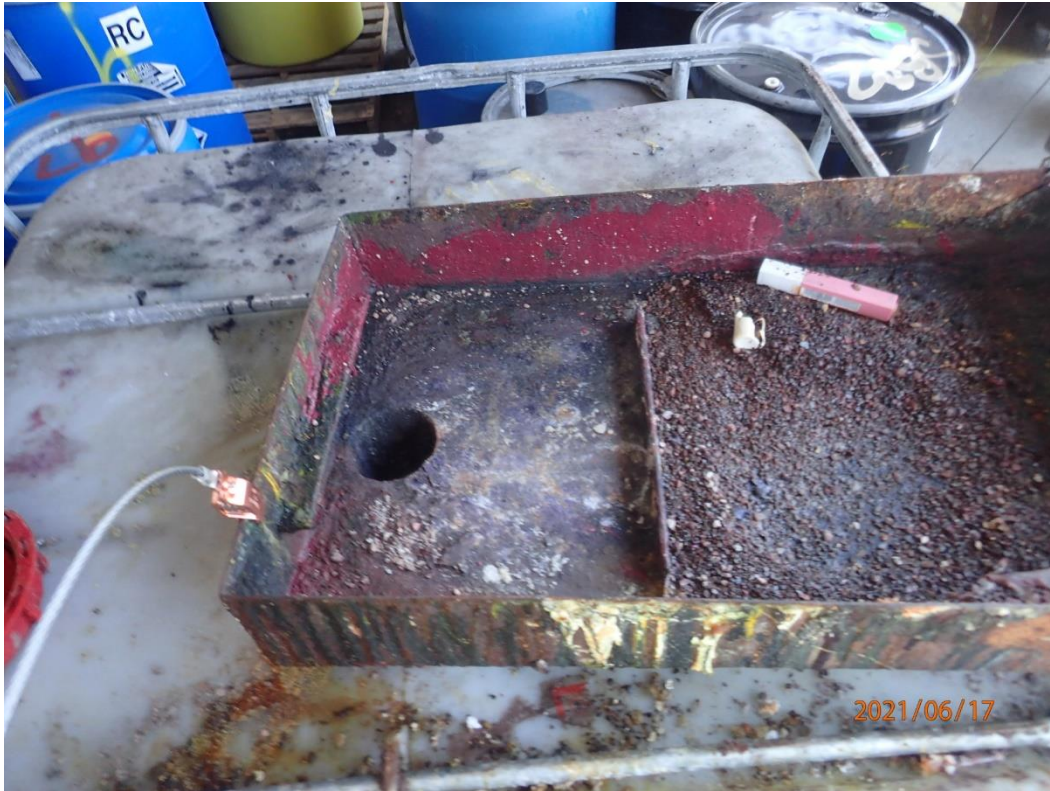
**Photo 14:** 250-gallon totes labeled Hazardous Waste, placarded, dated, not properly closed.

**Pursuant to Permit Condition III.G.2., Management of Containers, A container holding hazardous waste must always be closed during storage. Except when it is necessary to add, remove, sample, or inspect the waste.**

Facility personnel properly closed all containers prior to the end of the inspection.

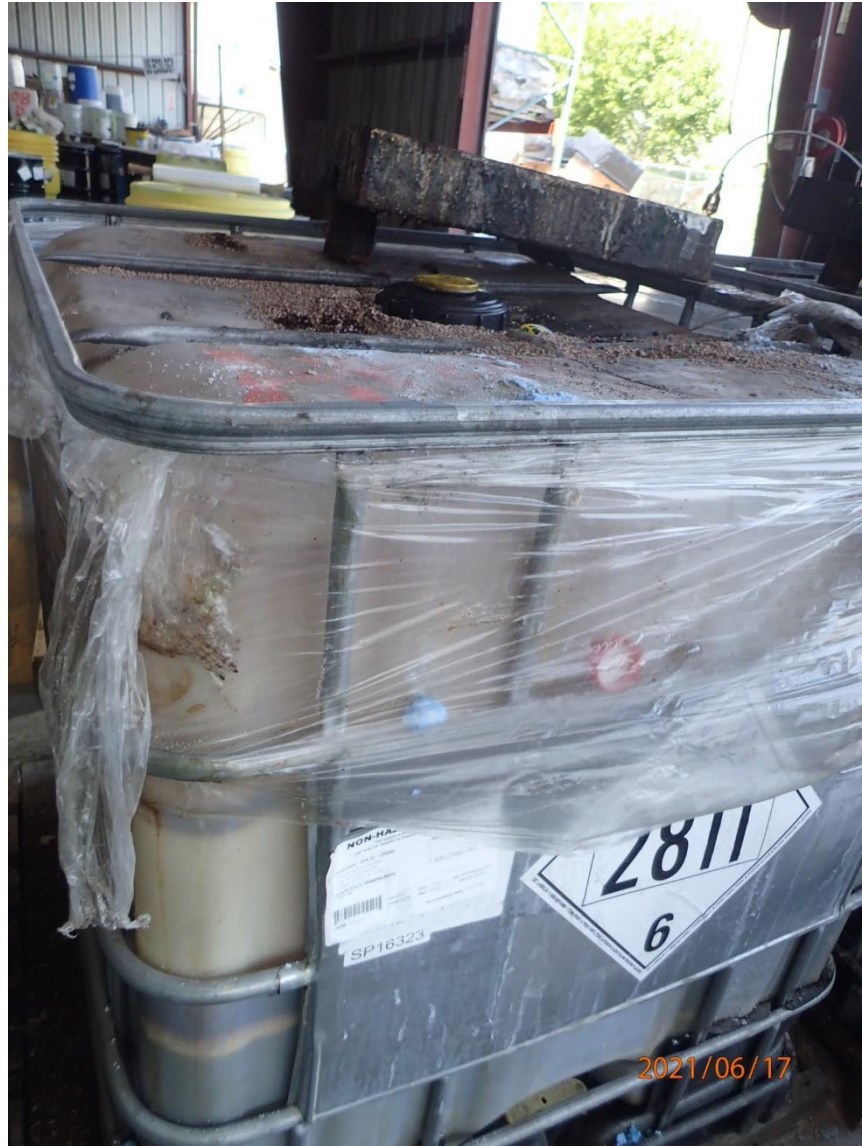
**Photo 15:** 250-gallon totes labeled Hazardous Waste, placarded, dated, not properly closed.

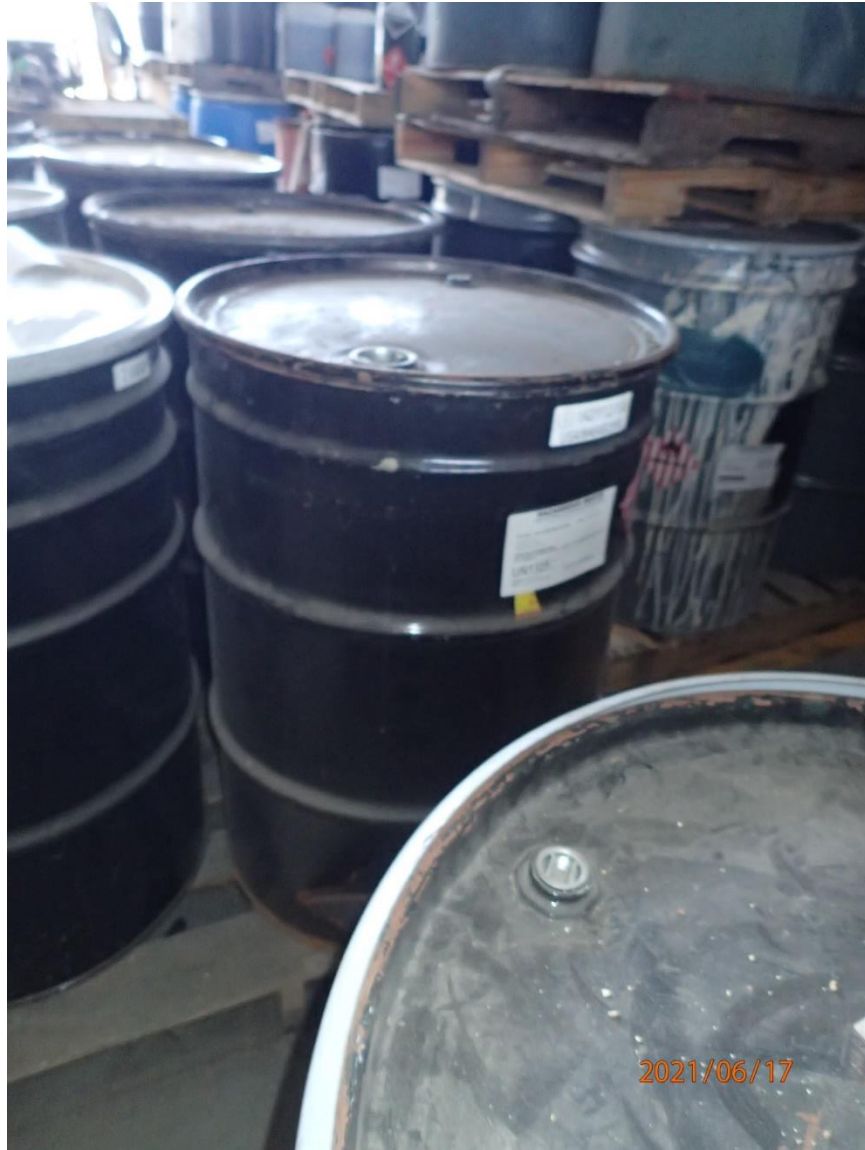
**Photo 16:** One of eight 55-gallon containers not properly closed, missing locking ring.

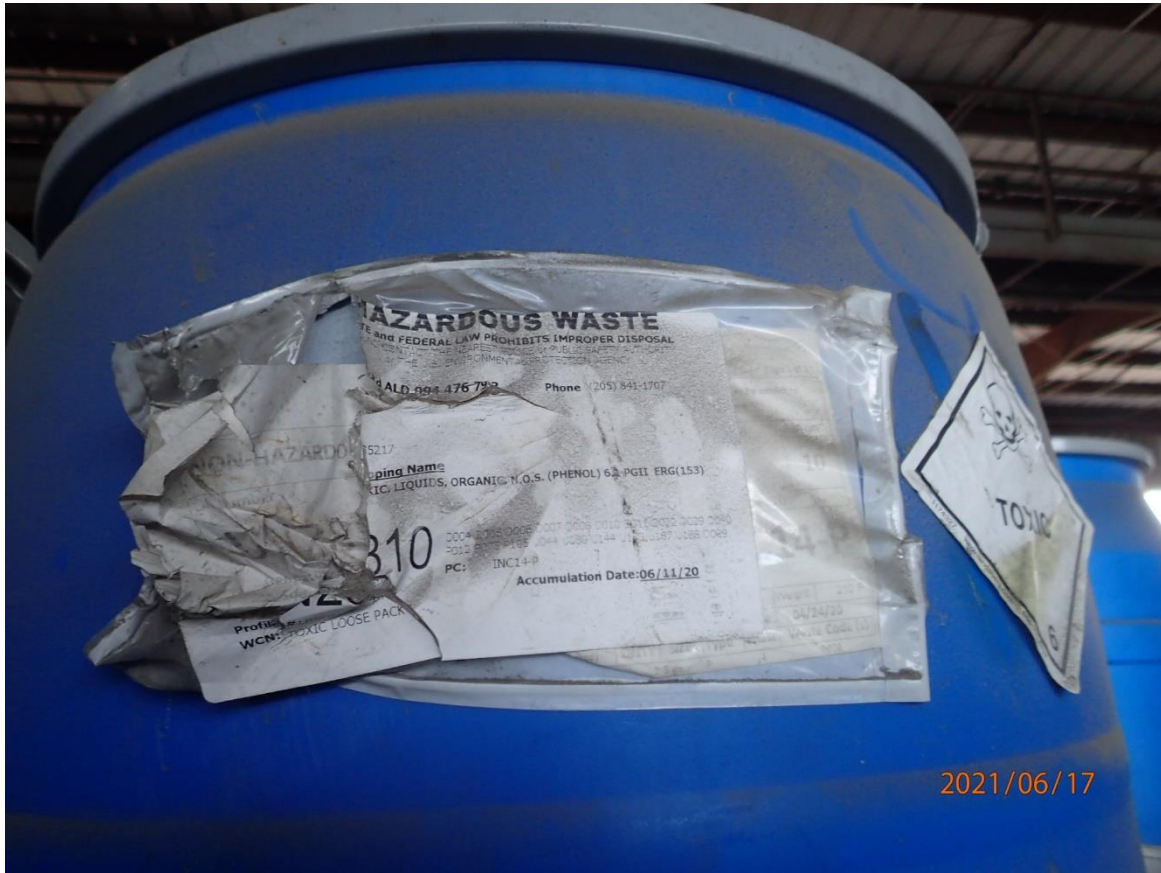
- Six (6) 55-gallon containers of Hazardous Waste with dates greater than one year (Photo #17).

Mr. Williamson stated that the dates were incorrect on the six containers that were dated over a year. After the inspection, Mr. Williamson provided the inspectors with documentation supporting his assertion and that the drums in question actually contained vermiculite to be used in the lab pack process (not waste). The waste that was previously in these drums had already been consolidated into other containers and shipped offsite. The six drums in question were inadvertently removed from their storage area and placed on pallets with other drums that contained waste the week of the inspection.

**Photo 17:** One of six 55-gallon containers of Hazardous Waste with dates greater than one year (06/11/20).

**Pursuant to Permit Condition II. L.2.b., Land Disposal Prohibitions and Treatment Standards, the storage of hazardous wastes restricted from land disposal under ADEM Admin. Code Rule 335- 14-9 is prohibited unless the requirements of ADEM Admin. Code Rule 335-14-9-.05 are met.**

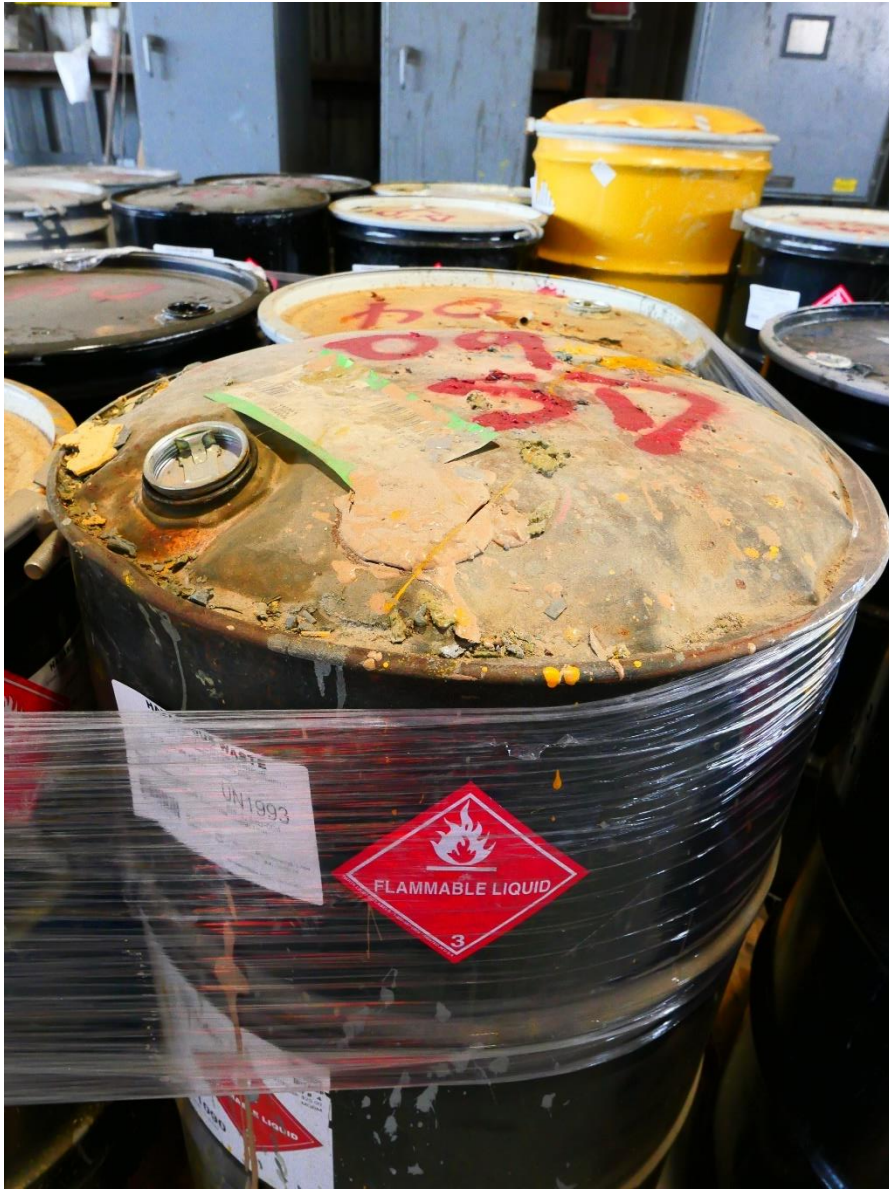
Container Storage Area-D: Container Storage Area D has a permitted storage capacity of 18,480 gallons. According to the facility's permit the concrete secondary containment in this area has a total capacity of 3,308 gallons and appeared to be in good condition with adequate aisle space. All hazardous waste containers in this area were properly labeled, closed, placarded, and properly dated. However, several containers were observed not to be in good condition, either due to rusting or bulging (Photo #18 and Photo #19). Mr. Williamson stated that these drums would be placed in an oversized drum.

**Photo 18:** Bulging drum.

**Pursuant to Permit Condition III.E. Condition of Containers, if a container holding hazardous waste is not in good condition (e.g., severe rusting, apparent structural defects) or if it begins to leak, upon discovery the Permittee shall immediately transfer the hazardous waste from such container to a container that is in good condition or otherwise manage the waste in compliance with the conditions of ADEM Admin. Code Rule 335-14-5.09(2).**

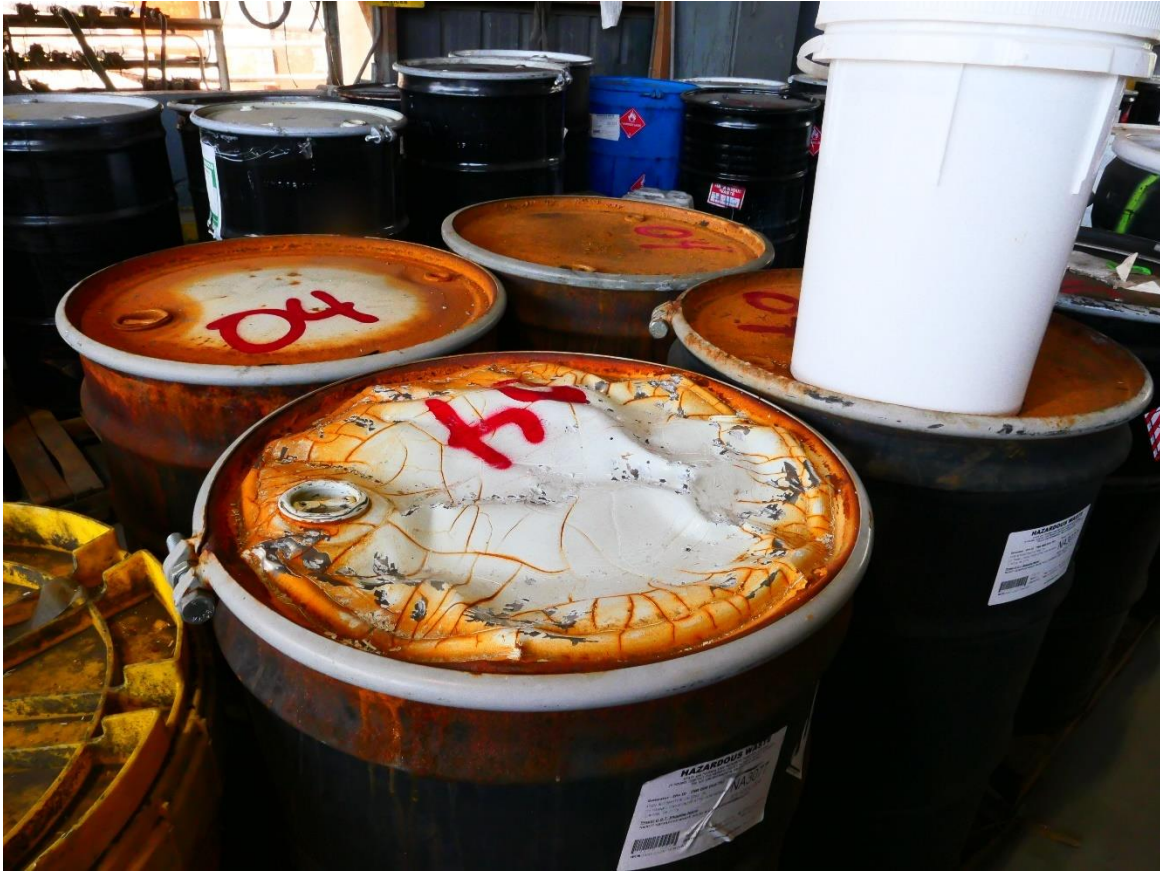
**Photo 19:** Rusted drums with damaged/ dented top.

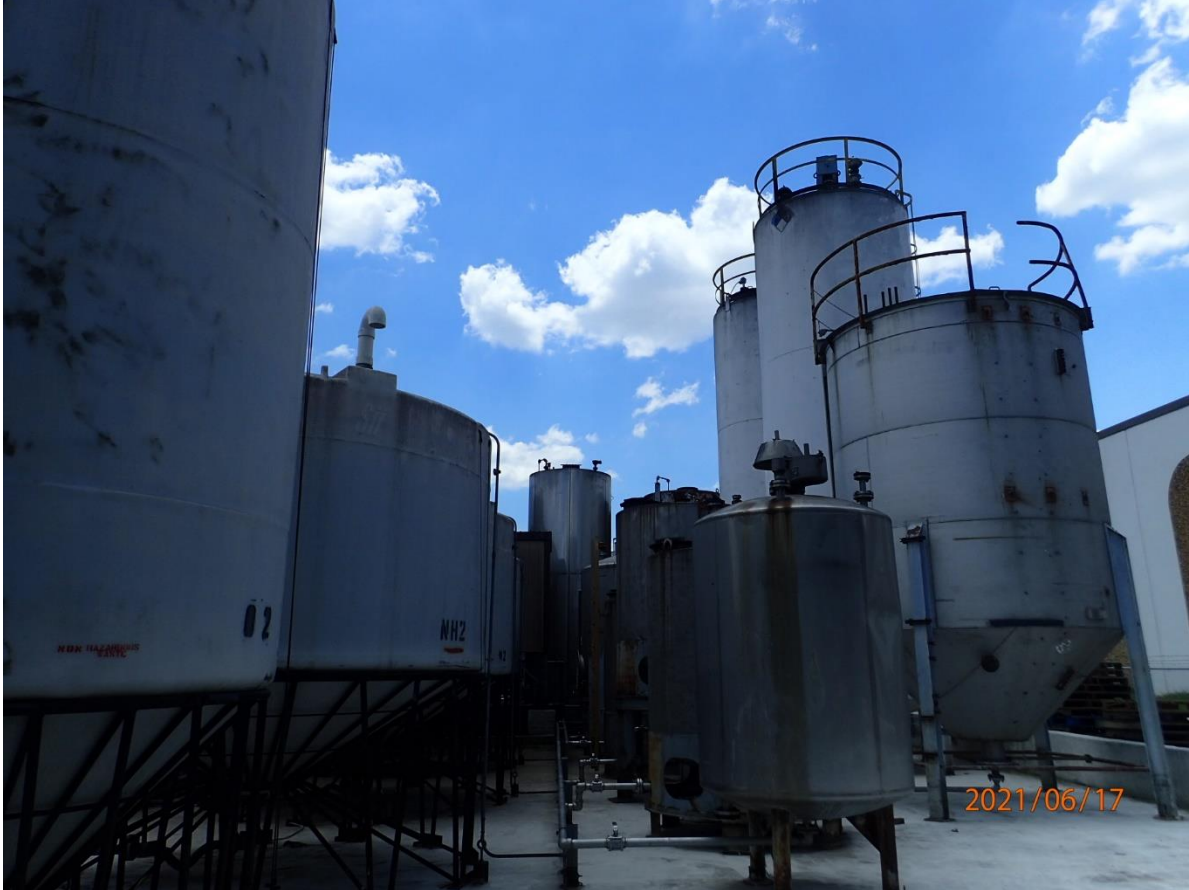
**Photo 20:** Tank System 1

- One (1) 4,100-gallon above ground storage tank (O-1), not in use.
- Three (3) 6,000-gallon above ground storage tanks (W-1, W-2, NH-2), not in use.
- Two (2) 18,000-gallon above ground storage tanks (B-5 and B-7), which store hazardous waste fuel generated by the Luwa® solvent recovery unit. These tanks were labeled with the words “Hazardous Waste”. Tanks lines and associated equipment (flanges/pumps/end caps) were tagged as required by Subpart BB (Photo #20).

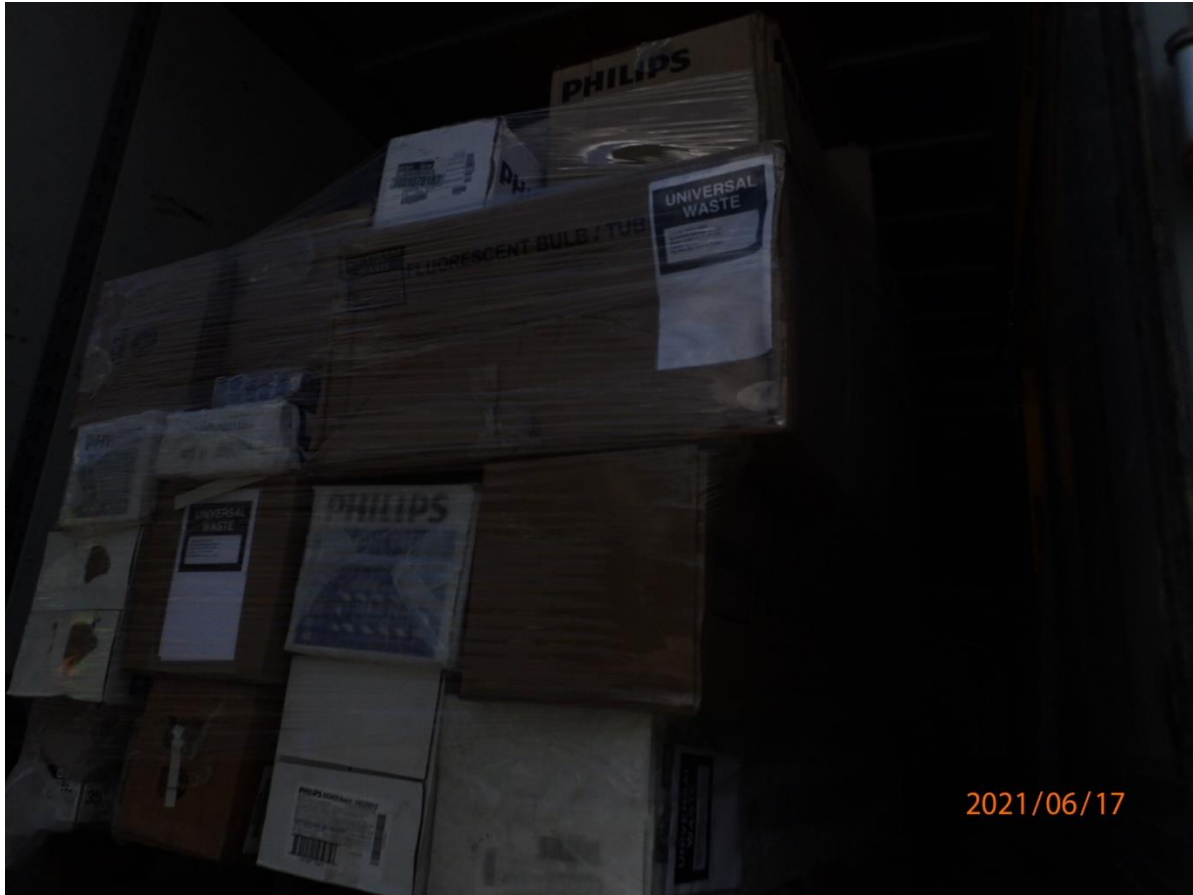
**Photo 21:** Universal Waste Storage Area

Universal Waste Storage Area: Universal waste was being stored in a trailer on the northside of the facility. The inspectors observed two pallets of cardboard boxes labeled “Universal Waste – Waste Lamps”. All boxes of universal waste were closed, dated, and properly labeled (Photo #21).
