## **RCRA Inspection Report**

Allworth, LLC  
500 Medco Road  
Birmingham, Alabama 35217  
EPA ID No: ALD094476793  
NAICS: 325998 – All Other Miscellaneous Chemical Product and Preparation Manufacturing  
562112 – Hazardous Waste Collection  
562211 – Hazardous Waste Treatment and Disposal

June 17, 2021

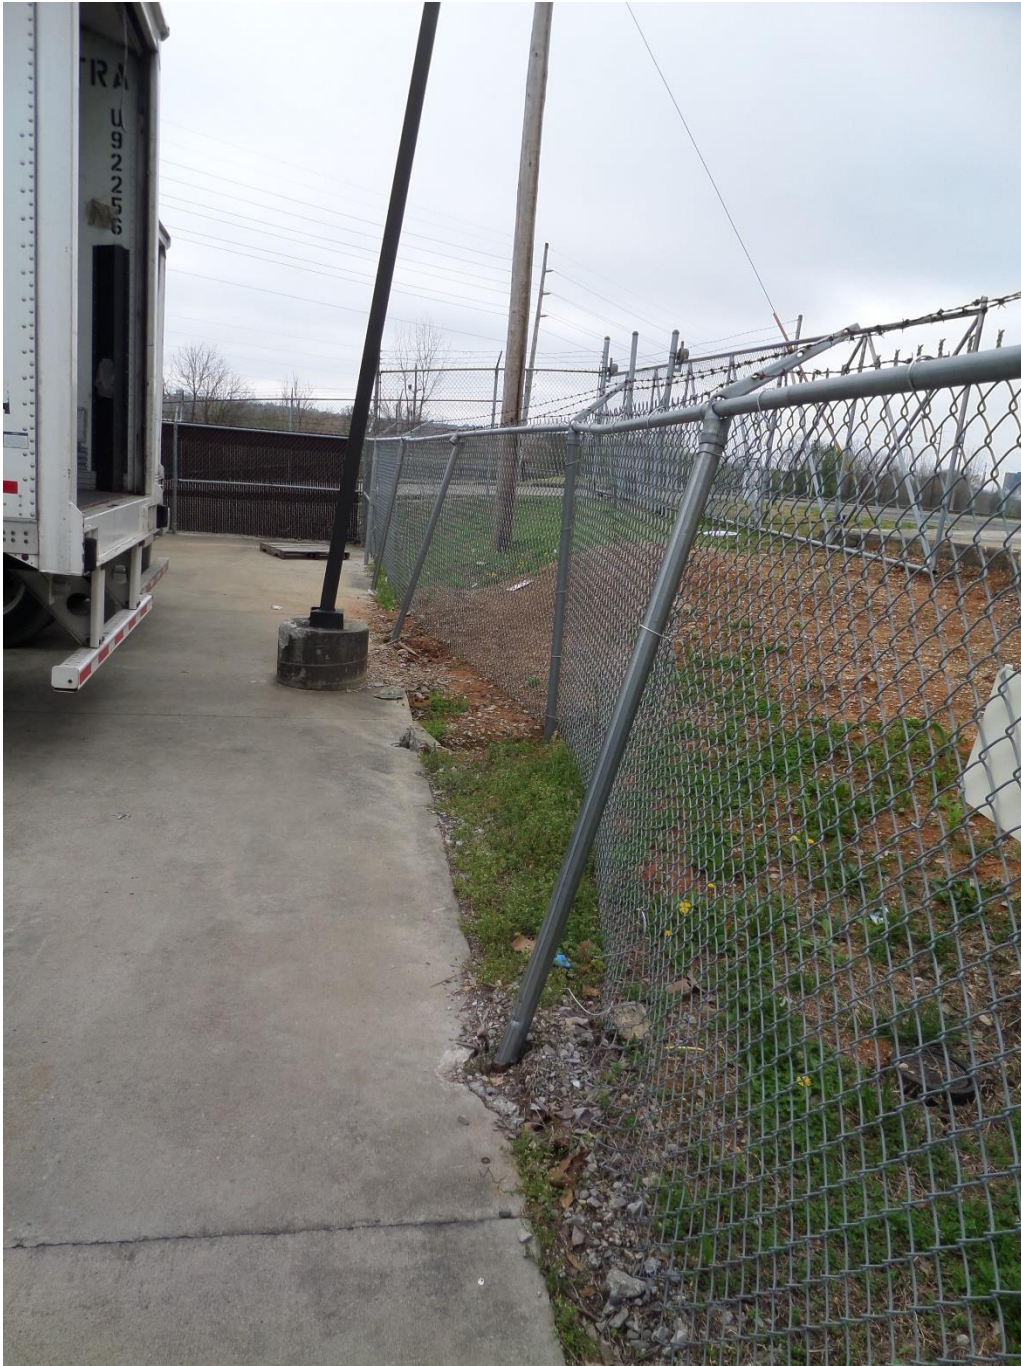
Security Fence: The perimeter fence surrounding the property appeared to be in poor condition in certain areas (Photo #22).

**Photo 22:** Fence in poor condition.

**Pursuant to Permit Condition II.B.2., Security, in order to comply with ADEM Admin. Code Rule 335-14-5-.02(5), the hazardous waste storage areas of the facility shall remain fenced with at least a six-foot high chain link fence. The fence shall be kept in good repair. All entrances to the permitted hazardous waste management areas shall be closed and locked when security and/or operations personnel are not present.**
