## RCRA COMPLIANCE EVALUATION INSPECTION REPORT

TAV Holdings, Inc.  
3311 Empire Boulevard SW  
Atlanta, Georgia 30354  
EPA ID # GAD033537663

October 6, 2021

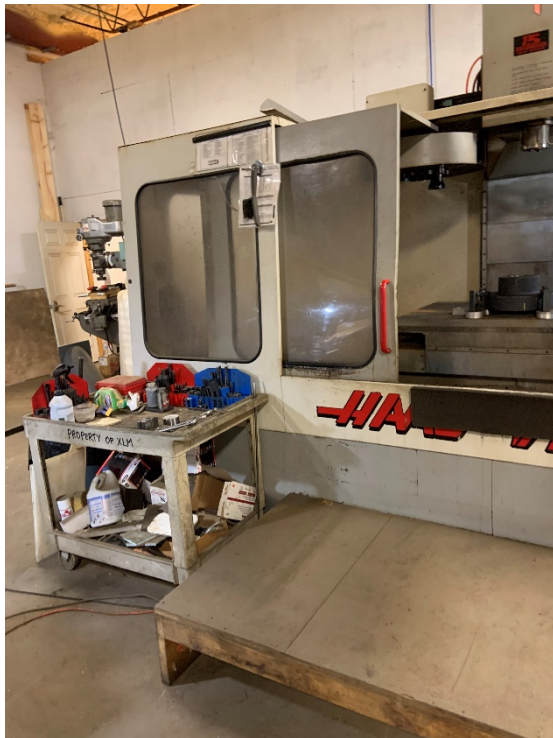
*Figure 1: IMG\_3070.jpg- CNC machine in the Shipping Building*

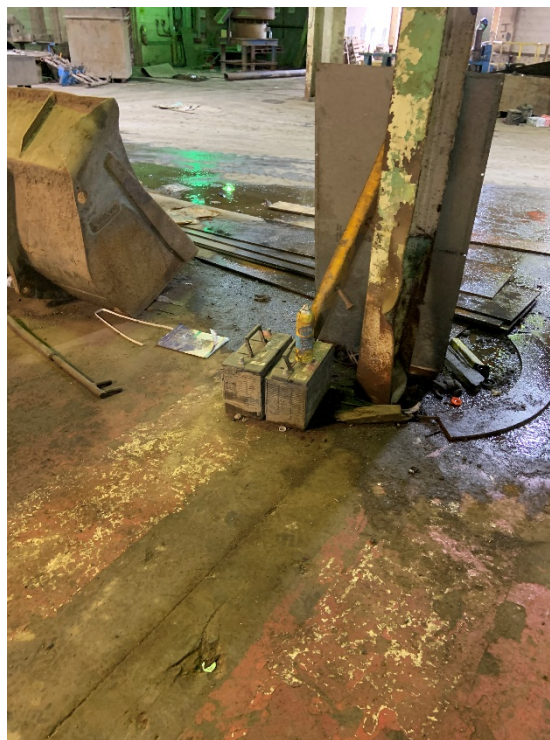
*Figure 24: IMG\_3093.jpg – Lead acid batteries*

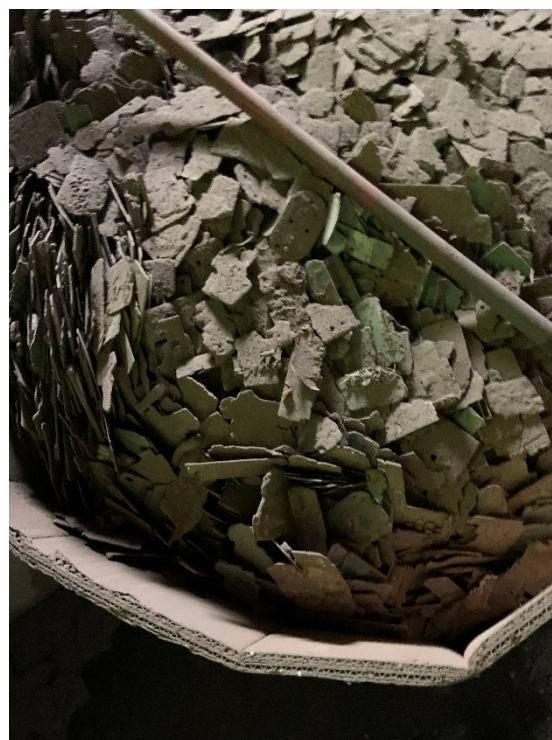
*Figure 28: IMG\_3097.jpg – Containers of electronic scrap circuit boards in the Keebler Building*

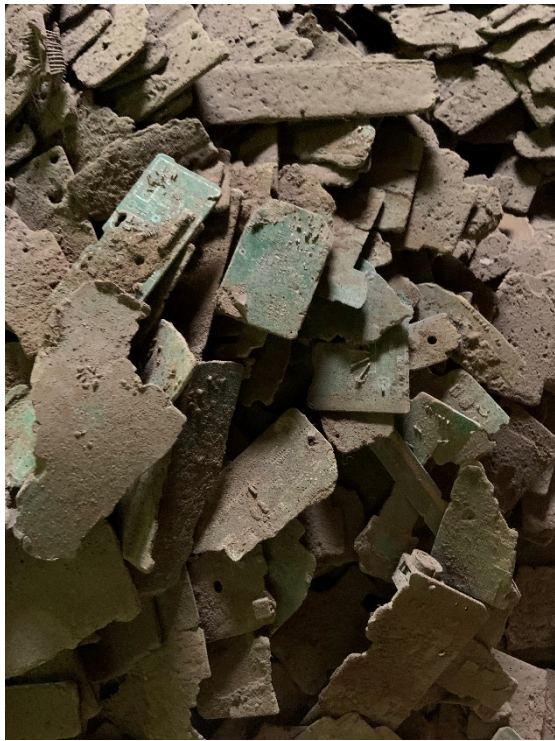
*Figure 29: IMG\_3098.jpg – Close up of apparently processed electronic scrap circuit boards in the Keebler Building*

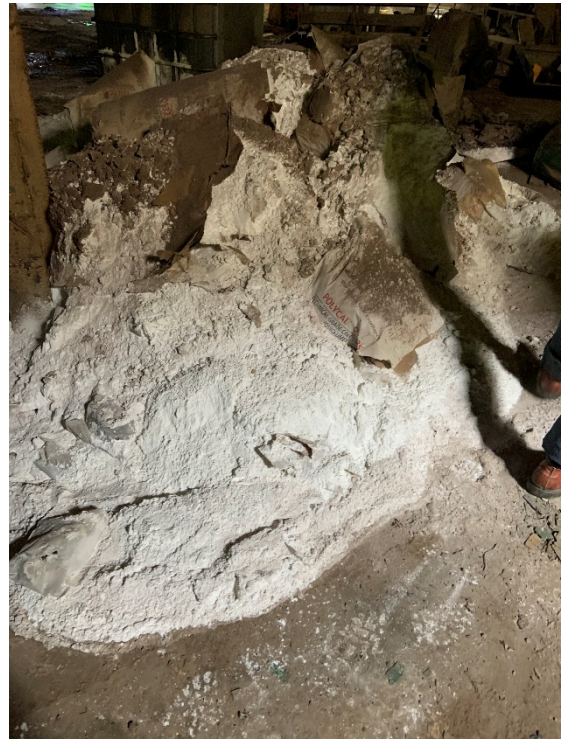
*Figure 30: IMG\_3099.jpg – Pile of quick lime in the Keebler building*

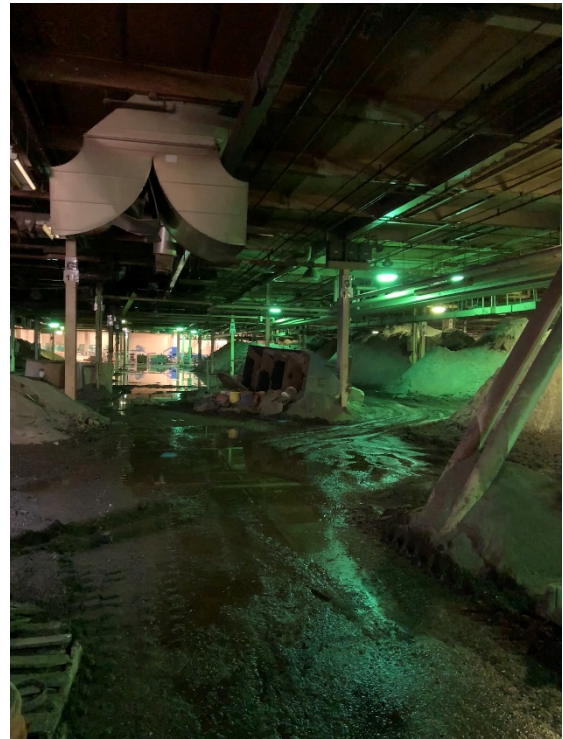
The Main Processing Area is inside the buildings. The facility utilizes ball mills, particle size separation, eddy current, and vibration to separate metal particles from the material. Inspectors observed that much of the building was being used to store waste that had already been processed at least once. The waste consisted of very small particle sizes, as seen in Figures 60 and 61. The facility claimed that they were storing the already processed solid waste material with the intent of continuing to process it and claimed that it had recoverable concentrations of copper. The inspectors asked how long the material had been stored and how frequently the material was processed. The facility did not provide any information demonstrating how long and/or how frequently the solid waste was processed/stored.

*Figure 34: IMG\_3103.jpg – Piles of solid waste stored in the Keebler Building*

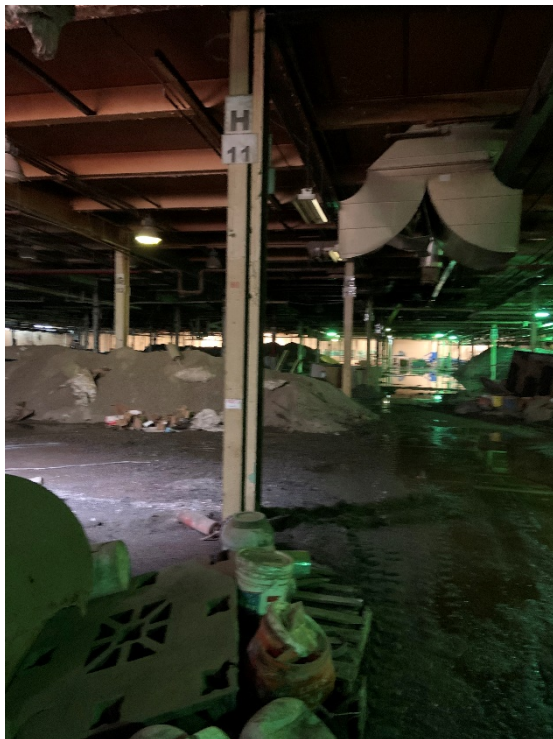
*Figure 35: IMG\_3104.jpg – Piles of solid waste stored in the Keebler Building*

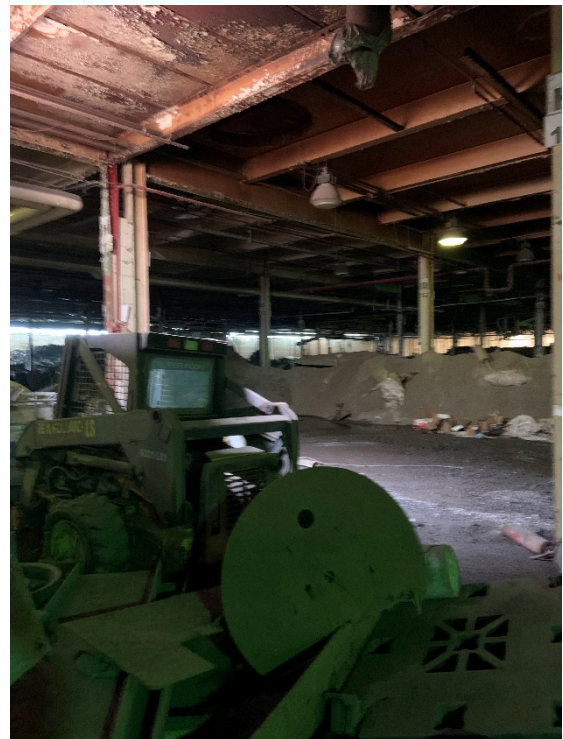
*Figure 36: IMG\_3105.jpg – Piles of solid waste stored in the Keebler Building*

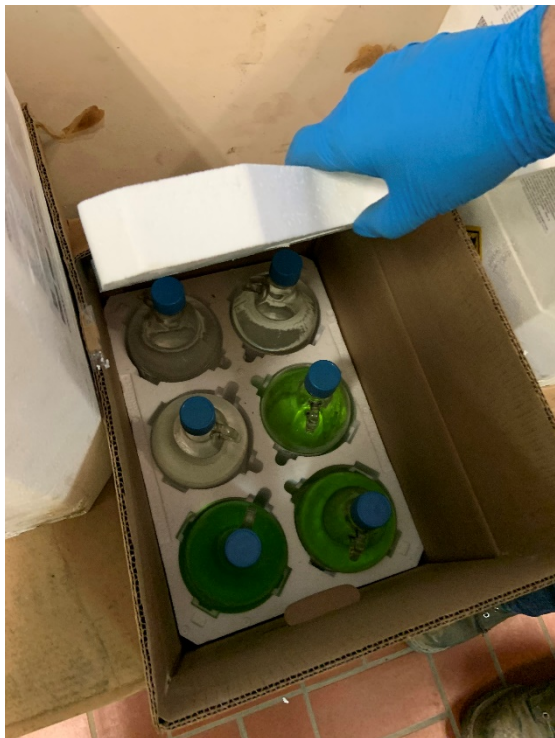
Facility representatives were able to inform inspectors of the percent metal content in various piles of the solid waste material onsite. The Facility Representative informed the inspectors of the onsite laboratory. The inspectors spoke with the Laboratory Manager who explained that all the solid waste sold from the facility is analyzed prior to leaving the facility, that at least some of the solid waste is analyzed prior to processing, and some in-process material had been analyzed. All the samples ever analyzed are stored in an onsite data system. The inspectors asked what the average amount of lead in the samples analyzed had been and requested the ability to review the data. The inspectors were informed that lead content could range from 0.25% to 13% but it was not clear what material this estimate was for. The data was not available for review at the time of the inspection. The inspectors observed a box holding nine (9) 2.5-liter bottles of waste nitric acid and waste hydrochloric acid. The bottles collecting waste were labeled with the product labels and were not labeled hazardous waste or dated. The technician estimated that a 2.5-liter bottle takes approximately 1 month to accumulate.

Figure 47: IMG\_3116.jpg – Acid waste in the lab

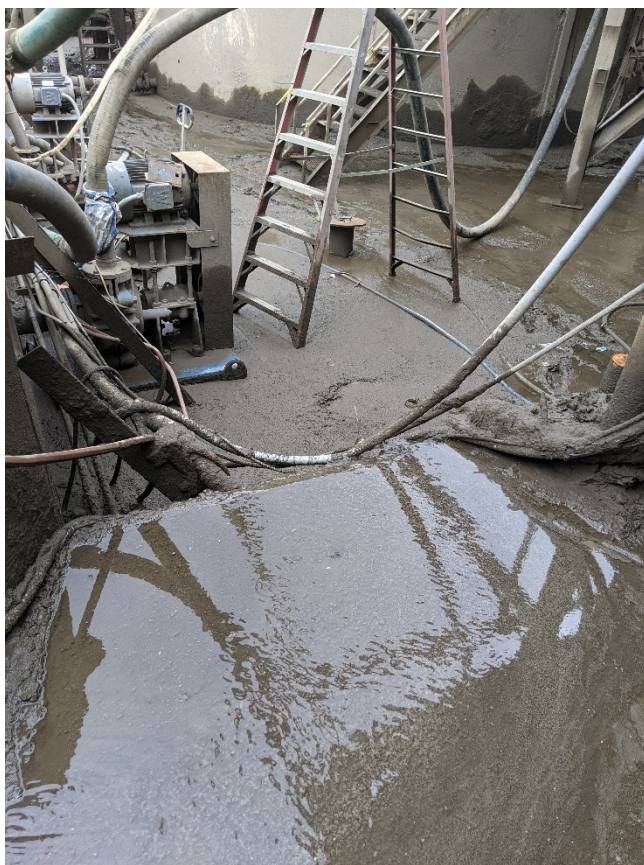
The processes all include the use of water. The facility collects stormwater in several areas at the facility and uses it in the processes. Much of the process water is swept out the doors of the process building, where it accumulates in low lying areas and it is pumped to a tank where flocculant is added to aid in the precipitation of solids from the water. The solids are removed by a backhoe and placed back into the processing. From the clarifier the water is pumped to a large tank. At the time of the CEI, the clarifier and the tank were observed to be overflowing. The secondary containment in the Wastewater Treatment (WWT) Area could not be properly inspected due to the accumulation of sludge on the surface. Figures 71 – 79 illustrate the condition of this area at the time of the CEI.

*Figure 66: PXL\_20211006\_145946590.jpg – Process wastewater and sludge flowing from the process onto the ground in the wastewater treatment area*

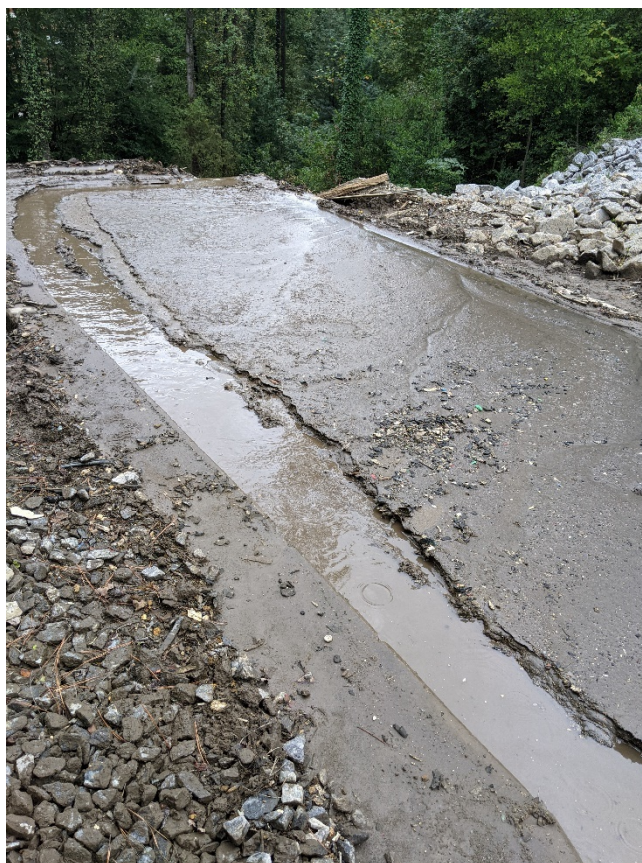
The inspectors observed Outfall 003. The area had a large concrete tank/settling basin that appeared to be used to separate solids from liquids. At the time of the CEI the basin was completely full of sludge. Evidence of stormwater and sludge overflowing the basin and by-passing the Outfall can be seen in Figures 100-106.
