**UNITED STATES ENVIRONMENTAL PROTECTION AGENCY**  
**REGION 5**  
**77 WEST JACKSON BOULEVARD**  
**CHICAGO, ILLINOIS 60604**

**SUBJECT:** CLEAN WATER ACT INSPECTION REPORT  
*Hayden Heights MHP, UMH Central OH, LLC, 5501 Cosgray, Dublin, Ohio,  
Franklin County*

**Facility Type:** *Extended aeration treatment plant (privately-owned mobile home park)*

**NPDES Permit Number:** *OH0136051*

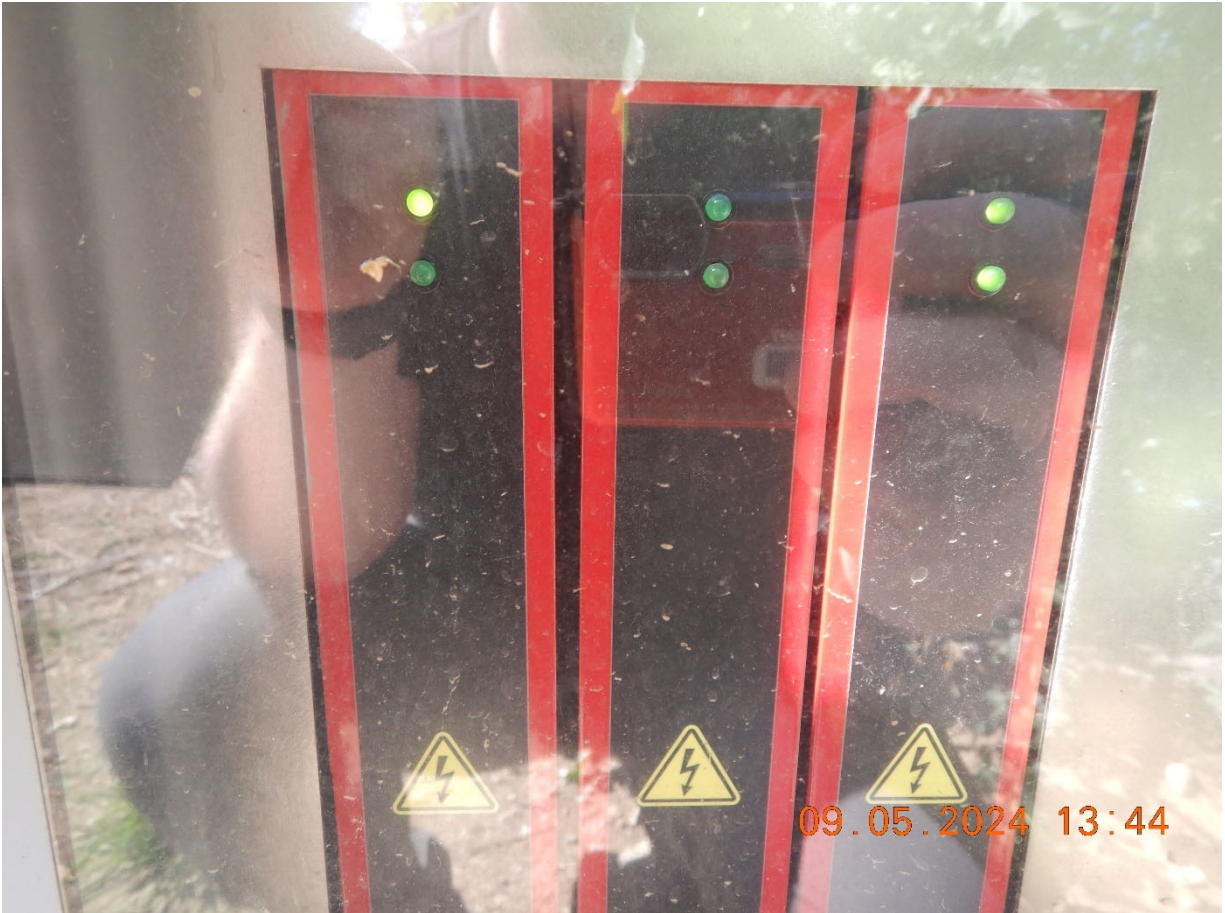
1: DSCN2288.JPG

Three of the six lamps were offline at the time of the inspection. Looking at the control panel shown in Photo 1, the bottom lamp on the left bank and both lamps in the center bank were offline. These are the same locations as the lamps which were offline during the June 5, 2024 inspection.

Description: At the time of the inspection, three of the six lamps were burned out, or offline. These are the same lamps which were offline during the inspection on June 5, 2024.

Bo Foster said the operator had planned to fix the UV system after the end of the summer monitoring season.

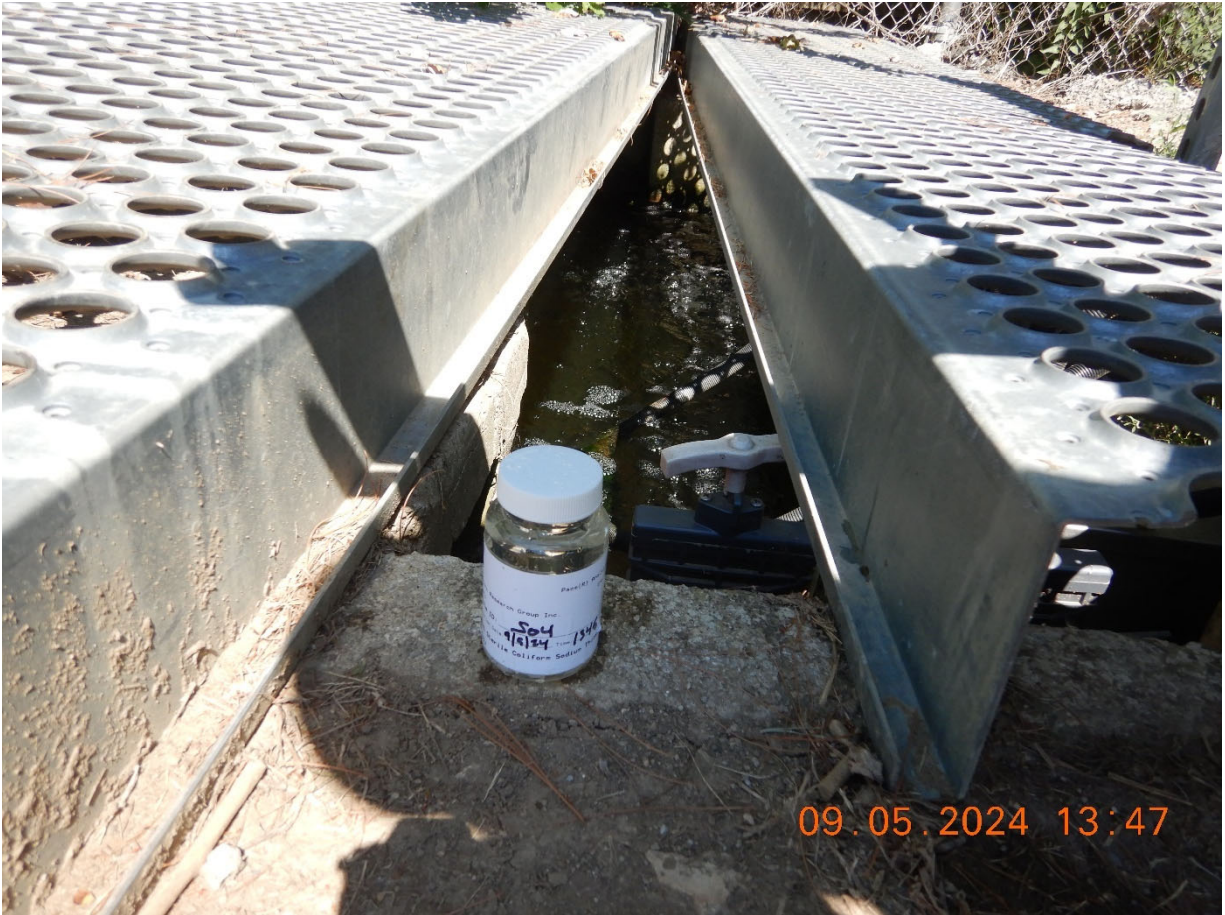
2: DSCN2289.JPG

Result of the E. coli sample taken during the inspection was 411 which is higher than the weekly and monthly averages. At the time of writing of this report, the other weekly and monthly values were not known.

Description: Sample S04, E. coli sample collected from the UV disinfection channel at the location which was identified by the operator during the June 5, 2024 as the location where compliance samples are collected for Outfall 001.

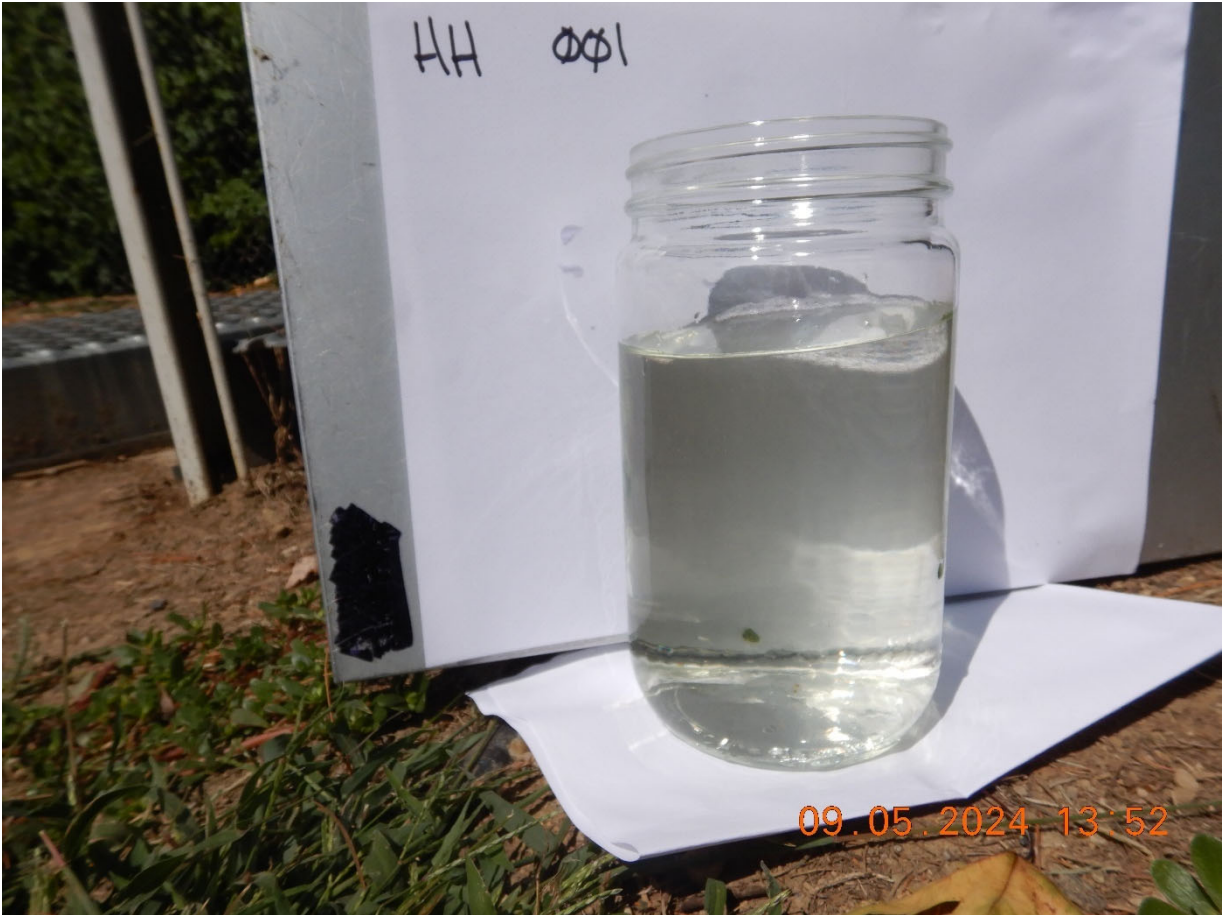
3: DSCN2290.JPG

Description: Visual grab sample collected form the UV channel at Outfall 001.

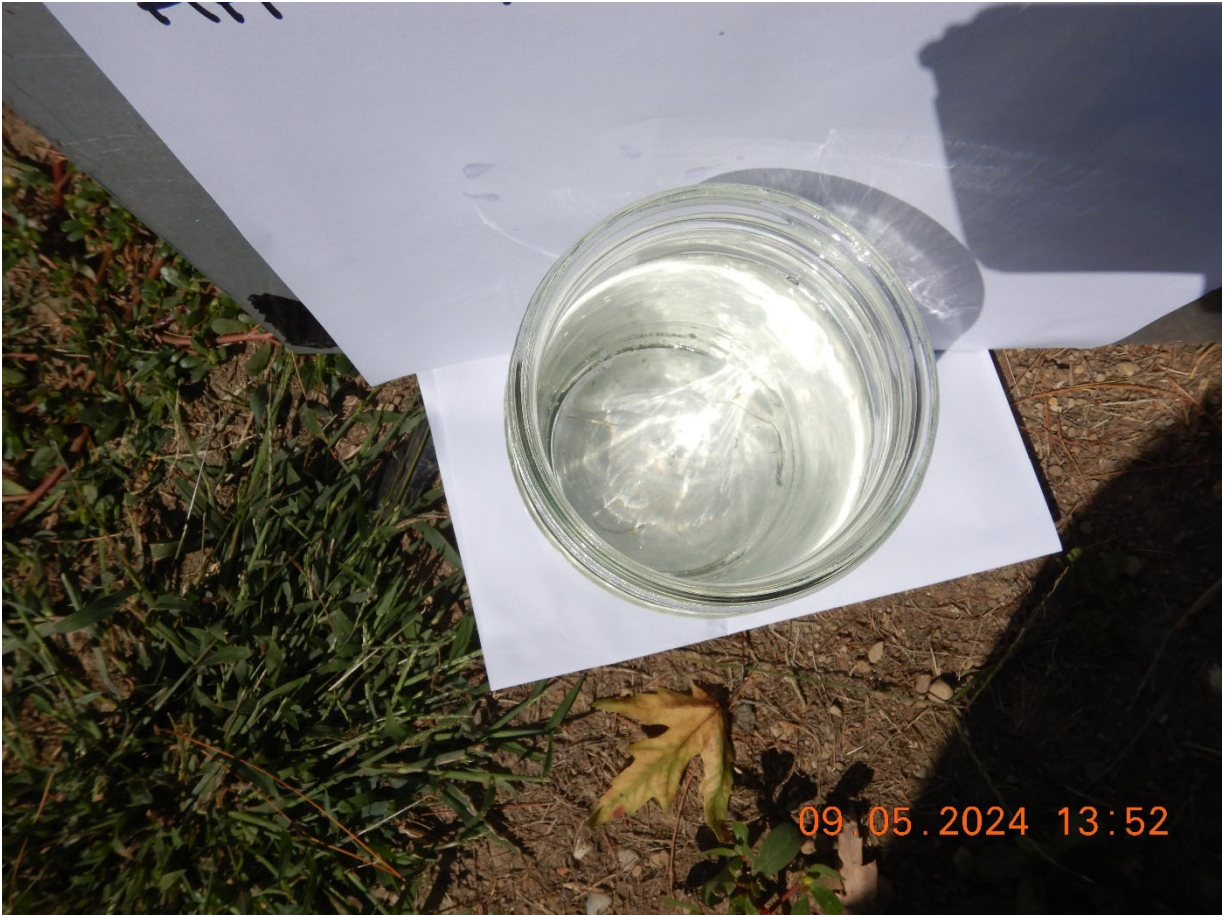
4: [DSCN2291.JPG](#)

Description: Visual grab sample collected form the UV channel at Outfall 001.
