## Region 6 - Enforcement & Compliance Assurance Division

### INSPECTION REPORT

| Inspection Date(s): | 07/13/2021 | |
| Company Name: | <b>Jacobs Dairy</b> | |

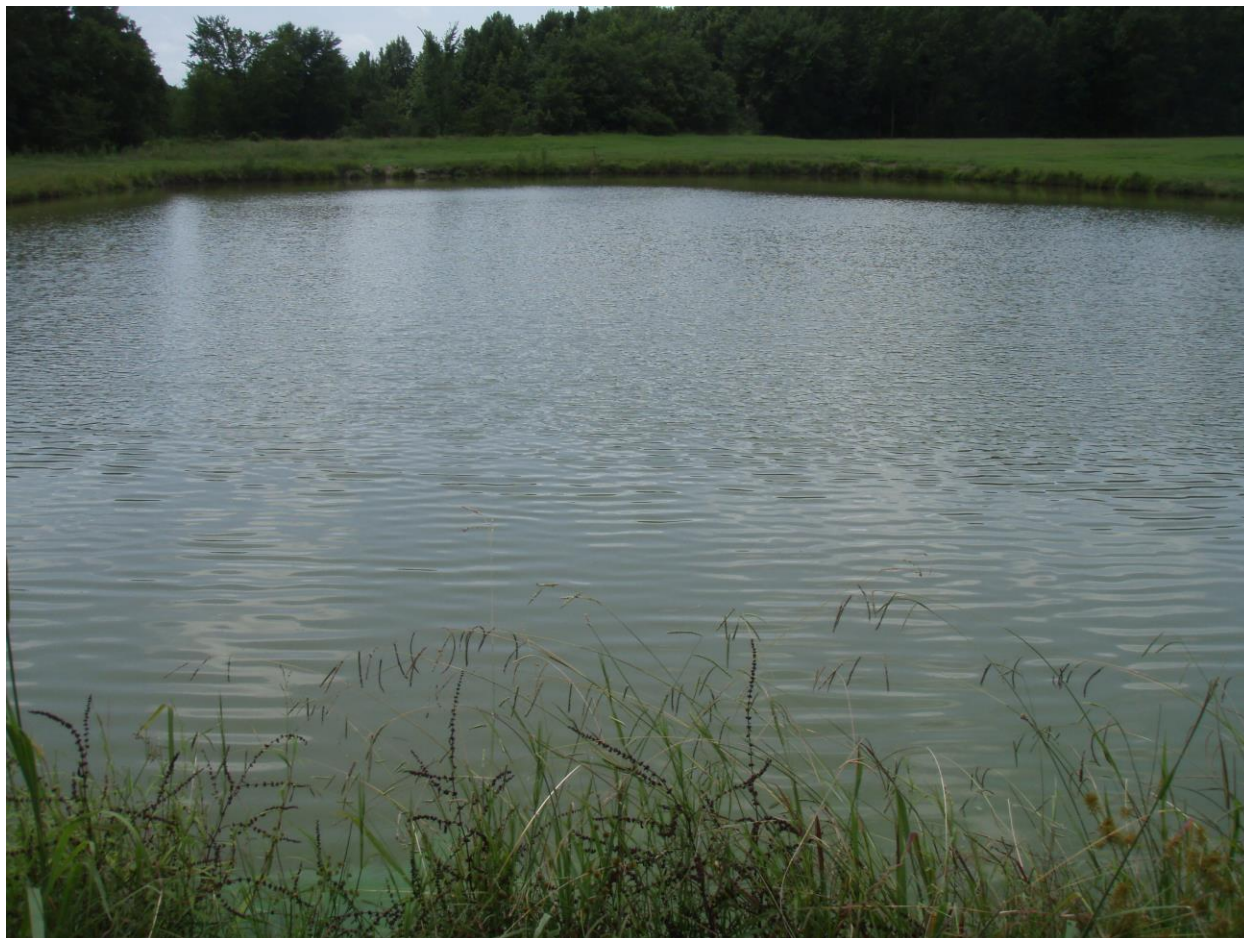
Photo No. 1

Description: The freshwater stock tank located west of the covered hay barn and feed commodities storage area, and south of the private road entrance to the dairy. The stock tank appeared to be unimpacted by CAFO nutrients and was essentially free of duck weed or algae. The view is toward the south.

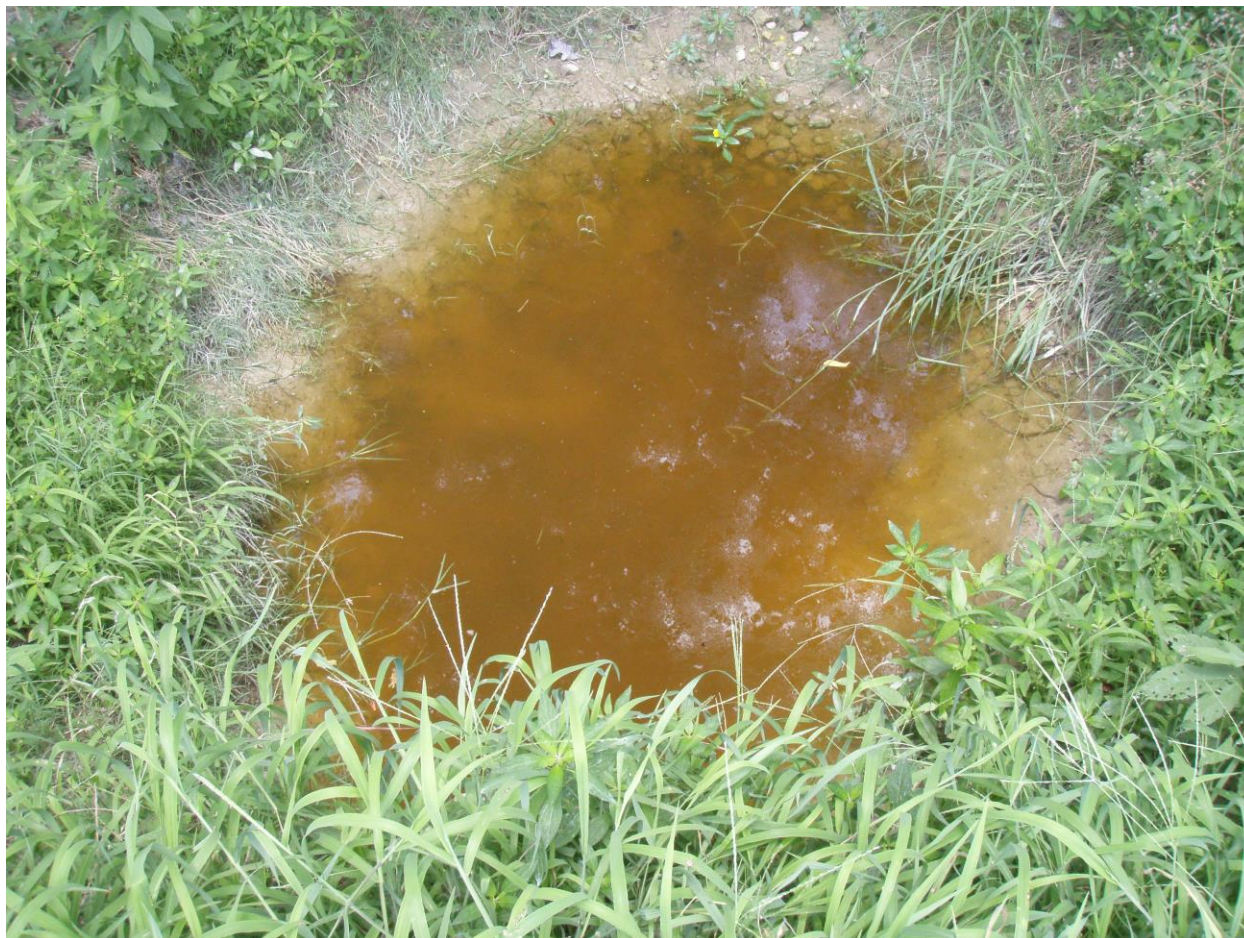
Photo No. 2

Additionally, an orange-brownish clear water was found in the bar ditch located just west of the covered hay barn and on the north side of the private road that serves as the dairy entrance (see Photos 2, 11 and 12). The pool of orange-brownish water was next to the drainage culvert that runs under the private road, across from the clean fresh-water stock tank. Only a few bales of hay remained in the covered hay barn and feed commodities storage area, and no source for this orange-brownish water could be found. All of the other upslope puddles of water within the bar ditches located along the private road only contained clear runoff water.

Description: A pool of orange-brownish (somewhat clear) water was found in the bar ditch located opposite of the stock tank shown in Photo 1. The source of this water coloration could not be determined during the inspection because all the other pooled storm water along this bar ditch, including those located on the south side of the private road next to the freshwater stock tank, and from around the hay/commodities storage barn were clear. The view is toward the north.

- 4) The unknown source of the clear orange-brownish water in the bar ditch along the Private Road entrance opposite the freshwater stock tank should be determined.

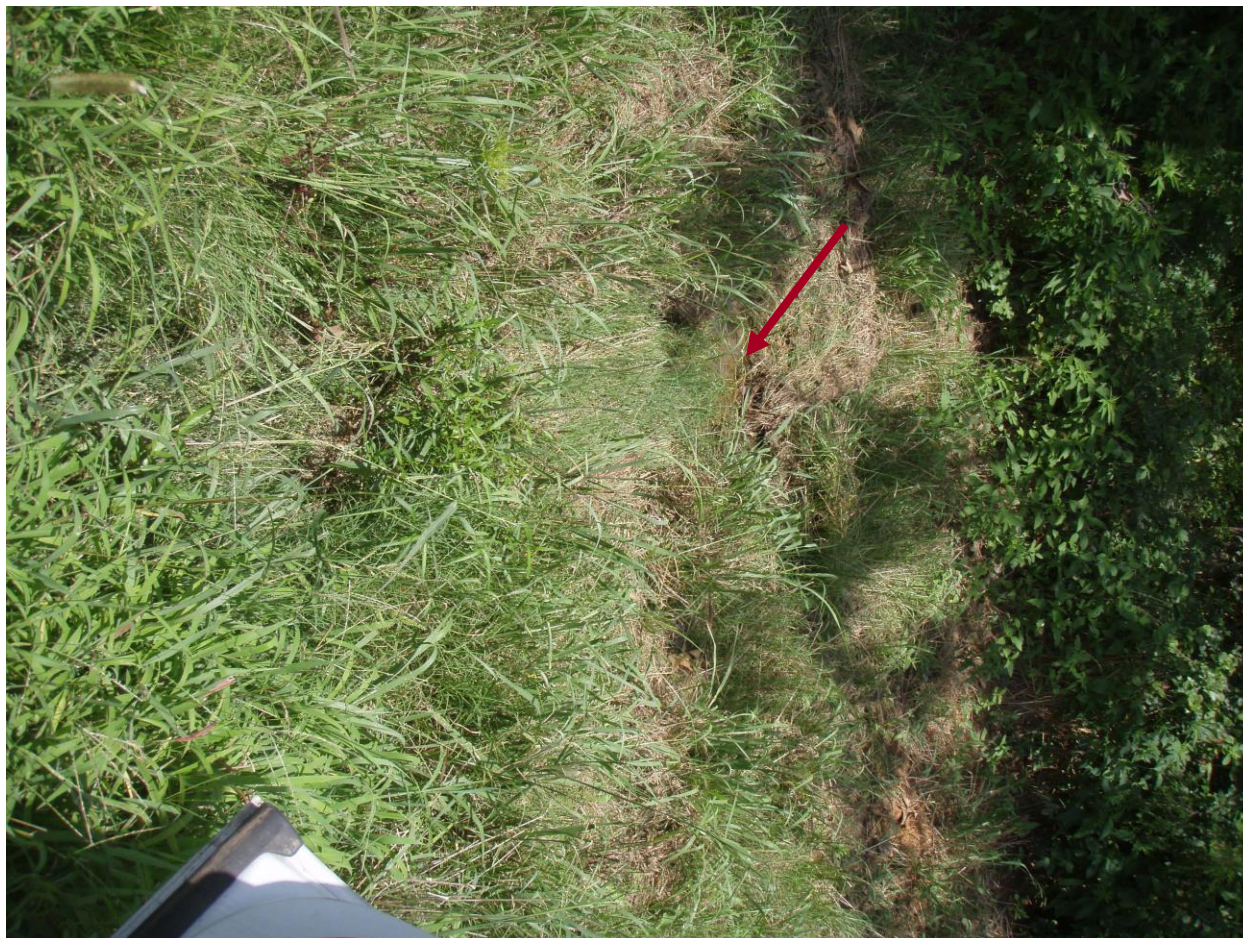
Photo No. 3

Description: The drainage area from the hay barn and commodities storage bins (both covered) and from the pond shown in Photo 6 was clear. This was located on the South side of the private road entrance. Note water is highlighted with a red arrow. The view is toward the west.

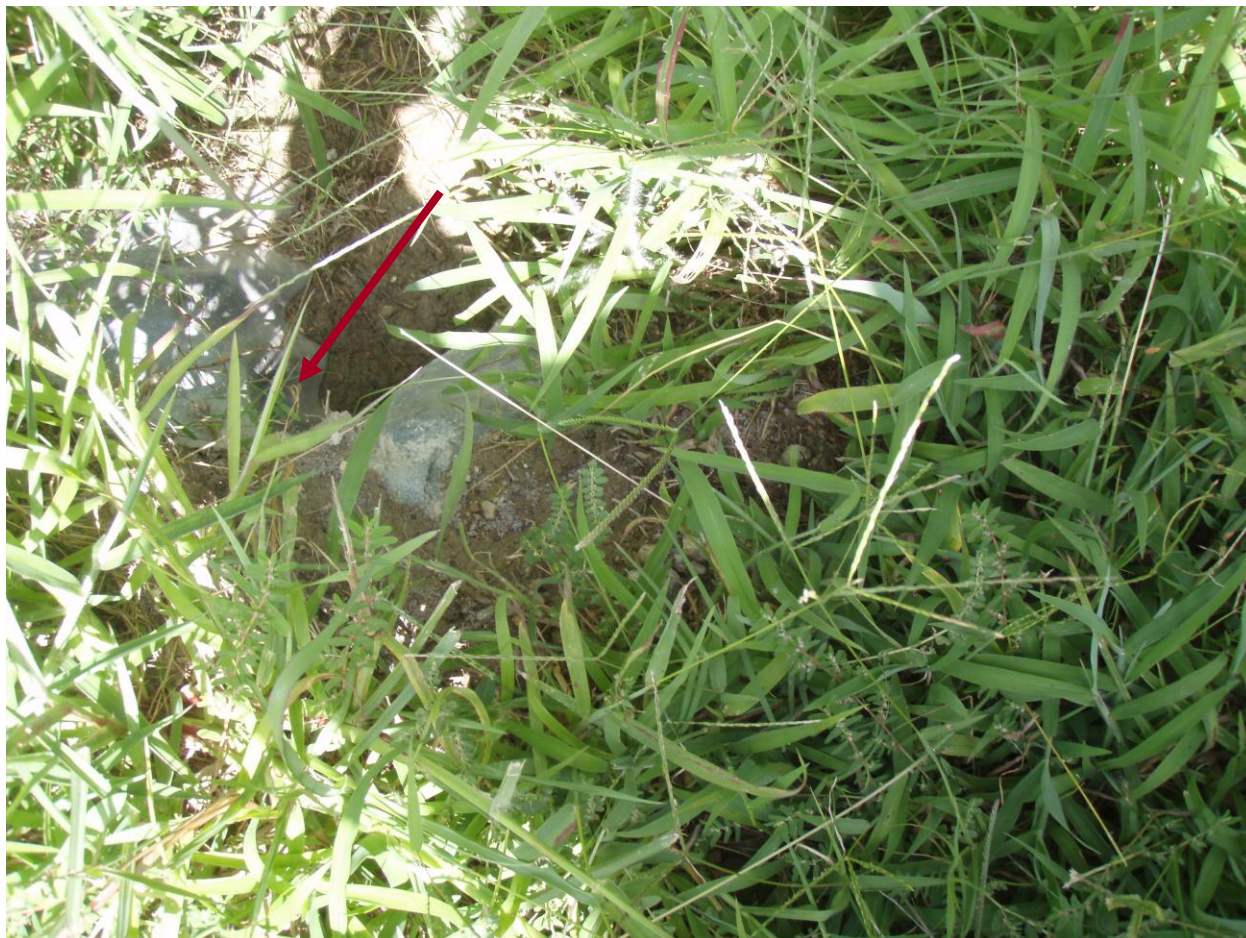
Photo No. 4

Description: The culvert (seen at the end of the red arrow) leading from the area seen in Photo 3 to the north side of the private road entrance, located opposite of the side of the road shown in Photo 3. The view is looking downward. No ponded water was seen on this side of the culvert.

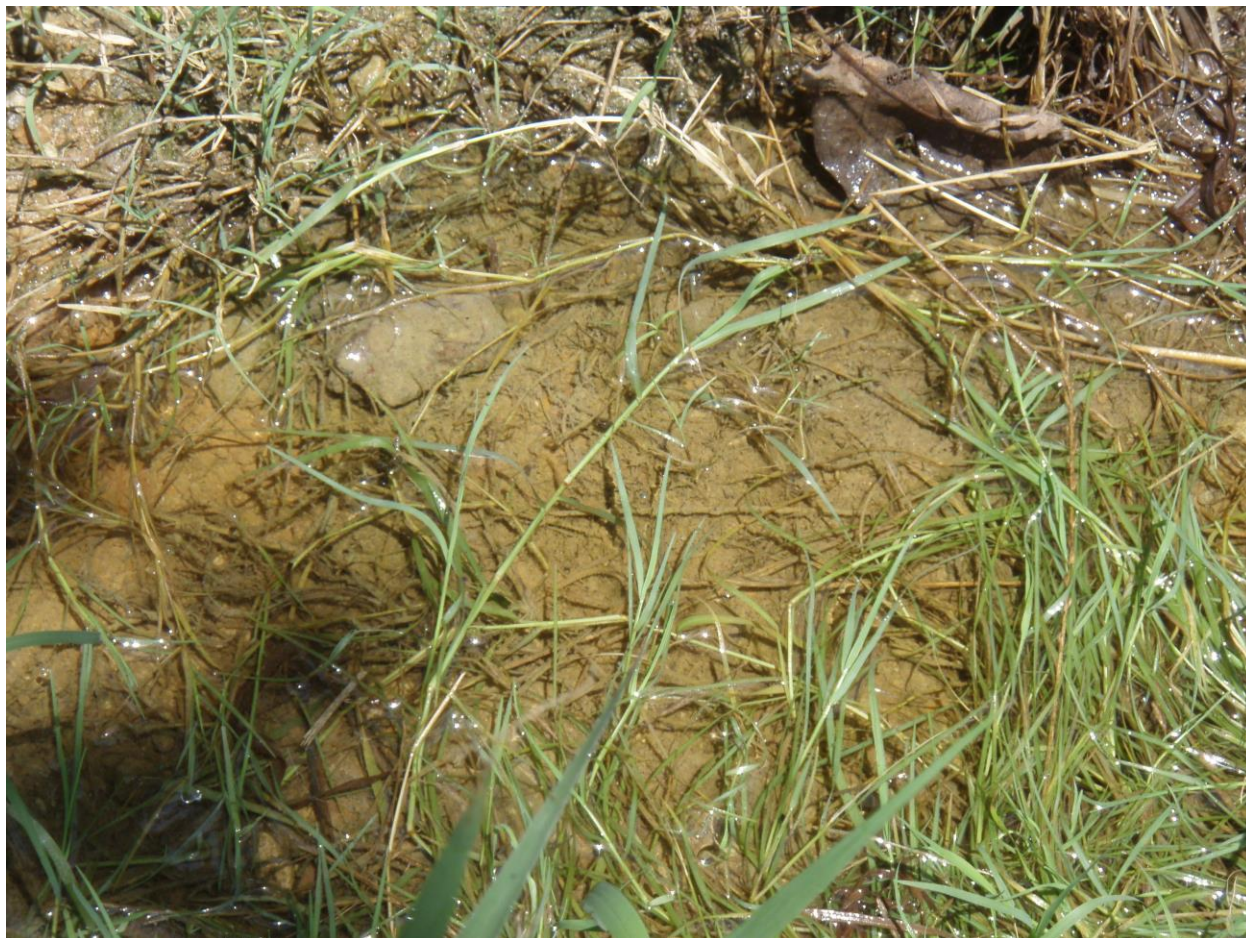
Photo No. 5

Description: View of the clear water that has pooled in the bar ditch, located northwest of the hay barn, along the south side of the private road entrance before it would enter the culvert. This pool of clear water was about 50' downslope of the small pool seen in Photo 3. The view is toward the south.

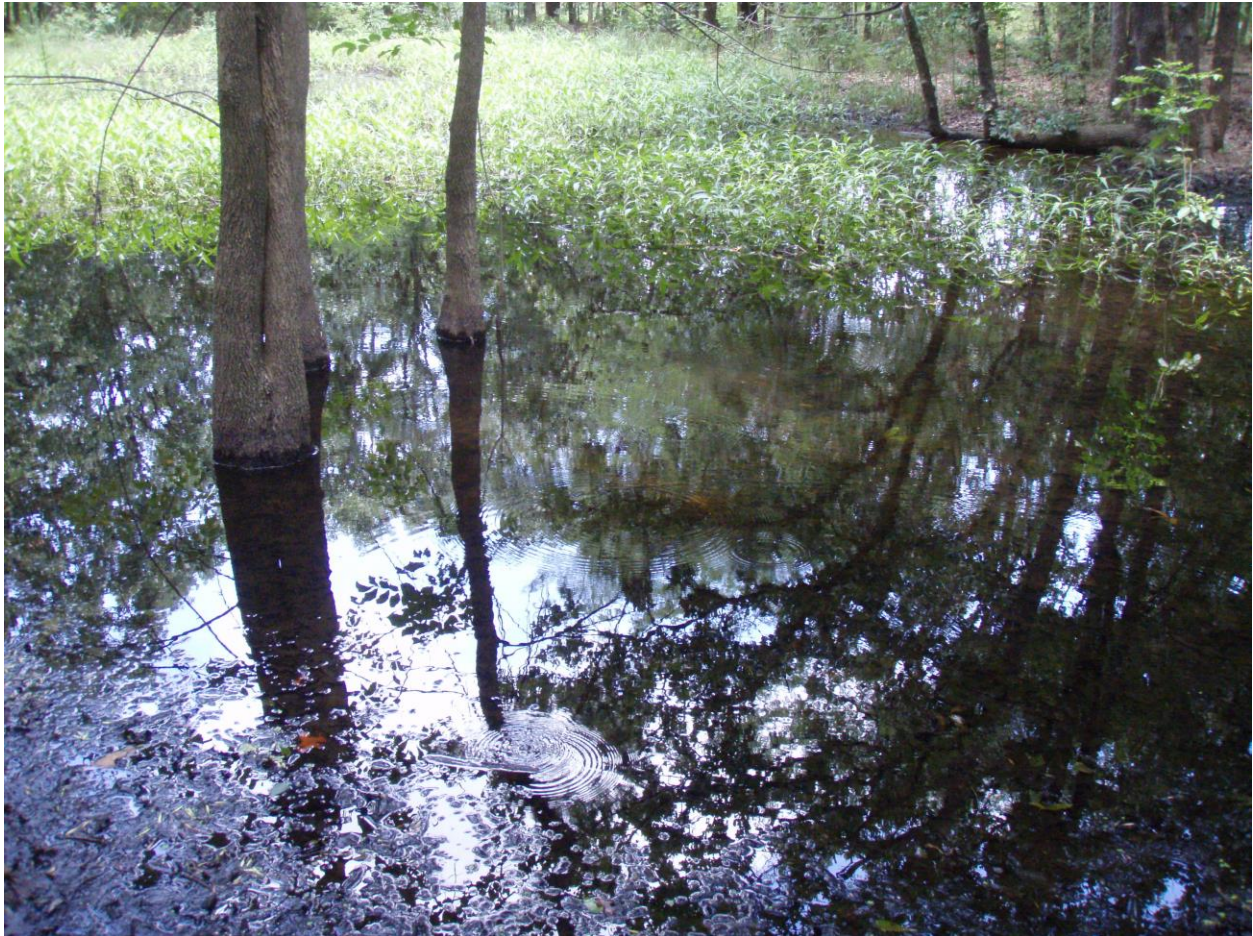
Photo No. 6

Description: The ponded water located southwest of the covered hay barn and commodities storage area. The pond is located within dense woods and surrounded by thick leaf litter. The water is clear but dark in color due to the years of leaf litter accumulation. This pond may discharge toward the areas shown in Photos 3-4. The view is toward the north, and the direction of potential flow was difficult to assess due to the flat topography and dense woods.

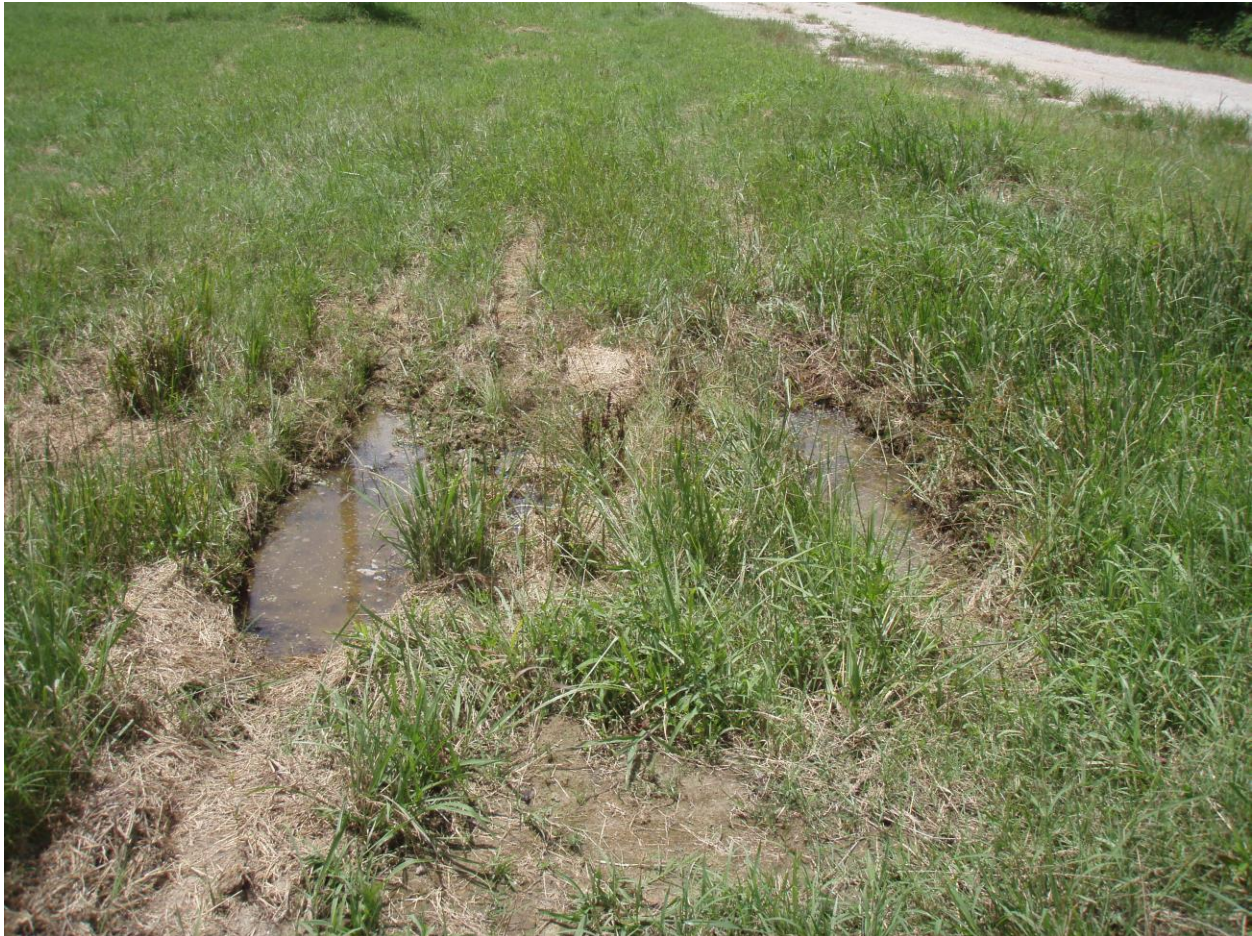
Photo No. 7

Description: Another view of the clear water leading to the pool of clear water seen in Photo 5. The view is toward the west and was taken from a point northwest of the hay barn.

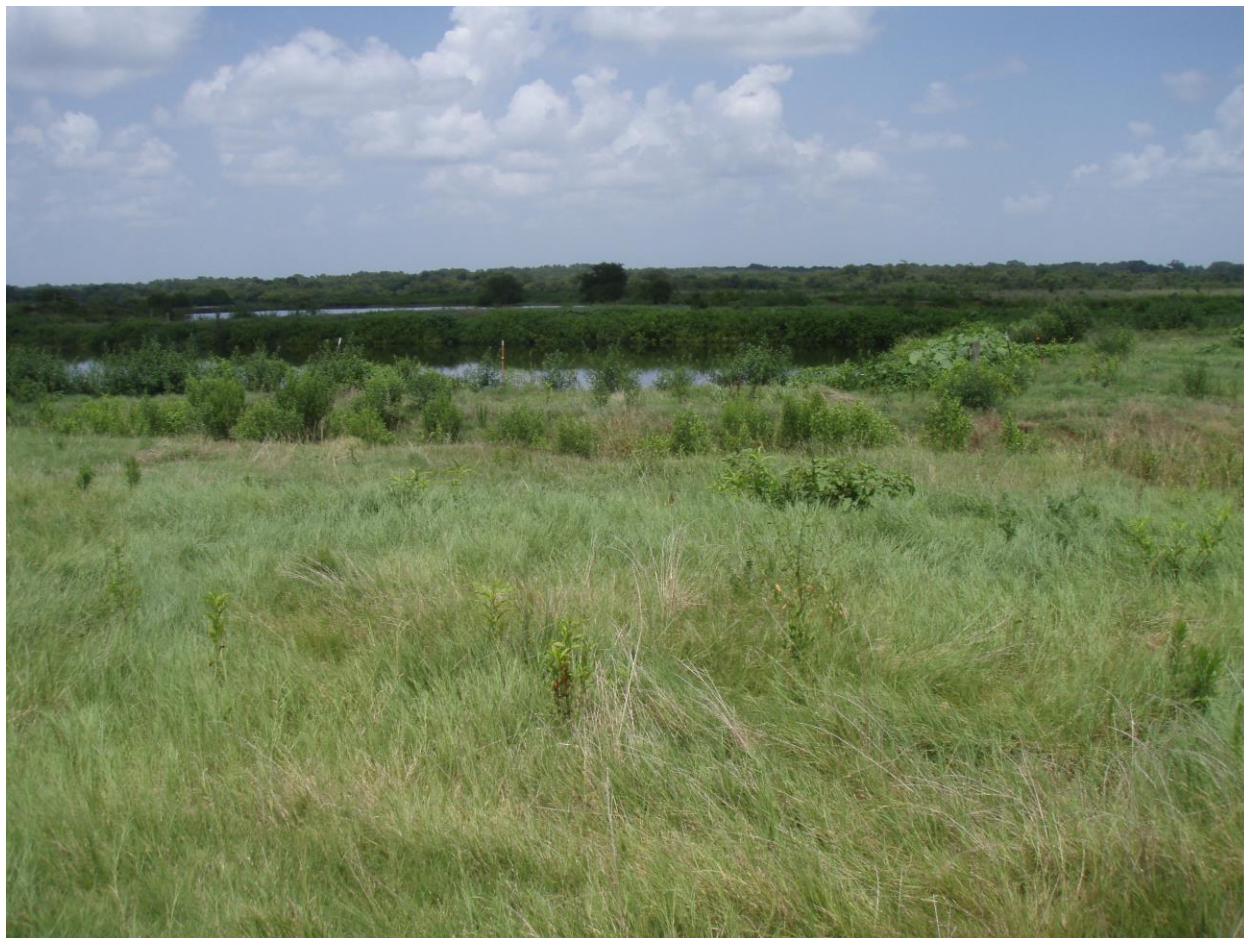
Photo No. 8

During the site inspection of Jacobs Dairy, I observed that the three retention control structures (RCS) were not being maintained. I was unable to access the embankments of the three units due to very dense and high vegetation, but I got as close as I could and photographed the condition of the lagoons (see photos 8 and 10). Due to the very dense vegetation, I was unable to locate RCS 1. The lagoons were

inaccessible due to the lack of proper and required maintenance such as mowing of vegetation and preventing trees from growing on the embankments of all three units. Lagoon markers were not visible, and I could not get close enough to determine whether they were discharging or had discharged recently.

Description: A view of RCS2 that is located on the south side of the dairy. The dense vegetation has grown tall and I was unable to safely access the embankment perimeter to assess the lagoon level and embankment condition. Neither was I able to assess whether there was any available freeboard. The view was toward the east.

- 1) The dairy is required to maintain their lagoons per the requirements of their TCEQ CAFO General Permit (Section III.A.10.(a)(c)(e) and (f)). This includes managing the embankments of the units, removing trees, mowing the perimeter to allow access and observe embankment integrity and maintaining a pole marker. Also, solids must be removed from RCS 1 as that unit's location could not even be discerned during the inspection.

- 2) Lagoon levels must be managed thru land application to maintain the capacity for the 25-yr/24-hr rain event (Section III.A.10.(a)(1) and (2)). This is to be accomplished thru weekly documented lagoon level measurements using the lagoon pole markers which were not visible during the inspection.

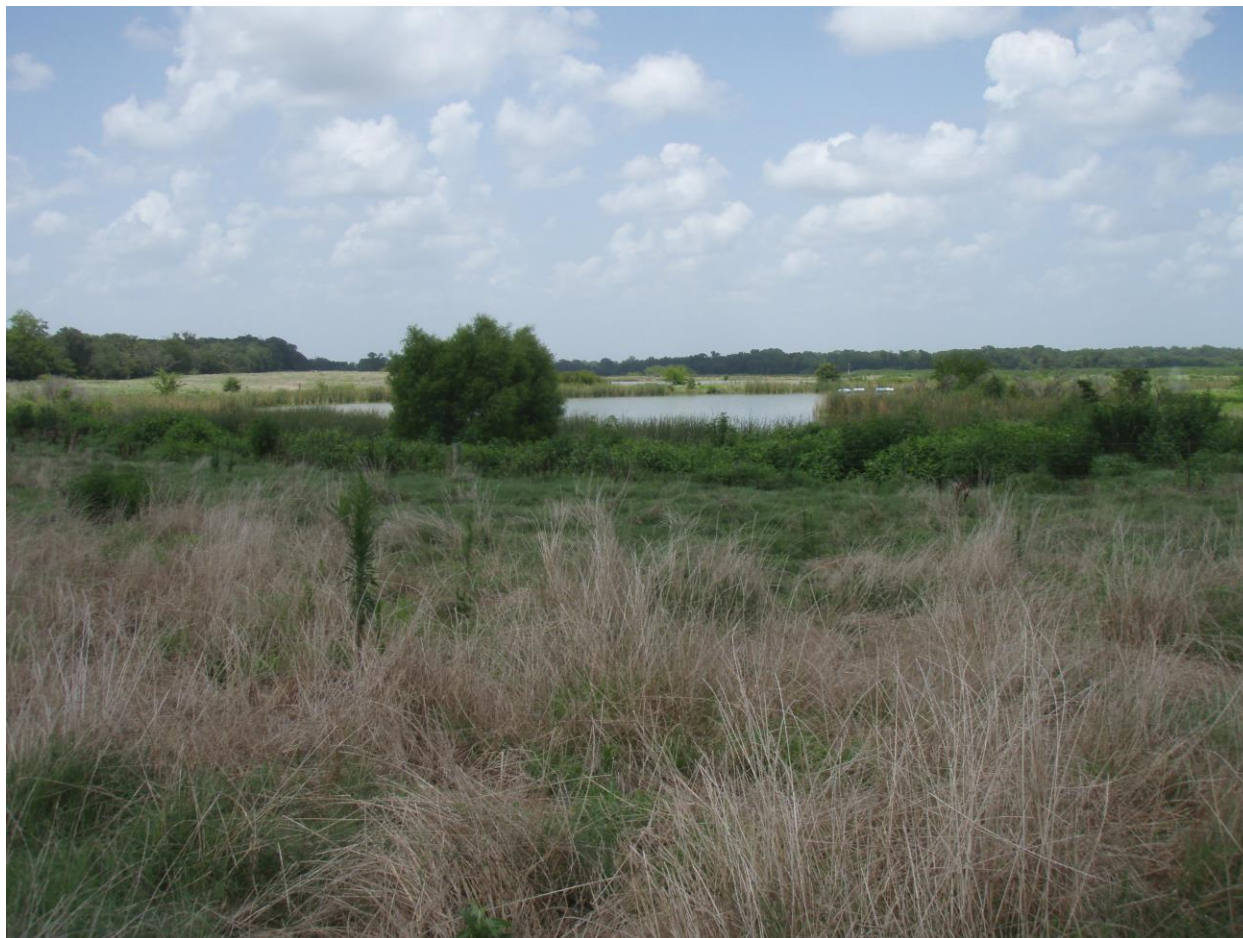
Photo No. 9

Description: A view of the freshwater stock tank that is located on the north side of what used to be a cattle pen. The dense vegetation has grown dense and there was no sign of any recent cattle grazing. The view was toward the north.

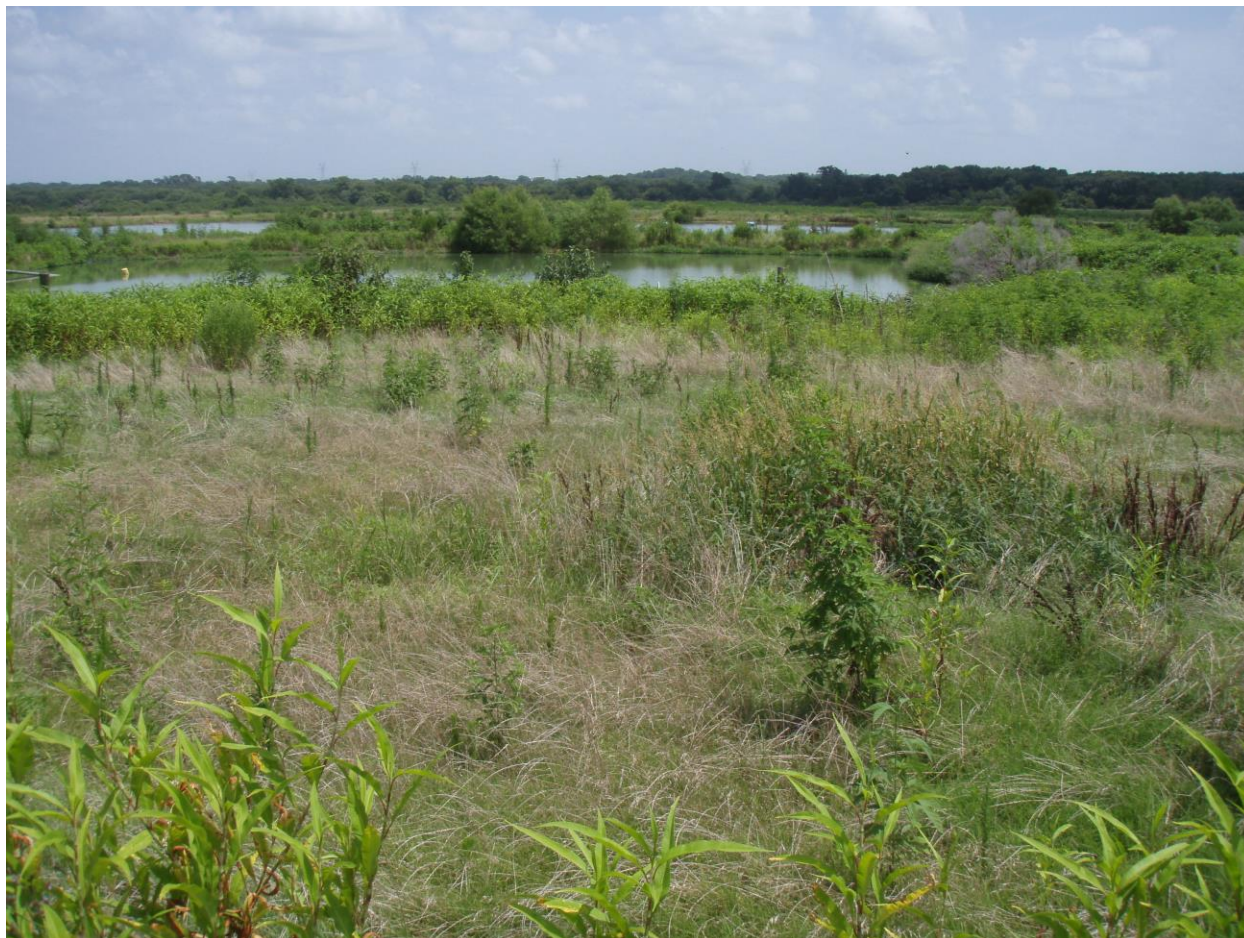
Photo No. 10

Description: The small northeast lagoon (RCS3). The conditions are comparable to RCS2, as the dense vegetation has grown tall and I was unable to safely access the embankment perimeter to assess the lagoon level and embankment condition. Neither was I able to assess whether there was any available freeboard. The view was toward the southeast.

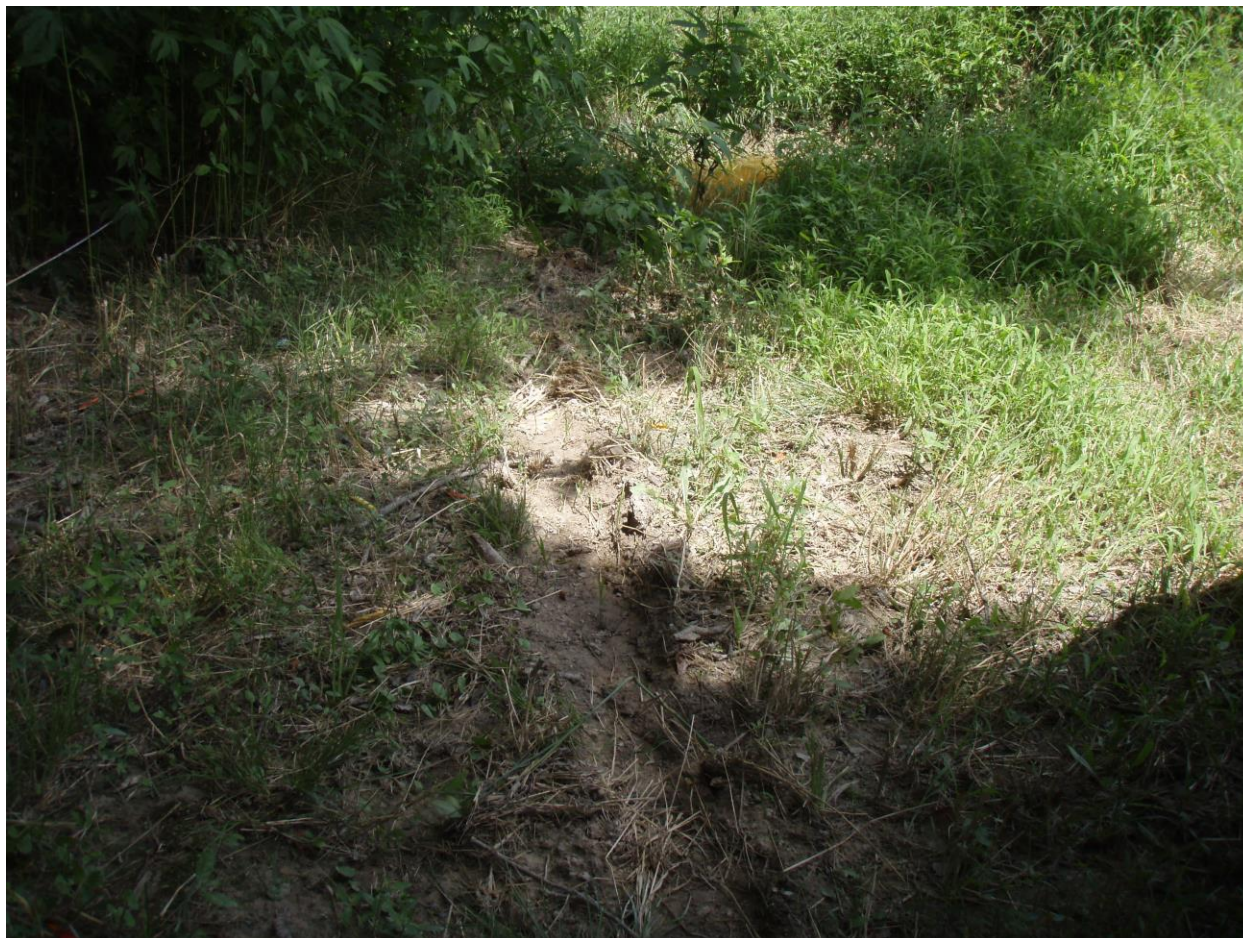
Photo No. 11

Description: A possible tire track leading toward the orange-brownish water seen in Photo 2. The dairy should monitor for possible illicit dumping at this unmanned and closed dairy. The tire track could have resulted from tractor mowing, or possibly a tanker truck. The source of the orange-brownish water could not be determined during the inspection. The view is toward the east.

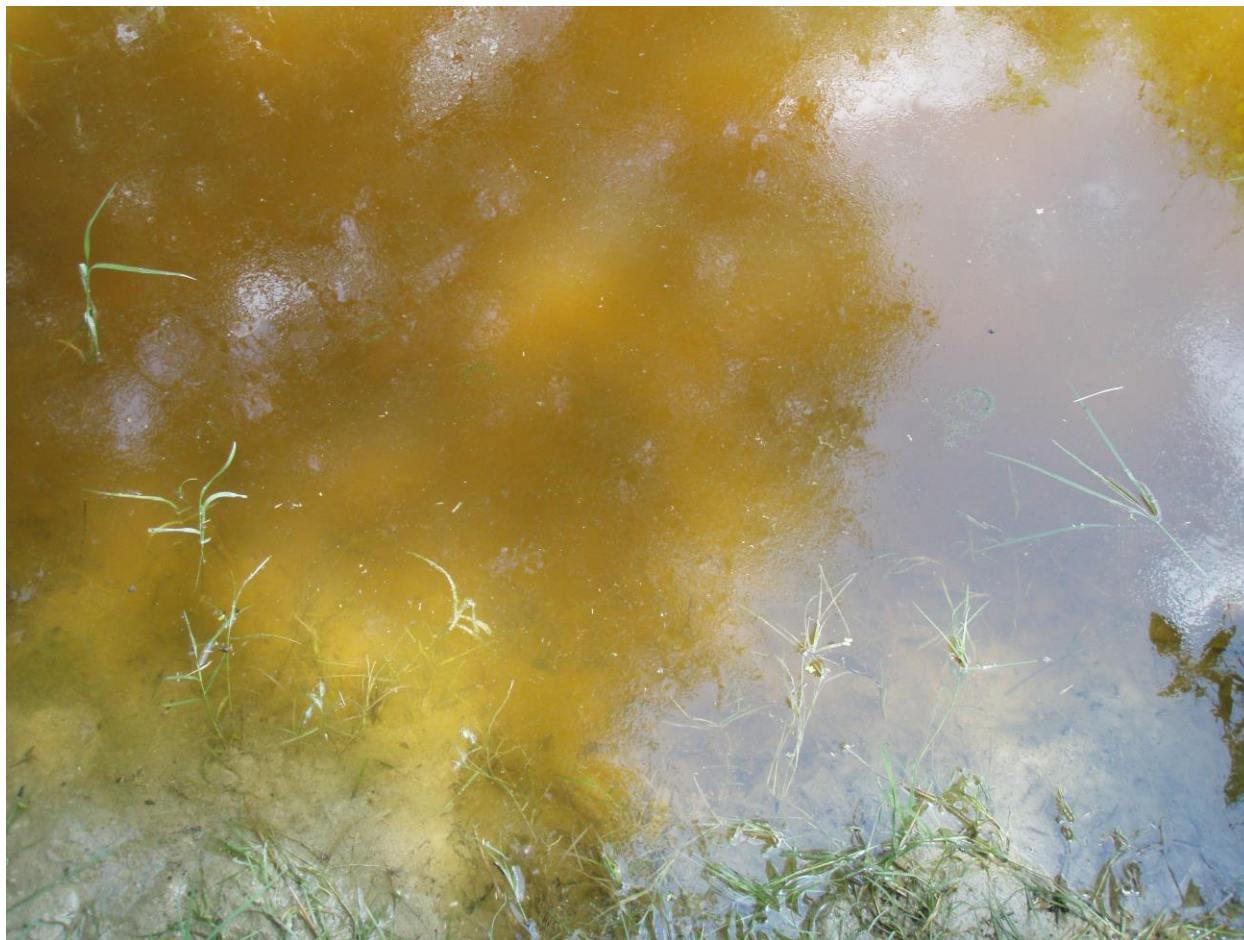
Photo No. 12

Description: A close-up view of the orange-brownish water. Water bugs and mosquito larvae were seen in the pooled water.

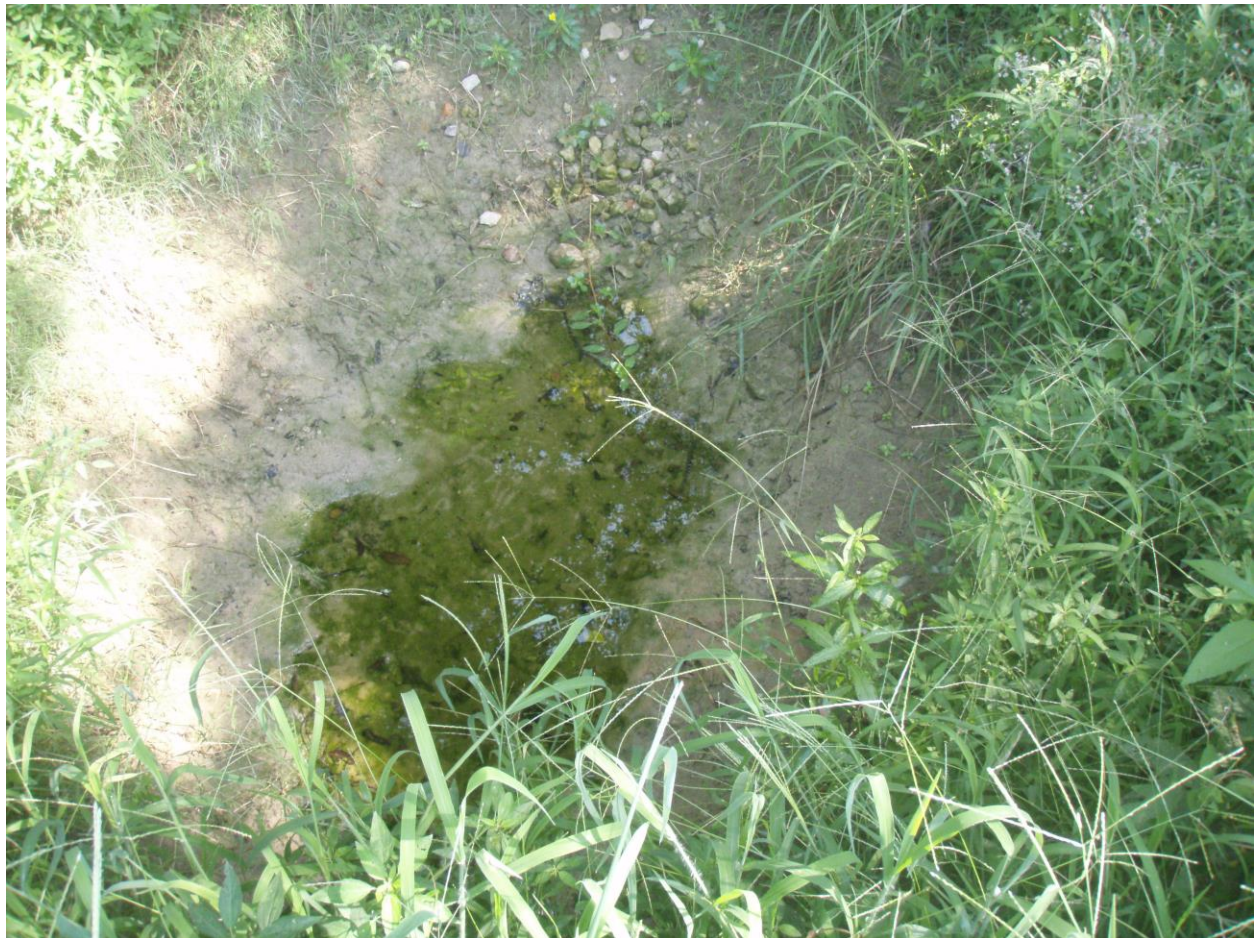
Photo No. 13

Description: During a brief follow-up visit to check on what was an orange-brownish and somewhat clear pool of water seen during the 7/13/2021 site inspection, I noticed that the orange-brownish water was gone, and now in its place was a clear pool of water with a slight greenish tint. I could not determine if the tint was due to algae or some other source. This photo was taken from the north side of the private road bar ditch looking down and to the north.

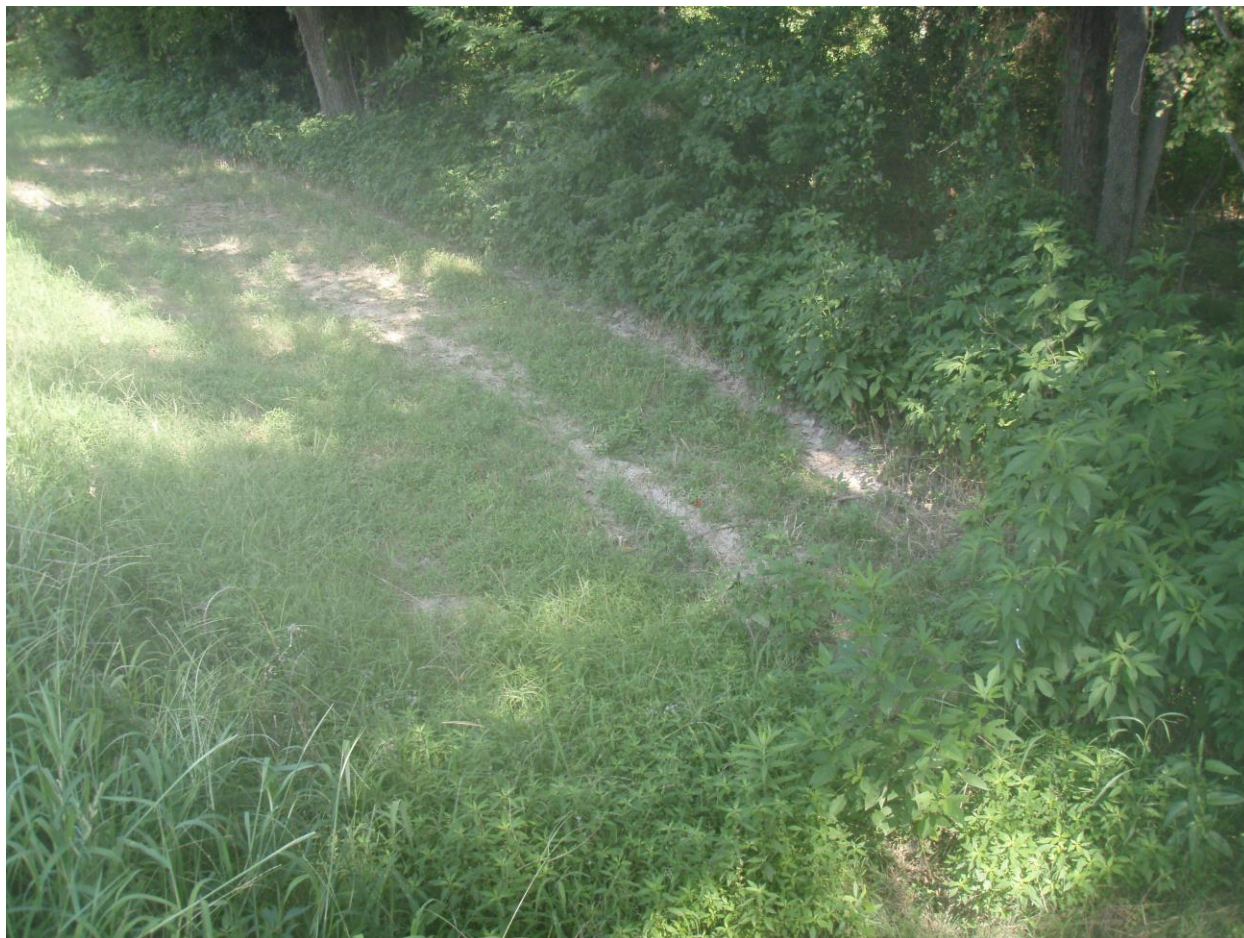
Photo No. 14

While conducting another Antoon Jacobs dairy site inspection (Jacobs Dairy II) on July 28, 2021, I took the time to look at the condition of the orange-brownish pool of water documented during the Jacobs Dairy inspection conducted on July 13, 2021. I found that the orange-brownish and somewhat clear pool of water found in the bar ditch was now gone, and in its place was a pool of clear water with a slight greenish tint (see Photo 13). I also photographed a set of tire tracks running thru the bar ditch leading to the pool of greenish water. I suspect that someone has been dumping some type of waste into the bar ditch (see Photo 14).

Description: During a brief follow-up visit to check on what was an orange-brownish and somewhat clear pool of water seen during the 7/13/2021 site inspection, I noticed that the orange-brownish water was gone, and now in its place was a clear pool of water with a slight greenish tint. I could clearly see that a vehicle has regularly driven down the bar ditch area toward the pool of what was now clear water with a slight greenish tint. I suspect that someone may be dumping some sort of wastewater into the bar ditch. The view was toward the west-northwest.
