**Compliance Evaluation Inspection Report**

City of Sevierville (McCroskey Island) STP

**Project No. CV-TN0063959-030724**

March 7, 2024

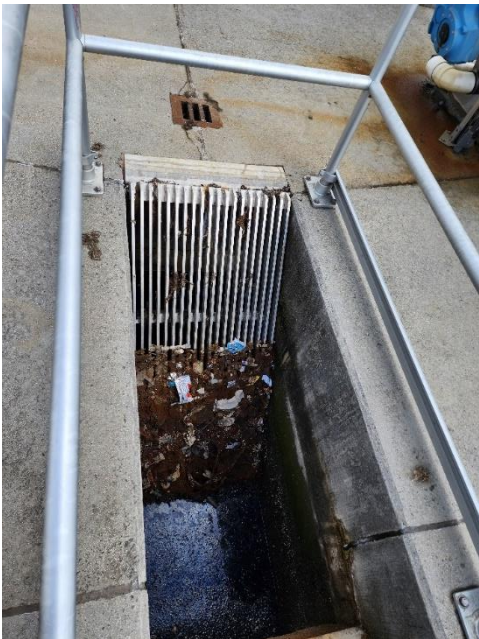
- Two Andritz mechanical bar screens we noted at the headworks to be clean and operational.
- Manual secondary bar screen was noted to contain a sizable amount of debris from previous usage during a power outage that occurred 3 weeks prior (photo #1). Manual secondary bar screen was cleaned during inspection (photo #2).
- The grit and grease removal treatment unit was offline due to two blower units being inoperable.

Photo 1: Secondary manual bar screen.

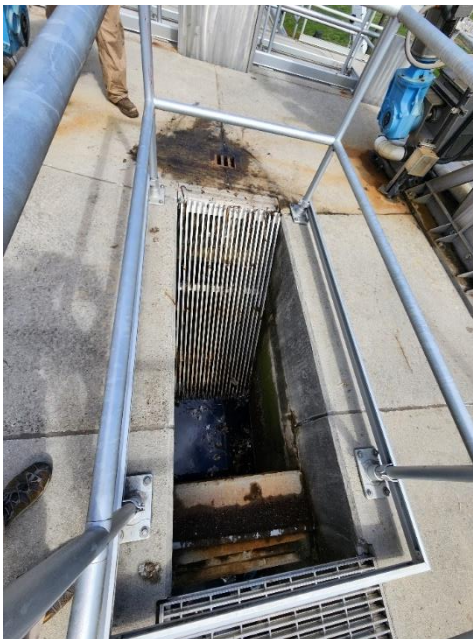
Photo 2: Secondary manual bar screen after cleaning.

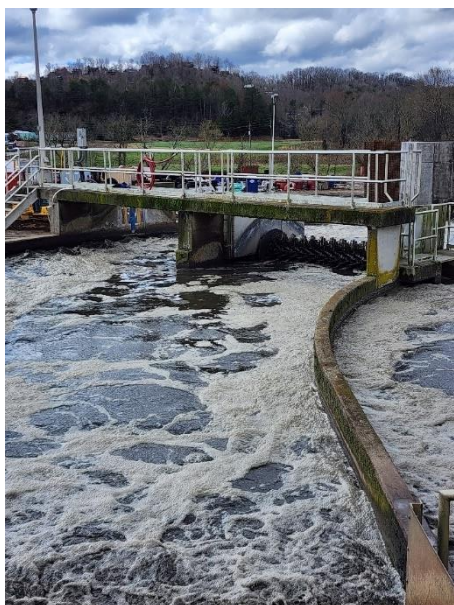
- Oxidation ditch was noted to contain high flow levels. One paddle set was inoperable due to a bearing malfunction (photo #3). Repair to bearing had been completed but paddle was unable to be installed due to high flows within the oxidation ditch.

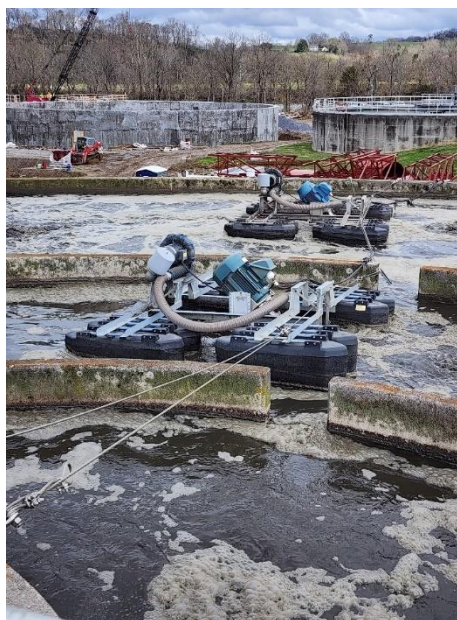
- Four floating aerators were noted in the oxidation ditch and had been installed to address reported ammonia violations (photo #4). These floating aerators were installed in pairs. The first set in 2020 and the second set in 2021.

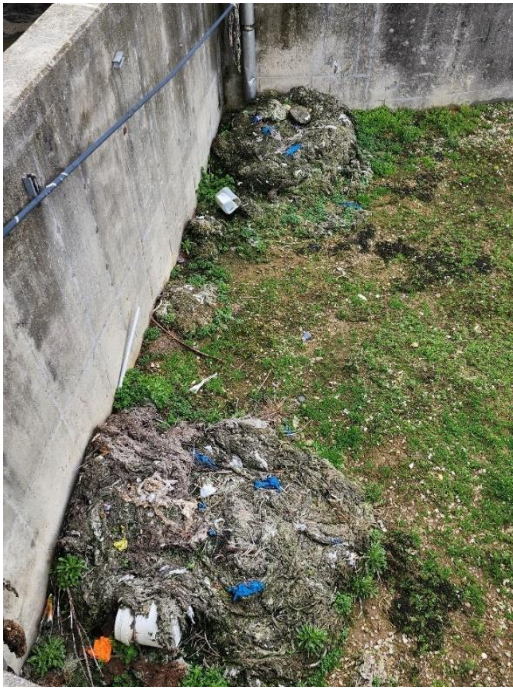
- Solids from previous clarifier maintenance were noted on ground against walls of clarifiers and outside of containment (photo #5).
- Clarifier #1 was designed with a floating weir. The weir is unlevel and results in uneven discharge from clarifier #1 (photo #6).

Photo 5: Solids on ground between clarifiers.

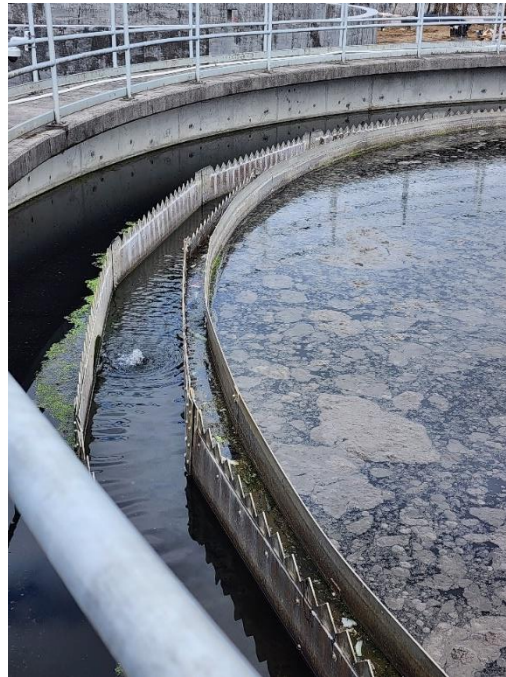
Photo 6: Unlevel floating weir in clarifier #1.

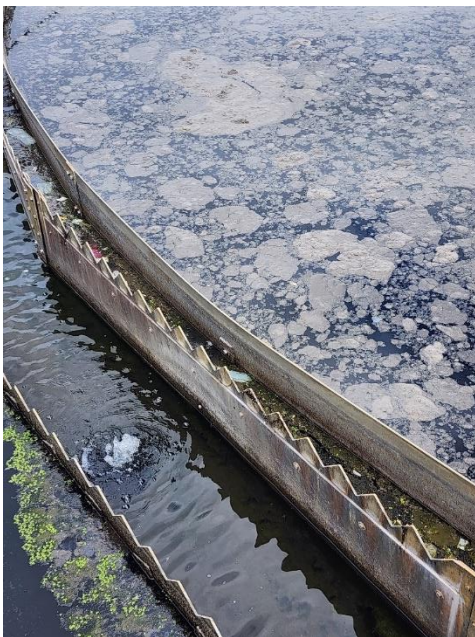
- Two clarifiers were observed receiving heavy flows. Both clarifiers appeared to have heavy solids buildup within the center wells (photo #8).
- Clarifier #1 and #2 both have heavy solids and grease on surface due to high flows and the grit and grease removal treatment unit being out of service (photo #7).

Photo 7: Floating grease and duckweed on clarifier #1.

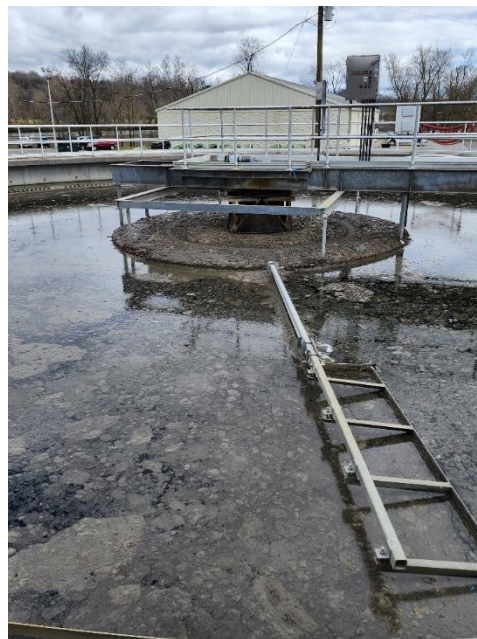
Photo 8: Center well of clarifier #1 full of solids.

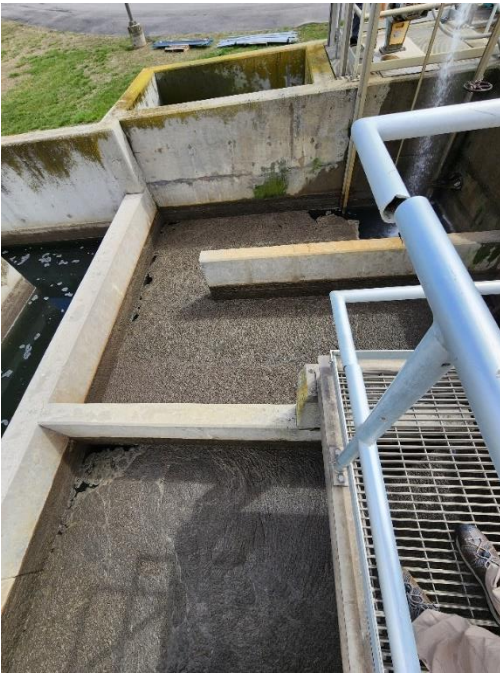
- The chlorine contact chamber was observed with floating solids/foam on the first six cells (photo #9 and #10).
- One ISCO Signature Series ultrasonic flow meter located at the effluent discharge read 7.5 MGD at the time of observation (photo #11).

Photo 9: Floating sludge/foam in chlorine contact chamber front section.

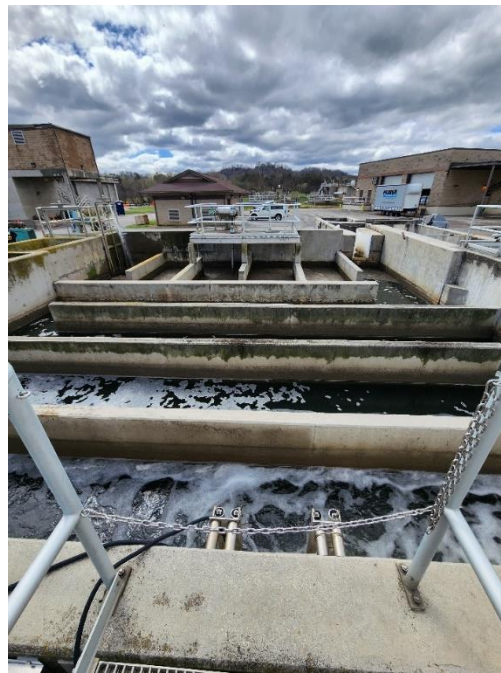
Photo 10: chlorine contact chamber full view.

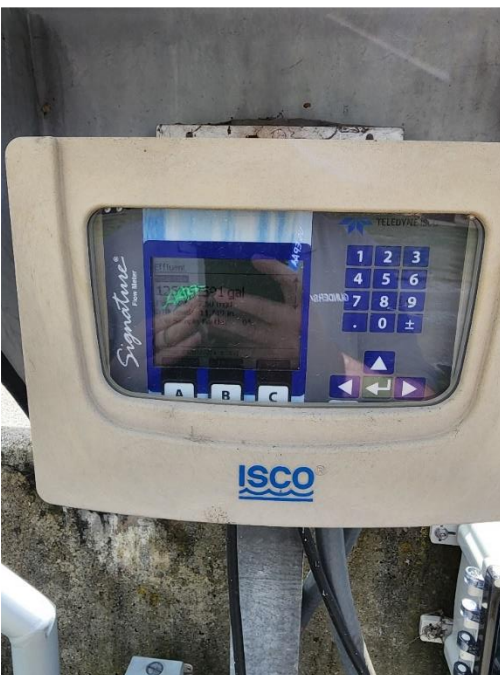
Photo 11: Effluent flow meter reading 7.5MGD.

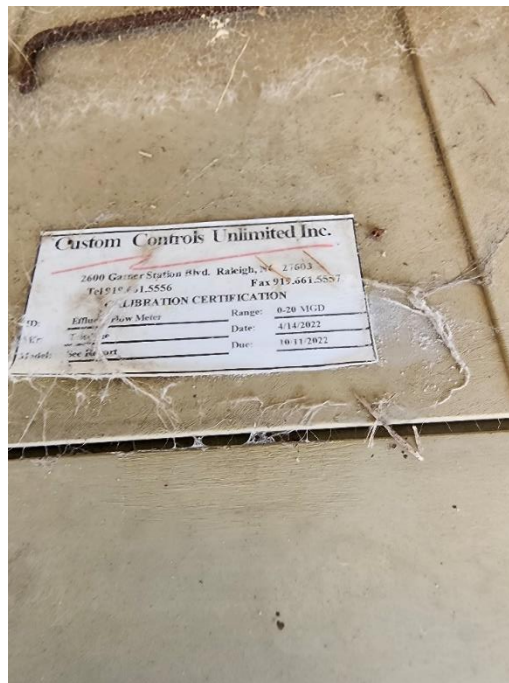
- The effluent ultrasonic flow meter's calibration sticker, located on unit, was observed to be out of date (photo #12). Updated calibration records were subsequently provided by Tonya Townsend, demonstrating calibration records were up to date. Next calibration date for effluent flow meter is 3/11/24.

Photo 12: Effluent flow meter calibration sticker.

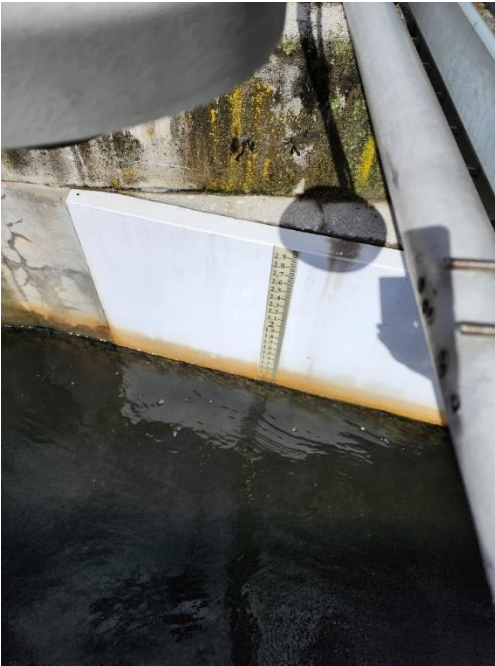
- The Parshall flume appeared free of defects, however the staff gauge had considerable debris and staining (Photo #13). This debris and staining resulted in poor visibility of gauge values.

Photo 13: 3-foot parshall flume staff gauge.

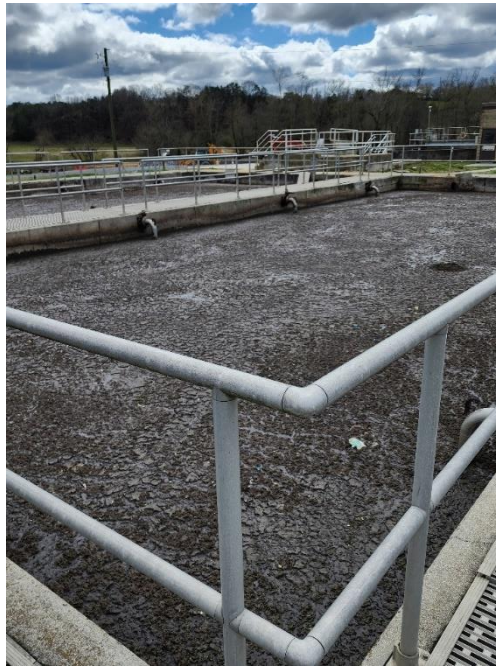
- The old aeration basin onsite was being utilized for sludge thickening (photo #14).

Photo 14: Sludge thickening in old aeration basin.

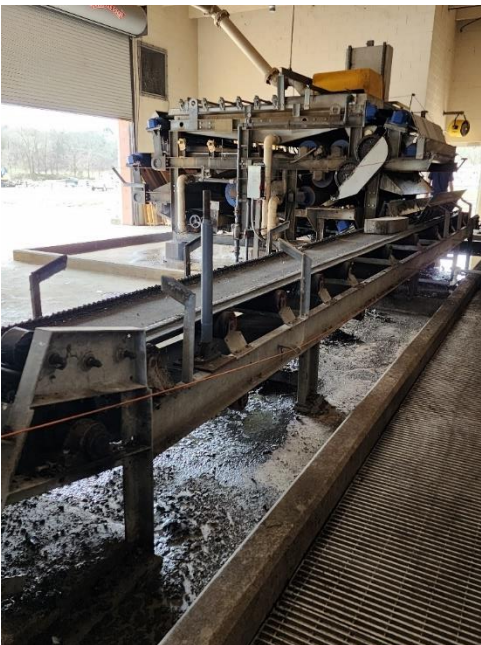
- The Ashbrook belt filter press was not operational due to mechanical malfunction (photo #15). The press had been offline for approximately 6 weeks, with sludge remaining under belt feed, but within containment (photo #16).

According to the Operator, the standard sludge disposal process is to aerobically digest it and dewater it by the Ashbrook belt filter press and then landfill it. At the time of inspection, the belt filter press was nonoperational. The Operator stated the belt filter press had been nonoperational for approximately six weeks.

Photo 15: Belt press out of service.

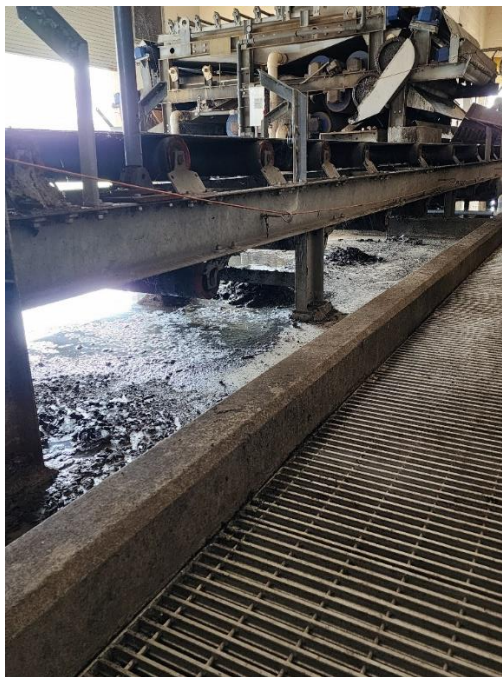
Photo 16: Sludge under belt press.
