**Re: Ryan Homes/NVR Inc. - Hawk Pointe Area 2  
EPA Compliance Evaluation Inspection (CEI), May 15, 2024  
NJPDES 5G3 Permit Number NJG0333433**

**COMPLIANCE EVALUATION INSPECTION REPORT**

<b>Program:</b> Construction Stormwater	<b>Inspection Type:</b> Compliance Evaluation Inspection
<b>Permittee Name:</b> Hawk Pointe Area 2 (Ryan Homes/NVR)	<b>NPDES/ICIS No.:</b> NJG0333433
<b>Inspection Entry Date:</b> May 15, 2024 <b>Inspection Entry Time:</b> 12:20 PM	<b>Inspection Exit Date:</b> May 15, 2024 <b>Inspection Exit Time:</b> 2:15 PM
<b>Facility Inspected:</b> Hawk Pointe Area 2 11 Limestone Blvd Washington Twp, NJ 07882	<b>Lat, Long:</b> 40.756951, -74.986148 <b>NAICS / SIC Code:</b> 1522: General Contractors: Residential Buildings, Other Than Single-Family
<b>EPA Representative(s):</b> Christina Palmrose-Krieger, EPA Region 2, 212-637-4049, <a href="mailto:Palmrosekrieger.Christina@epa.gov">Palmrosekrieger.Christina@epa.gov</a> Mikhail Mohammed, EPA Region 2, 212-637-4265, <a href="mailto:Mohammed.Mikhail@epa.gov">Mohammed.Mikhail@epa.gov</a> Patrick Whalen, EPA Region 2, 212-637-4290, <a href="mailto:Whalen.Patrick@epa.gov">Whalen.Patrick@epa.gov</a>

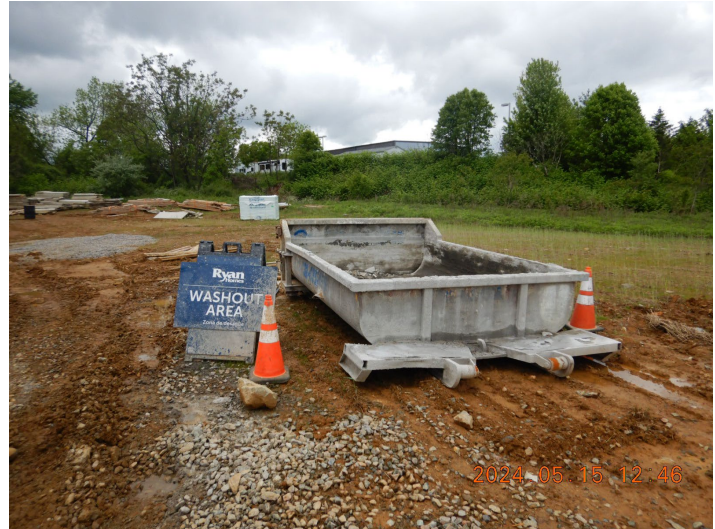
DSCN3232

1. At the time of the CEI, Asbury Farms and Ryan Homes/NVR, did not have a formal agreement in place or written documentation that described the delineation of soil erosion and sediment control measure responsibilities as it relates to the SPPP. Ownership and on-site responsibilities were ambiguous in certain locations of the Site, particularly in the rights-of-way areas and near the Ryan Homes/NVR shipping container and concrete washout area.
2. Part I.J.4.g states that designated washout areas shall be lined and bermed to prevent discharges to surface and ground water. Hardened concrete from the concrete washout shall be removed and properly disposed of. At the time of the CEI, EPA representatives observed that the concrete washout area was in need of maintenance. Water and sediment were pooling and running towards Clubhouse Drive (DSCN3231, DSCN3232, DSCN3233, DSCN3234).

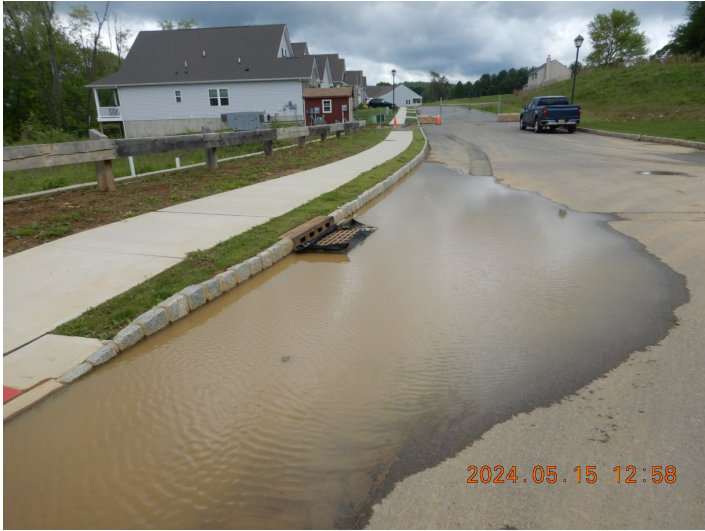
DSCN3237	Stormwater collecting around catch basin on Clubhouse Dr
DSCN3238	Stormwater collecting around catch basin on Clubhouse Dr
DSCN3239	Hole drilled next to catch basin by Asbury Farms staff to relieve stormwater collection – no sediment control measure to prevent sediment from entering catch basin through hole – located on Clubhouse Dr

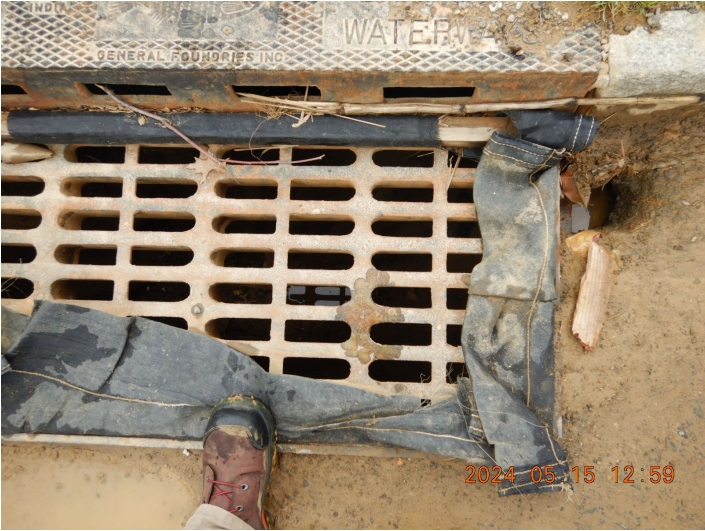
DSCN3240	Hole drilled next to catch basin by Asbury Farms staff to relieve stormwater collection – no sediment control measure to prevent sediment from entering catch basin through hole – located on Clubhouse Dr
DSCN3241	Stormwater collecting around catch basin on Clubhouse Dr
DSCN3242	Stormwater collecting around catch basin on Clubhouse Dr
DSCN3243	Retention basin under construction on north side of Site off of Clubhouse Dr
DSCN3244	Stormwater pooling around catch basin at the intersection of Limestone Blvd and Clubhouse Dr
DSCN3245	Intersection of Limestone Blvd and Clubhouse Drive
DSCN3246	Intersection of Limestone Blvd and Clubhouse Drive
DSCN3247	Filter sock and silt fencing being used along Limestone Blvd
DSCN3248	Filter sock and construction debris along Limestone Blvd
DSCN3249	Damaged filter sock in need of maintenance and sediment along Limestone Blvd
DSCN3250	Dumpster in need of repair on Limestone Blvd

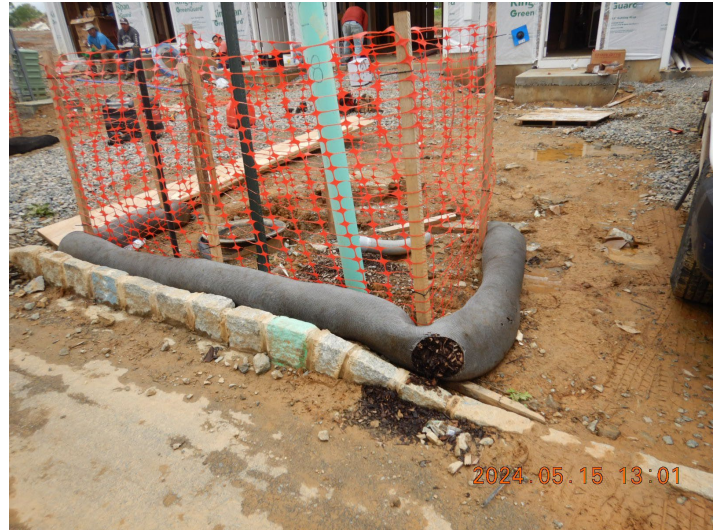
DSCN3249

- a. The Standards for Soil Erosion and Sediment Control in New Jersey states that sediment barriers should be repaired or replaced (fabric, posts, bales etc.) when damaged. Barriers shall be inspected daily for signs of deterioration and sediment removal. EPA representatives observed areas of silt fencing and filter socks were in disrepair surrounding individual lots in NVR's area of the Site along Limestone Blvd (DSCN3248, DSCN3249).

- b. The Standards for Soil Erosion and Sediment Control in New Jersey standards state that when soil begins to track onto paved surfaces, the aggregate must be replaced, or new aggregate added on top of the old. Sediment and material were observed on Limestone Blvd. The individual lot construction site entrances on Limestone Blvd needed maintenance (DSCN3248, DSCN3249, DSCN3250, DSCN3251, DSCN3257, DSCN3263, DSCN3265, DSCN3273).

- a. Silt fencing had been installed, reinstalled, and repaired along Limestone Blvd.
- b. Damaged filter socks had been replaced.
- c. Catch basins had been cleaned and new filter fabric had been installed along Limestone Blvd.
- d. Limestone Blvd had been swept and cleaned of sediment accumulation.
- e. Construction stone had been replenished in the entrances along Limestone Blvd.
- f. Two (2) dumpsters had been replaced.
- g. Temporary signage had been put up on the Ryan Homes shipping container.

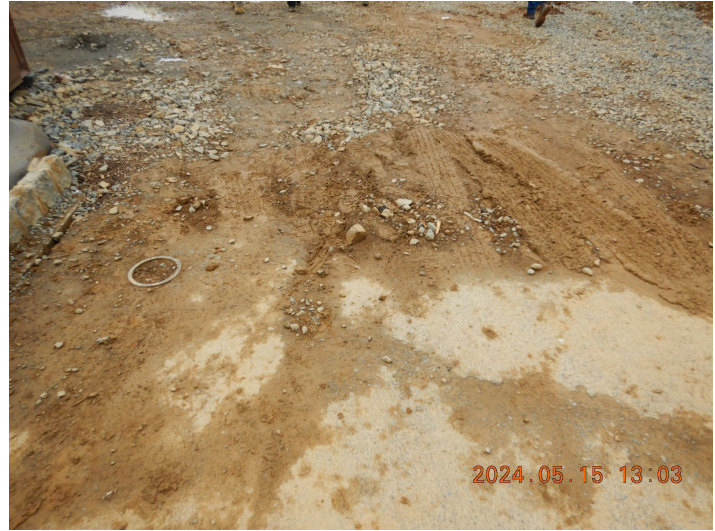
DSCN3251	Sediment and stormwater from the central area of Site running on to Limestone Blvd
DSCN3252	View from Limestone Blvd to central north area of Site; Dumpster and townhomes can be seen
DSCN3253	View of Limestone Blvd with townhome construction
DSCN3255	Dumpster used by Ryan Homes to collect construction waste – uncovered with hole in the bottom
DSCN3257	Catch basin with sediment accumulation in need of maintenance – Limestone Blvd
DSCN3258	Catch basin with sediment accumulation in need of maintenance – Limestone Blvd
DSCN3259	Dumpster used by Ryan Homes to collect construction waste - uncovered
DSCN3260	Uncovered dumpster along Limestone Blvd
DSCN3261	Dumpster along Limestone Blvd with holes in need of repair
DSCN3262	View of central area of Site along Limestone Blvd
DSCN3263	Sediment and stormwater along Limestone Blvd

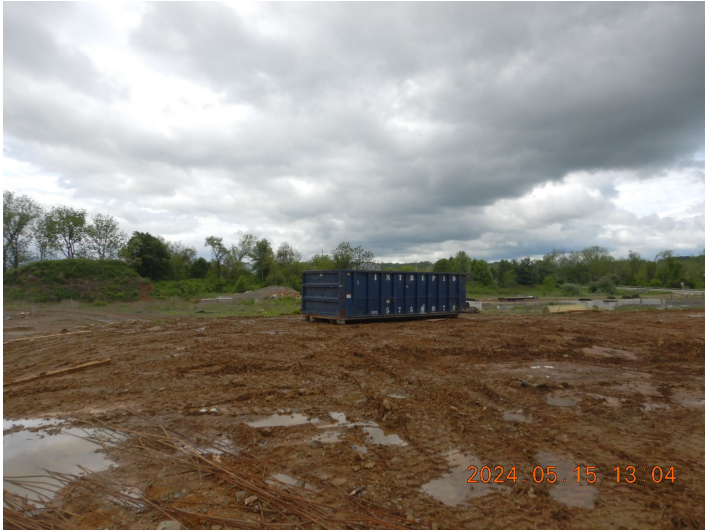
DSCN3255

4. Part I.J.3 of the Permit states that staged waste containers shall be maintained so as to prevent waste materials from overflowing, leaking, or blowing out of the container. Keep waste container lids closed when not in use and close lids at the end of the business day for those containers that are in use throughout the day. For waste containers that do not have lids the permittee shall ensure that the container is covered (e.g., a tarp), when not in use, to prevent contact of waste material with stormwater. EPA representatives observed that on-site dumpsters in need of repair and uncovered (DSCN3255 and DSCN3261).

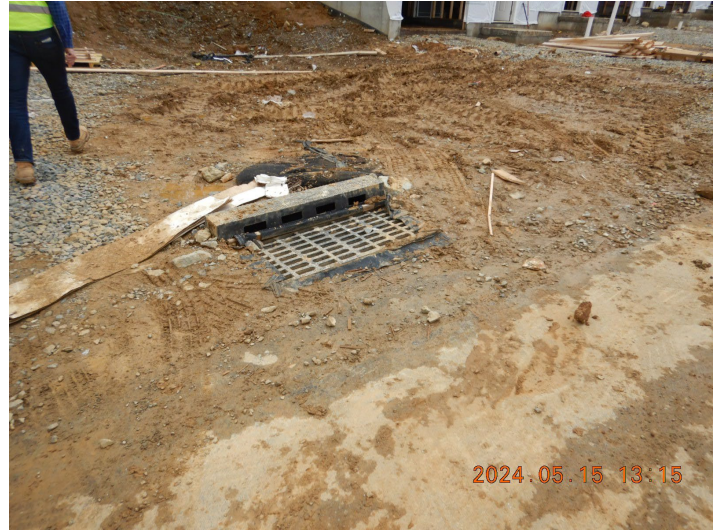
3. Part I.J.3 of the Permit requires the permittee to handle construction site waste that has the potential to be transported by stormwater discharges, including prevention of waste material from contacting stormwater. At the time of the CEI, EPA observed cardboard, debris and litter scattered on the ground throughout Ryan Homes/NVR's portion of the Site (DSCN3265, DSCN3268, DSCN3269, DSCN3270, DSCN3273, DSCN3274, DSCN3275).

DSCN3264	Sediment and stormwater along Limestone Blvd
DSCN3265	Inlet filter along Limestone Blvd in need or maintenance; construction and sediment debris around catch basin
DSCN3266	Inlet filter along Limestone Blvd in need or maintenance; construction and sediment debris around catch basin
DSCN3268	Inlet filter along Limestone Blvd in need or maintenance; construction and sediment debris around catch basin
DSCN3269	Inlet filter along Limestone Blvd in need or maintenance; construction and sediment debris around catch basin
DSCN3270	Inlet filter along Limestone Blvd in need or maintenance; construction and sediment debris around catch basin
DSCN3271	Construction materials along Limestone Blvd
DSCN3272	Construction materials along Limestone Blvd
DSCN3273	Inlet filter along Limestone Blvd in need or maintenance; construction and sediment debris around catch basin
DSCN3274	Inlet filter along Limestone Blvd in need or maintenance; construction and sediment debris around catch basin

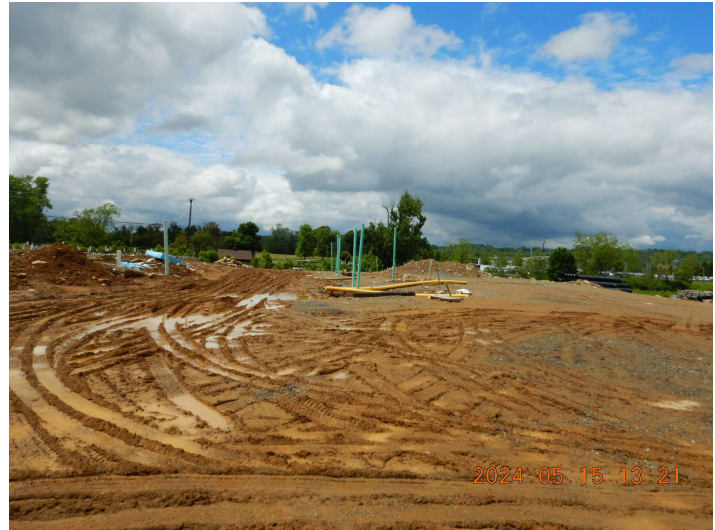
DSCN3284	Stormwater and disturbed soil south of Limestone Blvd facing west towards Route 31; foundation of Asbury Farms apartment building
DSCN3285	Stormwater and disturbed soil south of Limestone Blvd facing west towards Route 31; foundation of Asbury Farms apartment building
DSCN3286	Construction material and debris along south east portion of the Site

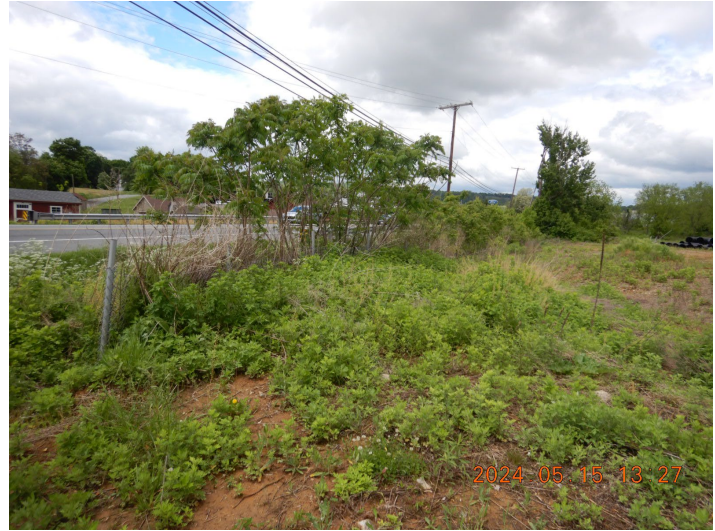
DSCN3287	Construction material and debris along south east portion of the Site
DSCN3288	Asbury Farms apartment building foundation in southern section of the Site
DSCN3289	View along the construction road running north to south to Limestone Blvd; facing northeast
DSCN3290	View along the construction road running north to south to Limestone Blvd; facing southwest to Rymon Rd entrance
DSCN3291	Sediment and dust seen on Rymon Rd entrance
DSCN3292	Sediment and dust seen on Rymon Rd entrance; track-out controls in need of maintenance
DSCN3293	Construction entrance/exit on Rymon Rd
DSCN3294	Construction entrance/exit on Rymon Rd
DSCN3296	Silt fencing in need of repair on southern edge of Site
DSCN3297	Silt fencing in need of repair on southern edge of Site
DSCN3298	Silt fencing in need of repair on southern edge of Site along Route 31
DSCN3299	Silt fencing in need of repair on southern edge of Site along Route 31

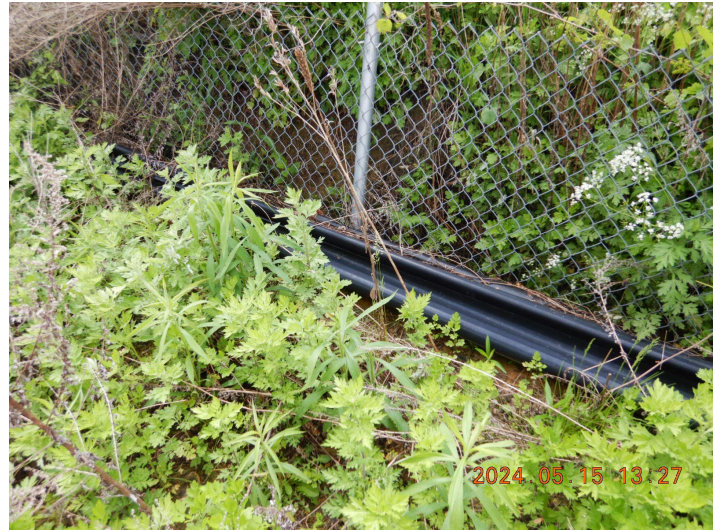
DSCN3301	Silt fencing in need of repair on southern edge of Site along Route 31
DSCN3302	Silt fencing in need of repair on southern edge of Site along Route 31
DSCN3303	Silt fencing in need of repair on southern edge of Site along Route 31
DSCN3304	Silt fencing in need of repair on southern edge of Site along Route 31
DSCN3305	Silt fencing in need of repair on southern edge of Site along Route 31
DSCN3306	Slope where stormwater runs towards Route 31; silt fencing in need of repair
DSCN3307	Slope where stormwater runs towards Route 31; silt fencing in need of repair
DSCN3308	Silt fencing in need of repair along Route 31
DSCN3309	Silt fencing in need of repair along Route 31
DSCN3310	Silt fencing in need of repair along Route 31; stormwater and sediment pooling in down silt fencing
DSCN3311	Silt fencing in need of repair along Route 31; stormwater and sediment

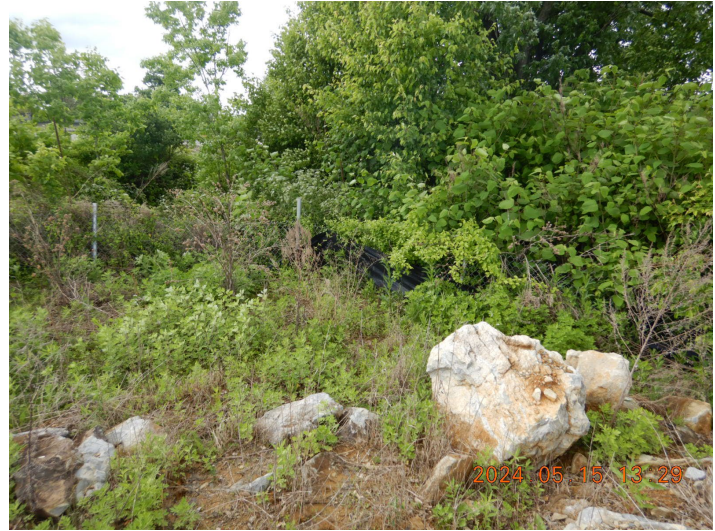
pooling in down silt fencing
DSCN3312	Down silt fence along southern area of Site
DSCN3313	Down silt fence along southern area of Site
DSCN3314	Construction material in central area of Site
DSCN3316	Construction material in central area of Site
DSCN3317	Harrington shipping container and materials
DSCN3318	Harrington shipping container and materials
DSCN3319	Harrington shipping container and materials
DSCN3321	Harrington shipping container
DSCN3322	Floodway on the north side of Clubhouse Dr
DSCN3323	Floodway on the north side of Clubhouse Dr
DSCN3324	Floodway on the north side of Clubhouse Dr
DSCN3325	Floodway on the north side of Clubhouse Dr
DSCN3326	Floodway on the north side of Clubhouse Dr
DSCN3327	Stormwater outlet running under Clubhouse Dr and into floodway to the north
DSCN3329	Stormwater outlet running under Clubhouse Dr and into floodway to the north
DSCN3330	Stormwater outlet running under Clubhouse Dr and into floodway to the north
