**CWA COMPLIANCE EVALUATION INSPECTION REPORT  
U.S. ENVIRONMENTAL PROTECTION AGENCY, REGION 5**

**Facility:** Quality Metal Finishing Company  
421 N. Walnut Street  
Byron, IL 61010

**NPDES Permit Number:** IL0003581

**Date of Inspection:** August 27-28, 2024

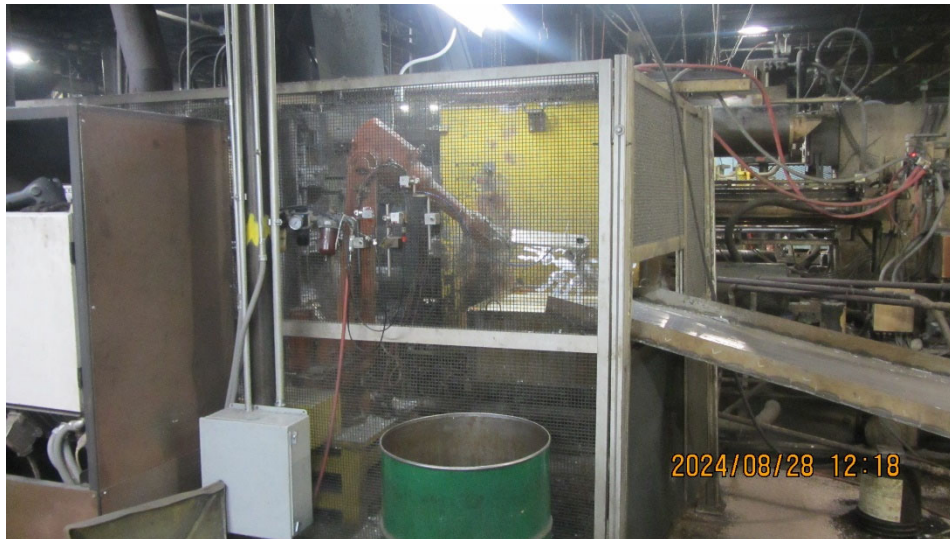
1: IMG\_1145

At approximately 12:10 pm, Mr. Middleton, Mr. Berger, Mr. Wohrley, and Mr. Reed began a walk-through of the facility, starting with facility's WWTP. While walking to the facility, the EPA and QMF representatives observed a quench bath used in the zinc dye casting process (Photograph 1 in Attachment A).

Description: Quench Bath

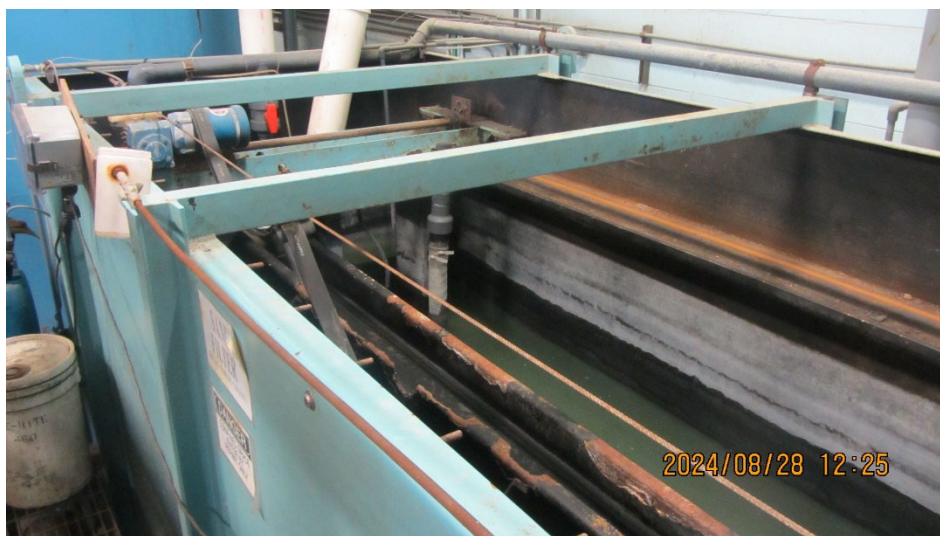
3: IMG\_1147

At the WWTP, the EPA inspectors first observed the sand filter treatment unit (Photograph 3 in Attachment A). Mr. Reed explained that influent to the sand filter would fill up an initial tank and then spill over into the filter. The EPA observed the sampling point used to take NPDES Permit compliance samples for Outfall 001 (Photograph 2 in Attachment A). The EPA noticed at the sand filter a pH readout which showed that the pH at the sand filter was 5.08 (which is outside the range for the NPDES Permit effluent limits for pH). The EPA asked Mr. Reed about the low pH reading, but Mr. Reed was unsure why the pH was at that level. The EPA then viewed the Outfall 001 composite sampler (Photographs 4 and 5 in Attachment A).

Description: Sand Filter

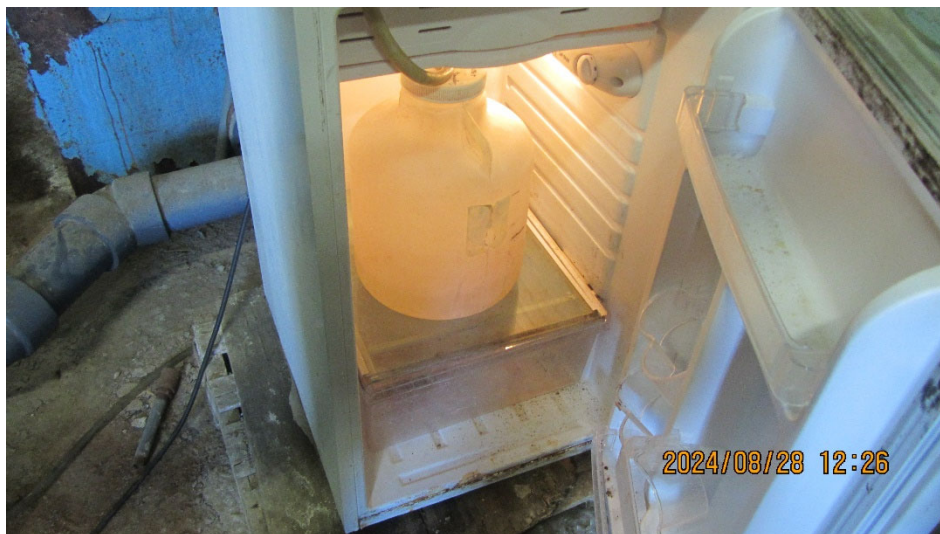
5: IMG\_1149

11. Refrigerator Thermometer: During the EPA's inspection, the EPA observed in both the Outfall 001 composite sample refrigerator sample collection area and in the sample storage refrigerator in QMF's laboratory that QMF did not have a calibrated thermometer within either unit. Without a calibrated thermometer, QMF would not be able to confirm that the temperature of the refrigerator was below 6 degrees Celsius throughout the sample storage process before analysis, as required by 40 C.F.R. Part 136 for some of the pollutant parameters.

Description: Outfall 001 Composite Sampler Refrigerator

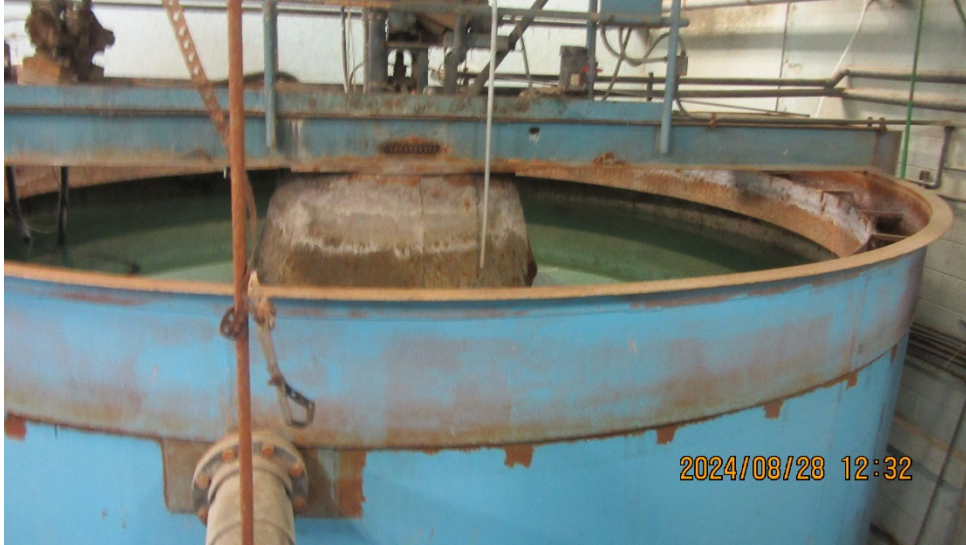
7: IMG\_1151

The wastewater is then pumped to the first floor of the facility to a 22,000-gallon clarifier. The clarifier sludge collecting arm on the bottom of the tank is broken and 2-3 years ago the facility replaced this clarifier with a smaller plate clarifier. This 22,000-gallon tank is now used as an equalization tank for the WWTP. Wastewater in the old clarifier/equalization tank is pumped to a mixing tank where the facility adds a polymer (GWT-4220) to assist in flocculation in the plate clarifier.

Next, the EPA and QMF representatives walked over to the plate clarifier. Photograph 7 in Attachment A shows the old clarifier tank. As indicated previously in this report, QMF uses the old clarifier tank as equalization storage within the WWTP. The EPA then viewed the plate clarifier (Photograph 8 in Attachment A). Mr. Reed told the EPA that the clarifier is drained and cleaned once a week. Mr. Reed also informed the EPA that the sludge accumulated in the clarifier is pumped manually to the sludge press as needed. The EPA also observed the clarifier pre-mixing tank where QMF adds a polymer to assist with settling in the plate clarifier (Photograph 9 in Attachment A).

Description: Old Clarifier/Storage Tank

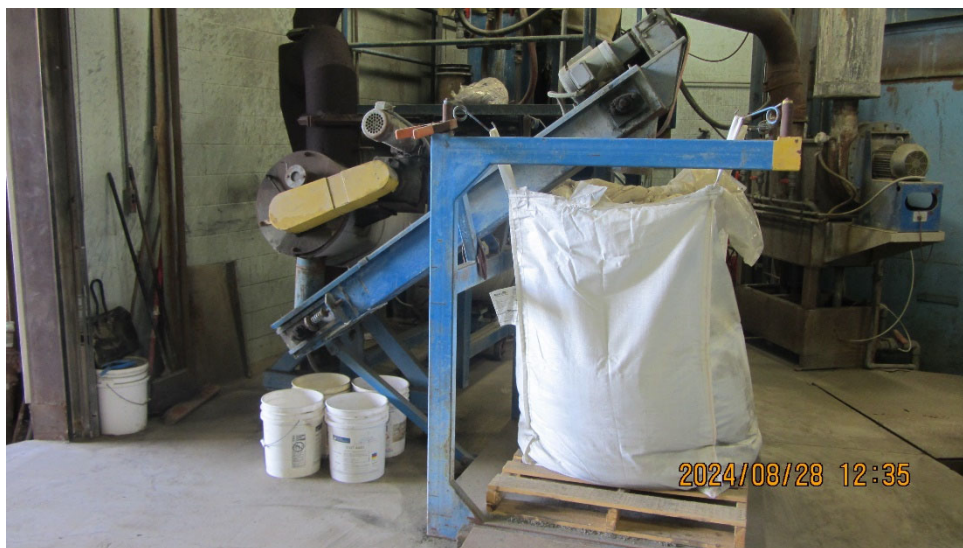
10: IMG\_1154

The EPA and QMF representatives then viewed the sludge press and the sludge dryer. Near the sludge press, the EPA observed the process sludge bags that contain the processed sludge ready for disposal (Photograph 10 in Attachment A). Mr. Reed estimated that 1 to 1.5 bags of processed sludge are filled each month. The EPA then walked over to the Outfall 001 flow meter readout panel (Photograph 11 in Attachment A) and observed that the flow through Outfall 001 was approximately 4.6 gallons per minute at this time. While walking out of the facility's WWTP, the EPA observed the polymer pumping equipment used to add the polymer to the clarifier mixing tank (Photograph 12 in Attachment A).

Description: Processed Sludge Container Bag

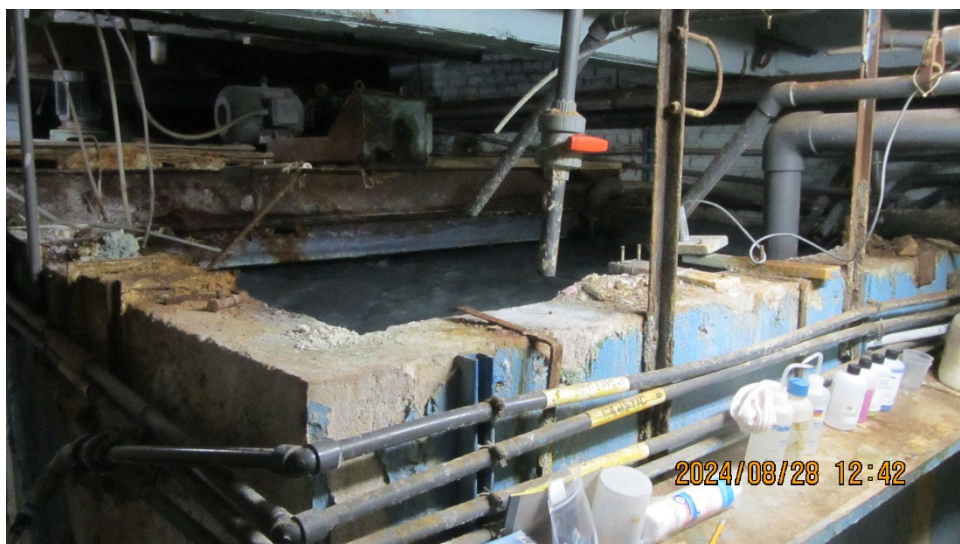
13: IMG\_1157

The EPA and QMF representatives next walked through the facility to the basement to look at the neutralization tank. The EPA observed that the neutralization tank is a rectangular concrete tank (Photograph 13 in Attachment A). Near the neutralization tank, the EPA observed the chrome reduction tank treatment unit (Photograph 14 in Attachment A). In this area were the pH

Description: Neutralization Tank

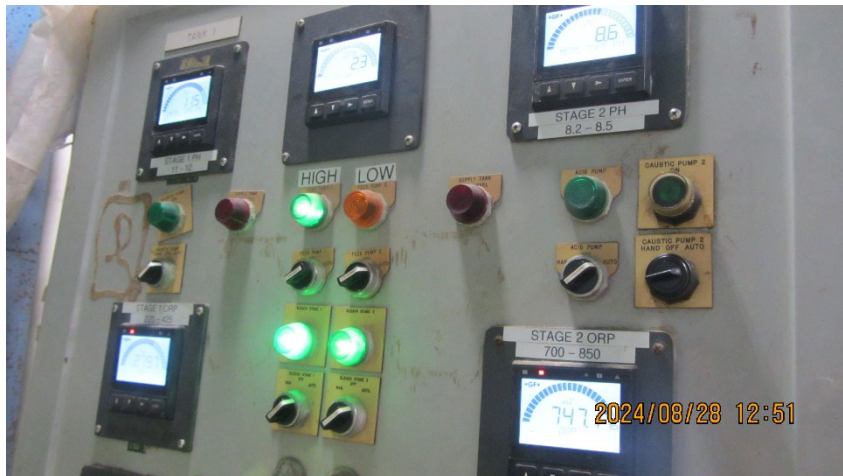
19: IMG\_1163

6. Cyanide Destruction Treatment: According to the Industrial Wastewater Management, Treatment and Disposal, Water Environment Federation (Manual of Practice No. FD-3), the second stage of typical cyanide destruction treatment should have a pH lower than 8.5 and an ORP raised to 790 mV. During the walkthrough of the facility's cyanide destruction treatment, the EPA observed the cyanide destruction treatment's control panel to indicate a pH of 8.6 and an ORP of 747 mV. These values are both outside the

Description: Cyanide Destruction Treatment Control Panel

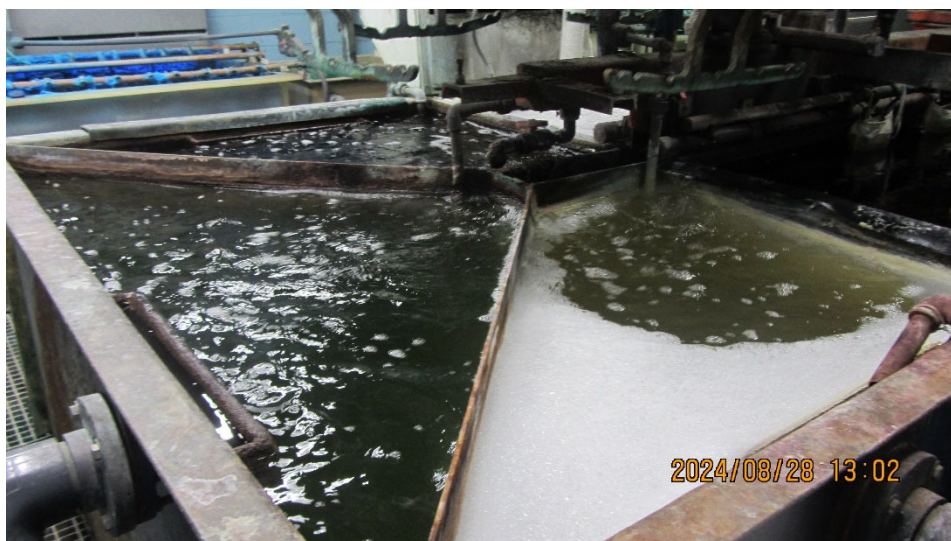
24: IMG\_1168

cause of this was a leaking steam pipe within a heating coil in the copper plating process. This heating coil is used to heat up the copper plating rinse water to an optimal temperature. Mr. Reed told the EPA that what QMF believed happened was a leak formed and, during infrequent water hammer events, the rinse water containing cyanide was able to enter the leak in the heating coil into the boiler feed water loop. From there, the boiler water was able to get into the other wastewater streams through other leaks that did not undergo cyanide destruction treatment, which included the nickel plating process. This would explain the high cyanide concentration within the neutralization tank from the mid-August sampling event.

walk down the line and near the beforementioned curve, the EPA observed the copper plating line and rinses (Photograph 24 and 25 in Attachment A). The EPA then continued walking the other direction on the other side and observed the hexavalent chrome plating line, which was fundamentally similar to the other two automated plating lines.

Description: Copper Plating Rinse

- The EPA learned during the inspection that repairs to the steam pipes have been made where leaks have been identified.

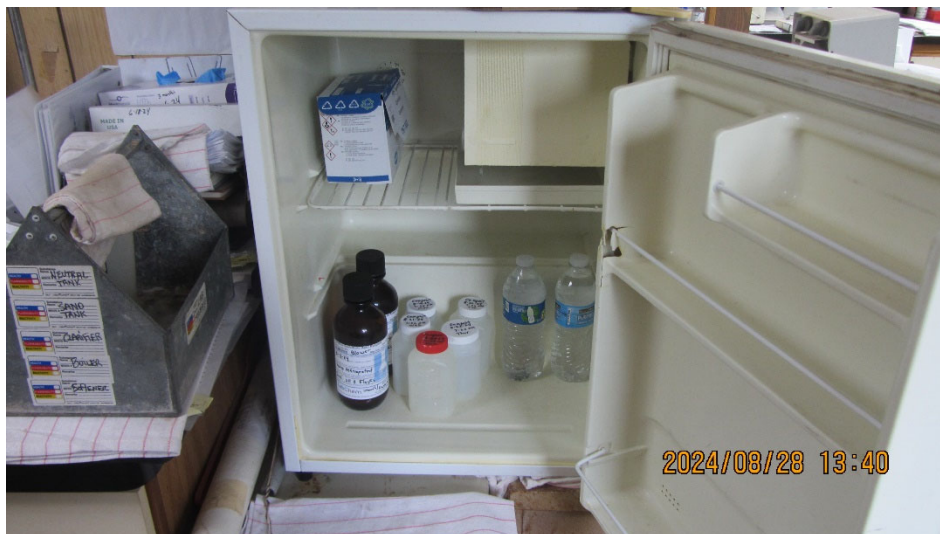
27: IMG\_1171

Description: Sampling Storage Refrigerator
