REPORT OF COMPLIANCE EVALUATION INSPECTION  
(INDUSTRIAL STORMWATER)

**BNSF Railway Company - Hobson Yard**

Authorization Number: **NER910391**

MAY 3, 2023

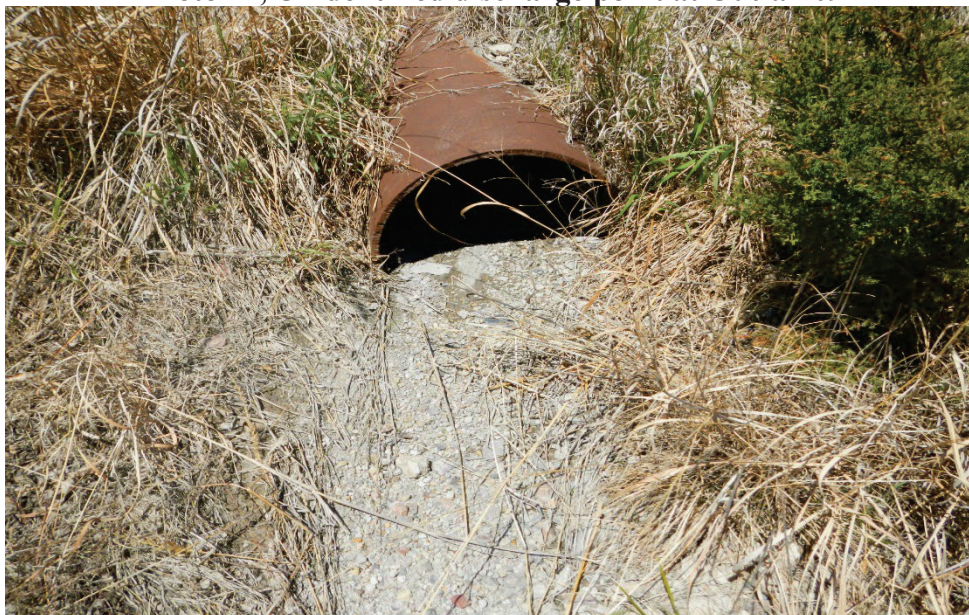
**Photo 22, Unidentified discharge point at Outfall 09**

3. During my visual observation of Outfall 09, I noticed there were two pipes located within a few feet of each other, (PVC and metal) both of which discharge to a low area that ponds and then infiltrates or evaporates. The 4” PVC (photo 21) was clear and evidence of discharge, the 8”-12” metal pipe however had 30% sediment deposit and evidence of discharge as shown in photo 22 below.

I asked Mr. Schroeder and Ms. Tran which pipe the SWPPP identifies as the outfall. Ms. Tran indicated the PVC pipe is the one monitored. As mentioned above, this outfall is located approximately 100 yards west of B-2 West Fueling Platform and is a storm sewer outlet which drains the southern side of the B-1 Fueling Platform. I further asked about the source of discharge via the metal pipe, Mr. Schroeder and Ms. Tran were unable to identify the source of the discharge. Further to the north I observed an inlet metal pipe (photo 24) pointing in the same direction as the outlet pipe of concern. However, we were unable to verify it was the same pipe.

- e. That there was a release sediment and deposition of sand at Outfalls 09, 03, and 09, as I observed during my site observation (photos 22, 34, and 38).

BNSF should investigate the source of discharge through the metal pipe at Outfall 09.

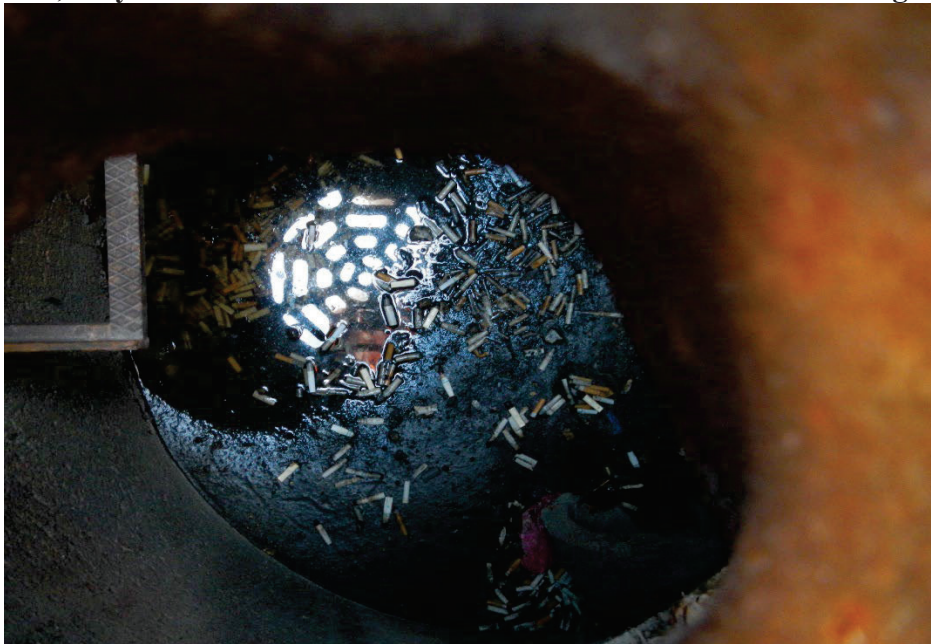
**Photo 3, Oily Substance in the stormwater inlet at the Material Storage area**

4. During the inspection, Outfalls 10, 11, 12, 02, and 04 had standing water at the mouth of the outlet. Outfalls 09, 01, and 03 had significant buildup of sediment and were in need of maintenance.
5. I issued NOPF #1, because I observed an oily substance and sediment in at least three stormwater inlets (photos 1, 3, and 8) and significant ground discoloration (photo 4) at the Material Storage area in the Yard.

- c. The oily substance and sediment in the stormwater inlet and ground discoloration at the material storage area.
  - d. The poor housekeeping practices in the vicinity of Outfall 07 and Outfall 08.
