**Region 6 - Enforcement & Compliance Assurance Division**  
**INSPECTION REPORT**

| Inspection Date(s): | 07/16/2024 | |
| Company Name: | <b>MidAmerica Environmental Holdings, LLC</b> | |
| Facility Name: | <b>USA Disposal – El Dorado</b> | |

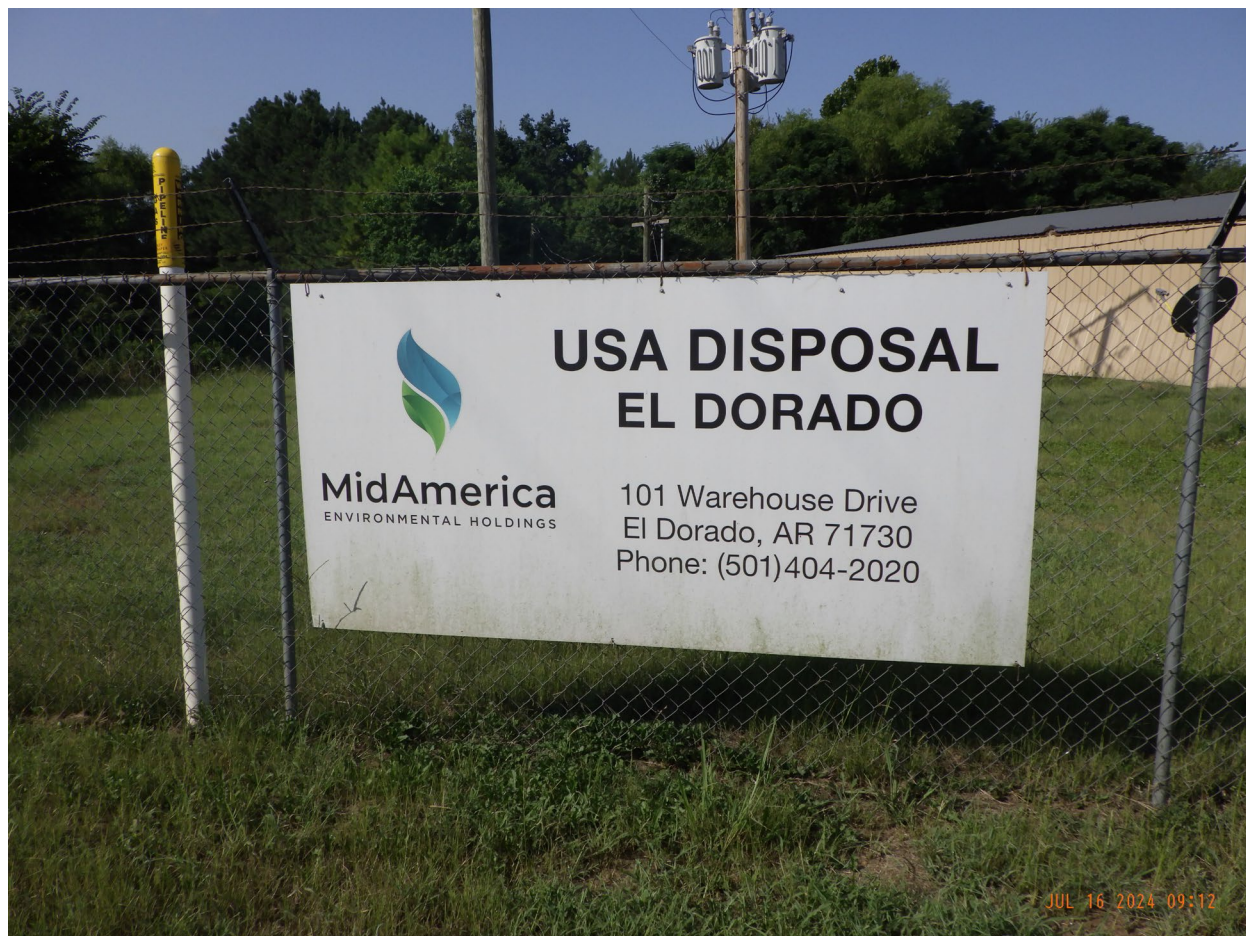
Photo No. 1

**Description:** Looking SSW, signage at the USA Disposal facility.

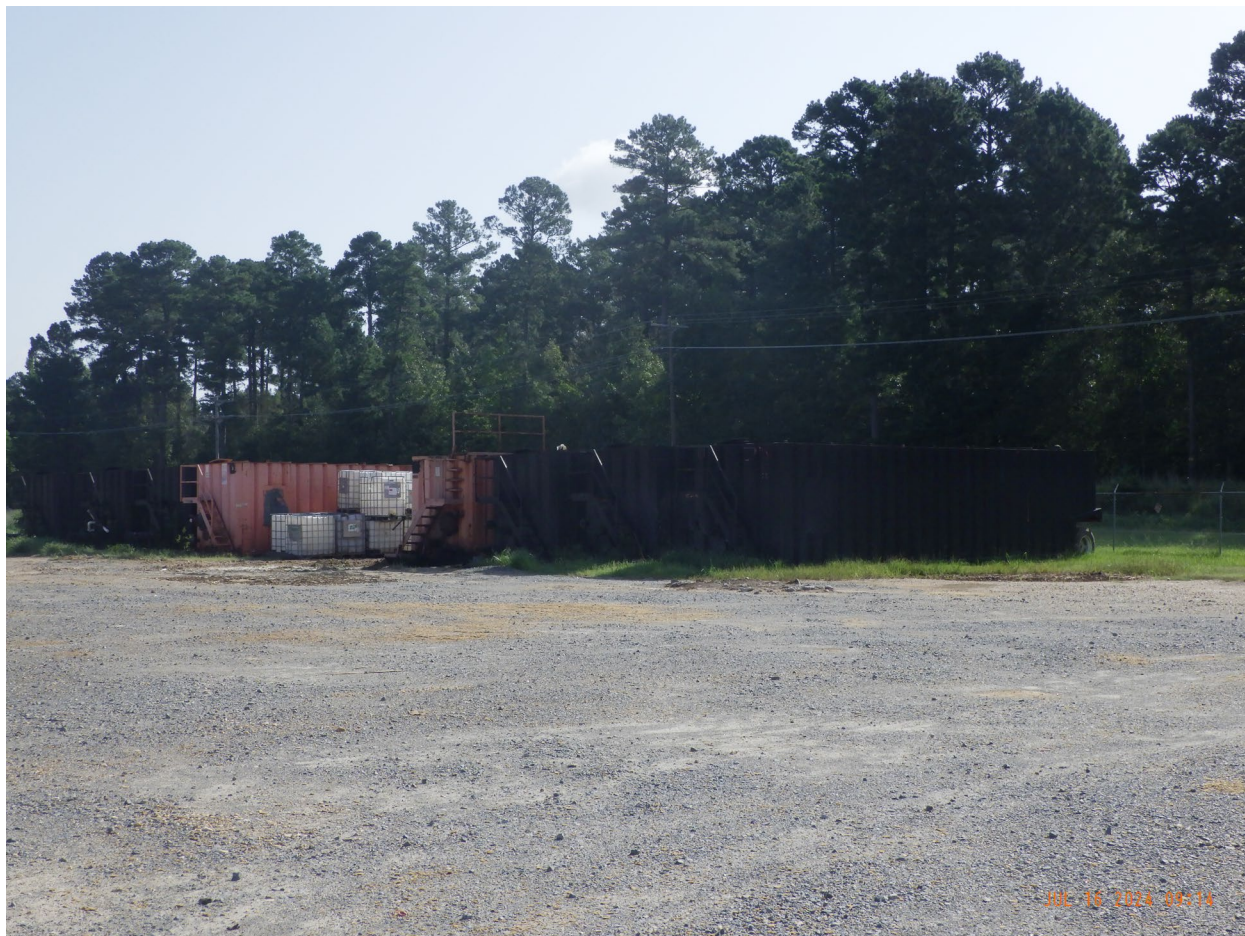
Photo No. 2

**Description:** Looking NE, frac tanks and portable totes stored at the facility.

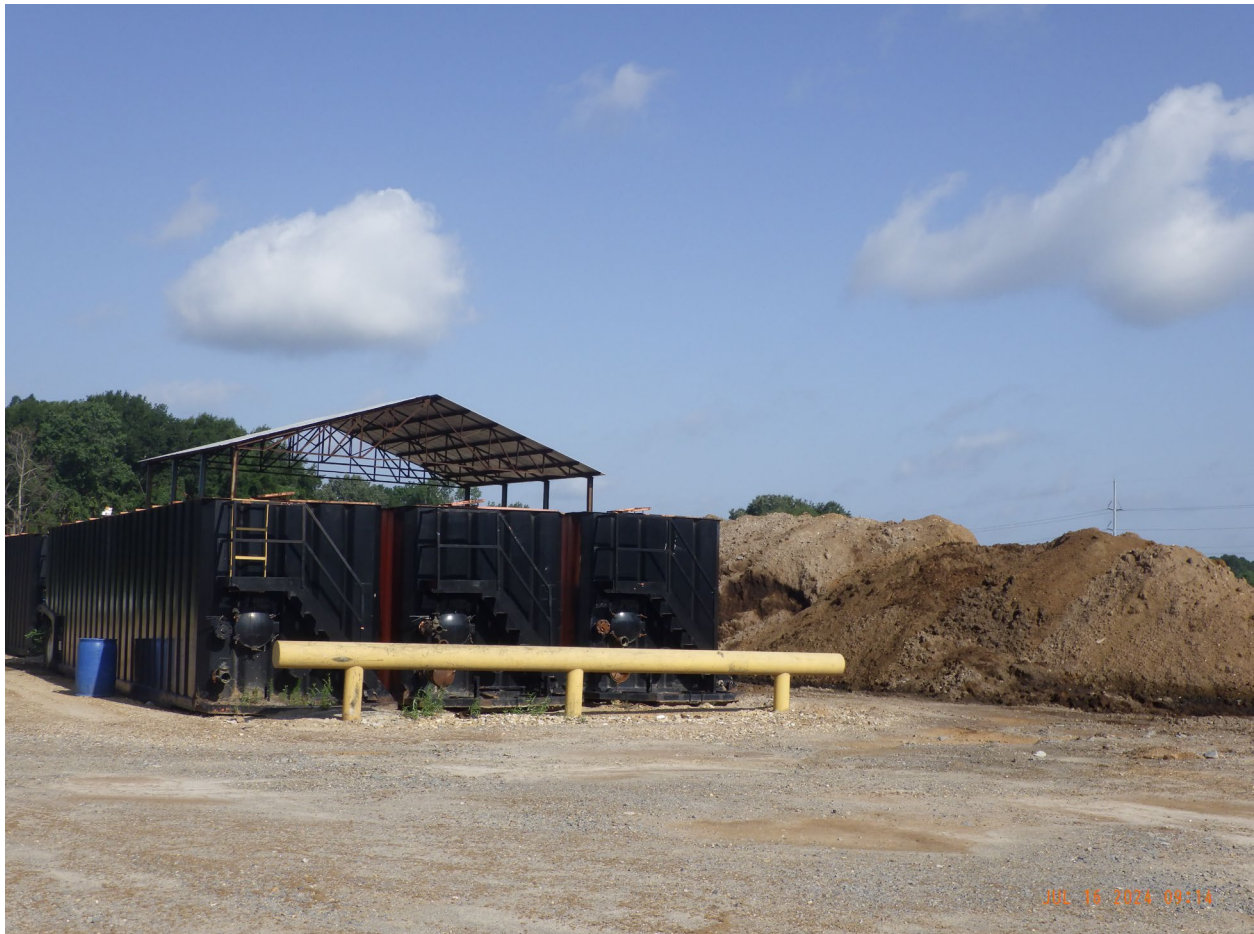
Photo No. 3

**Description:** Looking WNW, additional frac tanks and staged bulked material (liquid wastes mixed with sawdust) at the facility.

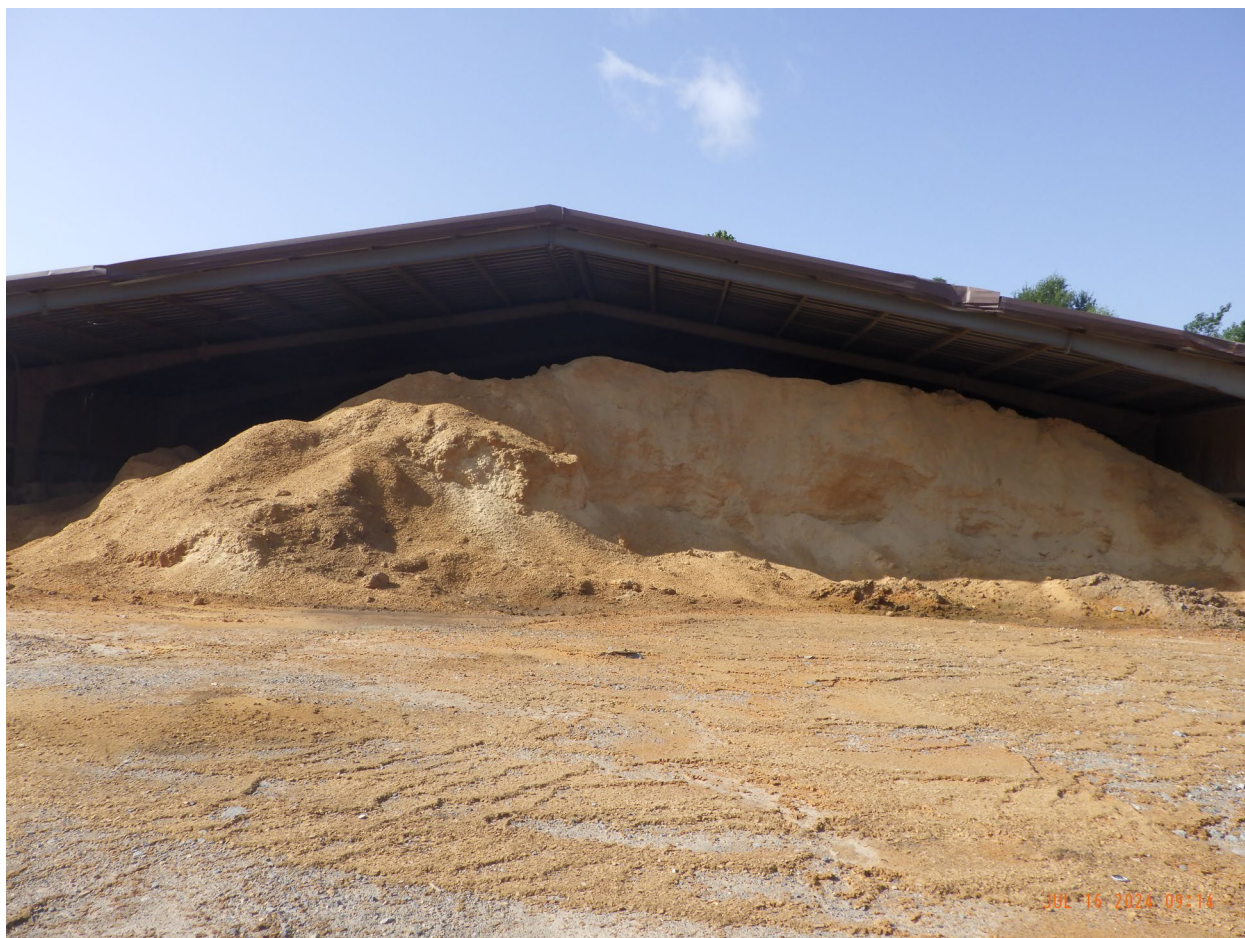
Photo No. 4

**Description:** Looking S, building used for sawdust storage.

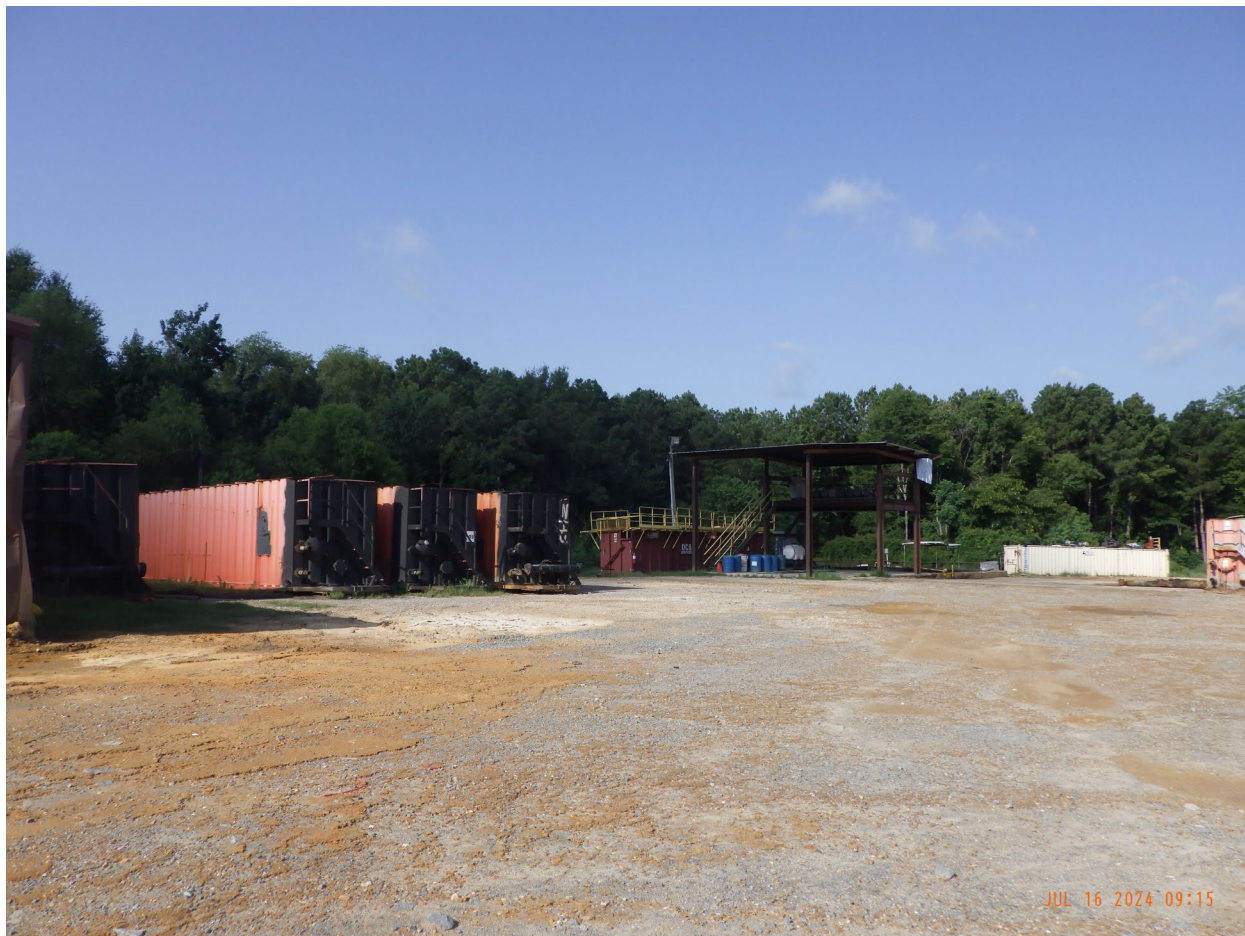
Photo No. 5

**Description:** Looking SW, frac tanks and former wastewater treatment area located at the facility.

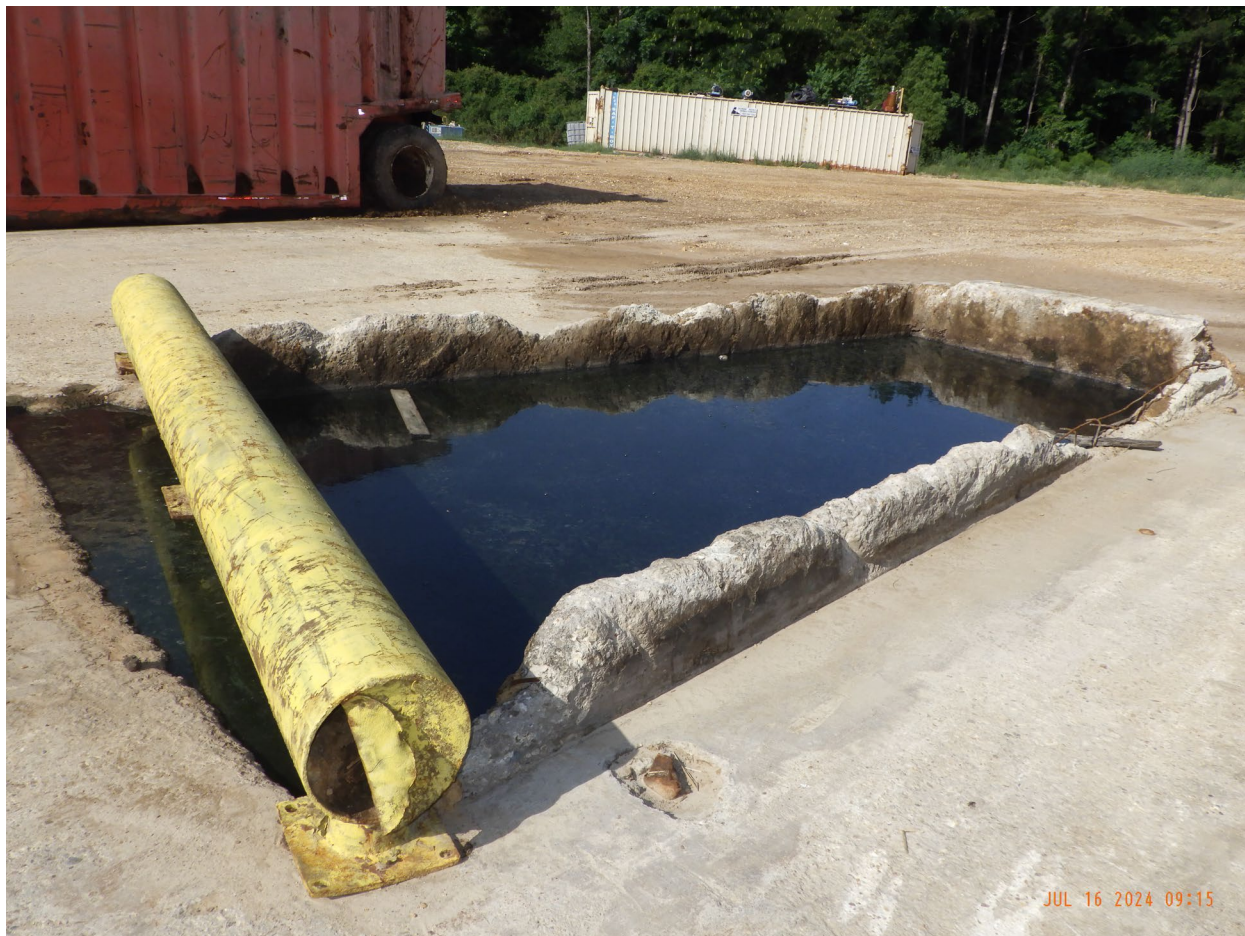
Photo No. 6

**Description:** Looking SSW, one of two concrete pits (South Pit) used to mix liquid wastes and sawdust.

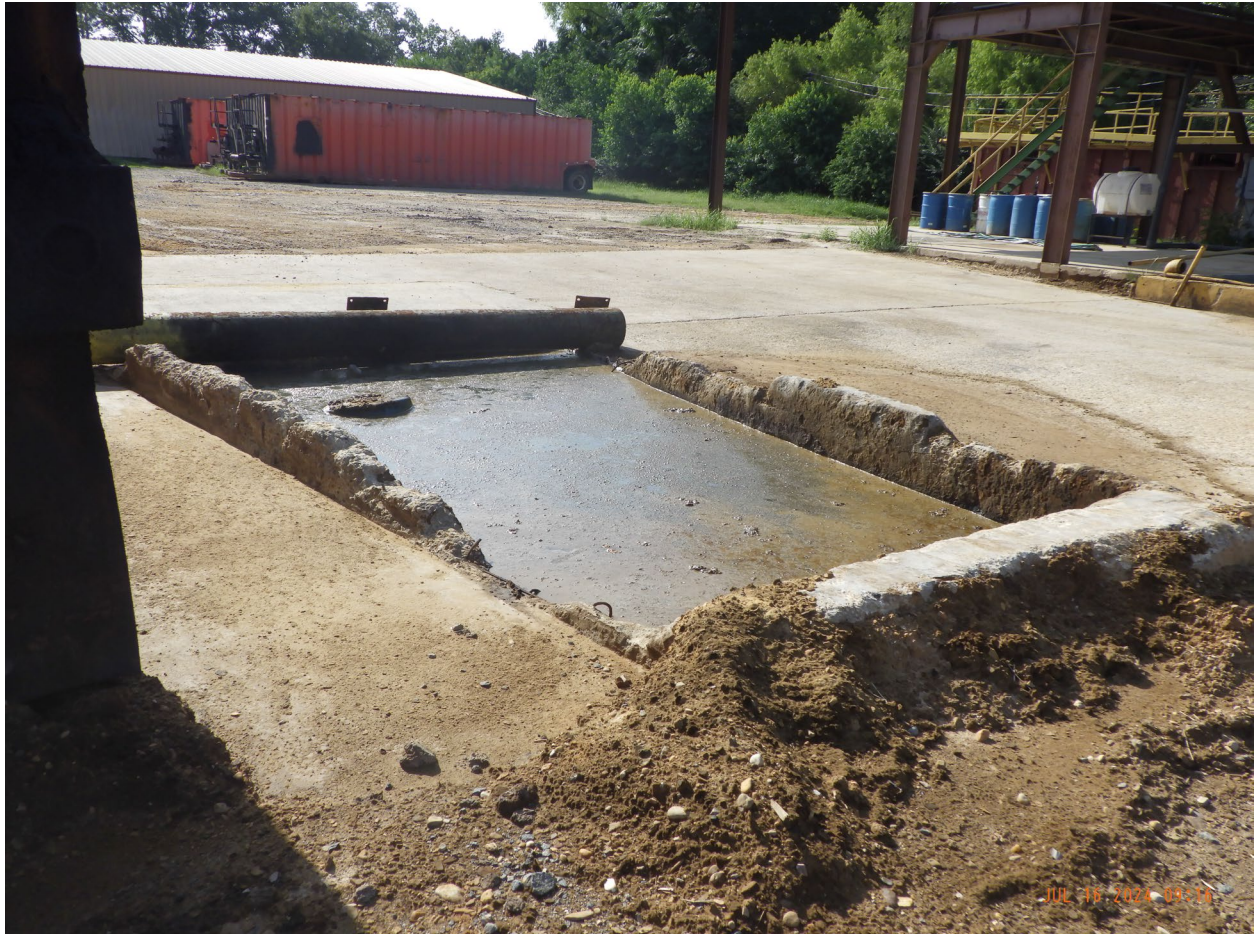
Photo No. 7

**Description:** Looking SE, two of two concrete pits (North Pit) used to mix liquid wastes and sawdust.

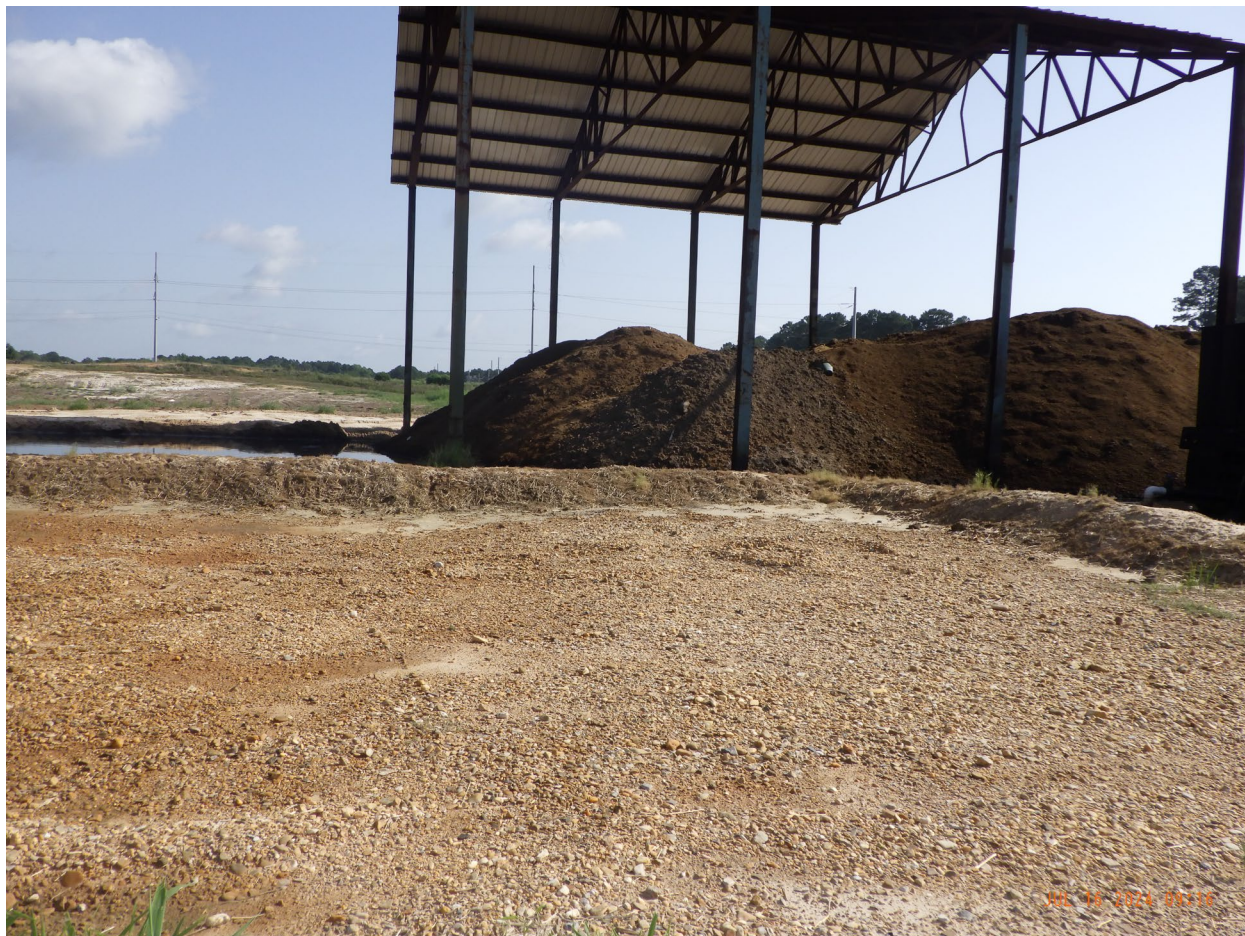
Photo No. 8

**Description:** Looking N, bulked material stored under a covering in front of a concrete pit used to catch any leachate running off the material.

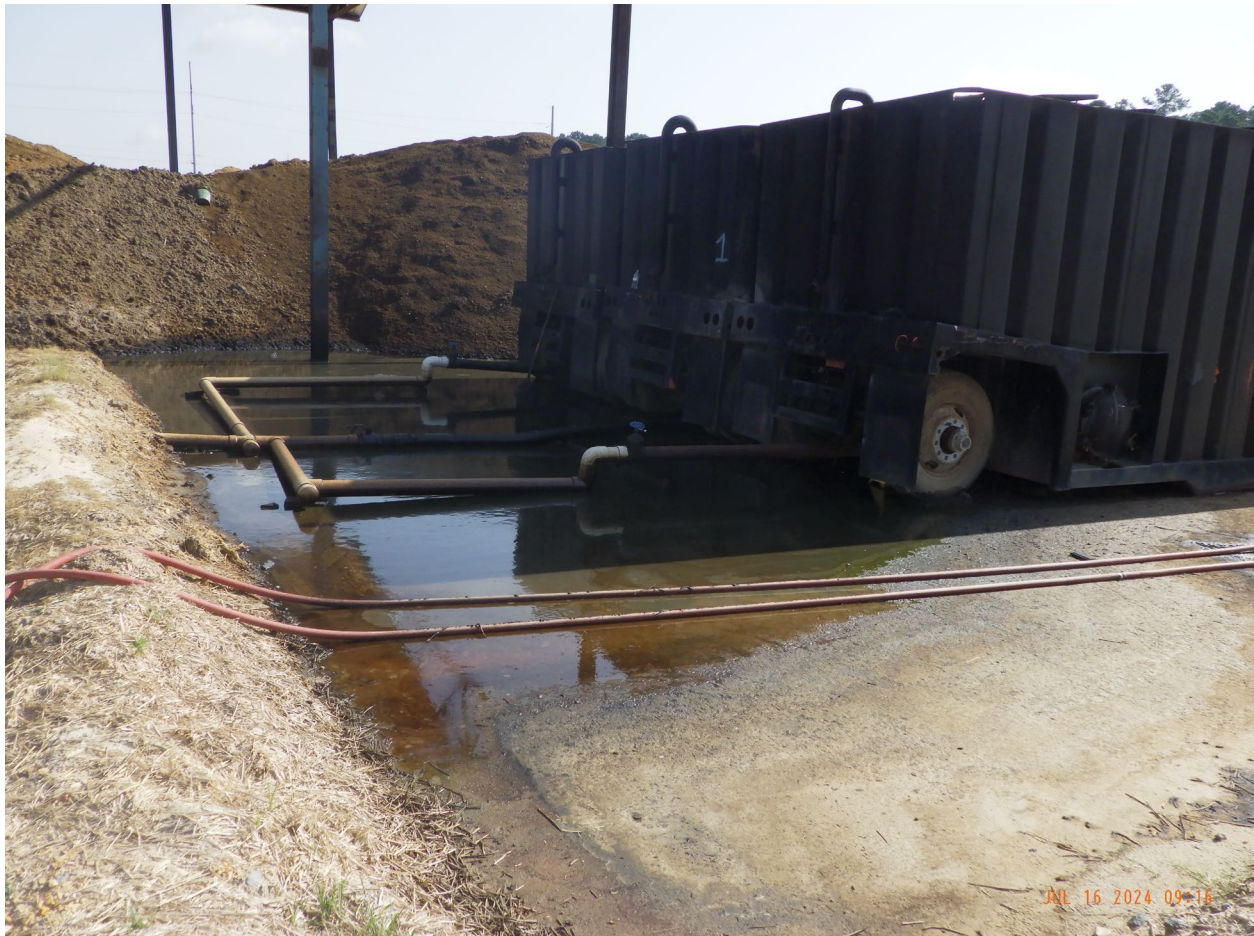
Photo No. 9

**Description:** Looking NNE, berm built up around frac tanks holding unknown liquid wastes.

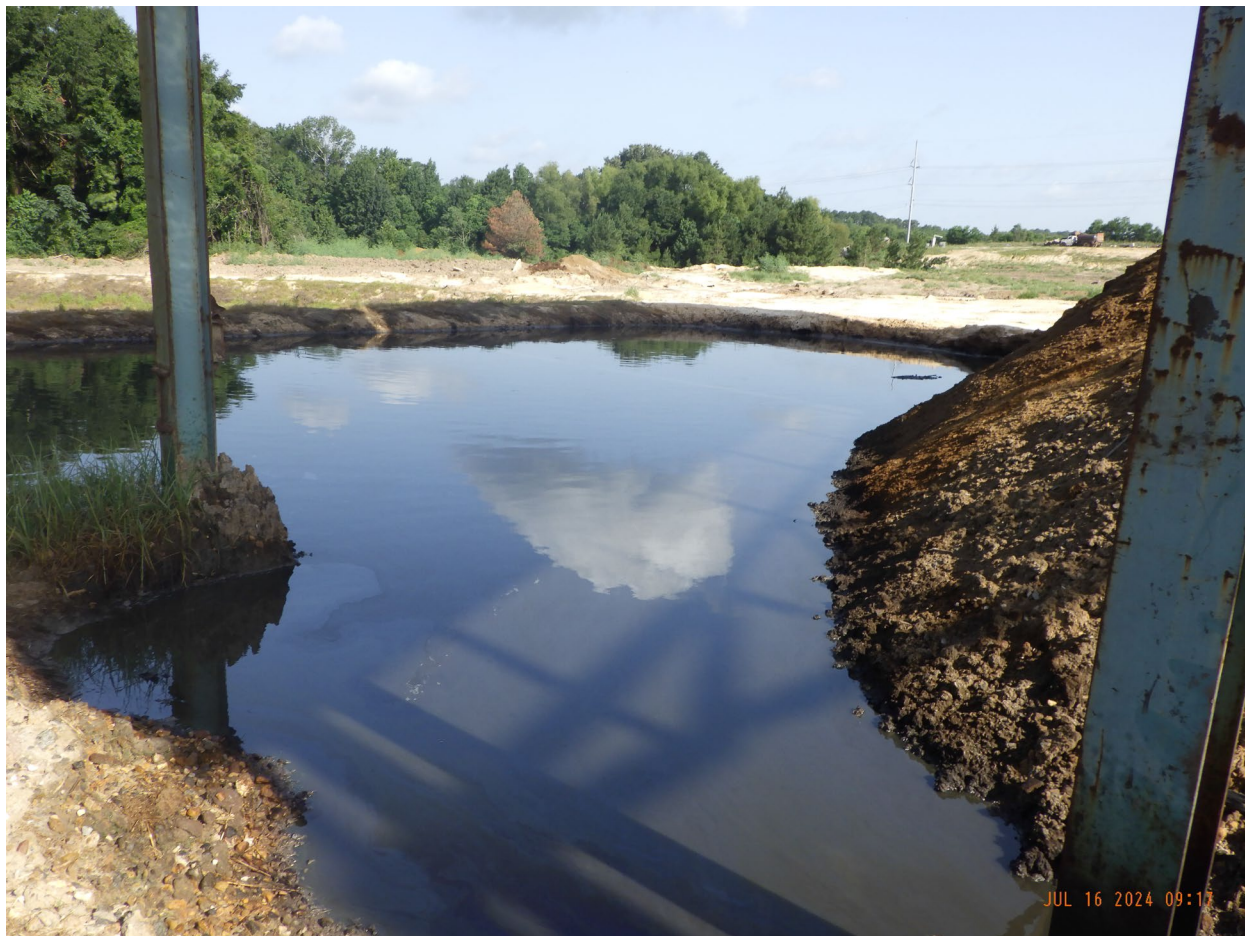
Photo No. 10

**Description:** Looking NW, bulked material under cover in front of the concrete pit used for collecting leachate from the bulked material.

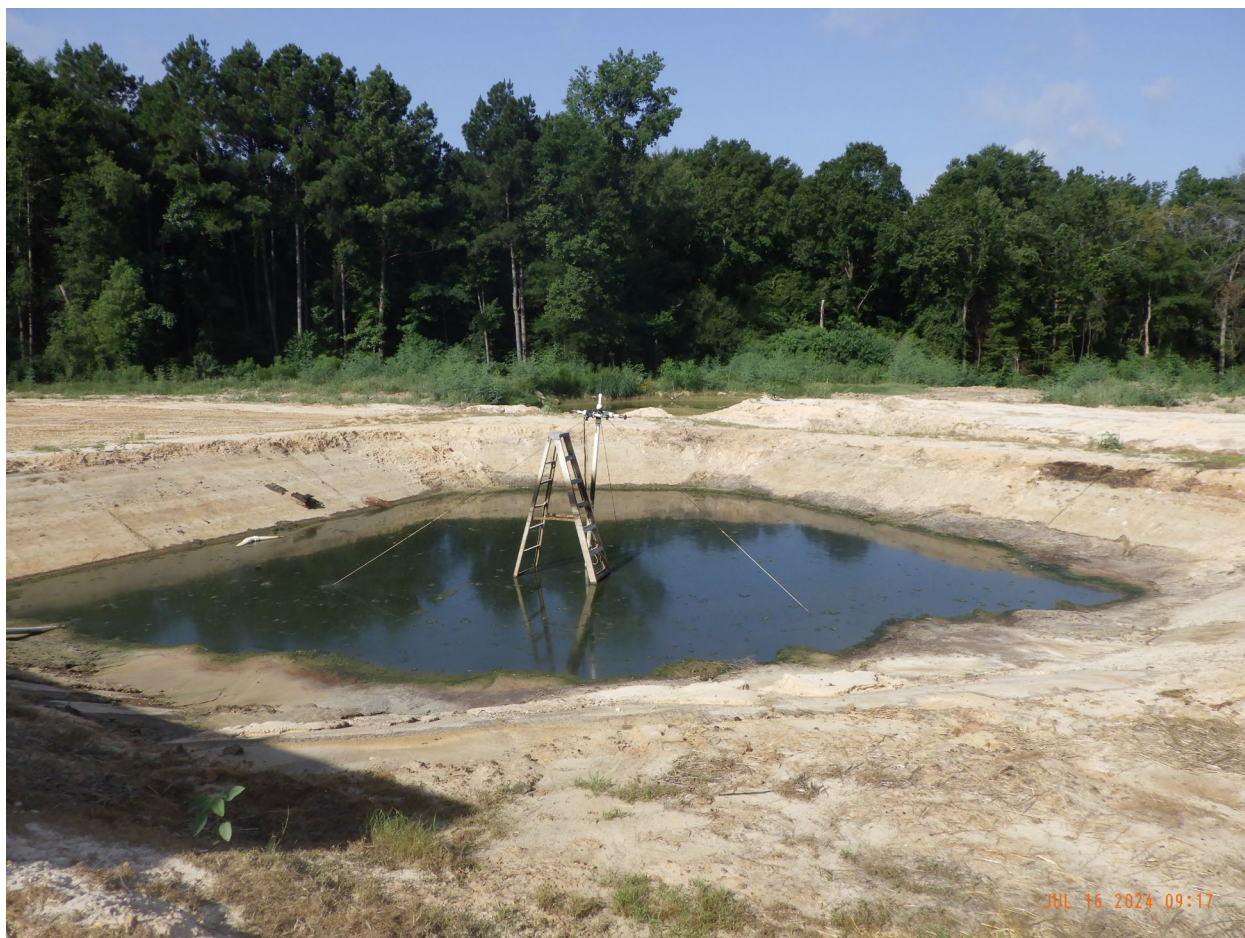
Photo No. 11

**Description:** Looking WSW, the concrete pit below the leachate collection pit. This pit was below the required freeboard level listed in the state-issued permit (5077-WR-7).

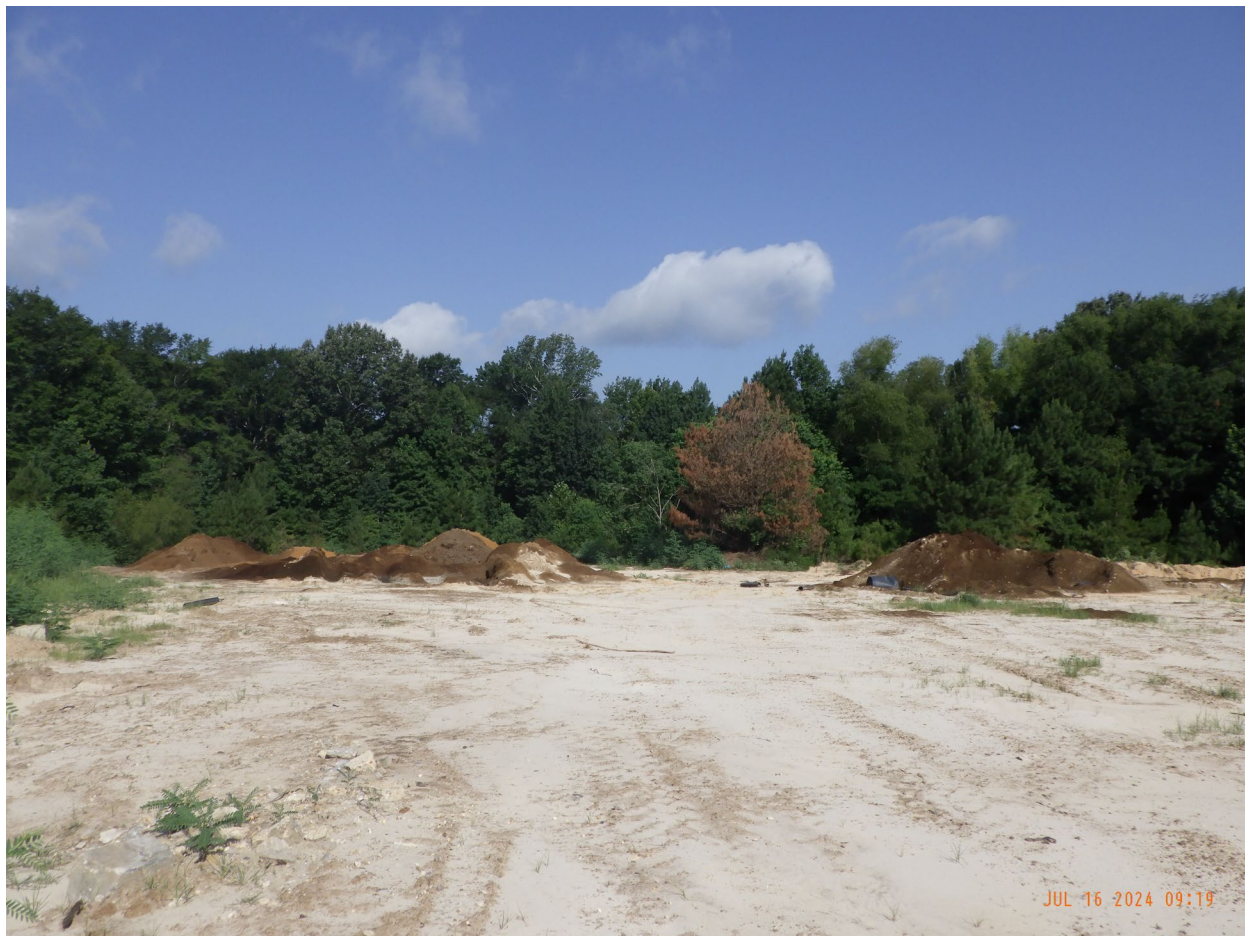
Photo No. 12

**Description:** Looking WSW, bulked material scattered around the facility property and dead trees noted at the property edge.

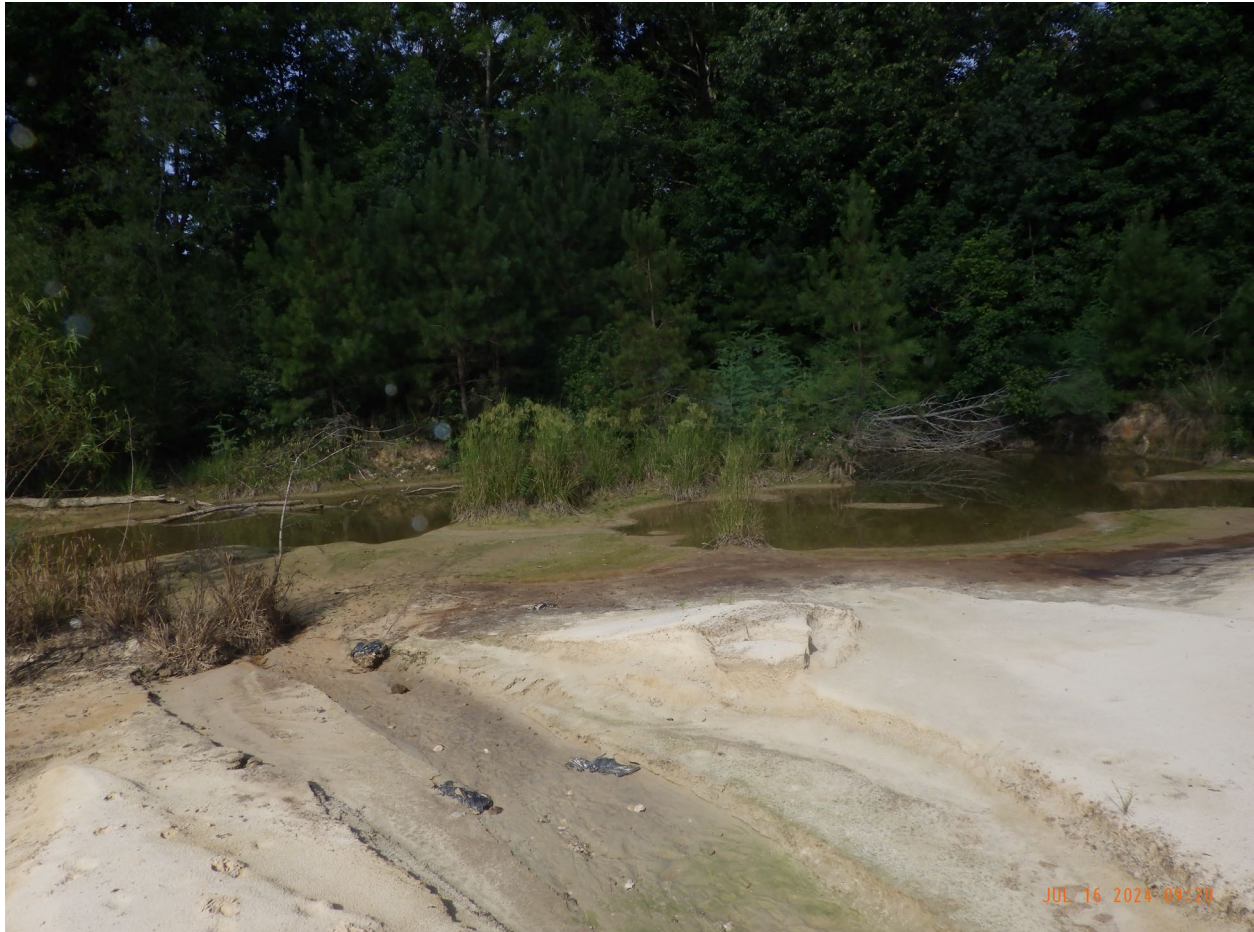
Photo No. 13

**Description:** Looking W, erodible soils from land disturbance activities, leachate staining from bulked material, and dead vegetation all observed within a wetland at the facility.

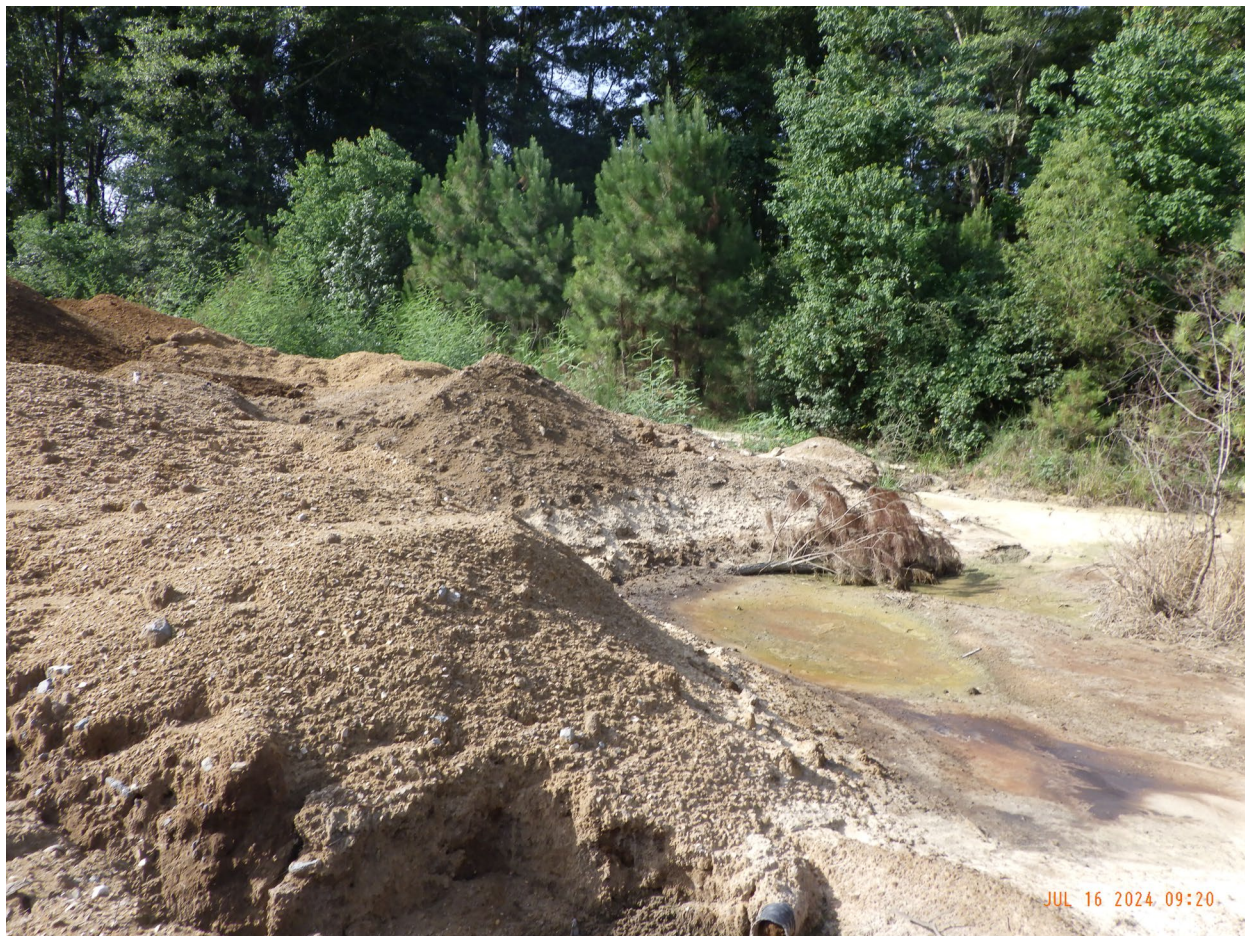
Photo No. 14

**Description:** Looking SSW, bulked material, with leachate staining, stacked adjacent to and placed into the wetland in Photo No. 13.

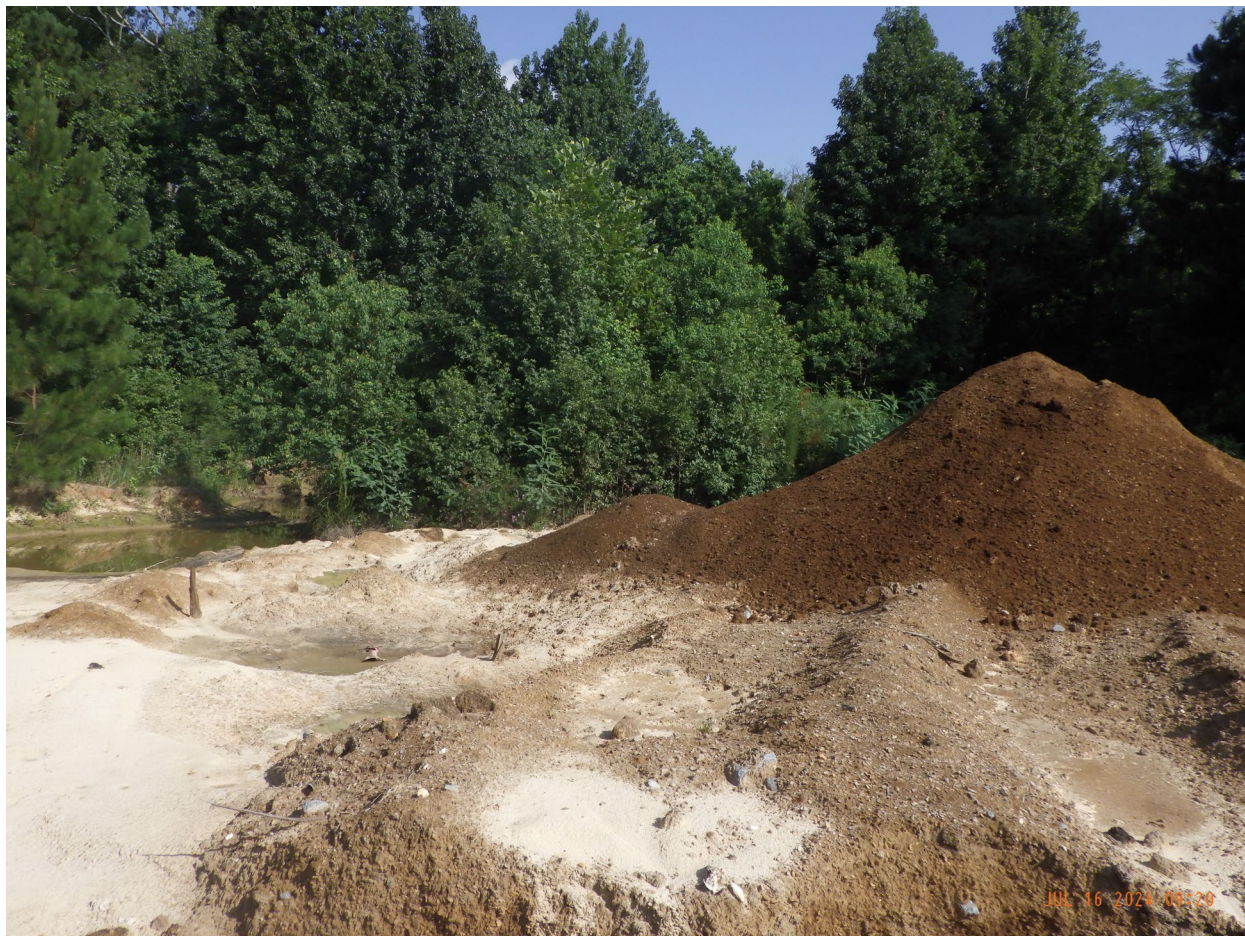
Photo No. 15

**Description:** Looking NW, an additional view of the bulked material stacked adjacent to and placed into the wetland in Photo No. 13.

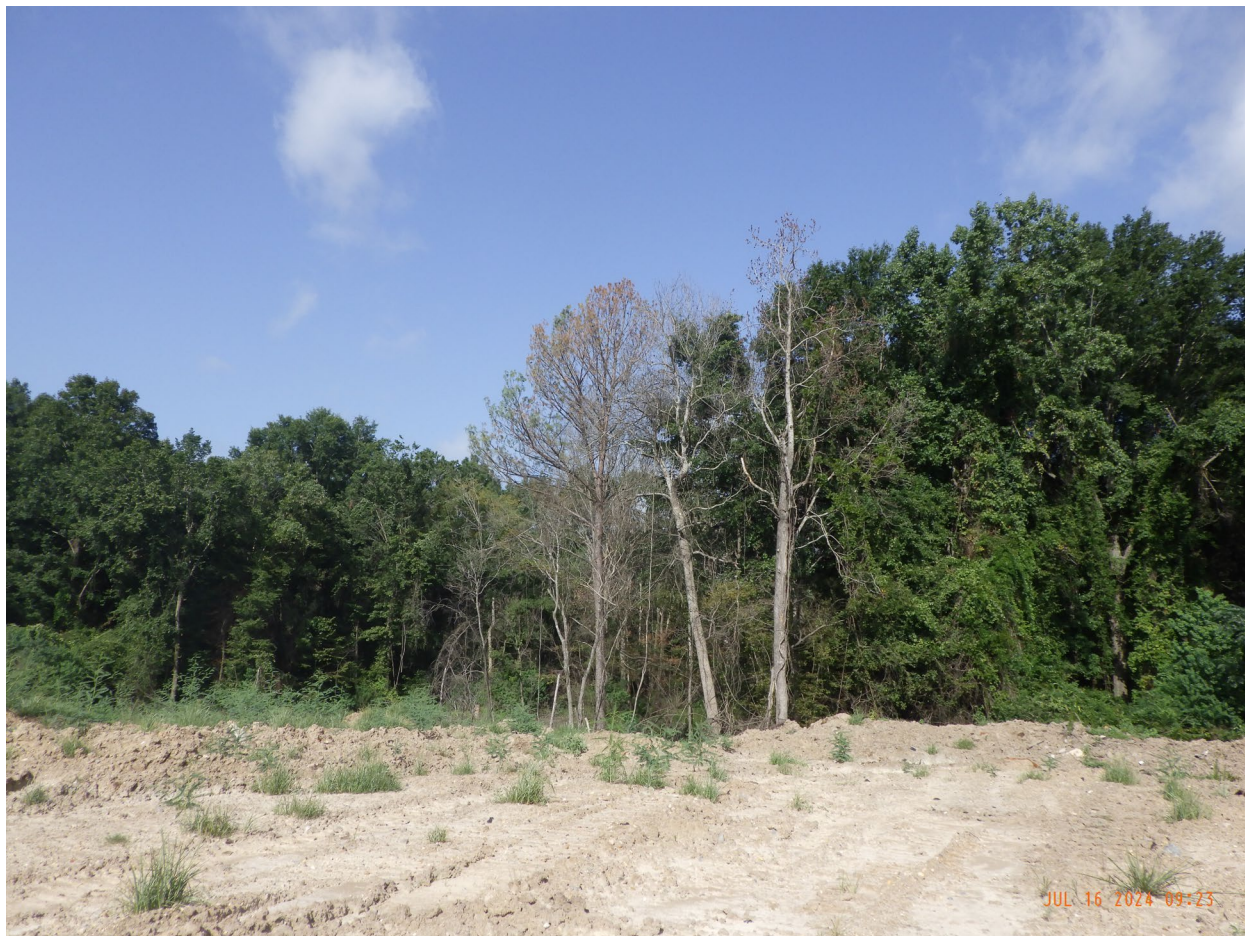
Photo No. 16

**Description:** Looking W, soil disturbance activities and dead vegetation at the perimeter of the property and within an additional wetland onsite.

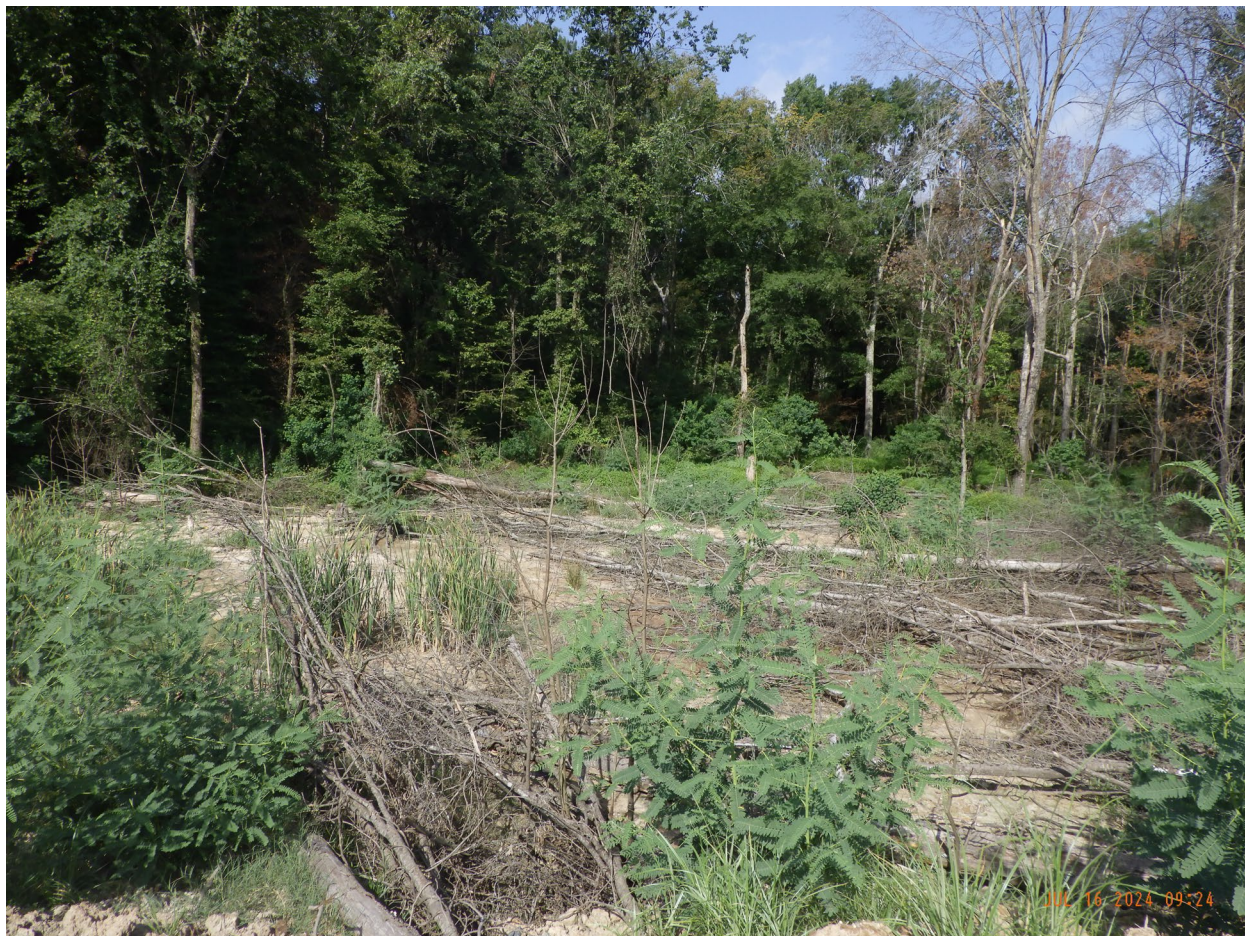
Photo No. 17

**Description:** Looking W, a closer view of the dead vegetation and erodible soils from Photo No. 16.

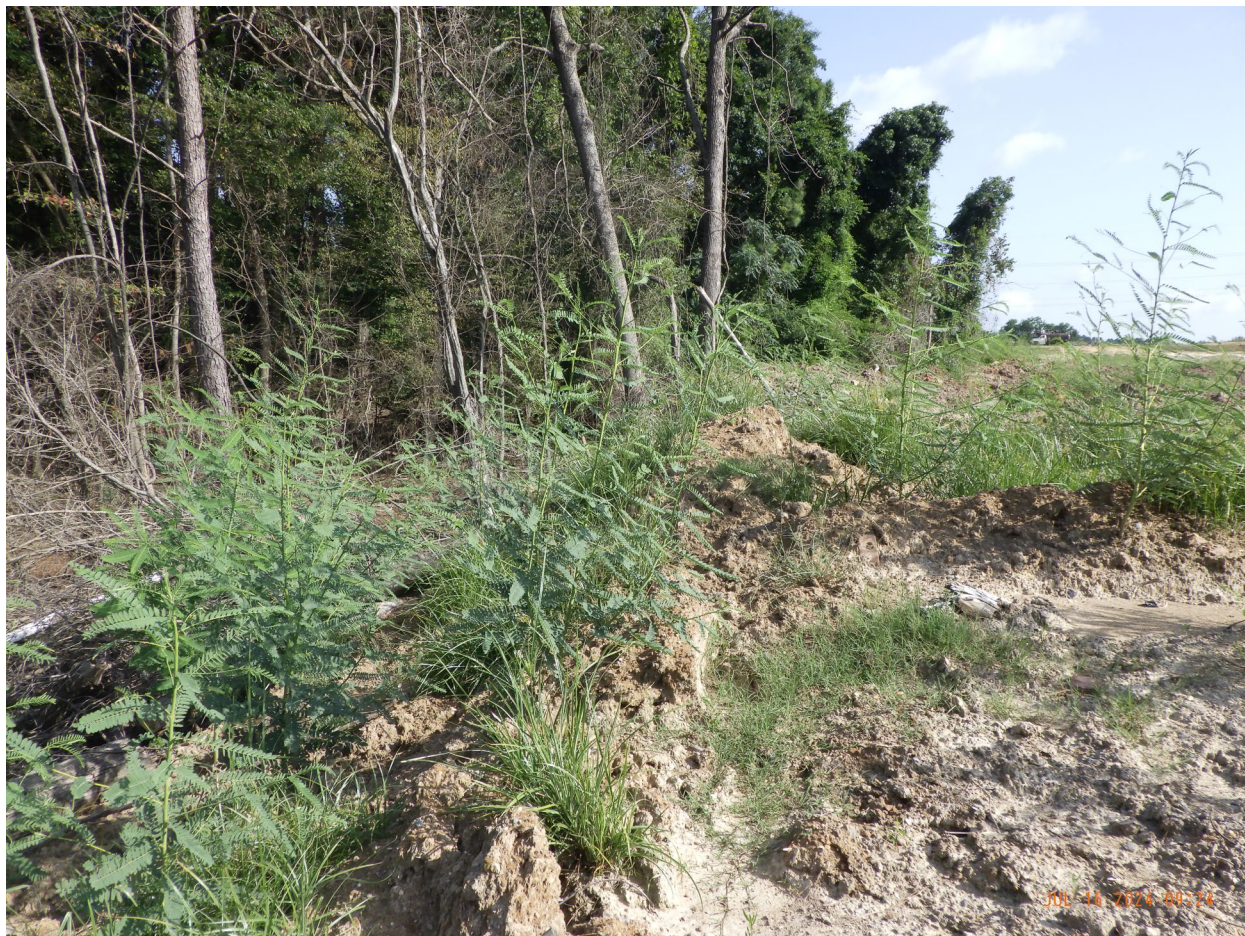
Photo No. 18

**Description:** Looking NW, an additional view of the dead vegetation and disturbed soil near the wetland in Photo No. 16 and No. 17.

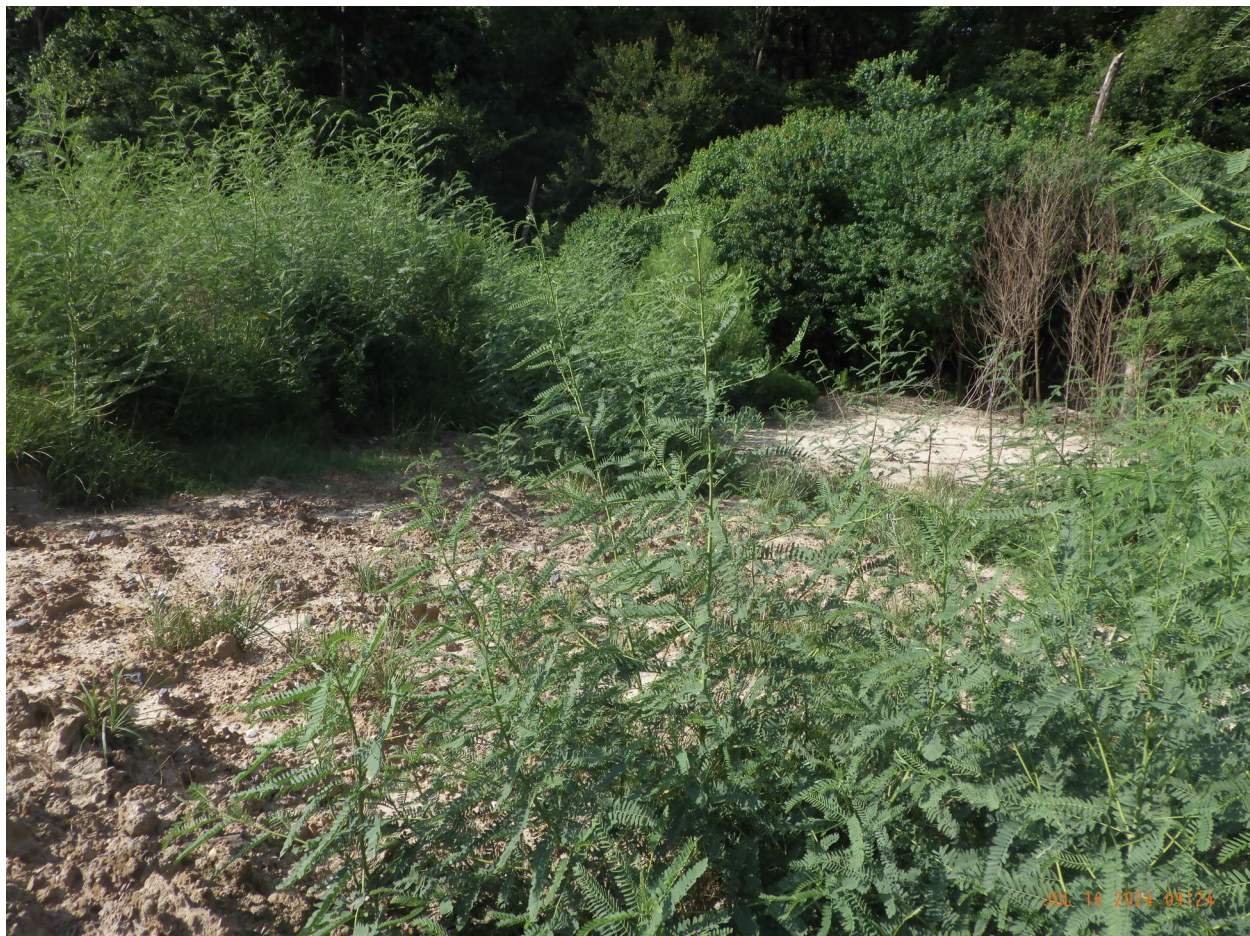
Photo No. 19

**Description:** Looking SSW, an additional view of the erodible soils adjacent to the wetland in Photo No. 16 through No. 18.
