**Region 6 - Enforcement & Compliance Assurance Division**  
**INSPECTION REPORT**

| Inspection Date(s): | 07/16/2024 | |
| Company Name: | <b>MidAmerica Environmental Holdings, LLC</b> | |
| Facility Name: | <b>USA Disposal – El Dorado</b> | |

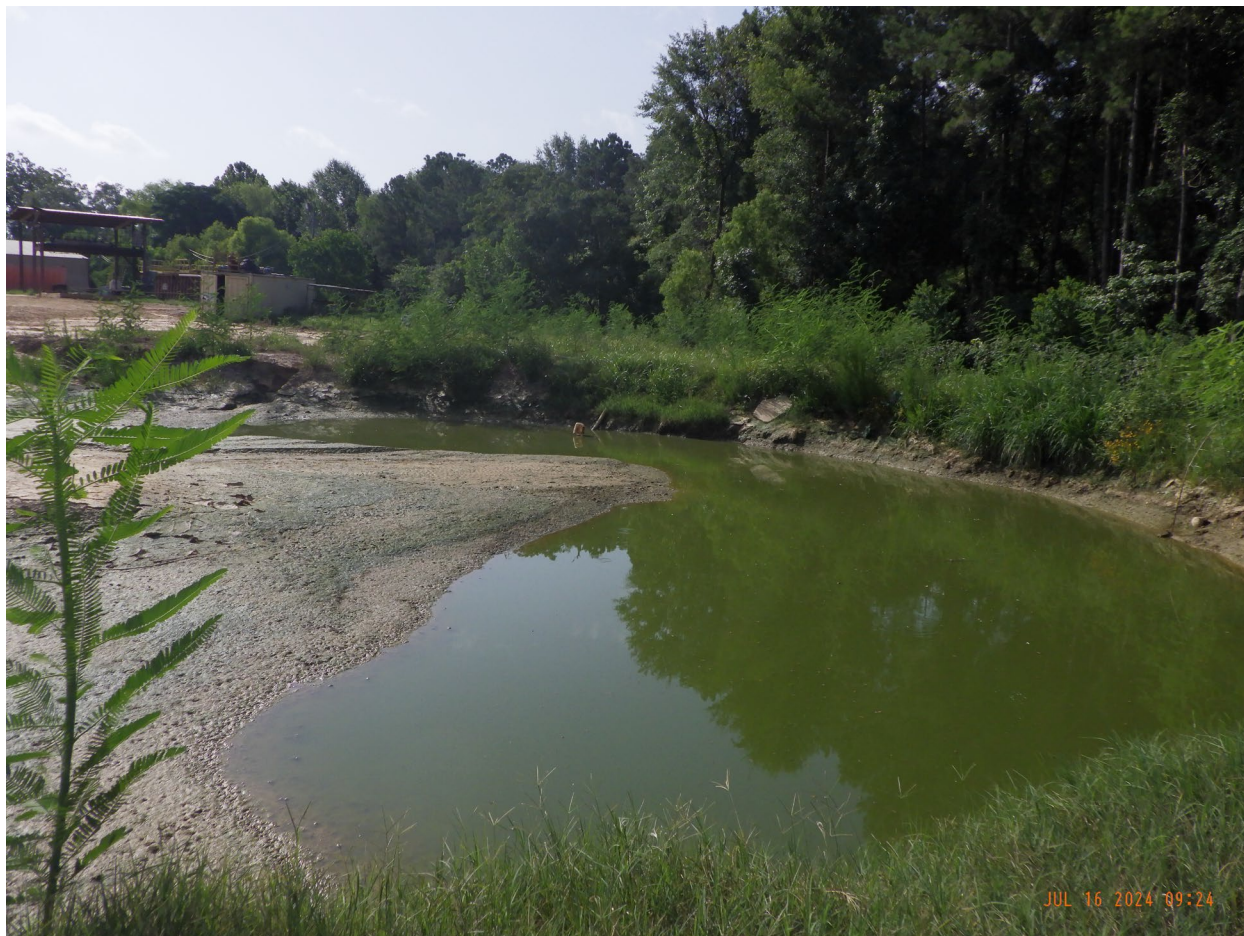
Photo No. 20

**Description:** Looking SSE, the stormwater pond, permitted by the state under an IGP (ARR001445), with a fluid level that was lower than the fluid level noted during the 05/22/2024 inspection.

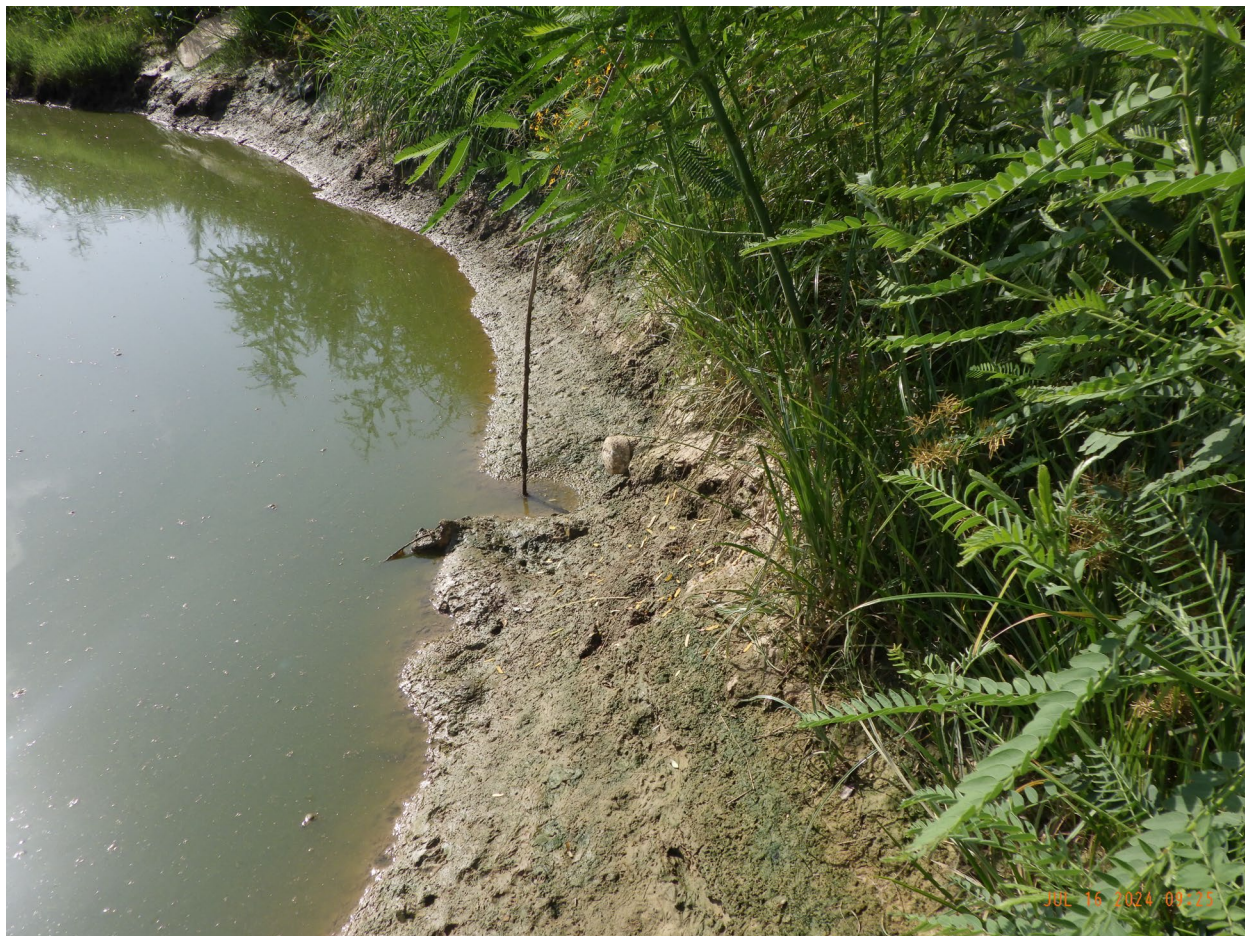
Photo No. 21

**Description:** Looking SSE, the upper drainpipe for the stormwater pond has been capped on the inside of the pond. The lower drainpipe was not observed.

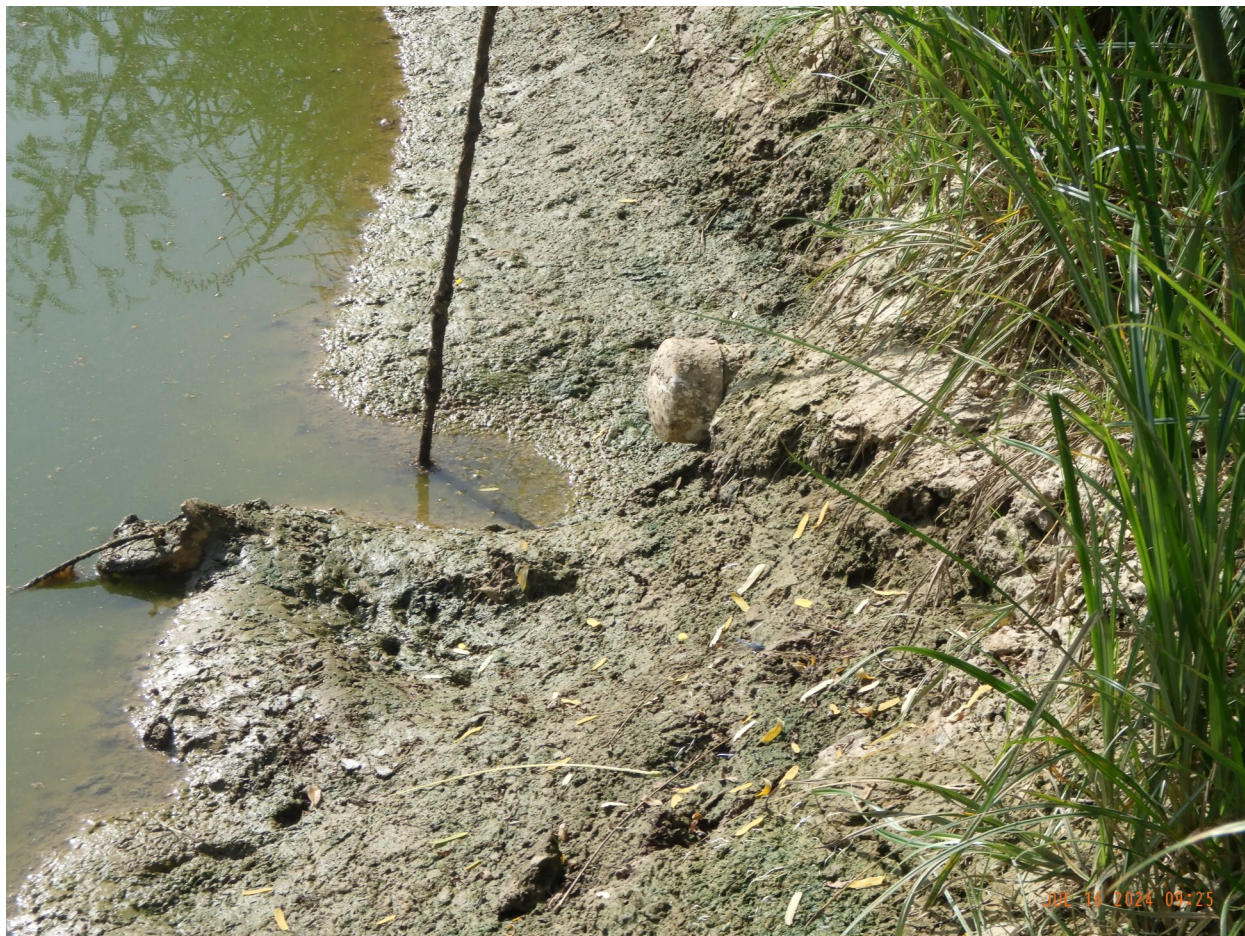
Photo No. 22

**Description:** Looking SSE, a closeup of the cap on the upper drainpipe in Photo No. 21.

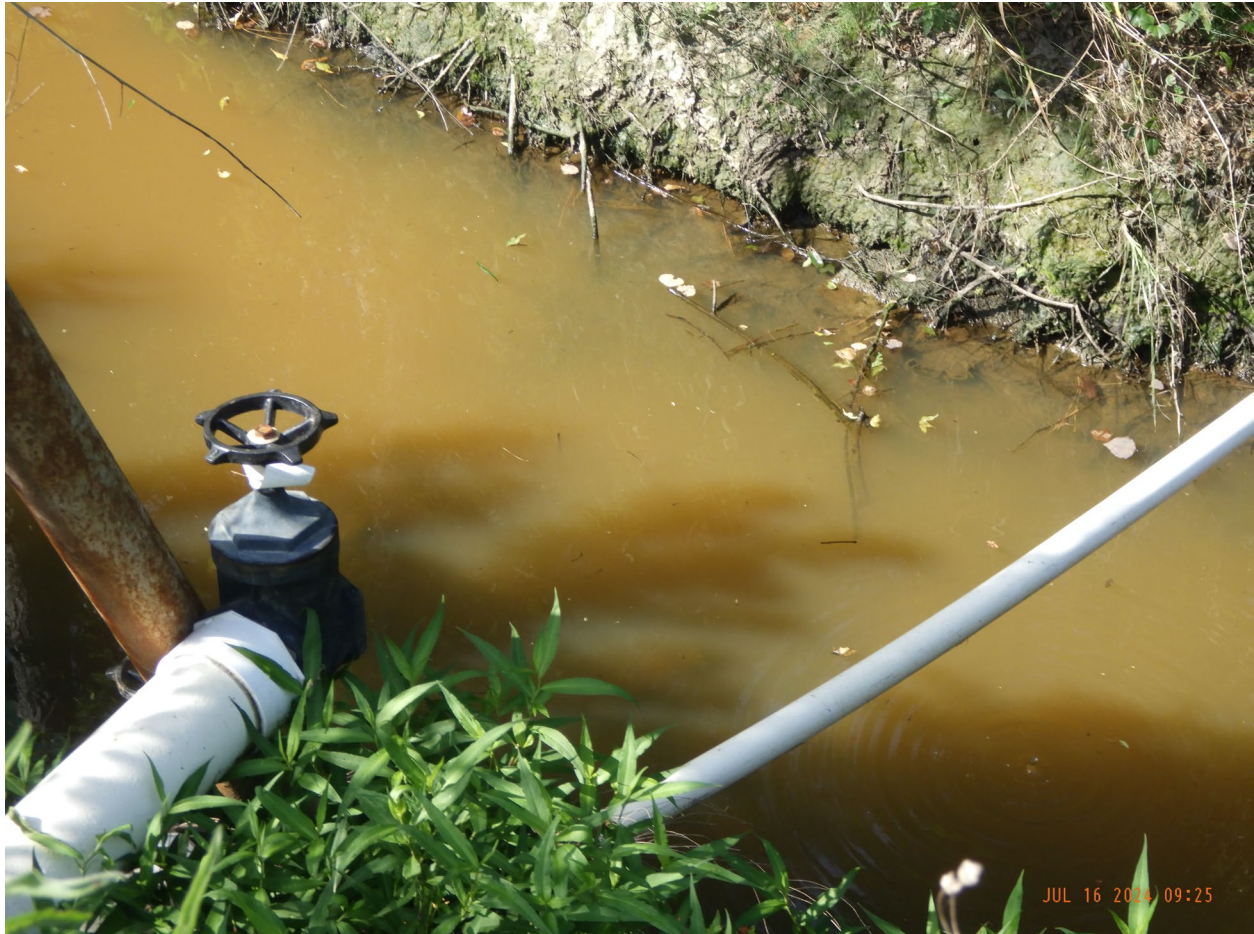
Photo No. 23

**Description:** Looking SSW, an exterior view of the upper drainpipe for the stormwater pond. The cap was off, but the valve was closed. The lower drainpipe was not observed. The thinner, white pipe in the photo was actively dripping into the receiving stream; source of pipe was unknown.

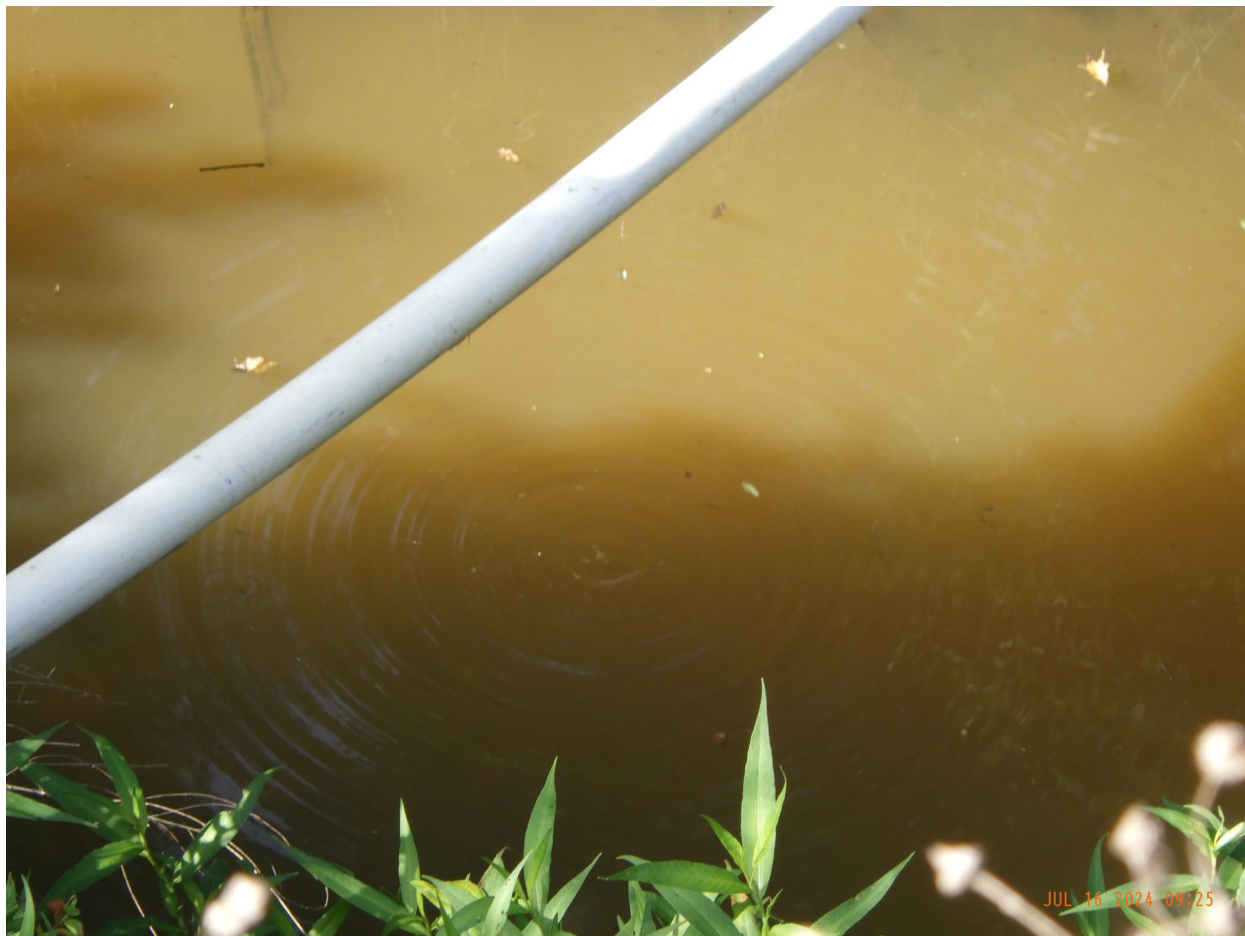
Photo No. 24

**Description:** Looking SSW, a closeup view of the thinner, white pipe (unknown source) actively dripping into the receiving stream from Photo No. 23.

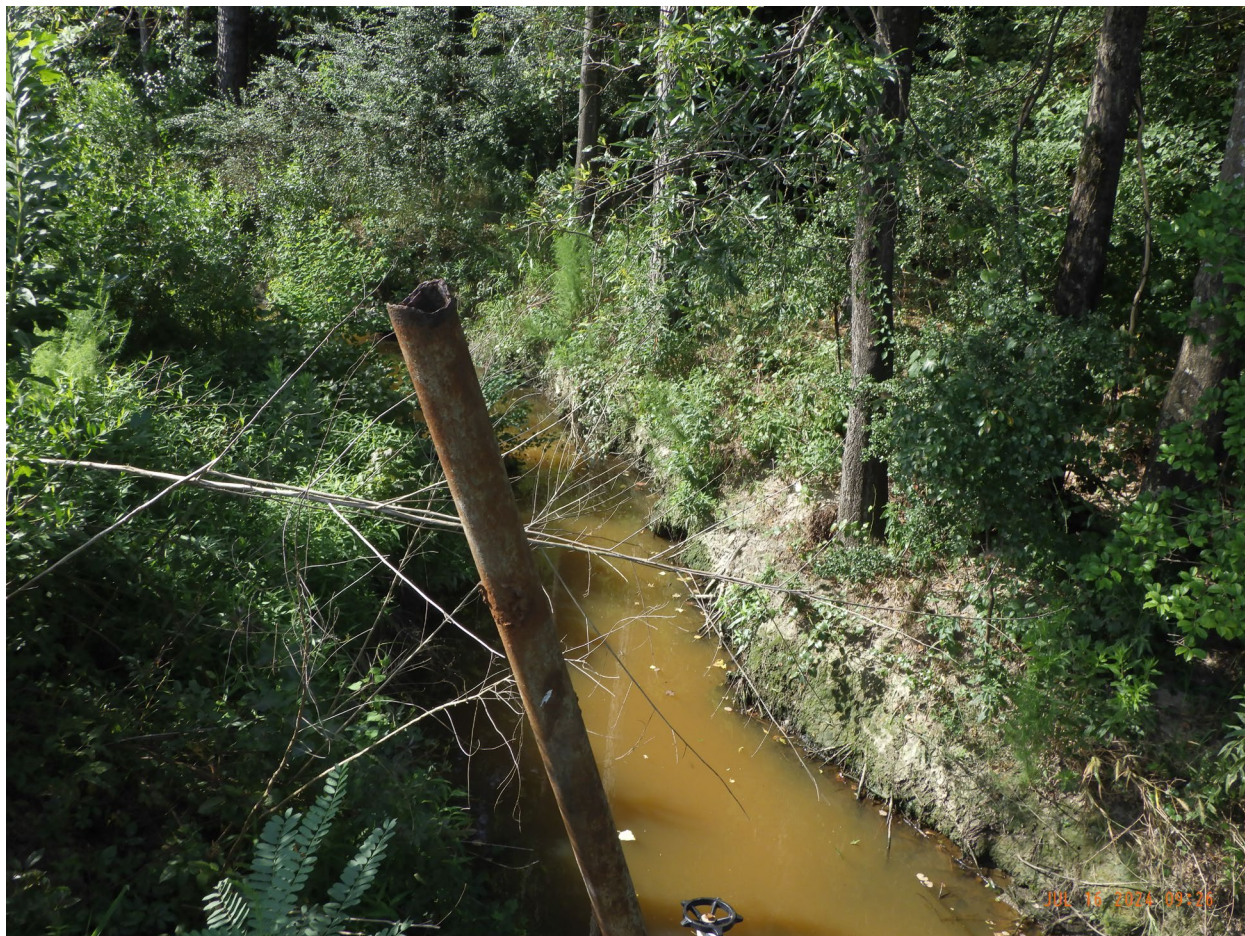
Photo No. 25

**Description:** Looking SSW, the receiving stream upstream of the stormwater pond drainpipes. Coloration of the stream was typical for the area, and live fishes were observed.

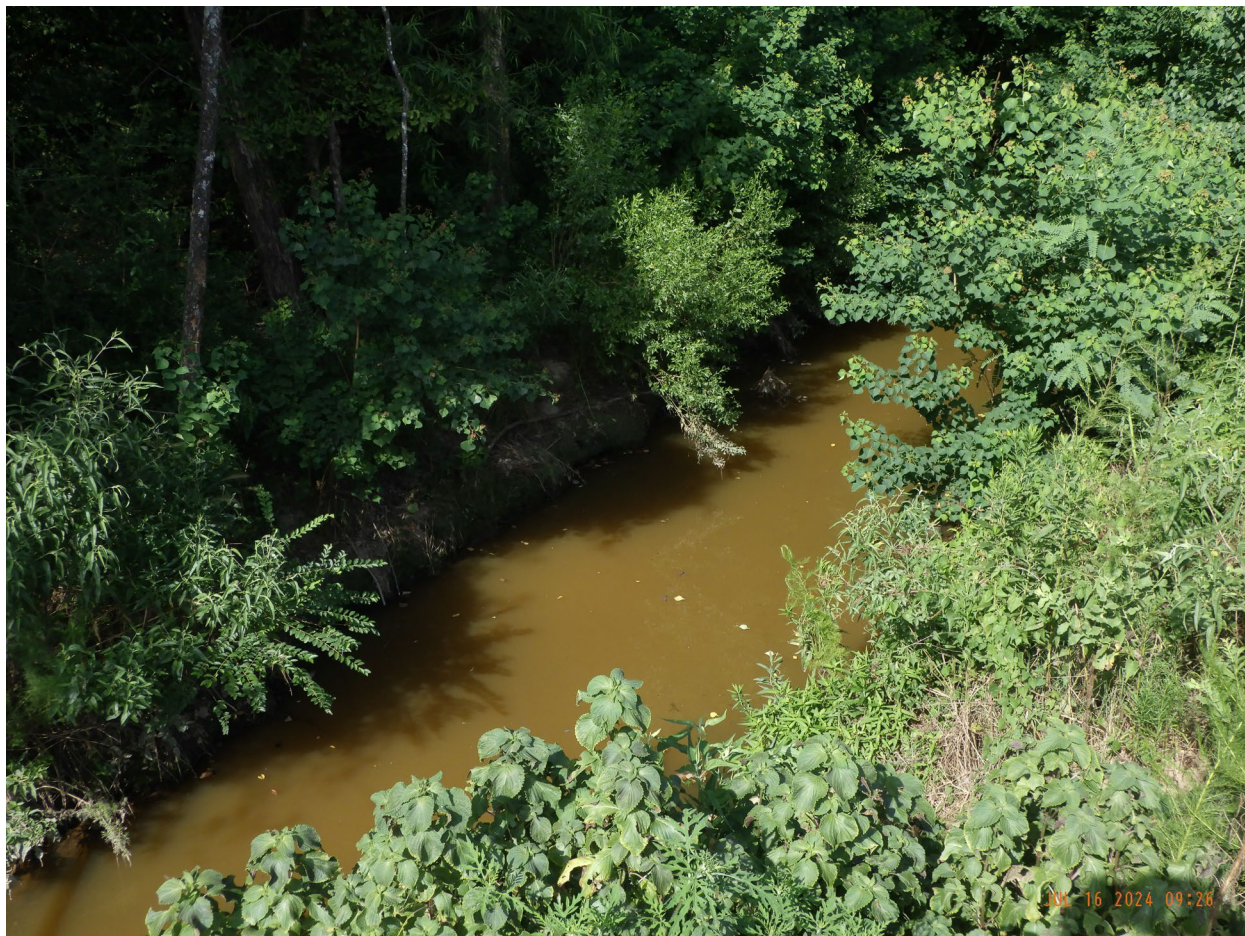
Photo No. 26

**Description:** Looking WSW, the receiving stream downstream of the stormwater pond drainpipes. Coloration of the stream was typical for the area, and live fishes were observed.
