## Region 6 - Enforcement & Compliance Assurance Division

### INSPECTION REPORT

| Inspection Date(s): | 05/21/2025 | |
| Company Name: | <b>Axtell WSC</b> | |

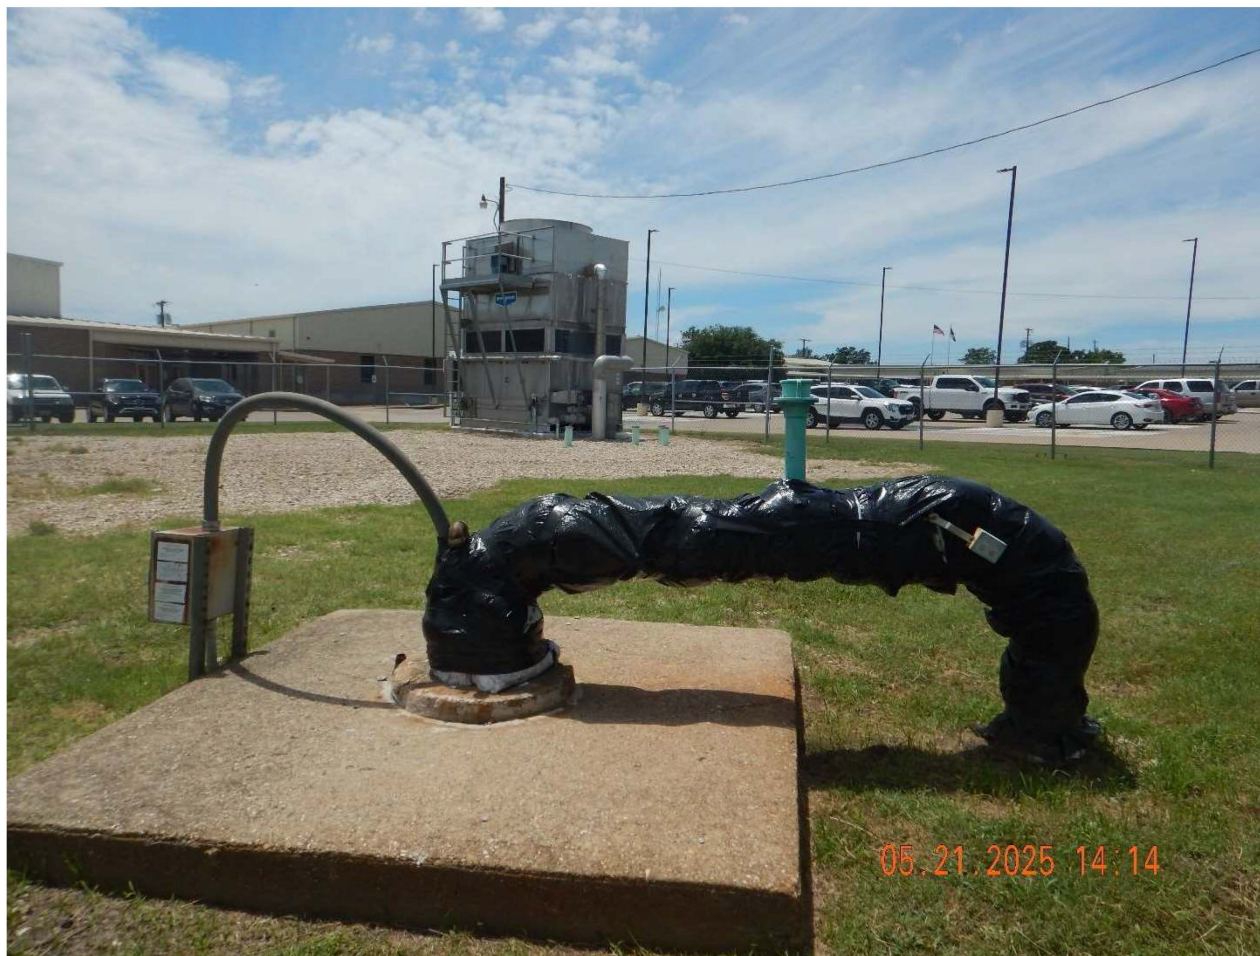
Photo No. 1

- **Well No.1**
  - We observed Well No.1 equipped with 200 GPM pump and the pipe from the well covered with the insulation materials at the time of inspection (Photo 1).

Description: Well No.1 equipped with 200 GPM pump

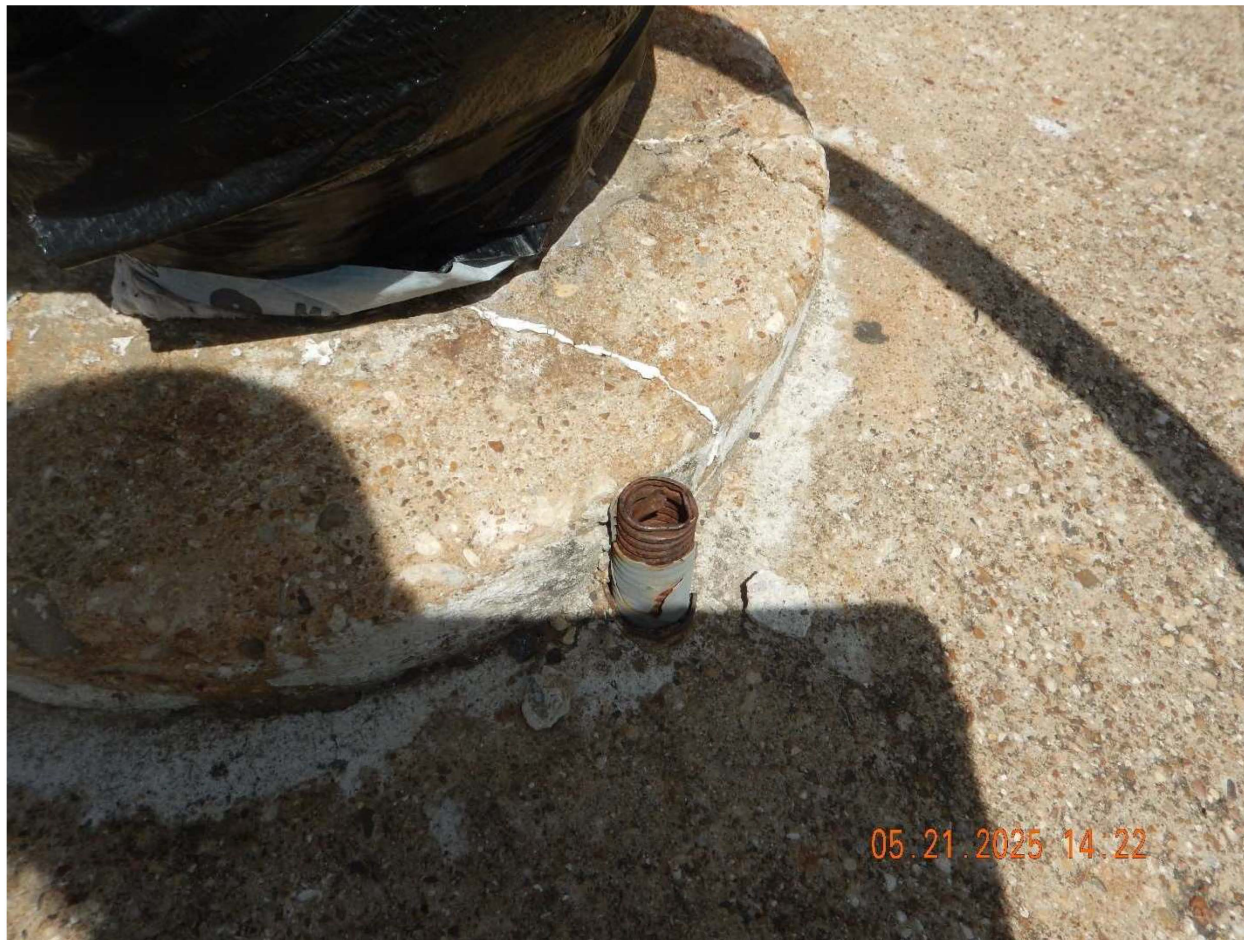
Photo No. 2

- An open conduit was observed in the wellhead of Well No. 1 (Photo 2; AOC 1).
- **Chlorine room**
  - We observed a chlorine room (Photo 3) with a door that displayed a chlorine warning sign and was equipped with a lock. At the time of inspection, chlorine cylinders were not chained (Photo 4; AOC 2).

- AOC No. 1.** An open conduit was observed at the wellhead of both Well No. 1 and Well No. 2.
- We recommend properly sealing or blocking the open conduit in both wells to prevent potential contamination and ensure the integrity of the water supply system.

Description: An open conduit on the wellhead of Well No. 1

- An open conduit was sealed at the wellhead of both Well No. 1 and Well No. 2 (**AOC No. 1**).
- The system installed chlorine sensor, and the chlorine cylinders were secured with chains (**AOC No. 2**).
- New screen was installed on the air release discharge line in the wellhead of Well No. 2 (**AOC No. 5**).
- Gaps under the fencing in Plant 1 and 2 were filled to enhance security and prevent unauthorized access or intrusion (**AOC No. 7**).
- Ripped mesh on the vent of Well No. 2 was replaced (**AOC No. 8**).

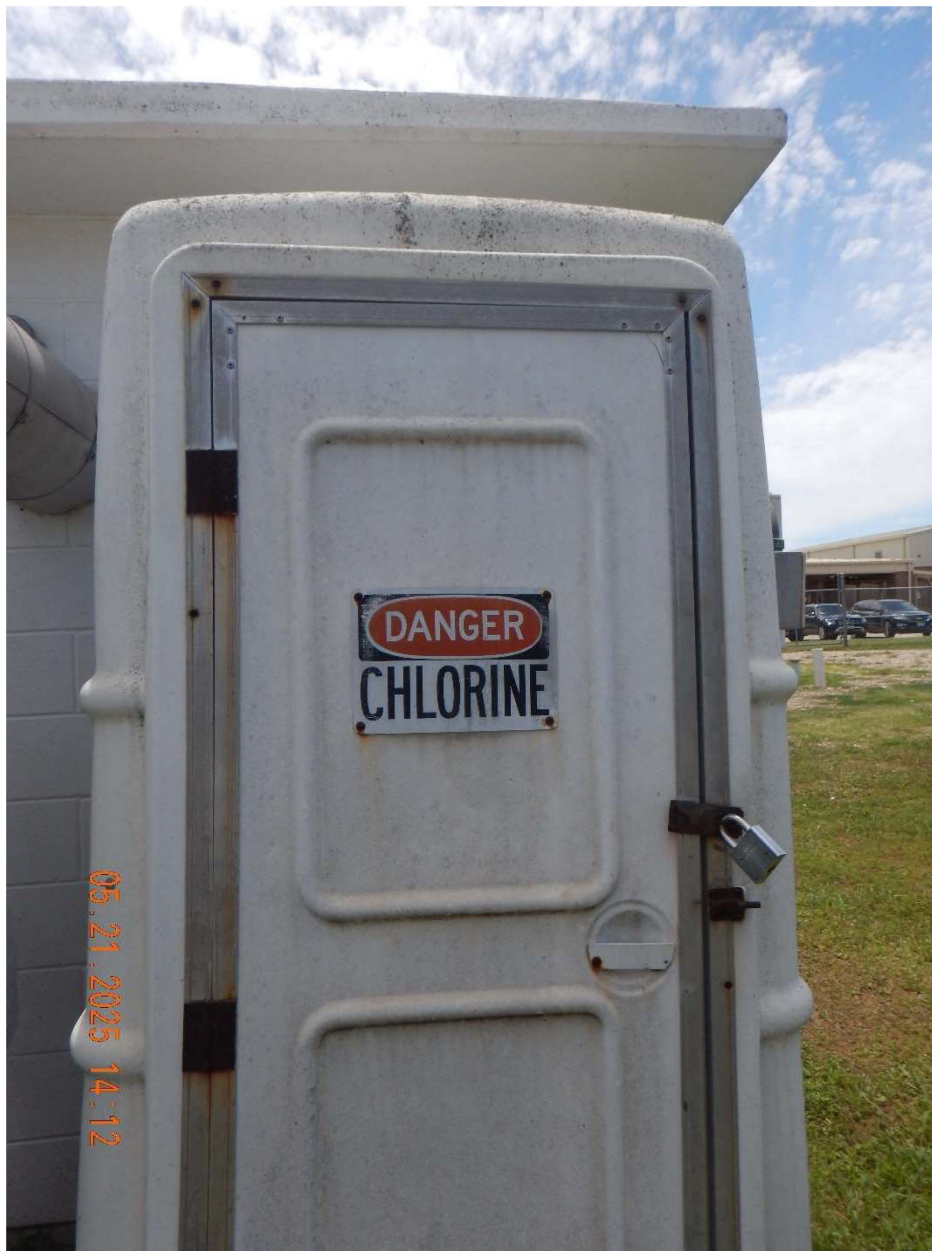
Photo No. 3

Description: A door that displayed a chlorine warning sign and was equipped with a lock.

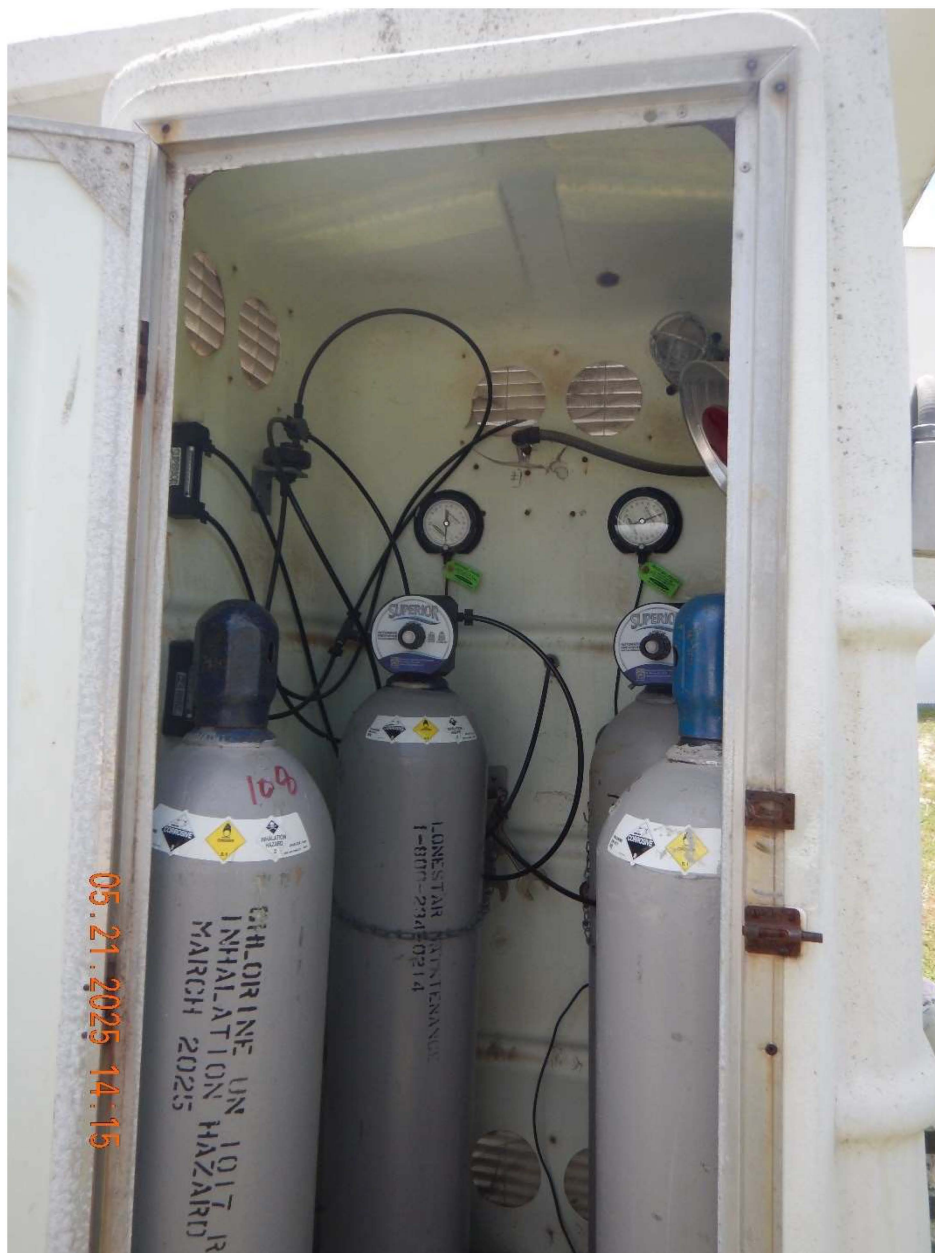
Photo No. 4

- AOC No. 2.** The chlorine room lacked several essential safety features, including a crash bar on the door, a window, sensors, and alarms for detecting chlorine leaks. Additionally, the chlorine cylinders were not secured with chains.

Description: Four chlorine gas tanks were stored inside, and two of them were actively in use

- We recommend securing the chlorine cylinders with chains and installing the necessary safety features. Chaining the cylinders can help store the tanks safely and prevent potential leaks. A crash bar on the door will facilitate a quick evacuation in case of a chlorine leak, while sensors and alarms will ensure prompt detection of gas leaks within the room.

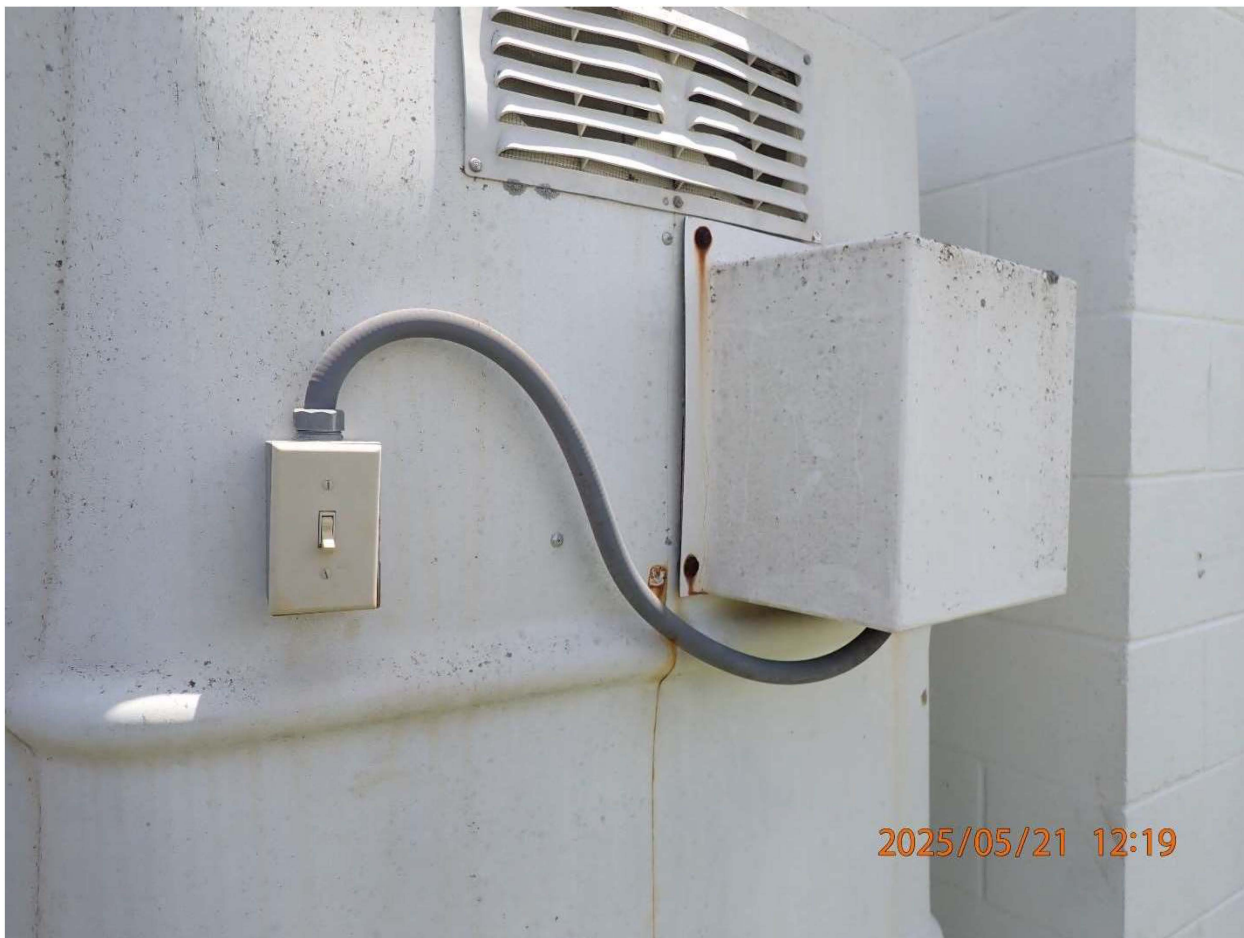
Photo No. 5

- The chlorine room was equipped with a ventilation system (Photo 5; AOC 3). The ventilation system operated manually, with its switch located on the outside wall of the chlorine room.

- AOC No. 3.** Ventilation system was operated manually with the switch on the outside wall of the room.
- We recommend configuring the system to activate automatically when the door is opened, as this provides a better practice for managing potential chlorine leaks.

Description: A ventilation system with its switch located on the outside wall of the chlorine room.

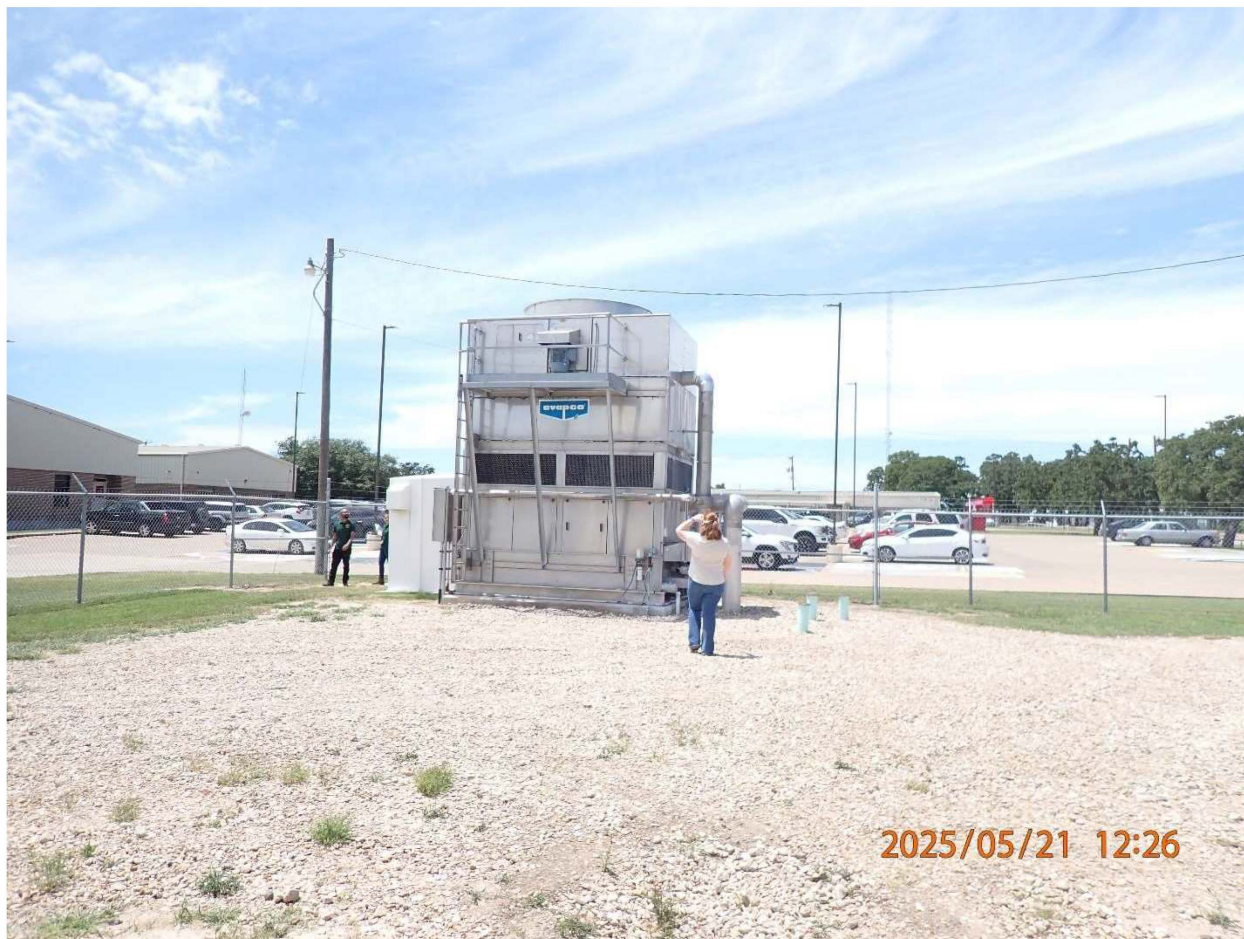
Photo No. 6

- **Cooling tower**
  - We observed a cooling tower (Photo 6) and discussed the geothermal and arsenic issues in the Trinity Aquifer. According to system representative, the average water temperature from their wells is approximately 130°F.

Description: A cooling tower utilized for adjusting water temperature.

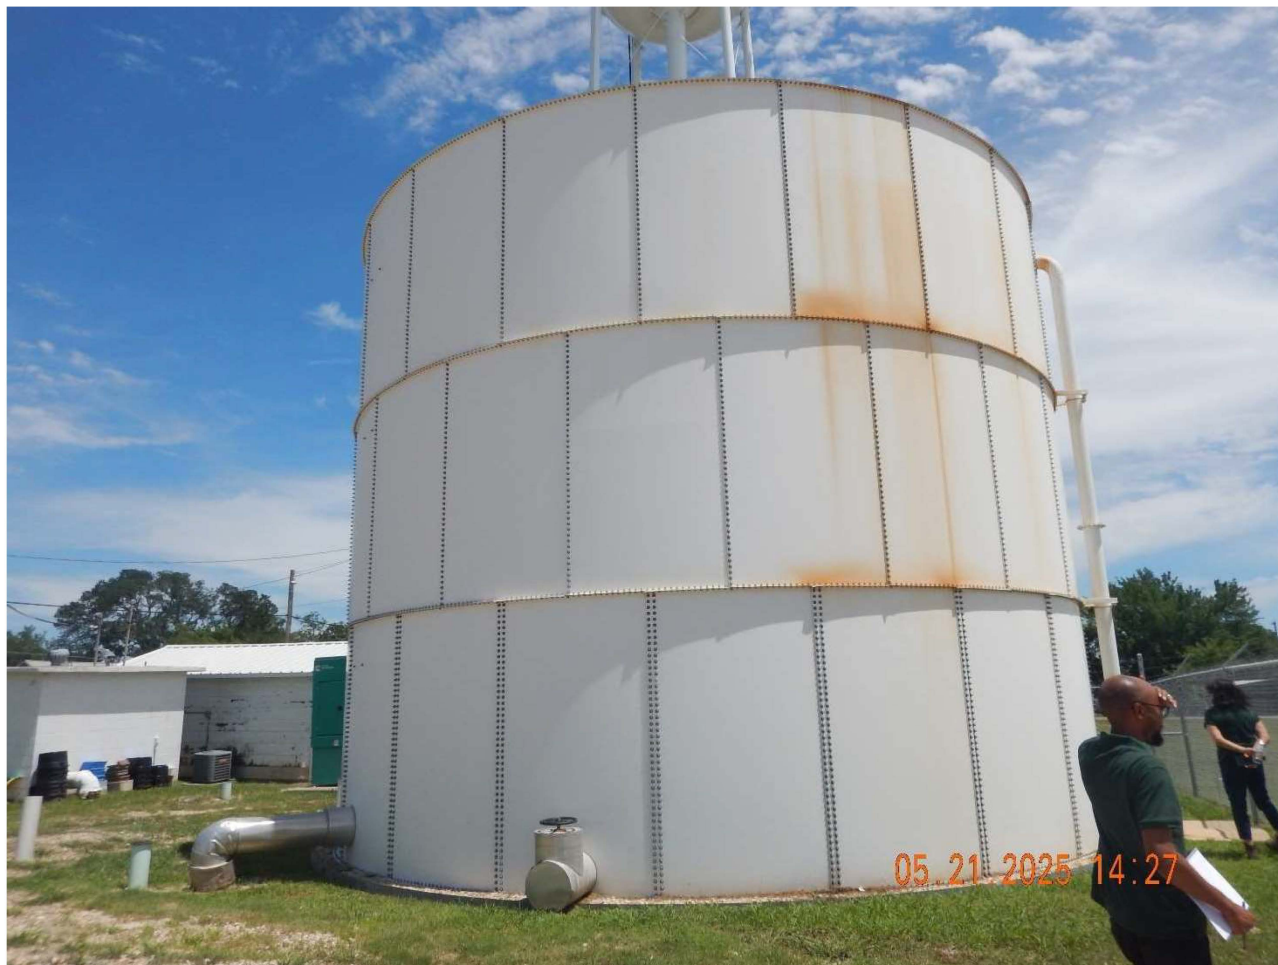
Photo No. 7

Description: 0.1 MG active ground storage in Plant 1

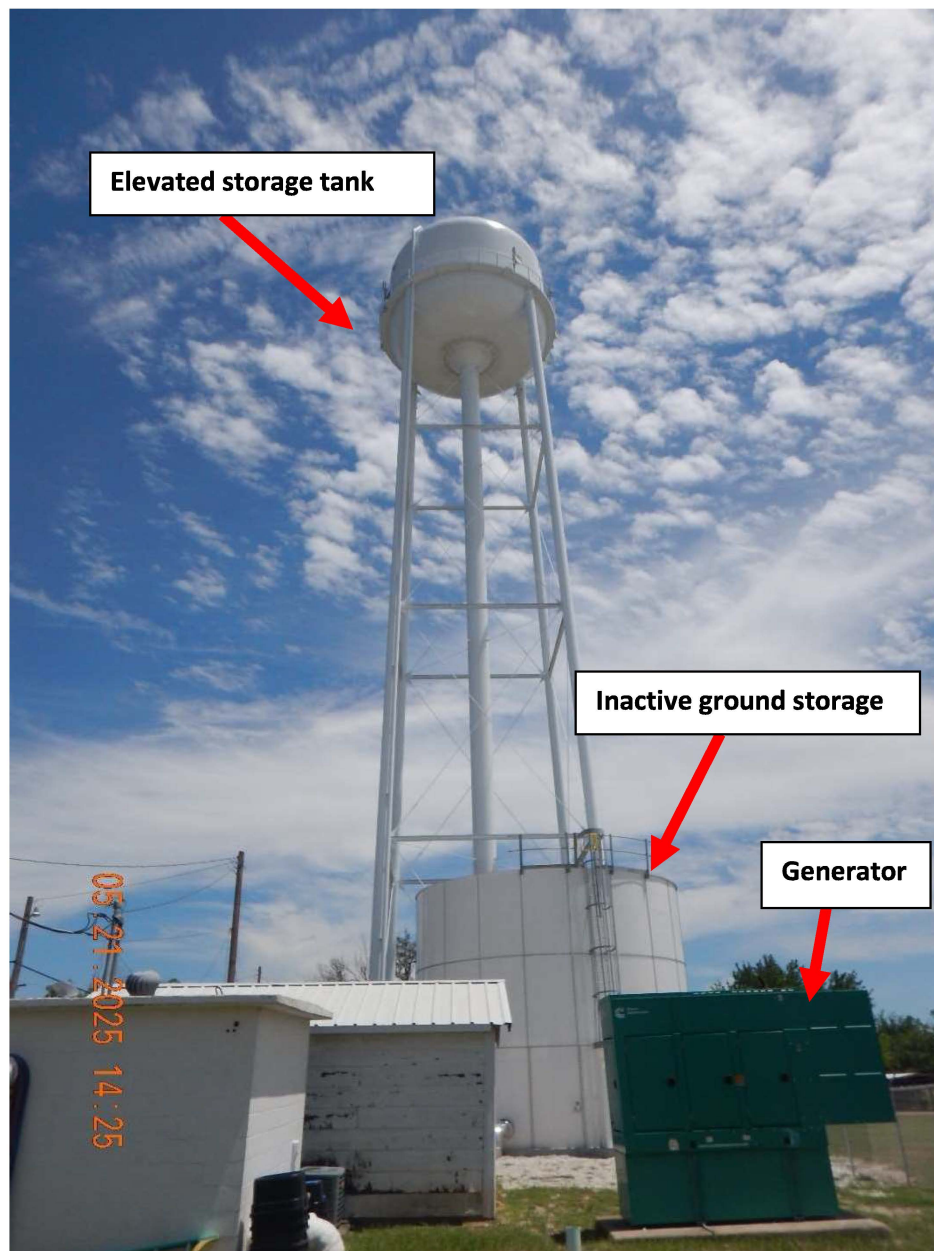
Photo No. 8

Description: Generator, 0.1 MG inactive ground storage, and 0.2 MG elevated storage tank in Plant 1

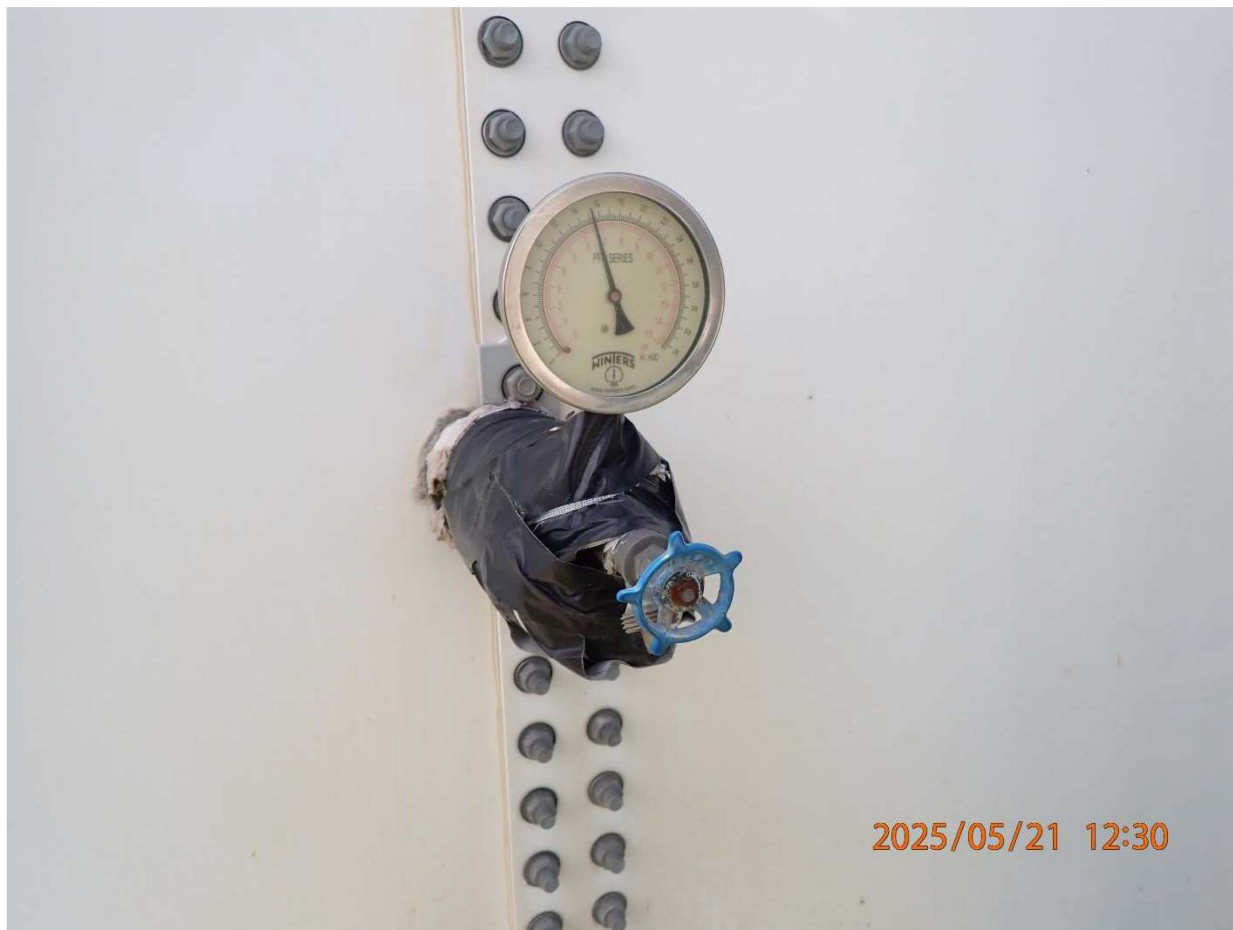
Photo No. 9

- **Ground Storage Tank**
  - Two 0.1 MG ground storage tanks were observed to be in good condition (Photo 7; Photo 8). One tank was active, while the other remained inactive. The inactive tank is planned to be used for mixing the system's water with treated water from a nearby public water system to reduce the arsenic concentration in the system's water. Threaded sample tap on the active tank didn't seem to have backflow prevention device. (Photo 9; AOC 4)

- AOC No. 4.** The threaded sample taps on both 0.1 MG active ground tank and 0.2 MG elevated storage tank did not appear to have backflow prevention devices.

Description: Threaded sample tap on the active tank. It didn't seem to have backflow prevention device.

- We recommend installing backflow prevention devices on the threaded sample taps to prevent potential contamination.

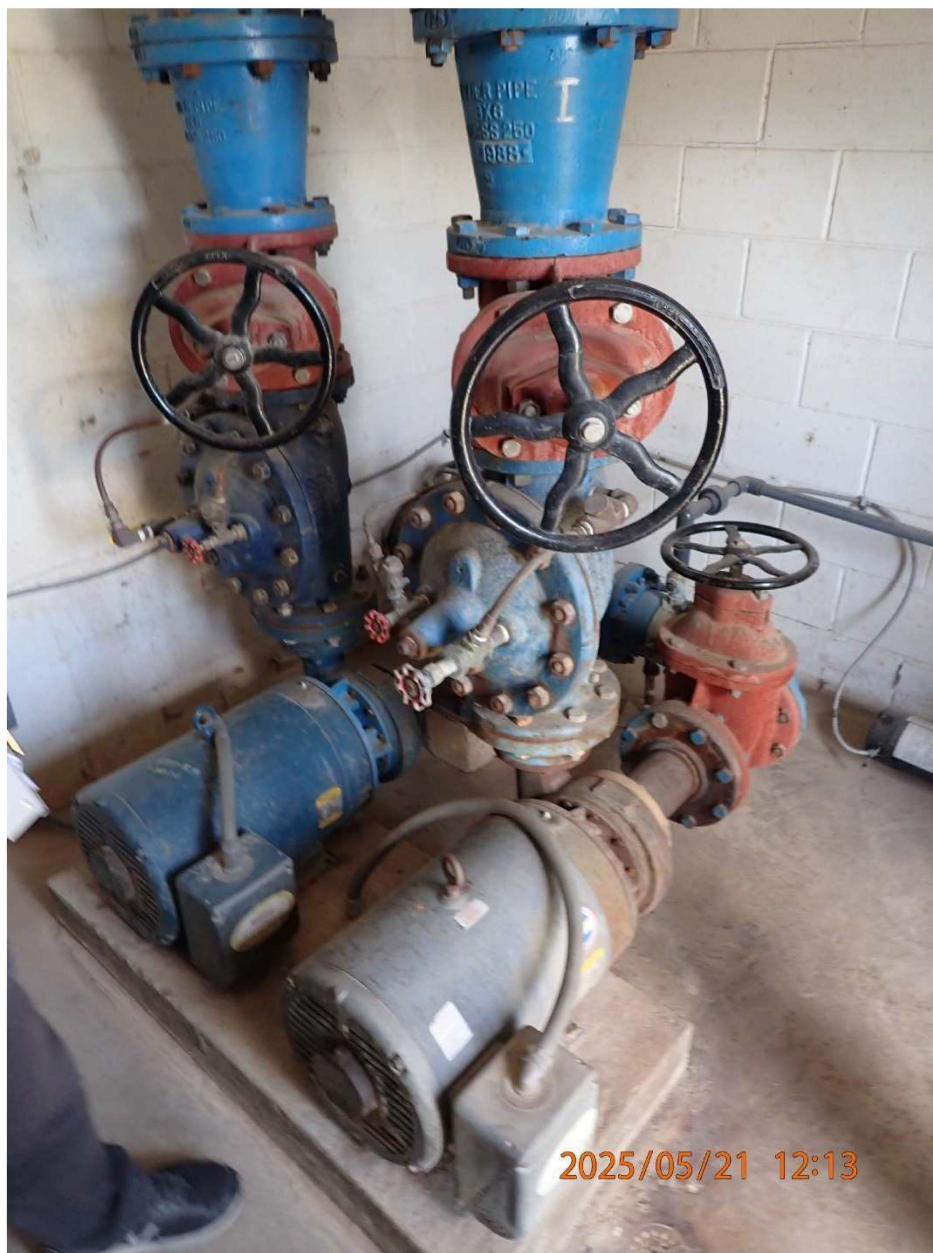
Photo No. 10

Description: Two service pumps with capacity 500 GPM each housed in the building

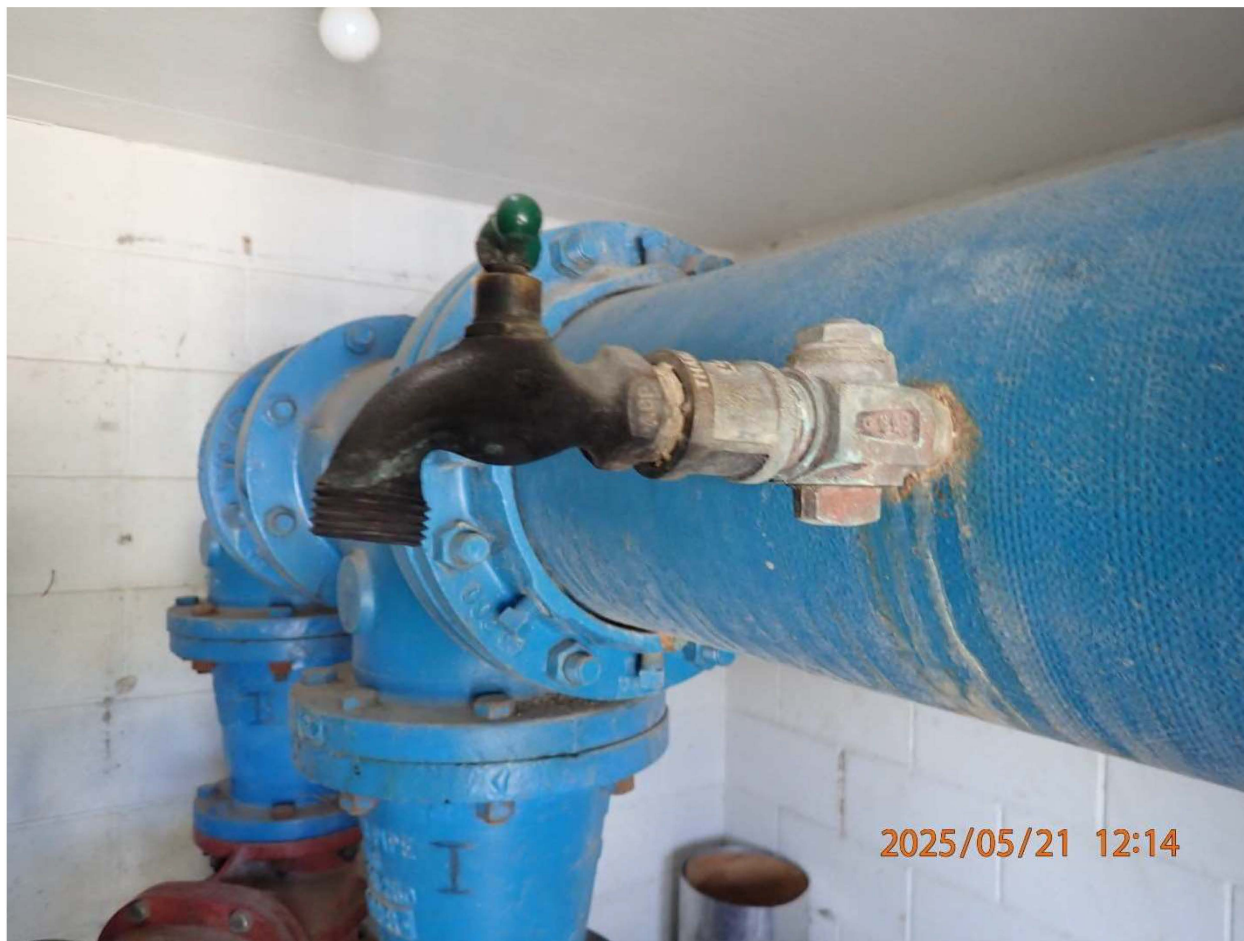
Photo No. 11

Description: The drain valve was equipped with backflow prevention device

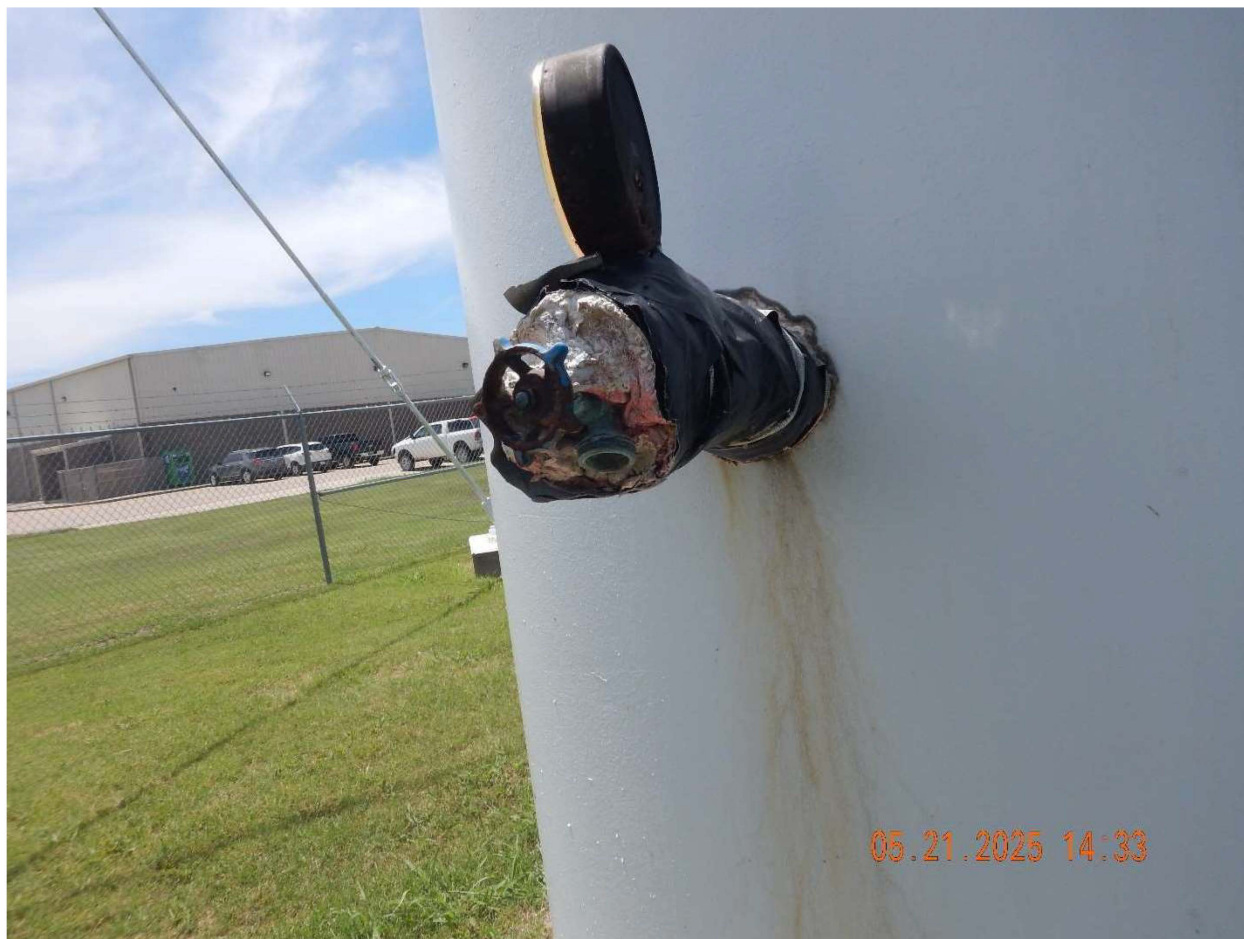
Photo No. 12

- **Elevated Storage Tank**
  - We observed a 0.2 MG elevated storage tank (Photo 8). The tank appears to have been built in 2010, and the height to the high level is 180 feet. Threaded sample tap on the elevated storage tank didn't seem to have backflow prevention device. (Photo 11; AOC 4)

Description: Threaded sample tap on the elevated storage tank. It didn't seem to have backflow prevention device.

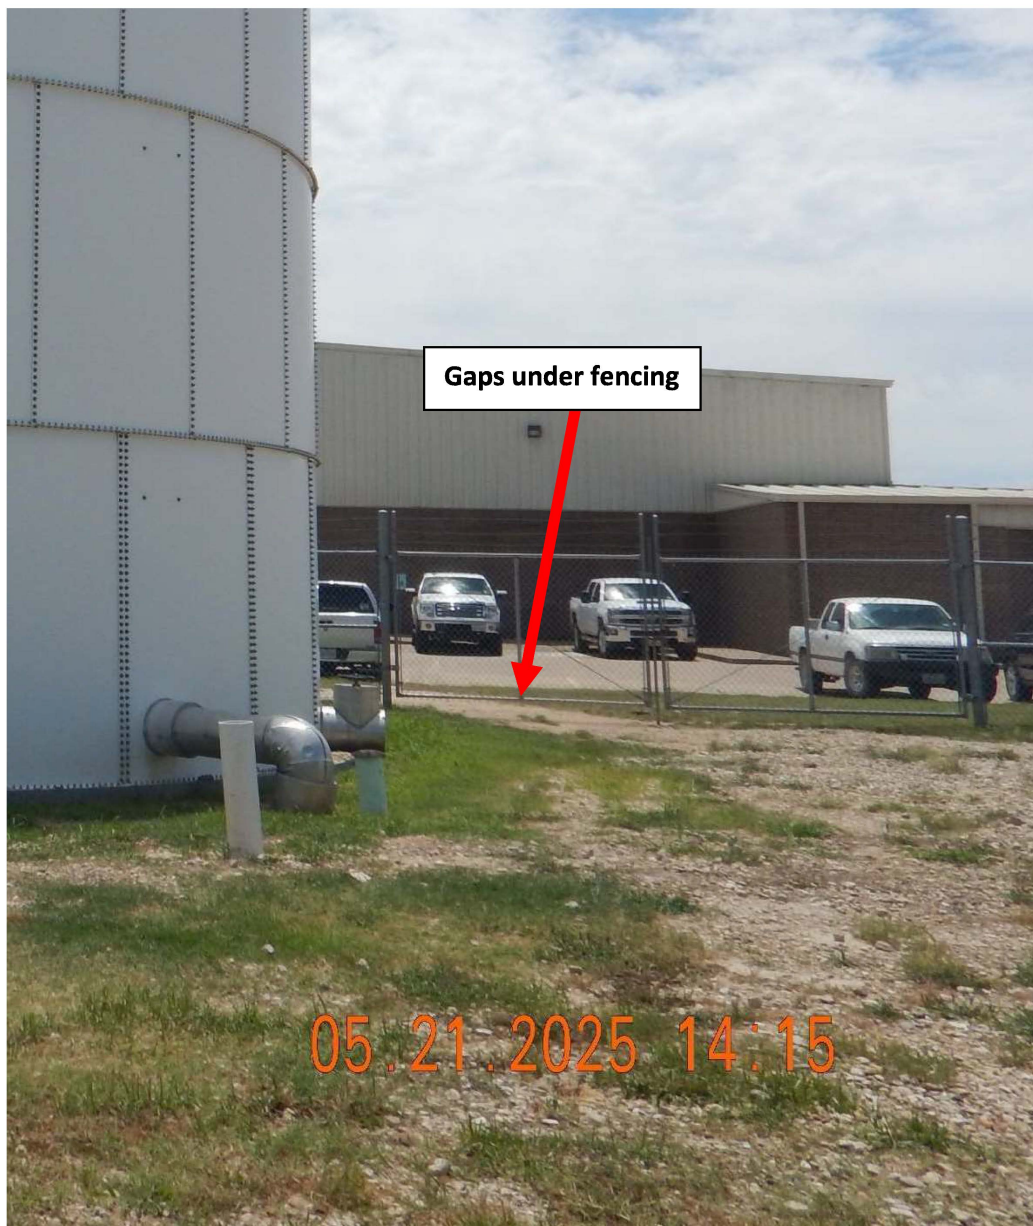
Photo No. 13

- **Fence**
  - We observed a fence surrounding the plant, which appears to be properly installed. However, there are some areas with gaps under the fencing due to erosion (Photo 13; AOC 7).

Description: Gaps under the fencing due to erosion

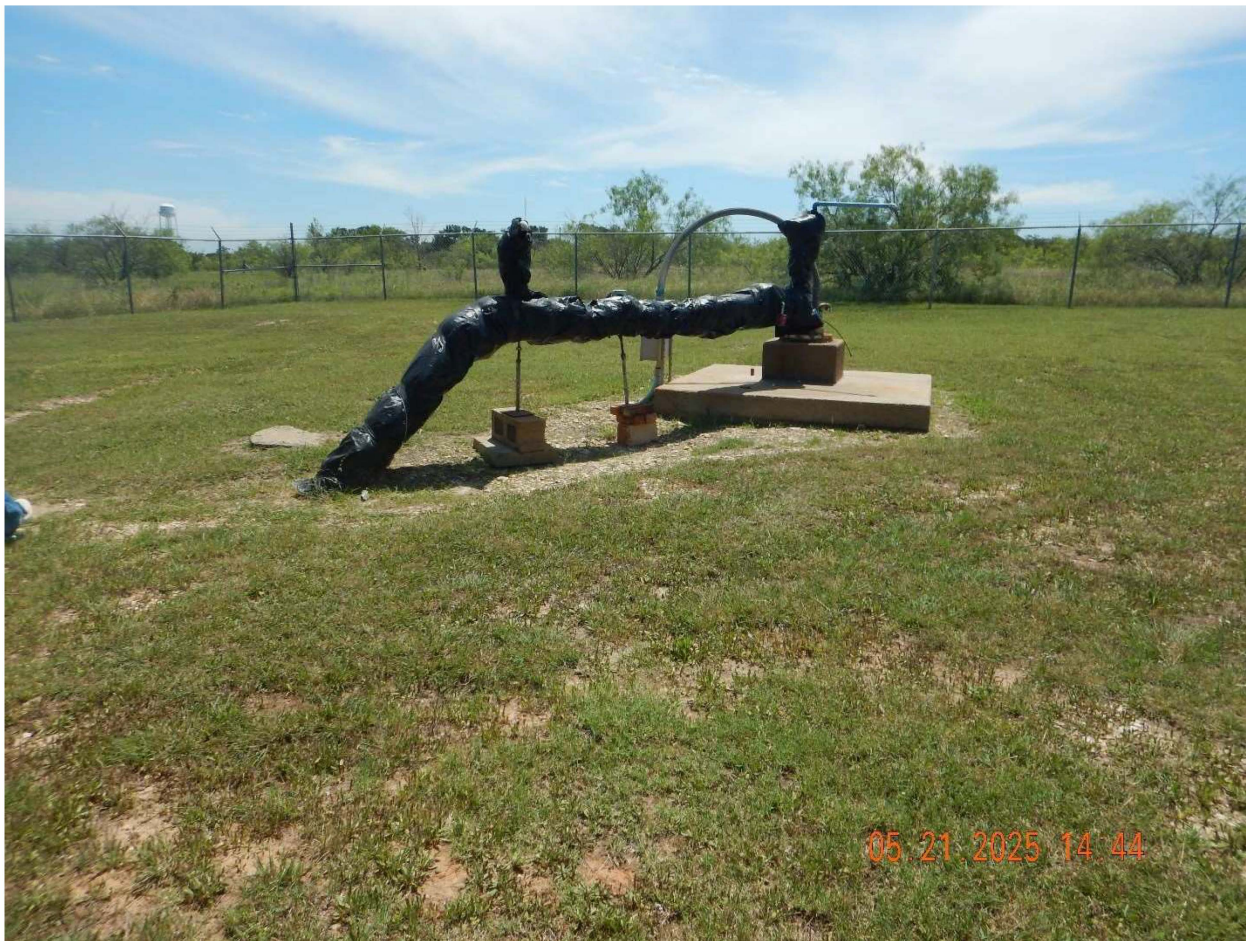
Photo No. 14

Description: Well No.2 equipped with 350 GPM pump and the pipe from the well covered with the insulation materials at the time of inspection.

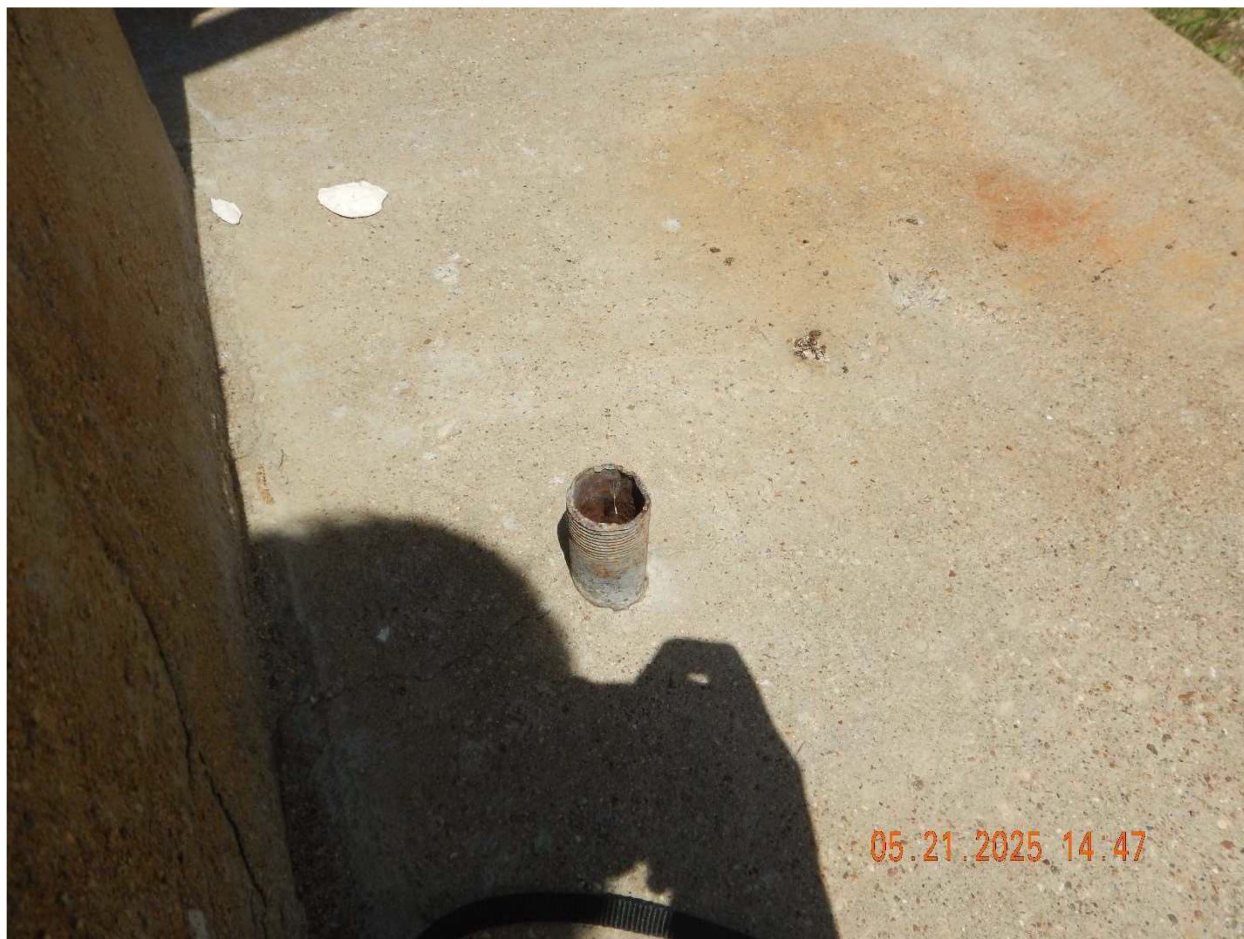
Photo No. 15

Description: An opening conduit was observed in the wellhead of Well No. 2.

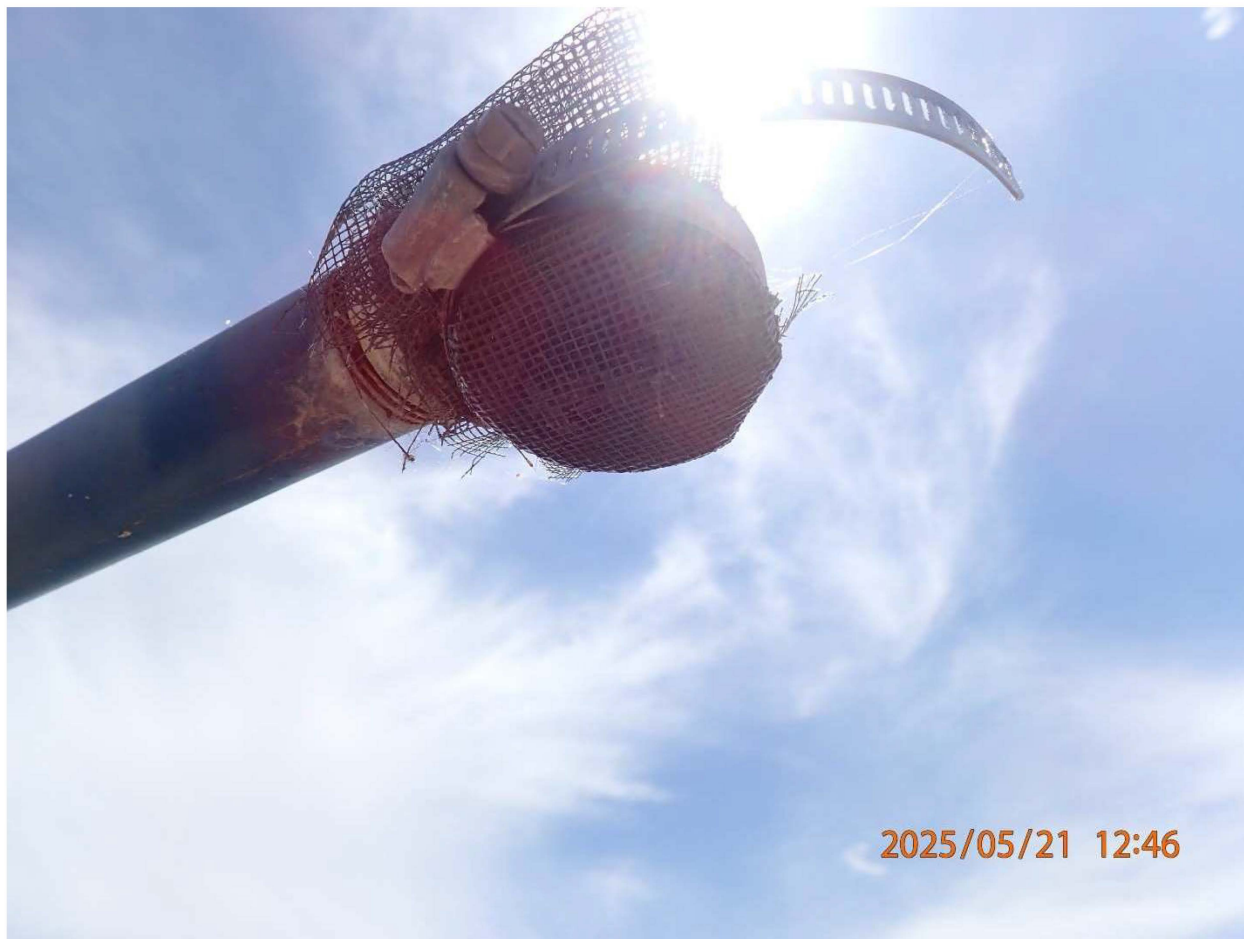
Photo No. 16

Description: The ripped mesh on the groundwater vent in Well No.2

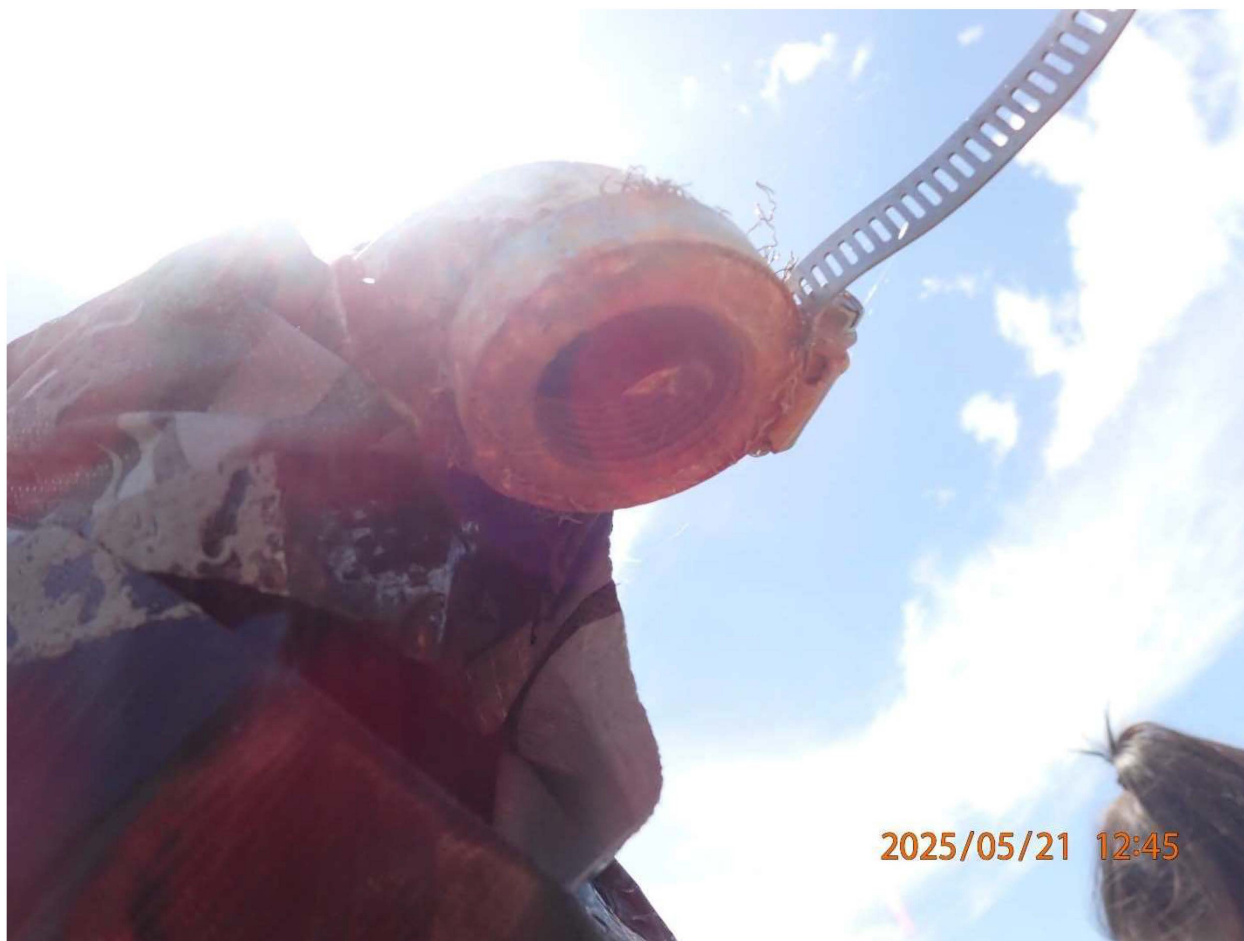
Photo No. 17

- AOC No. 5.** A missing screen was observed on the air release discharge line in the wellhead of Well No. 2.
- We recommend installing a screen on the air release discharge line to prevent potential contamination.
- AOC No. 6.** Temporary pipe supports were observed under the delivery line.
- We recommend installing permanent, structurally stable supports for the pipes. This will enhance structural stability and can increase the longevity of the pipe.
- AOC No. 7.** Gap under the fencing was found in Plant 1 and 2.
- We recommend eliminating the gap in both plants to enhance security and prevent unauthorized access or intrusion.
- AOC No. 8.** A mesh on the groundwater vent was found to be ripped in Well No. 2.
- We recommend replacing the mesh on the vents of the well to ensure proper protection and functionality.

Description: Missing screen on the air release discharge line in the wellhead of Well No.2

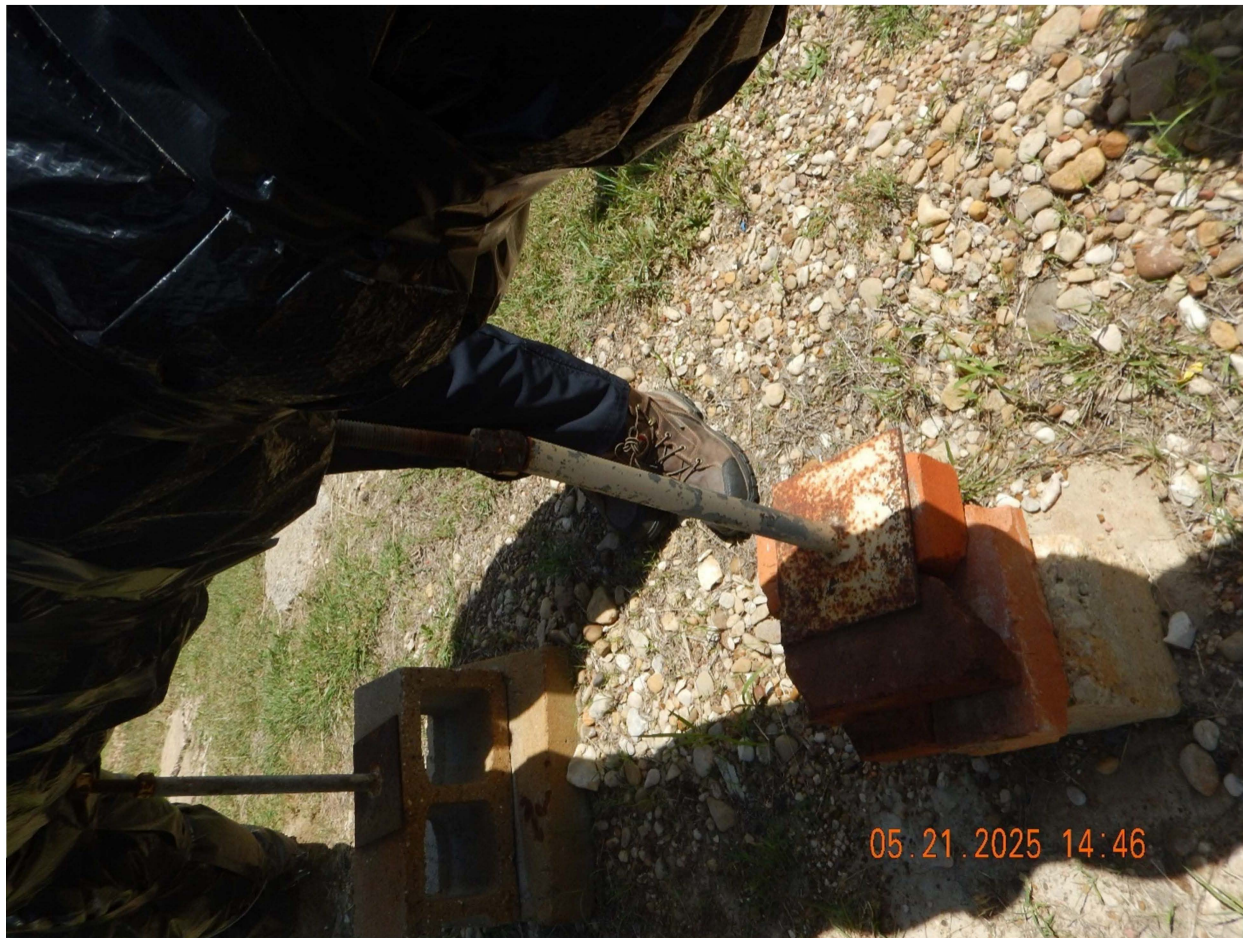
Photo No. 18

- We observed temporary pipe supports being used under delivery line. (Photo 18; AOC 6).
- **Generator**
  - A generator for emergency use was observed in Plant 2 (Photo 19). The generator in Plant 2 is operated by diesel fuel such as the generator in Plant 1. According to the system representative, the diesel fuel is not stored on-site and is delivered by the contractor as needed.
- **Fence**
  - We observed a fence surrounding the plant, which appears to be properly installed. However, we also found gaps under the fencing caused by erosion (Photo 20; AOC 7).

Description: Temporary pipe supports being used under delivery line in Well No.2
