## Region 6 - Enforcement & Compliance Assurance Division

### INSPECTION REPORT

| Inspection Date(s): | 05/21/2025 | |
| Company Name: | <b>Axtell WSC</b> | |

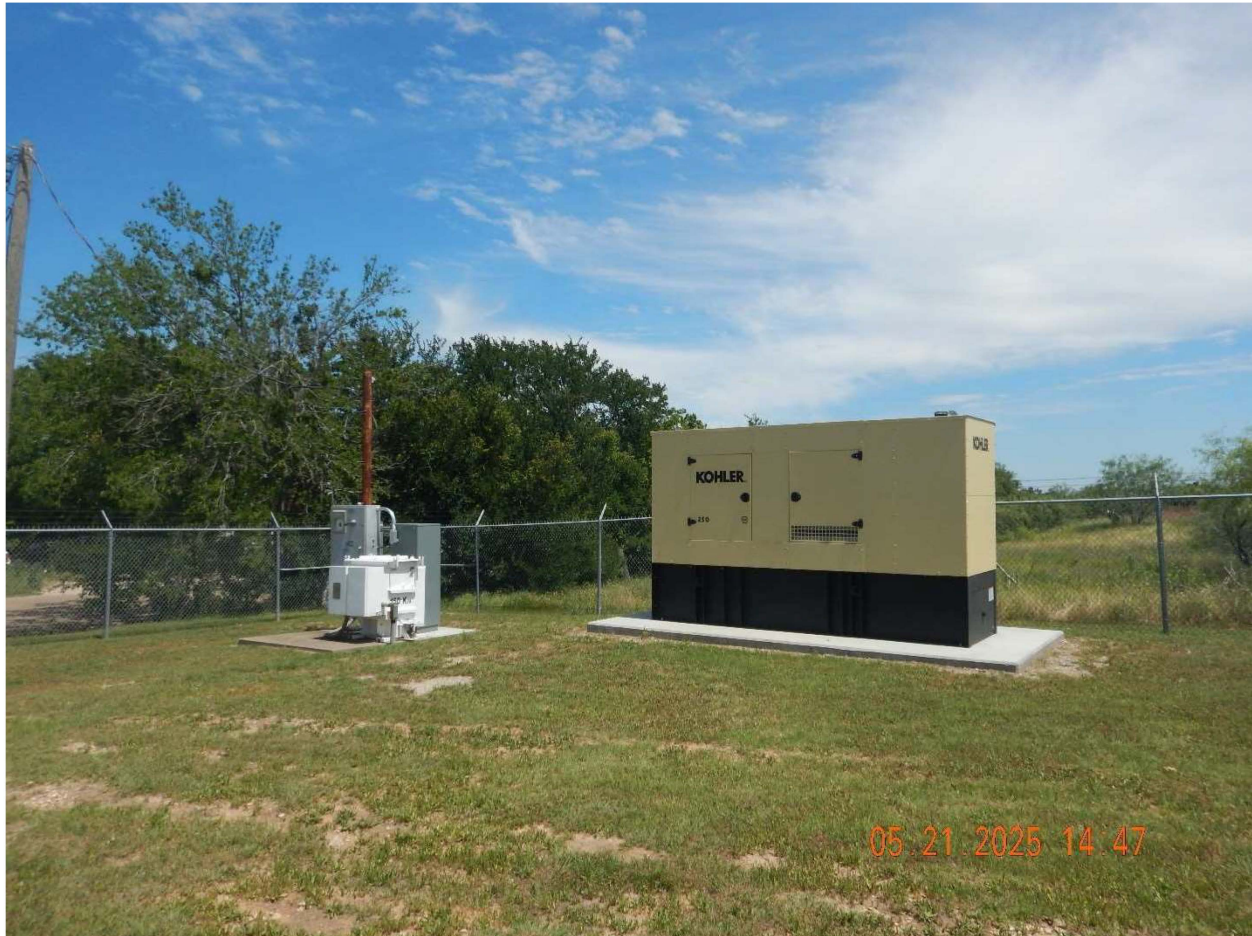
Photo No. 19

Photo File Name: DSCN6006.JPG  
Date of Photo: 05/21/2025  
Time of Photo: 14:47 PM  
Photographer: Fatima Shaikh  
Description: Generator located in Well No.2

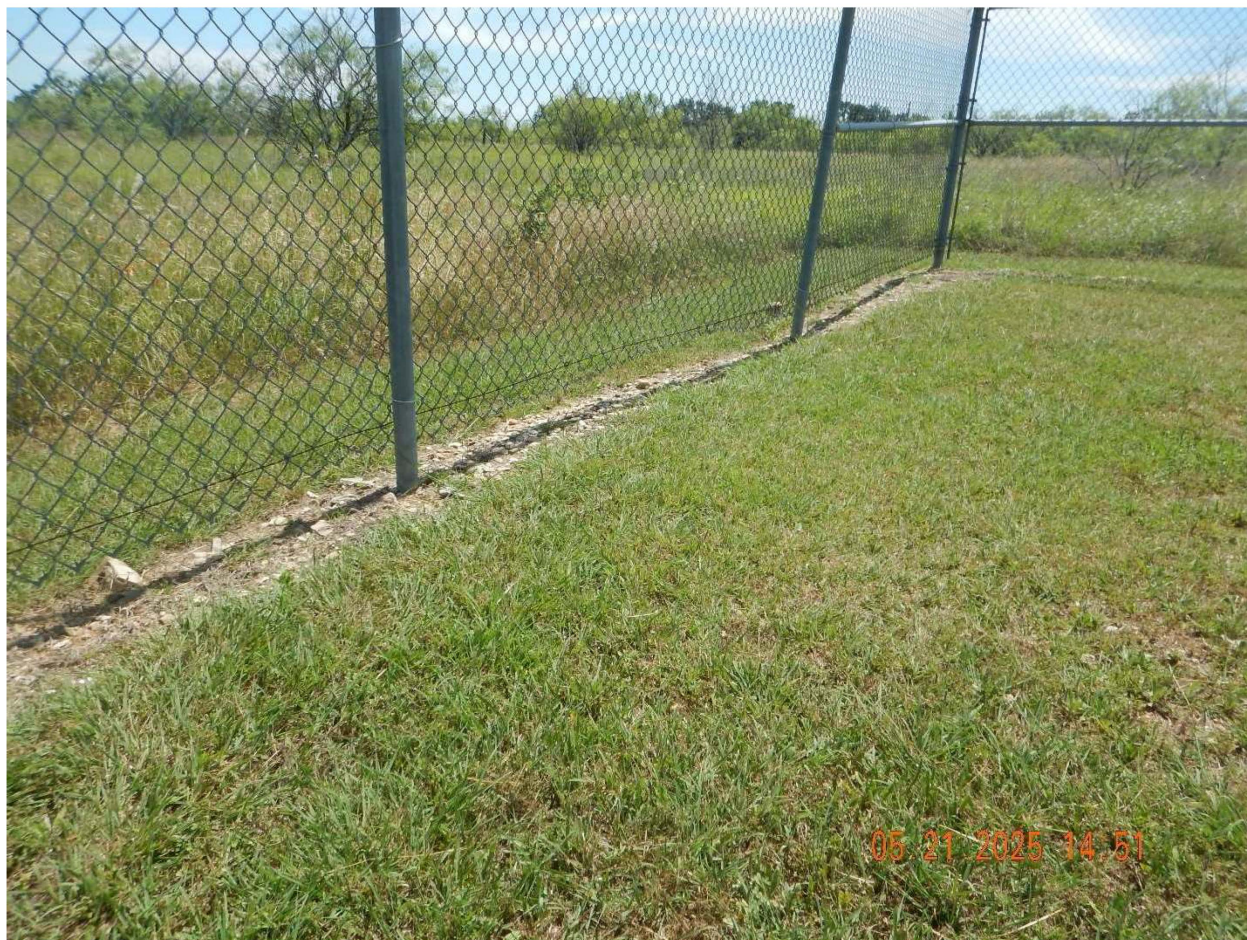
Photo No. 20

- We observed temporary pipe supports being used under delivery line. (Photo 18; AOC 6).
- **Generator**
  - A generator for emergency use was observed in Plant 2 (Photo 19). The generator in Plant 2 is operated by diesel fuel such as the generator in Plant 1. According to the system representative, the diesel fuel is not stored on-site and is delivered by the contractor as needed.
- **Fence**
  - We observed a fence surrounding the plant, which appears to be properly installed. However, we also found gaps under the fencing caused by erosion (Photo 20; AOC 7).

Description: Gaps under the fencing in Well No.2
