# SERVICE BULLETIN

No. Q1010 under BRAKES

## MANDATORY SAFETY CAMPAIGN

**BRAKE ANTI-WHEEL LOCK WIRING**  
(R. RD. U and DM with MVSS121 Anti-Lock System)

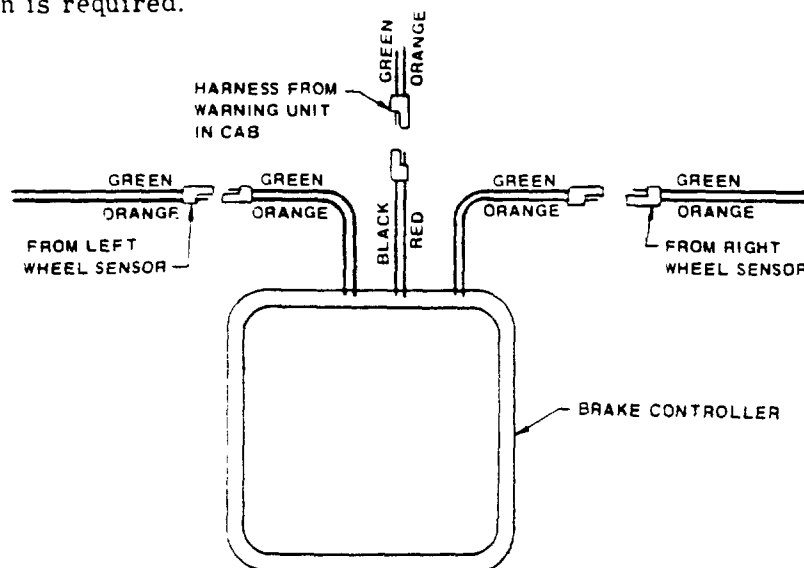
FIGURE 1  
HARNESS CONNECTIONS AT BRAKE CONTROLLER  
CORRECT

Check wiring color coding at the harness connections at front axle controller. If they are as shown in Figure 1, no further inspection or correction is required.

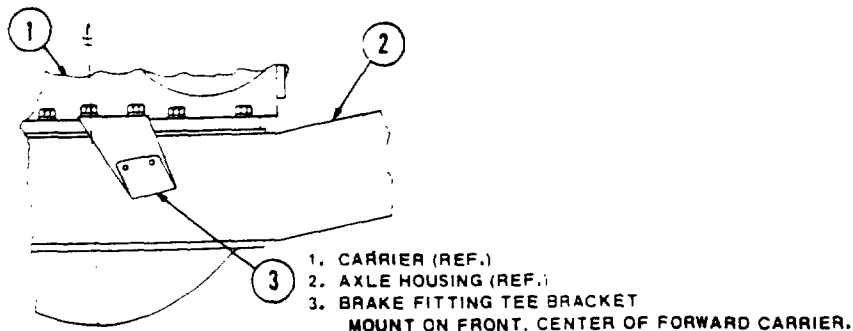
FIGURE 1  
BRACKET INSTALLATION

**INFORMATION AND RECOMMENDATION** The brake fitting tee bracket mounted on the front carrier is subject to failure caused by vibration. A bracket failure leaves the tee fitting unsupported and can result in a broken hose or connector fitting. Should this occur, loss of air pressure will cause the spring brakes to apply automatically. This condition occurs without prior warning to the operator.

Remove existing tee bracket and install new bracket. The bracket is located on the forward axle carrier and uses the carrier mounting bolts for attachment. See Figure 1. Tighten the attaching bolts 134 to 148 lb. ft. torque at installation of new bracket.
