# NPDES Compliance Inspection Report

## Woodgrain Millwork Nampa, Idaho

NPDES Permit Tracking Number  
# IDR053086

Inspection Date: March 1, 2024

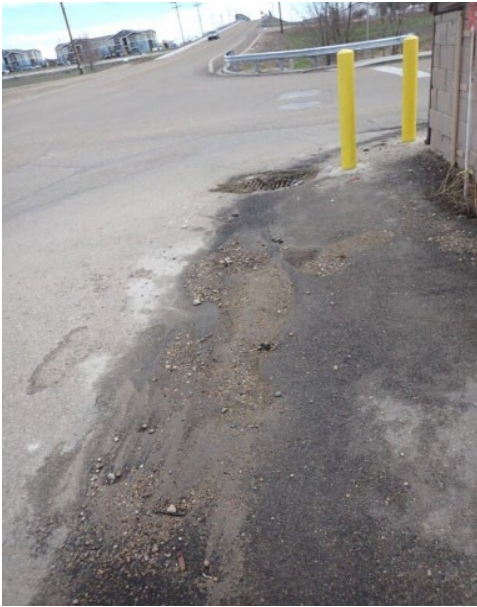
Photo #:01 (P3010250)

Additionally, we observed a storm drain just outside the Facility’s main administrative building in the southern parcel in which Mr. Wood did not know if it belonged to the City of Nampa or if it belonged to the Facility. According to the Facility’s SWPPP site map, it appeared the drain was marked as belonging to the City of Nampa sewer system.

Description: Facing east, photo of sedimentation leading to a storm drain outside the facility's main administrative building on the corner of West Karcher Road and Midland Boulevard. It is not known whether the storm drain belongs to the facility or if it is part of the City of Nampa's MS4 system.

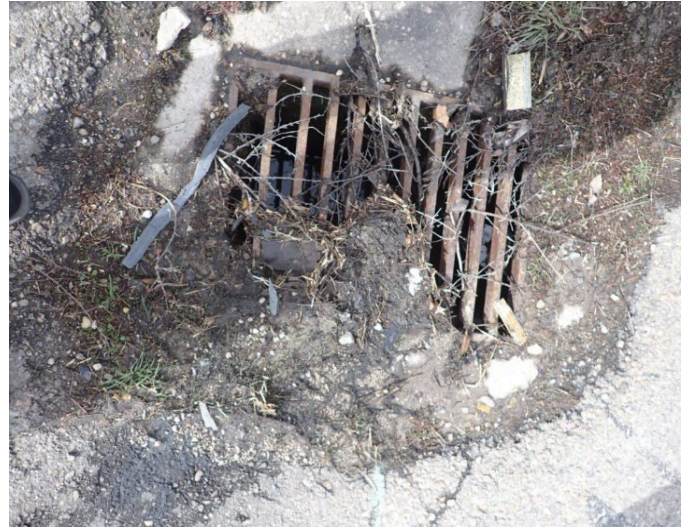
Photo #:02 (P3010251)

Description: Close-up photo of storm drain located outside the facility's main administrative building with sedimentation and debris. It is not known whether the storm drain belongs to the facility or if it is part of the City of Nampa's MS4 system.

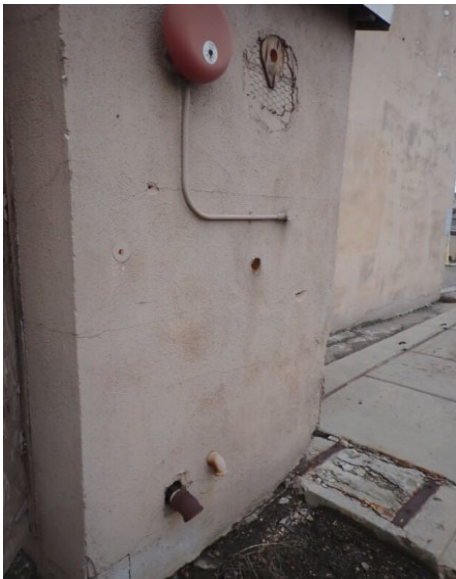
Photo #:03 (P3010259)

We observed the Facility’s main fire system in the southern parcel. Mr. Wood explained it was tested annually and water in the system was drained during that testing. Drained water from the system may leave the Facility via sheet flow or comeingle with stormwater during a rain event. The drained water during planned

Description: Facing north, photo of the facility's main fire system that is drained for testing once a year.

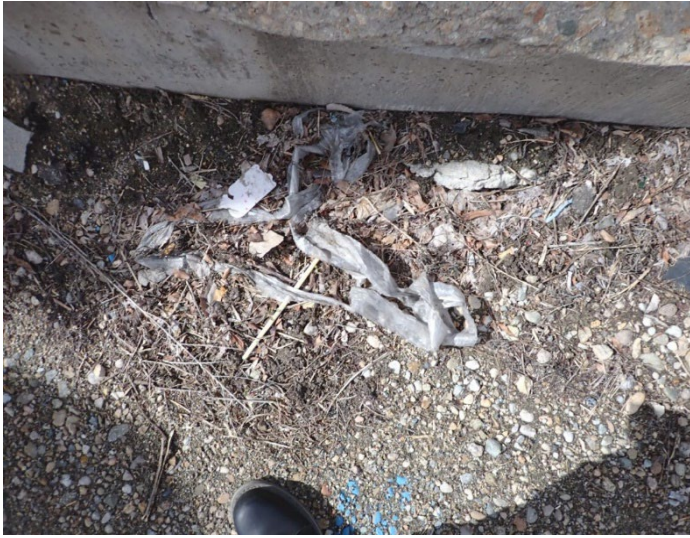
Photo #:05 (P3010261)

During the inspection we observed some debris and garbage in different areas of the Facility grounds including near the Indian Creek bank. Mr. Wood explained there were windy conditions in the past couple of days that may have brought debris and garbage into the Facility. A large garbage dumpster without a lid and otherwise uncovered also was observed at the Facility.

Description: Photo of some debris in the facility's southern parcel.

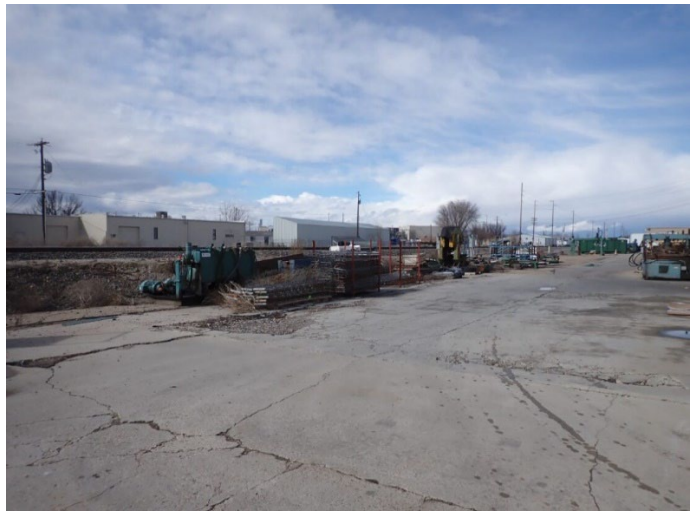
Photo #:07 (P3010269)

During the inspection, we observed various materials stored outside along the western perimeter of the Facility’s southern parcel. Mr. Wood explained the Facility was going through a transition period and the materials we observed were awaiting relocation within the Facility and were only being stored outside temporarily.

Description: Facing northwest, photo of materials temporarily stored outside along the facility's southern parcel's western perimeter. The facility was going through a transition and "work-in-progress" period in which materials outside are awaiting relocation at the facility or pick up for proper disposal.

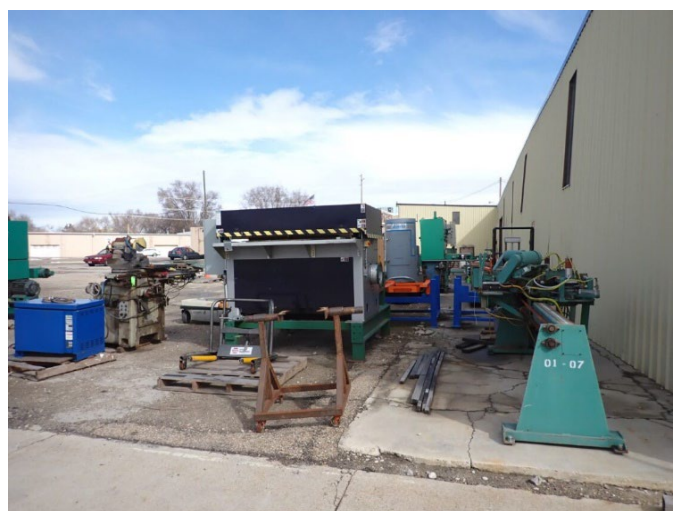
Photo #:08 (P3010275)

Description: Facing northeast, photo of additional materials temporarily stored outside in the facility's southern parcel. The facility was going through a transition and "work-in-progress" period in which materials outside are awaiting relocation at the facility or pick up for proper disposal.

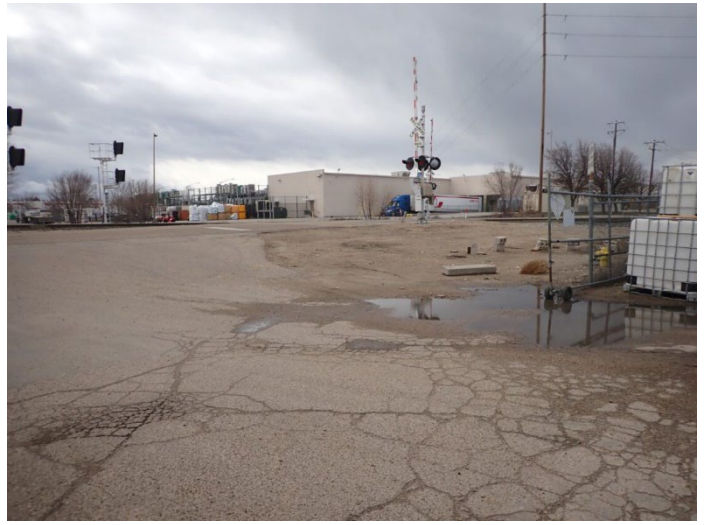
Photo #:10 (P3010286)

During the inspection, we observed stormwater pooling just outside the Facility’s main truck gate where vehicle traffic enters and exits that can lead to offsite tracking of sediment from vehicles.

Description: Facing southwest, photo of the facility's truck gate entrance/exit in the northern parcel with stormwater pooling outside the gate.

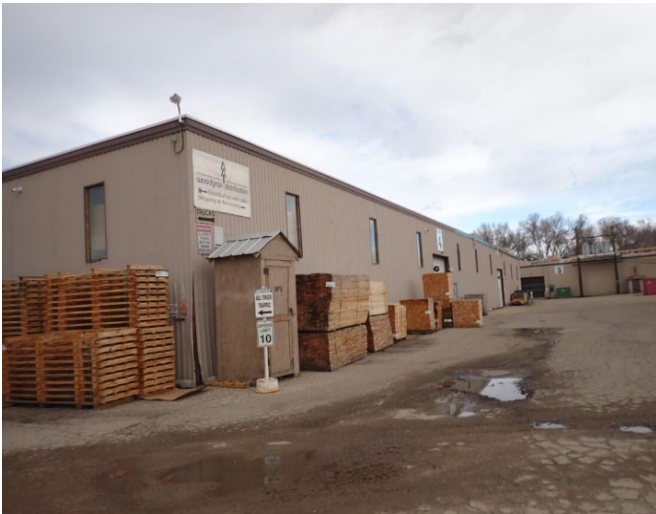
Photo #:11 (P3010290)

Description: Facing northeast, photo of a main truck traffic area in the facility's northern parcel that could be a possible source of vehicle track out to the truck gate during a rain event.

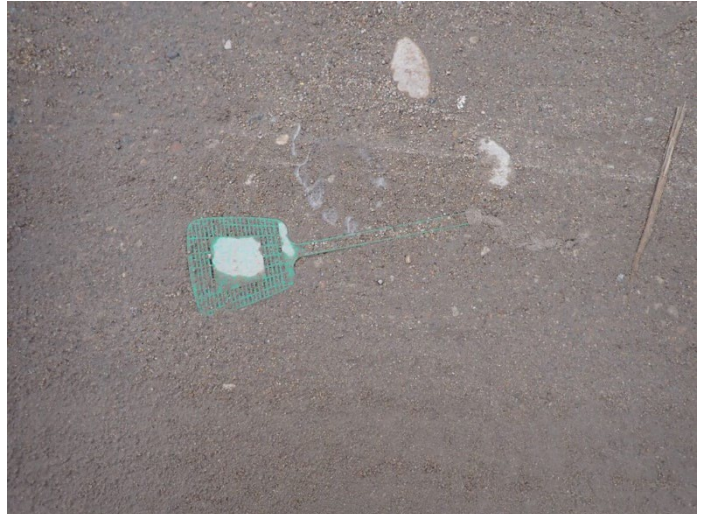
Photo #:12 (P3010293)

Description: Photo of plastic on the ground along the western perimeter of the facility's northern parcel.

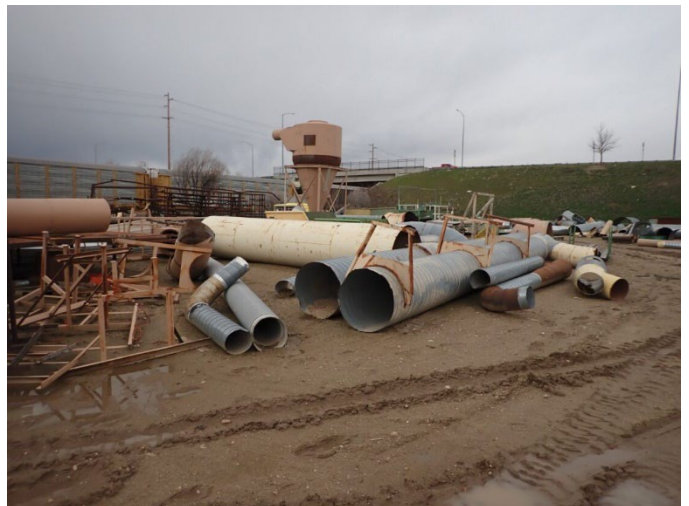
Photo #:16 (P3010316)

We also observed the “boneyard” of outdoor storage of various materials on impervious ground on the northwestern corner of the Facility. Stormwater in this area may not discharge to Indian Creek based on its location and drainage direction into another impervious area serving as an empty lot located directly East of the boneyard on the northeastern corner of the Facility. However, it appeared vehicle traffic occurred in the boneyard based on tire track presence.

Description: Facing northwest, photo of the facility's "boneyard" where materials are stored outside. The boneyard is located on impervious ground on the northwestern corner of the facility's northern parcel.

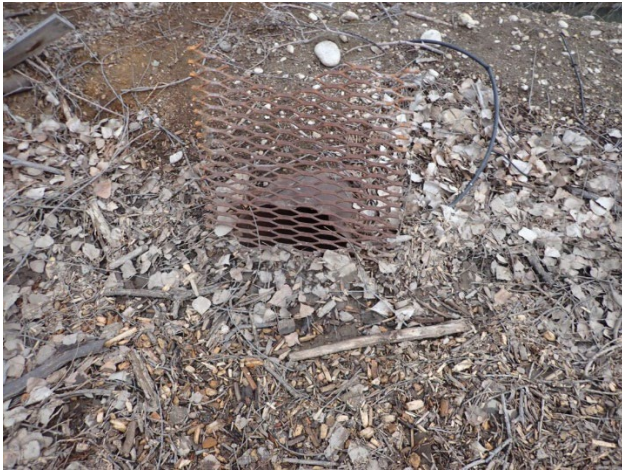
Photo #:23 (P3010347)

The Facility’s stormwater sample collection location, Outfall SW1, is not representative of all industrial activities conducted at the Facility. The Inspection Team observed three other discharge points along the eastern perimeter of the northern parcel that were not identified in the Facility’s SWPPP: one that discharged from a rooftop spout, one unnamed open discharge pipe with a metal screen, and another unnamed discharge pipe in which its source or discharge origin was unknown. No active discharges were observed from those other outfalls. Stormwater runoff and discharge through these other outfalls may come into contact with different industrial activities at the Facility compared to the industrial activity stormwater is exposed to and discharged from the monitored Outfall SW1.

Description: Facing east, photo of an unnamed discharge pipe with a screen to Indian Creek at the facility's eastern perimeter.

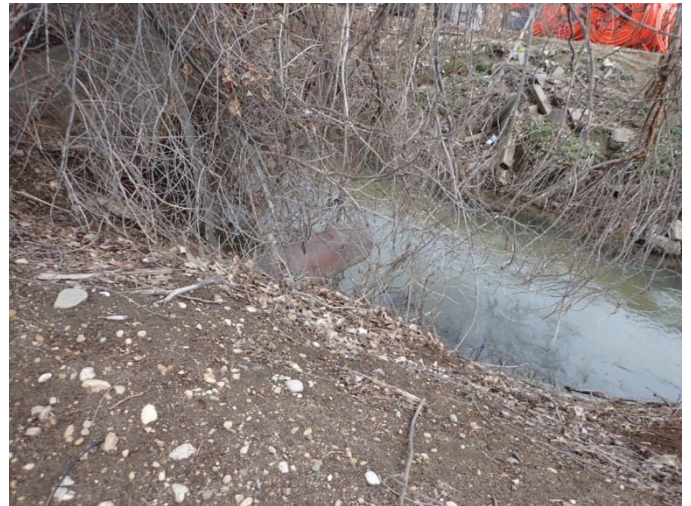
Photo #:24 (P3010348)

Description: Facing northeast, photo of the discharge end of the unnamed discharge pipe that would discharge into Indian Creek. No active discharge at the time of inspection.

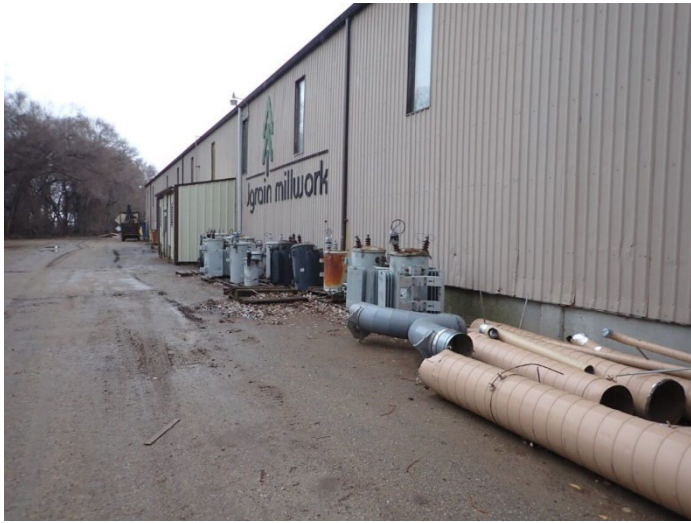
Photo #:25 (P3010353)

Description: Facing southeast, photo of additional material temporarily located outside next to the facility's building on the eastern perimeter.

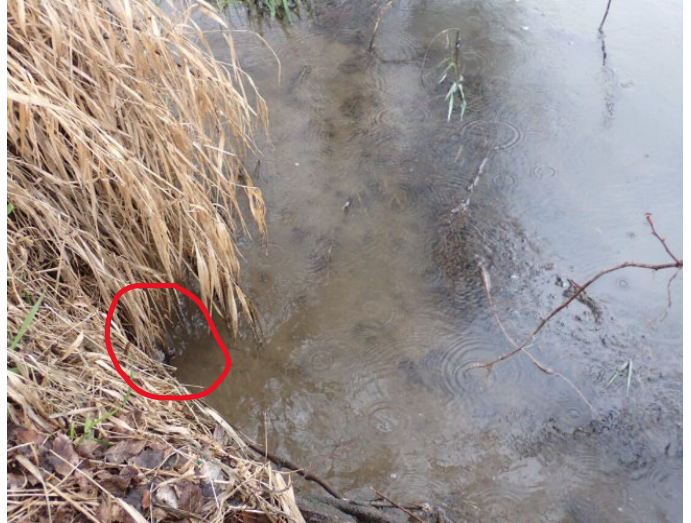
Photo #:26 (P3010356)

Description: Facing north, photo of the facility's monitored discharge point (Outfall SW1) slightly inundated by Indian Creek.

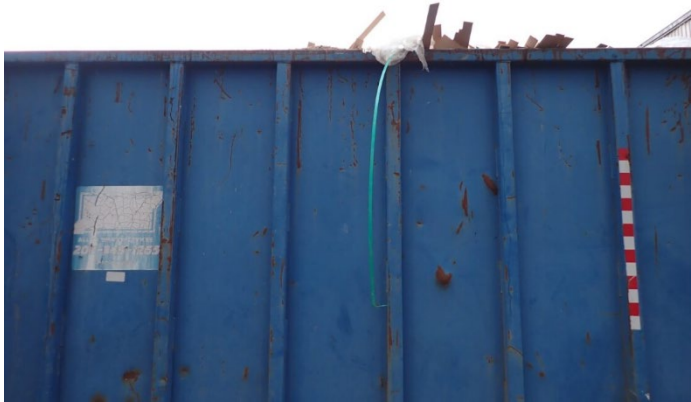
Photo #:27 (P3010358)

Additionally, Section 2.1.2.2.c states that dumpsters that do not have lids and could leak, and “ensure that discharges have a control (e.g., secondary containment)”.

Description: Photo of one of the facility's uncovered dumpsters.

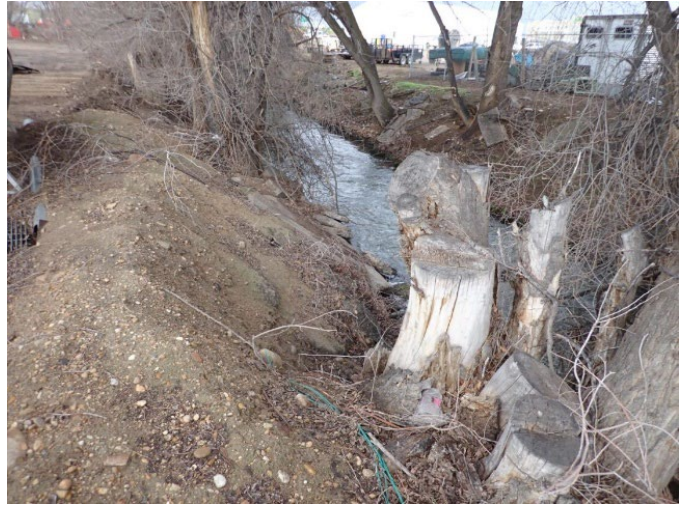
Photo #:30 (P3010365)

We observed loose material that make up a berm serving as a BMP along the Facility’s eastern perimeter in the northern parcel. Additional possible erosion and destabilization was observed adjacent to Indian Creek on the Facility’s eastern perimeter near a gated path leading to the Facility’s eastern parking area.

Description: Facing northwest, photo of possible erosion along some portion the facility's eastern perimeter's berm.

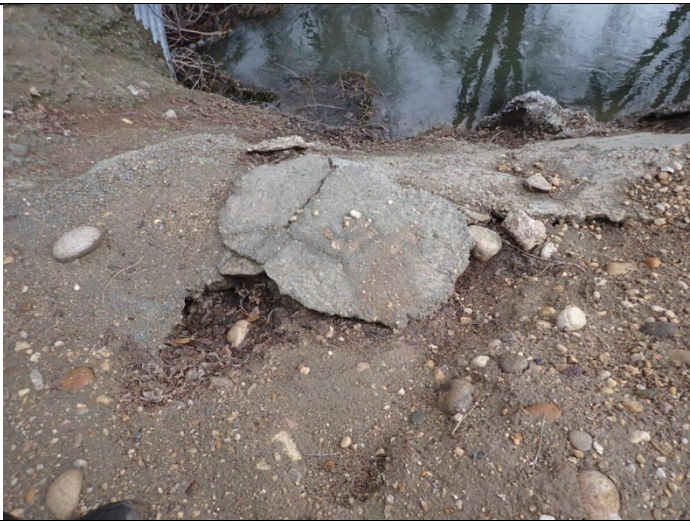
Photo #:31 (P3010369)

Description: Facing east, photo of possible erosion and destabilization along the facility's eastern perimeter potentially caused by rock chucks (small mammals) digging/burrowing.

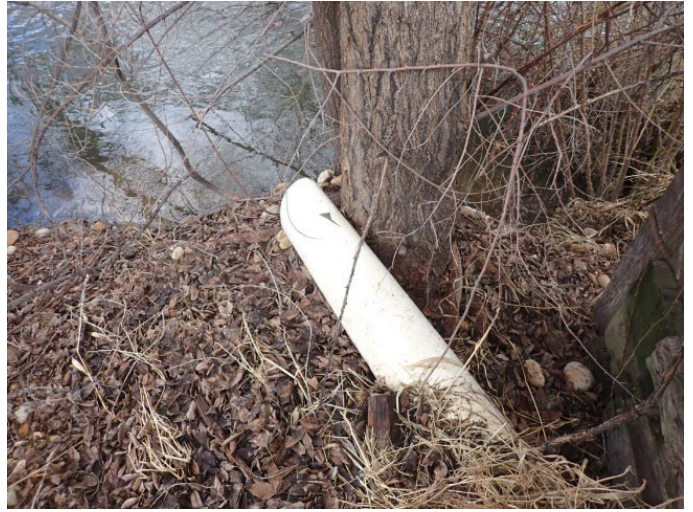
Photo #:34 (P3010391)

Description: Facing north, photo of another unnamed pipe that may or may not discharge into Indian Creek from an unknown source/location.

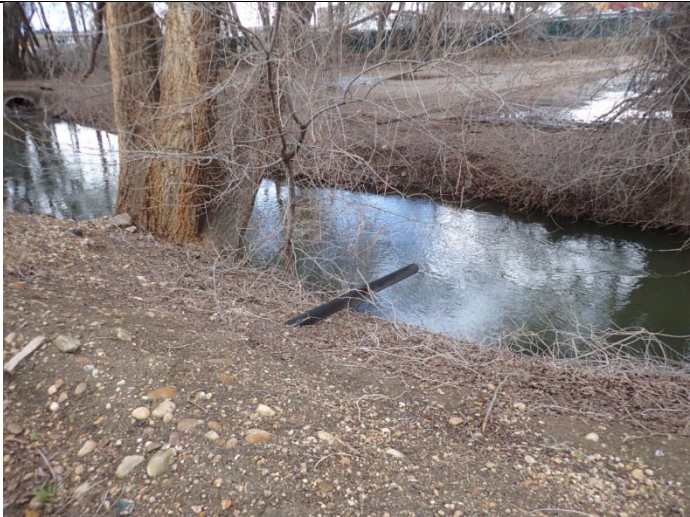
Photo #:35 (P3010393)

Description: Facing north, photo of a discharge pipe into Indian Creek from a rooftop downspout in the eastern part of the facility.

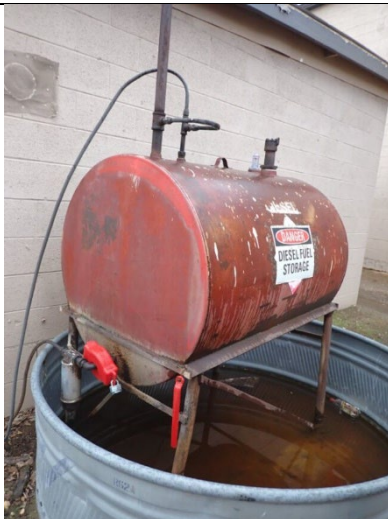
Photo #:39 (P3010389)

During the inspection, we observed several areas of fuel storage tanks and waste/spent oil and antifreeze in which spill kits were not seen in the vicinity of these areas. Spill kits were not seen throughout the entire site walkthrough; however, they may have been located inside a building that was not visited by the inspection team. Additionally, a fuel storage tank in the Facility’s northern parcel did not have legible NFPA labeling.

Description: Photo of a Facility diesel storage tank with secondary containment missing the NFPA label. A plastic bottle was also inside the secondary containment.

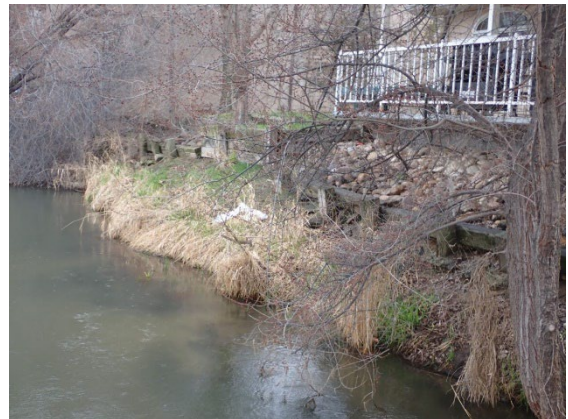
Photo #:40 (P3010401)

Description: Facing southeast and standing from the Facility's eastern parking area, photo of debris close to the western bank of Indian Creek behind the Facility's break room.
