### Compliance Inspection Report for Stormwater Discharges from Construction Activities (CGP)

| <b>Site/Project Name:</b> Insurance Auto Auctions-Millington | <b>NPDES Tracking Number:</b> TNR155426 | <b>Date Coverage was Issued:</b> 8/4/2023 |

**Entry Date/Time:** July 10<sup>th</sup>, 2024 / 9:00 AM

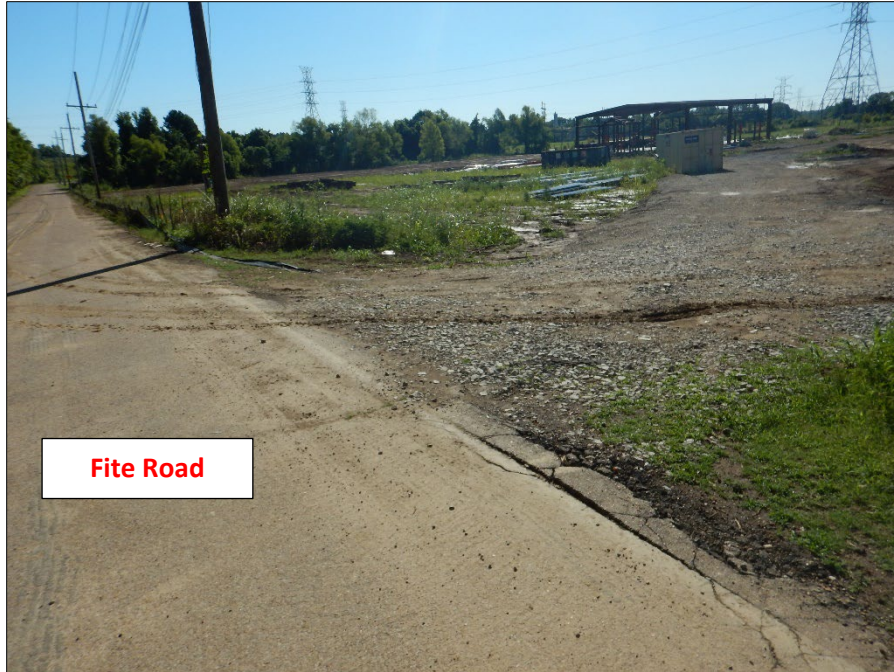
| d. Are EPSCs functioning correctly at ingress/egress points such that there is no evidence of track out? | No | <p>The Operator had not installed a stabilized construction entrance or other sediment control at the site entrance/exit off Fite Road [Refer to <b><u>Appendix B, Photograph Log (Photograph 1)</u></b>].</p> <p>Sediment track out was observed leaving from the Site onto Fite Road from the construction entrance/exit [Refer to <b><u>Appendix B, Photograph Log (Photograph 1)</u></b>].</p> |

The EPA Inspection Team observed one (1) construction entrance along Fite Road that was not stabilized [Refer to **Appendix B, Photograph Log (Photograph 1)**]. Sediment track out was observed leaving from the Site onto Fite Road from the construction entrance/exit [Refer to **Appendix B, Photograph Log (Photograph 1)**].

Photograph 1. View, facing northeast, of a Site entrance/exit off Fite Road. The entrance/exit did not have sediment controls, and sediment track out was observed leading from the Site onto Fite Road.

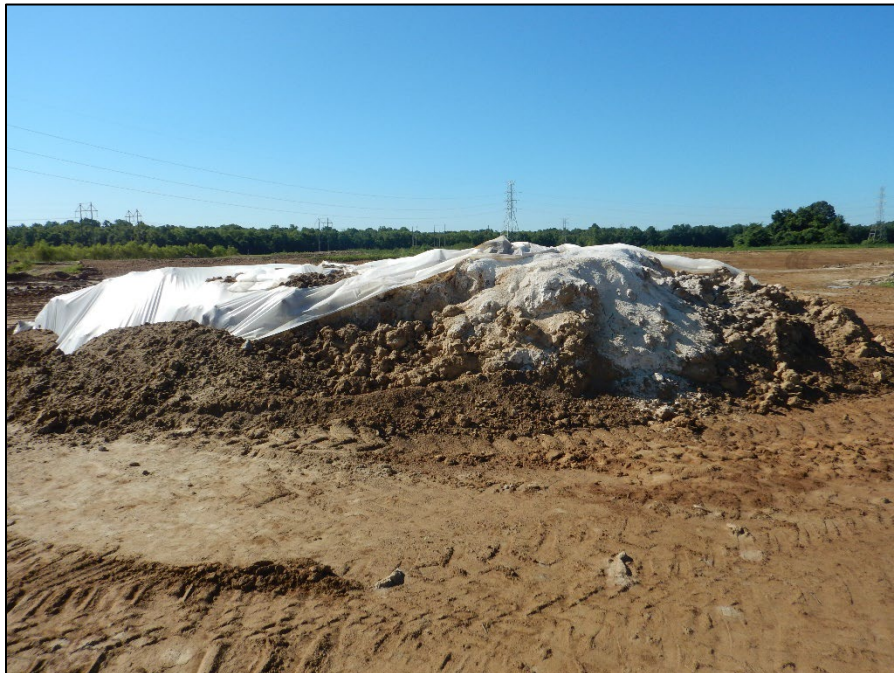
| <b>p. Proper Storage &amp; Control of Construction Debris &amp; Chemicals (i.e., sand, litter, paint, solvents, petroleum, &amp; etc.)</b> | No | The EPA Inspection Team observed one (1) partially covered lime and dirt pile without erosion or sediment controls in the center of the Site [Refer to <b><u>Appendix B, Photograph Log (Photograph 2)]</u></b> . |

Photograph 2. View, facing south, of a partially covered pile of lime and dirt in the center of the Site without erosion or sediment controls.

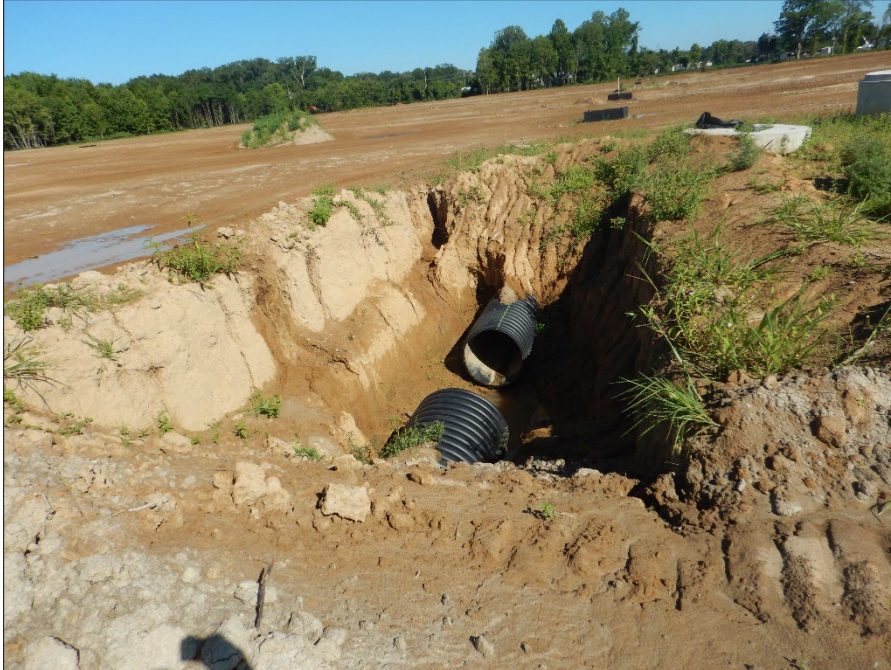
Photograph 3. View, facing northwest, of corrugated piping that was being installed in the southern portion of the Site.

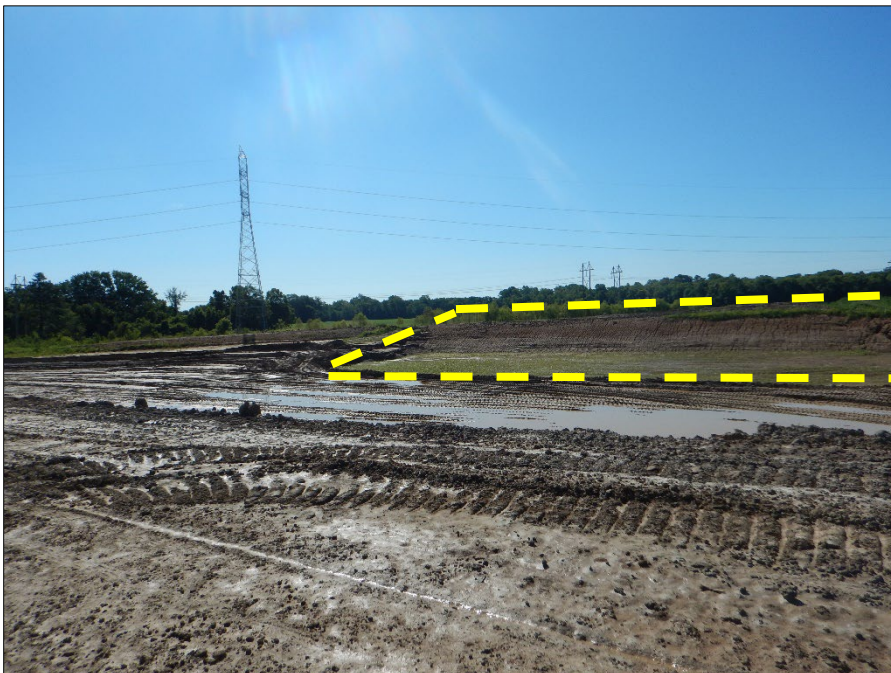
Photograph 4. View, facing southeast, of a disturbed area and sediment basin (dotted yellow lines) in the southeastern portion of the Site.

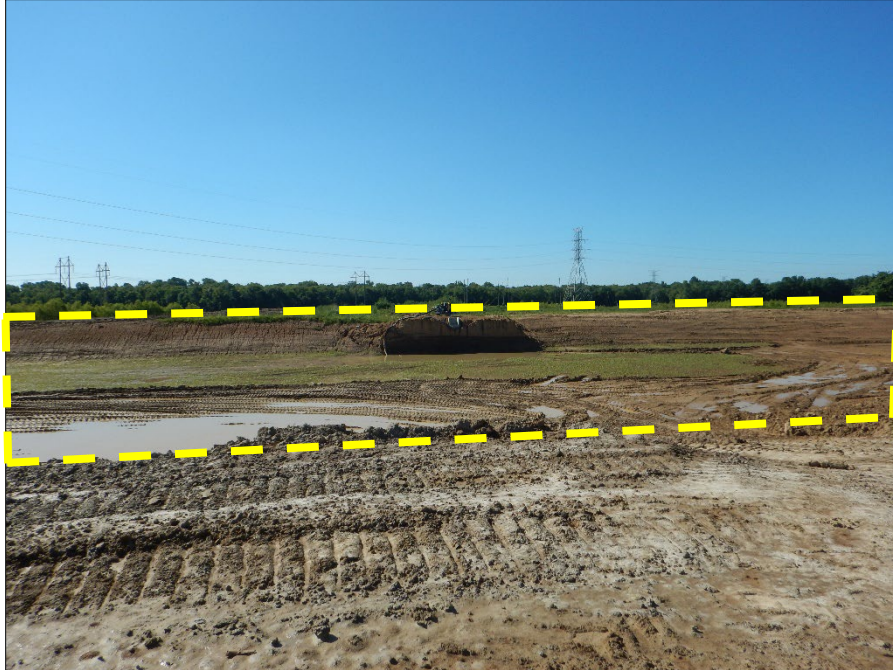
| b. Are EPSCs functioning correctly at all disturbed areas/material storage areas? | No | <p>At the time of the inspection, the Site's sediment basin was under construction, with two (2) of the four (4) planned inlets already constructed. With the sediment basin still being under construction, it was actively being used to collect surface flow from the Site, with no stabilization present along the embankments.</p> <p>According to the EPSC, the sediment basin should have been completely constructed before being used to collect and treat stormwater [Refer to <b><u>Appendix B, Photograph Log (Photographs 5-7, and 9)</u></b>].</p> |

Photograph 5. View, facing southeast of the sediment basin in the southeastern portion of the Site. At the time of the inspection, the basin had not been stabilized, but was being utilized by the Permittee as a temporary basin during construction.

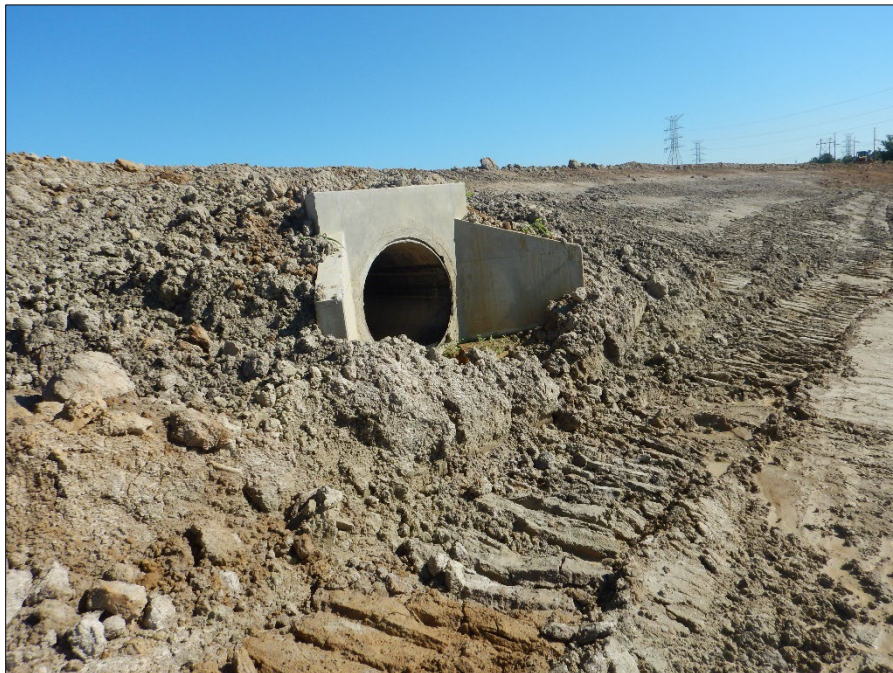
Photograph 6. View, facing north, of a headwall and pipe leading into the basin shown in [Photograph 5](#). At the time of the inspection, the stormwater piping had not been connected to this basin but had been connected to others.

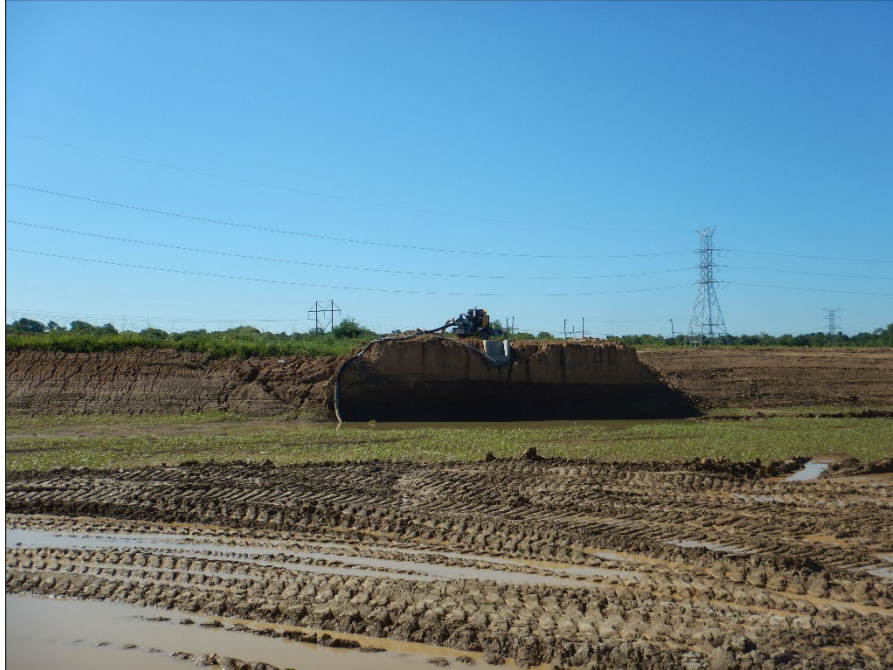
Photograph 7. View, facing southeast, inside the sediment basin shown in Photograph 5.

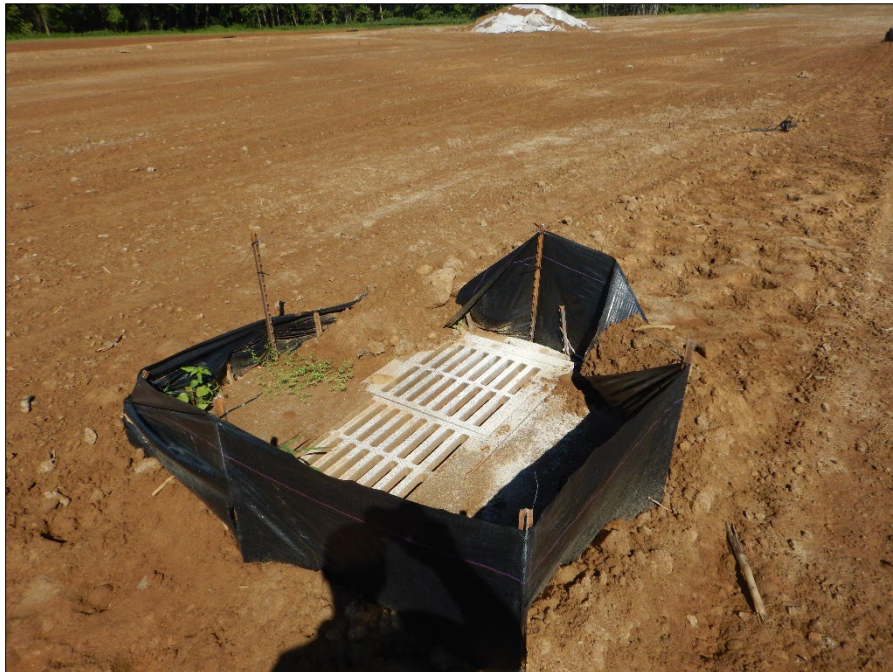
| | | <p><b><u>Photograph Log (Photograph 23)]</u></b>.</p> <p>One (1) inlet in the center portion of the Site had sediment deposited over the silt fence protection and into the inlet. The EPSC plan indicated that the inlet protection is a mineral aggregate mound surrounding the inlet [Refer to <b><u>Appendix B, Photograph Log (Photograph 8)]</u></b>.</p> |

Photograph 8. View of an inlet in the center of the Site where sediment had been deposited over the silt fence inlet protection and into the inlet.

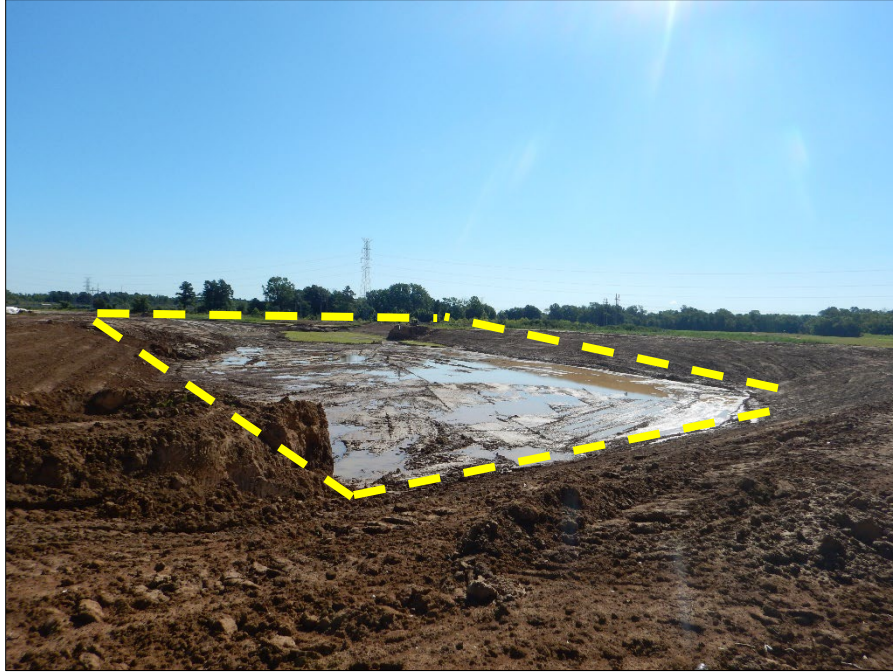
Photograph 9. View, facing northeast, of the basin shown in Photographs 4, 5, and 7.

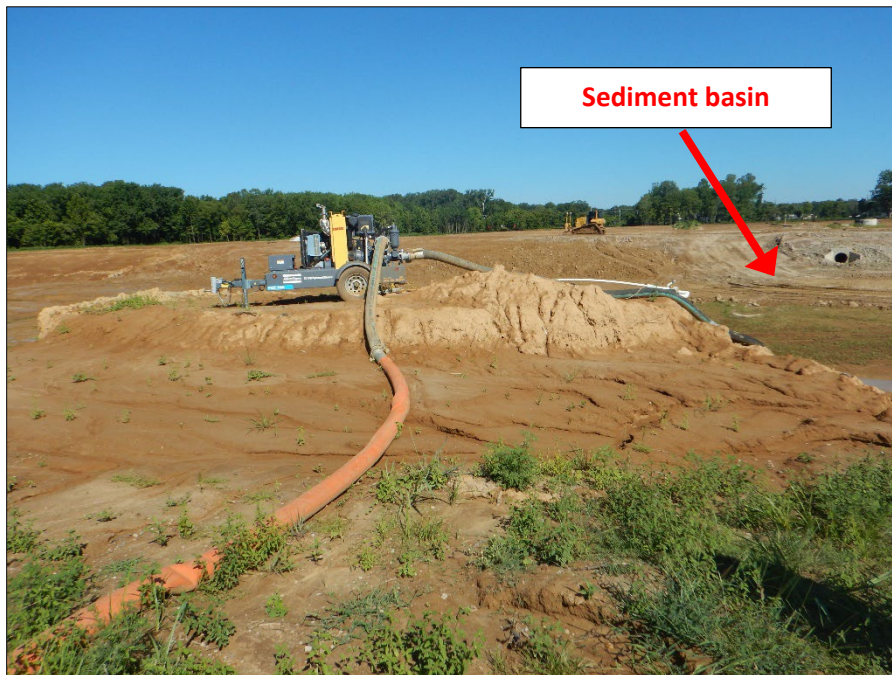
| e. If applicable, have discharges from dewatering activities been managed by appropriate controls? (permit section 4.1.3) If "No," describe below the measure to be implemented to address deficiencies. | Yes | The EPA Inspection Team observed one (1) pump at the sediment basin for the removal of excess water from the basin. The pump discharged to the southeast into a constructed channel, which then discharges to an open field further southeast. No pollutants were observed in the discharged waste at the time of the inspection [Refer to <b><u>Appendix B, Photograph Log (Photographs 10-12)</u></b> ]. |

Photograph 10. View, facing southwest, of a pump removing water from the sediment basin.

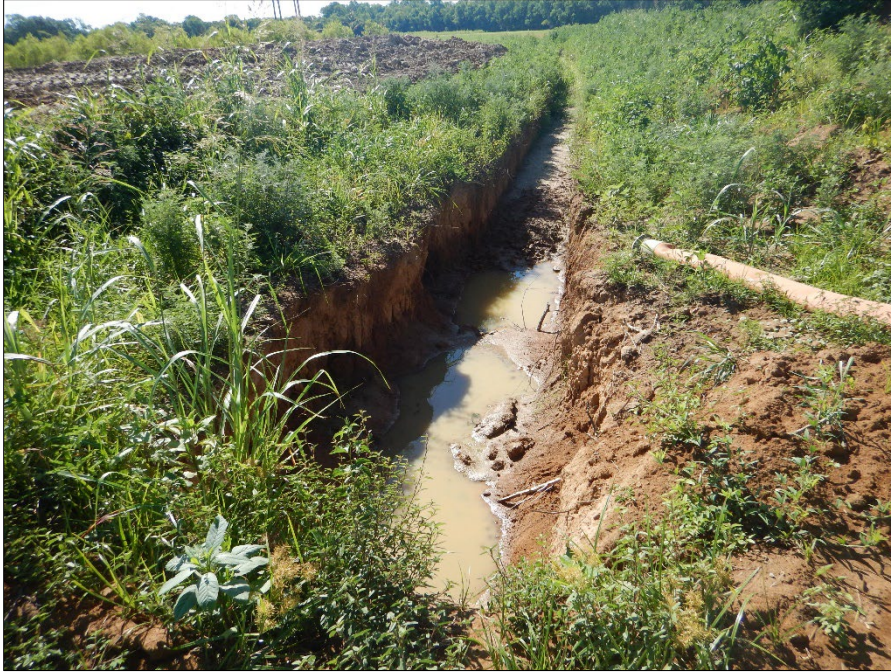
| c. Are EPSCs functioning correctly at outfall/discharge points such that there is no objectionable color contrast in the receiving stream, and no other water quality impacts? | No | <p>The EPA Inspection Team observed that the southwestern corner of the Site had sediment accumulation with no EPSCs present [Refer to <b><u>Appendix B, Photograph Log (Photograph 18)</u></b>].</p> <p>The EPA Inspection Team observed a constructed channel that went from the sediment basin pump to the Site's perimeter silt fence. The manmade channel's discharge point was being used as the outlet for the sediment basin pump. No pollutants were observed in the discharged waste at the time of the inspection [Refer to <b><u>Appendix B, Photograph Log (Photographs 11 and 12)</u></b>].</p> |

Photograph 11. View, facing southeast, of a manmade trench used for the discharge of the water pumped from the sediment basin.

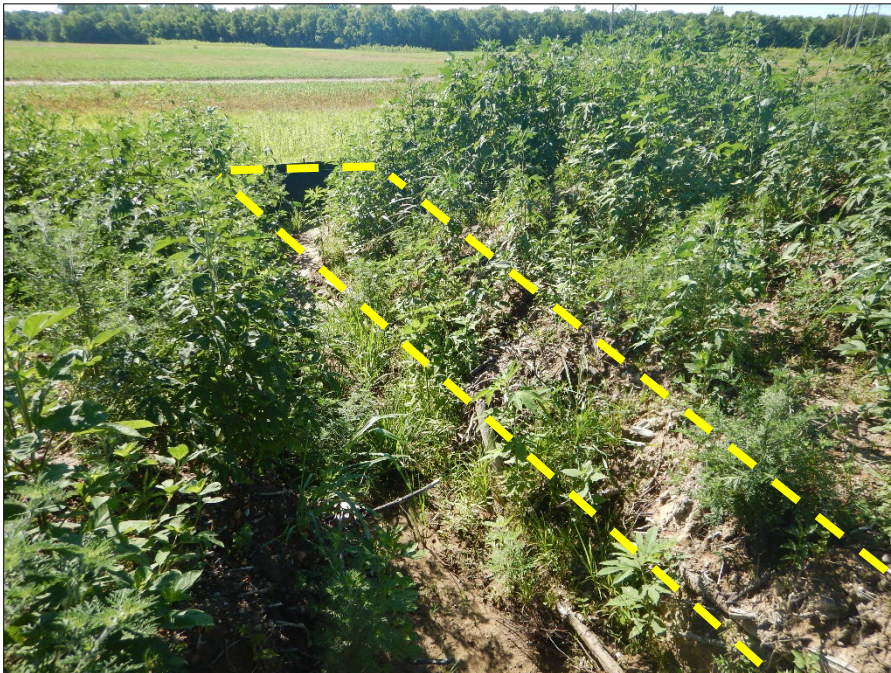
Photograph 12. Additional view, facing southeast, of the manmade channel (yellow outline) shown in Photograph 11. There was no evidence of sediment extending beyond the channel or offsite.

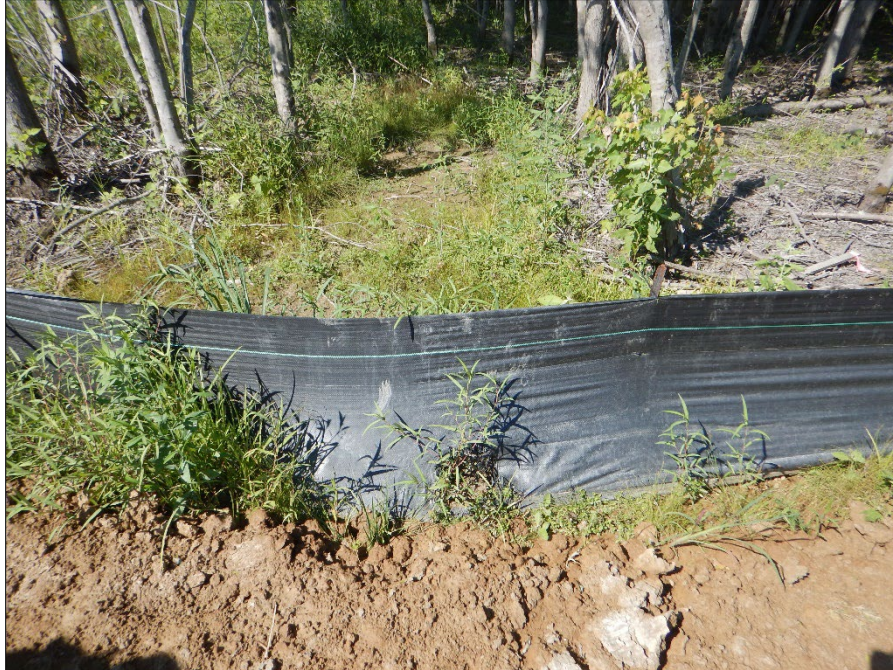
Photograph 13. View, facing southwest, of sediment and vegetation against the perimeter silt fence in the southern portion of the Site.

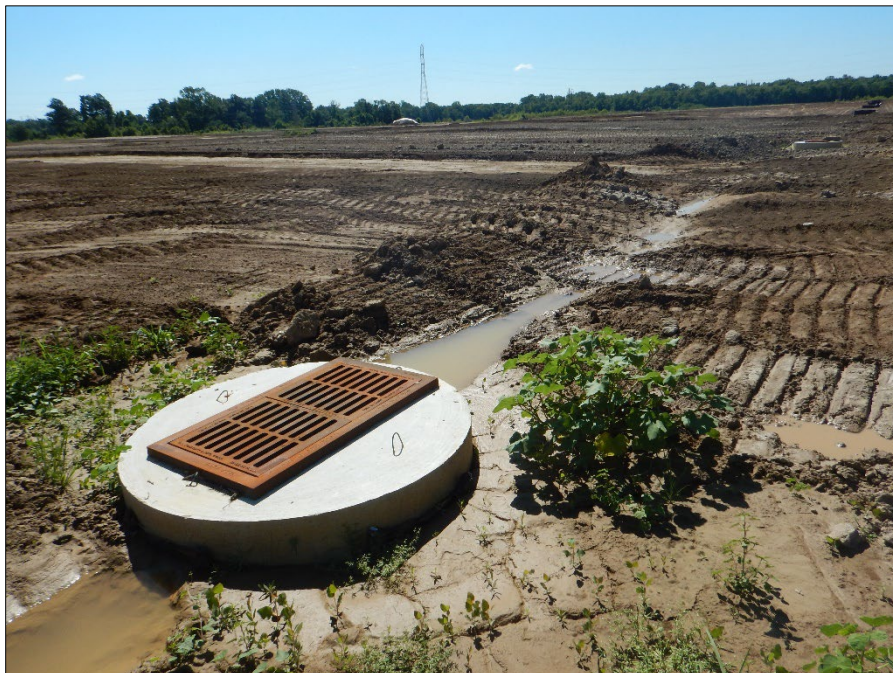
Photograph 14. View, facing east, of a raised inlet in the center of the Site.

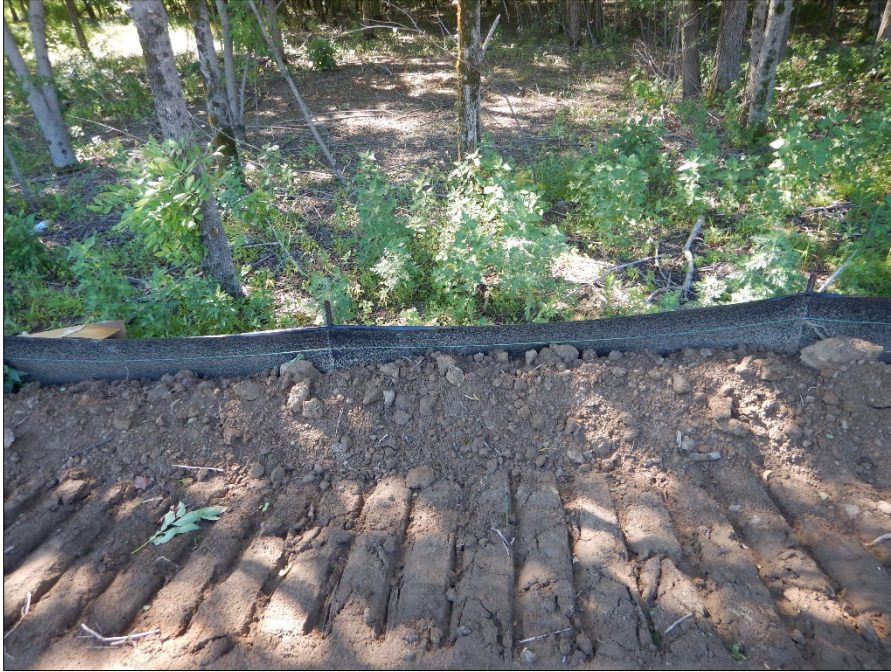
| current phase? | | The EPA Inspection Team observed sediment accumulation to the height of the silt fence in the southern, southwestern, western, and eastern portions of the Site [Refer to <b><u>Appendix B, Photograph Log (Photographs 15-17, 19-22, and 25)</u></b> ]. |

The EPA Inspection Team observed silt fence with sediment accumulation that reduced the capacity of the control by at least 50% [Refer to **Appendix B, Photograph Log (Photographs 15-17, 19-22, and 25)**] [Refer to **Appendix C, Exhibit Log (Exhibit 2)**].

Photograph 15. View, facing southwest, of sediment accumulation against the silt fence along the Site's southern boundary. Sediment had accumulated to at least half the height of the silt fence.

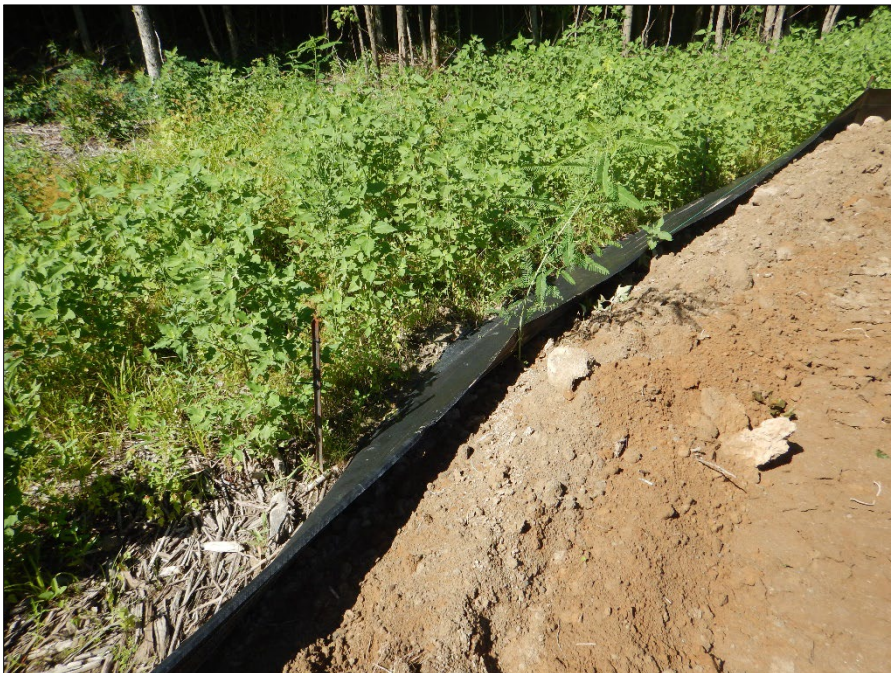
Photograph 16. View, facing south, of sediment accumulation against the silt fence in the southwestern portion of the Site. Silt fence in the area had separated from posts and required maintenance or reinstallation.

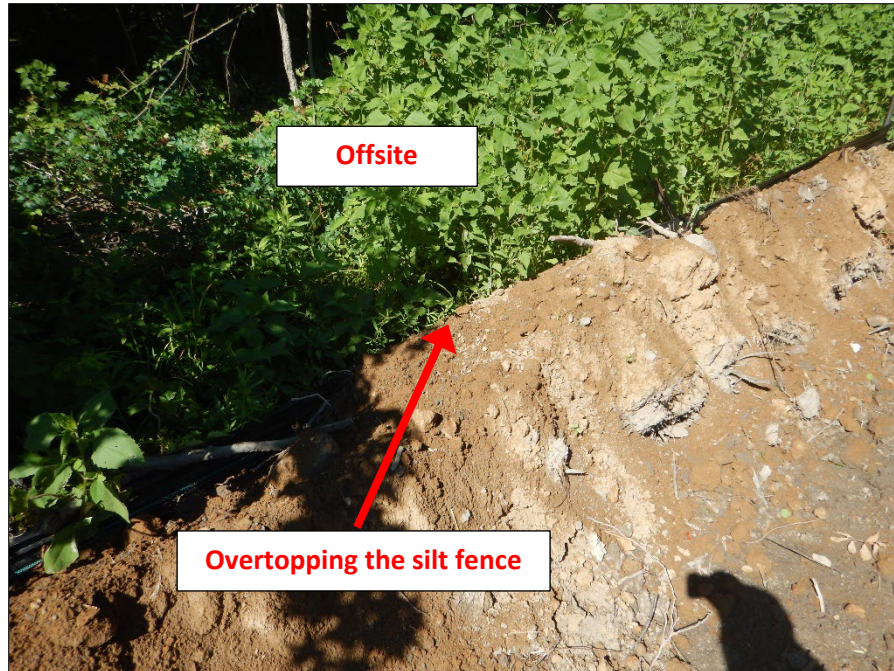
| Outfall, Stormwater Discharge & Receiving Water | YES | NO | |
|---|---|---|---|
| <b>c. Non-stormwater discharge observed</b> | X | | The EPA Inspection Team observed sediment discharge offsite in the southwestern, western, and eastern portions of the Site [Refer to <b><u>Appendix B, Photograph Log (Photographs 17, 18, 19, and 20)]</u></b> . |

The EPA Inspection Team observed evidence of sediment discharge offsite [Refer to **Appendix B, Photograph Log (Photographs 17, 18, 19, and 20)**].

Photograph 17. View, facing south, of sediment accumulation overtopping the silt fence in the southwestern portion of the Site.

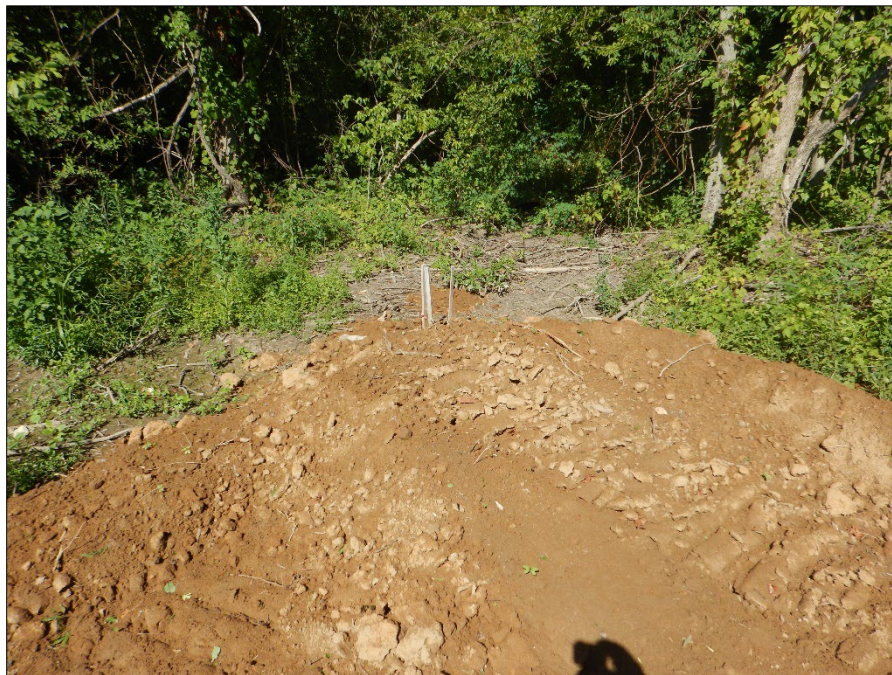
Photograph 18. View, facing west, of a lack of perimeter controls (e.g., silt fence) in the southwestern portion of the Site.

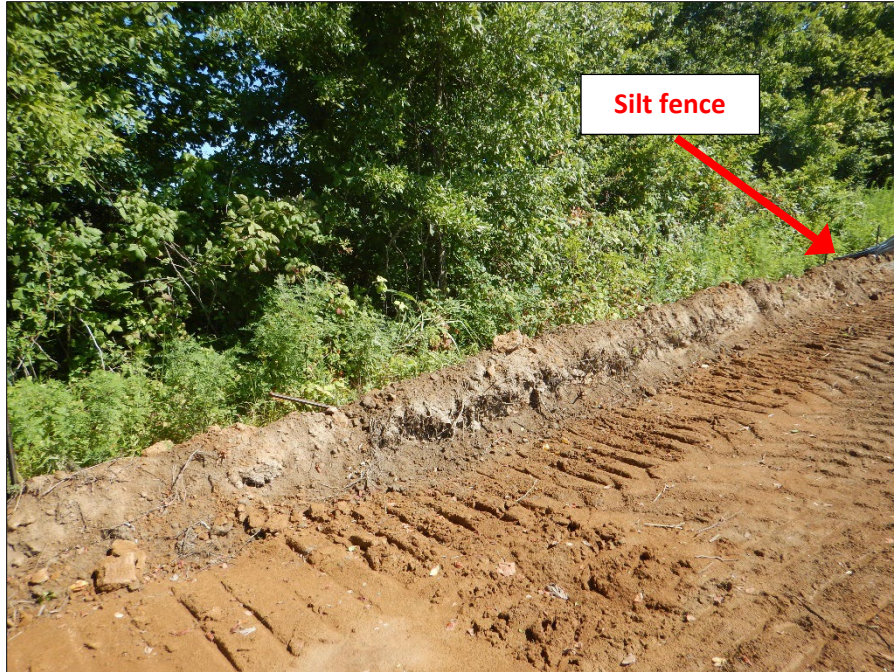
Photograph 19. View, facing north, of sediment accumulation overtopping the silt fence in the western portion of the Site.

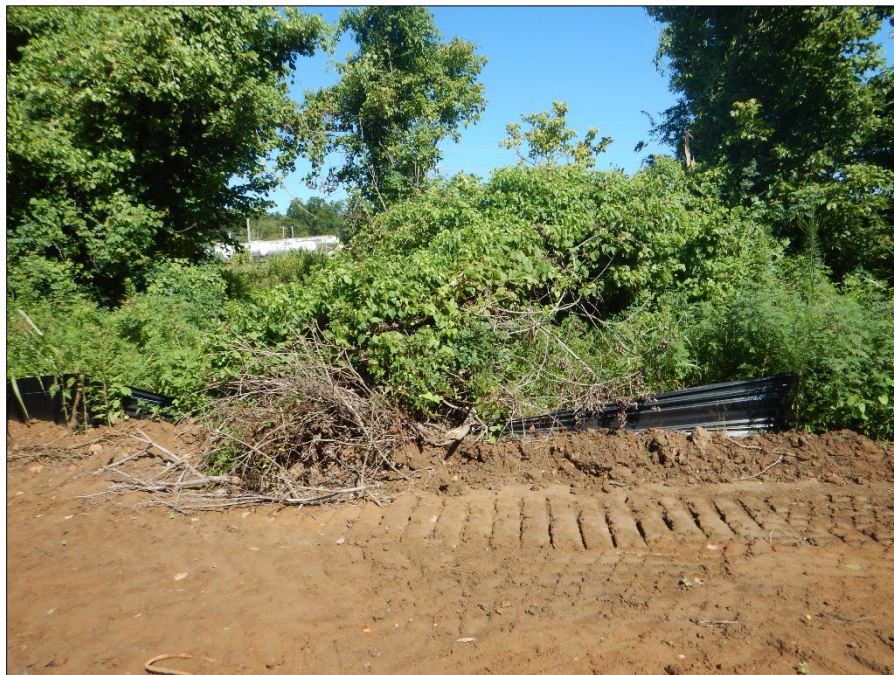
Photograph 20. View, facing east, of vegetation that had fallen and partially collapsed the silt fence on the eastern boundary of the Site.

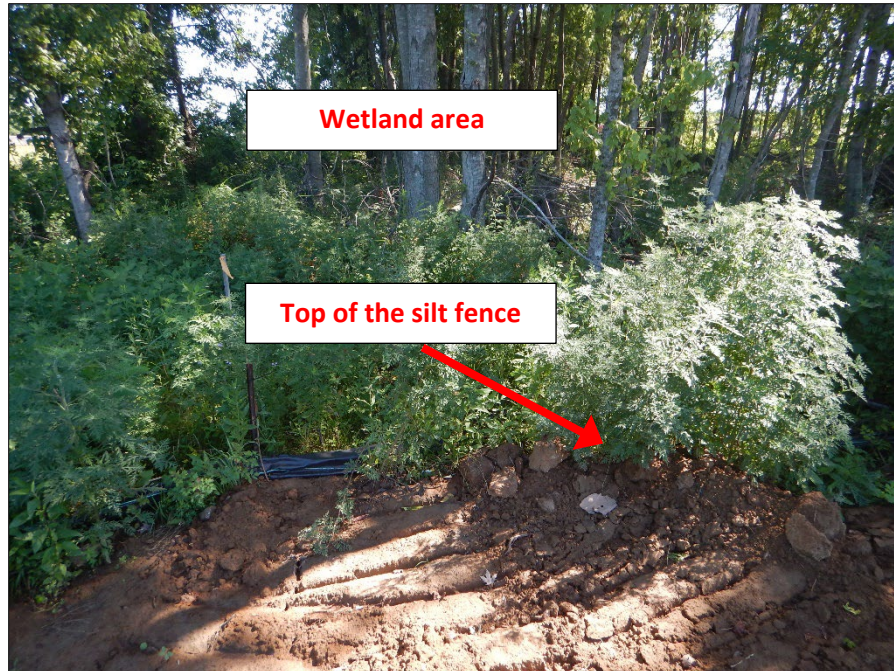
Photograph 21. View, facing northeast, of sediment accumulation to the height of the silt fence in the western portion of the Site.

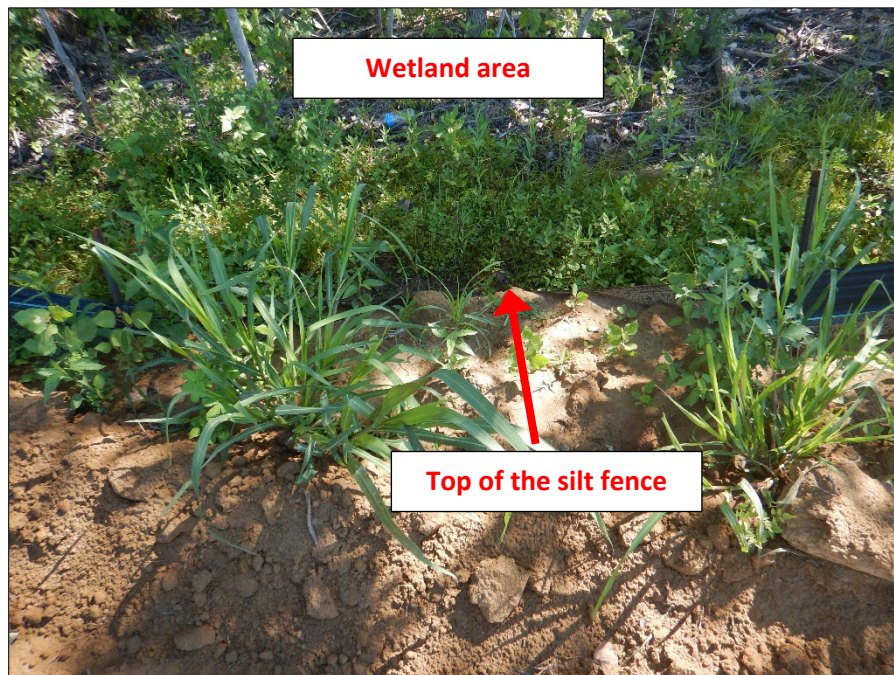
Photograph 22. View, facing northeast, of sediment accumulation to the height of the silt fence in the western portion of the Site.

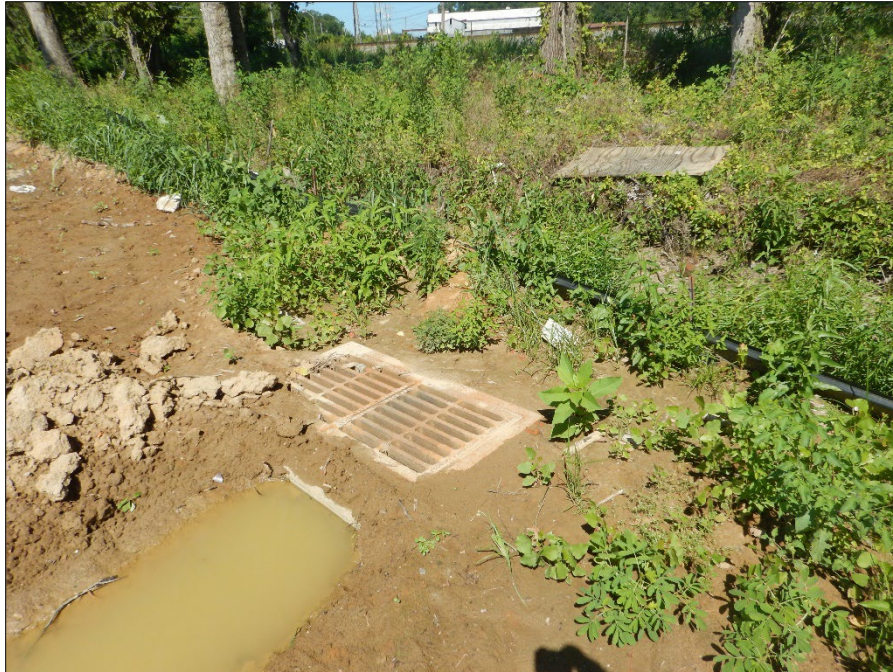
| k. Storm Drain Inlet/Outlet<br>Protection (Specify: Filter<br>Fabric, Gravel Bags, etc.) | No | One (1) inlet on the northwestern portion of the Site, between<br>the northernmost wetland and the construction entrance off Fite<br>Road before the railroad crossing, was unprotected and was<br>surrounded with accumulated sediment. The EPSC indicated that<br>the inlet should have protection in the form of a mineral<br>aggregate mound surrounding it [Refer to <b>Appendix B,</b> |

Photograph 23. View, facing southeast, of an inlet without any inlet protection to prevent sediment intrusion.

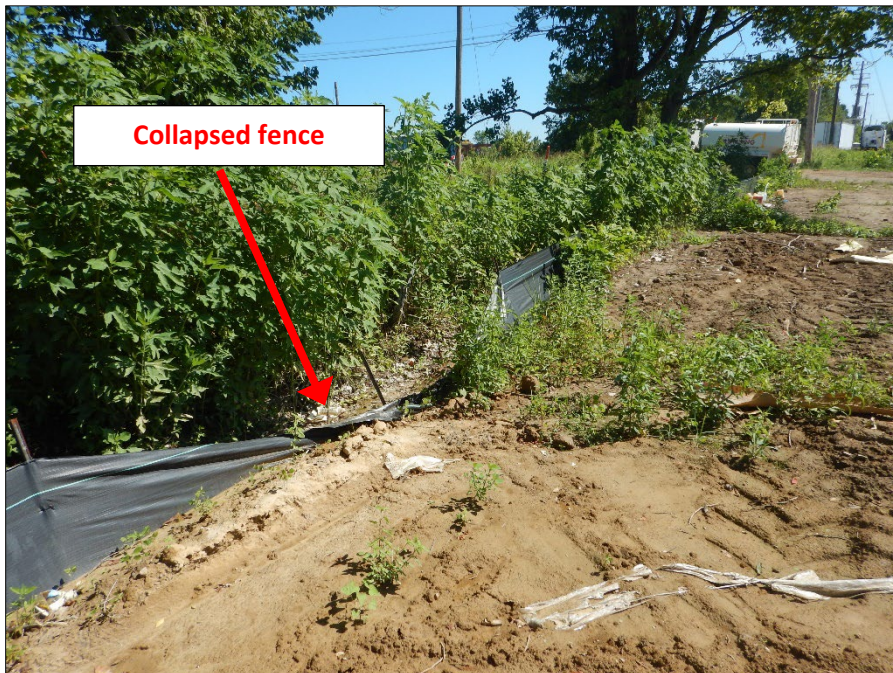
Photograph 24. View, facing southeast, of a collapsed silt fence along the Site's eastern boundary.

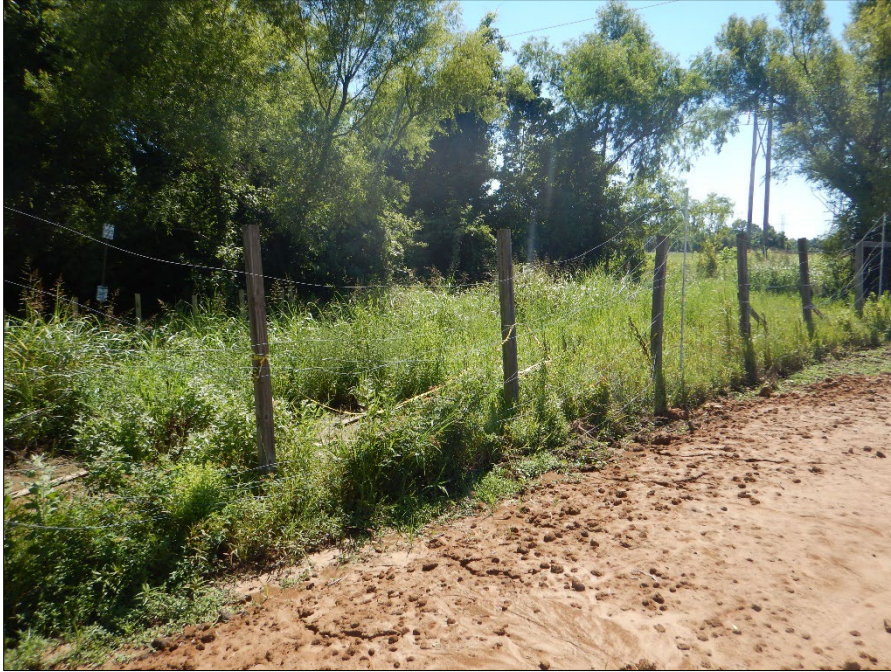
| Erosion Prevention and Sediment Controls (EPSCs) | Check BMPs Listed in the Plan | Note location, quantitative description, design issue, O&M deficiencies (including the nature and extent), and sediment off site in accordance with the <u>Tennessee Erosion Prevention &amp; Sediment Control Handbook</u> . |
|---|---|---|
| <b>a. Are all applicable EPSCs installed and maintained per the SWPPP per the</b> | No | The EPA Inspection Team observed that EPSC measures, namely the silt fence and check dams present in the EPSC plan, were not installed at the northeastern boundary of the Site. |

Photograph 25. View, facing northeast, of the northern boundary of the Site. According to the Site EPSC Plan, the Site should have silt fence along the northeastern boundary of the site. However, at the time of the inspection, no silt fence was present.
