| Inspection Date(s): | 07/23/2019 | | |
| Media: | RCRA | | |
| Regulatory Program(s) | Subtitle C – Hazardous Waste | | |
| Company Name: | <b>M&amp;K Plating, Inc.</b> | | |

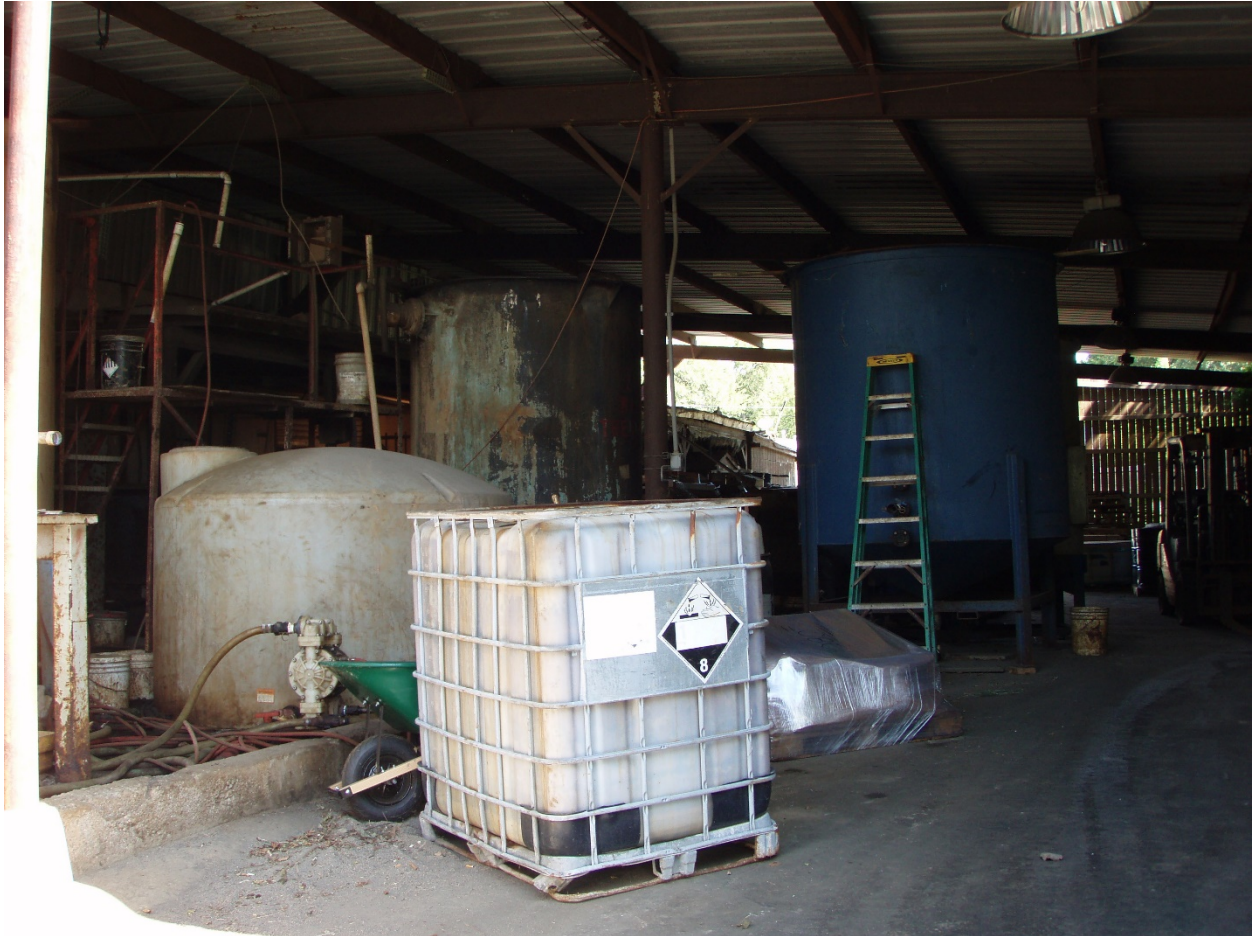
Photo File Name: P7230002

Mr. Curry started the tour at the receiving and shipping area where customers and products are received and shipped (Appendix C, photographs 3). The wastewater treatment area is directly across from the receiving area (Appendix C, photographs 2).

Description: View of wastewater treatment area (left). Receiving area is located off photo to the right.

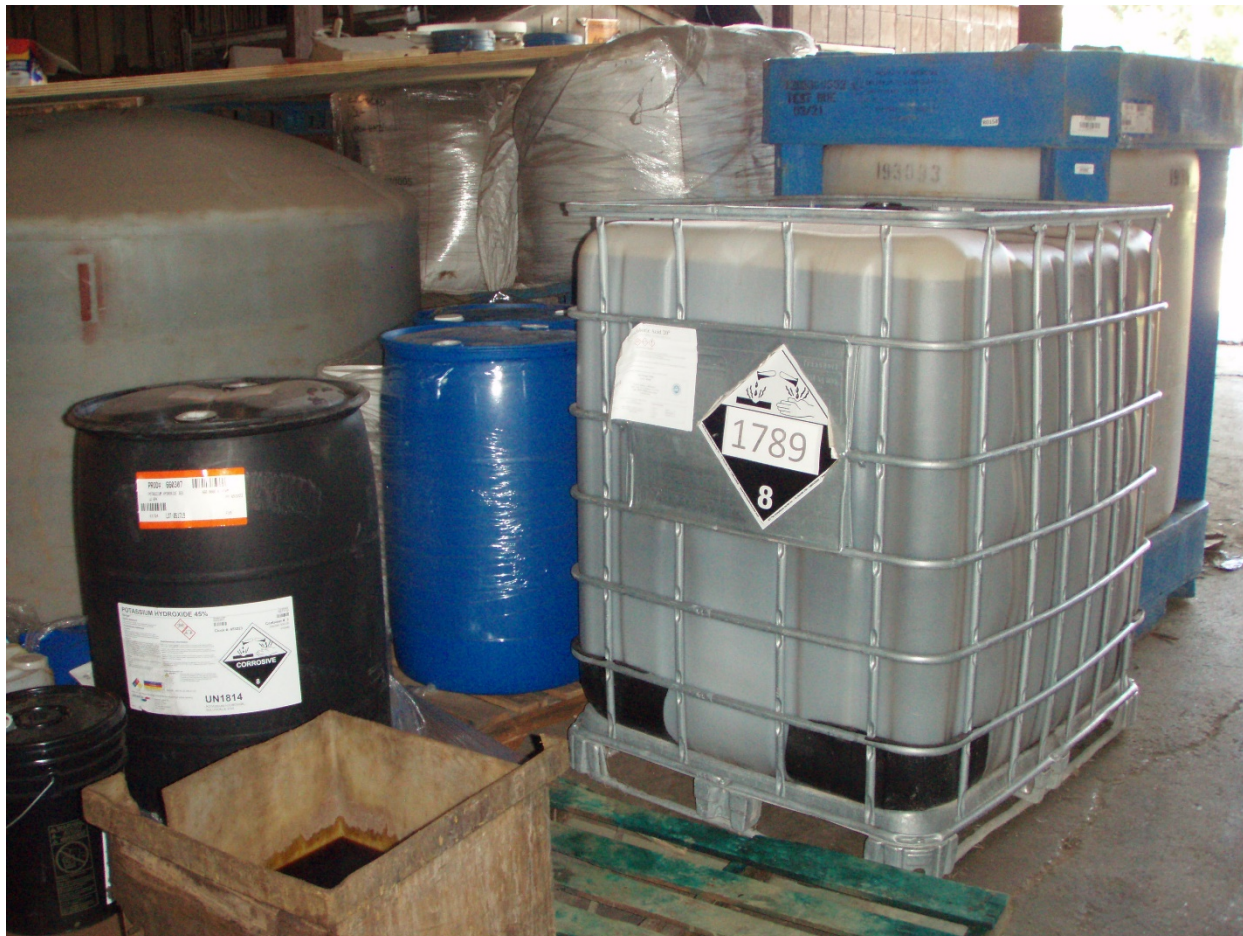
Photo File Name: P7230005

Description: Chemical storage area. Products used in processes on site.

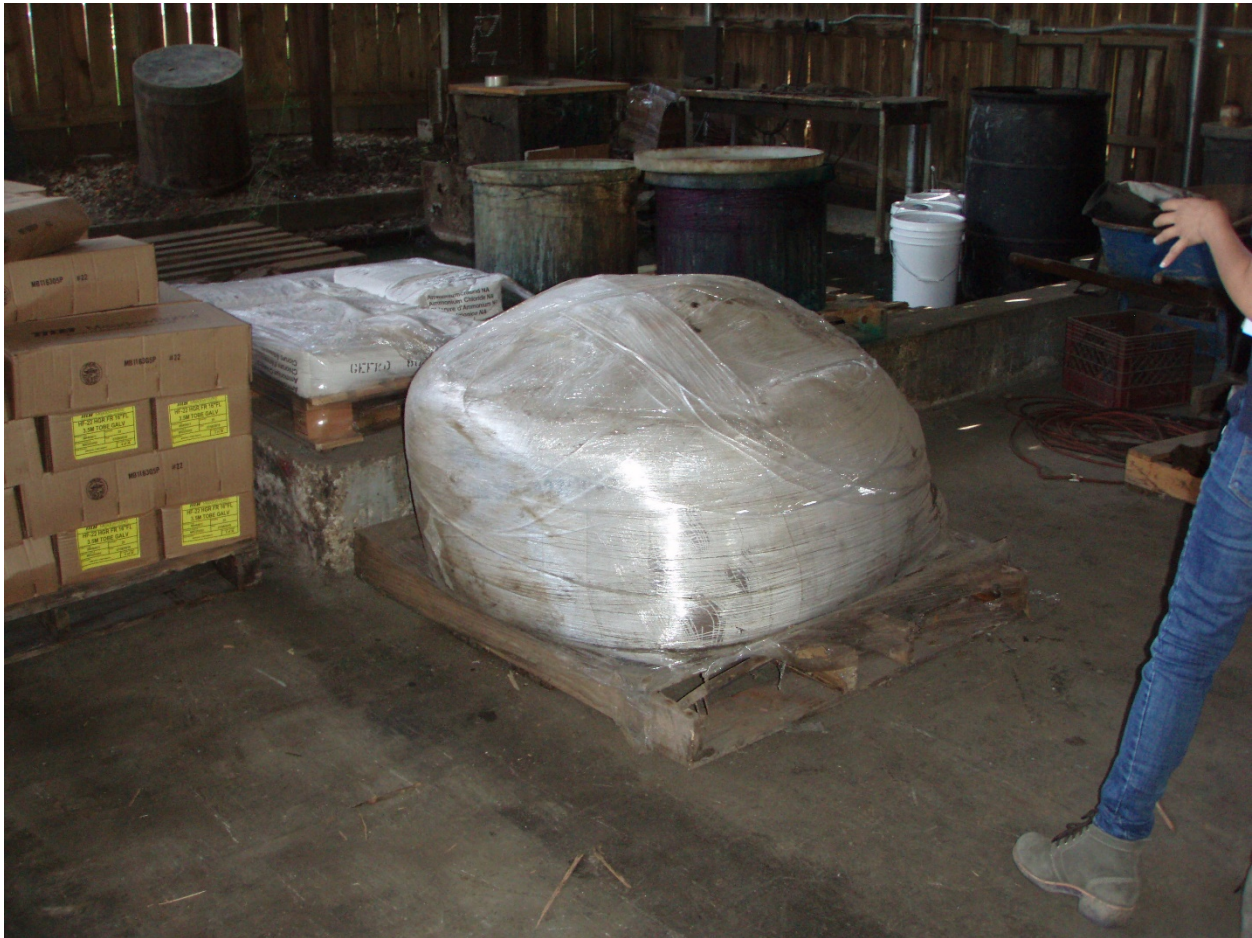
Photo File Name: P7230006

MKPI once operated a plating process that used black zinc and green dye. Mr. Curry said this operation is no longer in use. In the secondary containment area, we observed liquid residue of the operation (Appendix C, photograph 7). We also observed a super sack of wastewater sludge stored next to the black zinc secondary containment structure (Appendix C, photograph 6).

Description: Sack with waste sludge located next to black zinc area.

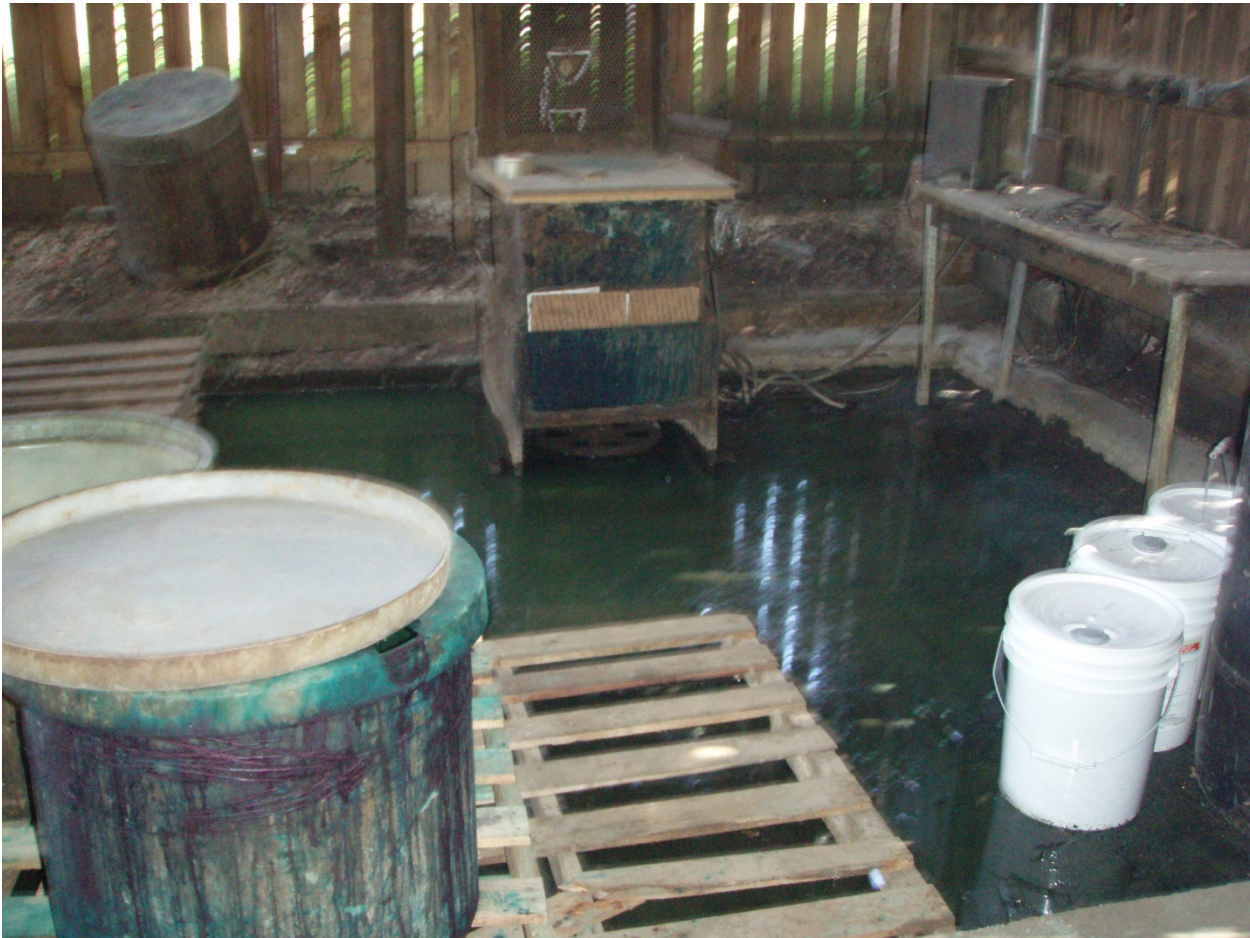
Photo File Name: P7230007

Description: Area previously used for black zinc. Owner said water contains green dye from black zinc process. Area last used 3 years ago per owner.

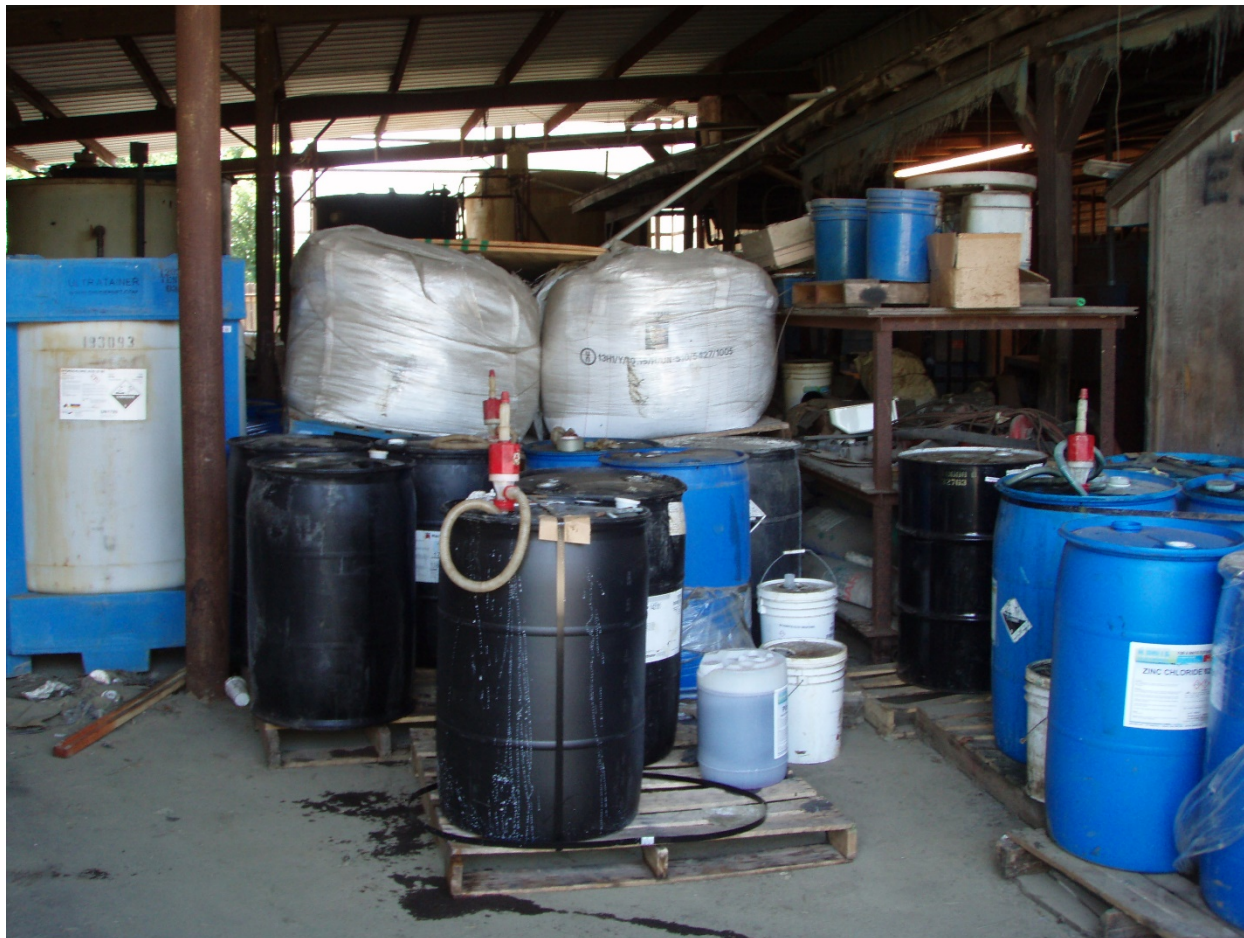
Photo File Name: P7230008

EPA observed sacks of zinc contaminated soil from prior spills and spilled material on the concrete near the black 55-gal drum. EPA asked Mr. Curry to identify the spilled material which he mentioned the possibility of being a zinc material. EPA observed three super sacks of sludge from wastewater treatment system. The sack in foreground was open (Appendix C, photographs 5, 8-10).

Description: Chemical product storage area. Includes sacks of zinc contaminated soil from prior spill.

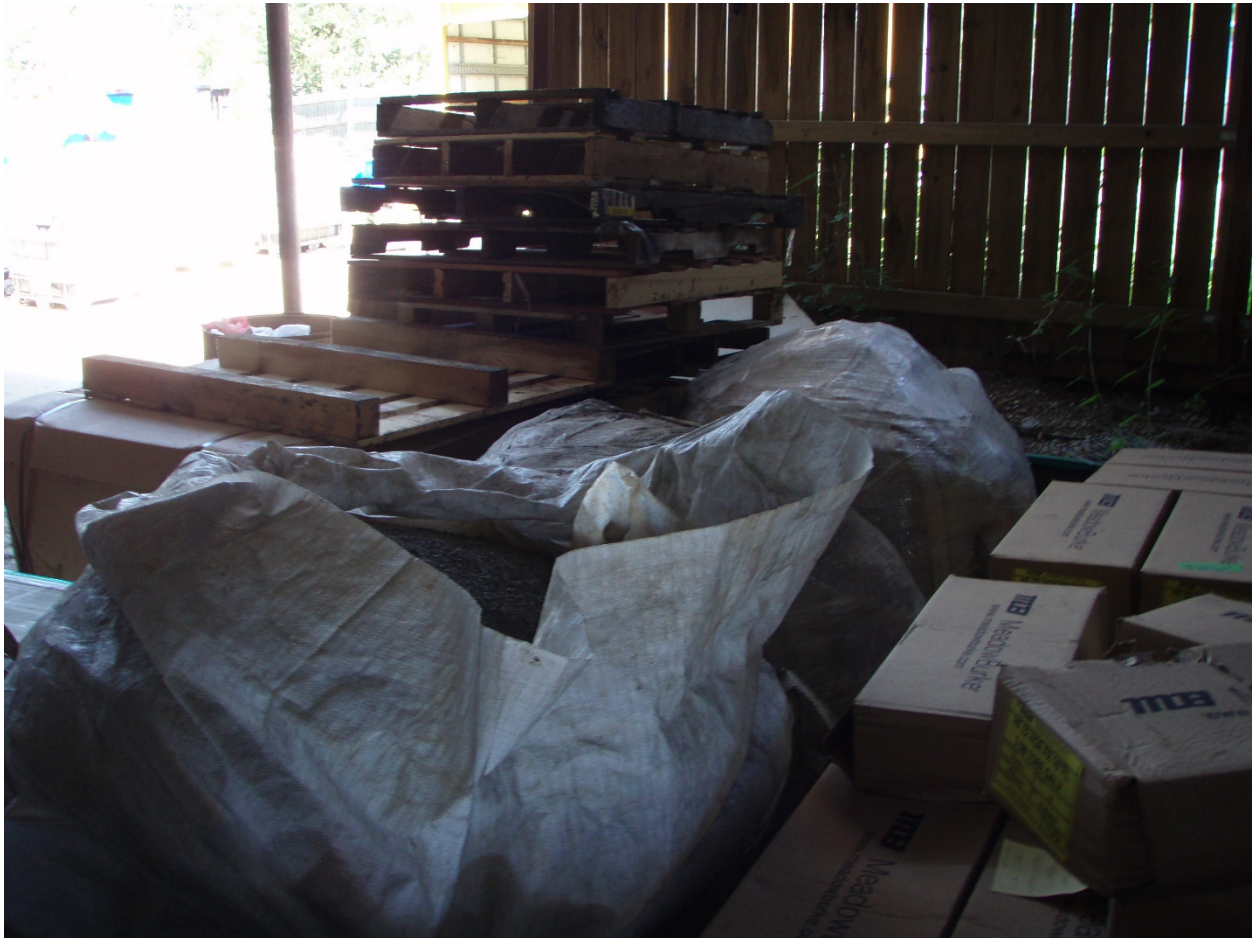
Photo File Name: P7230009

Description: Three sacks of sludge from wastewater treatment system. Sack in foreground is open.

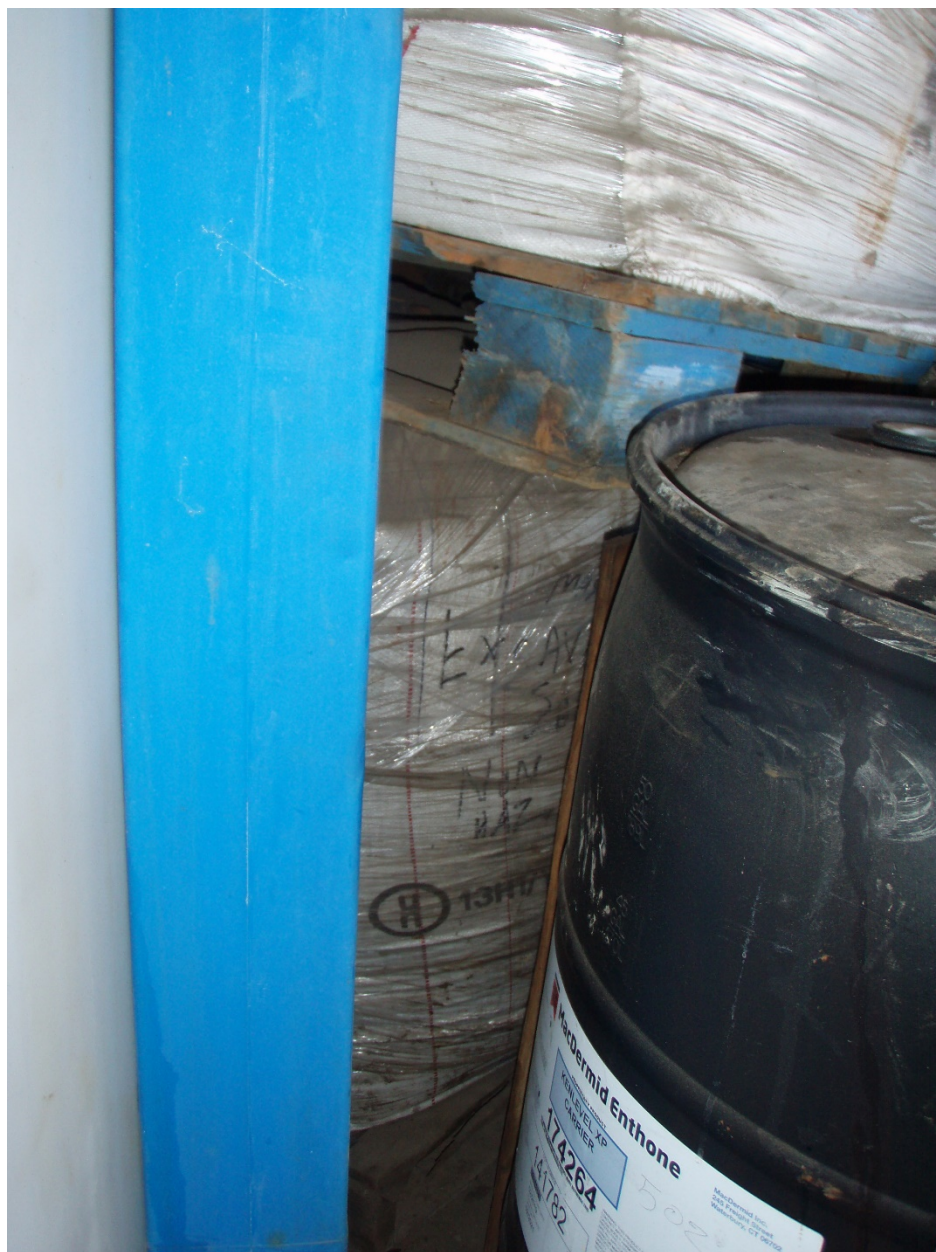
Photo File Name: P7230010

Description: Stacked sacks containing soil contaminated with zinc. Soils were contaminated from a spill on site. Stored in chemical product area.

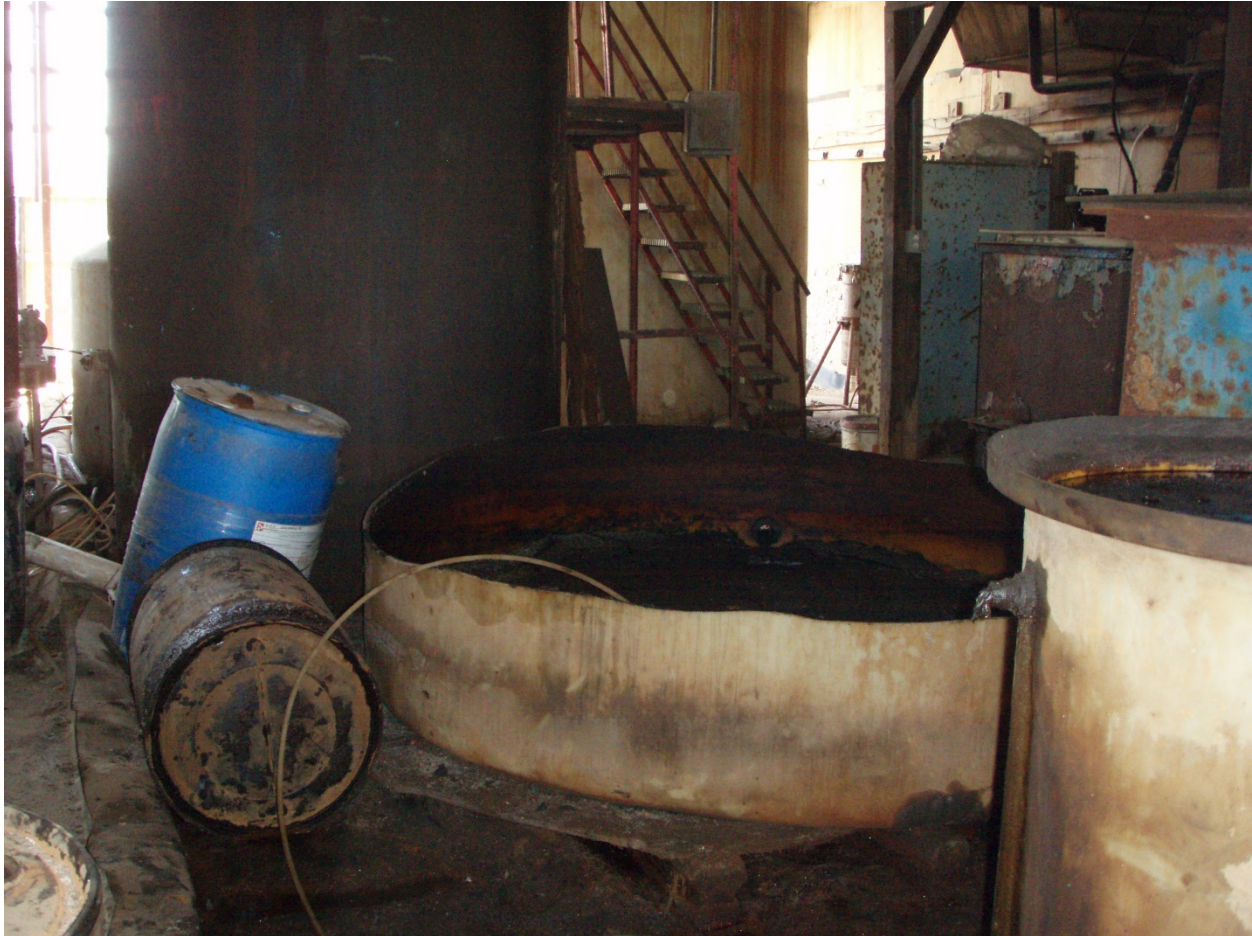
Photo File Name: P7230011

Description: Photo of wastewater treatment area. Shown: prior waste tank cut down but contains sludge.

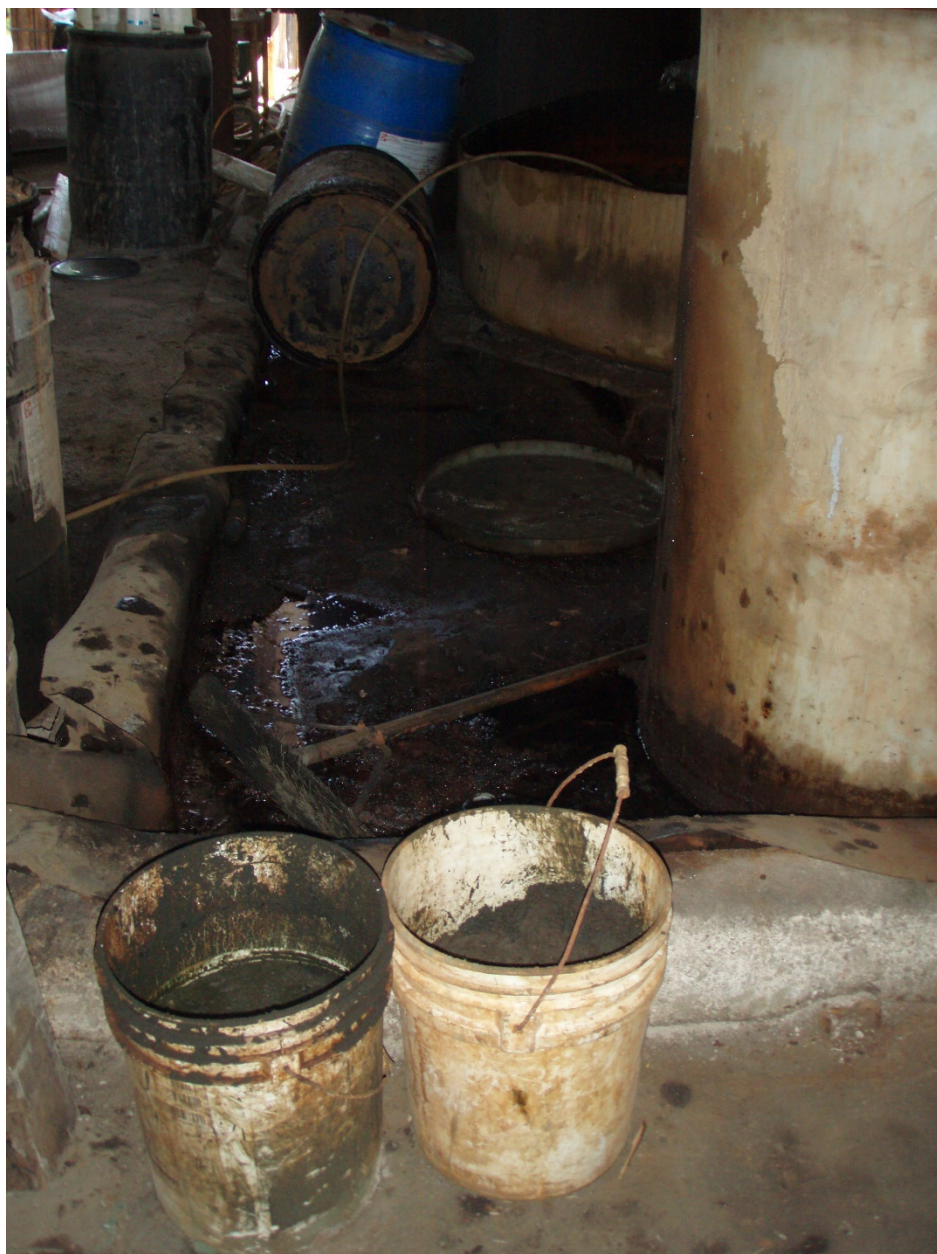
Photo File Name: P7230012

EPA observed two half-filled 5-gallon open buckets of sludge (Appendix C, photograph 12). We also observed spilled material on the floor of the secondary containment area (Appendix C, photograph 12). The material was not identified by MPKI. We observed filter cake from the filter press on the floor under the press bench (Appendix C, photograph 16). Behind the bench press was the press operation exposing the piping and mechanics of the press. This is the collection area of the filter pressed sludge material. It was noticed that sludge material was on the floor (Appendix C, photograph 18). The sludge carries a hazardous waste code of F006. We also observed a leak at the connection port of a tank next to the filter press in the WWTS (Appendix C, photograph 19). Mr. Curry informed us that the tank was full of untreated wastewater. An EPA representative also observed an opened sludge tank near the sludge holding tank #5 full of sludge material being stored for processing through the filter press (Appendix C, photographs 20). A City POTW discharge point near the sludge holding tank #5 was

Description: Photo of wastewater treatment area. Shown: curbing, two buckets with sludge, floor of containment area, and cut tank in background.

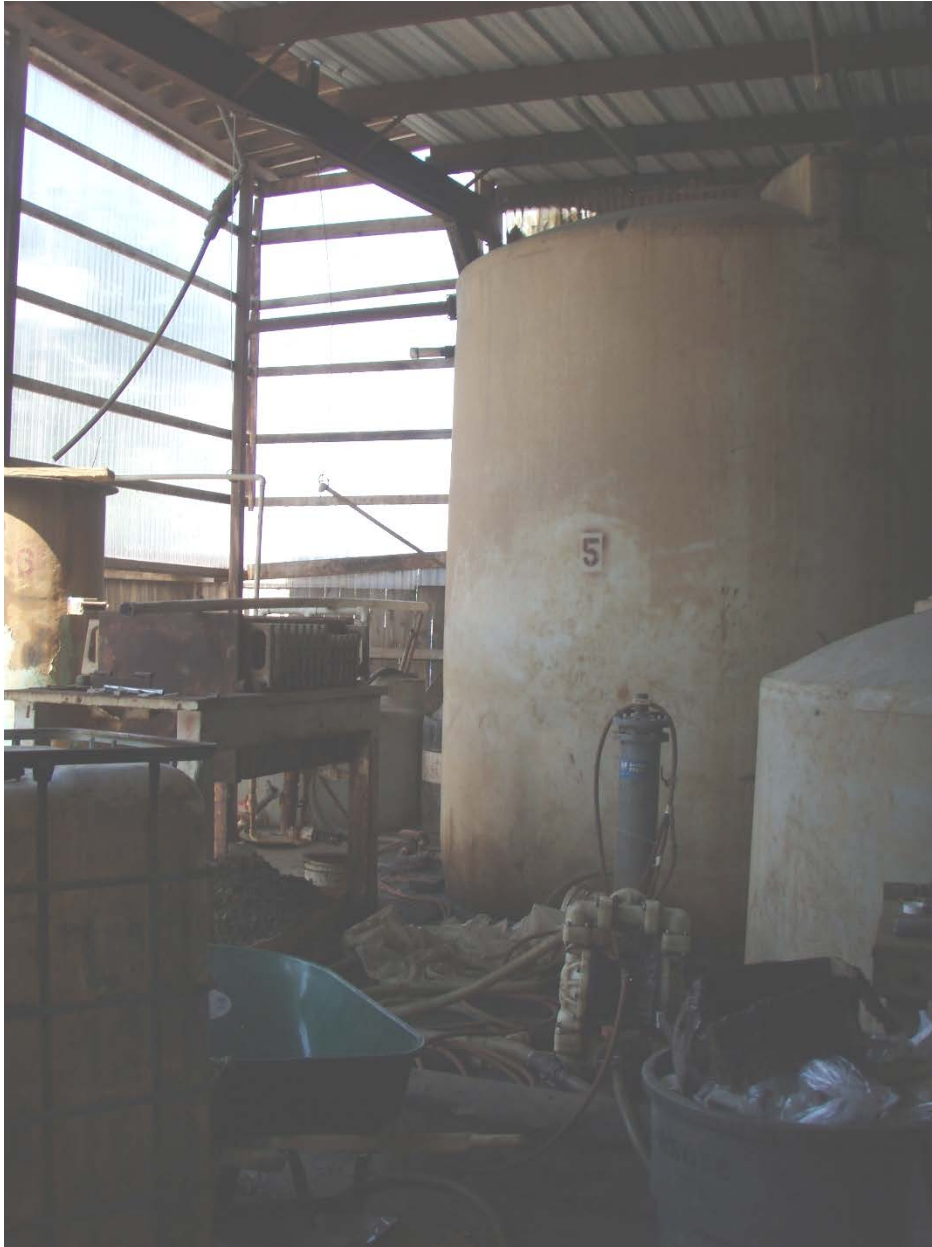
Photo File Name: P7230015

Description: Photo of wastewater treatment system. Shown: tank typically used for treated water (tank 5), filter (grey cylinder; center) and filter press (left). Photo lightened, and contrast lightened to show detail.

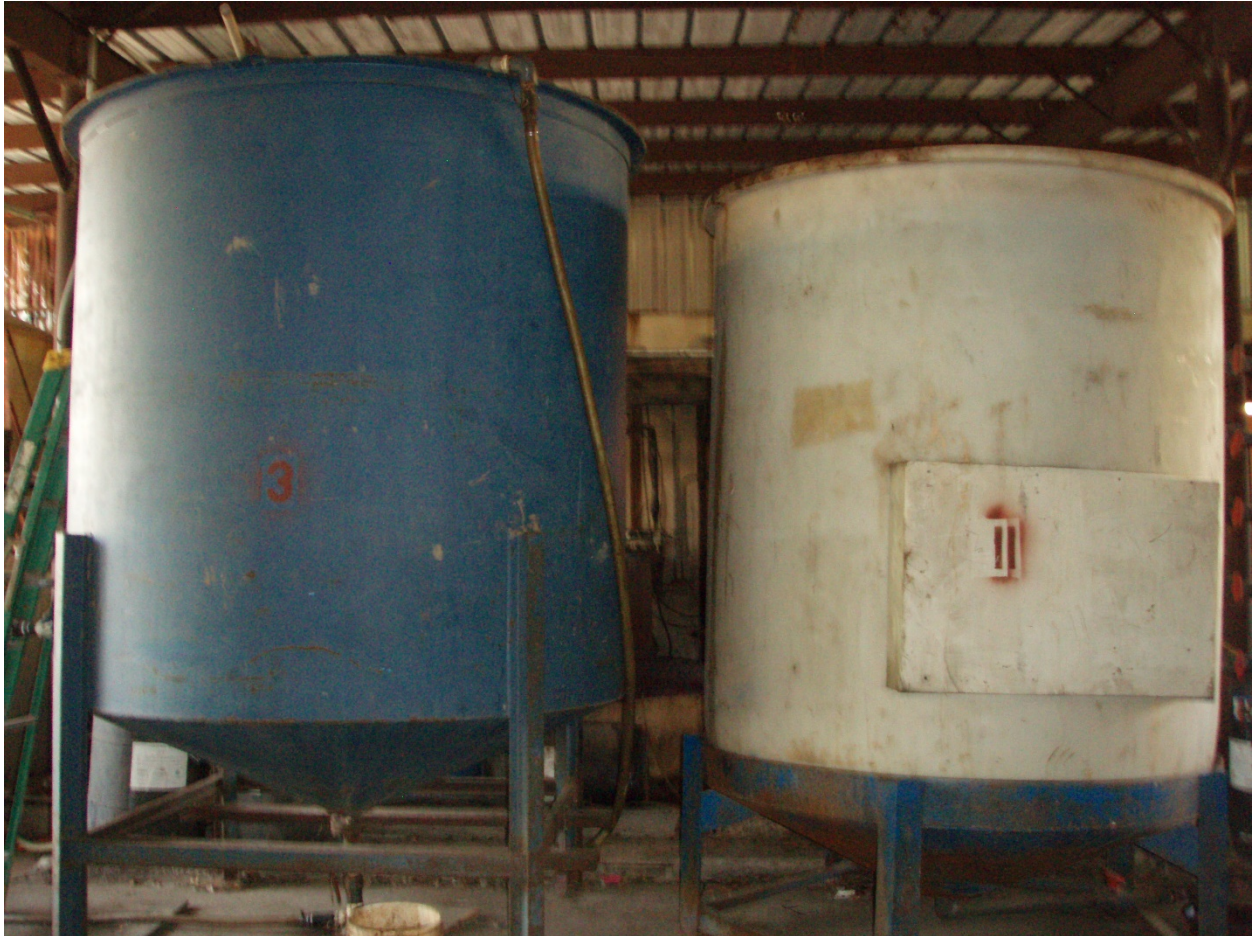
Photo File Name: P7230017

Description: Extra tanks brought in to hold treated wastewater prior to shipping off-site. Tank on left is metal and on the right is plastic.

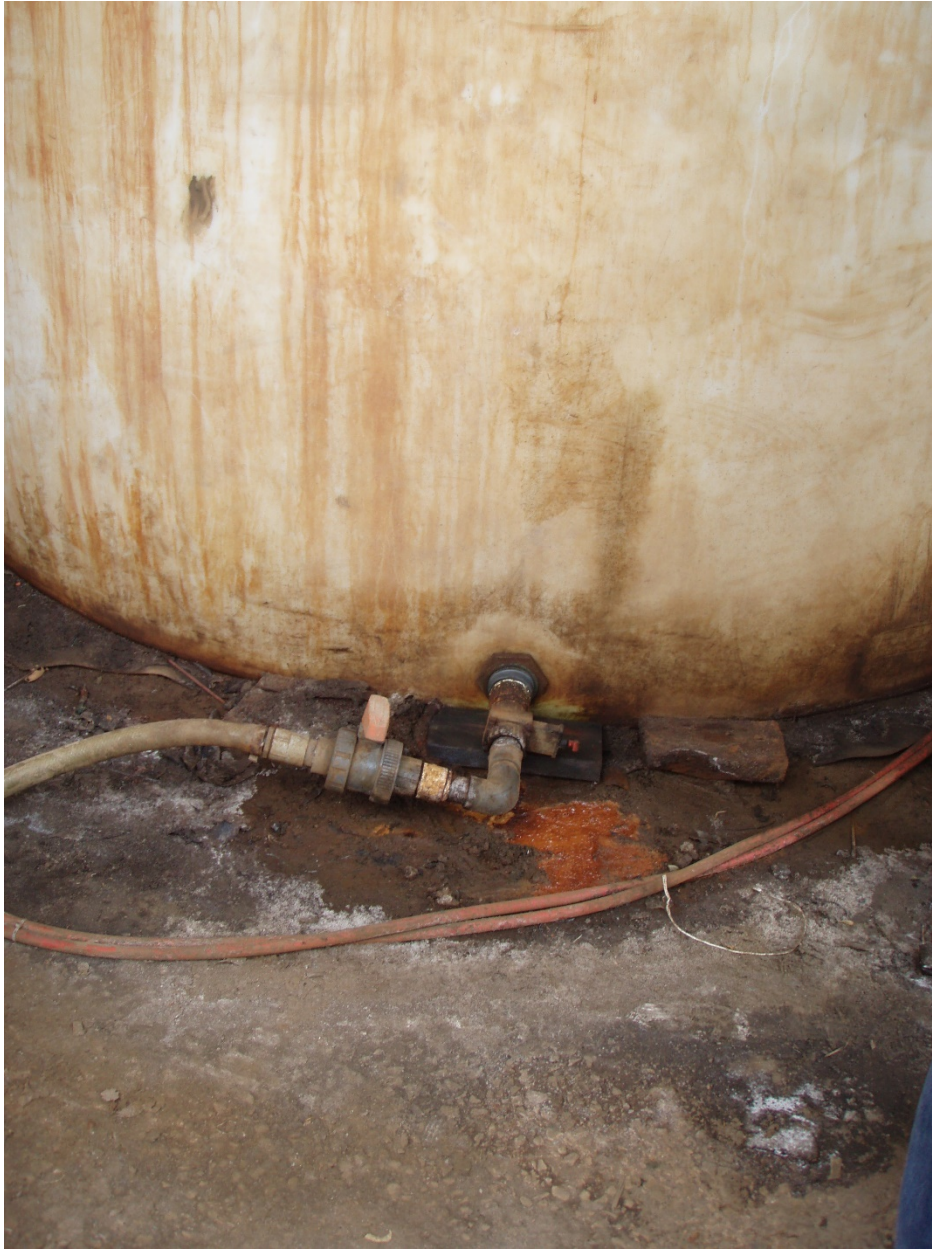
Photo File Name: P7230019

Description: Leak/spillage at connection to tank next to filter press. Tank is full of untreated wastewater per the owner.

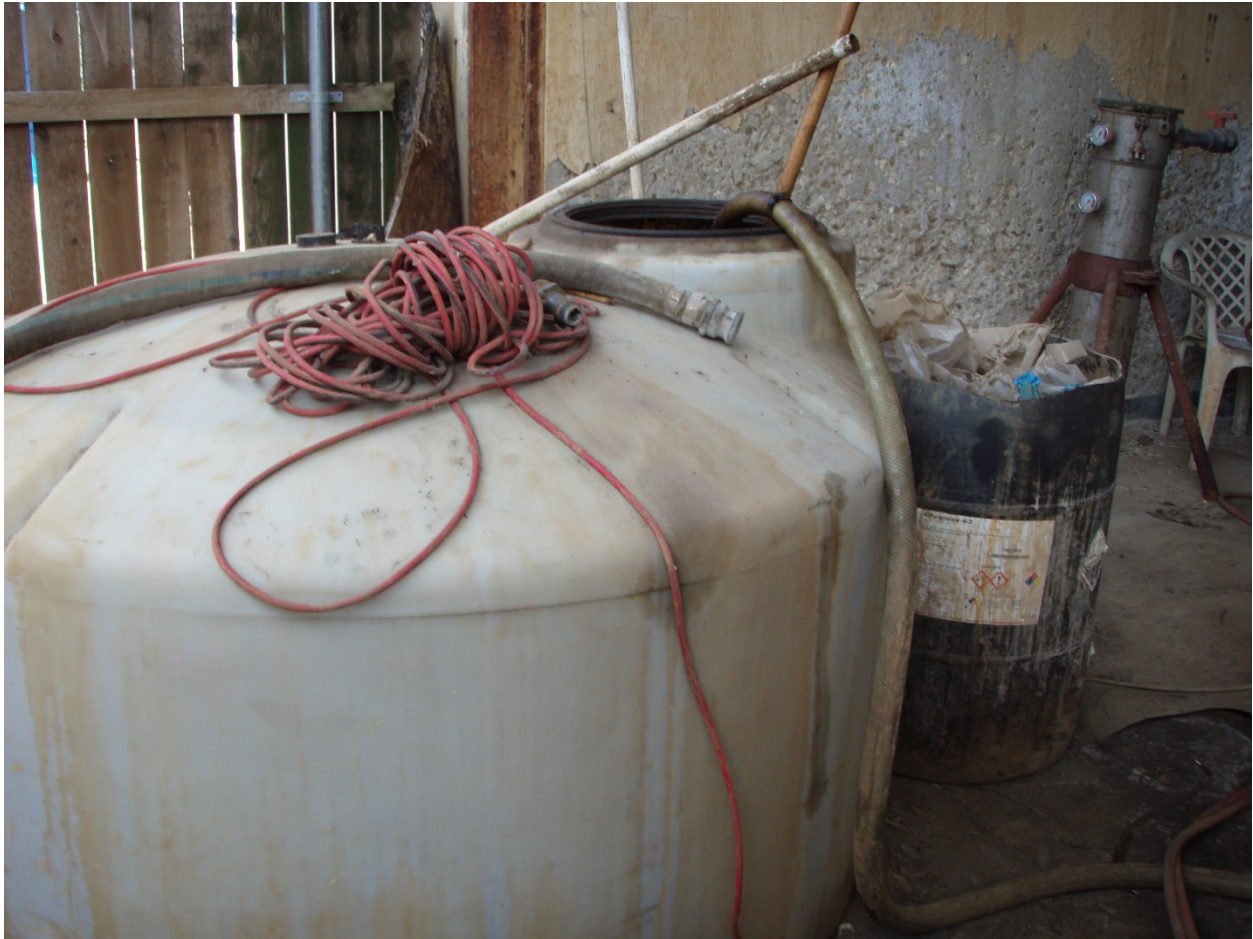
Photo File Name: P7230020

Description: Sludge tank within wastewater treatment containment area. During inspection full.

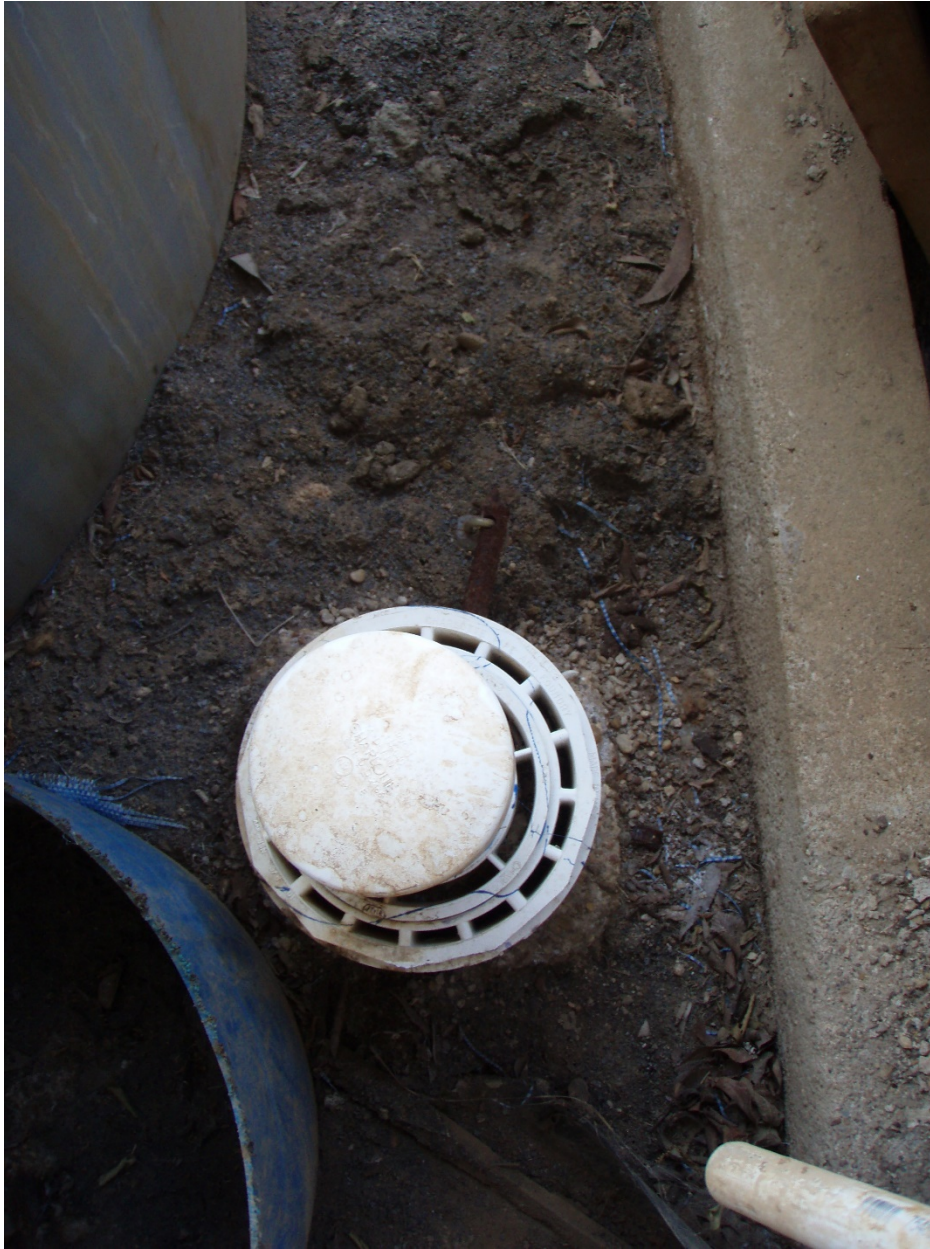
Photo File Name: P7230021

noticed by EPA representatives (Appendix C, photograph 21). The discharged point was locked by owner to prevent discharges.

Description: City POTW discharge point locked by owner to prevent discharges. Located in wastewater treatment containment area.

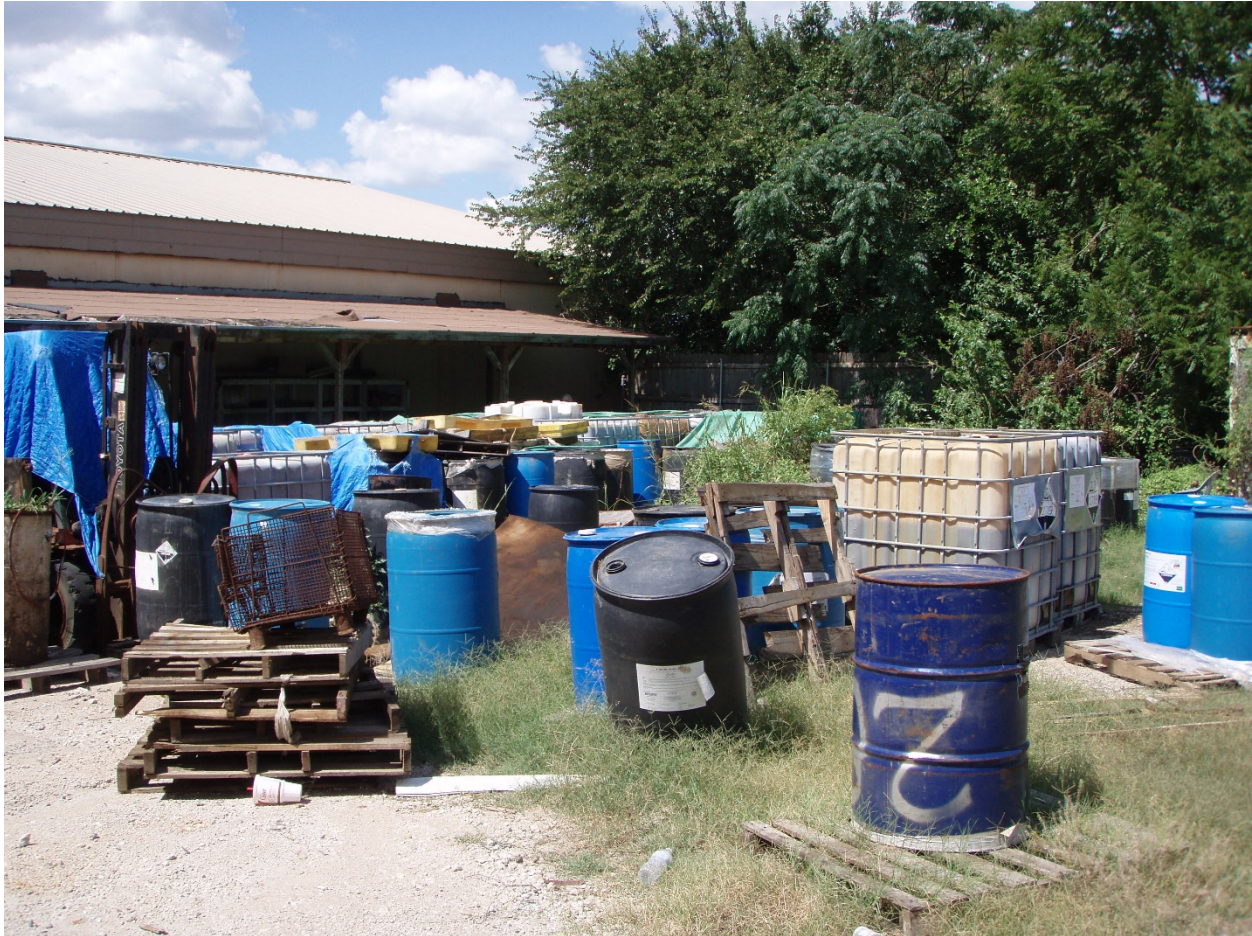
Photo File Name: P7230022

The storage yard is located outside on the north side of the MKPI property. Mr. Curry said MKPI is storing treated and untreated wastewater and wastewater sludge in totes and drums. Mr. Curry counted the number of containers during the inspection and there were 42 totes and 20 drums storing potentially hazardous waste (Appendix C, photograph 22-24). There was also observed the storage in process tanks in the area (Appendix C, photographs 23). The containers, totes, and tanks were missing hazardous waste labels and dates of accumulation/generation (Appendix C, photograph 22-24). Mr. Curry could not determine the length of time stored, but he gave an estimation of one year and 6 months.

Description: Back yard area used to store untreated wastewater/sludge in totes and drums. Owner counted 42 totes and 20 drums.

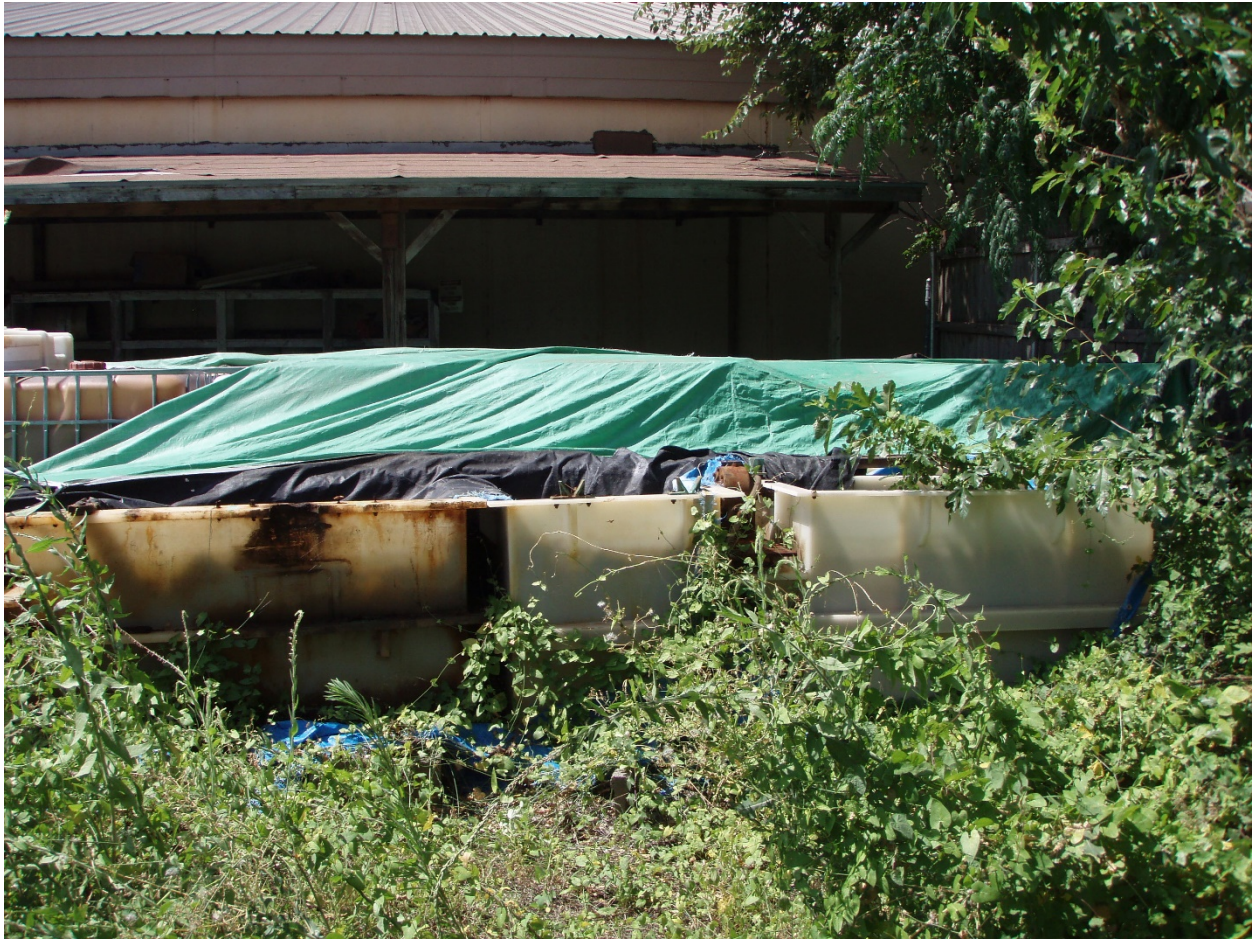
Photo File Name: P7230023

Description: Back yard area used to store totes and drums of untreated wastewater/sludge. View of old process tanks no longer used by M&K.

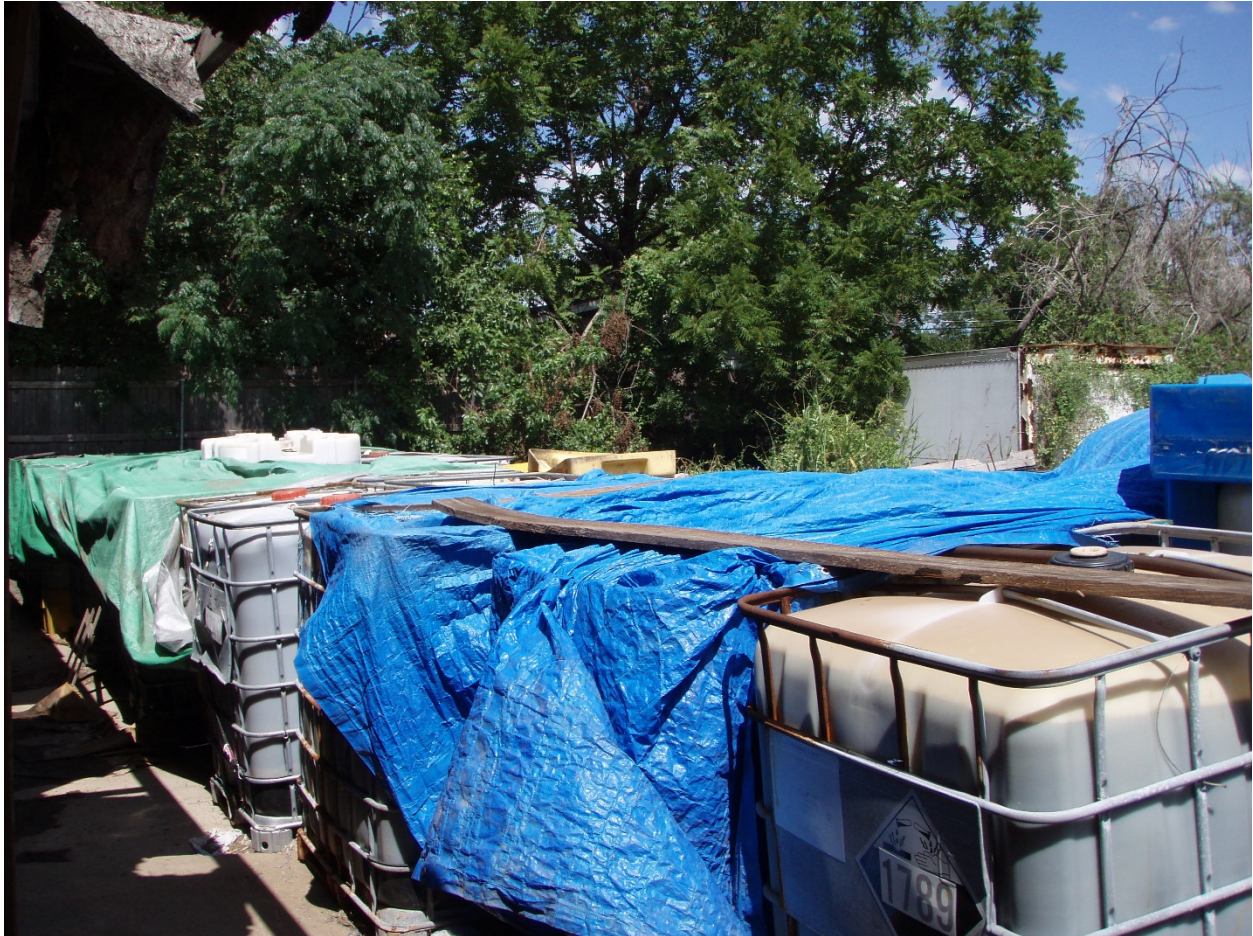
Photo File Name: P7230024

Description: Back yard area used to store totes and drums containing untreated wastewater/sludge.

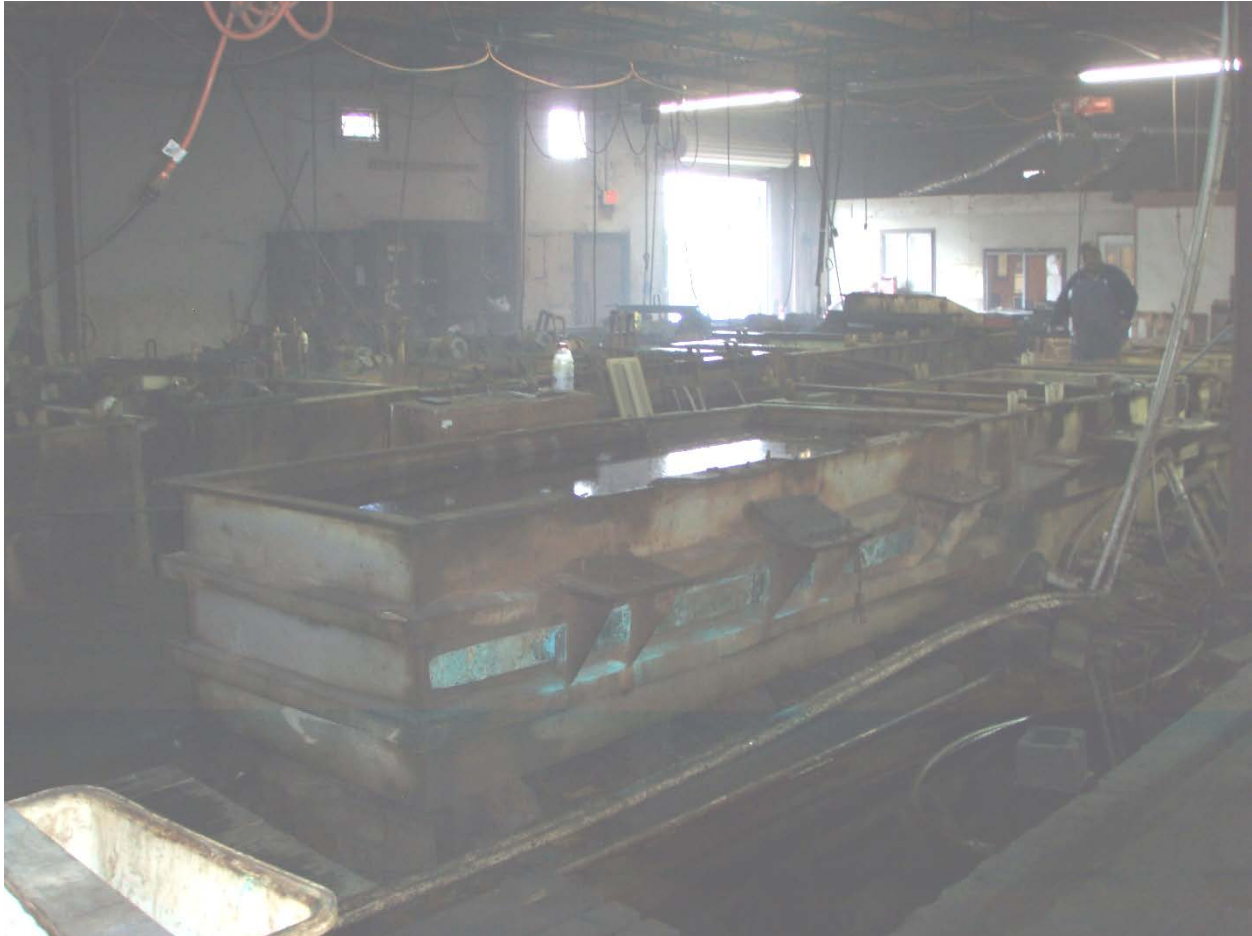
Photo File Name: P7230025

Mr. Curry identified two tanks being used to store electroplating wastewater and sludge: Tank 4 in barrel plating line #3 (Appendix C, photograph 25) and Tank 5 in the barrel plating line #1 (Appendix C, photograph 26). Mr. Curry said waste is held in the tanks until there is room in the WWTS. Normally the rinse water from the plating lines is piped directly to tanks in the WWTS for treatment, storage and disposal. Mr. Curry identified the hazardous characteristic of the untreated wastewater and sludge as D006 (cadmium), D007 (chromium), and F006. He said analytical testing for profiling the waste is conducted prior to disposal by the disposal firm hired by MKPI.

Description: Plating line 3 in foreground. Line one in background. Tank prominent in photo is being used to store untreated rinse/wastewater. Photo lightened to show detail.
