| Inspection Date(s): | 07/23/2019 | | |
| Media: | RCRA | | |
| Regulatory Program(s) | Subtitle C – Hazardous Waste | | |
| Company Name: | <b>M&amp;K Plating, Inc.</b> | | |

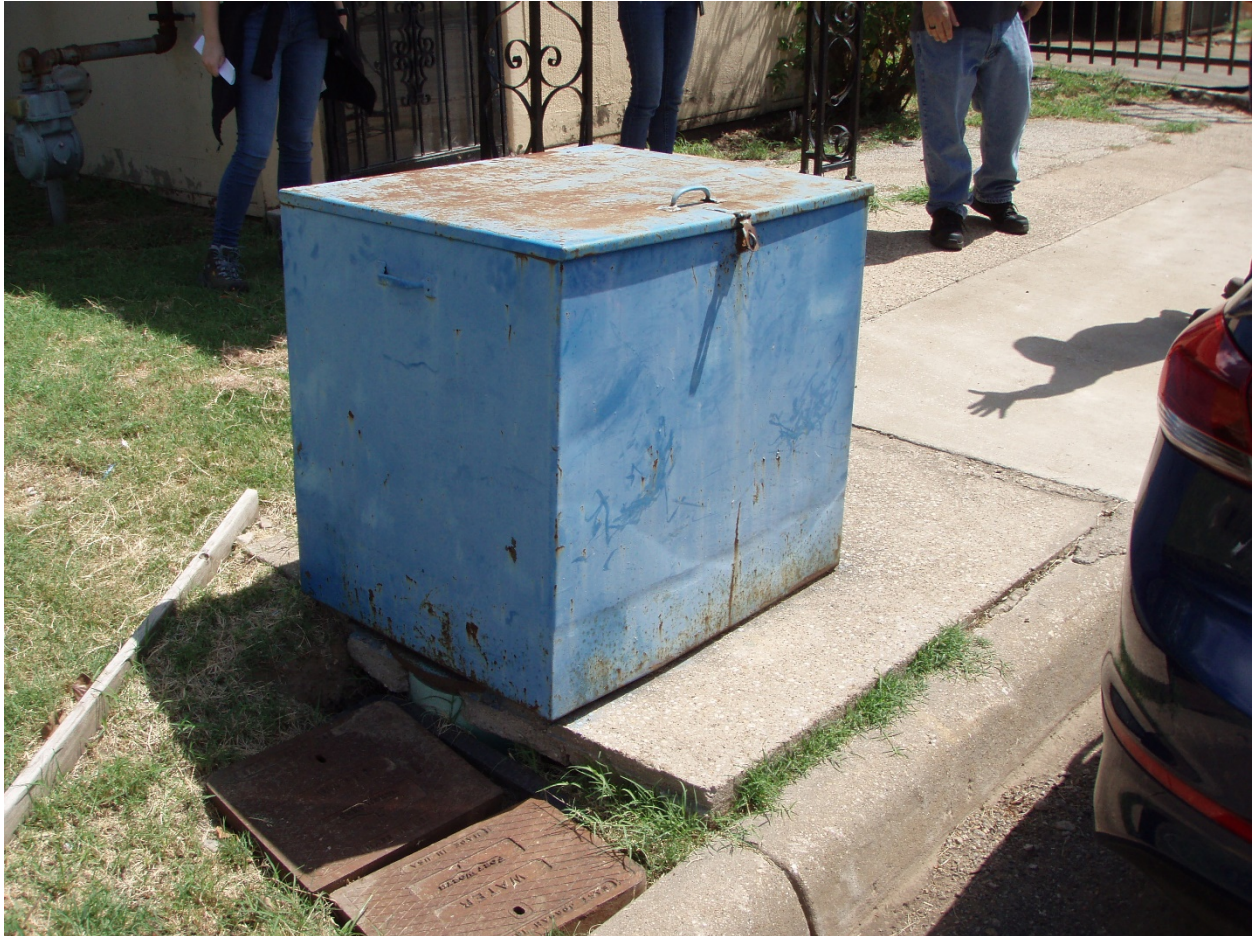
Photo File Name: P7230027

In front of MKPI are outfalls A & B in which the City of Fort Worth required MKPI to cease from discharge because of prior violation of their water permit. MKPI placed a locked steel container over each outfall. This was done to comply with city requirements (Appendix C, photographs 27 and 28).

Description: City POTW outfall monitoring well/sump A. Located in front of facility

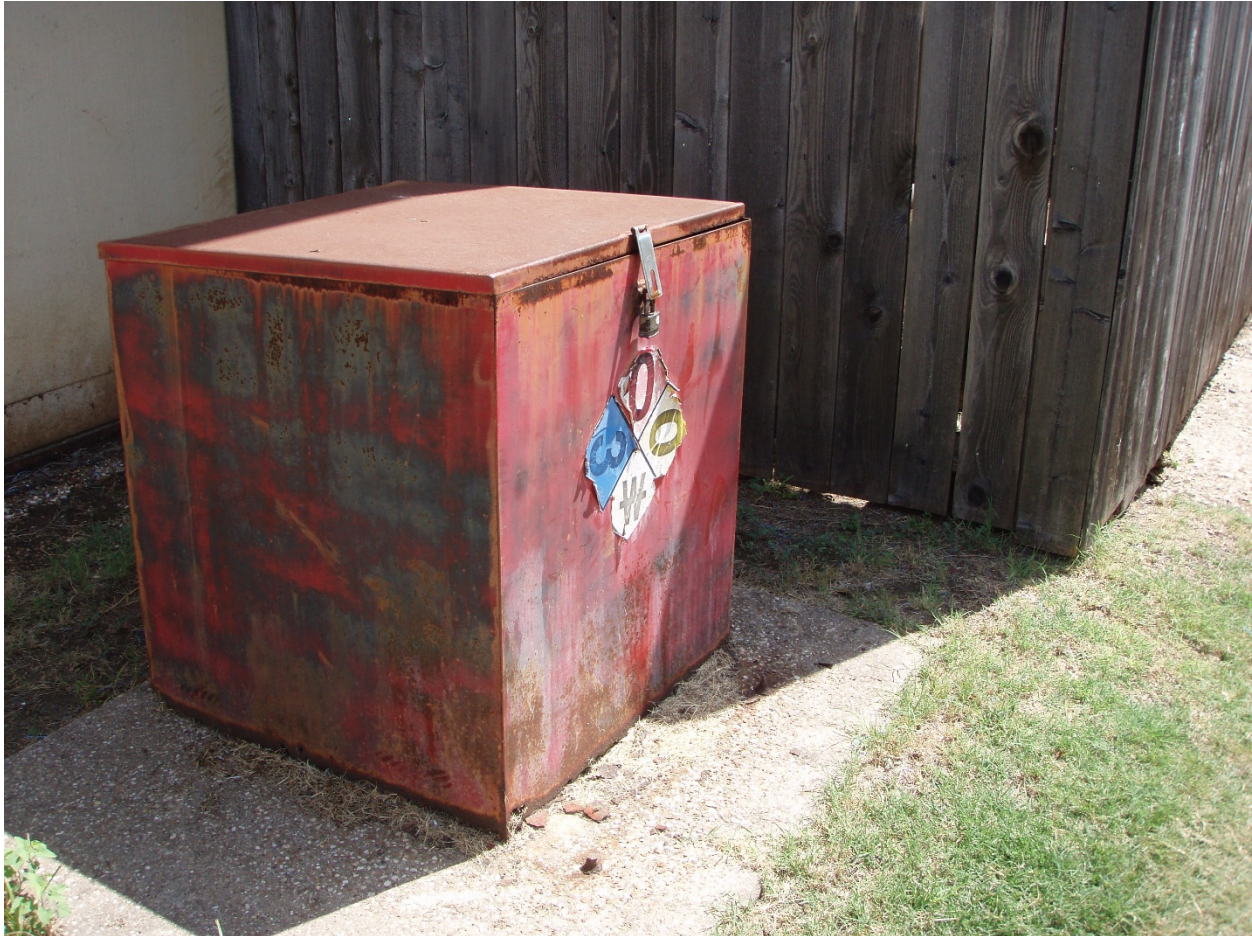
Photo File Name: P7230028

Description: City POTW outfall monitoring well/sump B. Located in front of facility
