## **RCRA Inspection Report**

Allworth LLC  
500 Medco Road  
Birmingham, Alabama 35217  
Jefferson County  
EPA ID: ALD094476793

**COMPLIANCE EVALUATION INSPECTION PHOTOGRAPHS**

**January 29-30, 2024**

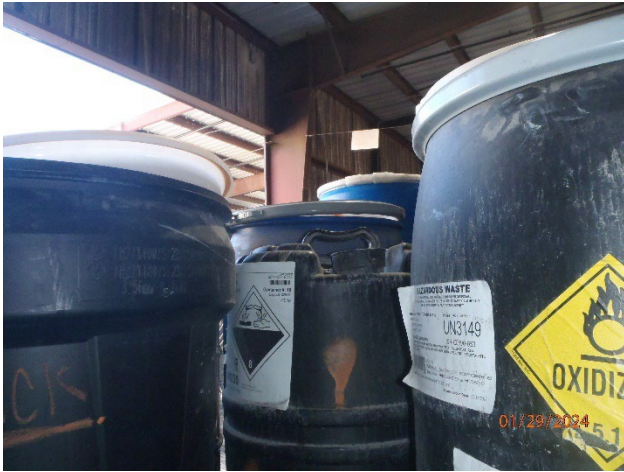
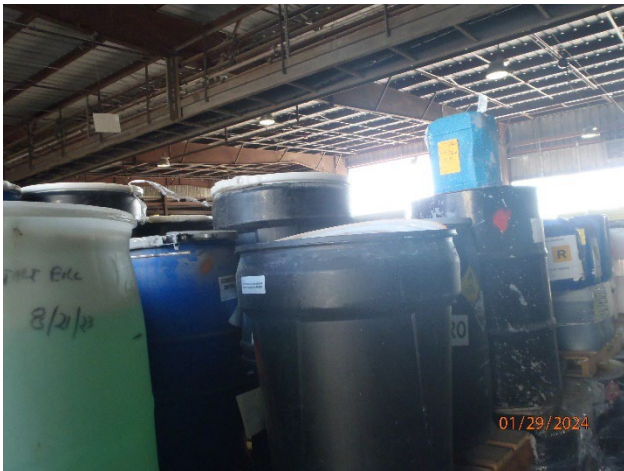
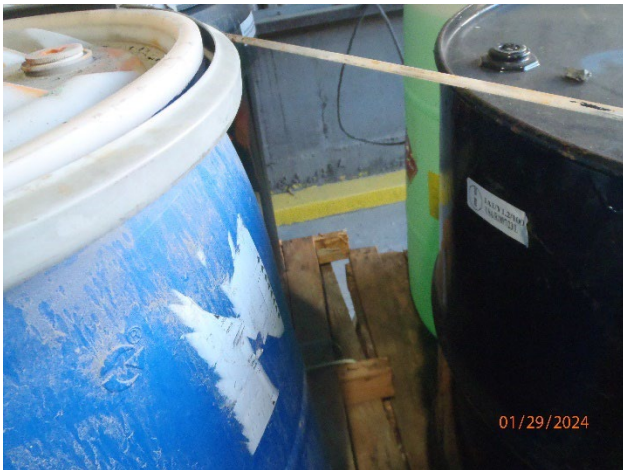
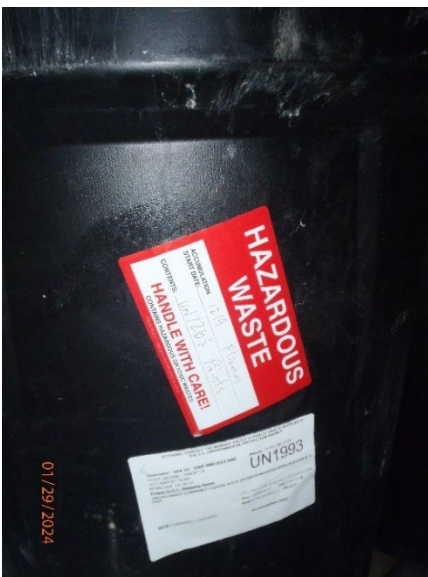
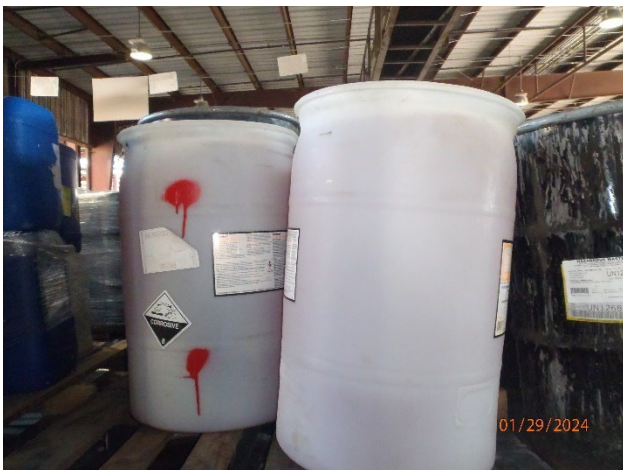
The inspectors observed in LA-1 that some containers had been "fingerprinted" by the facility to confirm their contents. After fingerprinting, the container is labeled with an Allworth hazardous waste label to indicate it was received for processing. Some containers were still waiting to be fingerprinted at the time of the inspection. The inspectors observed three containers that were not closed but had been accessed by the facility staff for fingerprinting, and several containers that did

not have the Allworth label (Pictures 7-8, 13-15). On January 30<sup>th</sup>, inspectors were told that the inventory that was in the LA-1 on the 29<sup>th</sup> had all been fingerprinted, received, and moved to container storage.

Picture 7 – Loading Area No.1 open container

Picture 8 – Loading Area No.1 open container

Picture 13 – Loading Area No.1 open container

Picture 14 – Loading Area No.1 container waiting to be received

Picture 15 – Loading Area No.1 unlabeled container

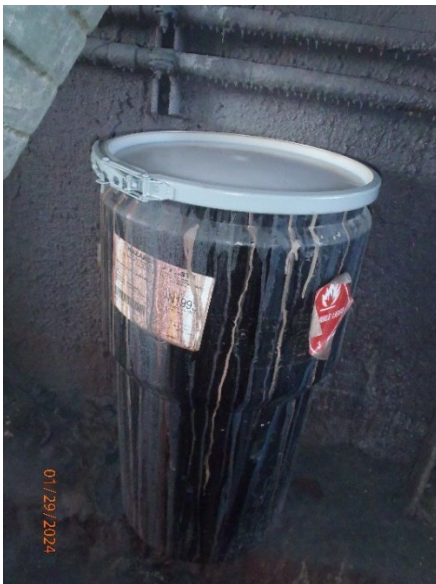
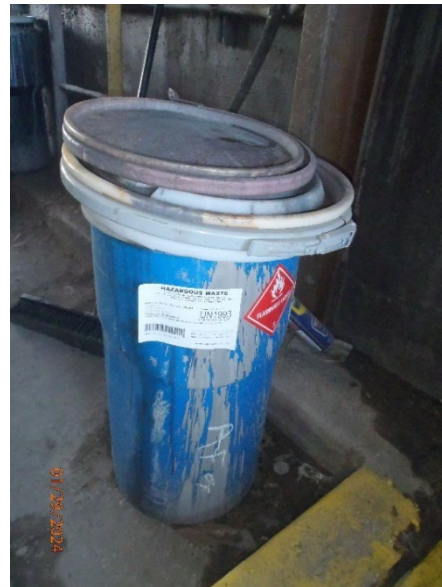
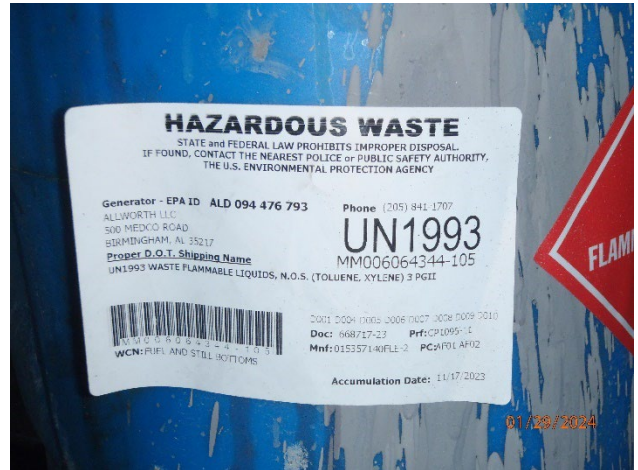
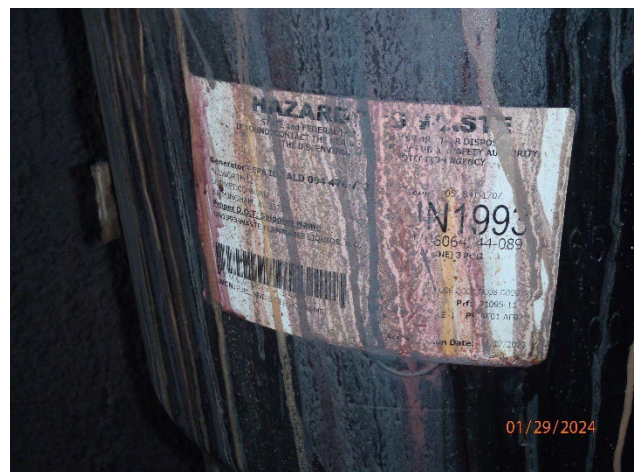
Two 15-gallon satellite accumulation containers (SAAs) were observed along the outside wall of LA-1 (Pictures 9-12), the blue container needed a new label because streaks made the label hard to read. In addition, the SAAs had start accumulation dates, and the inspectors recommended removing the dates until the containers were full and ready to move. The facility replaced the labels on the SAA containers.

Picture 10 – Loading Area No.1 SAA

Picture 11 – Loading Area No.1 SAA label

Picture 9 – Loading Area No.1 SAA needed new label

Picture 12 – Loading Area No.1 SAA label

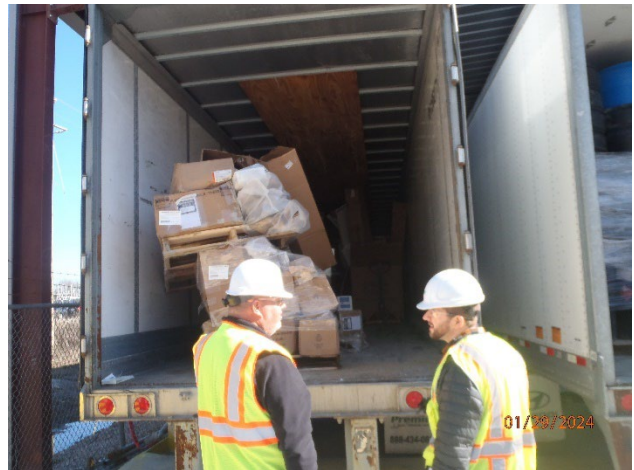
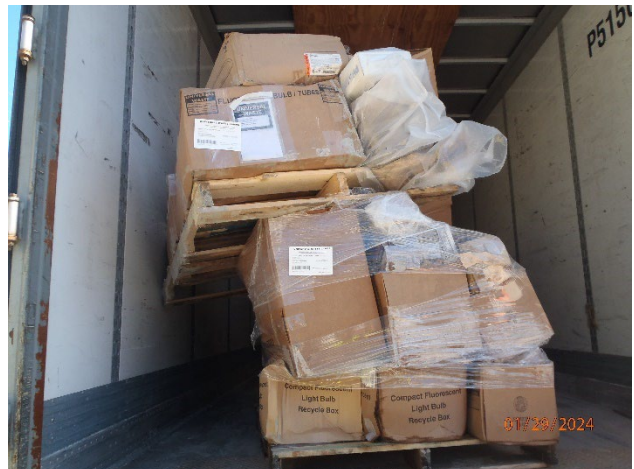
The inspectors observed that the two universal pallets had been dumped into the trailer and one pallet crushing the other (Pictures 16, 18). Shards of broken fluorescent lamps were observed on the floor of the trailer (Picture 17). The EPA inspector requested that the pallets be removed and rearranged to prevent further damage and releases of mercury. The facility personnel immediately removed the pallets and cleaned up the broken fluorescent lamp shards. The universal waste containers were observed closed, dated, and labeled.

Picture 16 – Permitted Trailer Storage Area UW trailer

Picture 18 – Permitted Trailer Storage Area UW trailer

**Pursuant ADEM Admin. Code r. 335-14-11-.03(4)(d) [40 C.F.R. § 273.33(d)], a LQHUW must manage universal waste lamps in a way that prevents releases of any universal waste or component of a universal waste to the environment.**

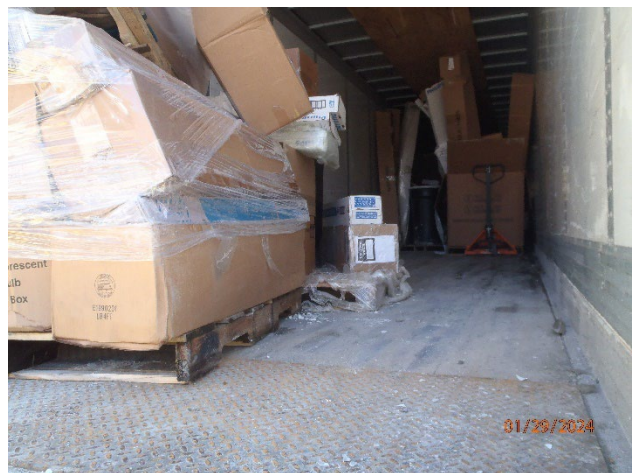
Picture 17 – Permitted Trailer Storage Area UW trailer broken lamp

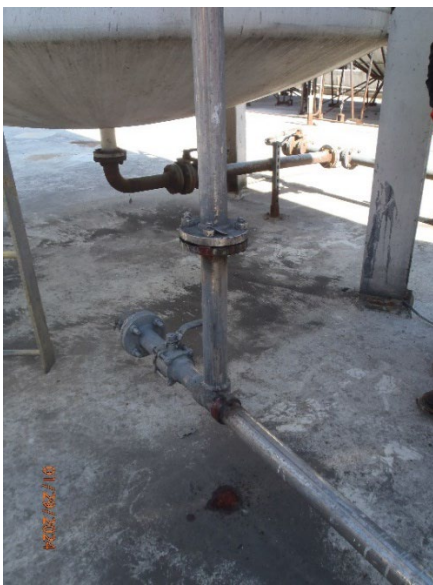
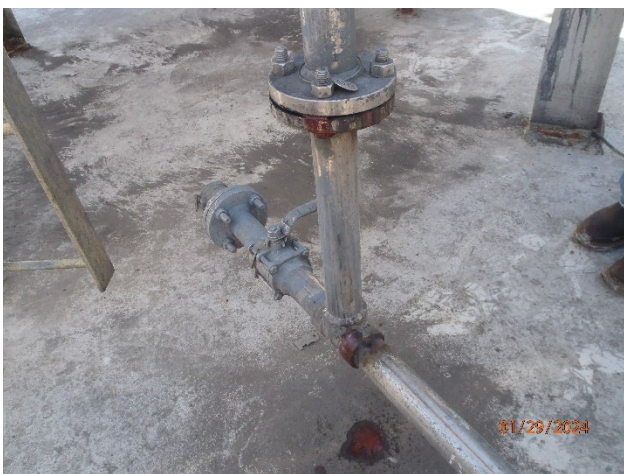
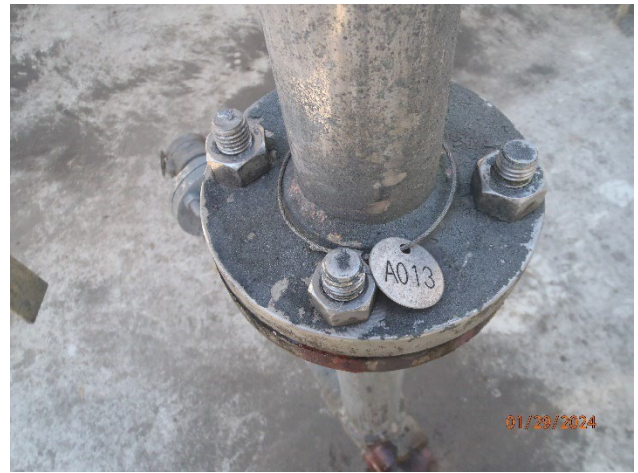
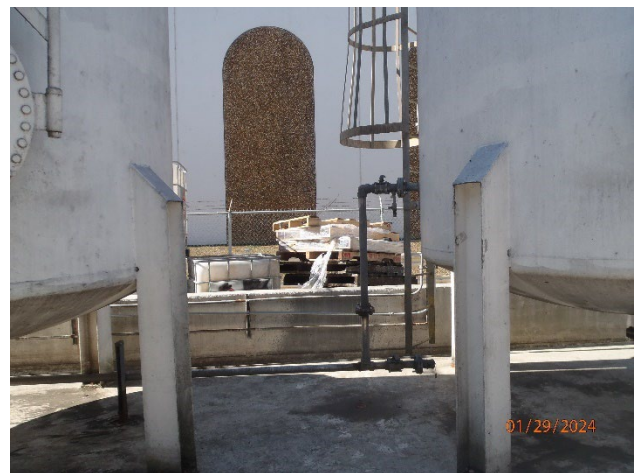
At the time of the inspection, the inspectors observed Hazardous Waste Tank B7’s flange A013 was leaking hazardous waste inside the secondary containment (Pictures 20-23). The facility personnel immediately addressed the cause of the leak and cleaned up the release (Picture 24).

Picture 22 – Tank System 1 Tank B7 flange A013 leaking

Picture 20 – Tank System 1 Tank B7 flange leak

Picture 23 – Tank System 1 Tank B7 flange leak

Picture 21 – Tank System 1 Tank B7 flange leak

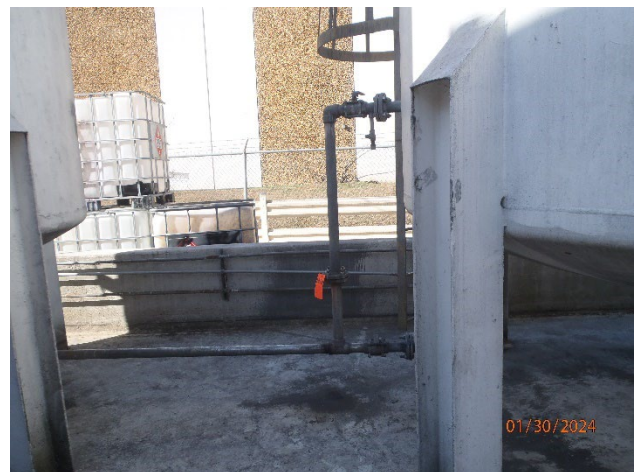
Picture 24 – Tank System 1 Tank B7 flange leak repaired

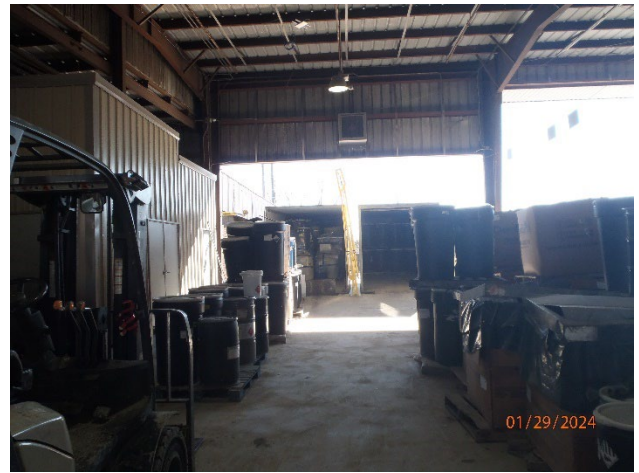
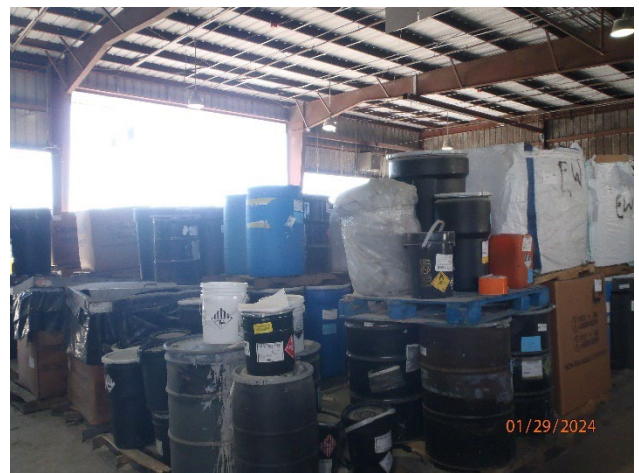
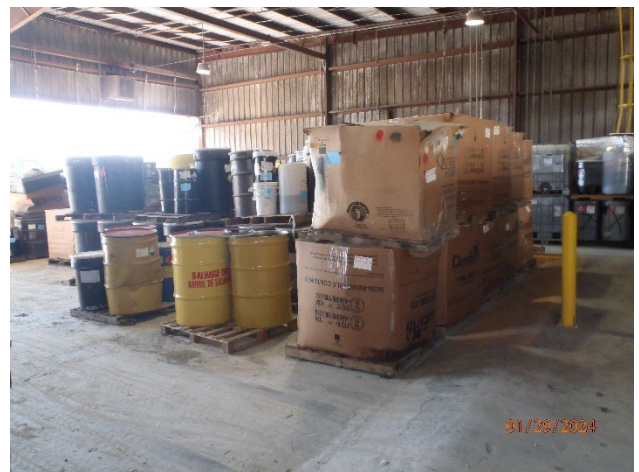
LA-2 primarily stores retail wastes that are sorted and repackaged in bulk. LA-2 consisted of two container storage areas, D and E. In Area E (Pictures 28-30), the inspectors observed that the cubic yard boxes were damaged from recent heavy rains. The facility had already marked the boxes for repacking. The remaining containers were closed, dated, and labeled. The secondary containment in this area appeared to be in good condition and the area had adequate aisle space. In Section D (Pictures 31-32), the inspectors observed that the containers were too close together and lacked aisle space, so that the inspectors could not individually view the labels on each container.

Picture 28 – Loading Area No. 2 – Retail Waste

Picture 29 – Loading Area No. 2 – Retail Waste

Picture 30 – Loading Area No. 2 – Retail Waste

**Pursuant to Permit Condition II.G.5., Required Aisle Space, the Permittee shall maintain aisle space to allow the unobstructed movement of personnel, fire protection equipment, spill control equipment, and decontamination equipment to any area of facility operation in an emergency (ADEM Admin. Code Rule 335-14-5 -.03(6)).**

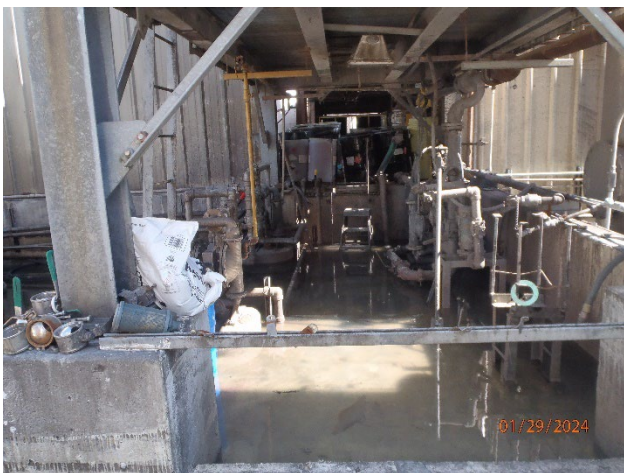
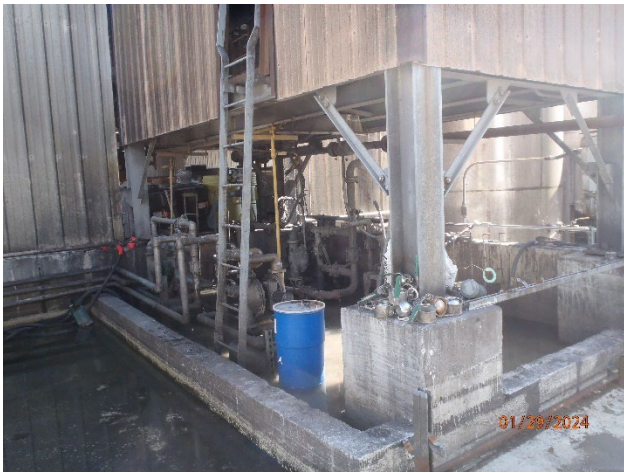
The pumphouse located between the LA-1 and Tank System 1 had four inches of rainwater inside the secondary containment (Pictures 25-26). The inspectors stated that the secondary containment had to be pumped out within 72 hours. The facility personnel immediately pumped out the area (Picture 27).

Picture 25 – Tank System 1 Pumphouse

Picture 26 – Tank System 1 Pumphouse secondary containment flooded with rainwater

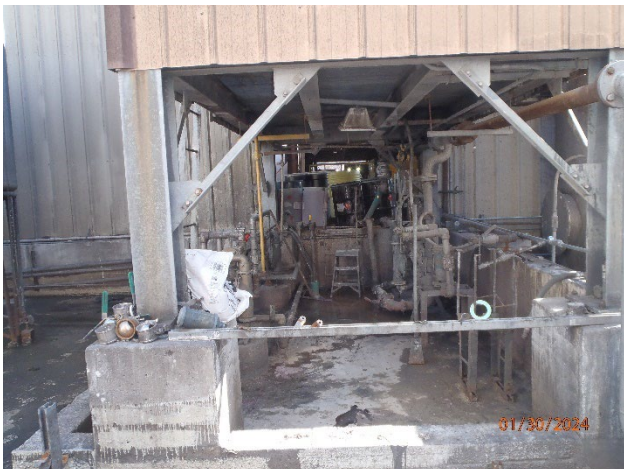
Picture 27 – Tank System 1 Pumphouse secondary containment pumped out

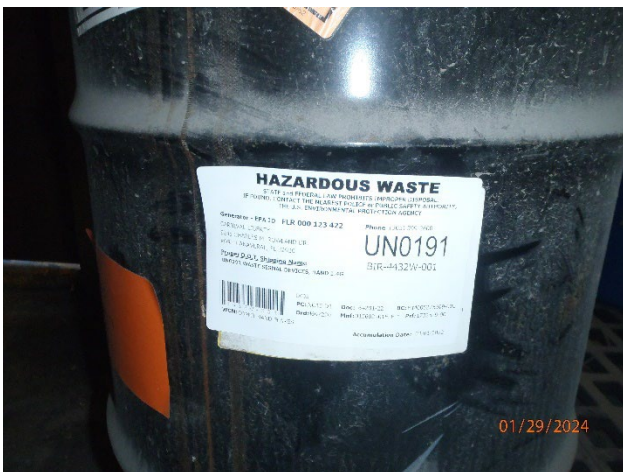
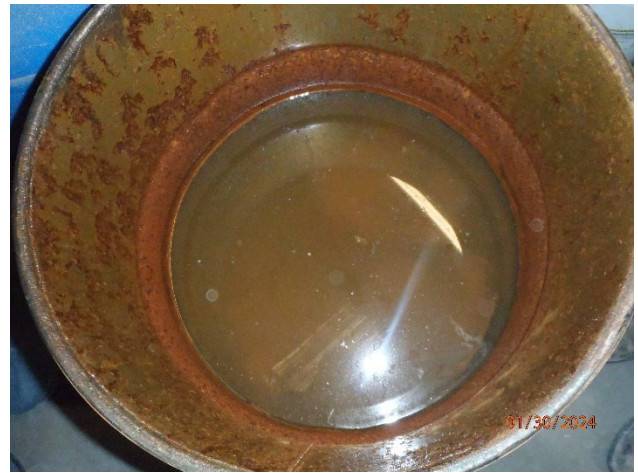
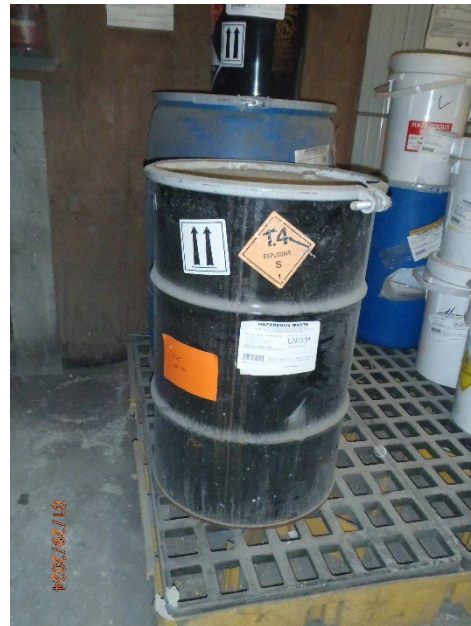
Container Storage F is in the Main Warehouse and between the LUWA and empty container storage trailers. This area primarily stores lab pack waste stored on top of spill containment pallets. Approximately 123 containers of hazardous waste were observed on top of spill containment pallets, varying in size between 5 to 55 gallons (Pictures 36-38, 43). At the time of the inspection, the inspectors observed a 30-gallon black container dated March 1, 2022, and October 1, 2022 (Pictures 39-41). Mr. Jones and staff immediately pulled the records on the container label and discovered that the original contents of discarded flares had been shipped for disposal in 2022. The container had been repurposed, but the original labels had not been removed and/or replaced with the new label with current contents and date. A new label was placed on the container (Picture 42).

Picture 40 – Upper Warehouse Container Storage F  
mislabeled drum contents – flares in water

Picture 41 – Upper Warehouse Container Storage F  
mislabeled drum

Picture 39 – Upper Warehouse Container Storage F  
mislabeled drum

**Pursuant to ADEM Admin. Code r. 335-14-3-.01(7)(a)5(i)(I)-(IV) [40 C.F.R. § 262.17(a)(5)(i)], which is a condition of the LQG Permit Exemption, a generator must mark or label its containers with the following: the words “Hazardous Waste”; an indication of the hazards of the contents; and the date upon which each period of accumulation begins clearly visible for inspection on each container.**

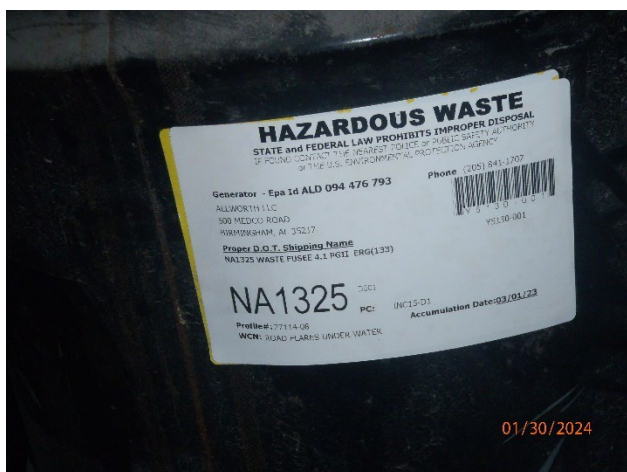
Picture 42 – Upper Warehouse Container Storage F label corrected

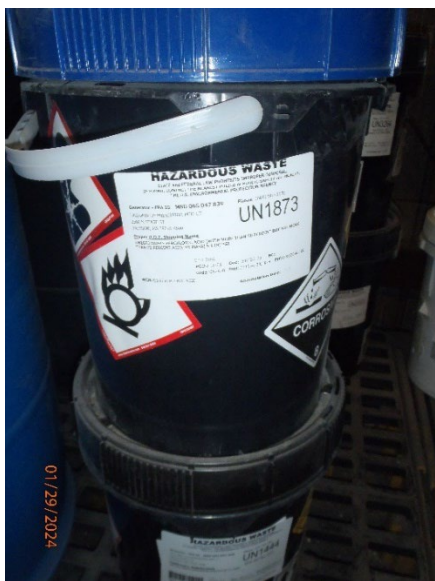
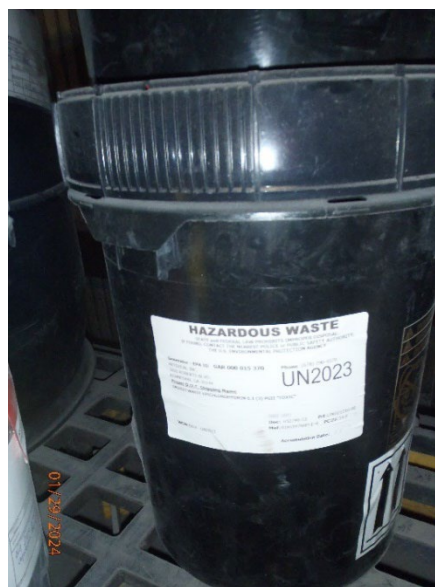
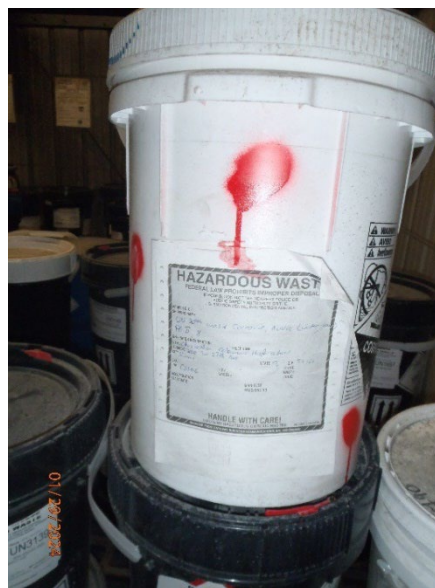
The inspectors also observed three 5-gallon containers missing the start accumulation dates (Pictures 44-46) (Picture 47), and a blue 15-gallon container that was not labeled and not closed. The facility immediately labeled the blue 15-gallon container but could not get the lid to close.

Picture 44 – Upper Warehouse Container Storage F drum missing Allworth label

Picture 45 – Upper Warehouse Container Storage F drum missing Allworth label

Picture 46 – Upper Warehouse Container Storage F drum missing Allworth label

**Pursuant to ADEM Admin. Code r. 335-14-3-.01(7)(a)5(i)(IV) [40 C.F.R. § 262.17(a)(5)(i)], which is a condition of the LQG Permit Exemption, a generator must mark or label its containers with the following: the words “Hazardous Waste”; an indication of the hazards of the contents; and the date upon which each period of accumulation begins clearly visible for inspection on each container.**

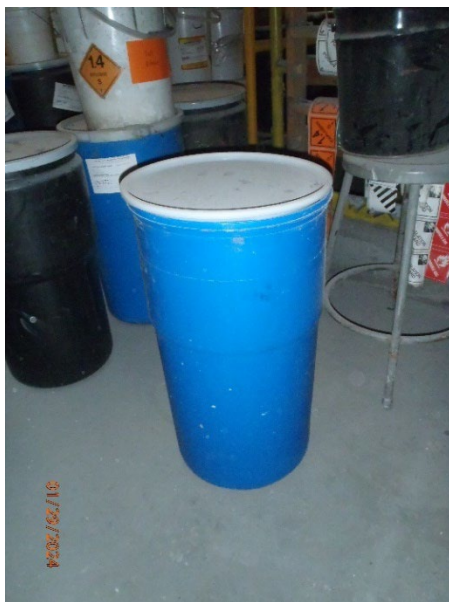
Picture 47 – Upper Warehouse Container Storage F open and unlabeled drum

**Pursuant to ADEM Admin. Code r. 335-14-3-.01 (7)(a)1.(iv) [40 C.F.R. § 262.17(a)(1)(iv)], which is a condition of the LQG Permit Exemption, (A) a container holding hazardous waste must always be closed during accumulation, except when it is necessary to add or remove waste; and (B) A container holding hazardous waste must not be opened, handled, or stored in a manner that may rupture the container or cause it to leak.**

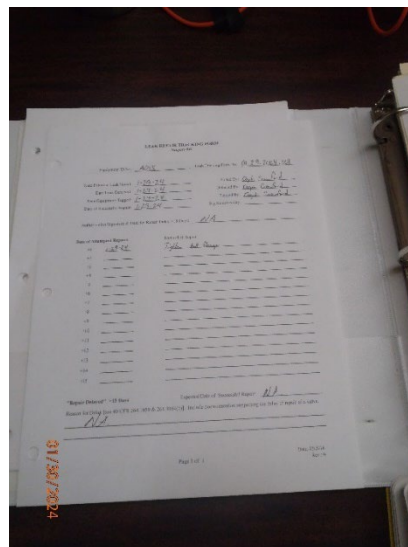
Leak detection and repair records were requested. The recent repair of flange A013 was documented in the records (Picture 56). Mr. Crawford explained that employees had to be retrained on the instrument pre-use calibration results and instrument calibration precision test because of miscalculations. The inspectors observed a memo in the records noting this issue. No issues were identified at the time of the review.

Picture 56 – Tank B7 flange A013 leak repair tracking form
