# **REPORT OF COMPLIANCE EVALUATION INSPECTION**

**AT**  
**City of Liberal Public Water Supply**  
**1401 East Pine**  
**Liberal, Kansas 67901**

**May 14-15, 2025**

**BY**  
**U. S. ENVIRONMENTAL PROTECTION AGENCY**  
**Region 7**  
**Enforcement and Compliance Assurance Division (ECAD)**

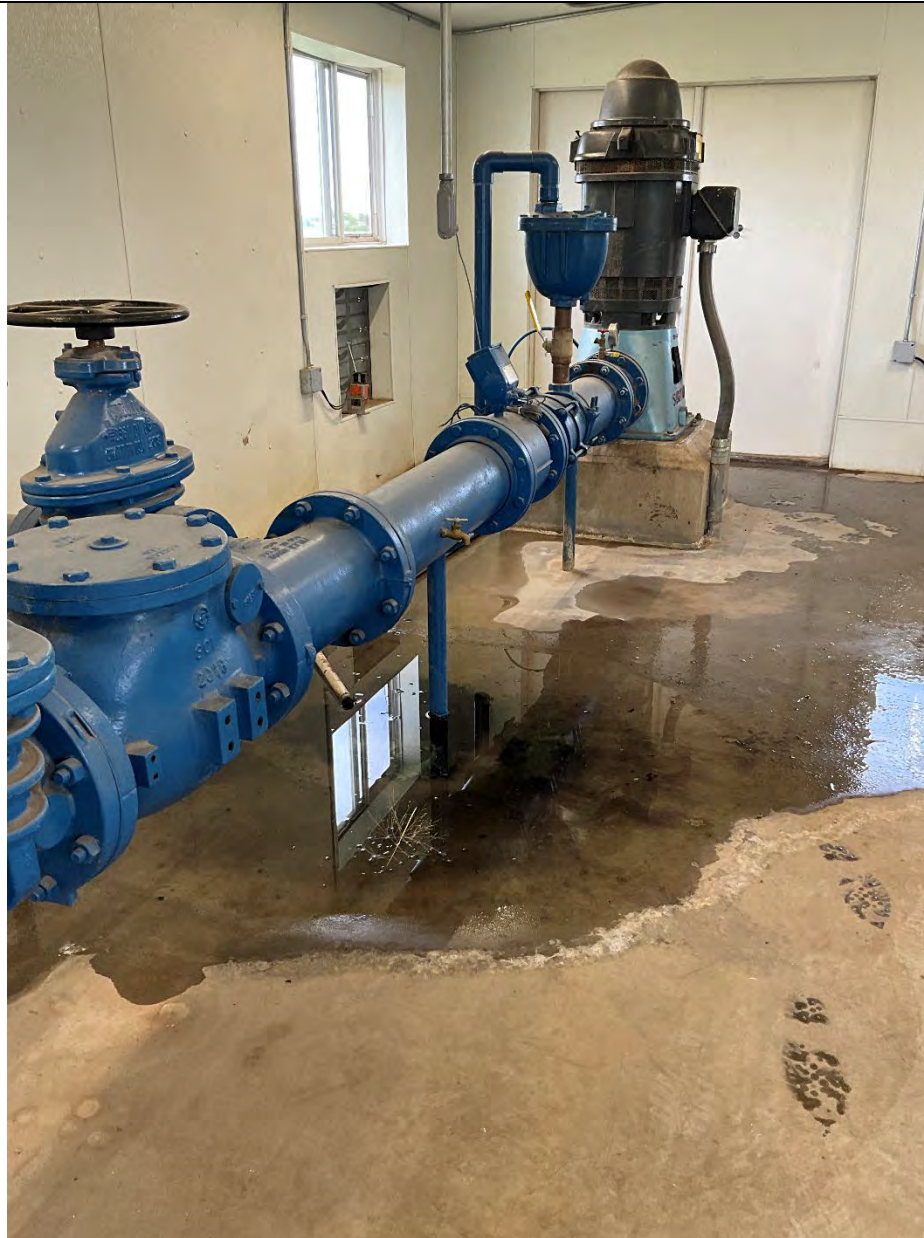
5

Well #45 – view of discharge line with pressure relief valve and isolation valve; Note the floor drain is clogged and water accumulation on the floor.

In Wells #45 and #2-8, water had accumulated on the floor of the well house. Each of the well houses were equipped with floor drains, as specified in the KS Minimum Design Standards, however, the drains were clogged preventing proper drainage. Mr. Rosales identified the causes of each of the drainage issues and explained that they would be addressed as soon as possible. This issue was discussed during the inspection; however, it was not noted on the NOPF but is included as Finding #26 in the Conclusion Section of this report.

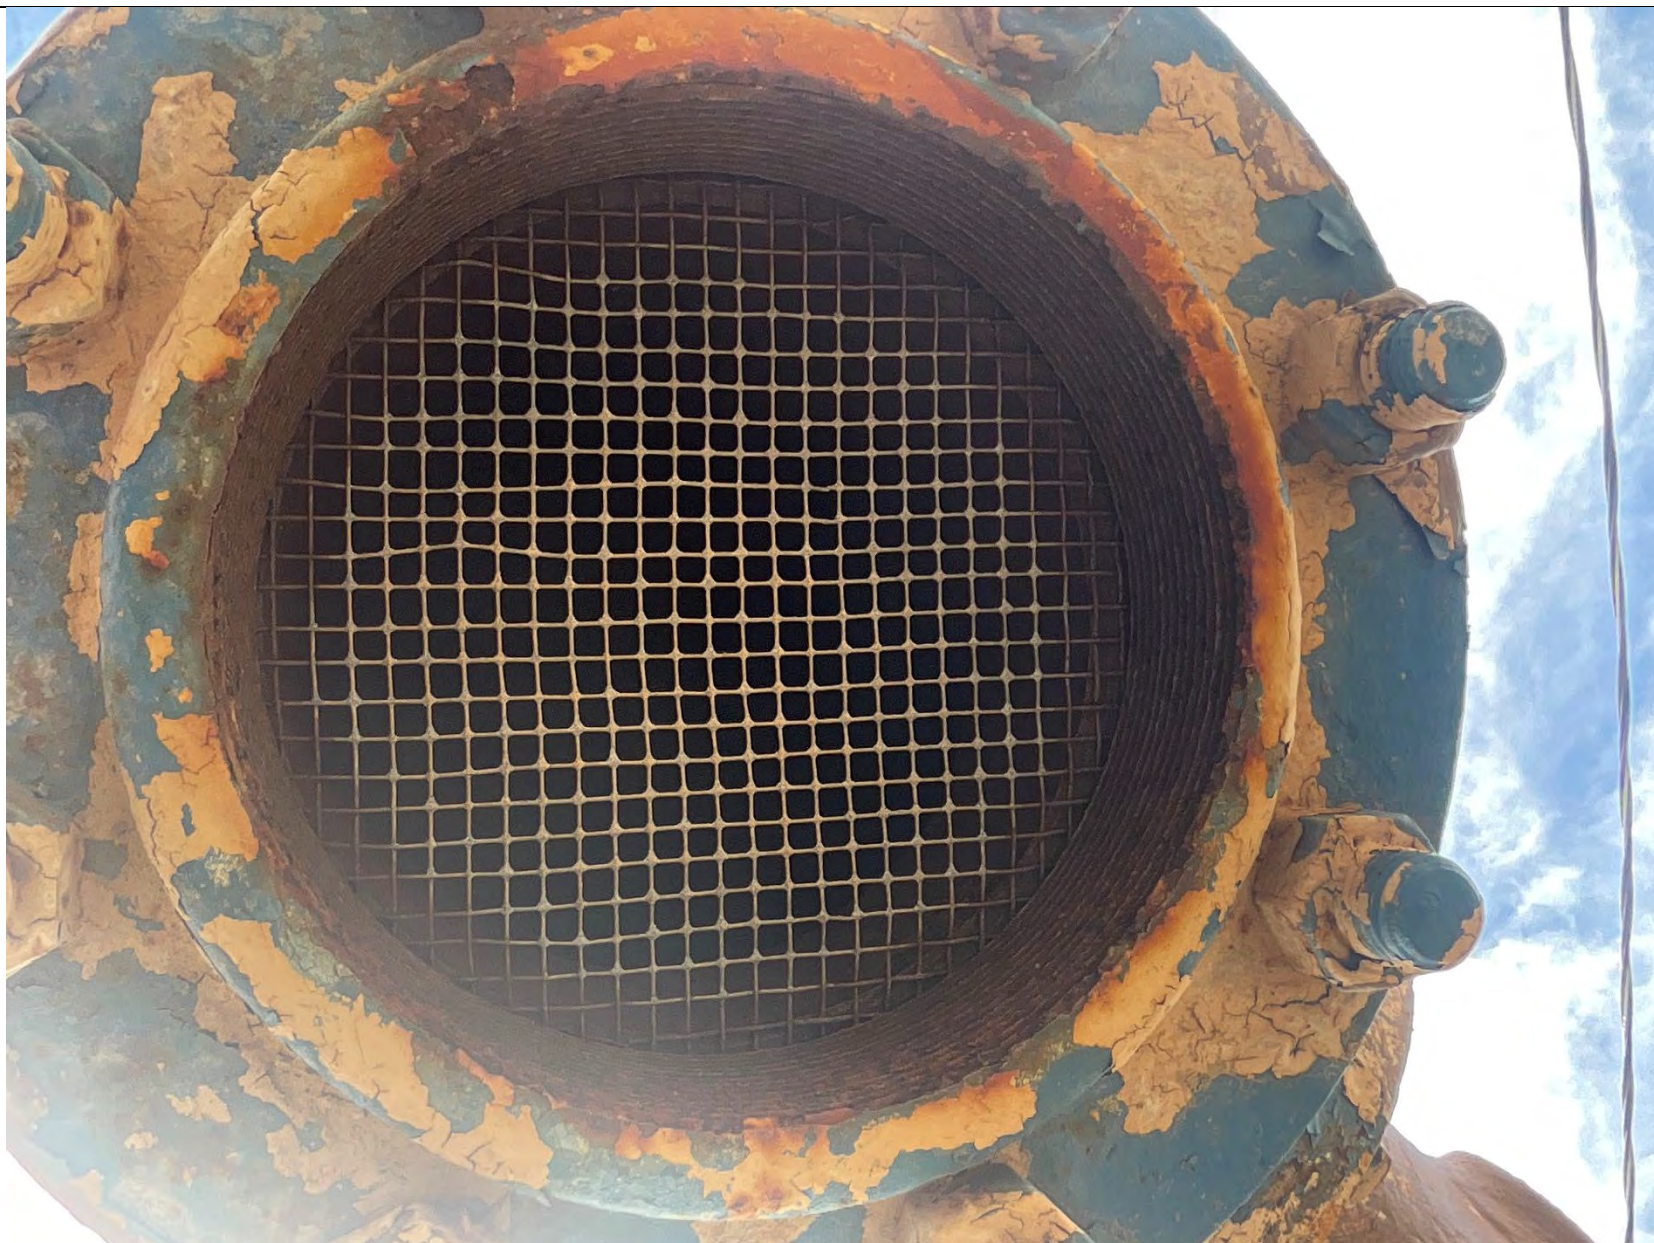
10

Station #4 – ground storage tank vent with large mesh screen (~4 mesh)

The vents for each of the GSTs were observed. The GST vent on Stations #2, #3, and #4 were equipped with large opening screens (Photographs #9, #22, and #40). Chapter VI for Water Storage Tanks of the KS Minimum Design Standards requires vents for GSTs to be equipped with 16-mesh screens to prevent insects from entering through the vents and into the storage structures. This issue was discussed with Mr. Rosales during the inspection, at the exit conference, and is noted at Finding #7 of the NOPF. Mr. Rosales explained that the City would evaluate the issue and replace the screens with the appropriate size. While observing the GST at Station #1 (Photograph #59), I noted that there were no vents provided for the two storage tanks. This was noted as Finding #12 of the NOPF, however, the tanks have been in operation since the 1940's and therefore would be not subject to minimum design standards for venting and Mr. Rosales explained that there have not been any operating issues due to the lack of vents.

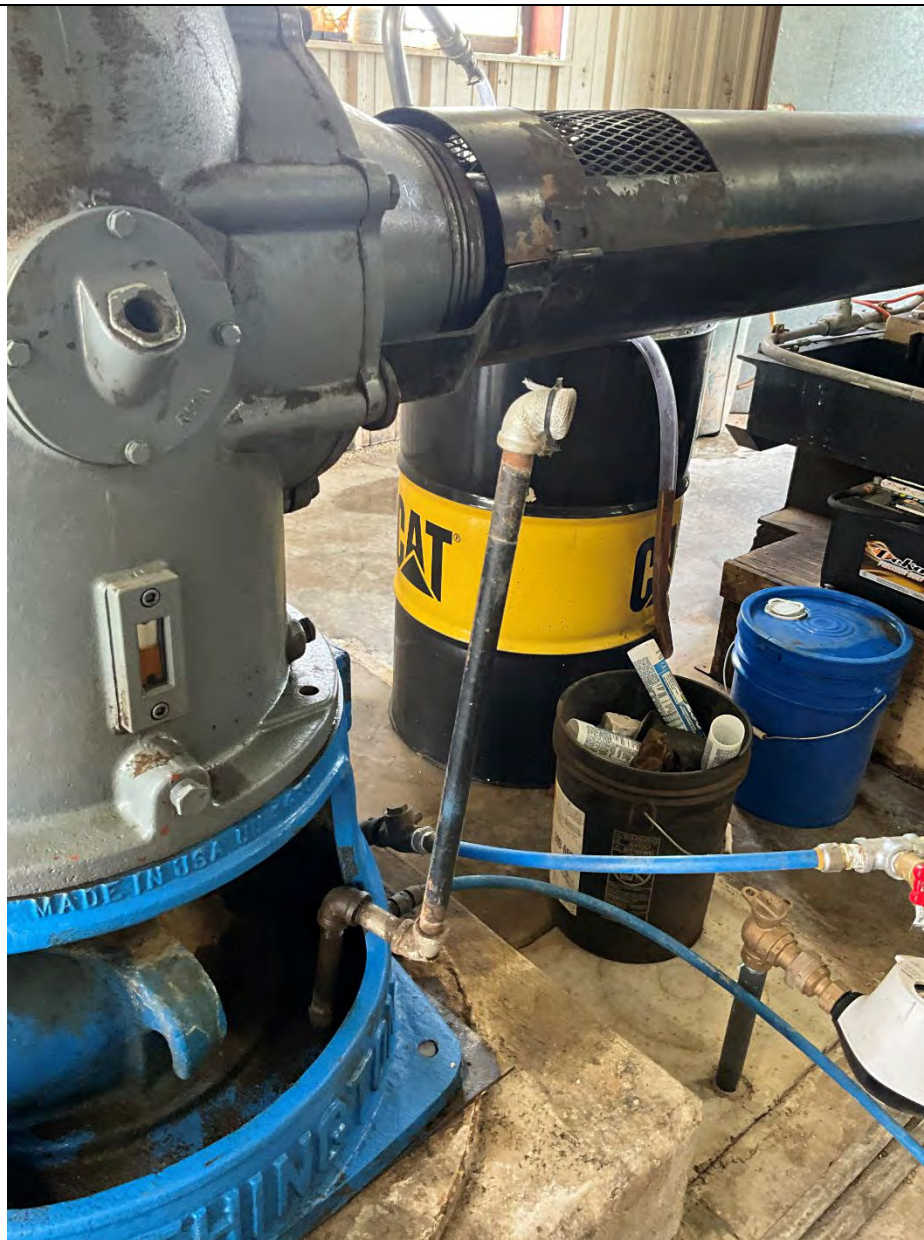
Well #34 – well casing vent extended but pointing outward; Also note the 55-gallon drum of lubricating oil near the pump base.

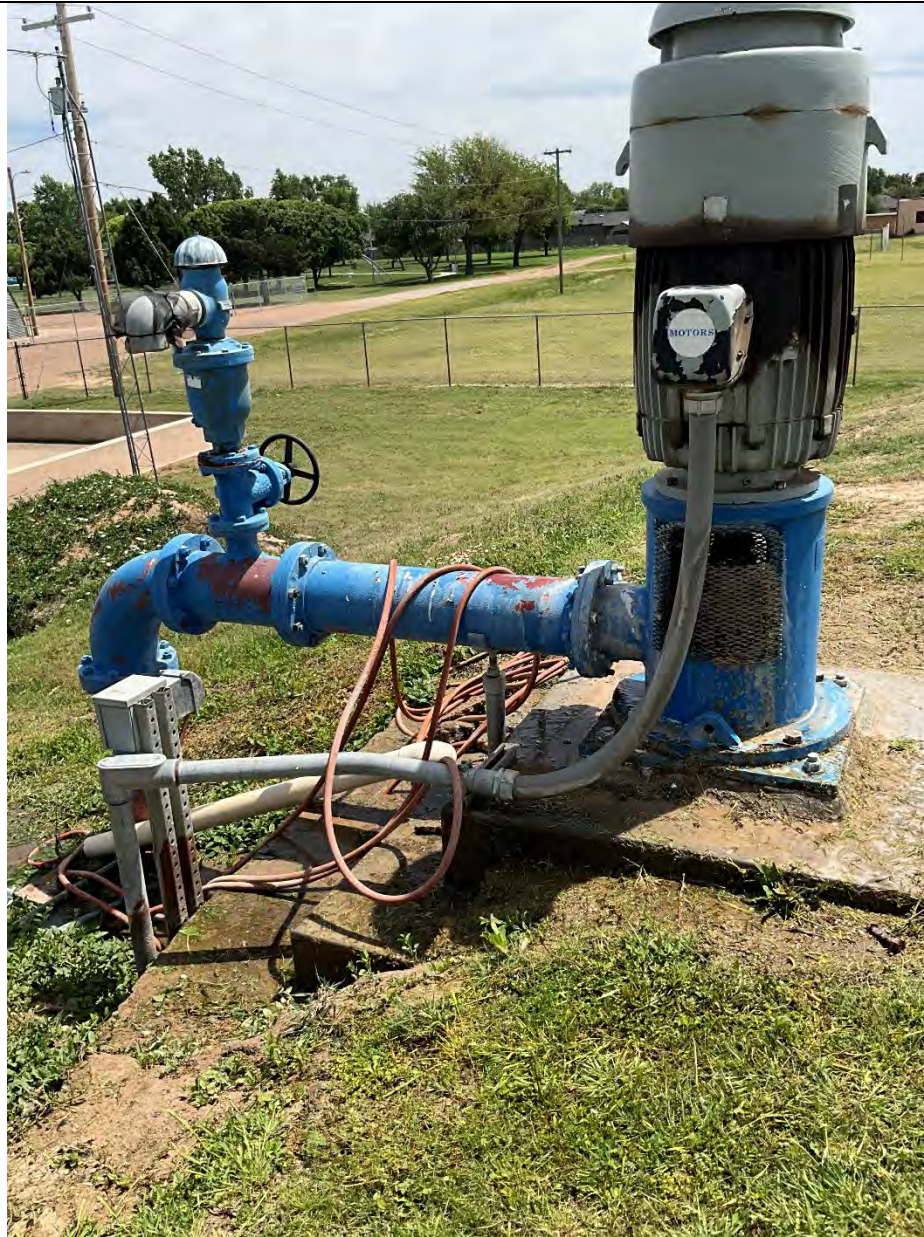
22

Station #3 – High Service Pump – packing leak

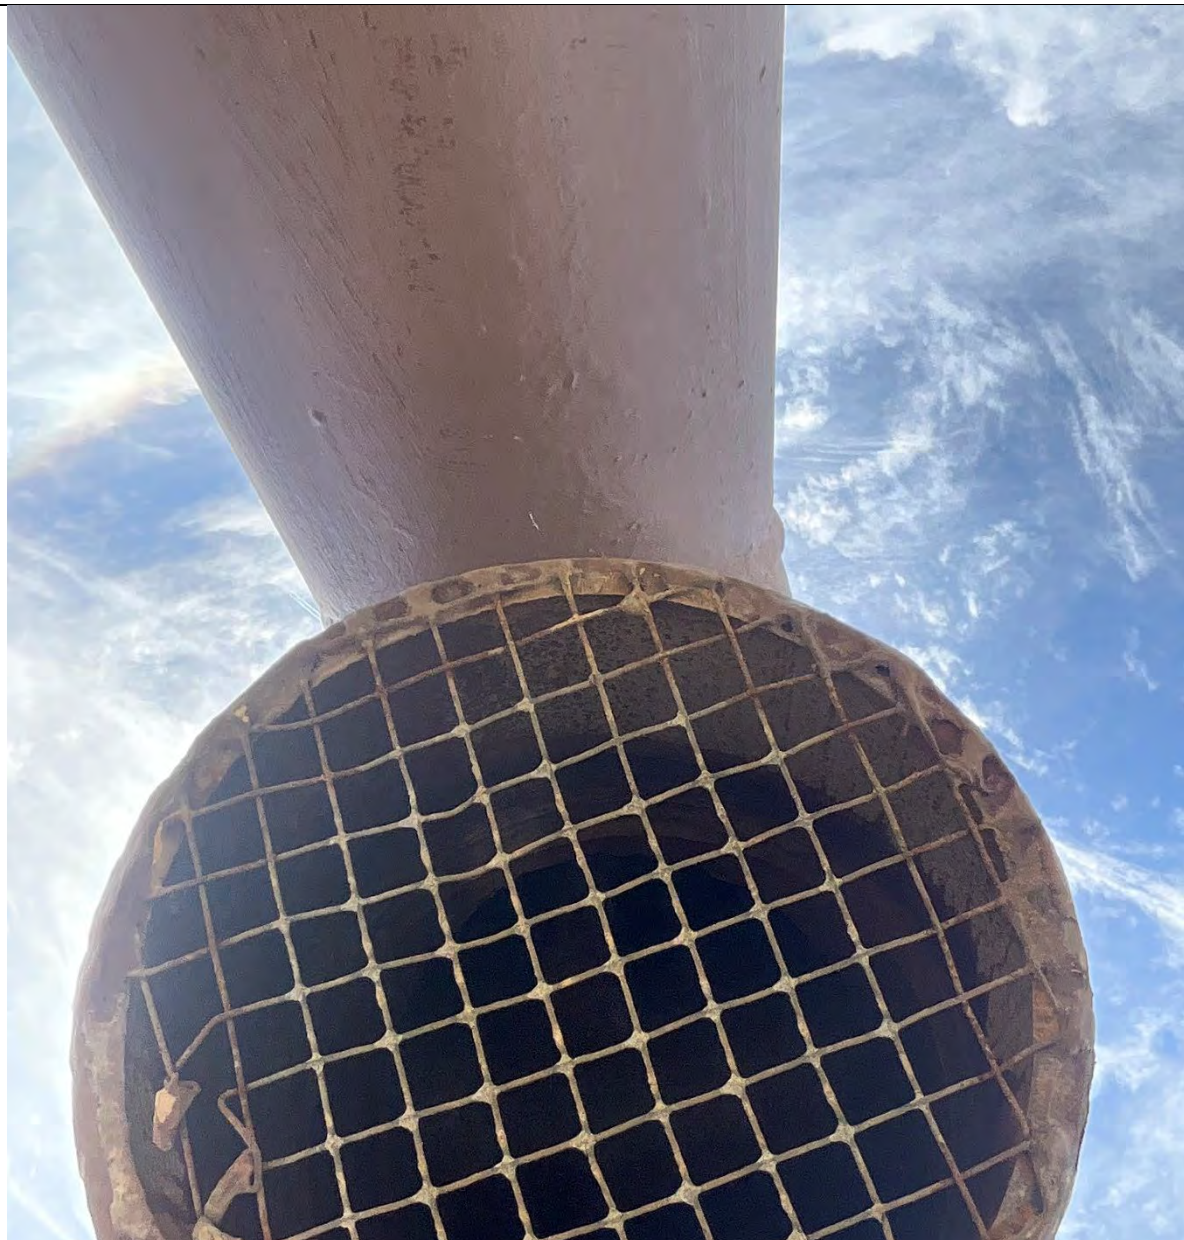
23

Station #3 – Ground storage tank vent screen with large mesh (4 mesh)

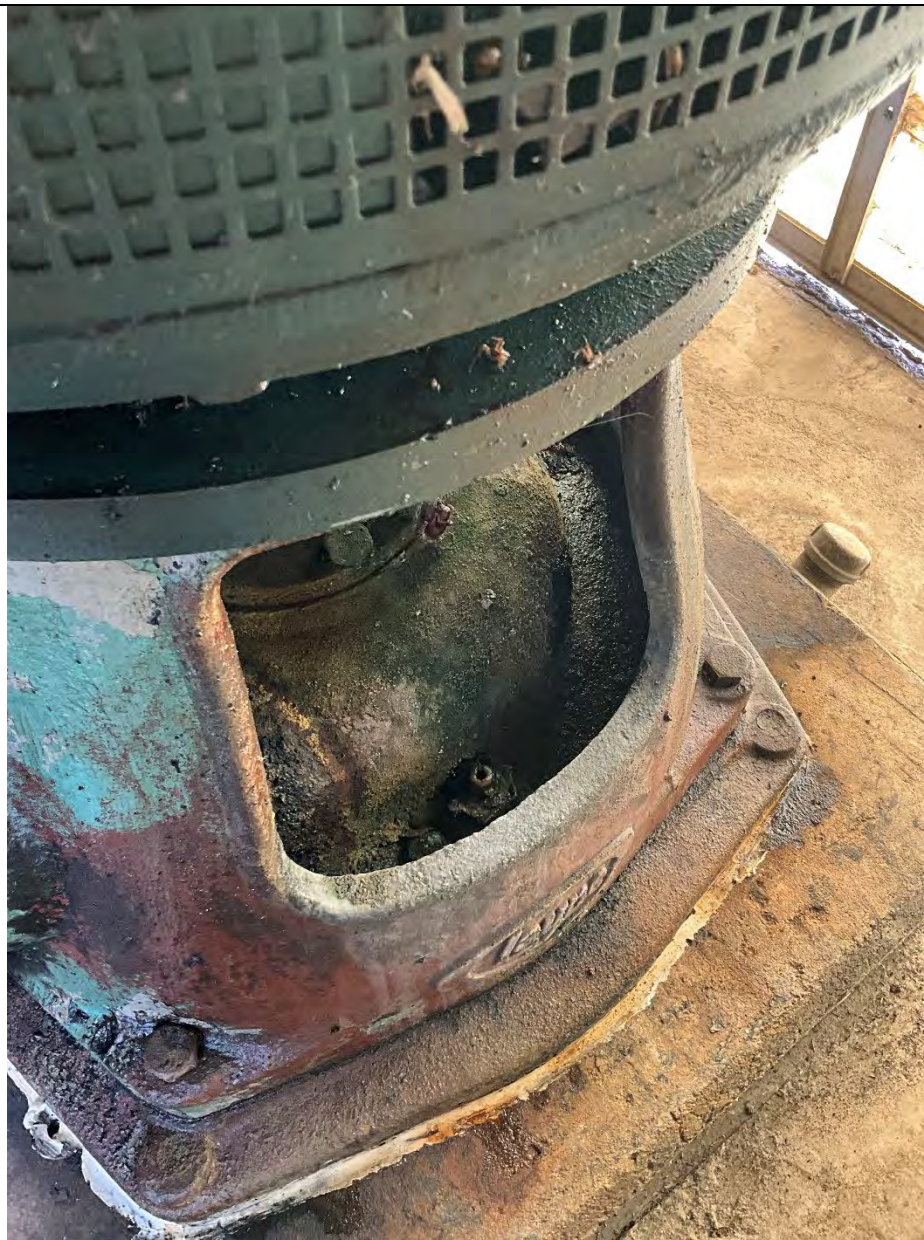
31

Well #3-3 without a casing vent

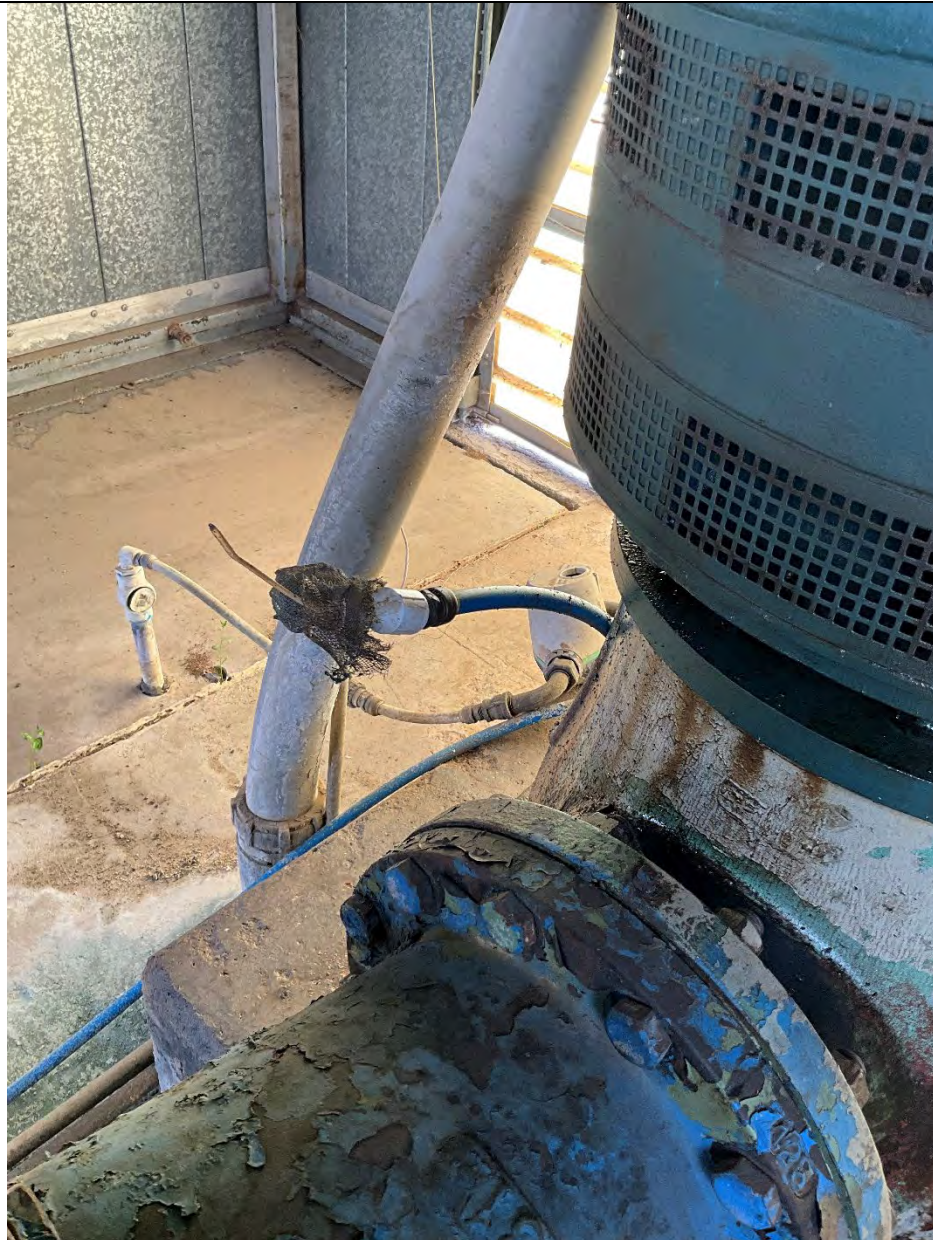
32

Well #3-3 drawdown tube extended and screened; however, facing outward and not downturned

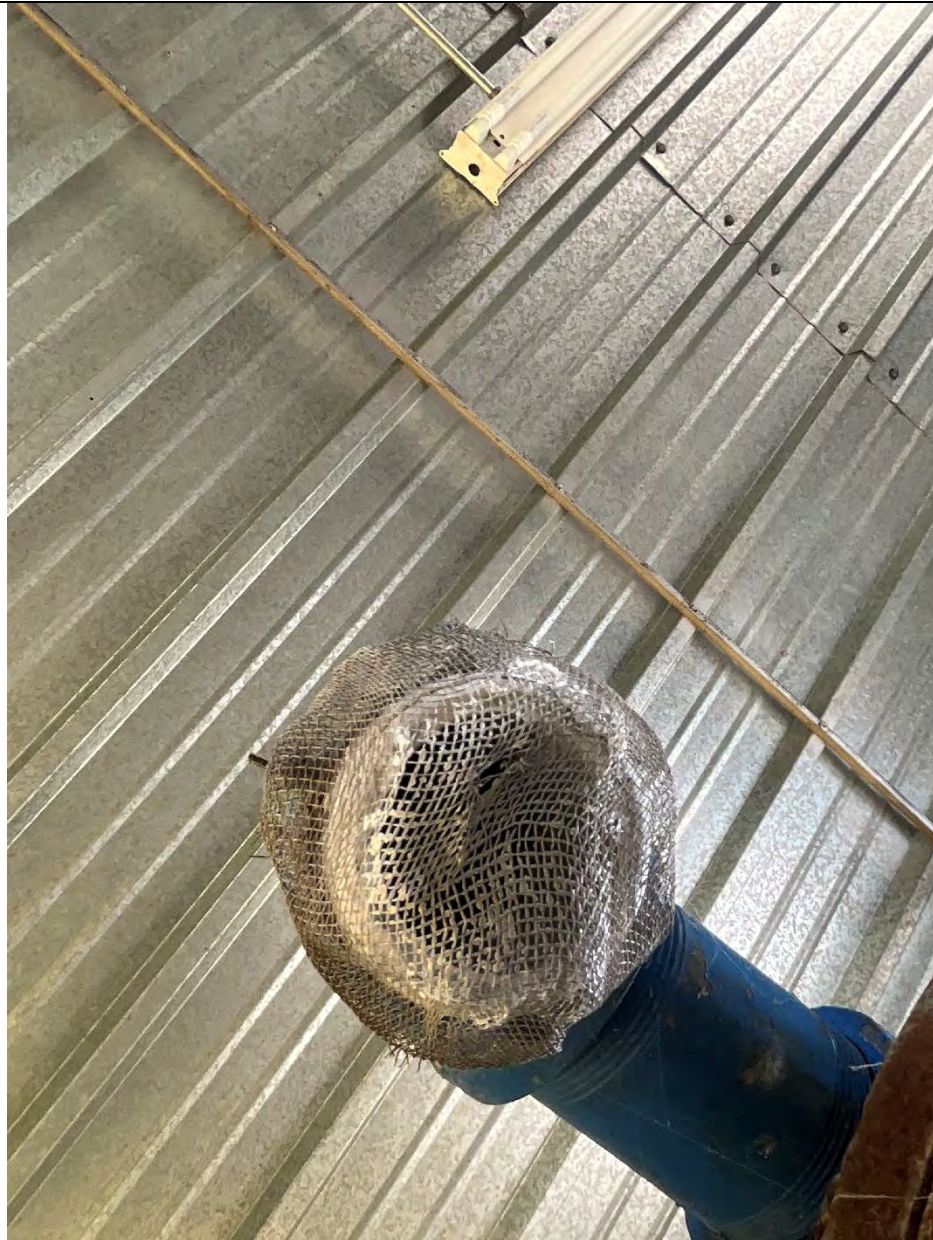
33

At Wells #3-3 and #1-7, I observed the screens on the pressure relief valves were torn or had large holes present in the mesh screens that cover the discharge points. Pressure relief valves expel excess pressure in the discharge lines of the well and draw air into the discharge line. The entry and exit of air into the discharge lines, through the pressure relief valves, provides a pathway for contaminants to enter the system, if the openings are not properly screened. Mr. Rosales explained that the screens are regularly inspected and replaced and that he would ensure the screens are replaced immediately. This finding was discussed with the system at the exit conference but was not noted on the NOPF. However, this finding is included as Finding #24 in the Conclusion Section of this report.

Well #3-3 – pressure relief valve discharge point with tears in the screen.

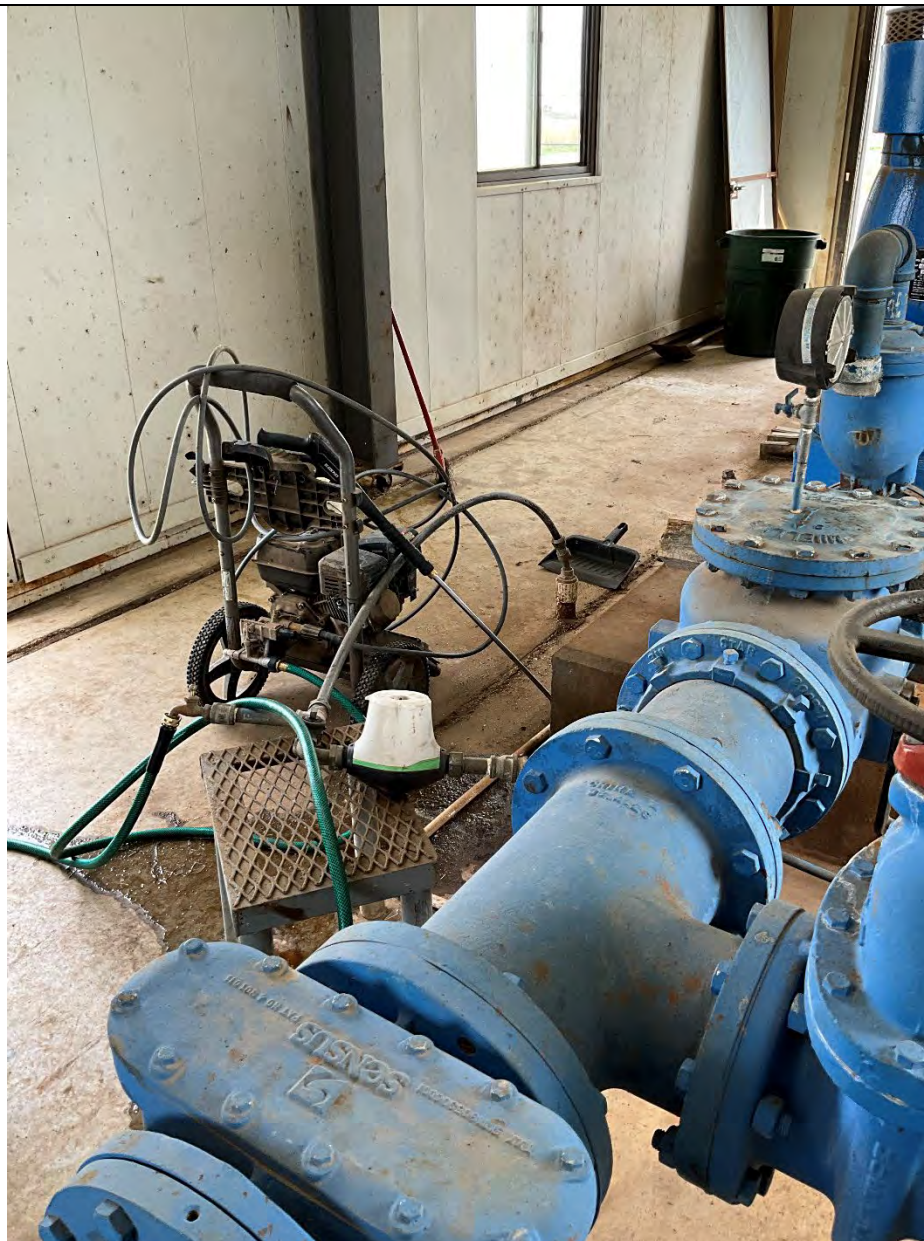
35

While inspecting Well #11, a power washer was observed in the well house. The power washer was connected with a garden hose, without a backflow prevention device or vacuum breaker, to the casing lubrication water line. This configuration posed a potential contamination risk because the water supply connection is from water that directly flows from and returns to the aquifer. If backflow would occur this cross connection could potentially cause contamination of the well. Mr. Rosales explained that the system has garden hose connectors with vacuum breaks, and these would be used in the future. The power washer was disconnected during the inspection. This issue is noted as Finding #22 of the NOPF.

Well #2-9 with pressure washer connected to the casing lubrication water line without a backflow prevention device or reduced pressure assembly.

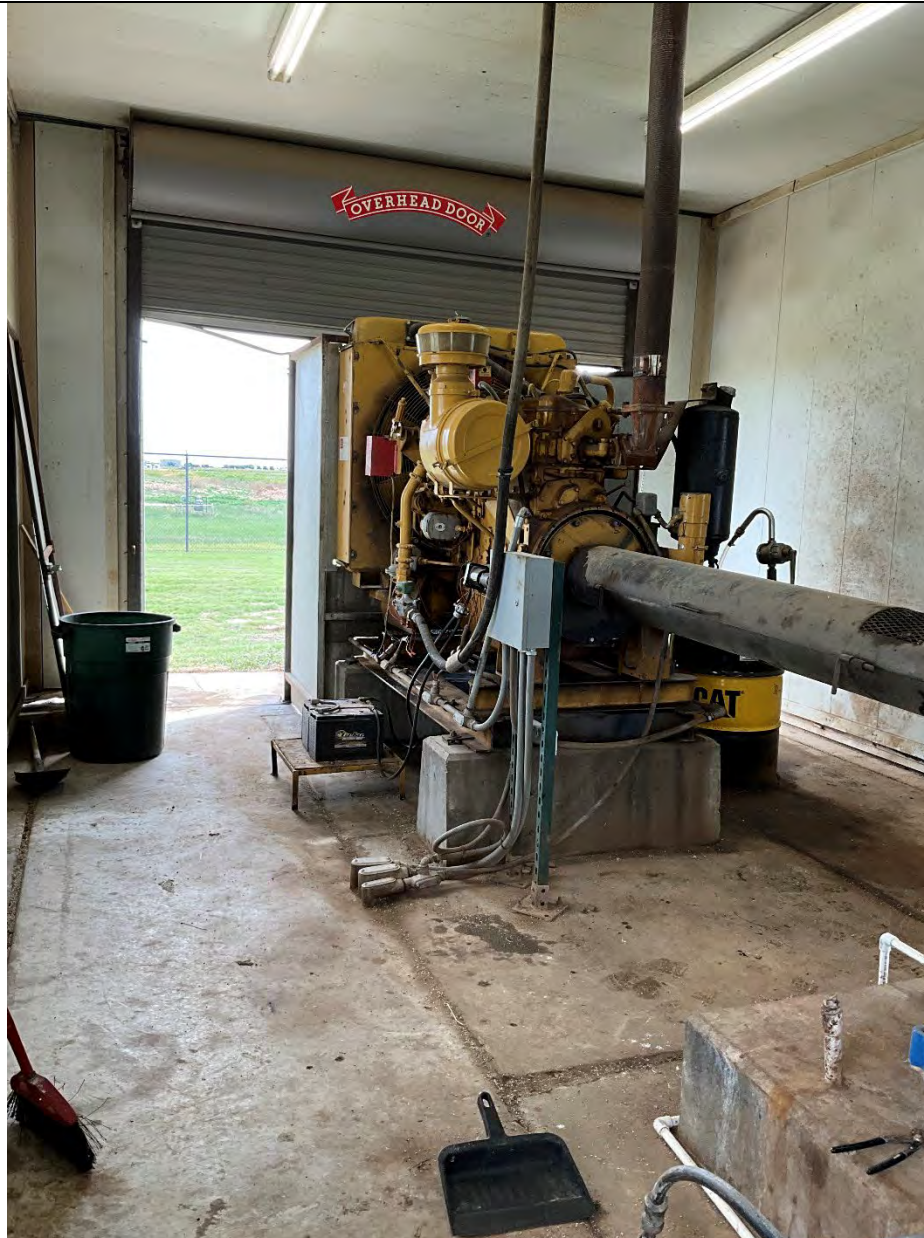
While touring multiple well houses served by natural gas and diesel powered pumps, I noted 55-gallon drums of oil used for lubricating the well pump motors (Wells #1-7, #2-9, and #3-4). The barrels of oil were located in close proximity (between two and ten feet) to the well pump bases. These barrels were not equipped with secondary containment and in the well house of Well #1-7, I observed spilled oil on the floor of the well house adjacent to the well pump base. I noted that oil-dry material had been placed over the spilled oil to absorb it. Mr. Rosales explained that lubricating oil is necessary for the operation of the natural gas-powered pumps and that oil is transferred from the 55-gallon drums to the smaller oil reservoir of the pumps. He noted that the transfer can be messy at times due to the small hand transfer pumps and that new electric transfer pumps have been identified and ordered. He explained that the spilled oil is normally cleaned immediately and that the new electric pumps should help with the transfer process. He also noted that secondary containment pallets could be installed to prevent any leaks from reaching the floor. I explained due to the close proximity of the well base and casing, that the spilled oil presented a situation for potential contamination of Well #1-7 and that the barrels of oil in these

wells should have secondary containment to prevent any spills or leaks from reaching the floor. This issue was noted as Finding #15 in the NOPF and discussed with the system at the exit conference.

Well #2-9 view of second natural gas powered pump; note the 55-gallon barrel of oil near well pump base.

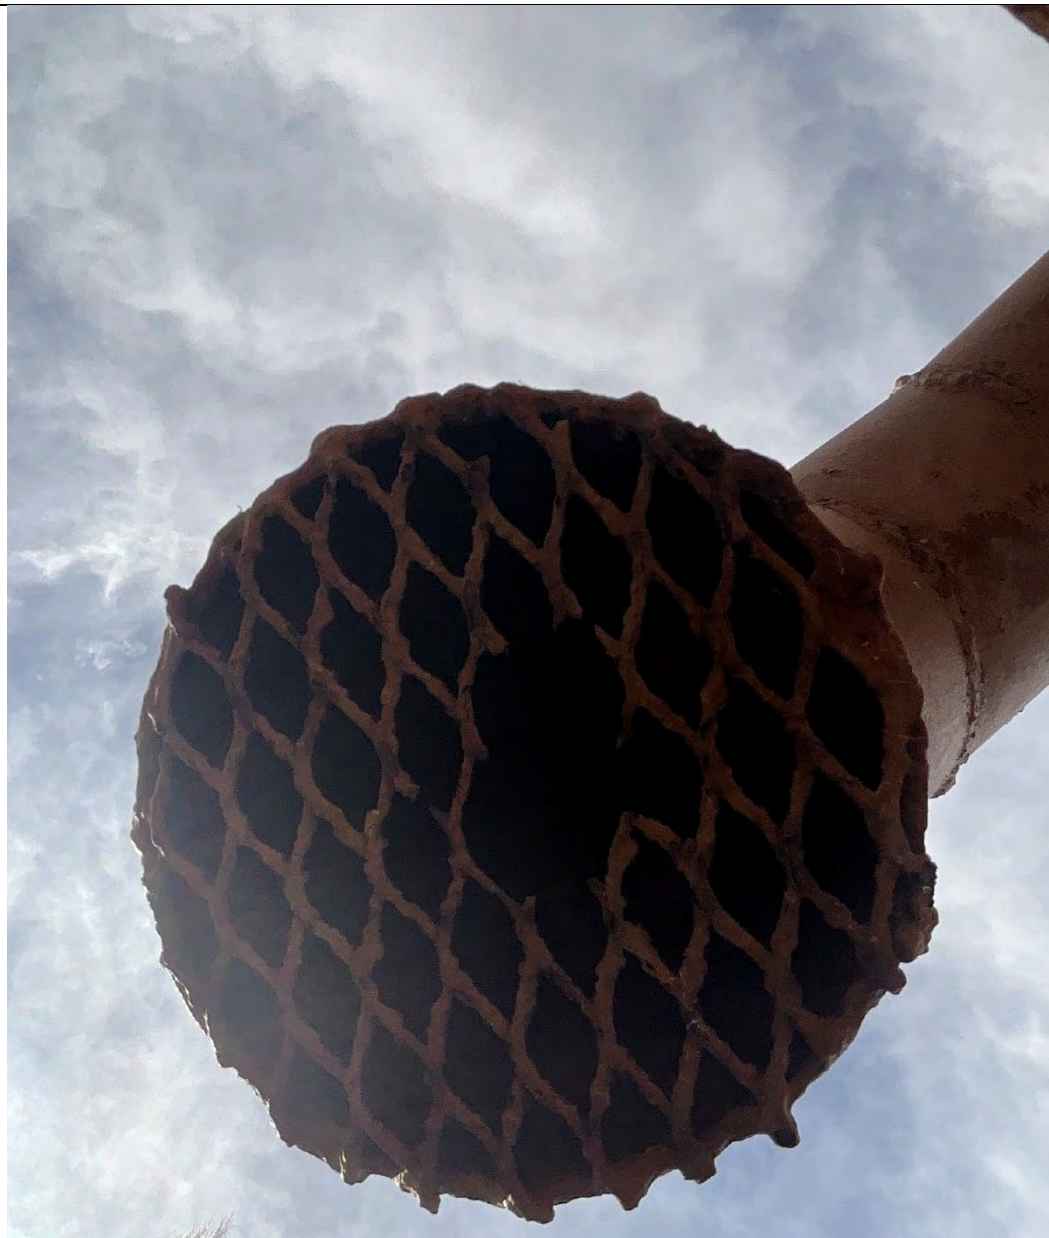
41

Station #2 - GST vent with large mesh screen and large hole in the screen

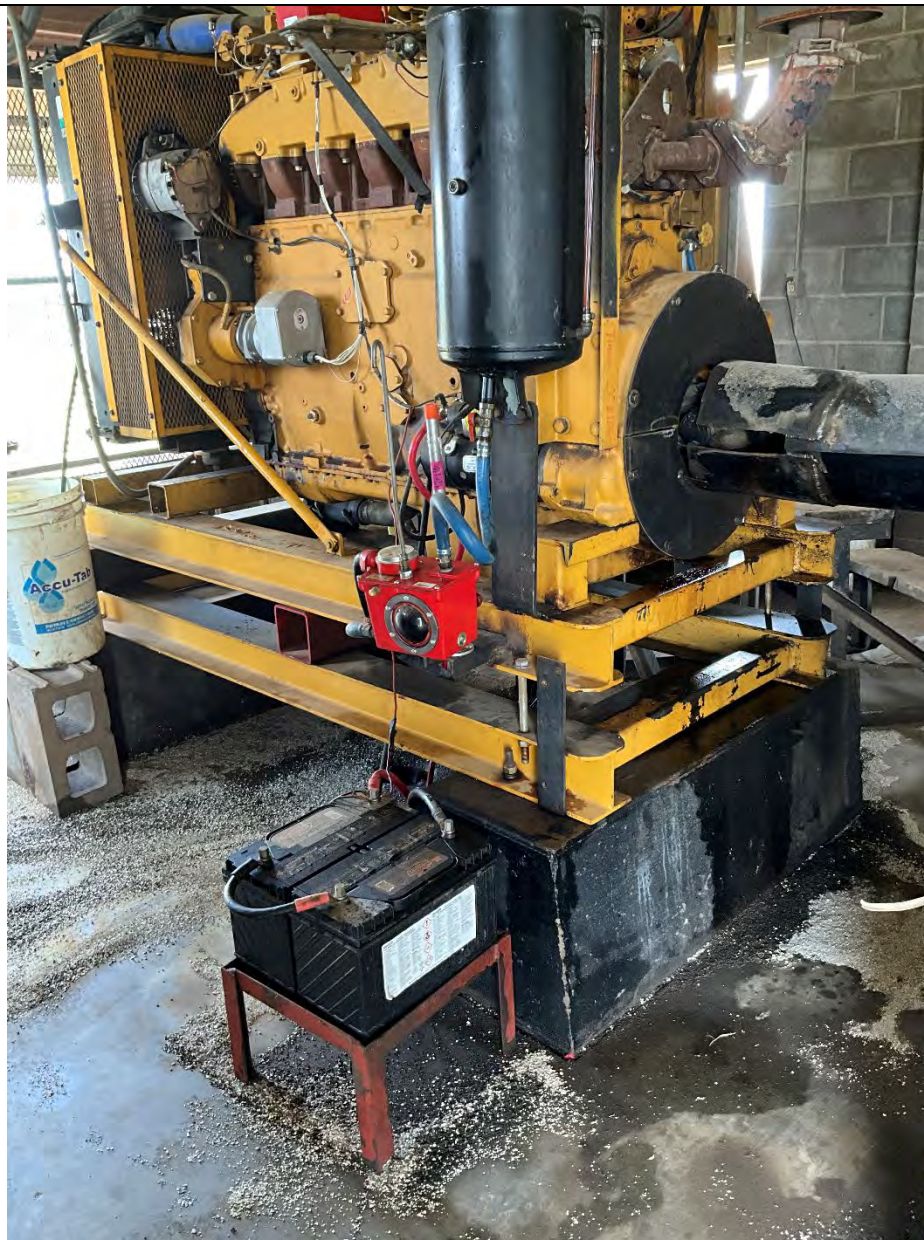
43

Well #2-7 – natural gas powered generate with oil spill on the floor adjacent to the pump base.

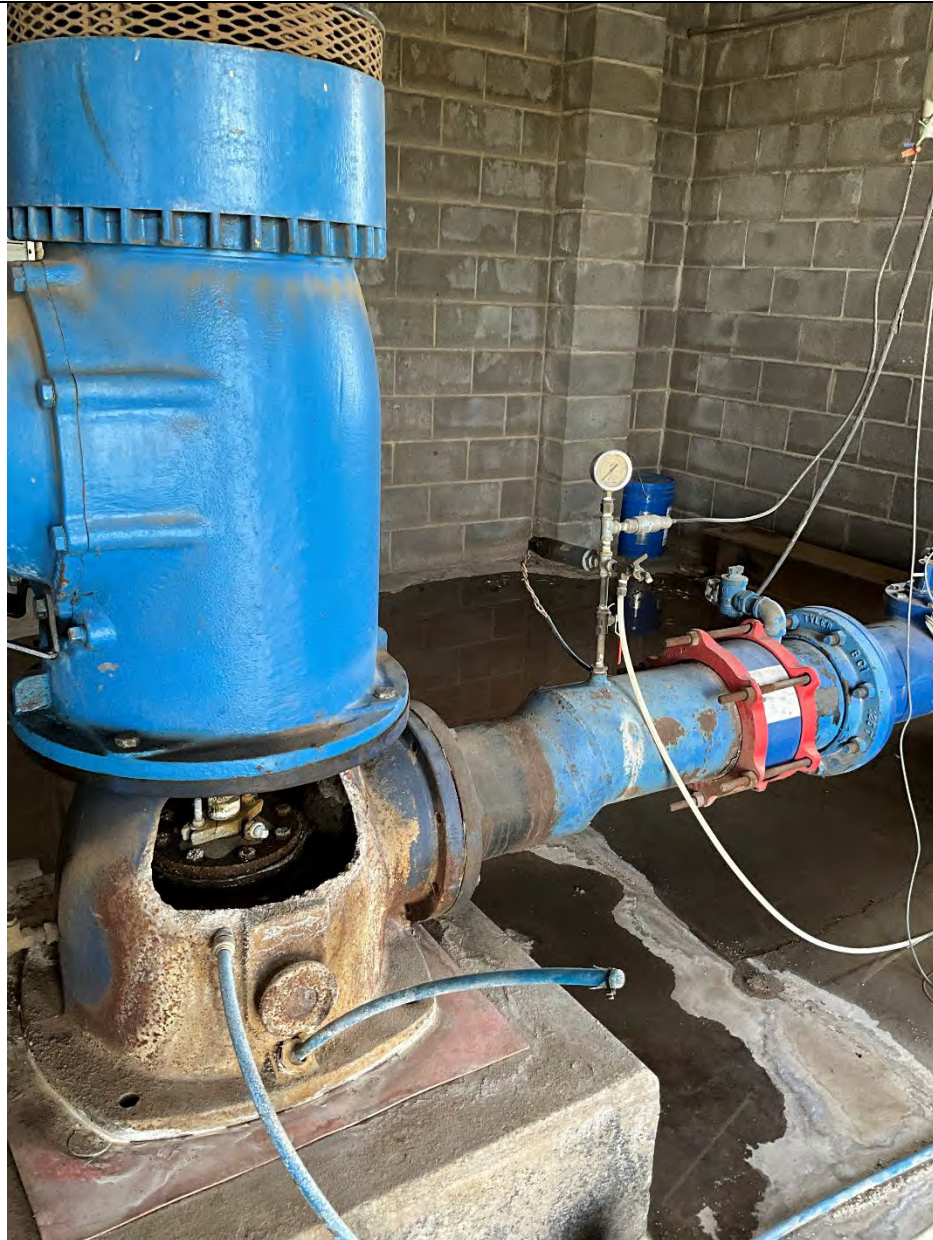
Well #2-7 – floor drain clogged and water accumulating on the floor of the building

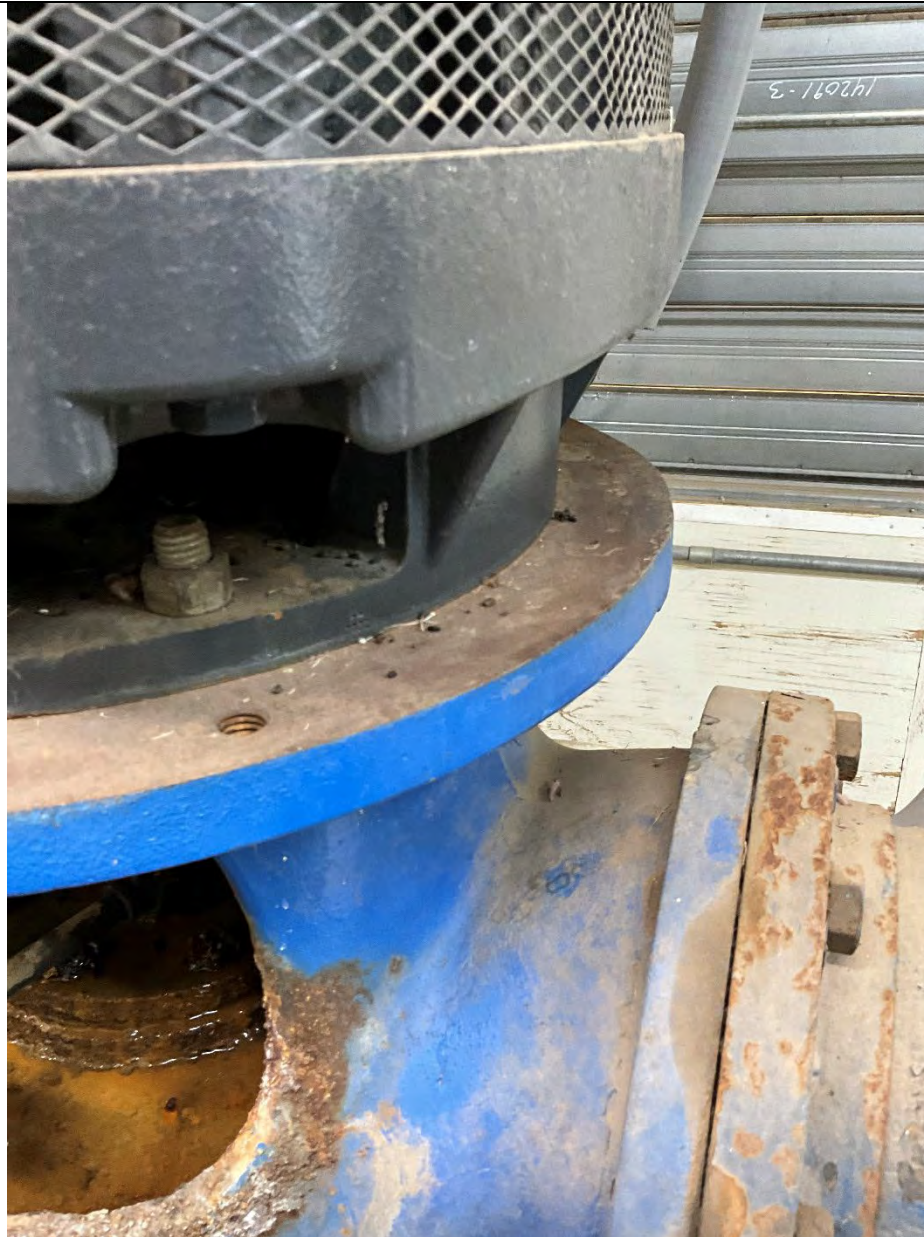
47

| <b>5-3</b> | Mouse droppings and a rodent nest observed on the well pump (Photograph #46-47, Finding #16); Uncovered electrical junction box with wire connections exposed (Photograph #48, Finding #17). Casing vent and drawdown tubing combined (Finding #4). |

While inspecting the well house of Well #53, I observed mouse or rodent droppings on the well pump. After further investigation, I observed a rodent nest inside the well pump. This issue was immediately addressed by system staff by removing the nest, and we discussed preventative measures that could be conducted to prevent rodents from entering the well houses. Mr. Rosales explained that he had contacted a pest exterminator, and that traps or appropriate poisons would be added around the well houses to prevent infestations. Rodents pose a potential sanitary concern with potential contamination entering the well or causing significant damage to the well pump or electrical pump components. Measures should be conducted to prevent rodents from entering or remaining in well houses or their components. This finding was noted as Finding #16 on the NOPF.

Well #53 – mouse droppings on the well pump

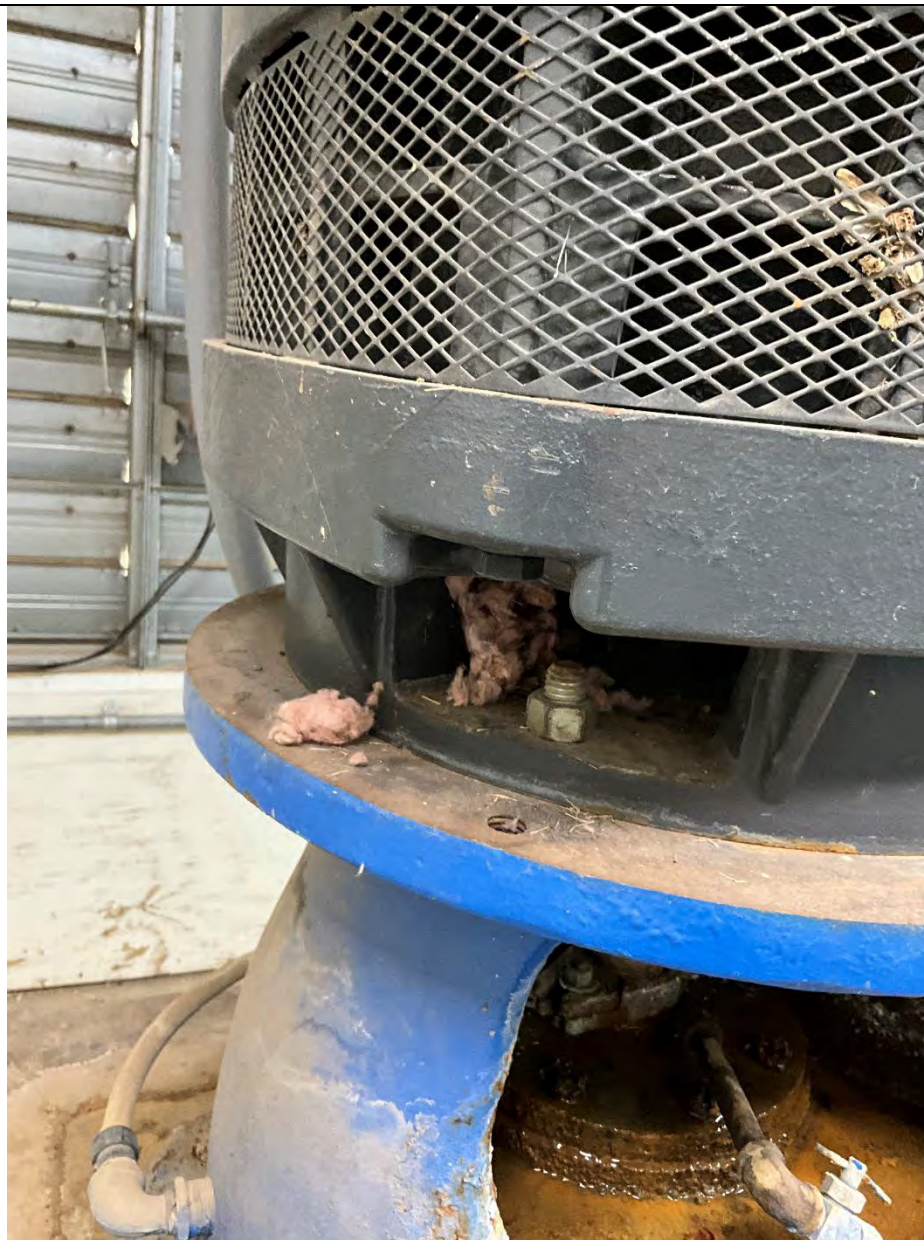
48

Well #53 – mouse nest in the electrical pump

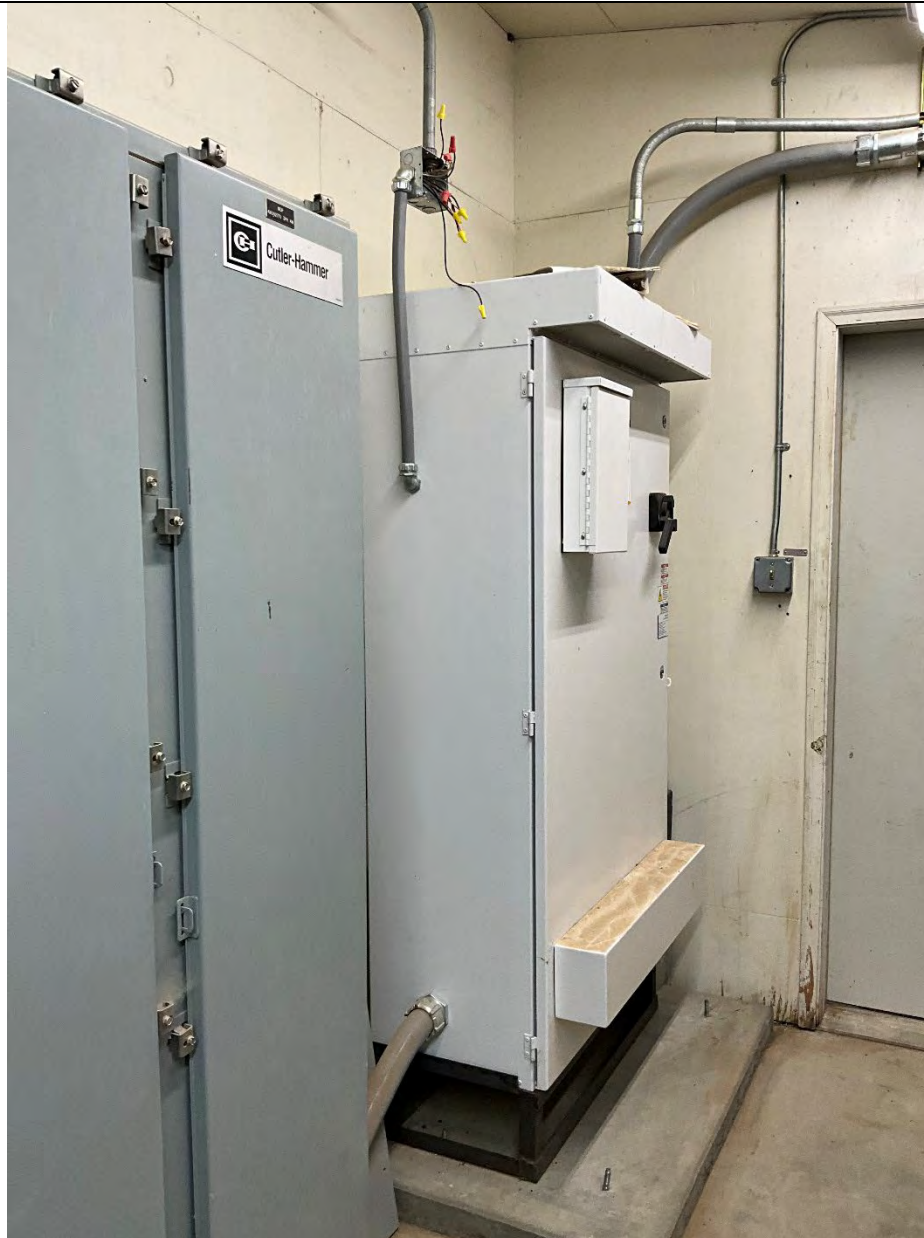
49

Well #53 – uncovered electrical junction box from the variable frequency drive (VFD) panel
