# **REPORT OF COMPLIANCE EVALUATION INSPECTION**

**AT**  
**City of Liberal Public Water Supply**  
**1401 East Pine**  
**Liberal, Kansas 67901**

**May 14-15, 2025**

**BY**  
**U. S. ENVIRONMENTAL PROTECTION AGENCY**  
**Region 7**  
**Enforcement and Compliance Assurance Division (ECAD)**

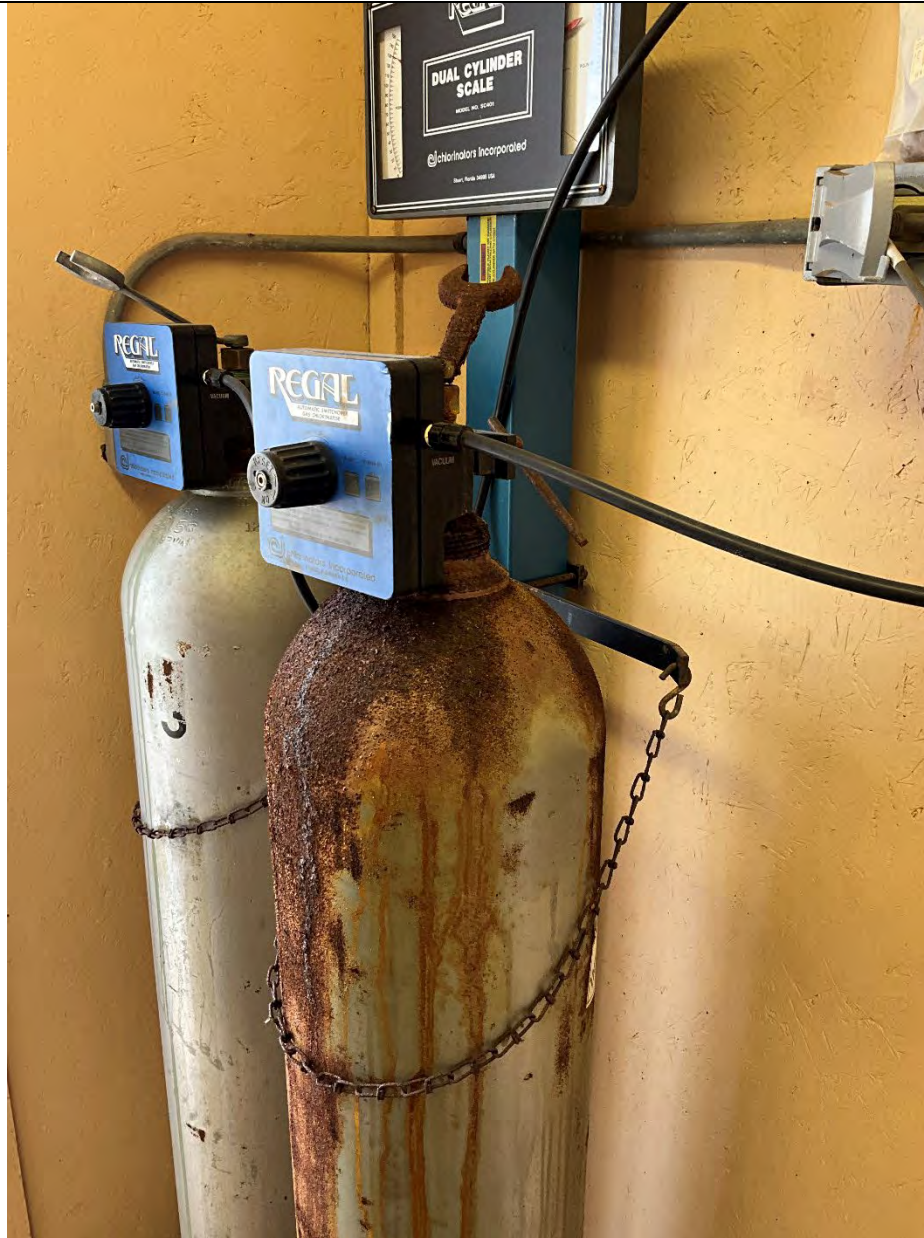
| <b>63</b> | Well out of service due to chlorine injection pump malfunction (Photograph #50, Finding #19). Significant corrosion noted on the gas chlorine cylinders (Photograph #49, Finding #19). Low free chlorine residuals (<0.2 mg/L) recorded at the well sampling site since March 2025 (Finding #19). |

At the time of the inspection, Well #63 was out of service due to issues with a chlorine injector pump. Mr. Rosales explained the well had been down for several months due to the injection pump malfunctioning. I observed significant corrosion on the gas chlorine cylinders in the chlorine room, and Mr. Rosales explained that this occurred when the injection pump malfunctioned and caused a leak. The chlorine gas had since been turned off. Mr. Rosales explained that chlorine injector pump was being repaired and that the city planned to have the well up and running before the summer months or when the highest system demand occurs. With the system being under a voluntary water restriction, the loss of a well could inhibit the system's

Well #63 – gas chlorine cylinders with heavy corrosion due to cylinder leak

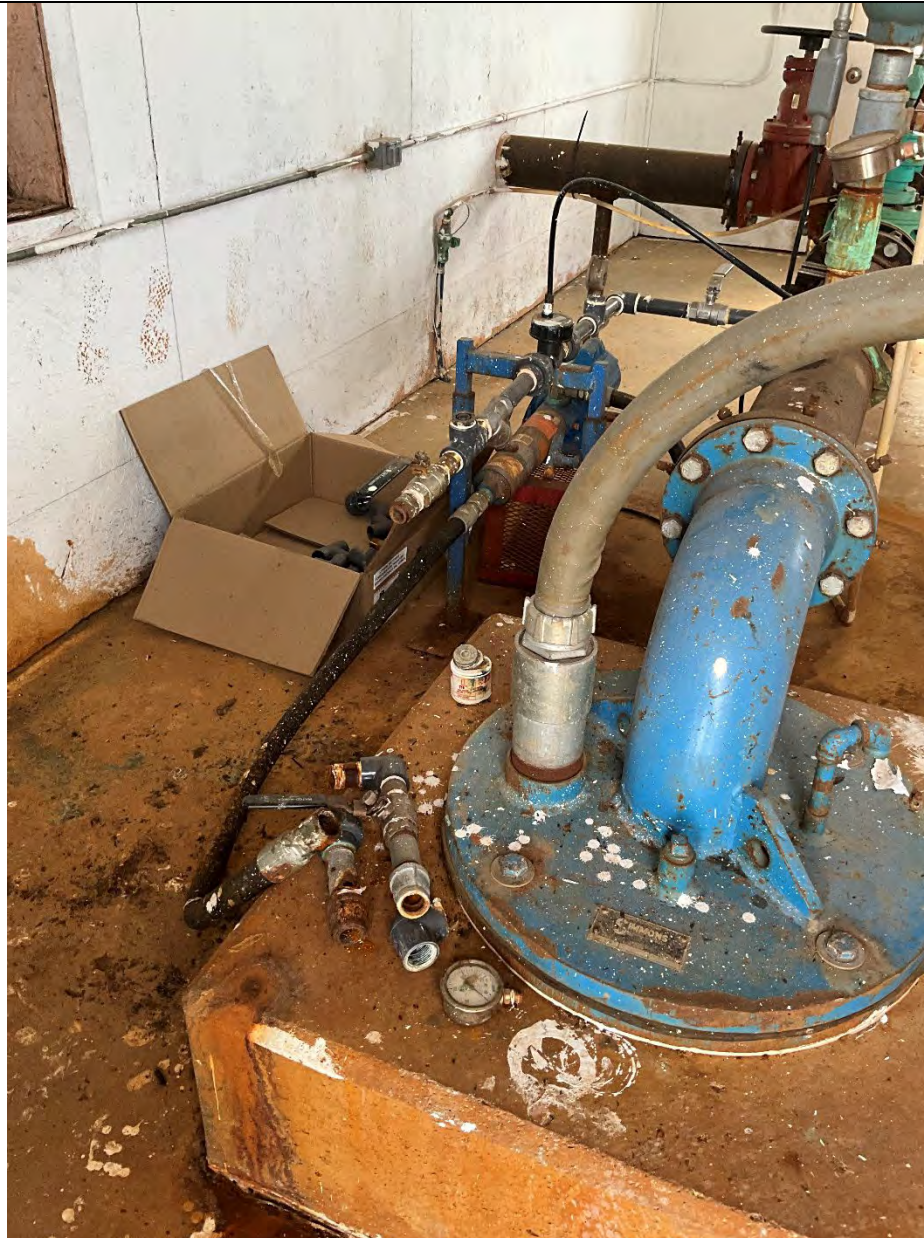
51

Well #63 – well out of service due to chlorine injection pump repair

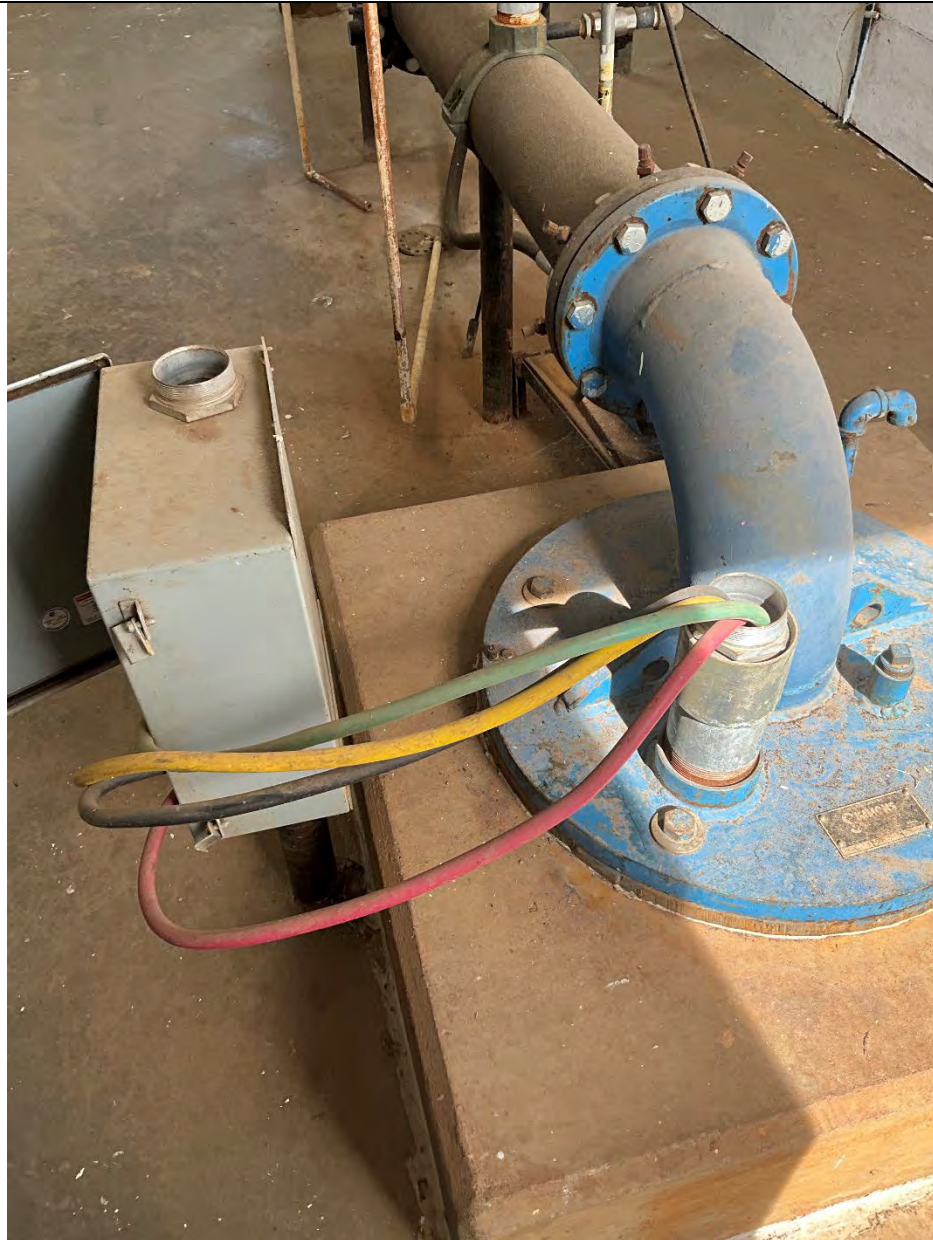
| <b>62</b> | Submersible pump missing conduit covering wires from the electrical box to the casing, presenting an open pathway to the well casing (Photograph #51, Finding #20). |

Well #62 – submersible pump electrical wiring without conduit from the junction box to the well casing.

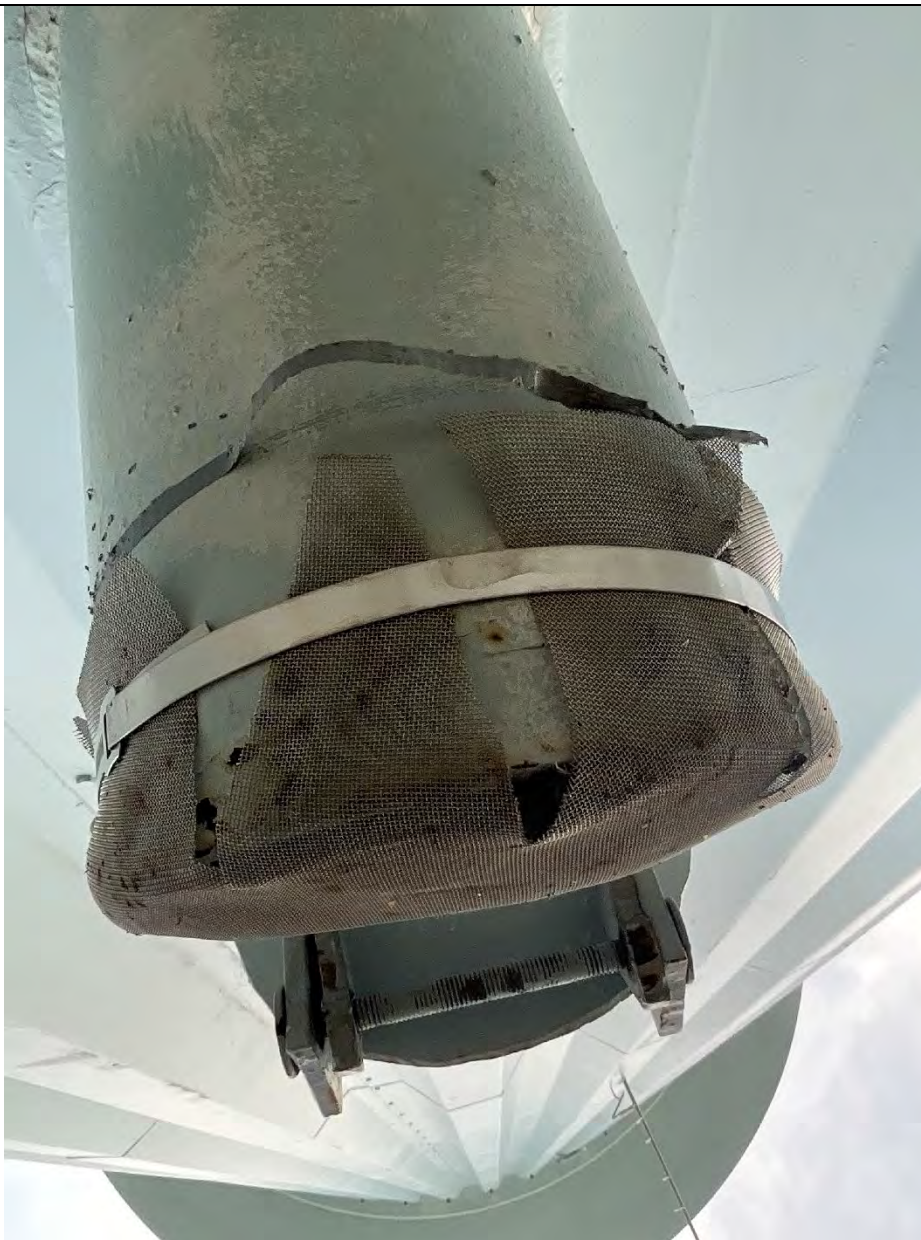
53

During the inspection, I visually observed every finished water storage structure from the ground level. I observed the foundation condition and overflow of the elevated storage tank. I noted the overflow screen was torn and had large holes in it and was in need of being replaced (Photograph #52, Finding #13). Below the recently installed manway of the tower, a large hole was present in the ground from the water eroding the area after the tower was drained to replace the opening. A wooden pallet had been placed at the base to cover the hole (Photograph #52, Finding #14). These issues were discussed with Mr. Rosales at the exit conference and noted in the NOPF.

Water tower overflow screen with tears in the bottom of the screen

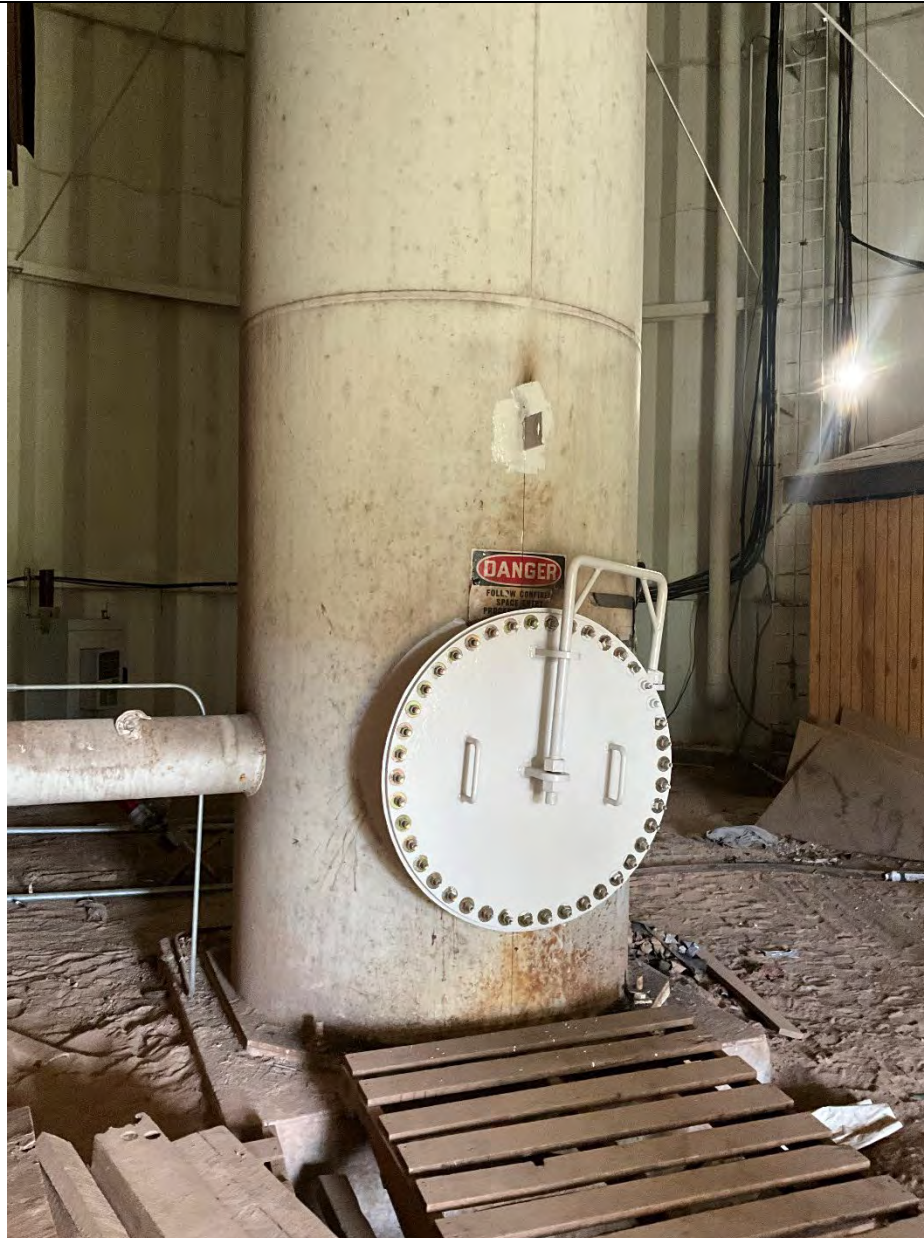
54

Water tower new manway installed; note the pallet below the manway where the ground was heavily eroded due to water flow after draining.

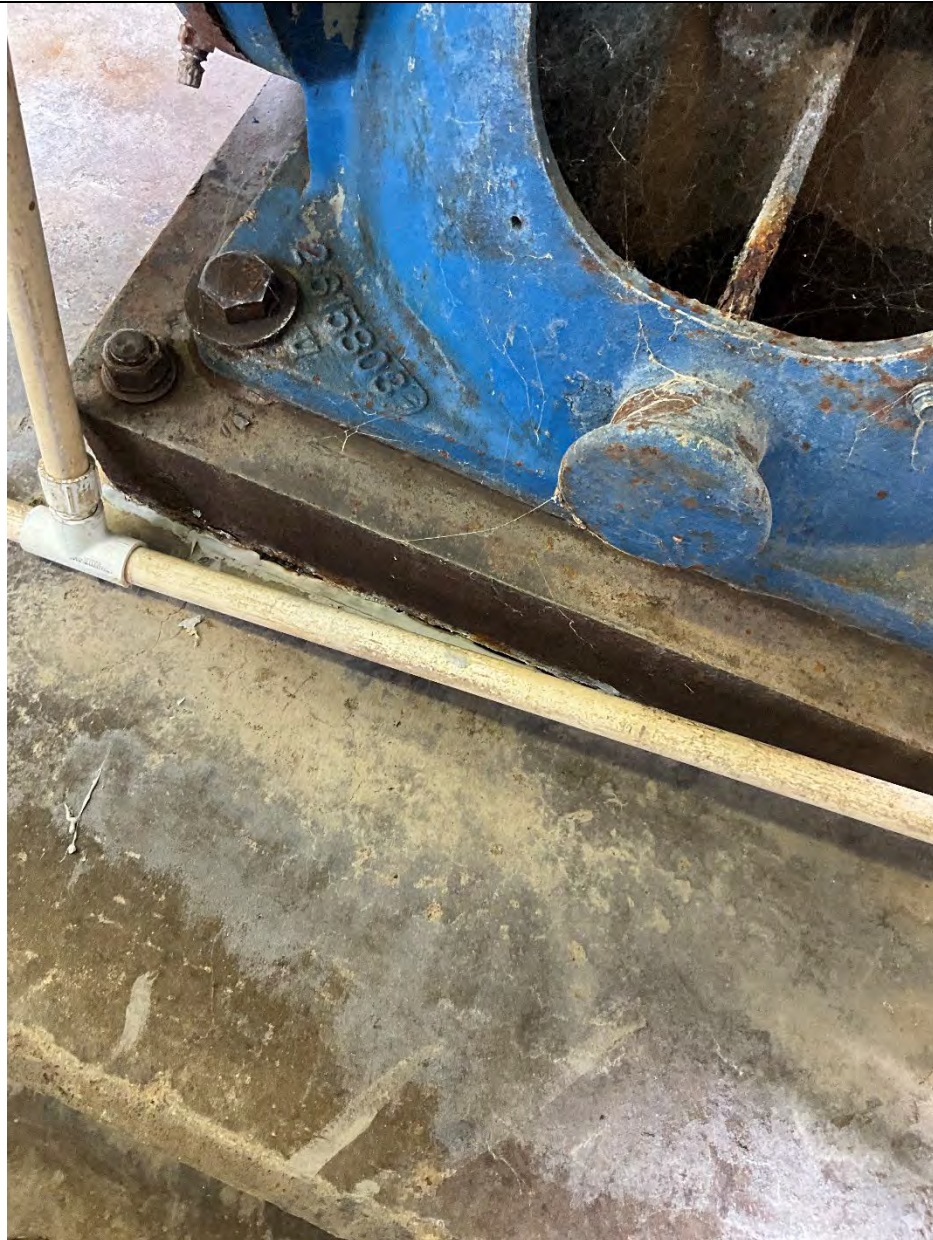
56

The sanitary seal or casing seals of Wells #52 and #11 were cracked or there were gaps in the sanitary seal between the well pump and the pump base that did not provide for a watertight seal. The sanitary seal is important to maintain proper well pressure and to prevent contamination from being potentially being drawn into the well casing from an unprotected opening. KS Minimum Design Standards – Casing Seal and Discharge Piping section requires that, *“The metal base plate of the pump discharge head assembly shall be grouted and bolted or otherwise securely sealed to the concrete base that supports the pump discharge head assembly so as to be watertight.”* This issue was discussed with Mr. Rosales during the inspection, in the exit conference, and noted as Finding #18 on the NOPF. Mr. Rosales explained that the seals would be recalked to seal the openings. In addition, while inspecting Well #62, I observed that the electrical wiring to the submersible pump were not covered with conduit from the electrical junction box and extended to the casing cover. The lack of conduit presented an opening to the casing where potential contaminants could enter the well similar to the sanitary well seal requirements. According to the KS Minimum Design Standards, Sanitary Well Seal requirements, *“The top of the pitless unit shall be securely fitted with a sanitary well seal, which creates an air and watertight seal. The pitless unit shall also be designed to receive a contamination proof conduit for power purposes.”* Mr. Rosales explained that the wiring to the submersible pump had been shortened and when this occurred the wiring was not long enough for the previous conduit fitting and a new piece of conduit was required. He explained that the conduit would be repaired. This issue was noted as Finding #20 on the NOPF.

Well #1-1 - gap in sanitary seal between well pump and well base

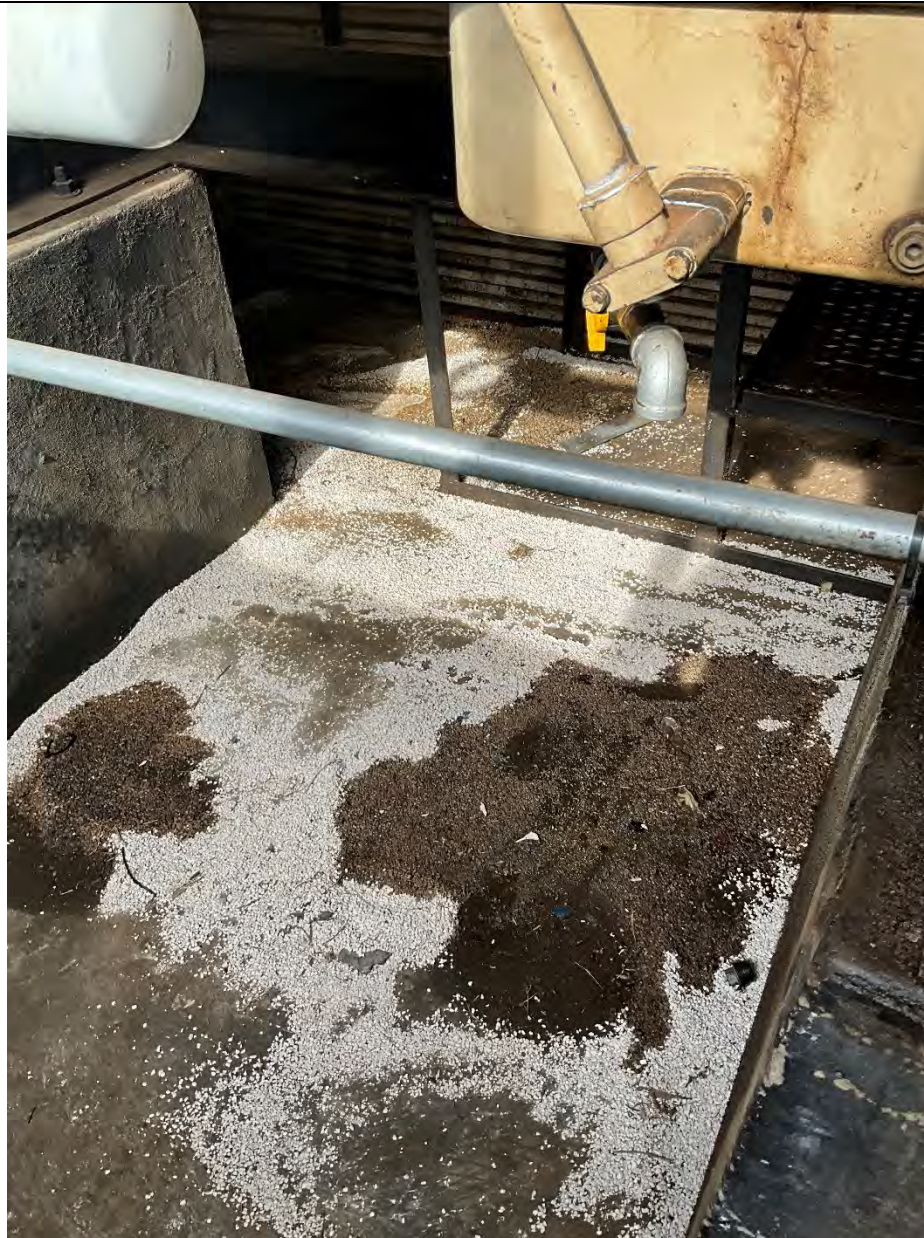
58

Well #1-7 – oil spilled on the floor of the well building below the natural gas-powered generator.

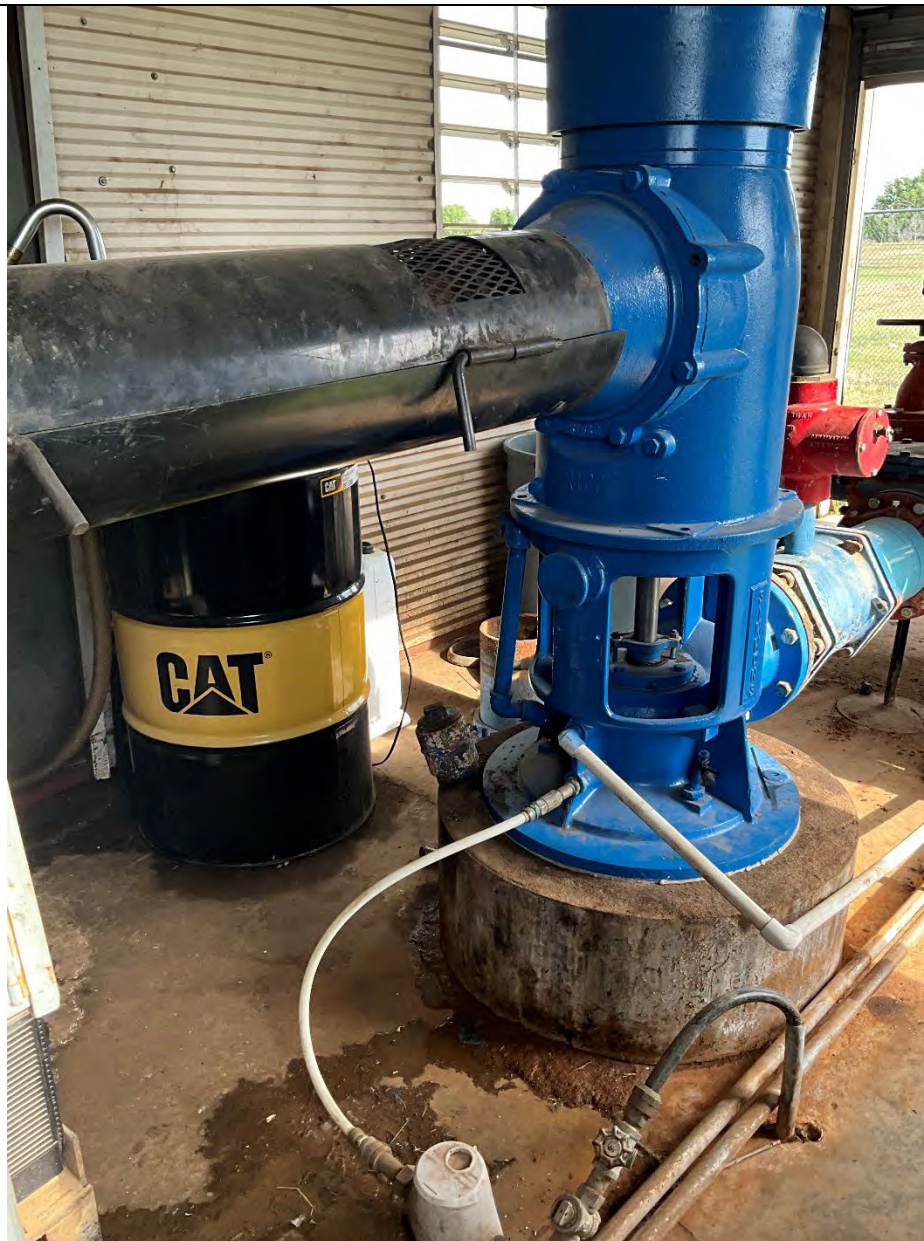
59

While touring multiple well houses served by natural gas and diesel powered pumps, I noted 55-gallon drums of oil used for lubricating the well pump motors (Wells #1-7, #2-9, and #3-4). The barrels of oil were located in close proximity (between two and ten feet) to the well pump bases. These barrels were not equipped with secondary containment and in the well house of Well #1-7, I observed spilled oil on the floor of the well house adjacent to the well pump base. I noted that oil-dry material had been placed over the spilled oil to absorb it. Mr. Rosales explained that lubricating oil is necessary for the operation of the natural gas-powered pumps and that oil is transferred from the 55-gallon drums to the smaller oil reservoir of the pumps. He noted that the transfer can be messy at times due to the small hand transfer pumps and that new electric transfer pumps have been identified and ordered. He explained that the spilled oil is normally cleaned immediately and that the new electric pumps should help with the transfer process. He also noted that secondary containment pallets could be installed to prevent any leaks from reaching the floor. I explained due to the close proximity of the well base and casing, that the spilled oil presented a situation for potential contamination of Well #1-7 and that the barrels of oil in these

wells should have secondary containment to prevent any spills or leaks from reaching the floor. This issue was noted as Finding #15 in the NOPF and discussed with the system at the exit conference.

Well #1-7 – well pump connected to the natural gas generator; note the 55-gallon drum of oil near the well base.

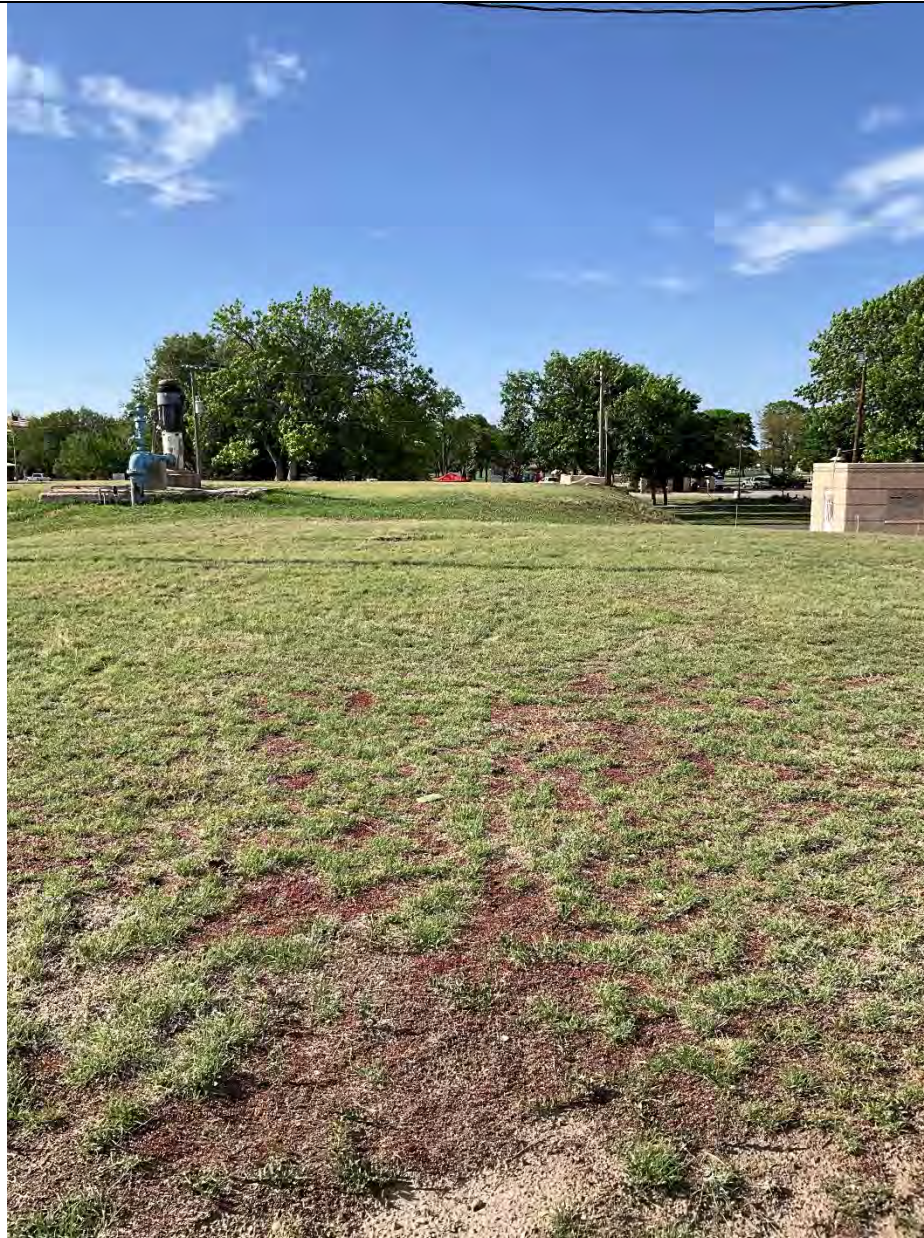
Station #1 – View of the top of two GSTs and the high service pump and chlorine storage building in the background; note no vent on either of the GSTs
