## Photographs for Western Stone

Inspection Type: RI-Stormwater

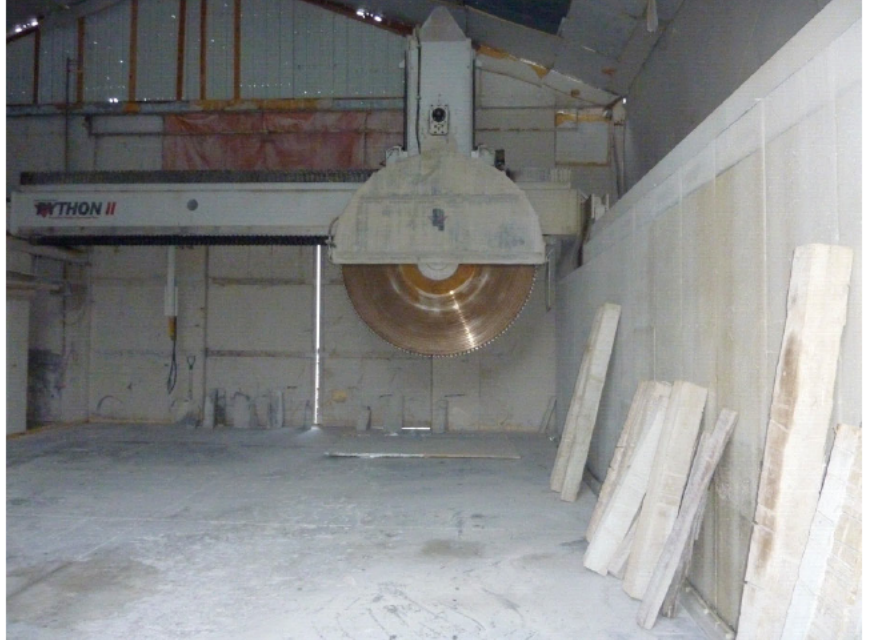
Photo number 790 taken by **Privacy** on 11/15/2023.

Saw used in cutting rock. Located in the only building at top of site. When in use, water sprays from hose on left and collects in a trough along the building wall on the right hand side. Trough leads to settling tanks south of the building (see photos 792 & 793).

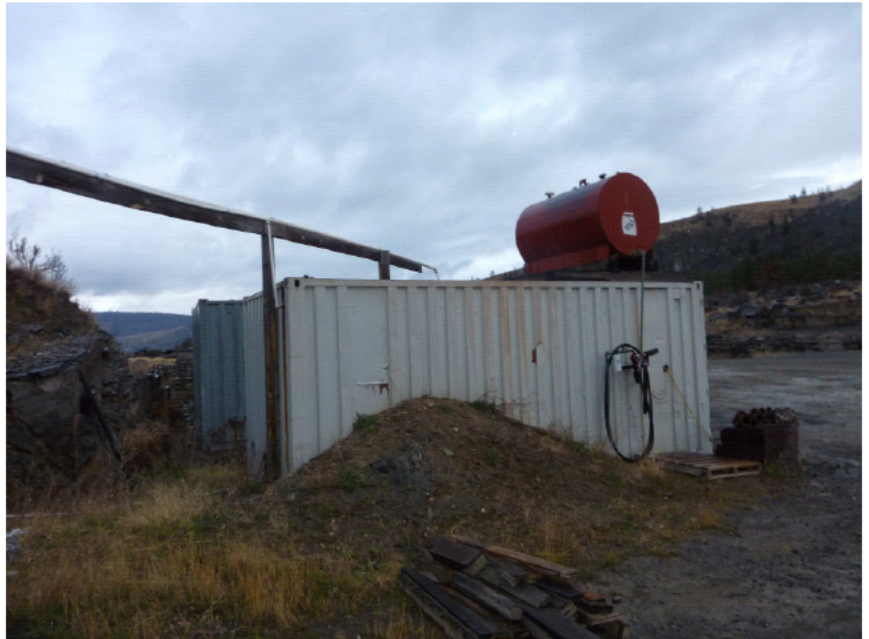
Photo number 791 taken by **Privacy** on 11/15/2023.

Fuel tank for on-site vehicles (red tank) sitting on top of storage shed. White piping on board frame is from the on-site well into the building and used to augment reuse water when the saw is in use.

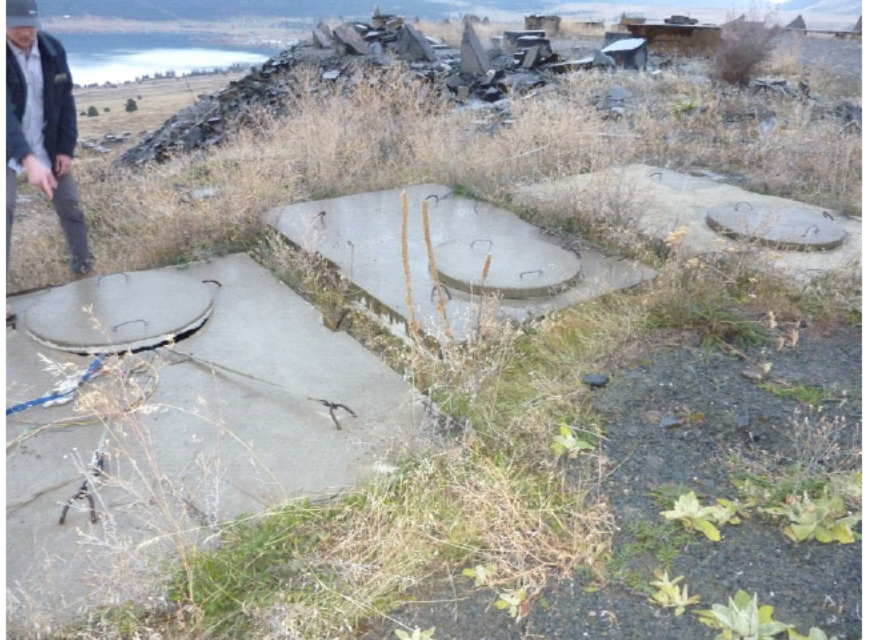
Photo number 792 taken by **Privacy** on 11/15/2023.

Process water goes from trough inside the building, into one of three settling tanks located south of the building.

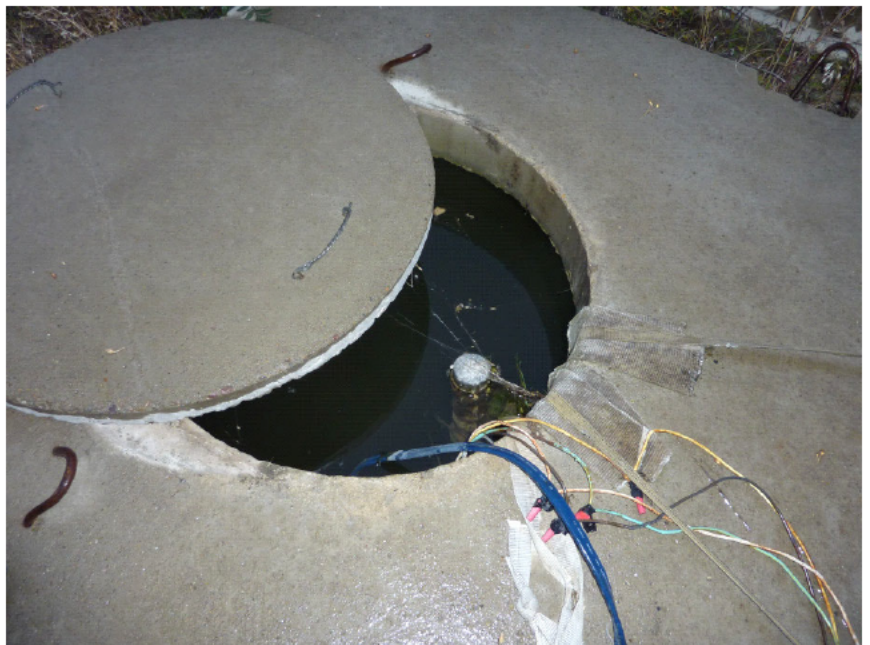
Photo number 793 taken by **Privacy** on 11/15/2023.

Settling tank showing pumping apparatus which pumps clean top water back to the saw for re-use.

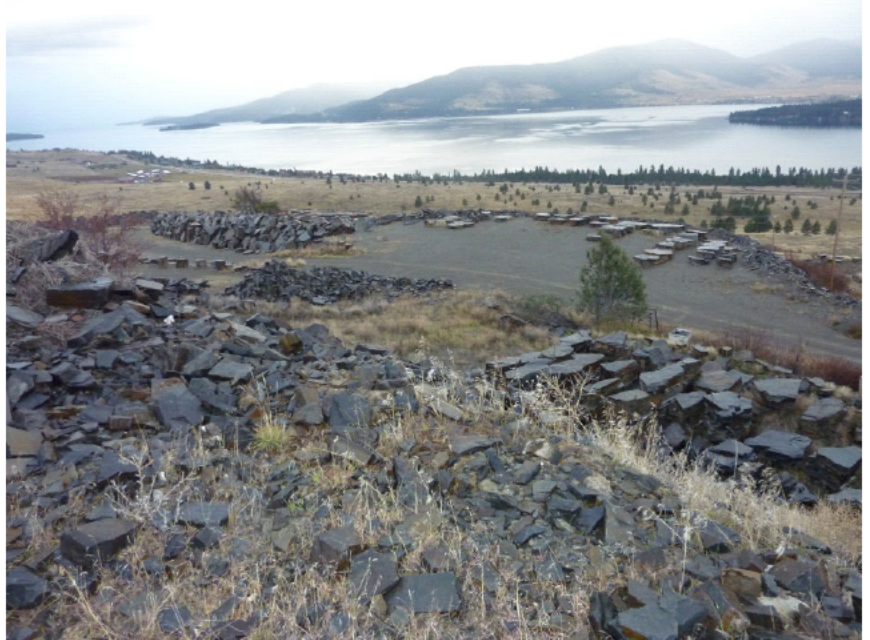
Photo number 794 taken by **Privacy** on 11/15/2023.

Overview of some inventory on-site.

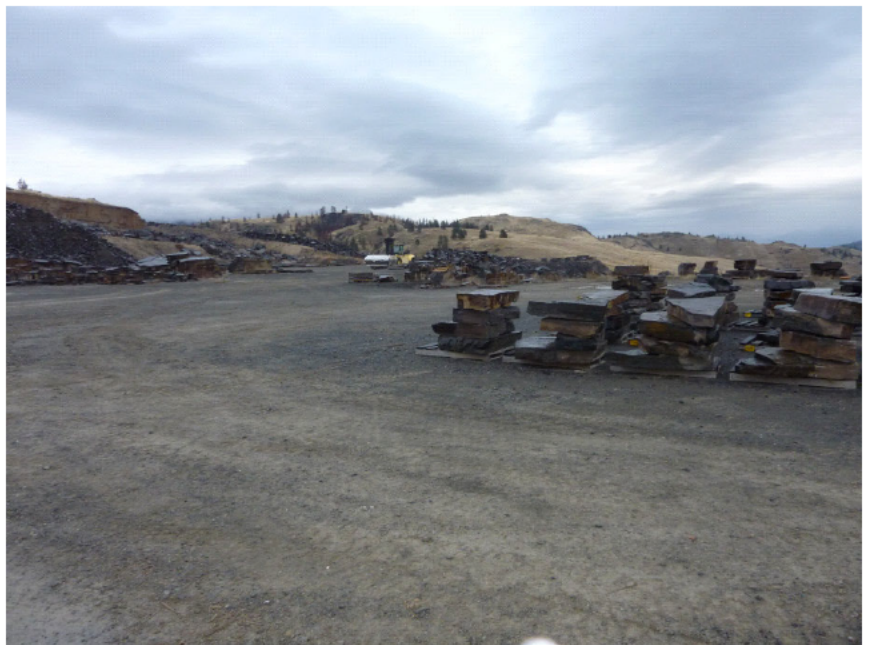
Photo number 795 taken by **Privacy** on 11/15/2023.

Main platform at facility with inventory stacked in various locations throughout site. Tractor with water tank and perforated PVC pipe used in summer months for dust control.

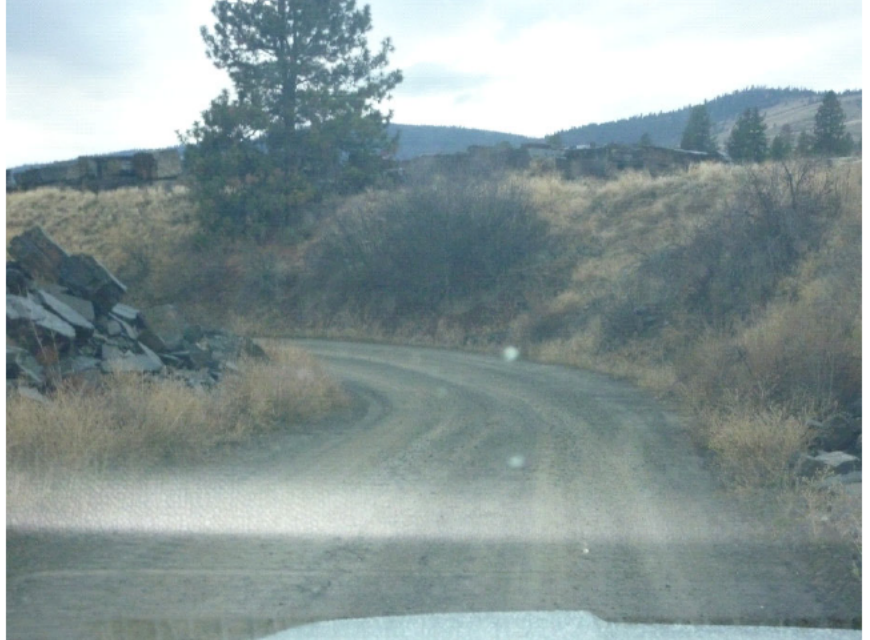
Photo number 796 taken by **Privacy** on 11/15/2023.

Roadway with vegetated ditches.

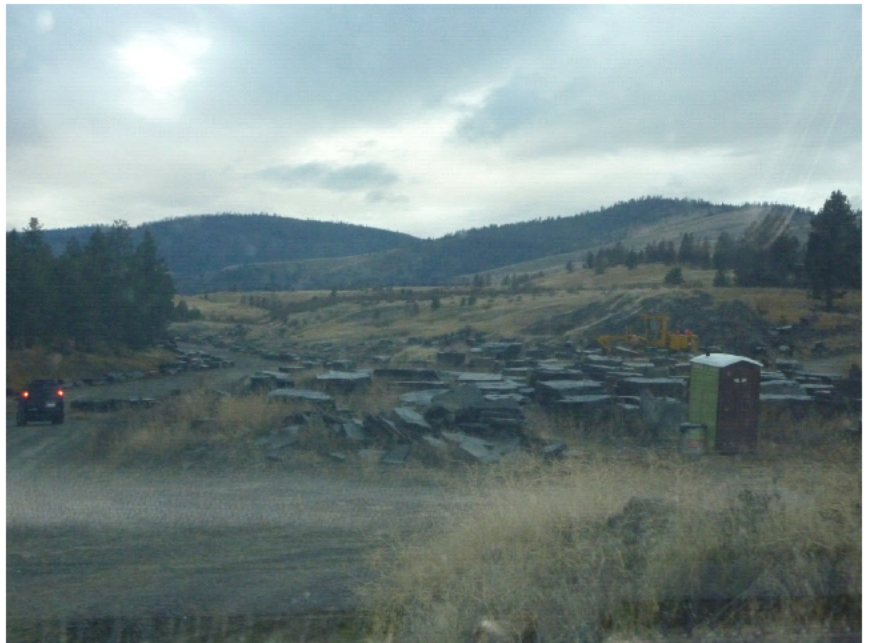
Photo number 797 taken by **Privacy** on 11/15/2023.

Some inventory in the northwestern part of the site.
