**Well Inspection**  
**Osage DNR / Environmental Protection Agency**  
**1201 Elm Street, Suite 500**  
**Dallas, Texas 75270**

| | | <b>Lease Name</b> | Tidal Osage I | | |
| | | <b>Well ID</b> | TO-4-15 | | |
| <b>Inspection Reason</b> | Plugging Witnessed | <b>Responsible Company at Time of Inspection</b> | Calgary Energy, LLC | | |

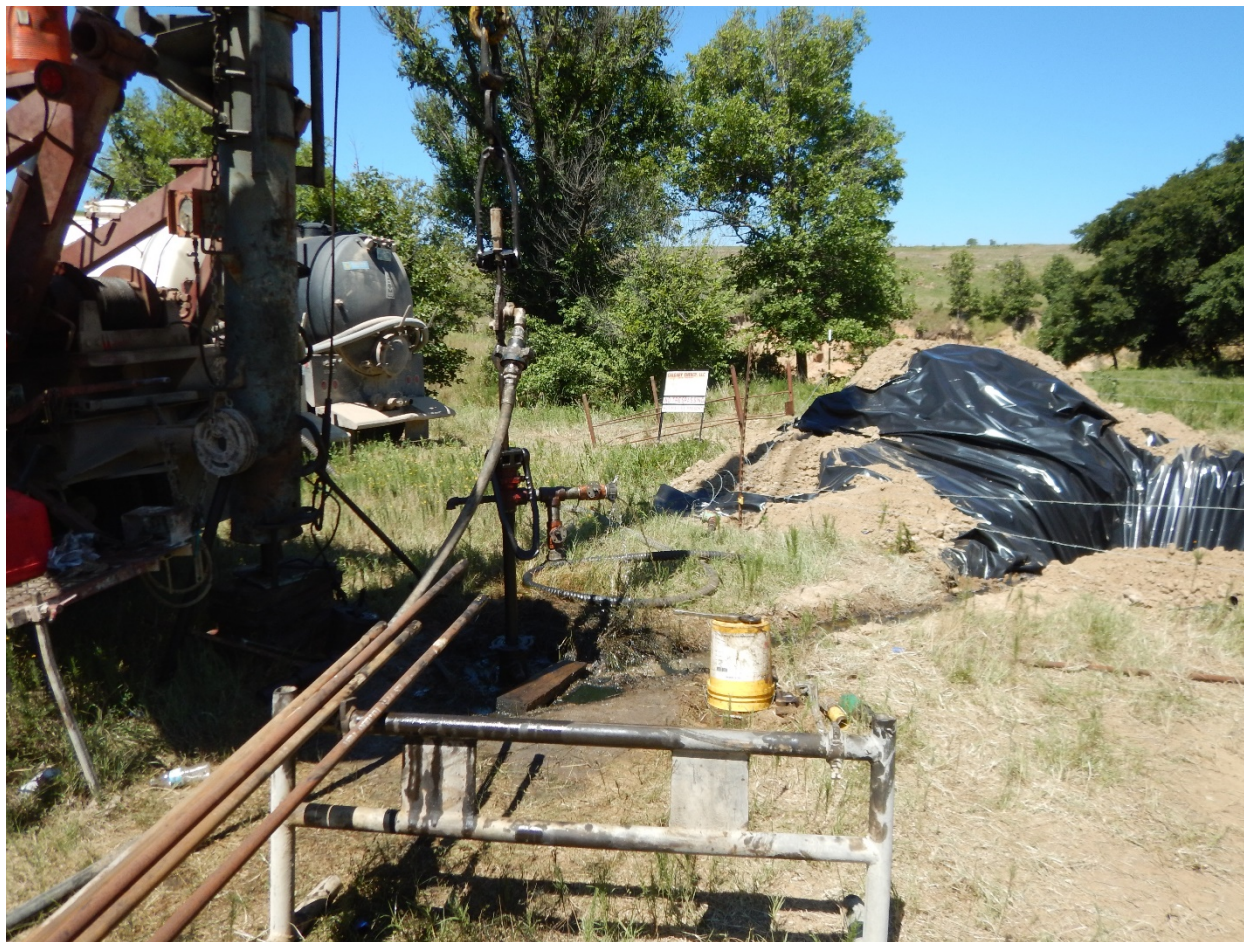
Photo No. 1

**Description:** This was a photo of well OS1077000 (Tidal Osage 1 – 4-W15). This photo shows the workover rig setup on the well, the plastic lined catchpit on the north edge of the well location and the cement pumping line connected to the 1-inch tubing which has been run to total depth to begin pumping cement.
