# NPDES Compliance Inspection Report

**Knife River Corporation**

Boise, Idaho

**Inspection Date: 9/16/2024**

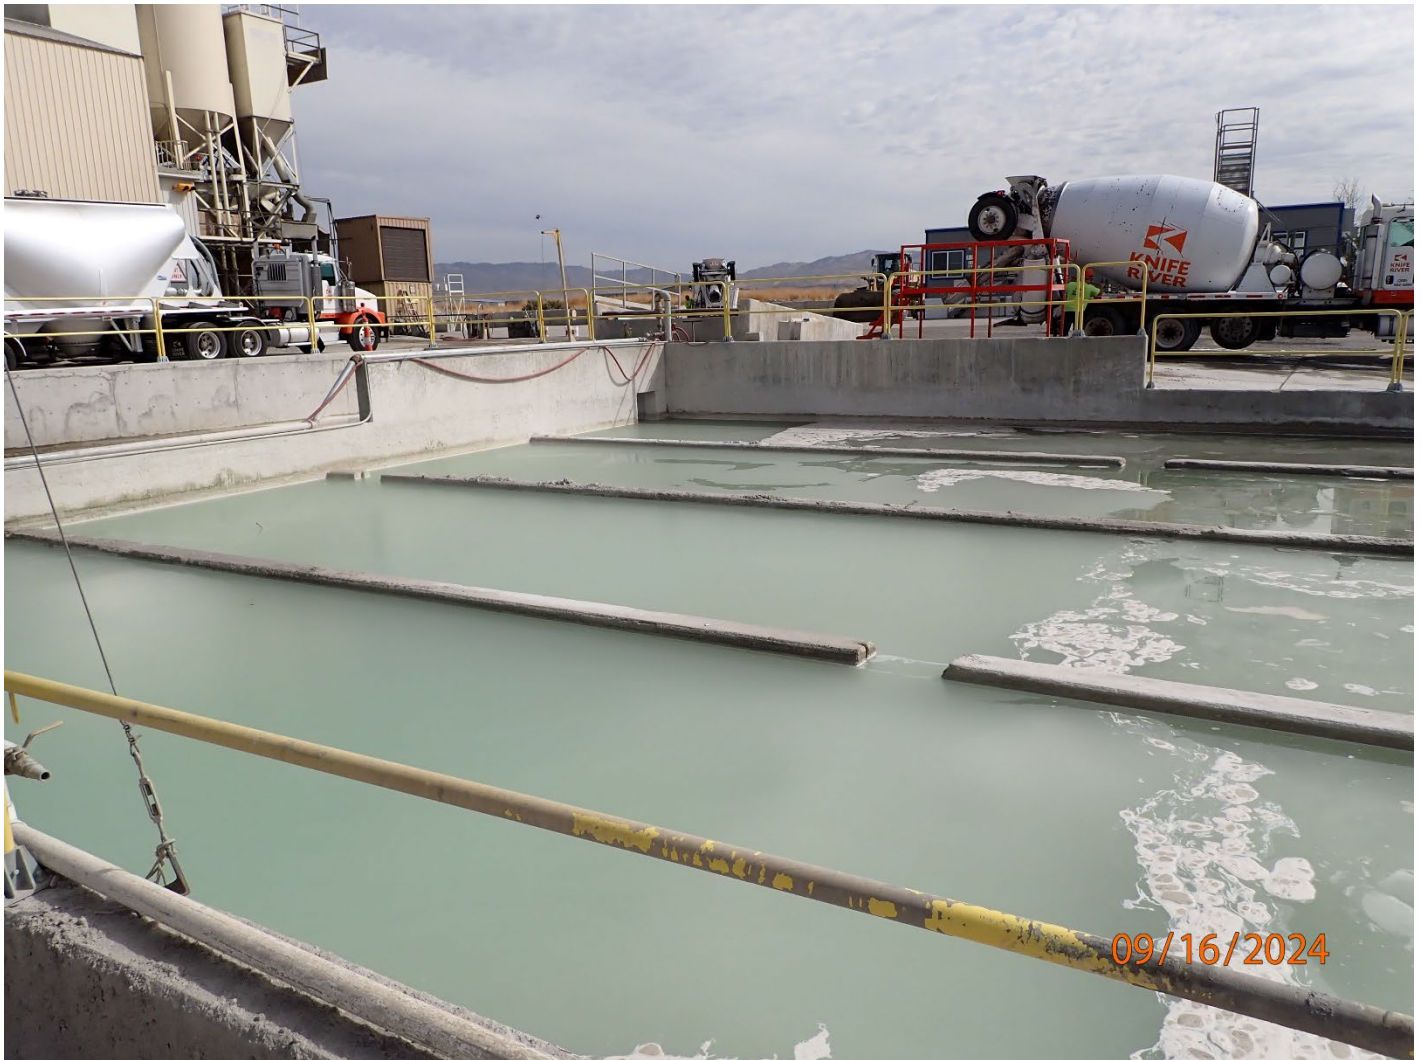
The facility includes a gravel pit that is located on the northern side of the property. Sand and gravel are excavated and stockpiled at the gravel pit. These aggregates are then used to manufacture batch concrete. Transit mixers (concrete trucks) that return to Knife River, after offloading concrete at various job sites, are often cleaned onsite. Aggregates are also used to blend with heated asphalt oil before loaded and hauled off to work sites. Industrial activities exposed to stormwater include asphalt batch plant operations, concrete read-mix batch plant operations, vehicle parking, concrete washout (**Photo 1**), aggregate storage, and loading/offloading.

*Photo 1 - Concrete washout area*

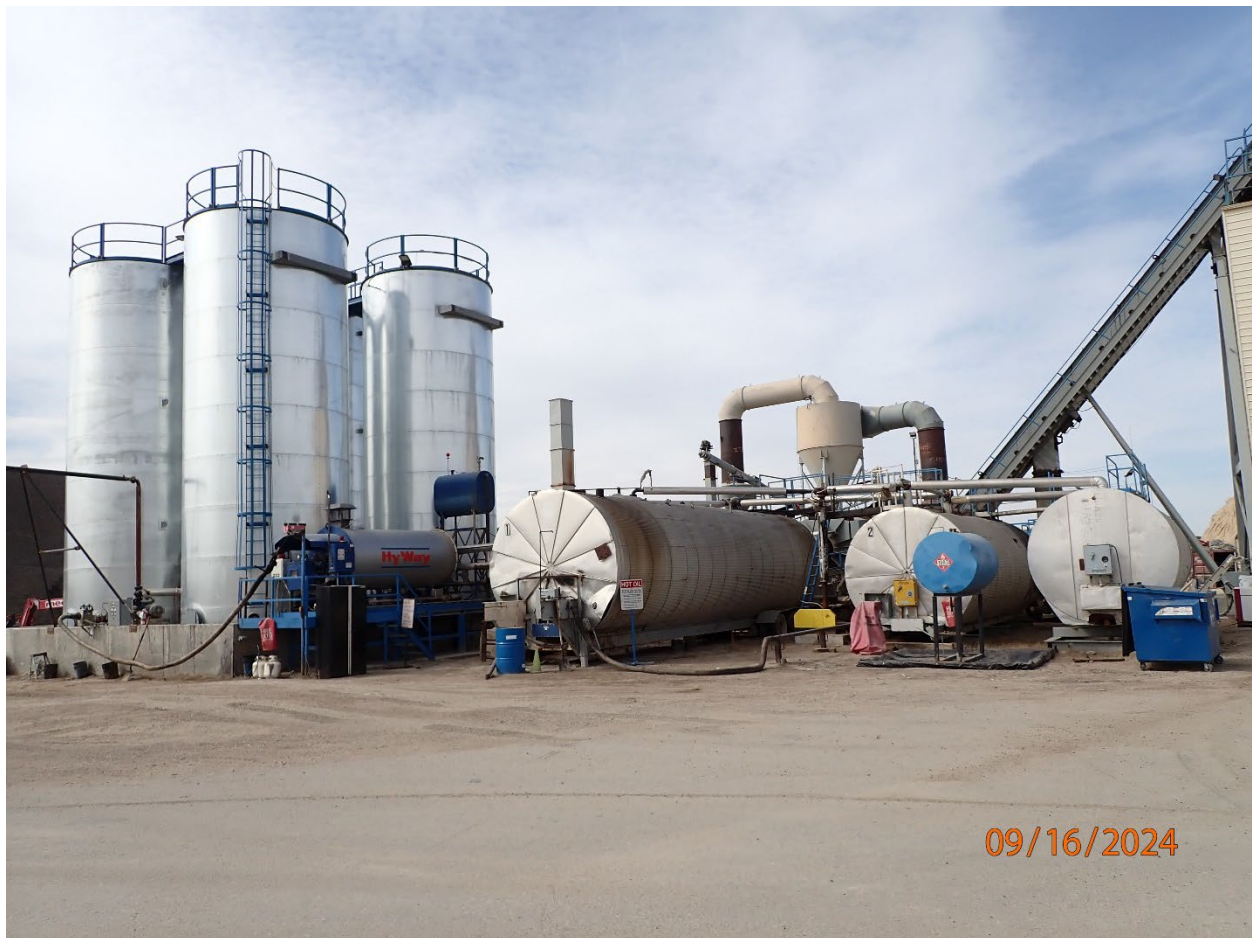
Knife River – Mountain West occupies approximately 40 acres of land with approximately with approximately 35 acres being exposed to precipitation. The facility is an asphalt batch plant (**Photo 2**) and a ready-mix concrete plant (**Photo 3**). There is also an equipment maintenance shop onsite along with fueling bays, an equipment parking area (**Photo 4**), an equipment wash area, used oil storage, and a materials storage area (**Photo 5**). The asphalt plant and

*Photo 2 - Asphalt plant*

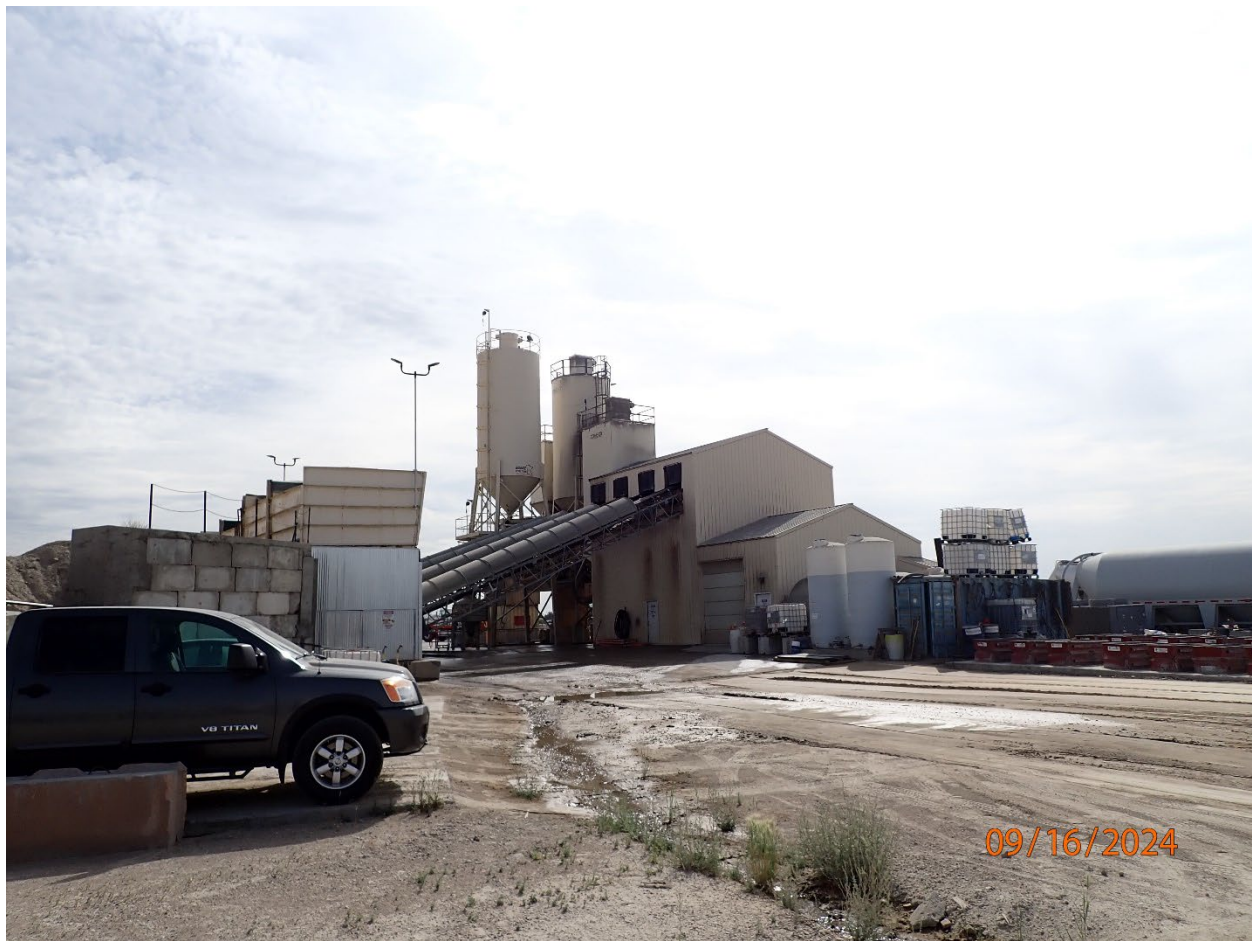
*Photo 3 - Ready-mix cement plant*

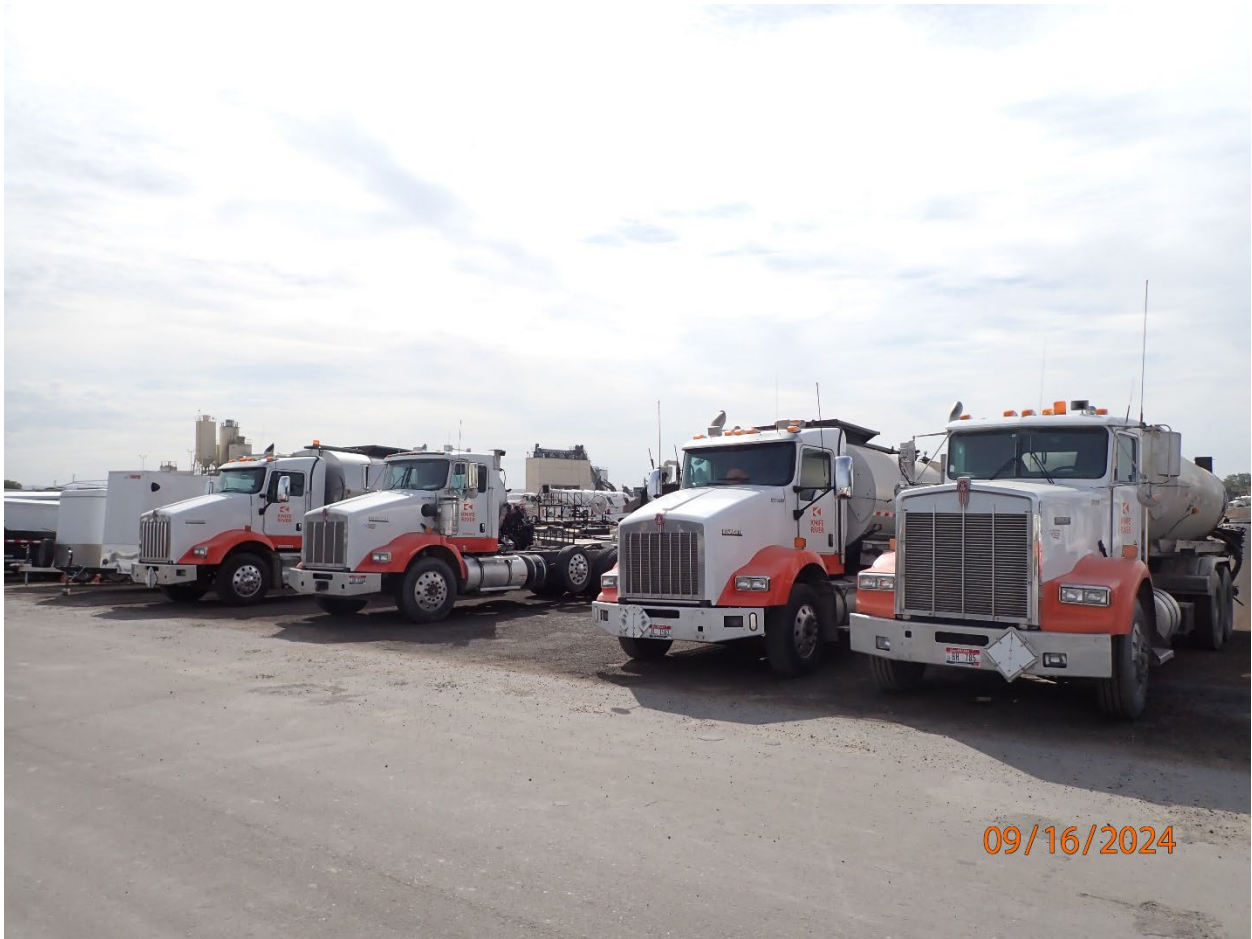
*Photo 4 - Equipment parking area*

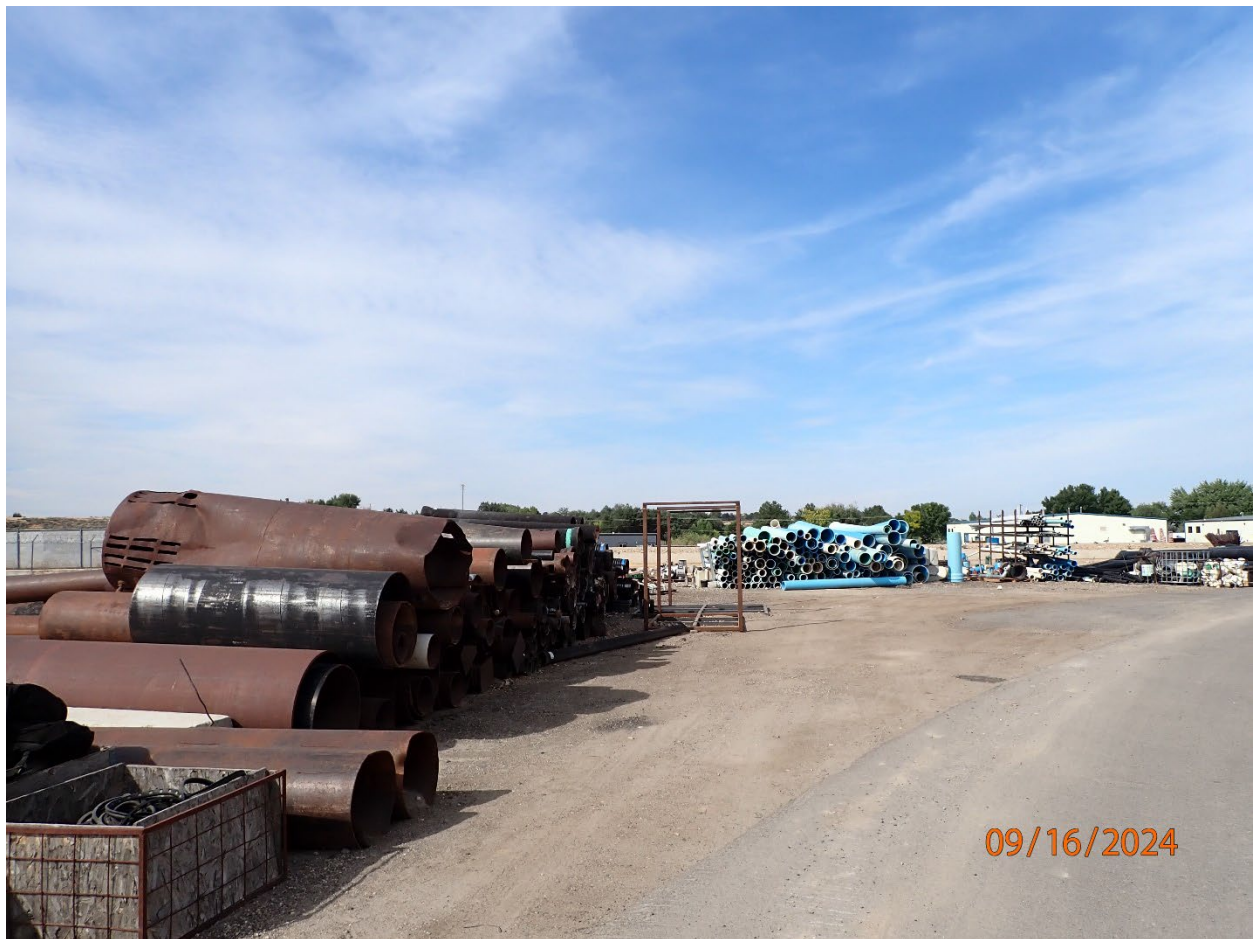
*Photo 5 - Materials storage area*

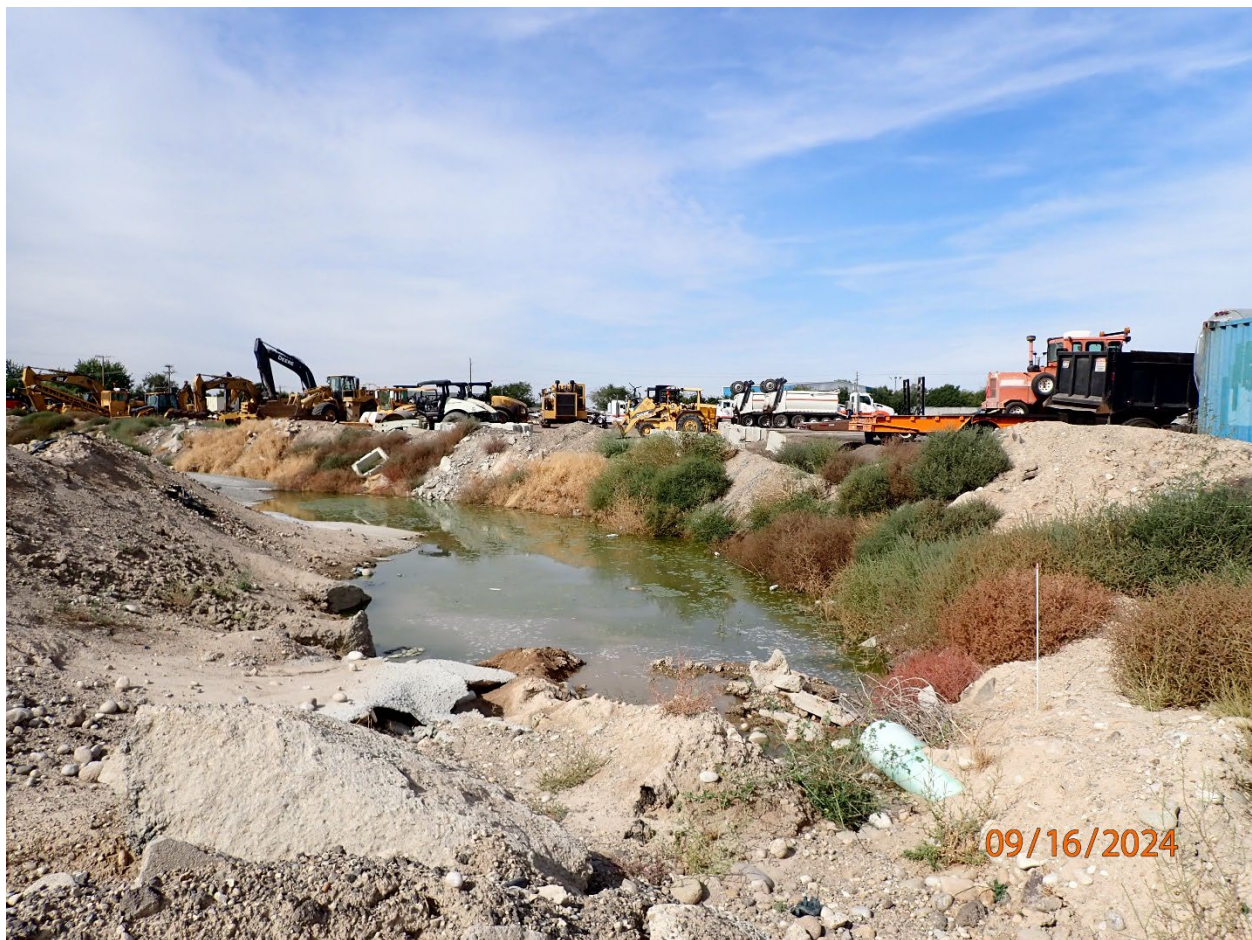
ready-mix concrete plant are on the northern side of the property while the equipment maintenance area is towards the southern part of the property. The gravel pit (**Photo 6**) onsite is used to excavate and stockpile gravel & sand. It is usually filled with stormwater that eventually permeates the substrate below.

*Photo 6 - Gravel pit with stormwater retention*

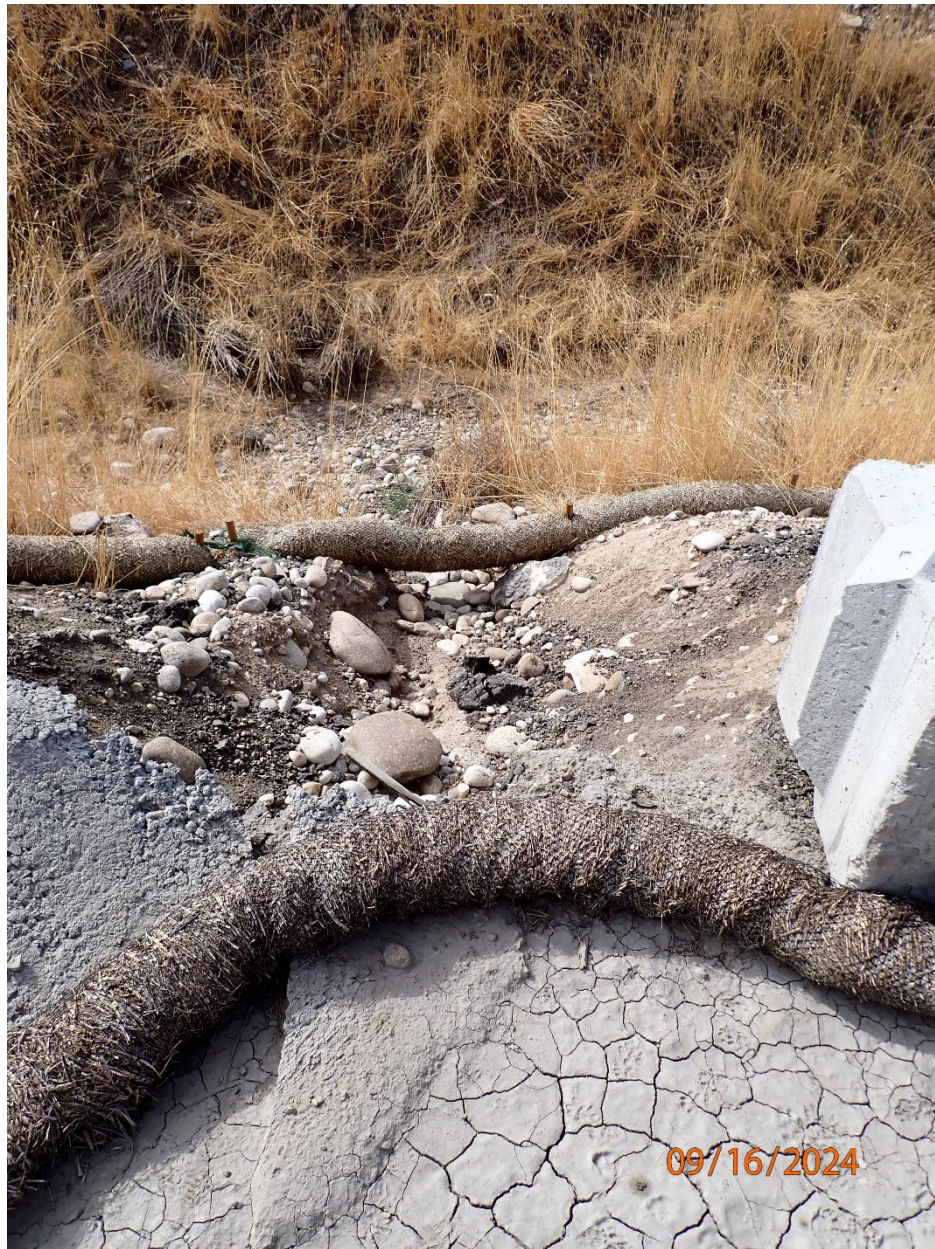
Much of the site has been graded so that the majority of stormwater is contained onsite, but there appears to be some minor erosion (**Photos 7 & 8**) from stormwater runoff on the south side of the property and along Fivemile Creek (**Photo 9**).

*Photo 7 - Minor erosion leading into Fivemile Creek (dry)*

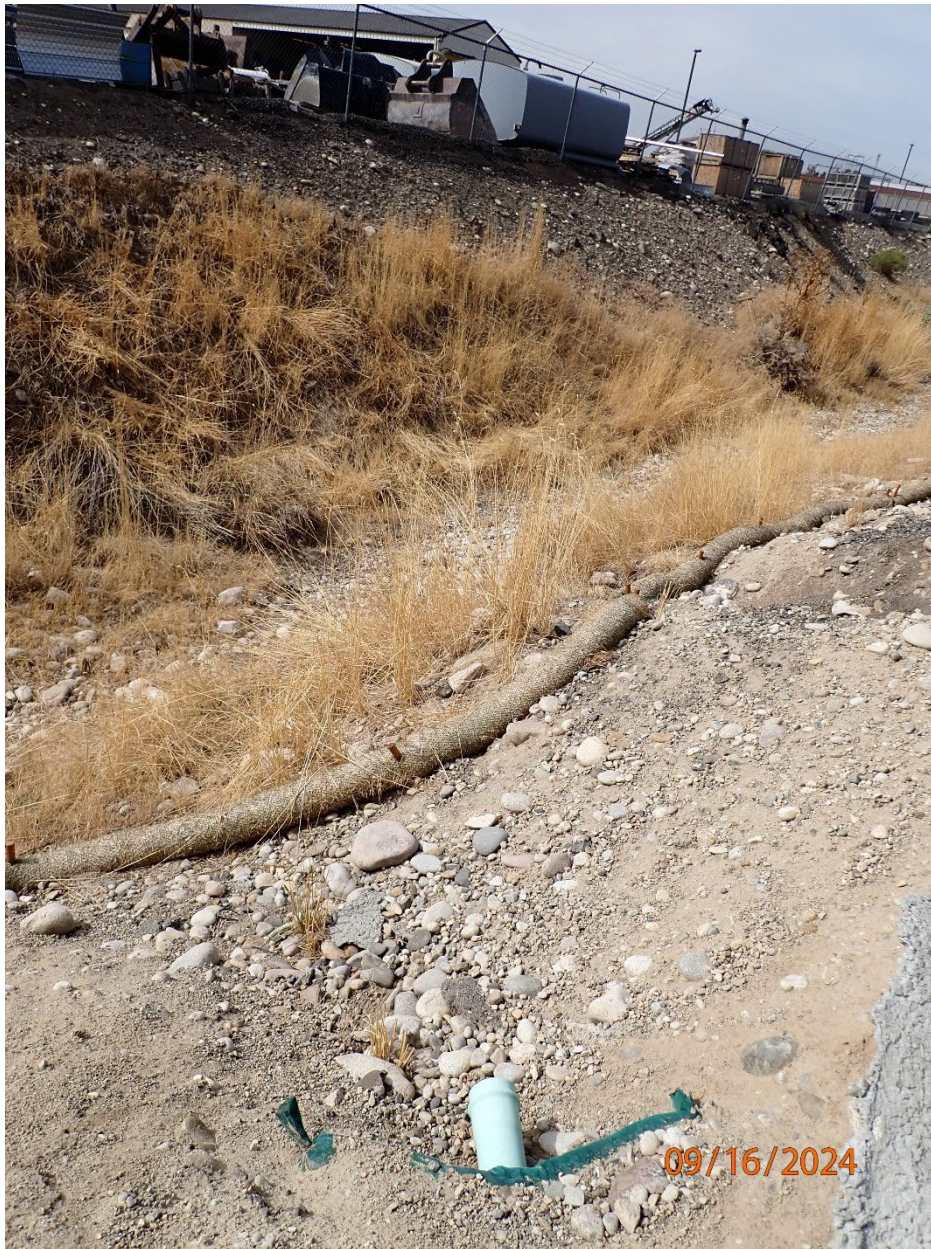
*Photo 8 - Small area of erosion leading into Fivemile Creek (dry)*

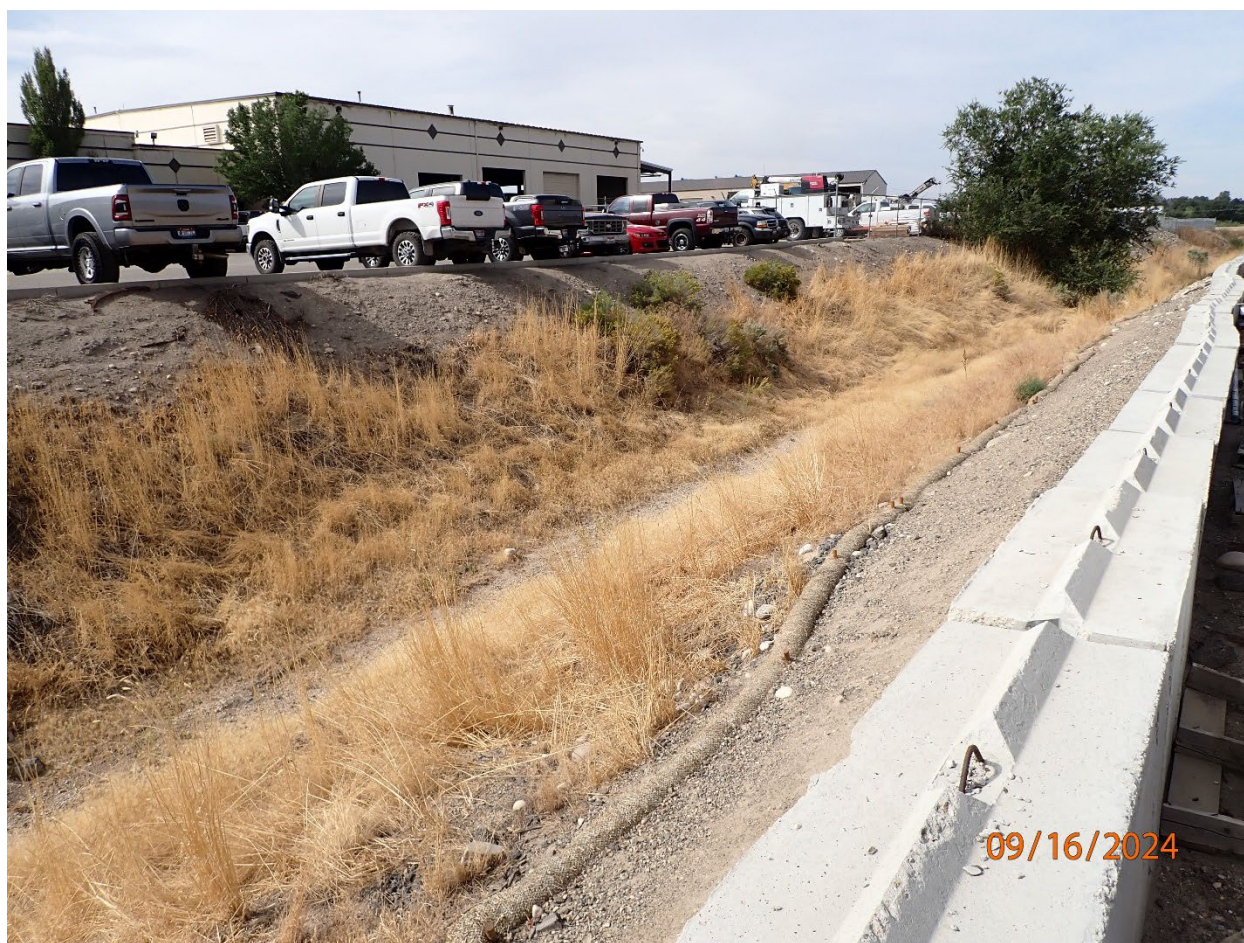
*Photo 9 - Fivemile Creek (dry)*
