# "UNUSUAL INCIDENT"

Date: February 18, 1976

Area: "Ponsol" Spray Dryer #2 - 743 Bldg.

Nature of Incident: Leak of propane to atmosphere.

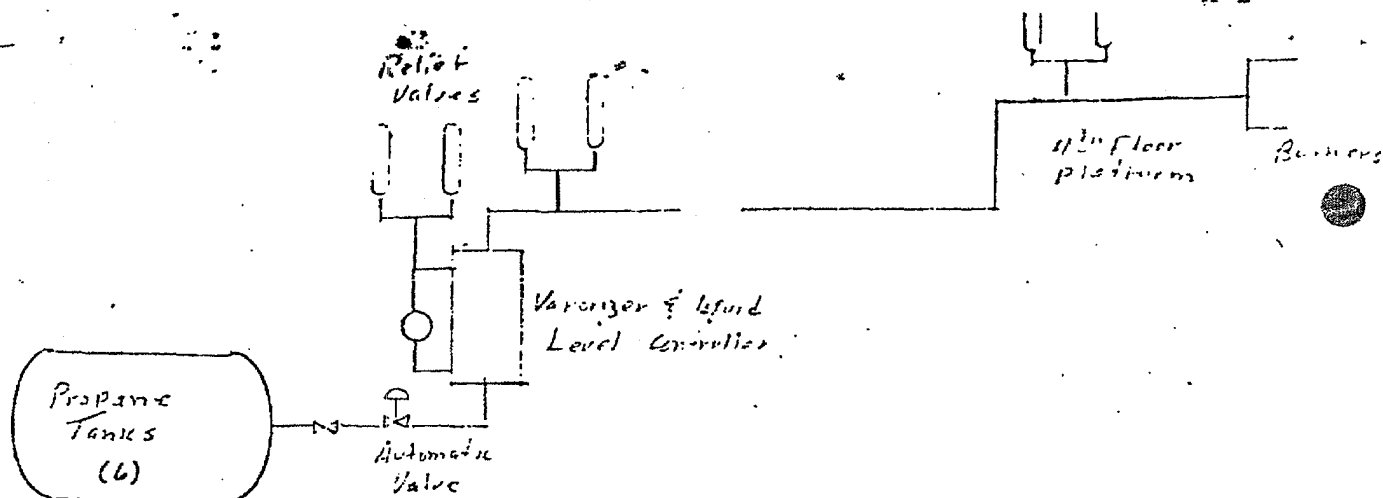
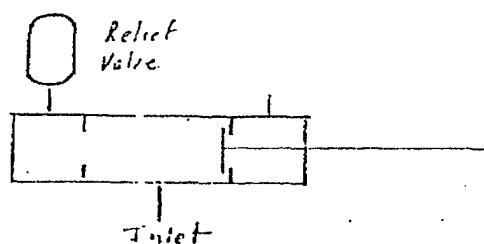
An investigation immediately following the incident revealed that the three relief valves had been removed on the day shift for routine inspection and that the 3-way valve beneath each relief valve had been set wrong (see attached sketch). The 3-way valves were reset properly and the unit was started up without incident. The inspected relief valves were installed the next day. The investigation also revealed that approximately 500 gallons of liquid propane was discharged to the atmosphere over a 15-20 minute period.

Correct

Incorrect

1. Relief valves in the propane system are not to be removed until the procedure is reviewed on the spot by members of the Engineering Department supervision and the Operating Department supervision (L. P. Winfield and C. H. Turner).
2. Valving and tagging is to be done only by operating personnel specifically authorized by area management (C. H. Turner).
3. Area supervision will strengthen shift turnover procedures to assure that all information is included and reviewed (H. R. Steinbruck).
4. Two-part red tags will be adopted by Operations at "Ponsol" S.D. #2 so that an on-the-spot reminder of uncompleted work will be present in the Operating Control Room (C. H. Turner).
5. Consideration will be given to replacing the dual relief valve system with a single relief valve or replacing the present 3-way valve with one of another design (W. J. King and J. J. Pietrantonio).
