## Hydrocarbons Tech Center Reactive Chemicals Handbook

## Hydrocarbons Reactive Chemicals Hazards

### ACETYLENE/ACETYLIDES

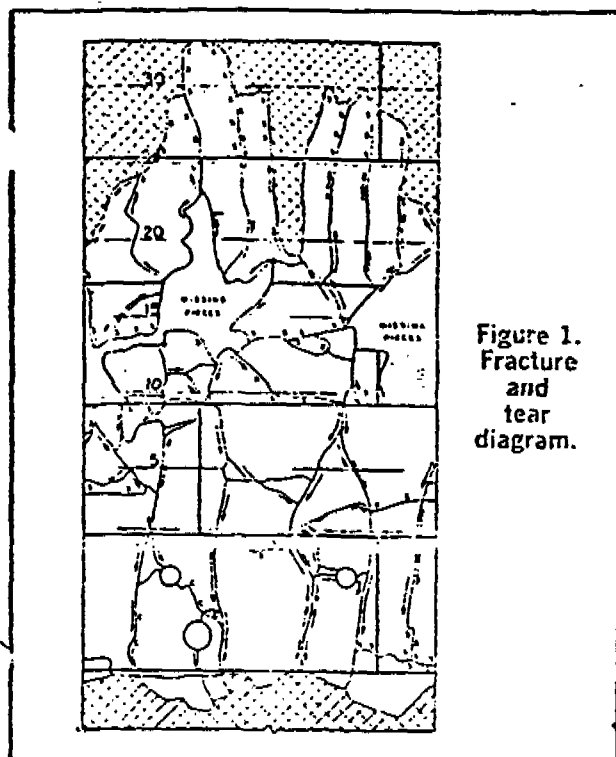
Figure 1.  
Fracture  
and  
tear  
diagram.

their shapes reproduced to scale on the drawing. The result is the fracture and tear diagram, Figure 1.

Approximately 90% of the separated shell pieces were found and located on the drawing. The low recovery of pieces in the  $\frac{3}{4}$  in. thick shell ring No. 3, and the relatively small size of the pieces found suggest that the most intense force prevailed in this area. The crosshatched areas at the bottom and top of Figure 1 represent shell plate not fragmented. The bottom section consisted of 8- to 10 ft. of the skirt that had remained attached to the column foundation. The upper crosshatched area represents a portion of the upper 100 ft. of column shell which remained intact.

Further examination of the shell fragments confirmed the location of the explosion. The torn edges of many of the fragments exhibited chevron marks, while other edges were smooth and in a few places showed evidence of a slight thinning by drawing. The appearance of the edges of the fragments is an indication of the speed and direction of fracture. A rapid crack propagation in the range of 2,000 ft. sec. and above is termed cleavage. Cleavage fractures leave chevron markings on the edge surface which point back to the origin of the crack. Conversely, a low rate of crack propagation is termed shear. Shear failures occur at rates less than 500 ft. sec., and may show thinning of the material adjacent to the edge. Fractures that propagate at rates between 100% shear and 100% cleavage may exhibit characteristics of both (1).

The results of the examination of the fragment edges are shown in Figure 1. The arrows indicate the direction of shell fracture as evidenced by chevron markings. The letter "S" refers to fractures that appeared to have undergone shear failure. The letter "C" indicates chevrons that did not positively show the direction of tear. The few edges that showed no indication of either the type or direction of failure had been severely damaged by hitting other objects.

shell ring No. 3 centers the maximum intensity of the blast between the 10th and the 18th trays. The high incidence of shear between the 25th and the 33rd trays is explained by the fact that the fracture stopped in this region.

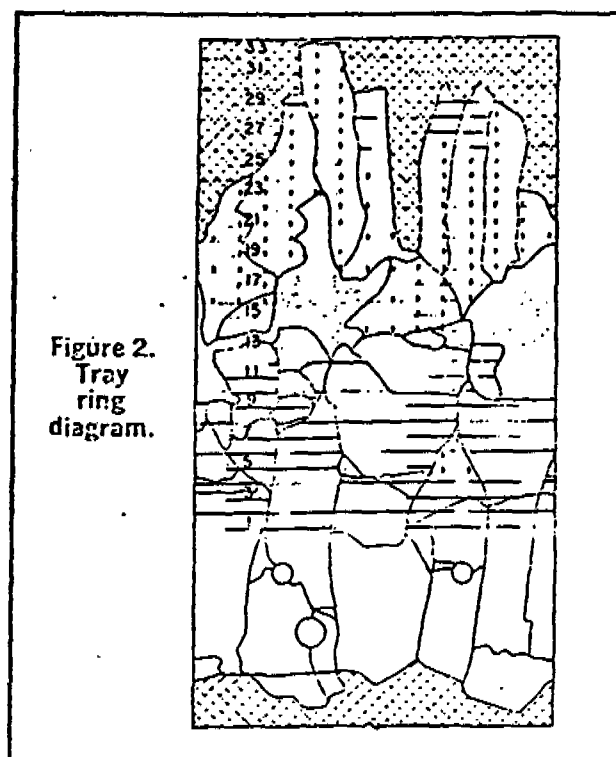
Figure 2.  
Tray  
ring  
diagram.

Tray support rings had been attached to the inside of the column shell at 12 in. spacing throughout most of the fractured area. Each shell piece was examined to determine 1) if tray rings remained or 2) if missing, whether the weld metal remaining showed which way the tray ring broke off.

The results of the tray ring examination are shown in Figure 2. The wide bands superimposed on the lighter tray ring outlines represent ring segments that remained attached to the shell. All other tray rings were missing, and in many cases the direction of tear could be determined. The arrows on Figure 2 show the direction of tear as evidenced by a shear lip produced by drawing of the material.

(tray Nos. 23 to 25), the trays had been torn from the rings, and the rings bent inward. The shearing of ring slot between tray Nos. 11 and 12 probably was caused by a pressure surge that caused the trays to move up the column like a piston. A "blast" of tray sections in a remaining column is shown in Figure 3. It is significant that the rings remained attached to the shell pieces below the tenth tray. This and other evidence is evaluated later in this article.

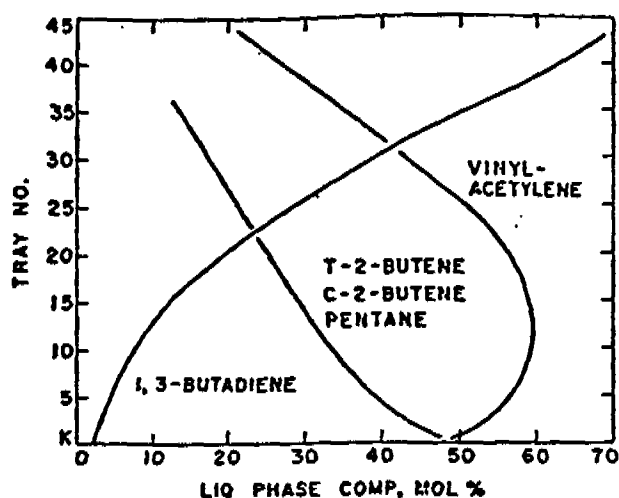
Figure 8. Final liquid-phase composition profiles as predicted by the unsteady-state model.

The batch distillation calculation was carried out until 24.4% of the material originally in the system had been withdrawn as product. At this point, the material left in the system was representative of the process conditions at the time of the explosion. In Figure 8, final liquid-phase composition profiles are reproduced as predicted by the unsteady-state model. Mole percentages of 1,3-butadiene, vinylacetylene, and the other major components present are given for the column base (K), and for the bottom 15 actual trays. The 1,3-butadiene content of the column base has been stripped down to about 2 mole %, while the concentration rises with increasing tray number from the bottom. The vinylacetylene content of the column base is 48%, and a maximum vinylacetylene concentration of 59 mole % has built up in the vicinity of tray Nos. 10 to 15, caused by the depletion of butadiene and the subsequent partial separation of vinylacetylene from the butenes. Above tray No. 15 the vinylacetylene concentration decreases. Damage to the column extended from the base section to an elevation corresponding to the 33rd tray; the liquid-phase vinylacetylene concentration throughout this volume is predicted to have been upwards of 40 mole %. The area of maximum fragmentation of the column shell centered around tray Nos. 10 to 15; the vinylacetylene concentration in this volume is predicted to have been in the range of 57- to 59%.

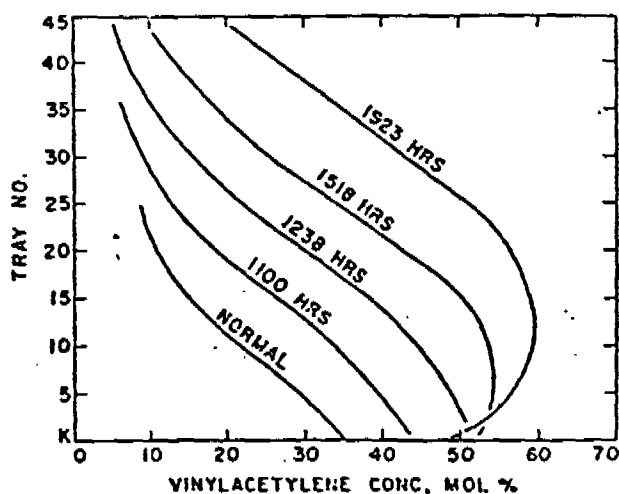
Figure 9. The development of the vinylacetylene profile.
