**Region 6 - Enforcement & Compliance Assurance Division**  
**INSPECTION REPORT**

| Inspection Date(s): | 11/06/2019 | |
| Company Name: | <b>Jamie Oil, Inc.</b> | |
| Facility Name: | <b>Ezzell Lease</b> | |

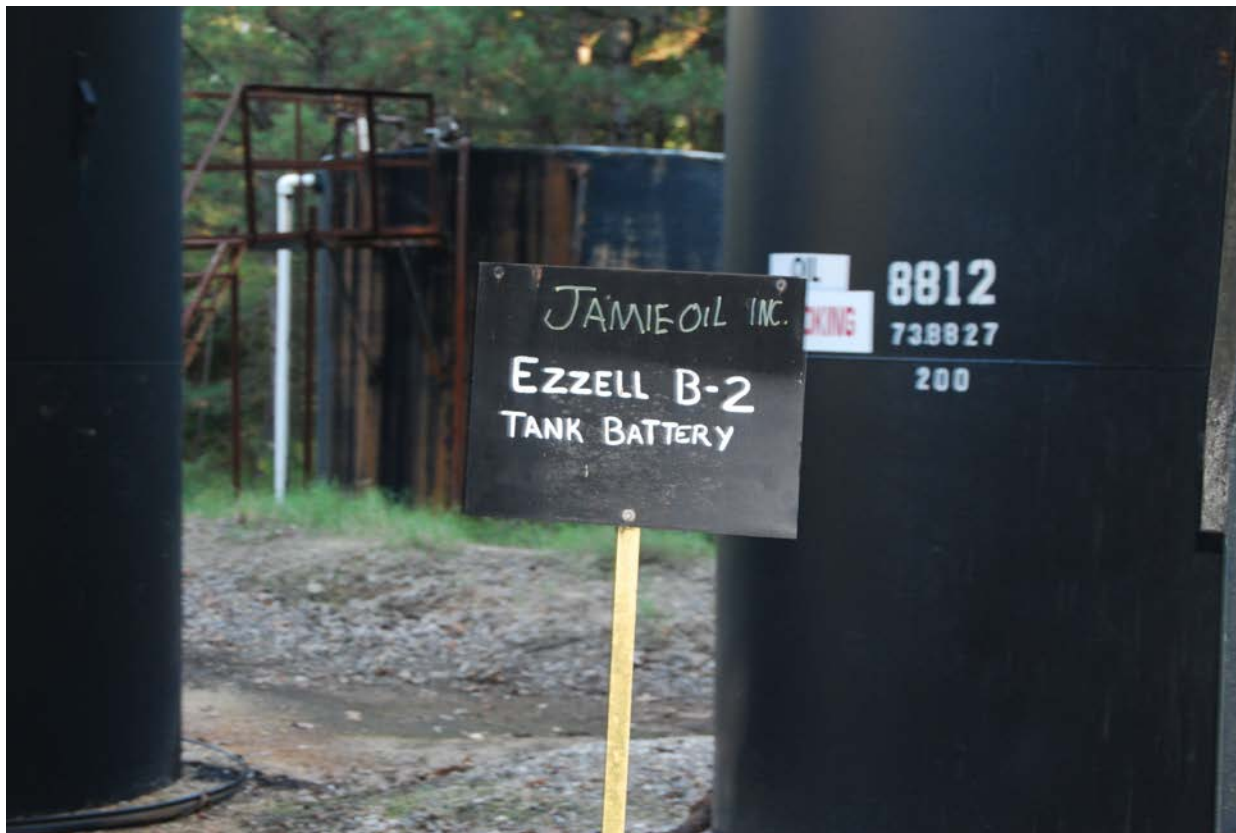
Photo No. 1

Description: The source of the discharge was the tank battery, or facility, associated with this lease.

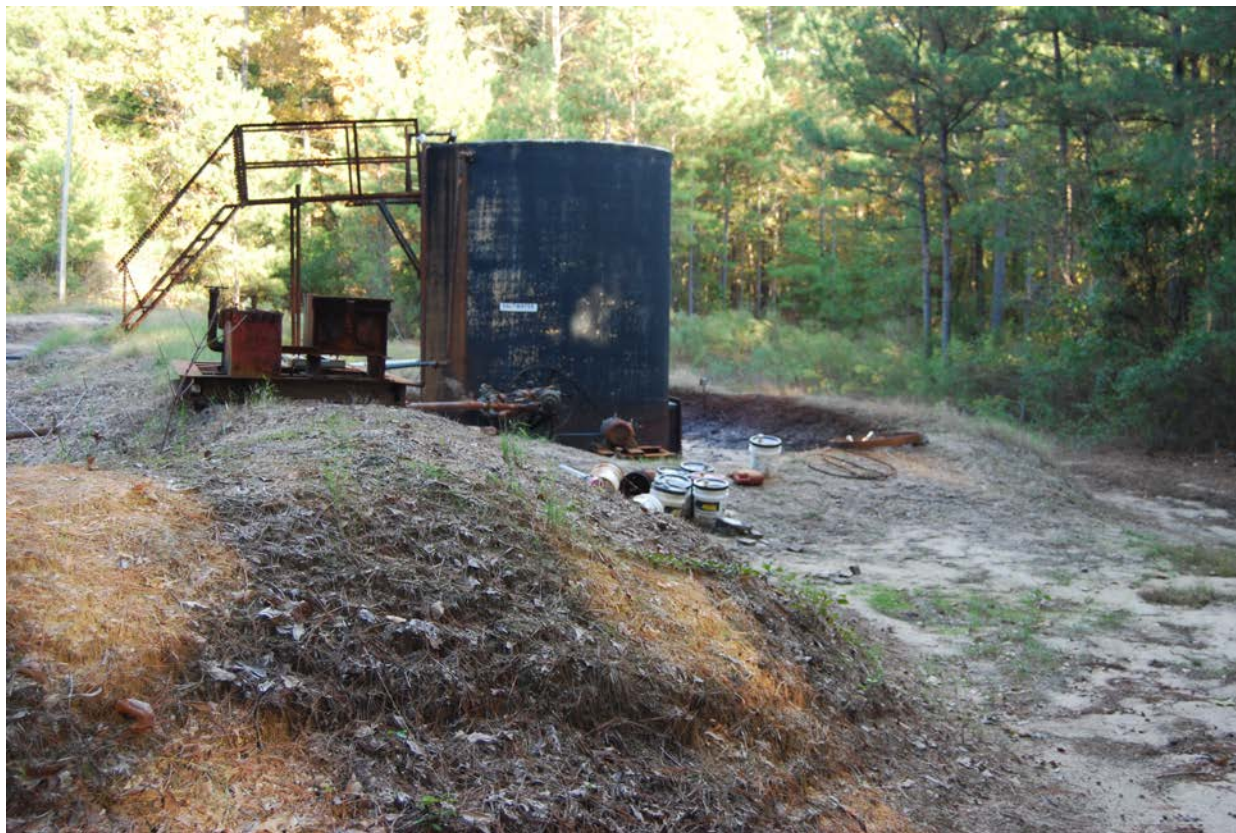
Photo No. 2

Description: An overview of the tank battery, or brine facility.

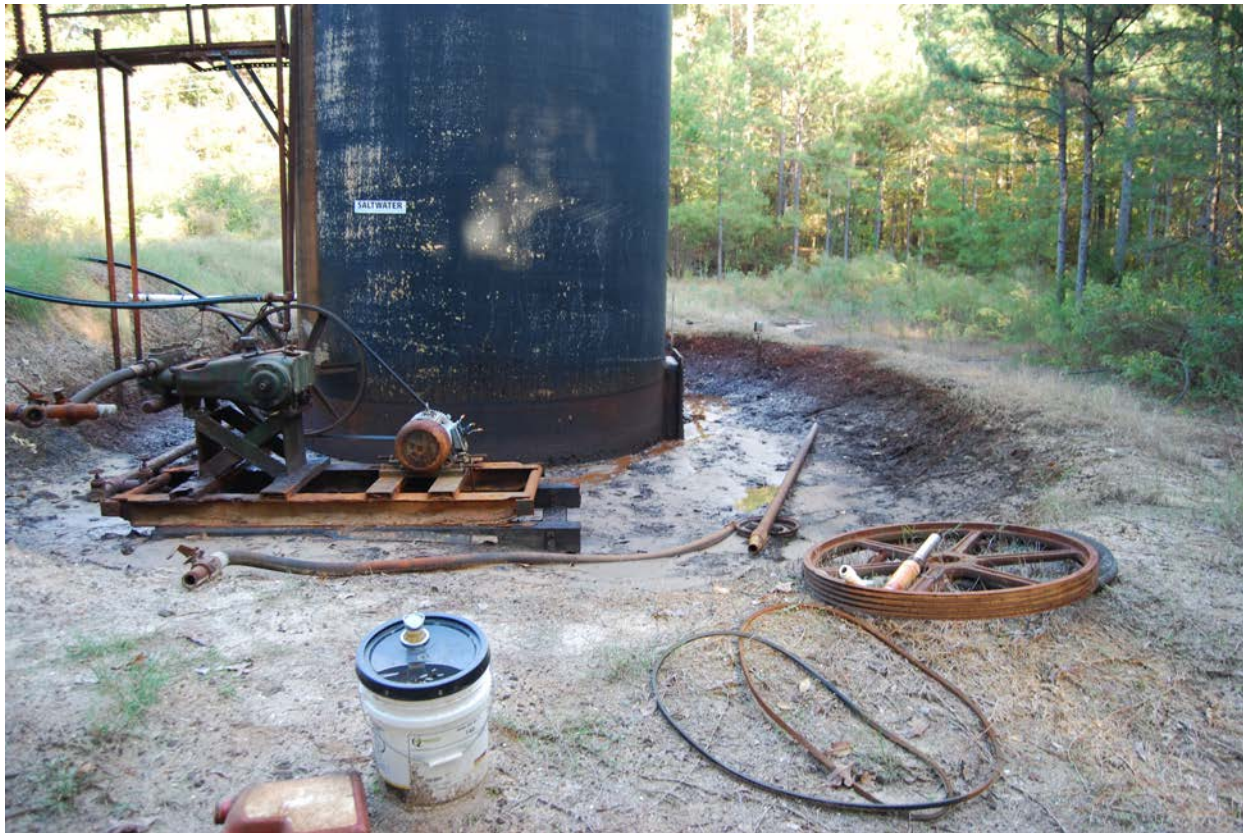
Photo No. 3

Description: A close-up of the brine facility, which the secondary containment pit had recently been drained.

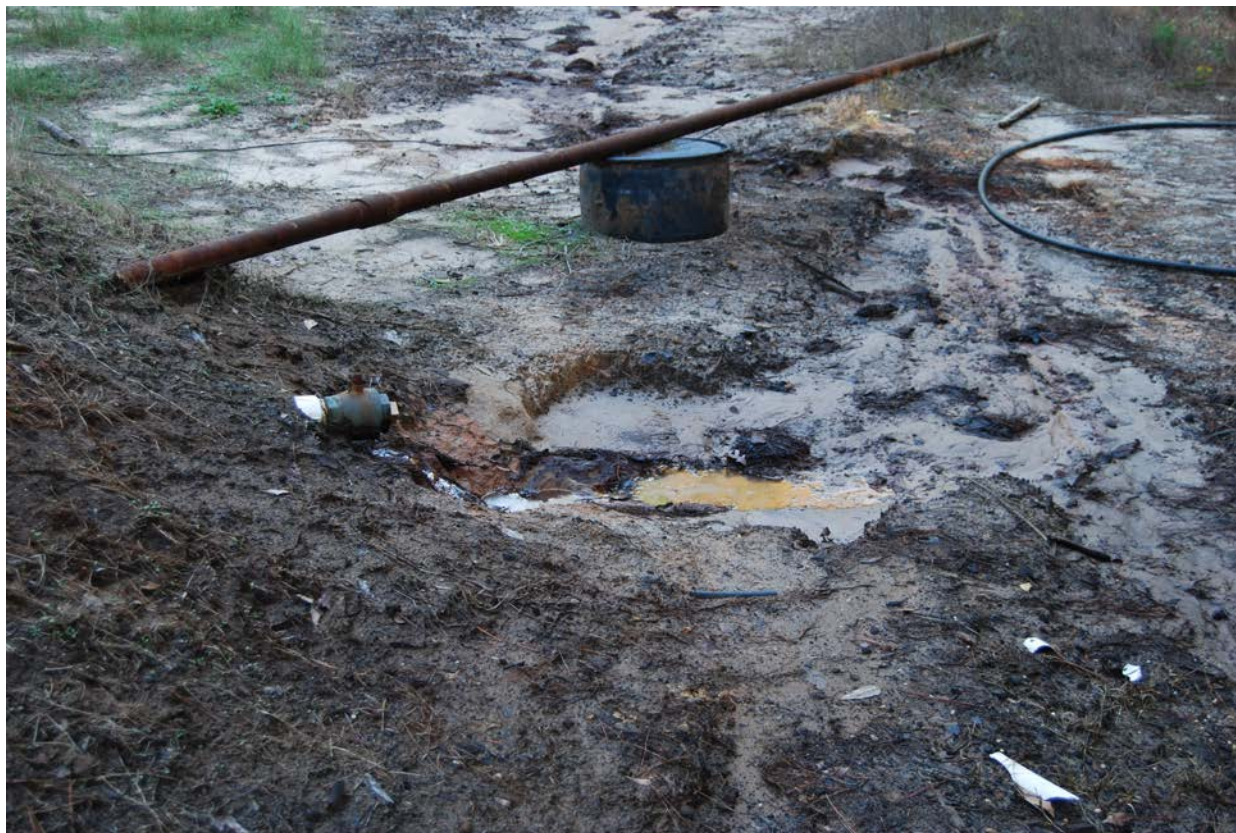
Photo No. 4

Description: This was the observed drain pipe recently used to empty the secondary containment at the brine facility.

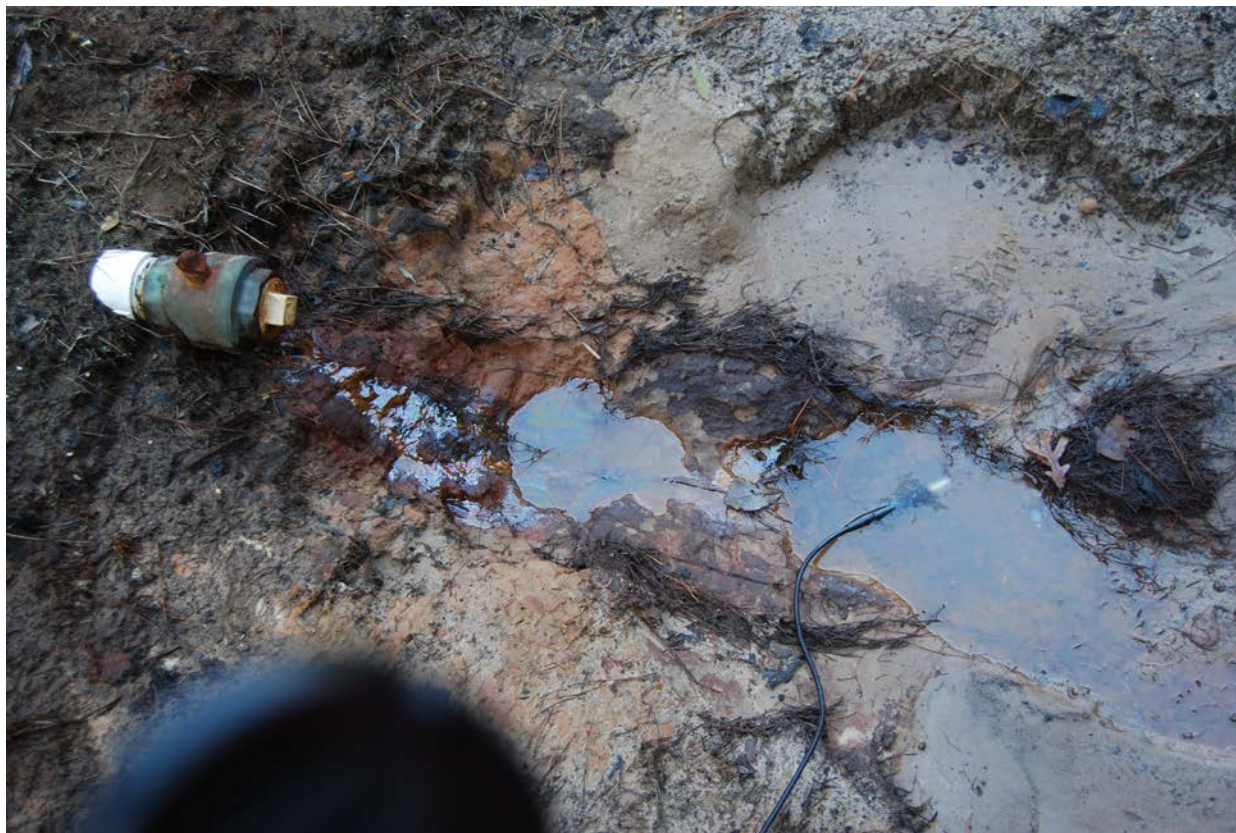
Photo No. 5

Description: A close-up of drain pipe used to empty the secondary containment. I observed the valve/plug was leaking.

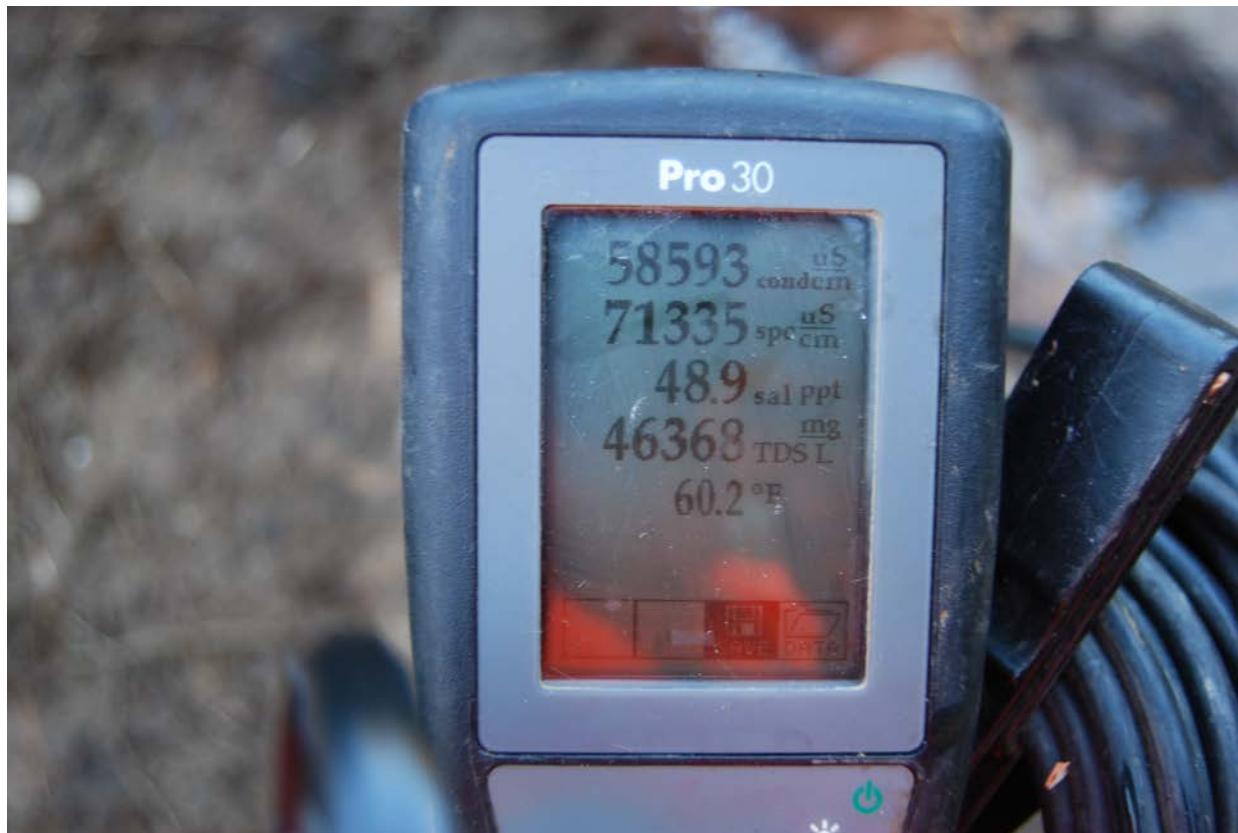
Photo No. 6

Description: With a calibrated YSI Pro 30 Conductivity meter, I took a Total Dissolved Solids (TDS) reading at the drain valve, or point of discharge, which was measured 46,368 milligrams per liter (mg/L).

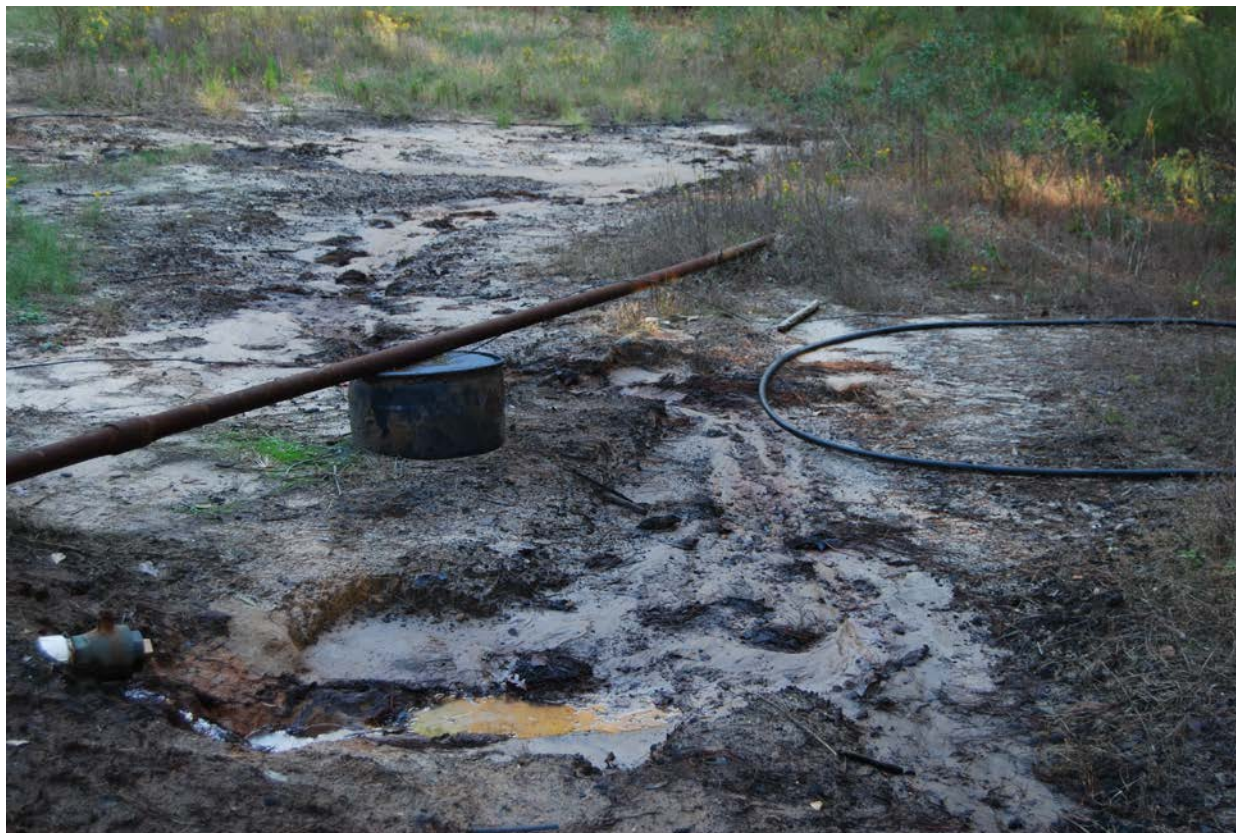
Photo No. 7

The discharge of produced water from the tank battery area and the flow line were observed. The pollutants reached Salt Creek and the adjacent marsh. Surface damage along the flow path and damage to vegetation at Salt Creek was observed.

Description: The flow of the discharge path was observed from the drain valve towards Salt Creek and the associated marsh.

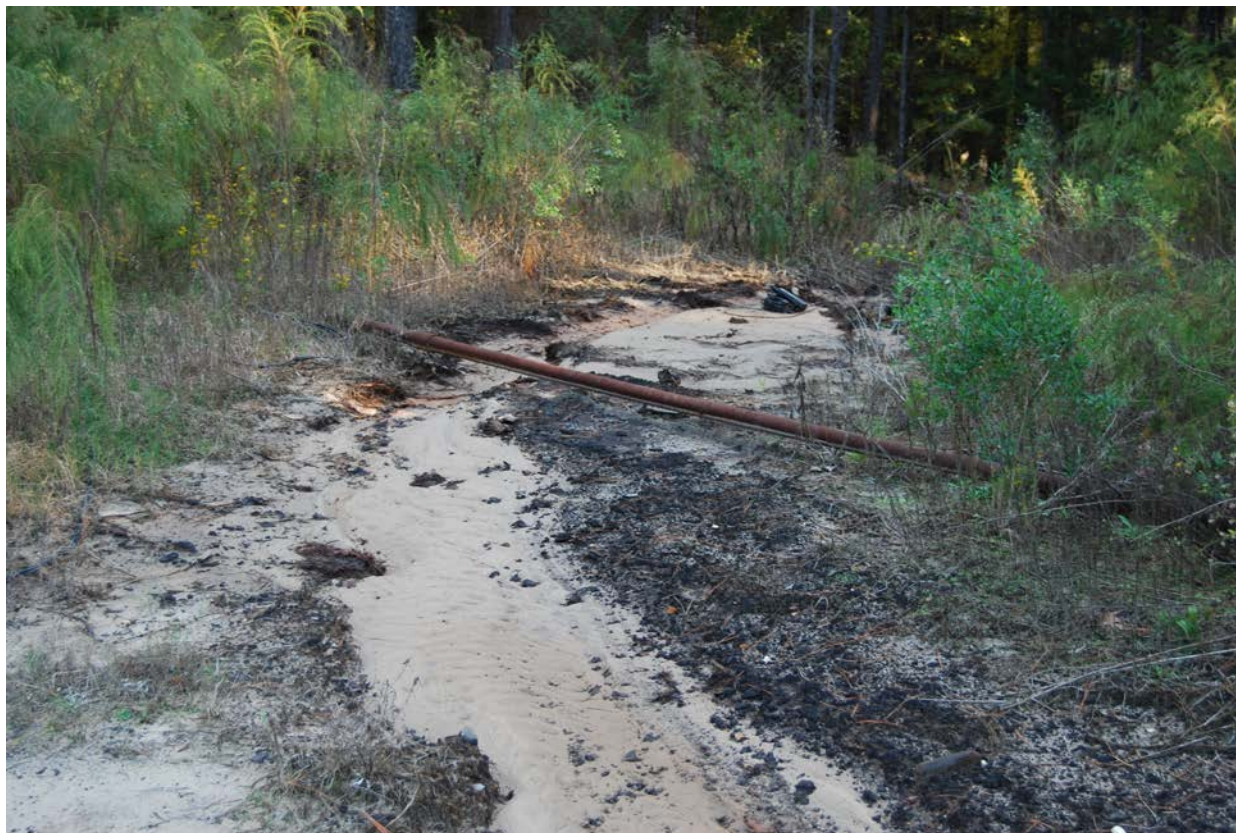
Photo No. 8

Description: The flow path of the discharge was observed here and then it flowed down the hill to Salt Creek and the adjacent marsh. I observed oil staining and pools of brine at this location.

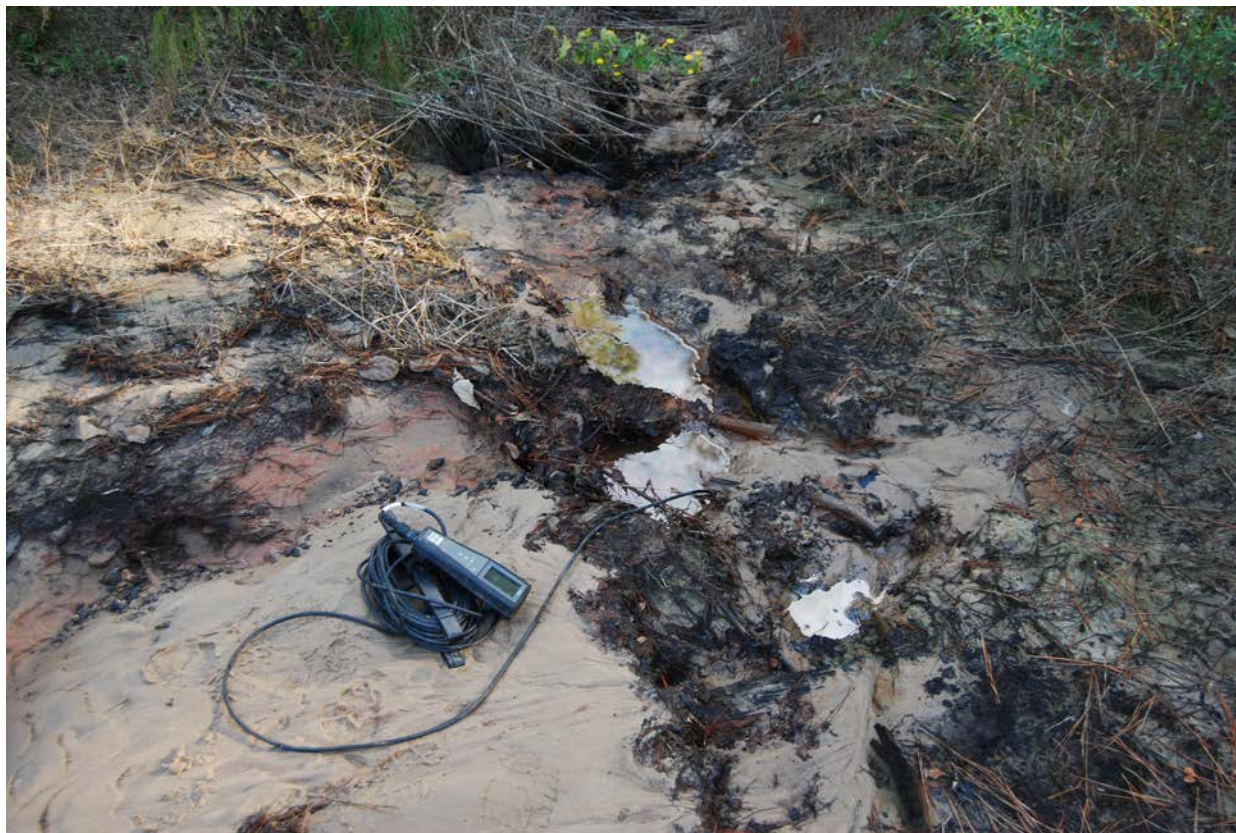
Photo No. 9

Description: A pool of brine along the flow path was seen before the discharge descended the steep hill to Salt Creek.

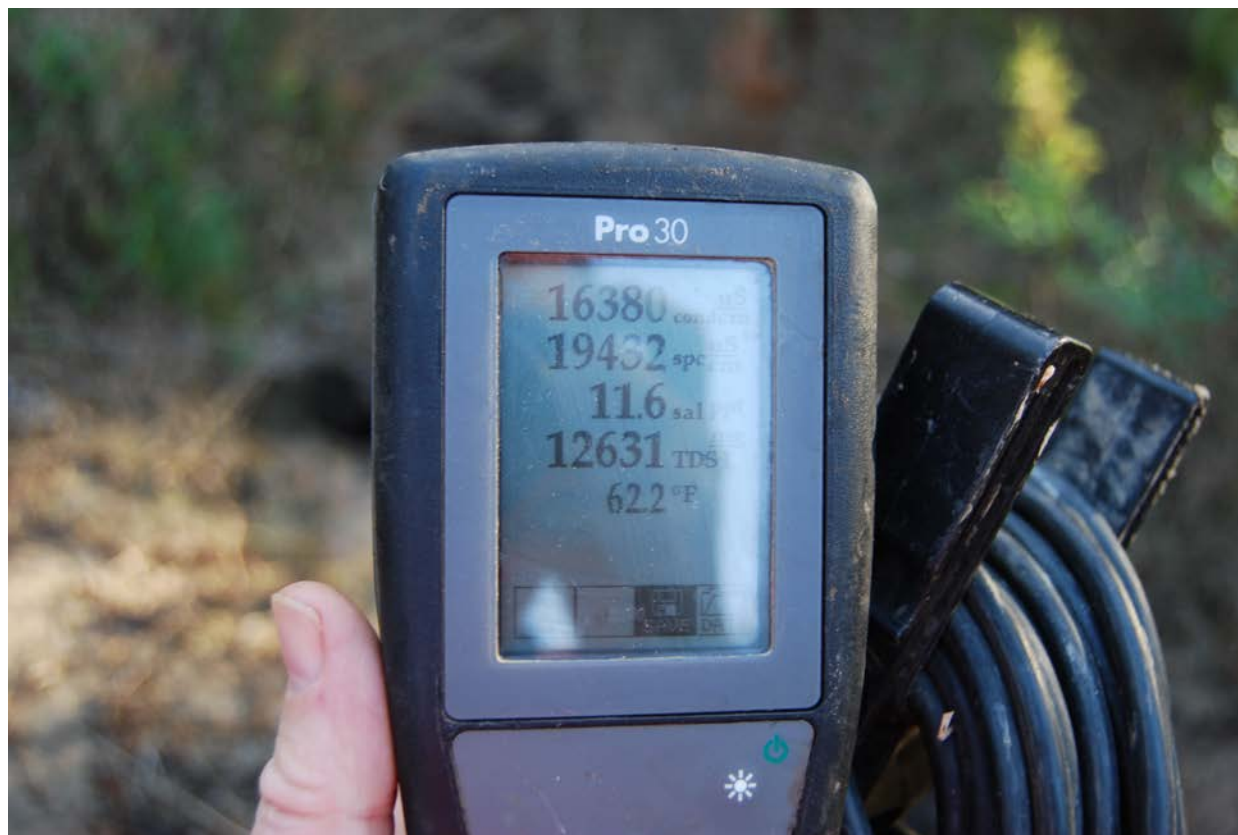
Photo No. 10

Description: The TDS at the point shown in Photo 9 was measured 12,631 mg/L.

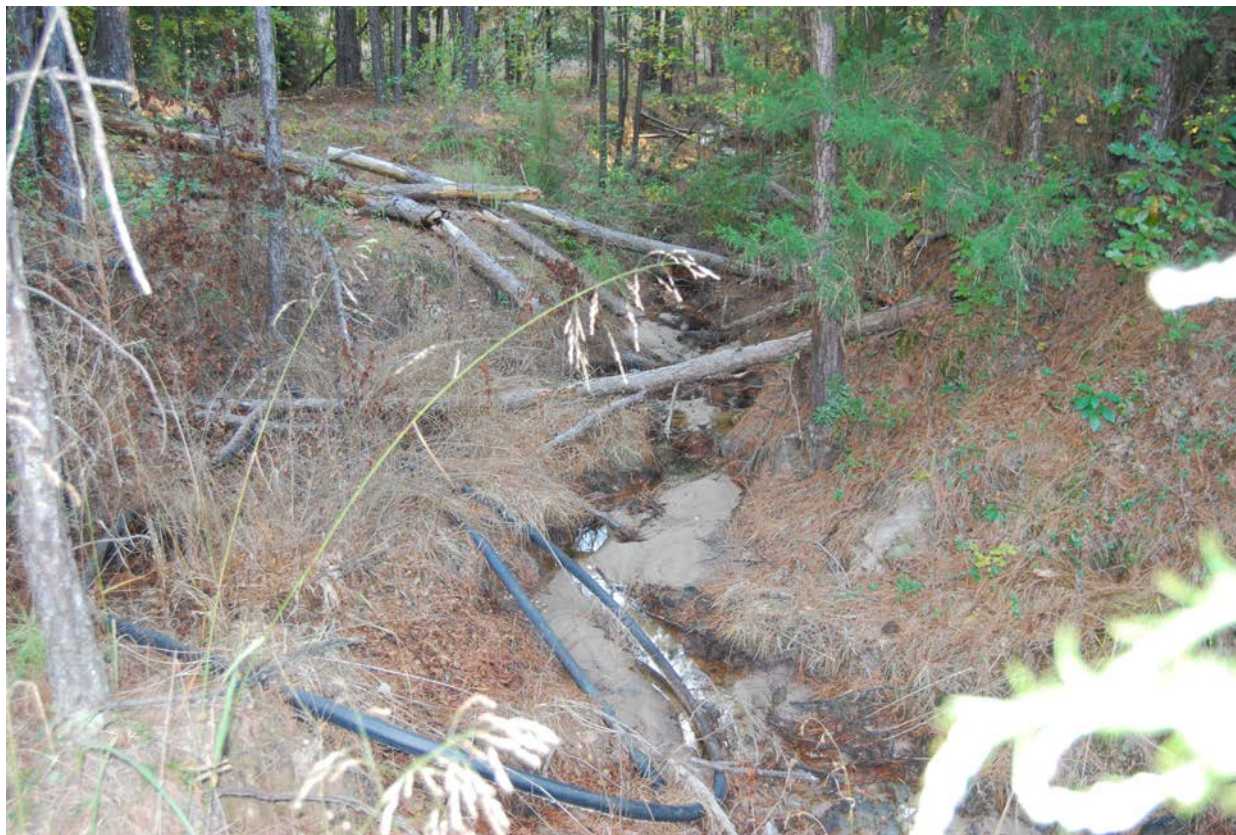
Photo No. 11

Description: This was the discharge flow path down the steep hill to Salt creek and the adjacent marsh.

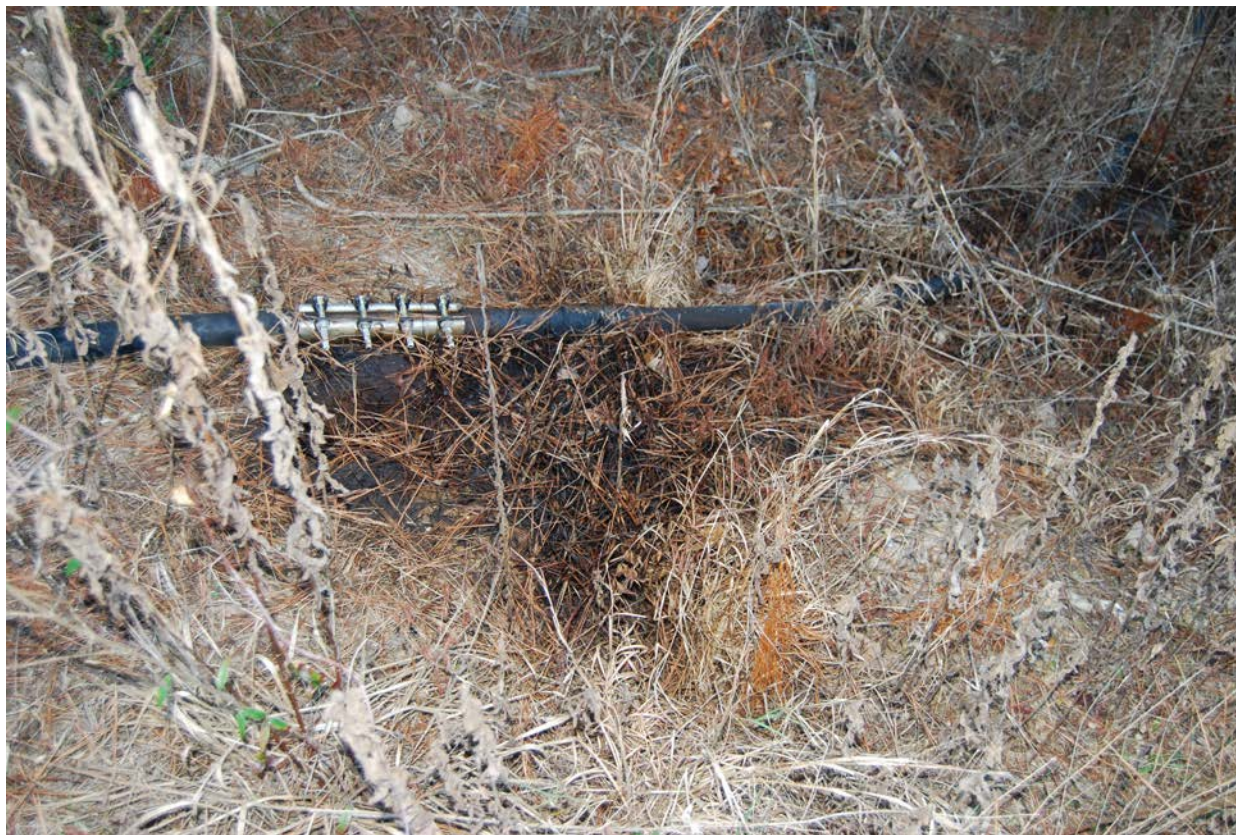
Photo No. 12

Description: I discovered a recently repaired flow line that had leaked down the same hill to Salt Creek. It was located about ¼ of the way down the same hill and would have entered the same drainage flow path.

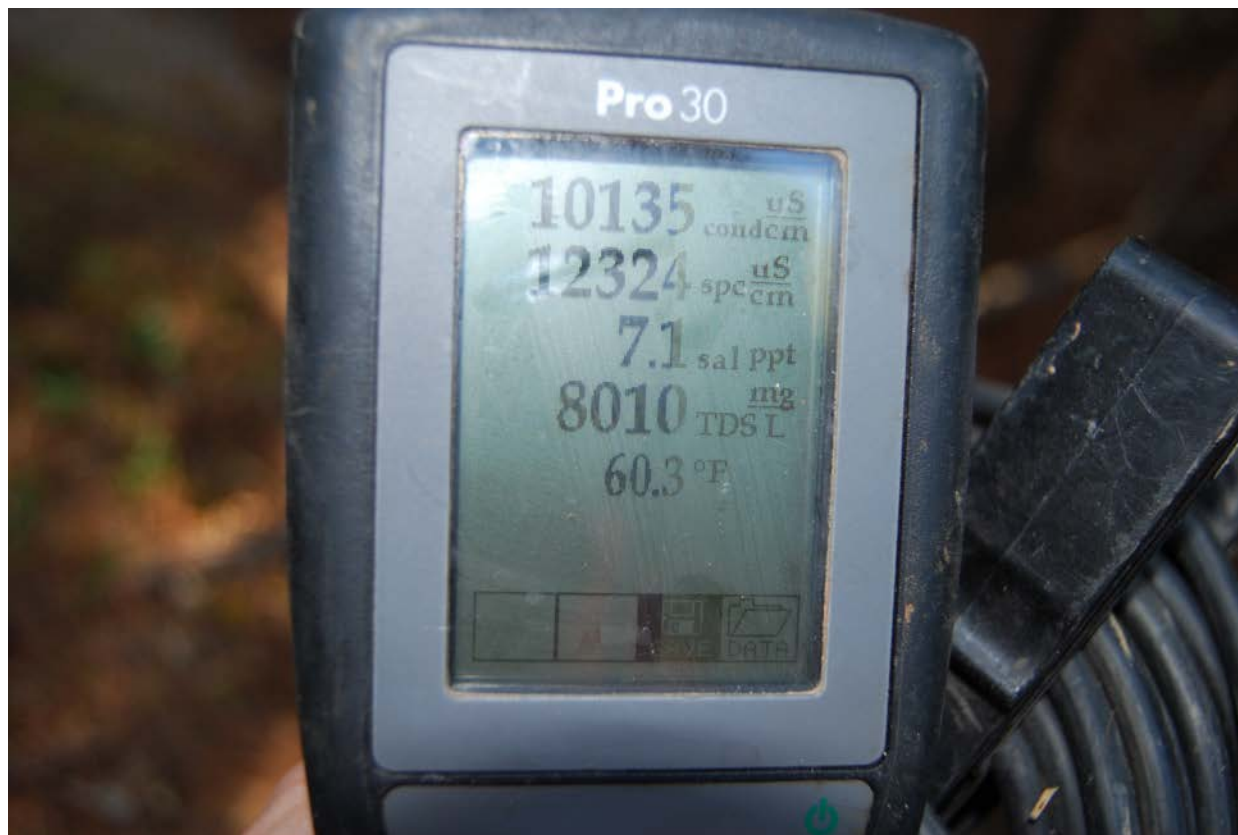
Photo No. 13

Description: I took a TDS reading about half way down the hill along the flow path and it was measured 8,010 mg/L.

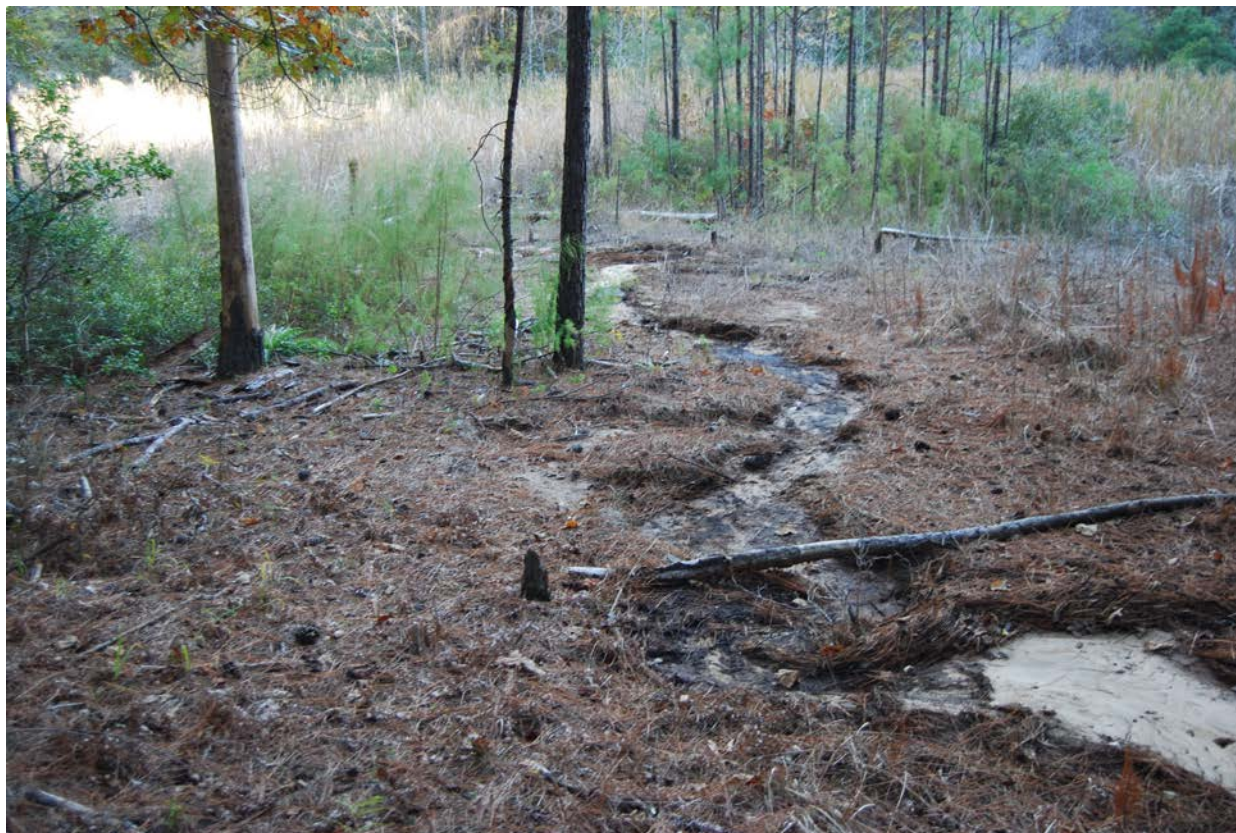
Photo No. 14

Description: The discharge entered the Salt Creek and the marsh here. I observed oil staining here as well.

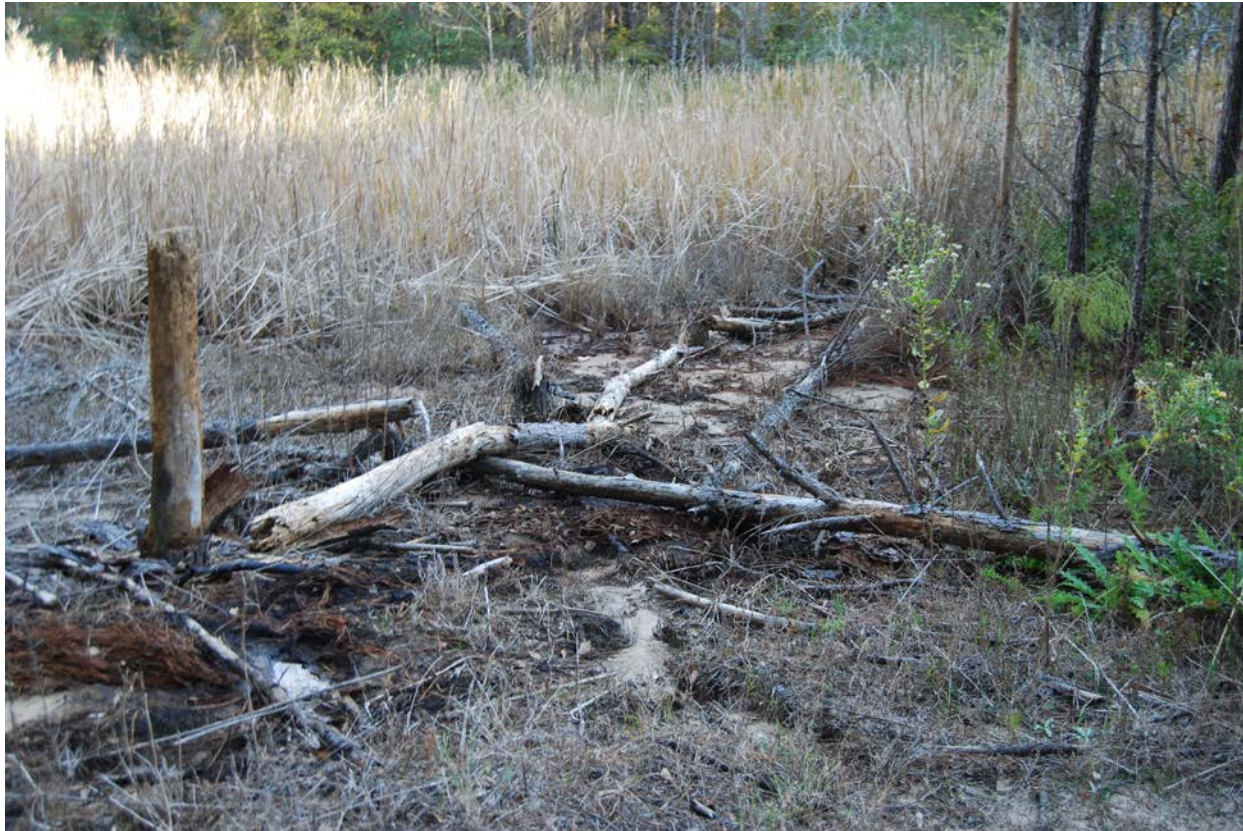
Photo No. 15

Description: Here was a close-up of the brine discharge that entered Salt Creek and the marsh.

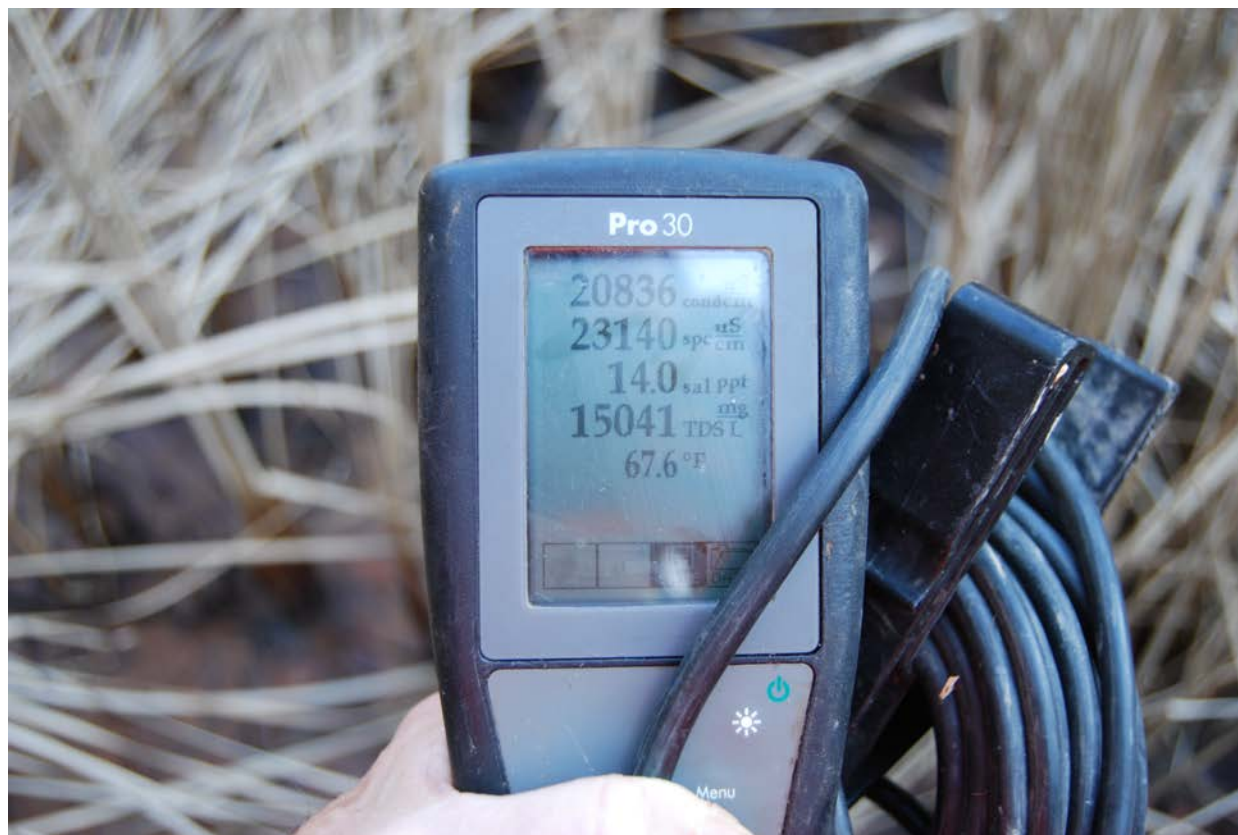
Photo No. 16

Description: The TDS of Salt Creek and the marsh at point of entry was measured 15,041 mg/L.

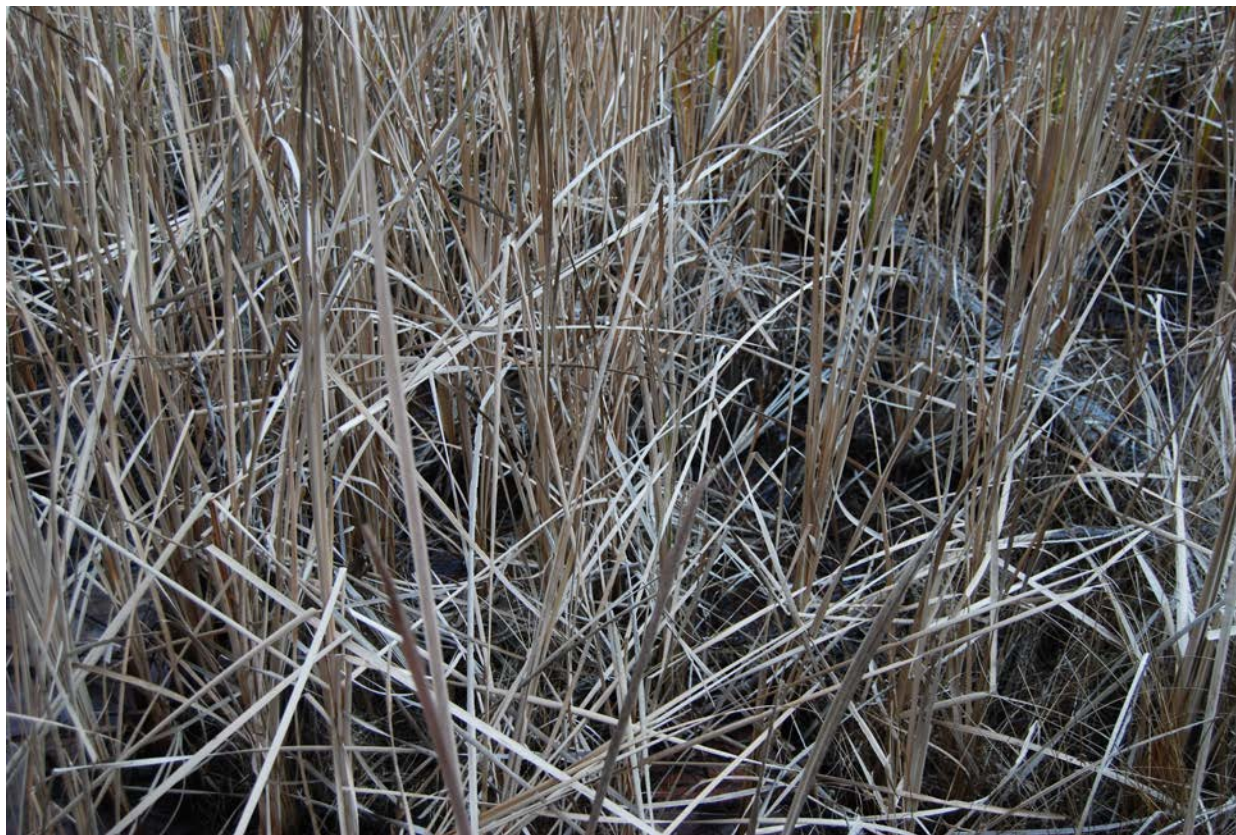
Photo No. 17

Description: This was the marsh slightly south (deeper and closer to Salt Creek) of the discharge entry point.

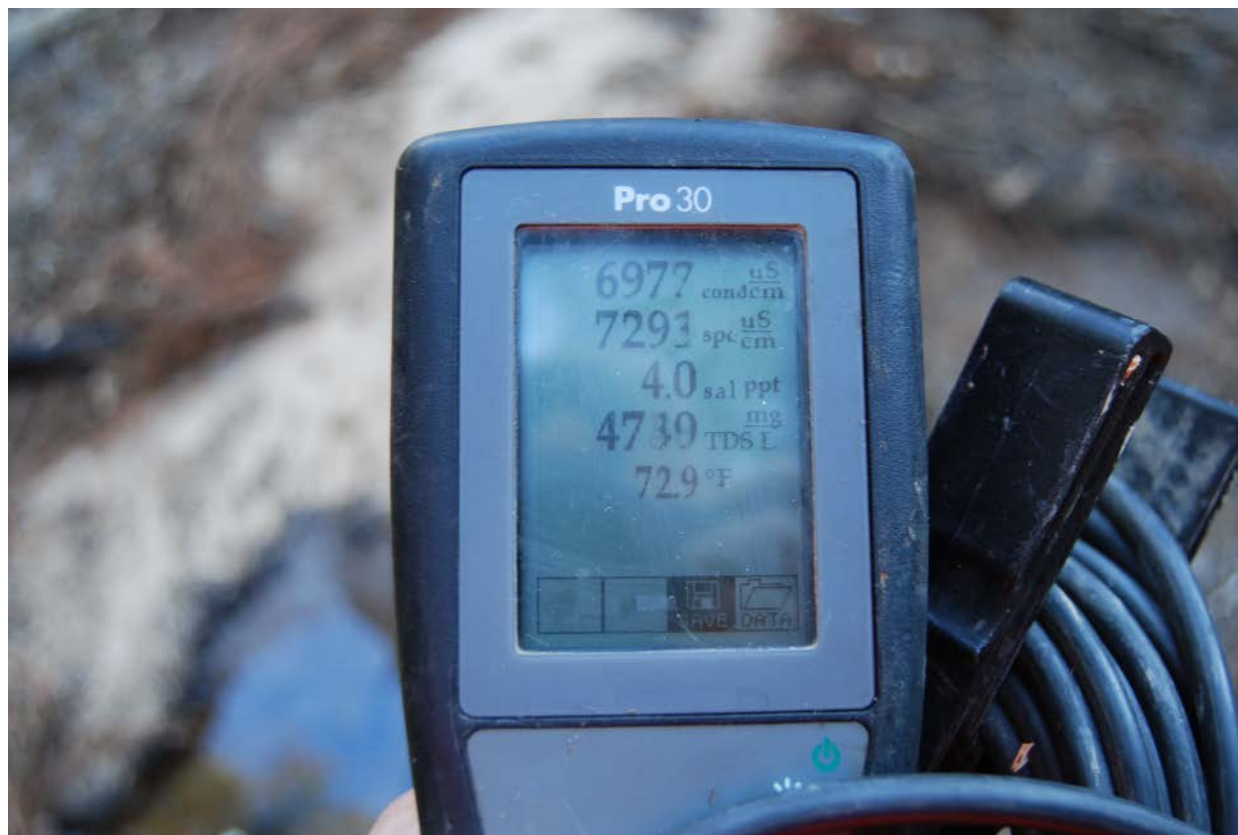
Photo No. 18

Description: The TDS of the marsh farther south of the main entry point of the discharge was measured 4,739 mg/L.

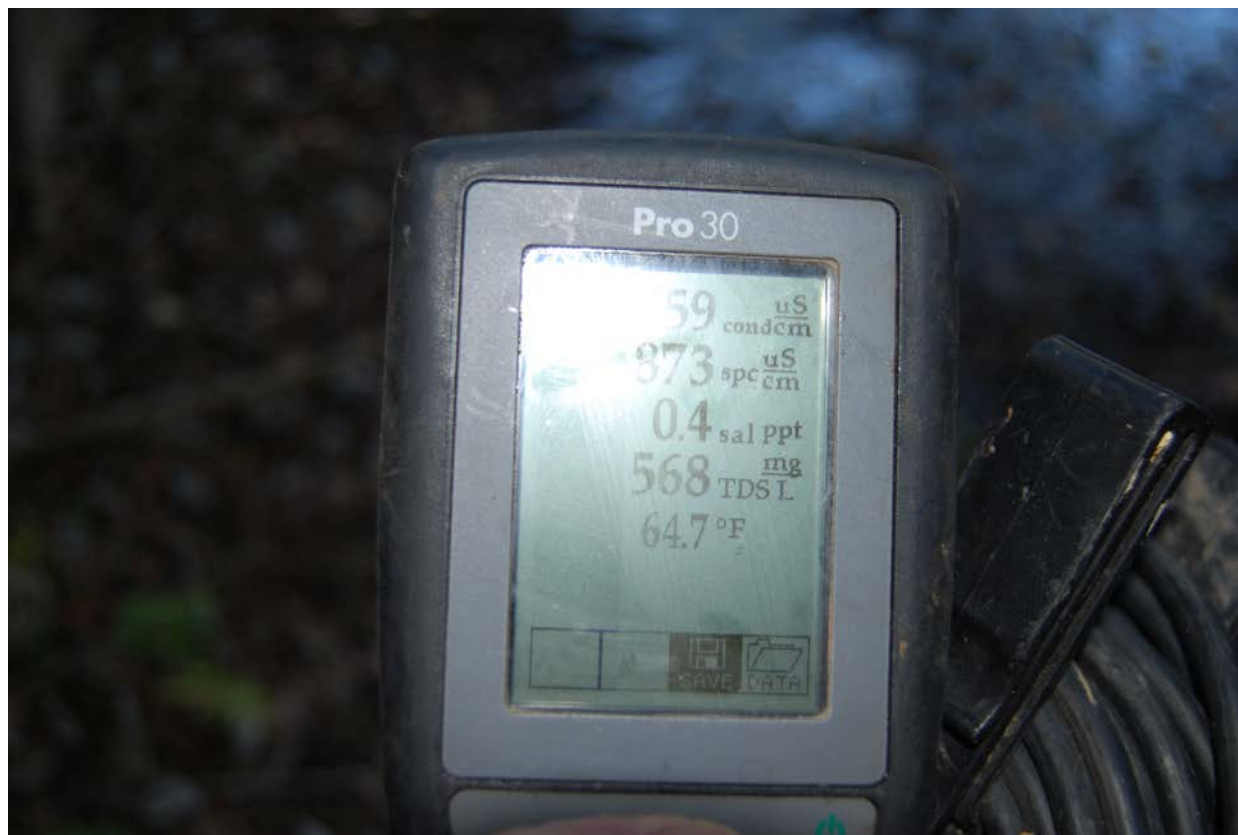
Photo No. 19

Description: The TDS of Salt Creek upstream of the discharge entry point was measured 568 mg/L. Darkness (lighting) prevented a photo of the marsh and Salt Creek during the inspection.

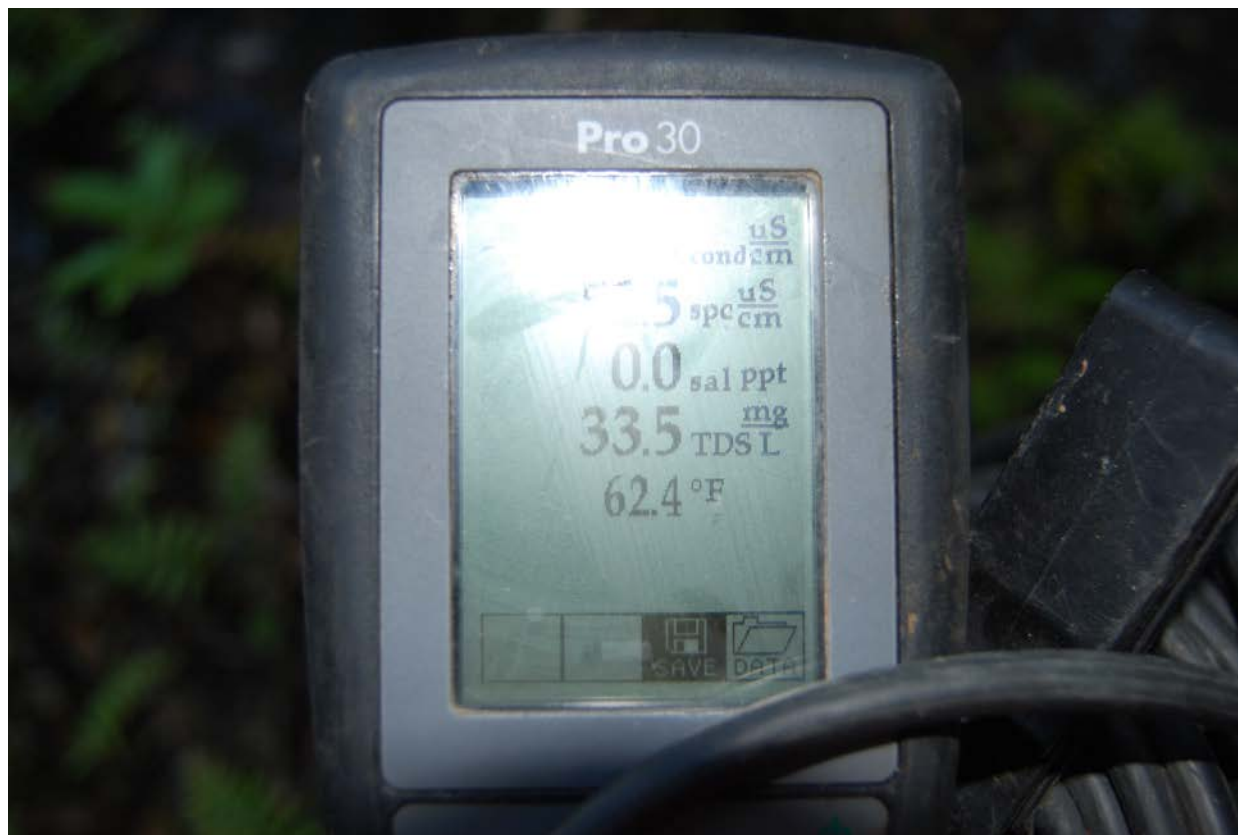
Photo No. 20

Description: The TDS of Salt Creek farther upstream of the location measured in Photo 19 was taken and the TDS measured here was 33.5 mg/L.
