**UNITED STATES ENVIRONMENTAL PROTECTION AGENCY**  
**REGION 5**  
**77 WEST JACKSON BOULEVARD**  
**CHICAGO, ILLINOIS 60604**

**SUBJECT:** CLEAN WATER ACT INSPECTION REPORT  
*Heritage Thermal Services, Inc. 1250 St. George Street, East Liverpool, Ohio*

**NPDES Permit Number:** *OH0107298*

**Date(s) of Inspection:** July 30 through August 1 and August 27, 2024

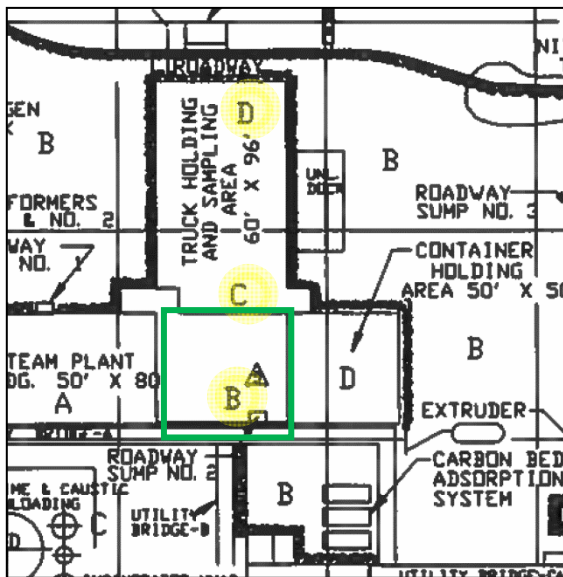
Figure 1: Attachment B.3 from the NPDES Permit Application

2. Locations of industrial activity and storm water catchments were not consistent with the NPDES Permit Application. The "Stormwater Collection Areas" Attachment B.3 to the January 19, 2021, version of the NPDES Permit Application shows the approximate locations of Area 'A', Area 'B' and Area 'C' sewer sheds. A comparison of the Attachment B.3 to the Area 'A' sewers (VonRoll C-01-1-00009/10/11/12) , the Area 'B' Sewers (VonRoll C-03-1-00002/3) noted several inconsistencies:

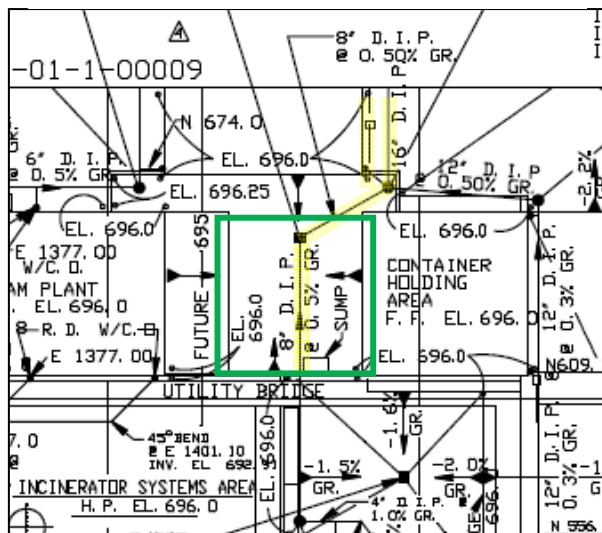
Figure 3: Excerpt from drawing C-01-1-00011 of the Area 'A' sewer. Yellow highlight is Area 'A' sewer

The Area 'A' sewer drawing (VonRoll C-01-1-00009 and 11) shows all downspouts from the Truck Holding and Sampling Area are connected to the Area 'A' sewer and the inlet in the paved area south of the Truck Holding and Sampling Area is also connected to the Area 'A' sewer also. An excerpt of that drawing is included in Figure 3 below. Copies of the Area 'C' sewer could not be located. Figure 2 shows an excerpt of the Area 'B' sewer system which shows a roadway collection sump south of the concrete storage pad, but does not show the drainage, nor the inlet in the concrete pad as being connected to the Area 'B' sump. The concrete pad located south of the Truck Holding and Sampling Area is used to store salt for the water softening system.

The NPDES permit application indicates the concrete storage pad is tributary to Area 'B', but the drawings show the pad is connected to an Area 'A' sewer. The permit application drawing also shows that there is a portion of the roof which is tributary to an Area 'C' sewer, but that condition is not consistent with the available drawings, nor the site conditions at the time of the inspection. The figures on the next page show excerpts from Attachment B.3, Area 'A', and Area 'B' sewer drawings. The green square represents the approximate extent of the concrete storage pad. The yellow highlighting shows the locations of the relevant designations and appurtenances.

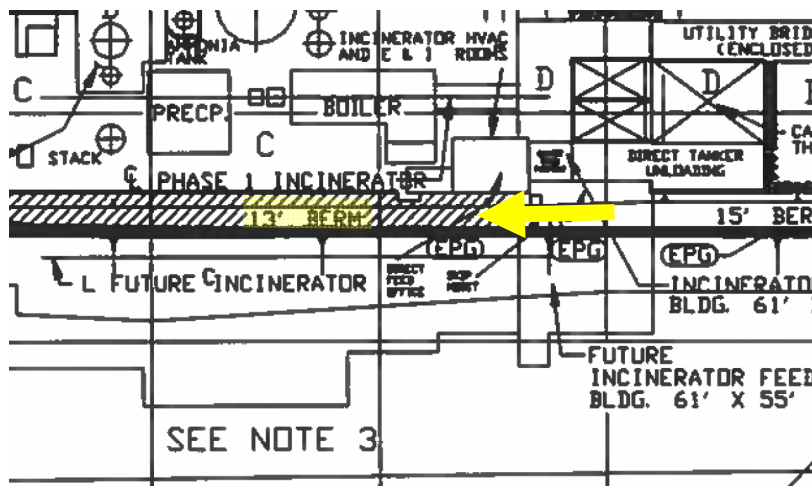
Figure 4: Excerpt from Attachment B.3 from the NPDES Permit Application

- b) Attachment B.3 from the NPDES Permit Application shows a berm located along the southern edge of the facility and between the incinerator and emissions control facilities and the Ohio River.

At the time of the inspection, there was no berm present, nor curb, and the pavement along the southern edge of the facility was pitched toward the Ohio River. The drawing excerpt (Figure 4) below is from the NPDES Application, the arrow shows the approximate location of the photo (Figure 5), included below, taken during the EPA inspection. At the time of the inspection a condensate drain was draining across the pavement, and toward the Ohio River.

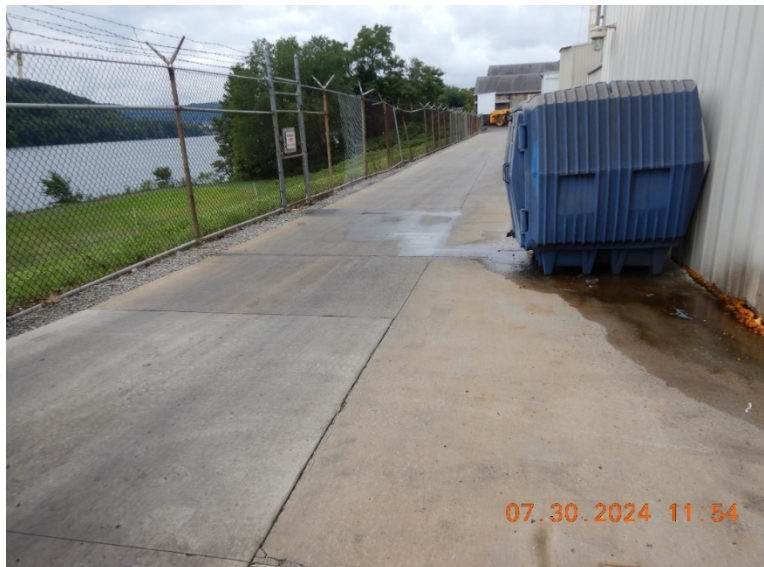
Figure 5: Photo from inspection, water was flowing from right to left across the pavement toward the Ohio River seen in the background

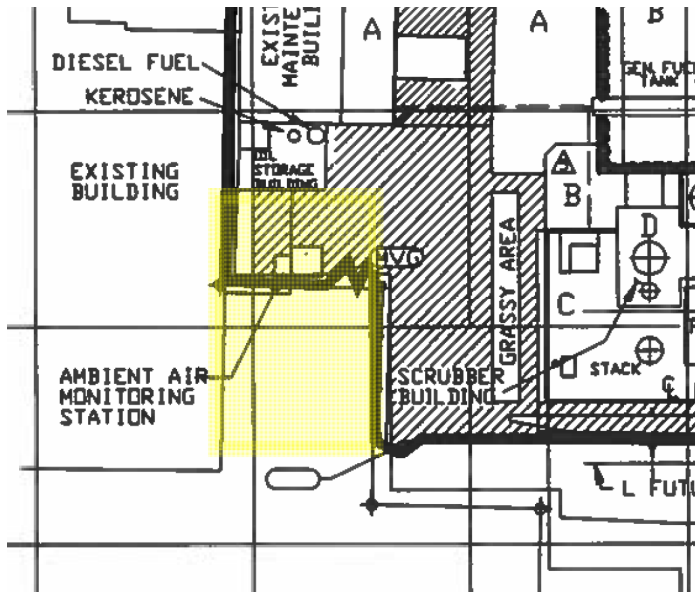
- c) Attachment B.3 from the NPDES Permit Application does not show the location of the metal fabrication area known as 'Brass Alley'. The drawing excerpt (Figure 7) below is from the NPDES Application, the yellow rectangle is the approximate location of 'Brass Alley' as shown on a recent aerial (Figure 6), provided below.

Figure 7: Excerpt from Attachment B.3 of the NPDES permit application. Yellow highlighting is the approximate location of 'Brass Alley'

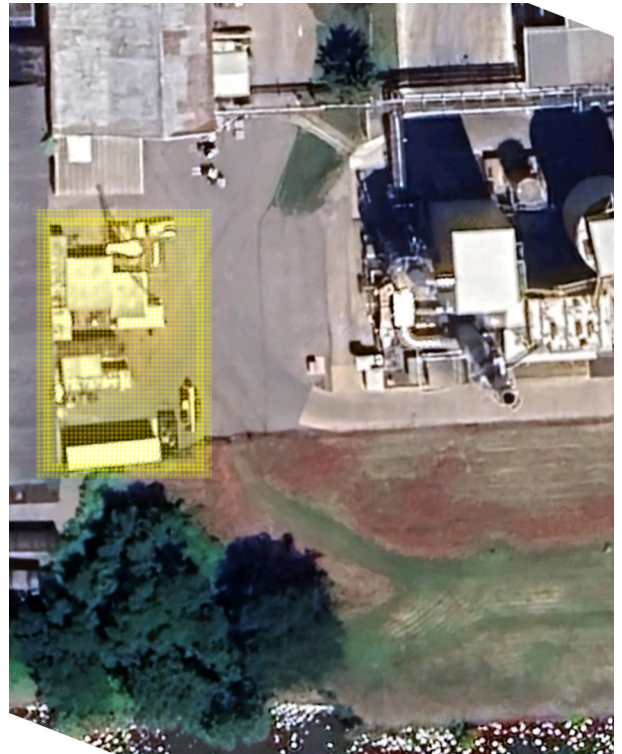
Figure 6: Aerial of the site, yellow highlighting is the approximate location of 'Brass Alley'

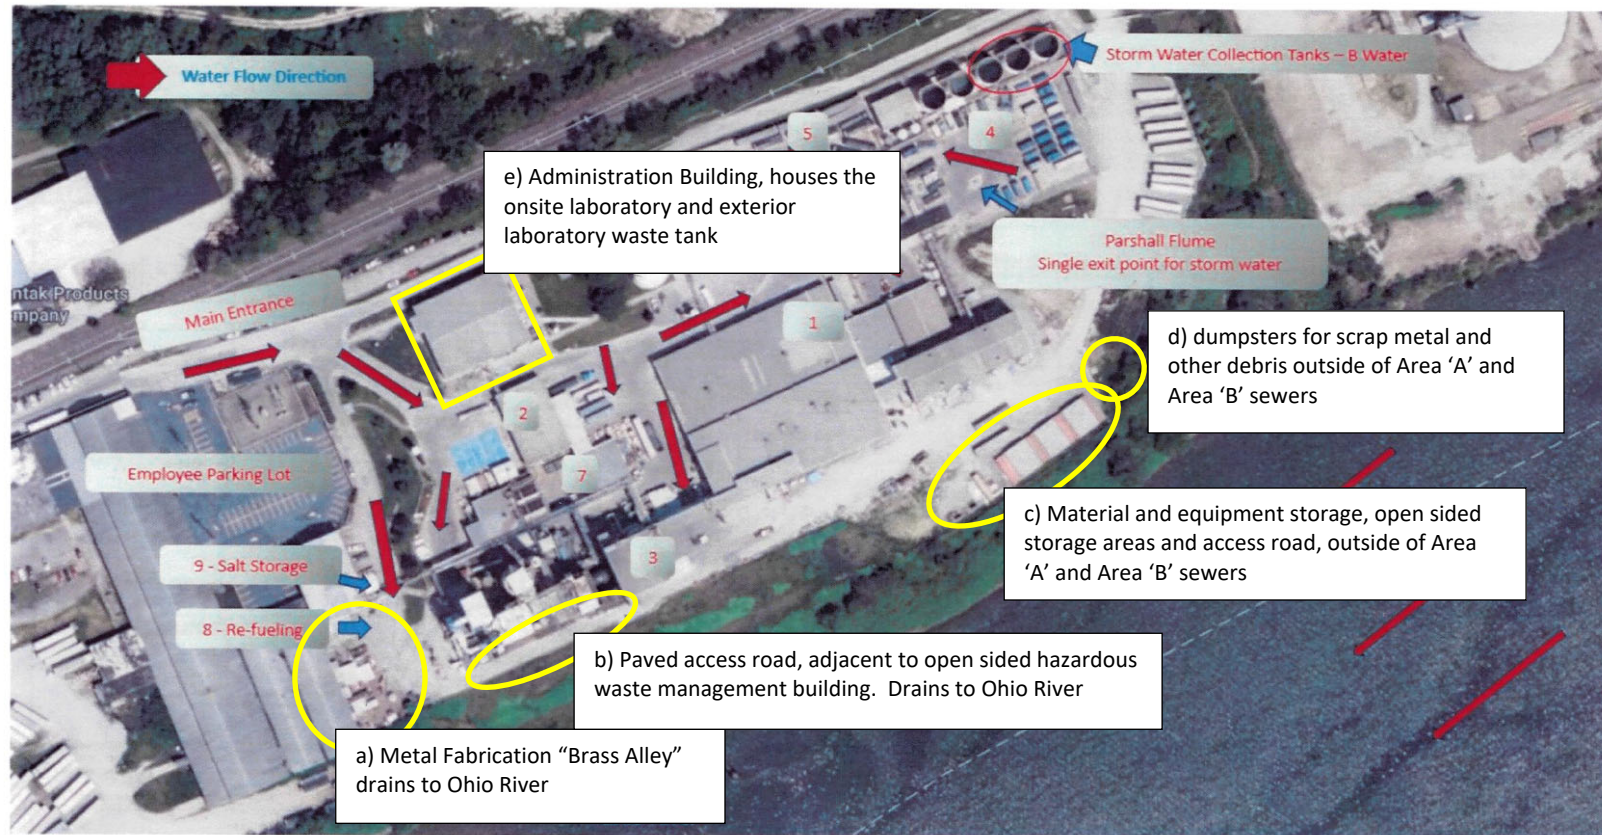
Figure 3- Site Map/Exposed Activity Locations

The aerial on the next page, labeled "Figure 3 – Site Map /Exposed Activity Locations" is annotated in yellow showing the locations described above.

This is Figure 3 the Site Map from the SWPPP – Yellow annotations are EPA’s observations made during the August 2024 Inspection

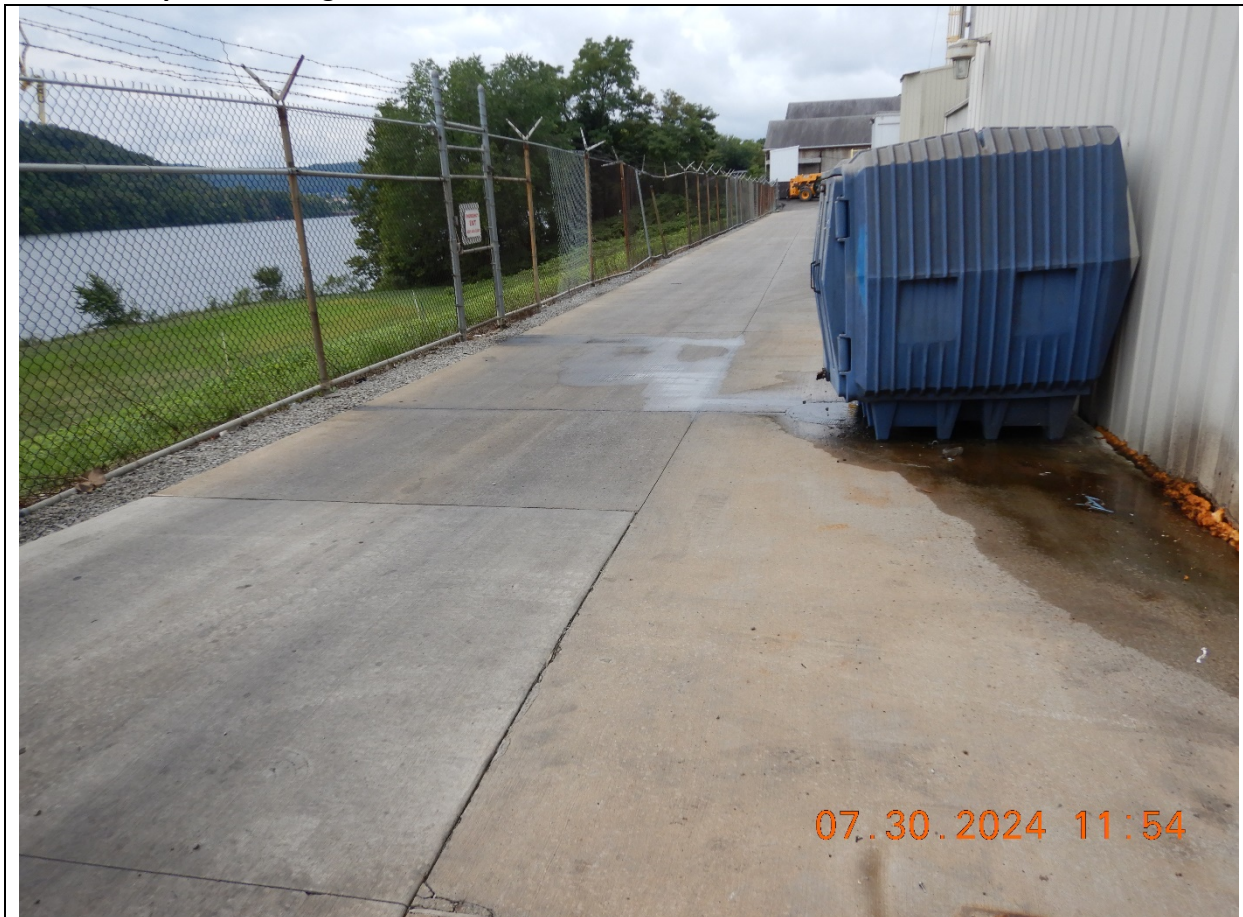
**1: DSCN2198.JPG**

b) Paved access road, adjacent and to the south of the open sided hazardous waste management building. This access road is tributary to the Ohio River. Jonathan Moody observed a condensate drain flowing across this roadway toward the Ohio River, the concrete in this location was stained with a wheel pattern (Photo 1). The pavement was adjacent to a portion of the building housing the incinerator and an open-sided construction housing emissions control equipment and the emissions stack. The drawings included with the NPDES permit applications and the drawings of the original facility grading plan (VonRoll C-01-1-00011 Rev 4) show a large earthen berm constructed in the location of this access road. The berm, nor curbing, was present at the time of the inspection.

**Description:** Located south of the incinerator building. At the time of the inspection a condensate drip from an air conditioning unit was flowing across the pavement, from north to south, towards the Ohio River. The map in the NPDES permit application indicates there is a berm present at this location. No berm was visible at the time of the inspection.

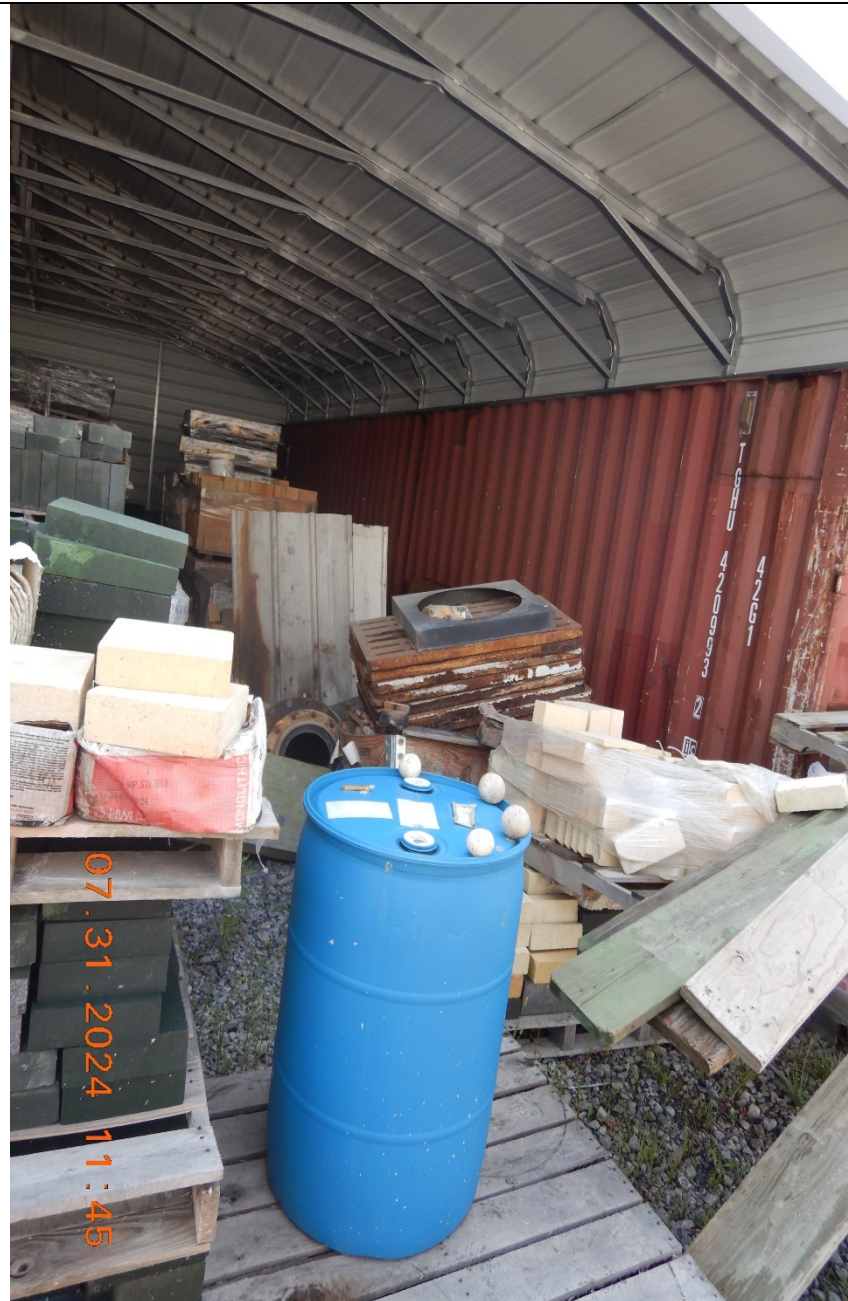
10: DSCN2207.JPG

storage structure and the vehicle access to the storage structures were not shown on the map included in the attachment to the NPDES permit, nor in the SWPPP.

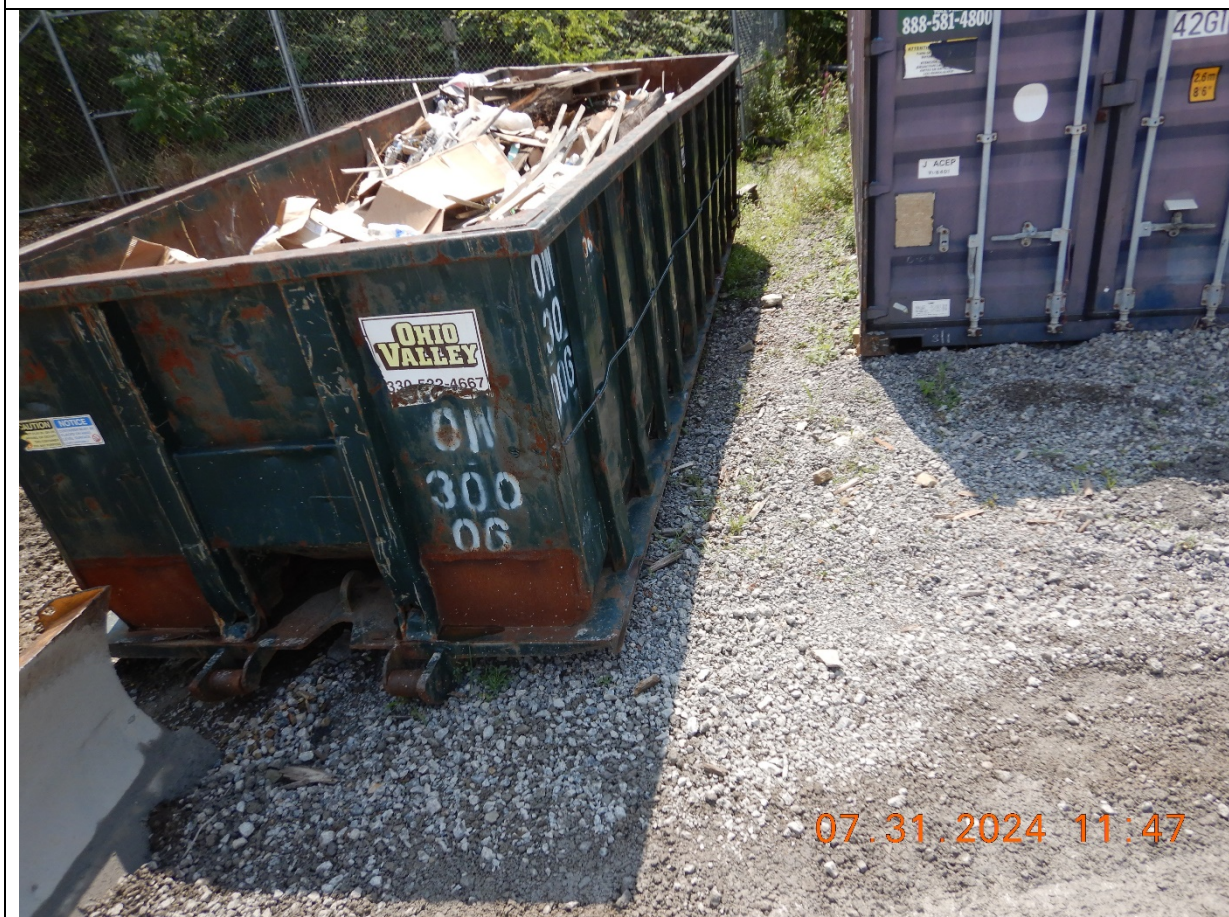
11: DSCN2208.JPG

Description: Dumpsters located adjacent and to the east of the open-sided storage structures, and adjacent to the Ohio River. At the time of the inspection, Jon Zoppelt said that these dumpsters were being used for both facility operations and construction activities, but no hazardous materials were placed in these dumpsters.

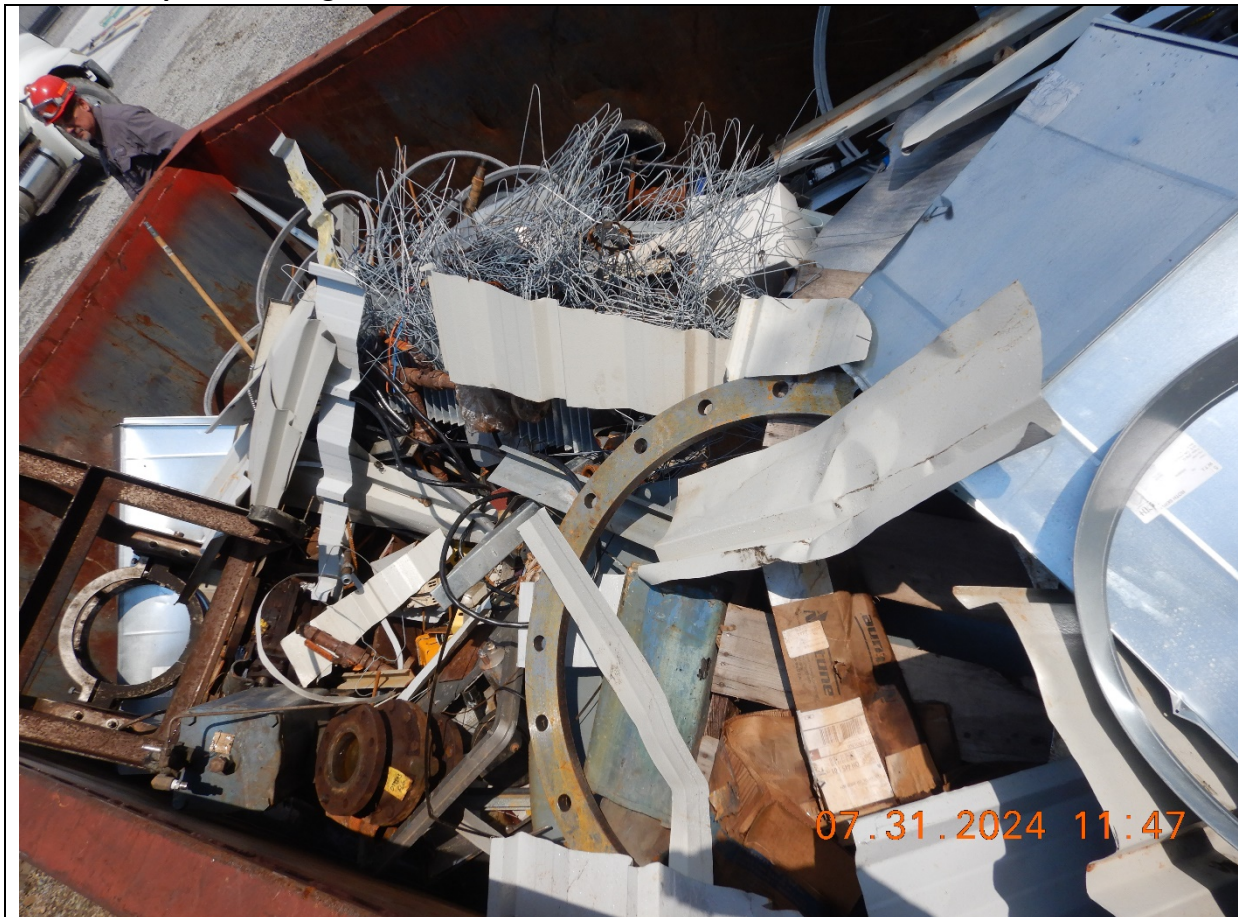
12: DSCN2209.JPG

Description: Dumpsters located adjacent and to the east of the open-sided storage structures, and adjacent to the Ohio River. At the time of the inspection, Jon Zoppelt said that these dumpsters were being used for both facility operations and construction activities, but no hazardous materials were placed in these dumpsters.

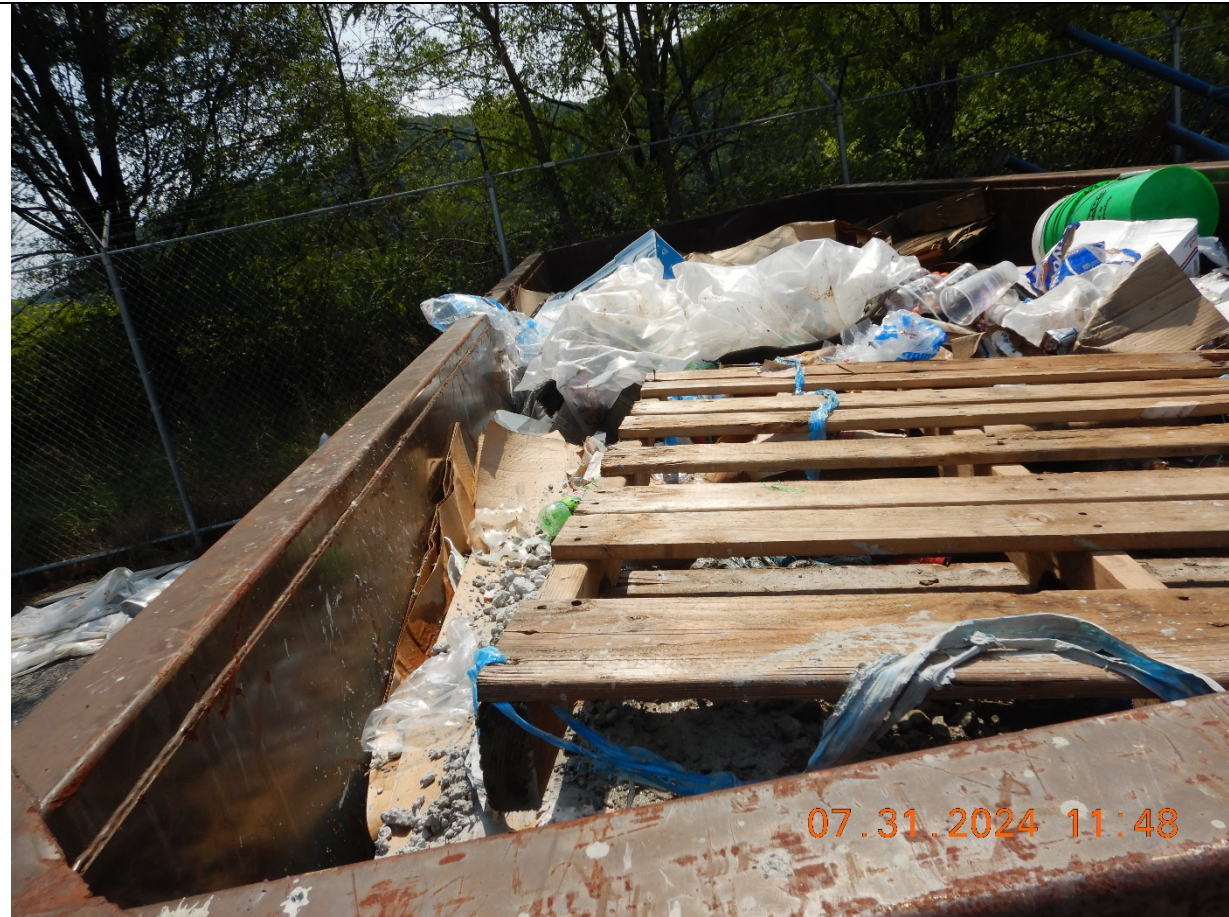
13: DSCN2210.JPG

Description: Dumpsters located adjacent and to the east of the open-sided storage structures, and adjacent to the Ohio River. At the time of the inspection, Jon Zoppelt said that these dumpsters were being used for both facility operations and construction activities, but no hazardous materials were placed in these dumpsters.

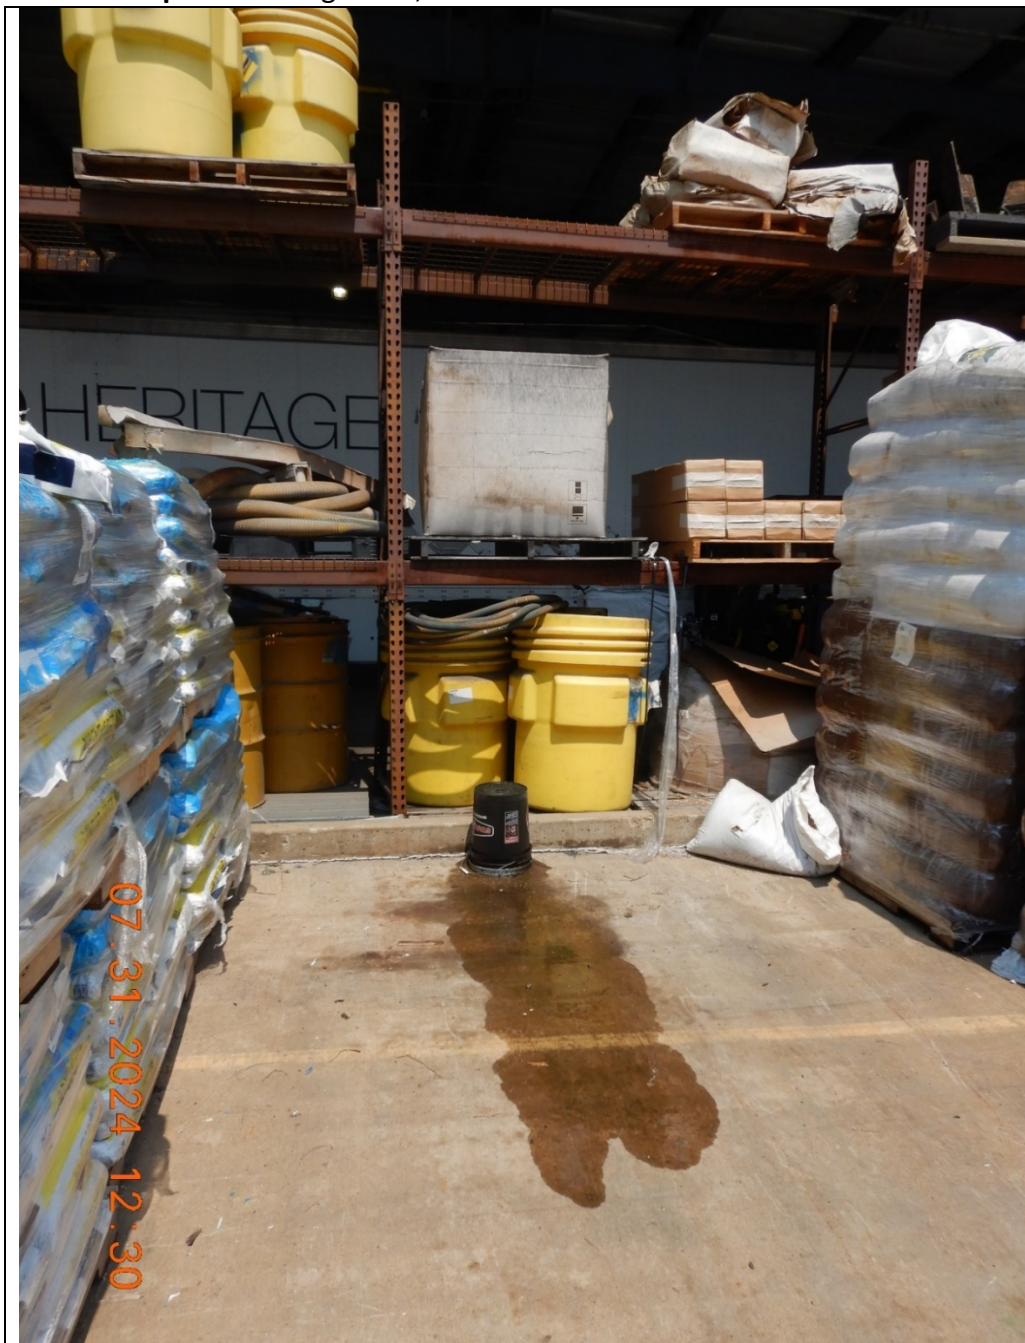
23: DSCN2220.JPG

permit application, this area is an Area 'B' drainage, however the VonRoll drawing, and the Area 'B' sewer map show the drainage in this area is tributary to Area 'A'.

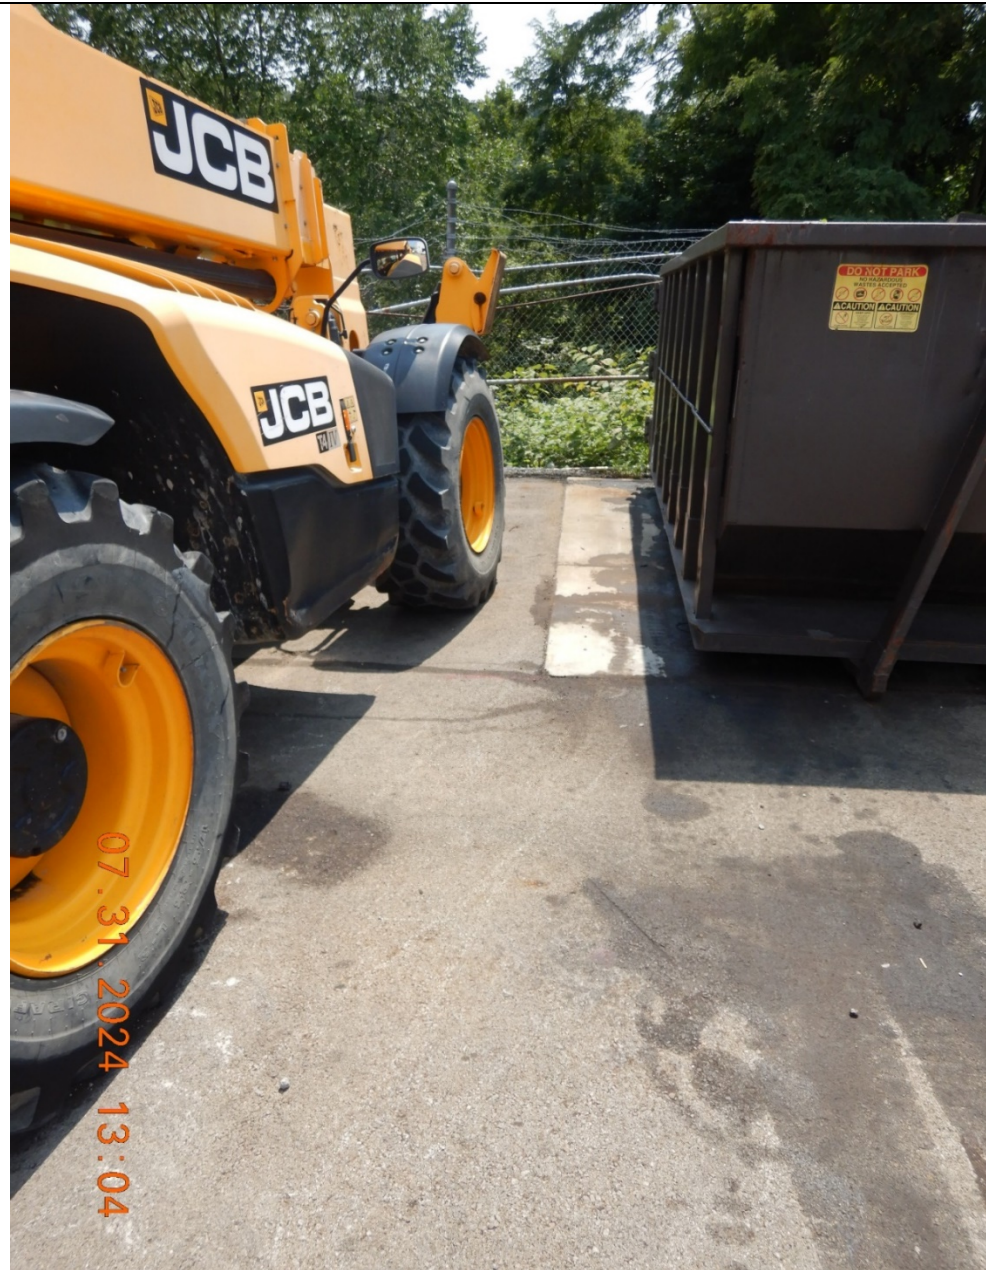
27: DSCN2224.JPG

a) Metal Fabrication “Brass Alley” which is tributary to the Ohio River. Jonathan Moody observed metal cutting equipment (Photo 28), and a dumpster (Photo 24) present in this area, as well as staining on the concrete (Photos 27-29) and a residual amount of water on the river side of the dumpster with a flow pattern toward the Ohio River (Photo 30). The refueling area associated with “Brass Alley” appears in the SWPPP which appears to be tributary to the Area ‘A’ sewers. The majority of “Brass Alley” including the metal fabrication (Photo 28), laydown (Photo 26), and dumpster (Photos 25) were not included in the SWPPP, nor the NPDES permit application.

Description: Near the southwest corner of the facility, in an area adjacent to and tributary to the Ohio River. This area is known as 'Brass Alley'. There was a dumpster here, the pavement around the dumpster was stained and discolored, and there was standing water near the dumpster.

There was a dumpster here. This activity/area was not included in the NPDES permit application, nor the SWPPP.

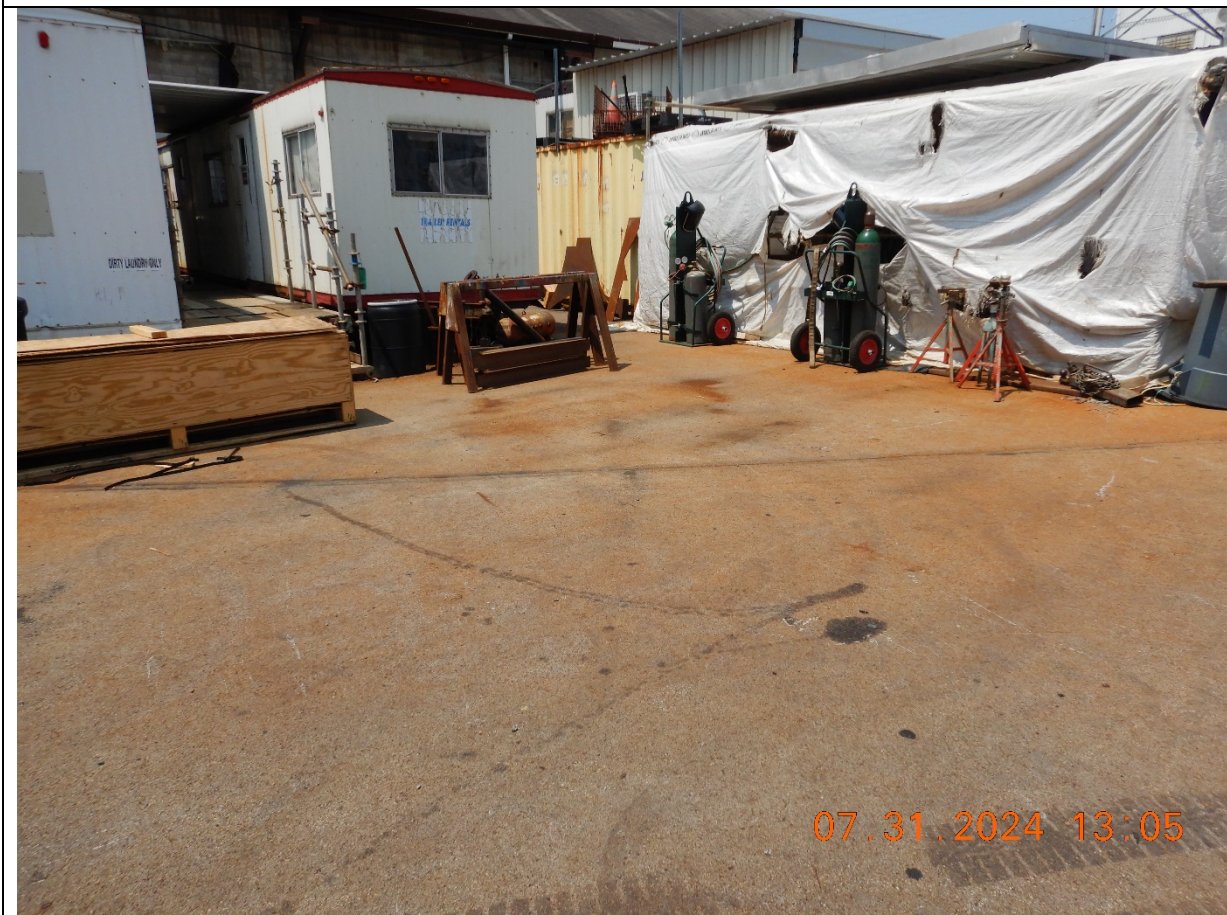
28: [DSCN2225.JPG](#)

Description: Near the southwest corner of the facility, in an area adjacent to and tributary to the Ohio River. This area is known as 'Brass Alley'. Metal fabrication activities occur in this area. The pavement in this area was discolored and stained. This activity/area was not included in the NPDES permit application, nor in the SWPPP.

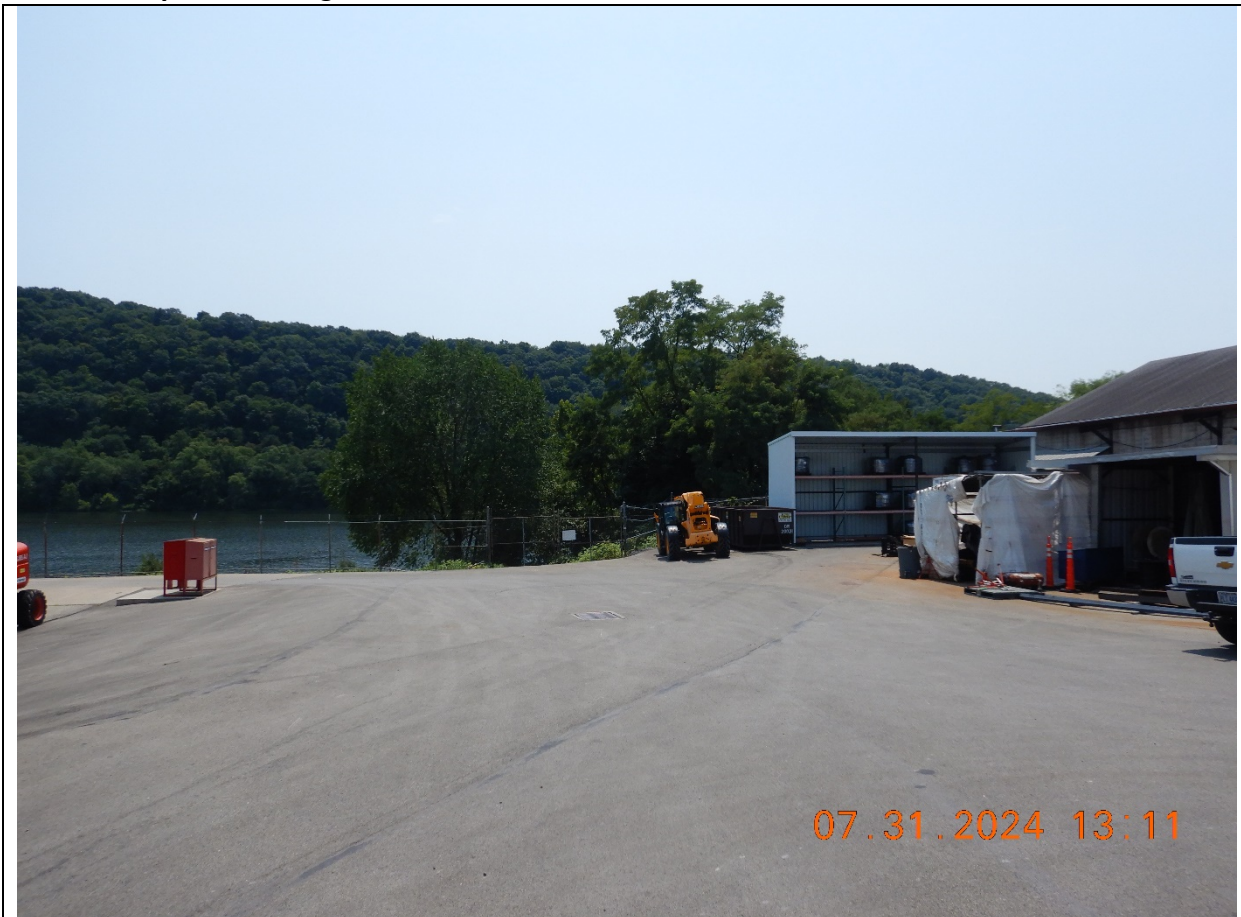
29: DSCN2226.JPG

Description: Near the southwest corner of the facility, in an area adjacent to and tributary to the Ohio River. This area is known as 'Brass Alley'. Metal fabrication activities occur in this area. The pavement in this area was discolored and stained. This activity/area was not included in the NPDES permit application, nor in the SWPPP.

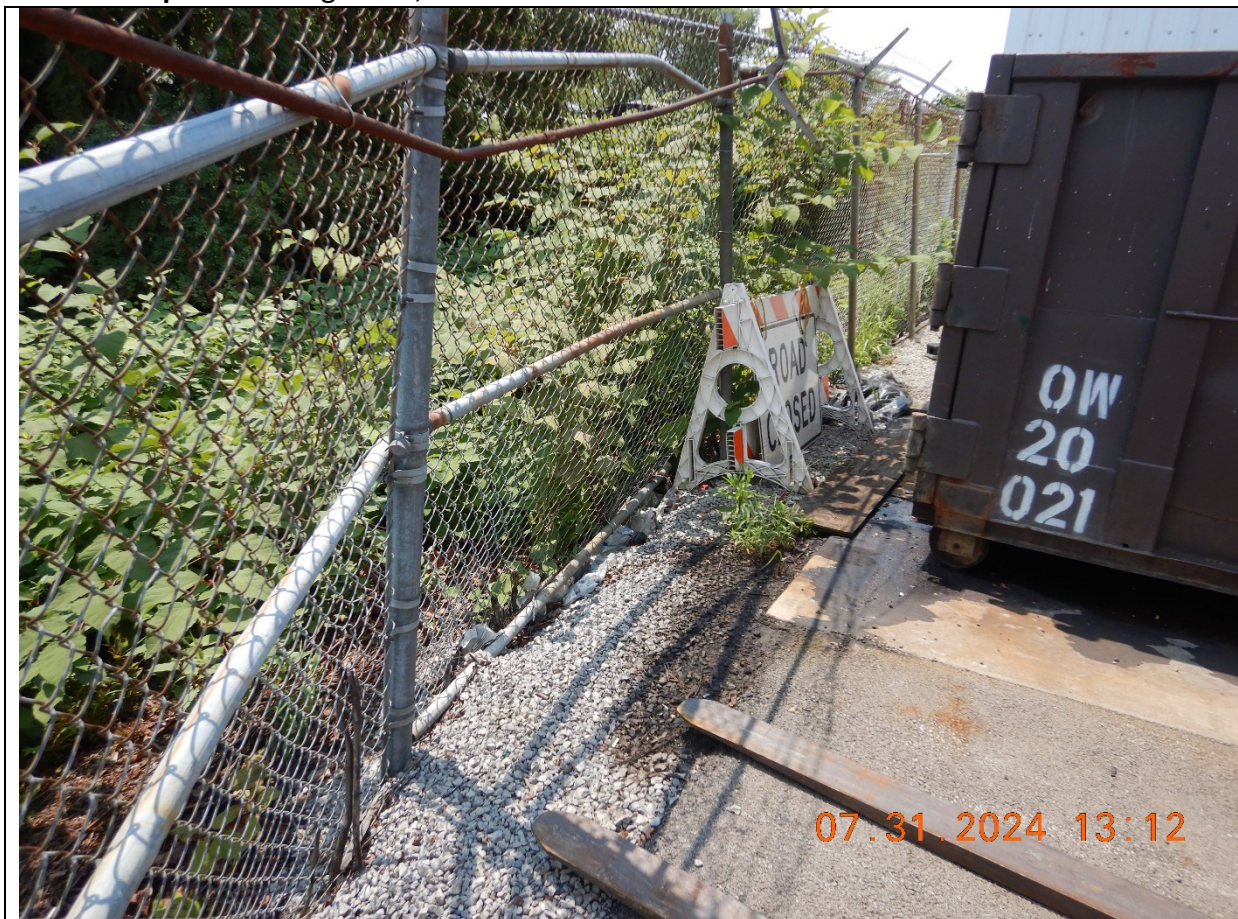
30: DSCN2227.JPG

Description: Near the southwest corner of the facility, in an area adjacent to and tributary to the Ohio River. This area is known as 'Brass Alley'. Looking behind the dumpster shown in Photos 24, 25 and 27. The Ohio River is the left of the camera. The gravel off the edge of the pavement was discolored and stained.
