**Purpose:** NPDES SSO Inspection Trip Report

**Facility:** City of Cahokia Heights, Illinois

**Dates of Inspection:** May 4, 2022 – May 6, 2022

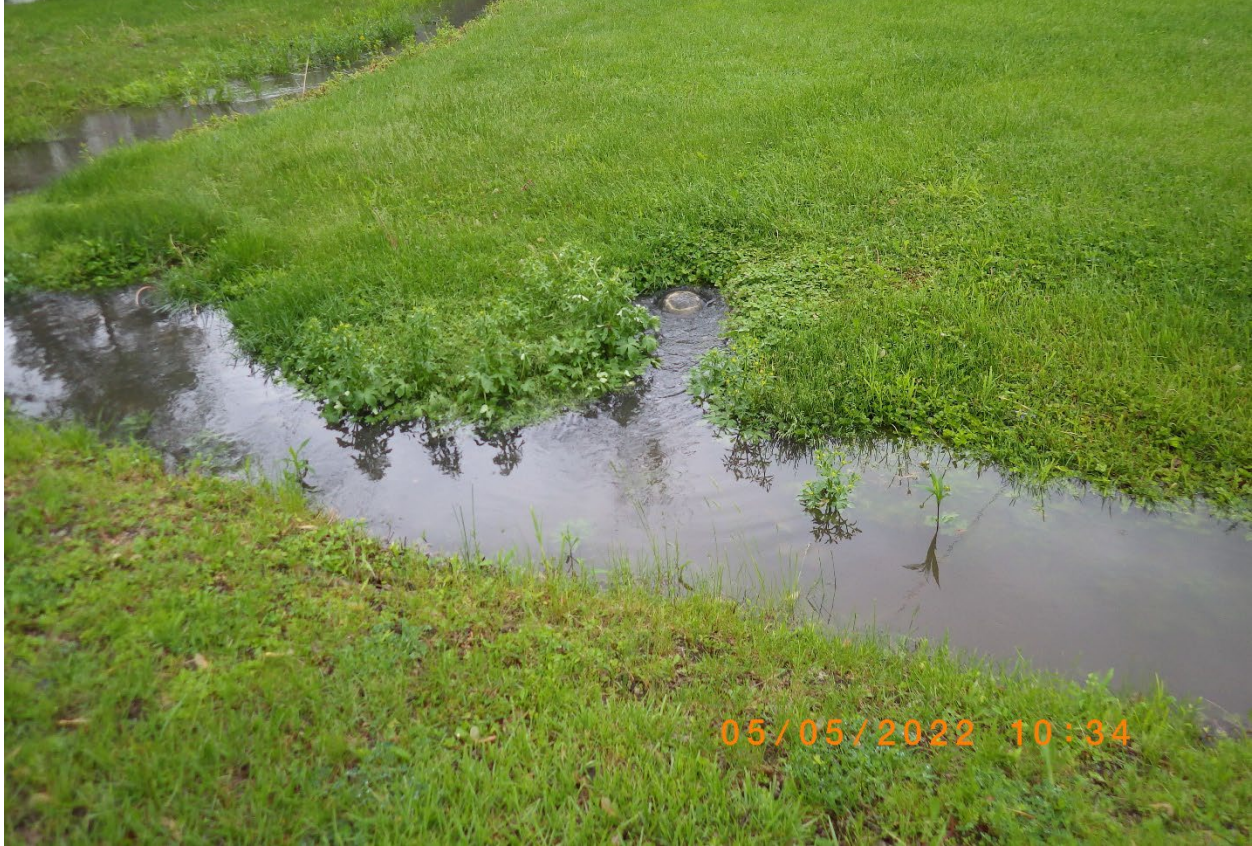
1: BELL0001 (edited to remove Personally Identifiable Information (PII))

Description: SSO from the cleanout on North 82<sup>nd</sup> Street.

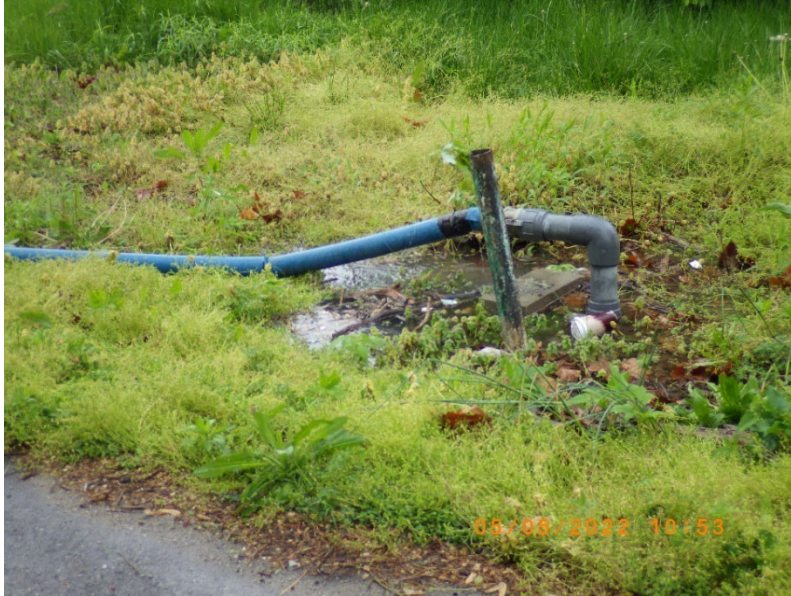
2: BELL0002

Description: The non-functioning lift station at Lake Street and 71<sup>st</sup> Street was being bypassed by the City of Cahokia Heights personnel. The hose used to bypass the lift station leaked sewage. One of the leaks of sewage went into the ditch by the side of the 71<sup>st</sup> Street.

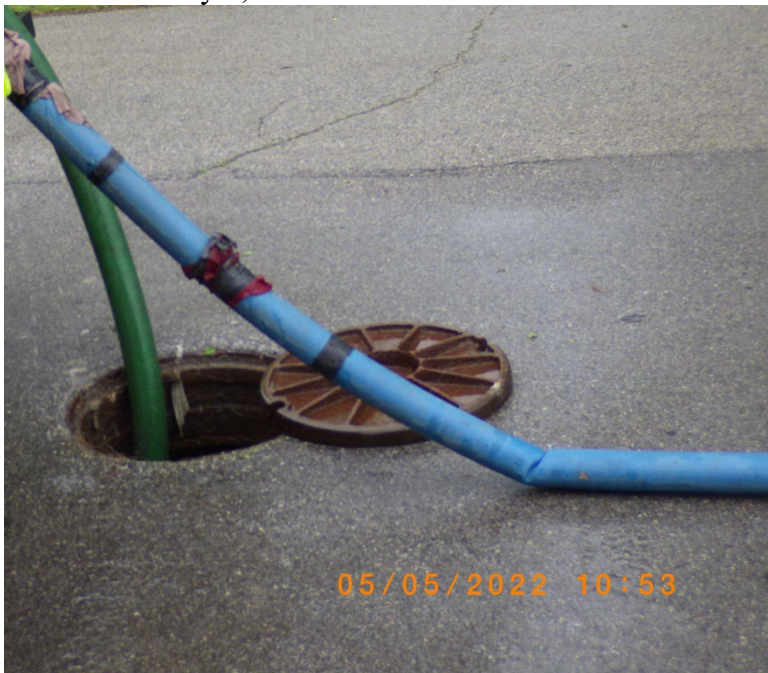
3: BELL0003 (edited to remove PII)

Description: Two other hose leaks from the bypass hose dripped back into the wet well.

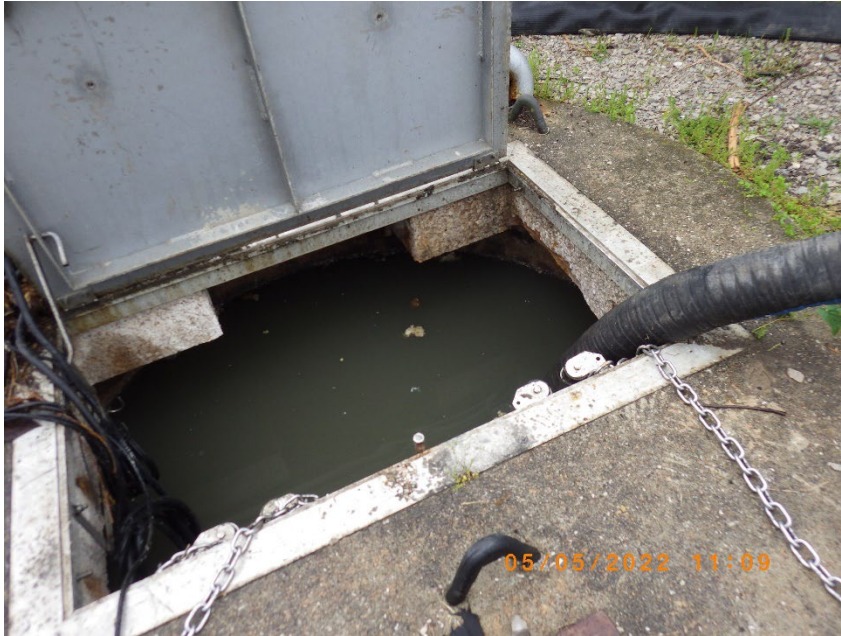
4: BELL0004

Description: The wet well at the Golden and Dorsey lift station was almost full.

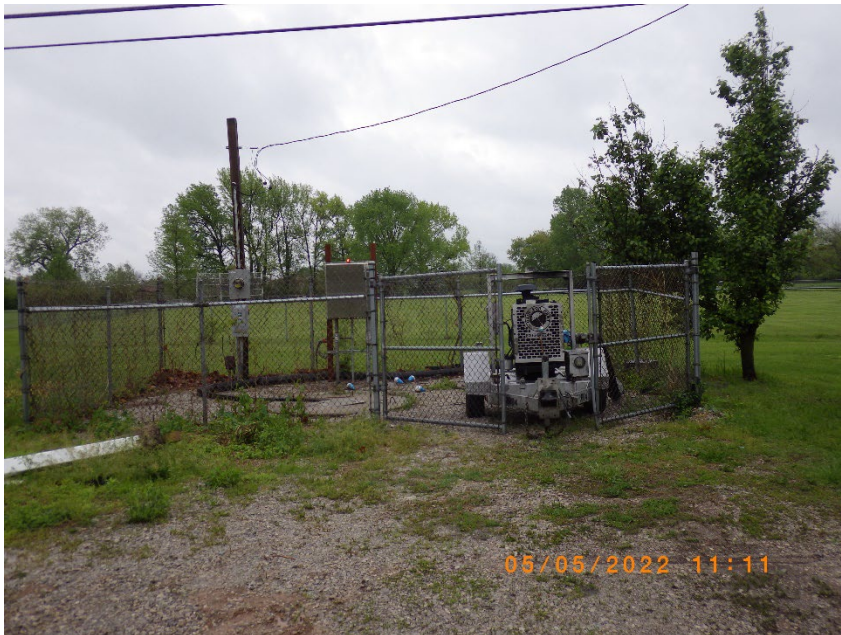
5: BELL0005

Description: A tow behind pump was parked at the Golden and Dorsey lift station. City personnel manually turn it on to dewater the wet well.

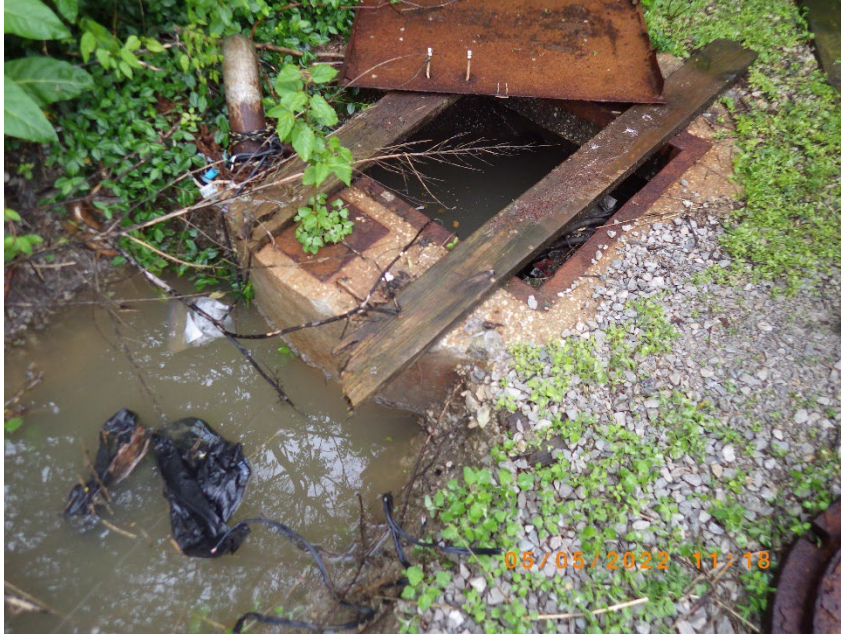
6: BELL0006

Description: The wet well at the Pocket Road lift station was approximately 90% full.

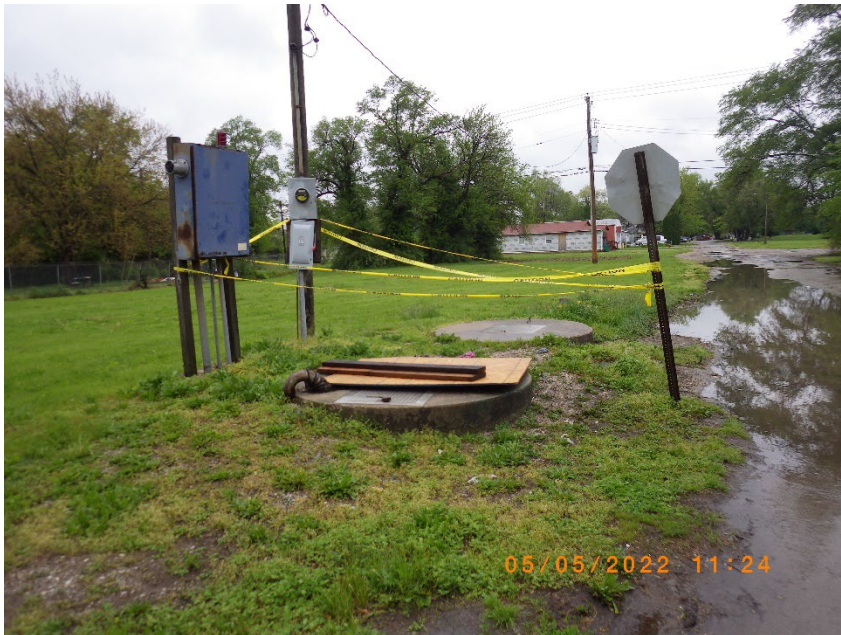
7: BELL0007

Description: Jackson Street lift station is non-functioning and needs to be manually dewatered by City personnel.

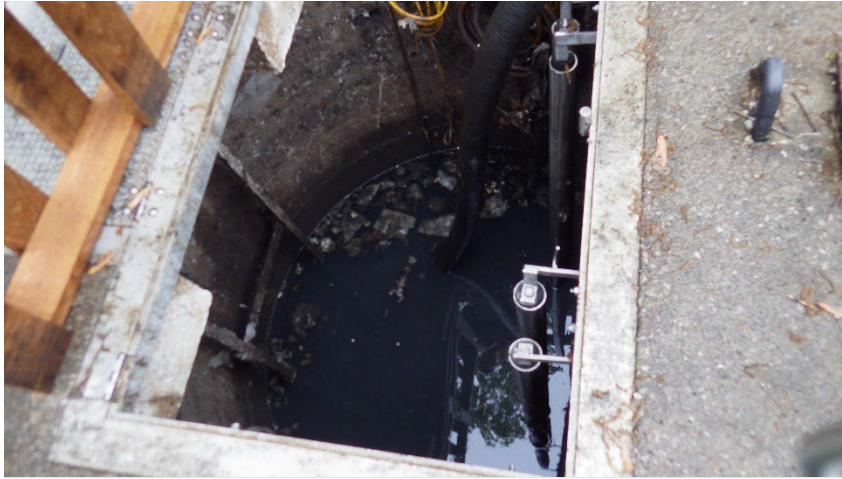
8: BELL0008

Description: The Pfeiffer Street wet well level was low on the day of the inspection.

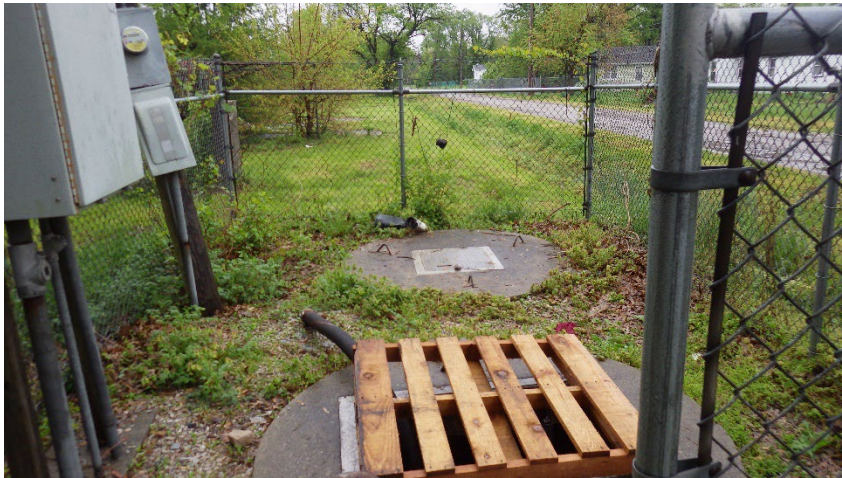
9: BELL0009

Description: An overview of the Pfeiffer Street Lift Station.

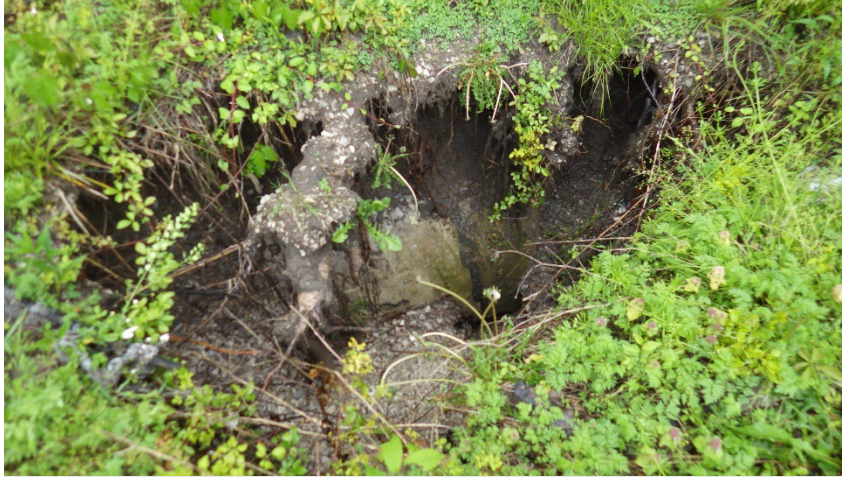
10: BELL0010

Description: Open erosional hole by a storm water pipe near the Diversion Station. There is a crack in the pipe that was first observed by EPA in April, 2022.
