**UNITED STATES ENVIRONMENTAL PROTECTION AGENCY  
REGION 8  
RESOURCE CONSERVATION AND RECOVERY ACT**

**Facility Name:** American Gilsonite Company

**Date of Inspection:** October 25, 2022

Compliance Evaluation Inspection

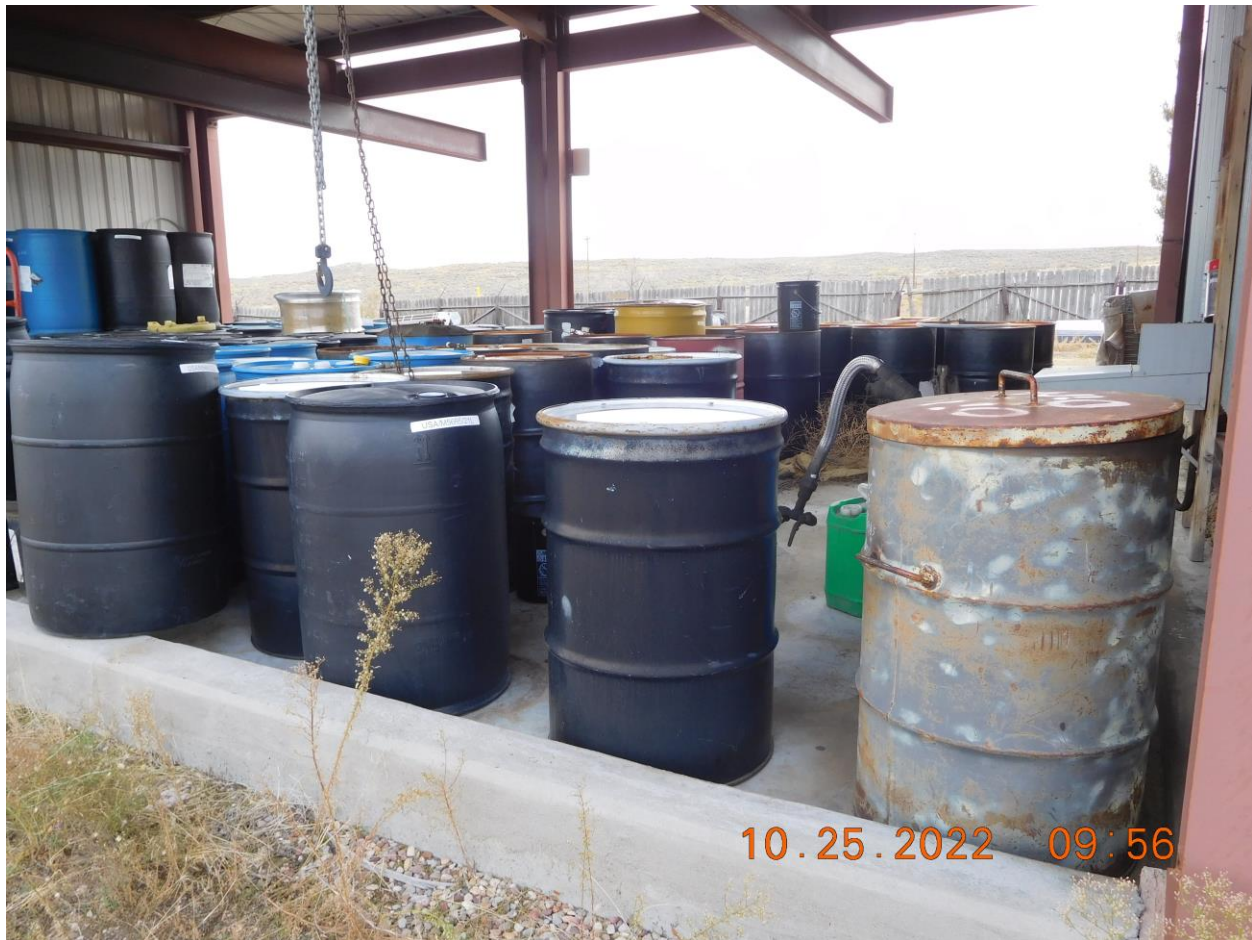
In the northern portion of the oil dock I observed several dozen 55-gallon drums in storage, including 14 drums of used oil and soil, 8 drums of antifreeze, one drum of used oil in an overpack container, one

drum of used oil from lab 470 (contained new material that could not be used so was in storage for disposal), 4 drums of surfactant awaiting reuse, one drum of waste diesel fuel with water, as well as two five-gallon containers of used glycerin and one five-gallon container of used saw oil with water. In addition, several empty 55-gallon drums were stored in the area, including empty sulfuric acid drums. See photos 1-3.

Photo 1, DSCN1620.jpg, photo of the north portion of the oil dock, facing east/northeast.

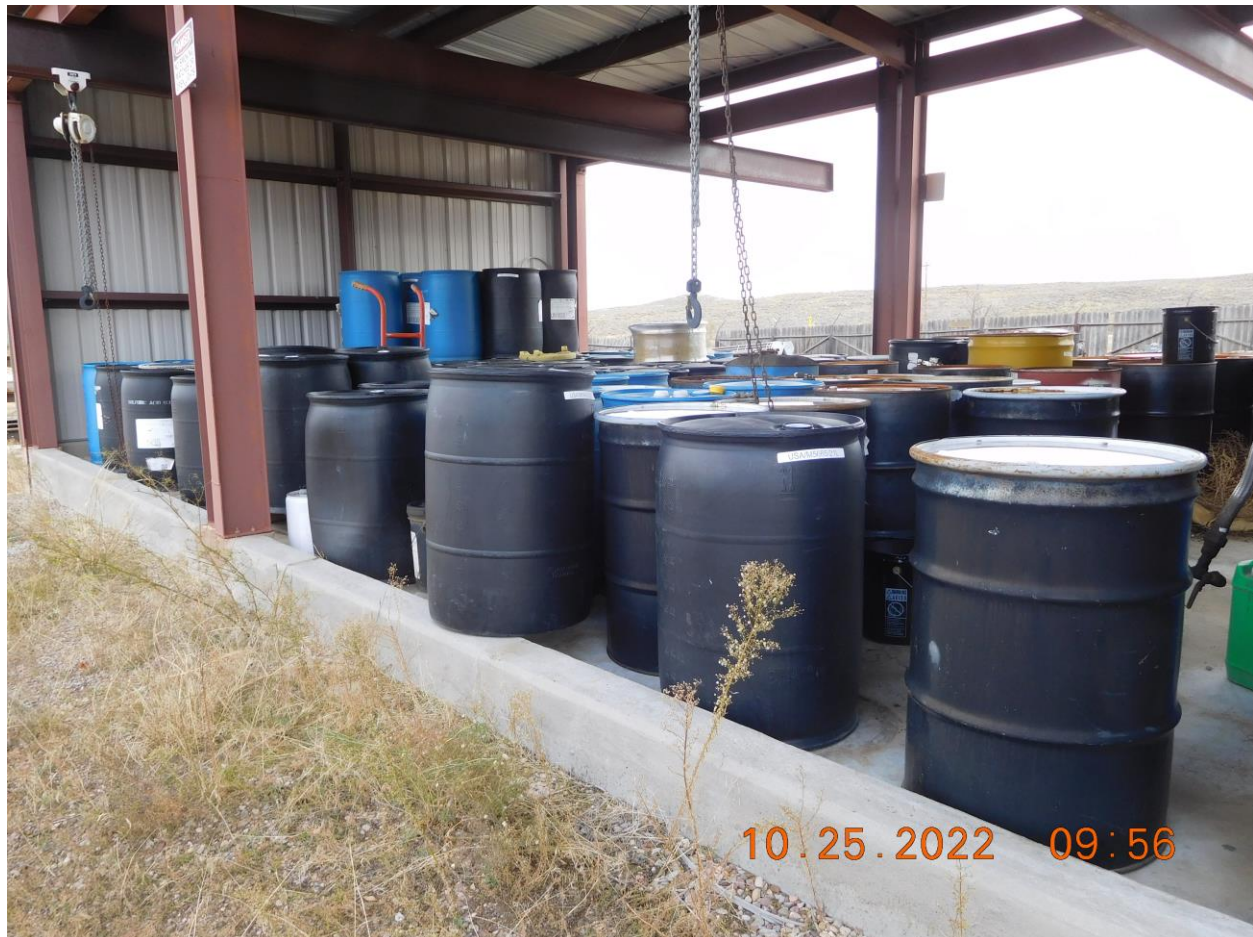
Photo 2, DSCN1621.jpg, photo of the same area shown in photo 1, panned left.

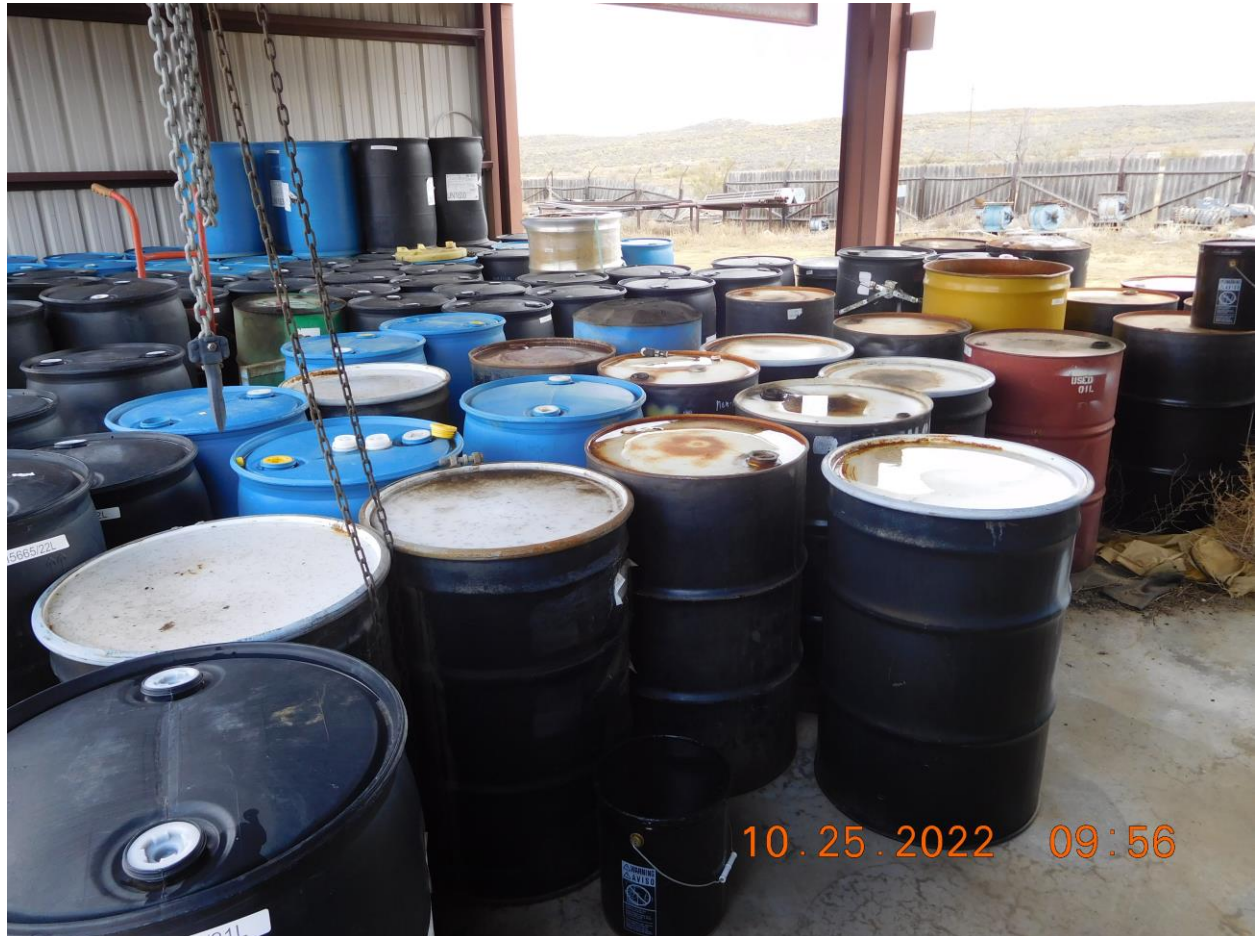
Photo 3, DSCN1622.jpg, photo of the north portion of the oil dock, taken from the interior south side.

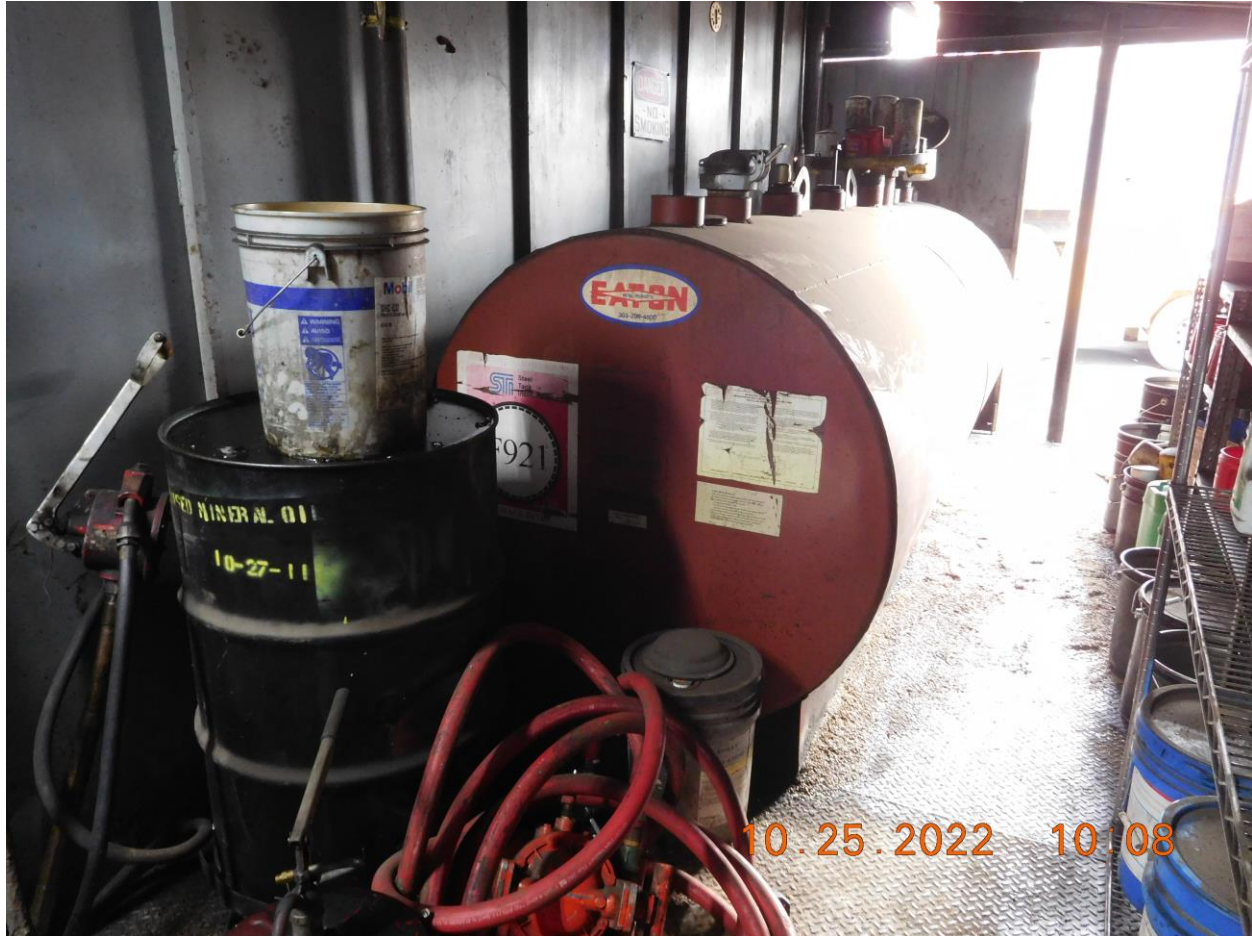
In the maintenance shop area, I observed a used oil tank (photo 4), one 55-gallon drum marked on one side "Used Mineral Oil" and on the other side marked "Used Antifreeze" (see photos 4 and 5), one open, unlabeled bucket containing a sludgy, oily looking waste that appeared to be floating on water in the bucket, a blue used oil bin in the shop that was not marked with the words "Used Oil", a closed oily rags can, a 55-gallon aerosol can puncture drum that was initially open but was closed as I observed (photos 6-8), and a parts washer (photos 9 and 10). Prior to leaving the maintenance shop area, I observed that the incorrect marking on the 55-gallon drum that had two separate markings had been painted over so that only "Used Antifreeze" was left marked on the container (photo 11).

Photo 4, DSCN1623.jpg, photo of the used oil tank and a drum marked “Used Mineral Oil” located in the Maintenance Shop area. See also photo 5.

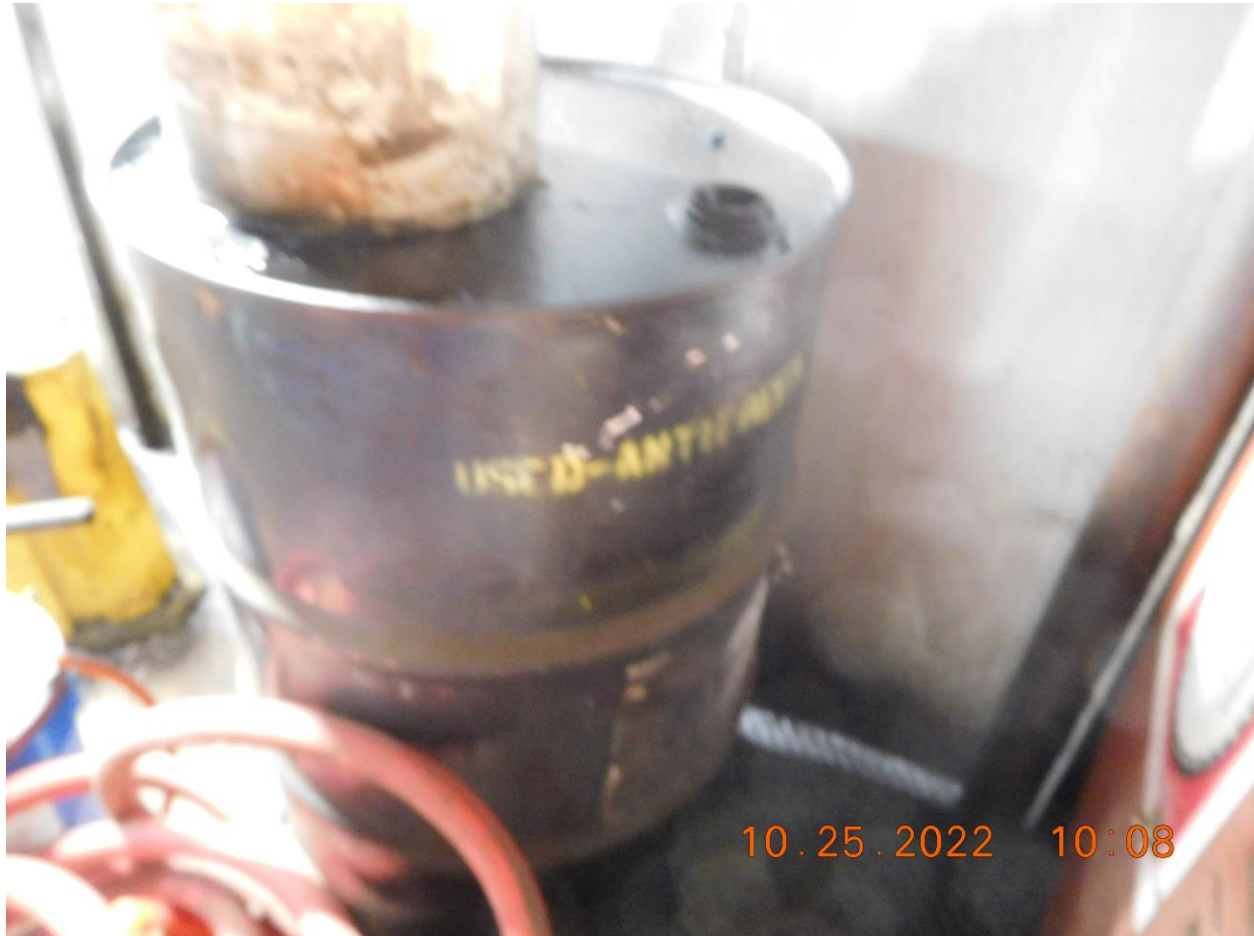
Photo 5, DSCN1624.jpg, photo of the other side of the drum shown in photo 4, marked on this side of the drum with “Used-Antifreeze”.

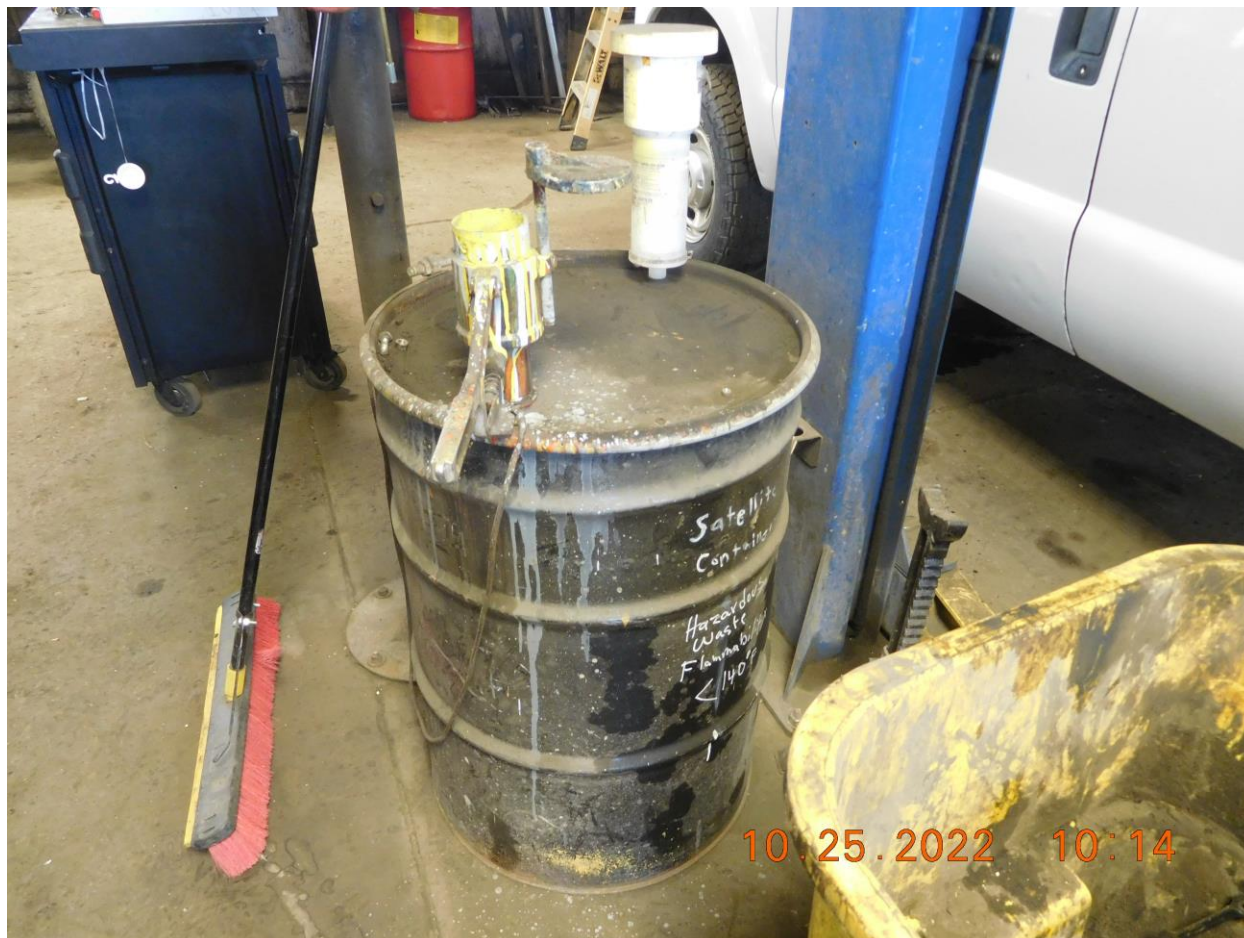
Photo 6, DSCN1625.jpg, photo of an aerosol can puncture drum located in the maintenance shop.

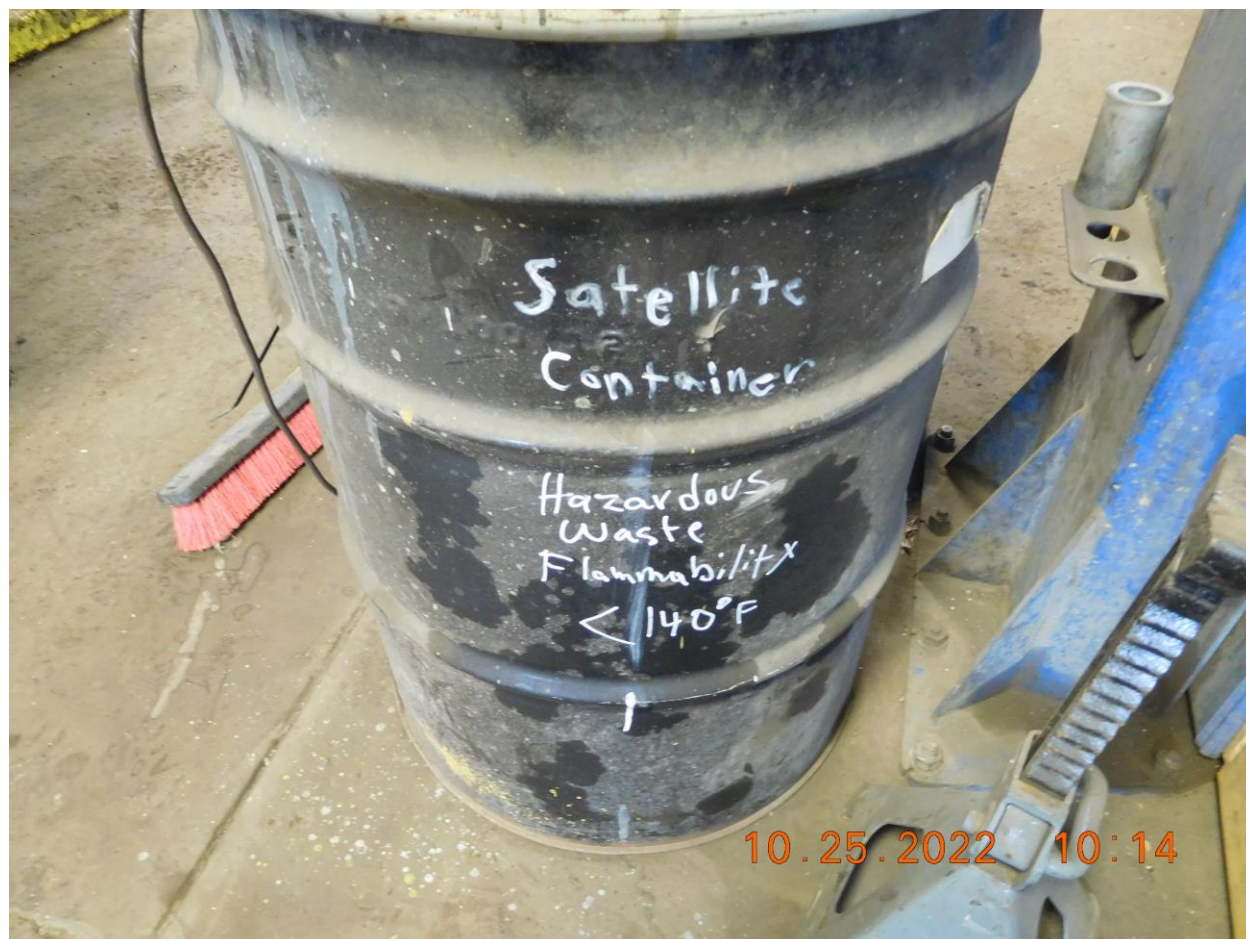
Photo 7, DSCN1626.jpg, photo of the markings on the drum shown in photo 6.

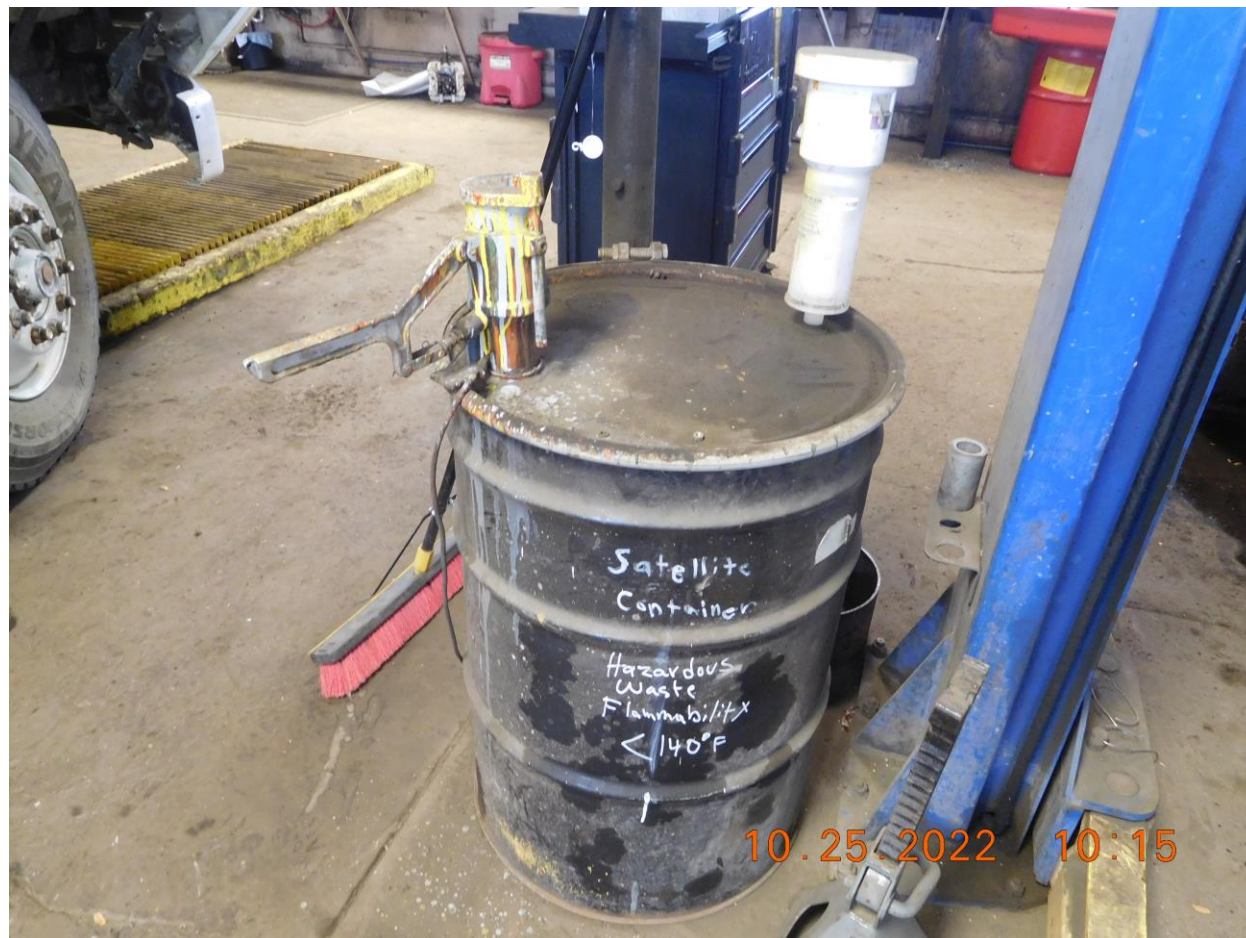
Photo 8, DSCN1627.jpg, photo of the same drum shown in photos 6 and 7 after facility personnel closed the puncturing mechanism lid.

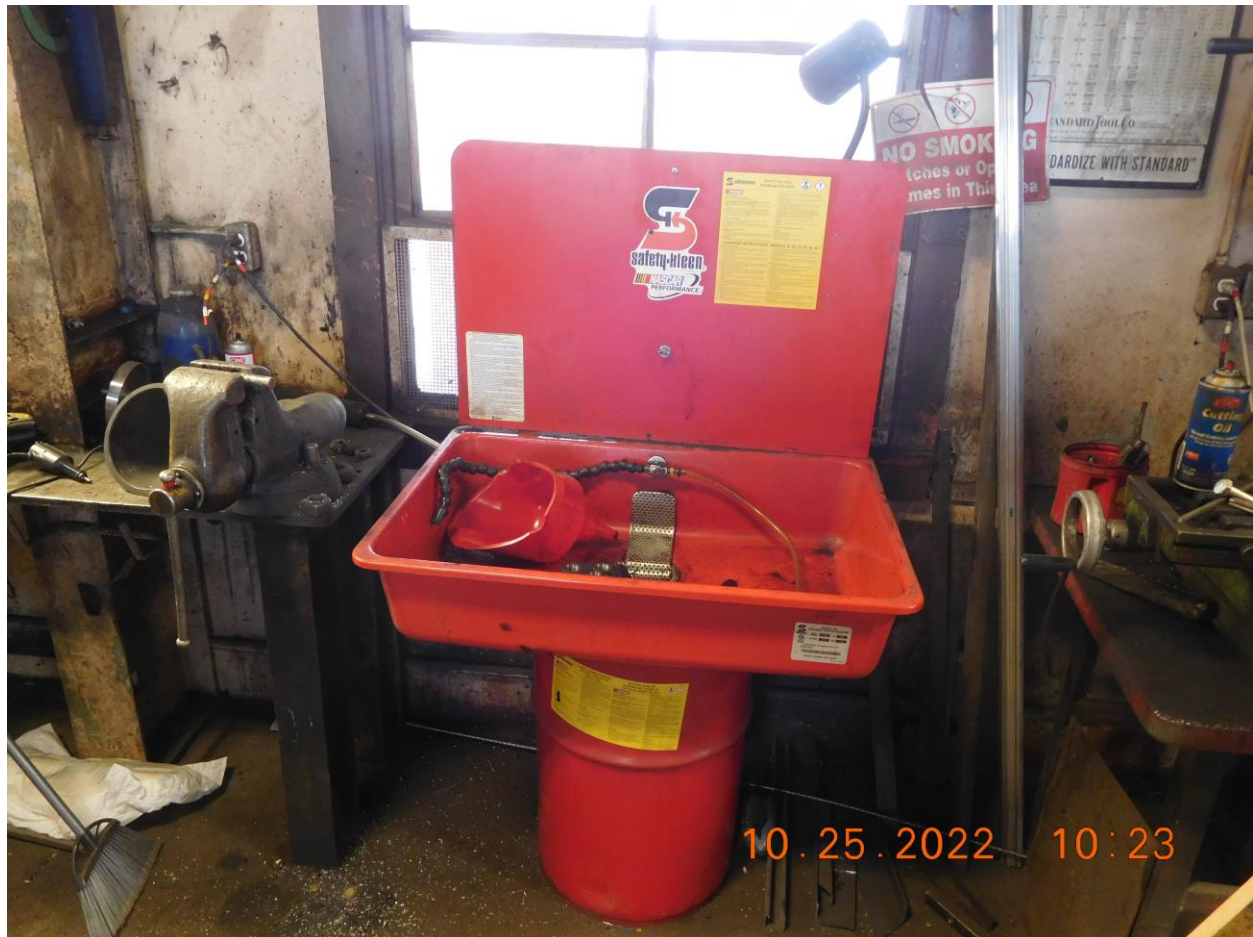
Photo 9, DSCN1628.jpg, photo of a parts washer located in the maintenance shop.

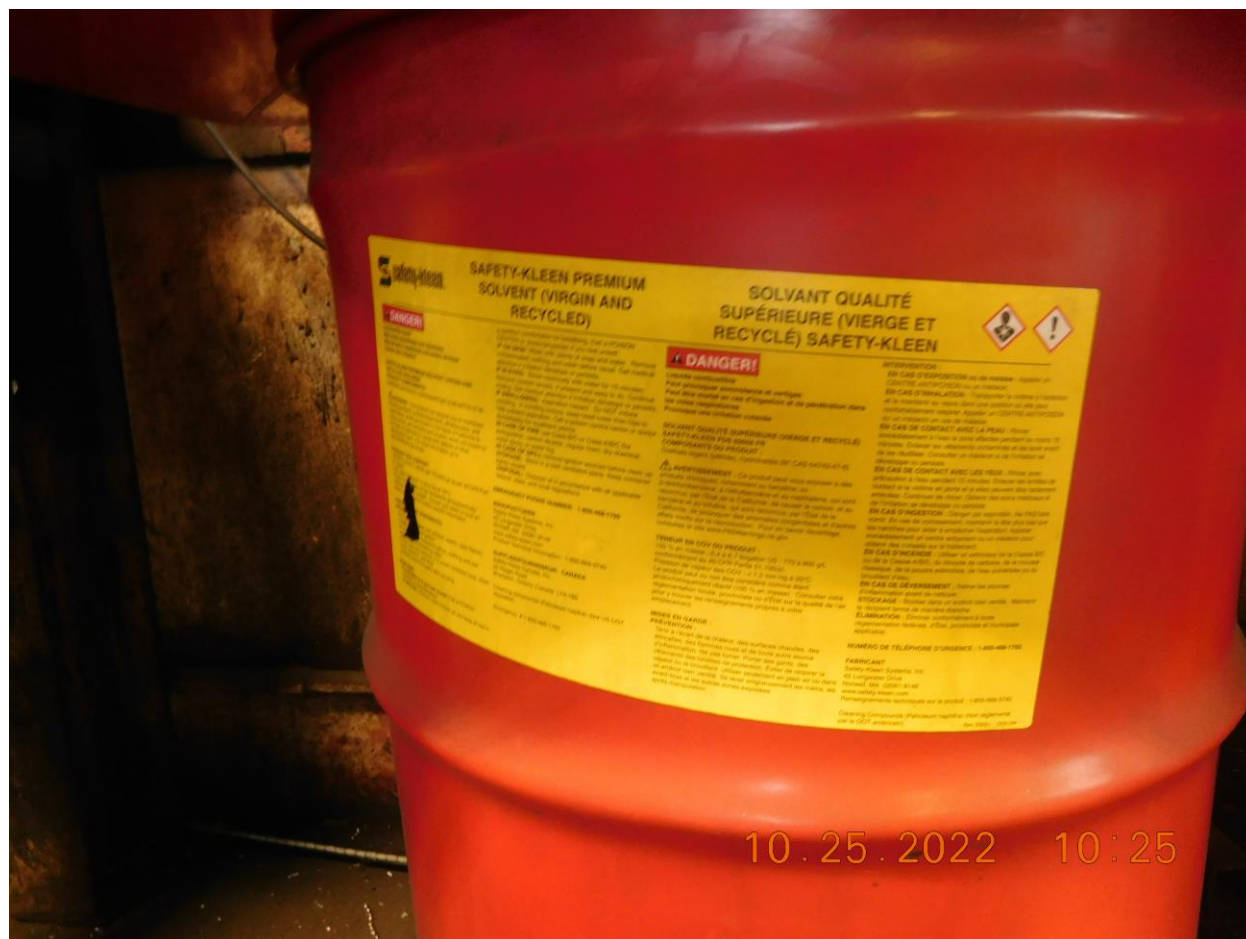
Photo 10, DSCN1629.jpg, photo of the label on the parts washer shown in photo 9.

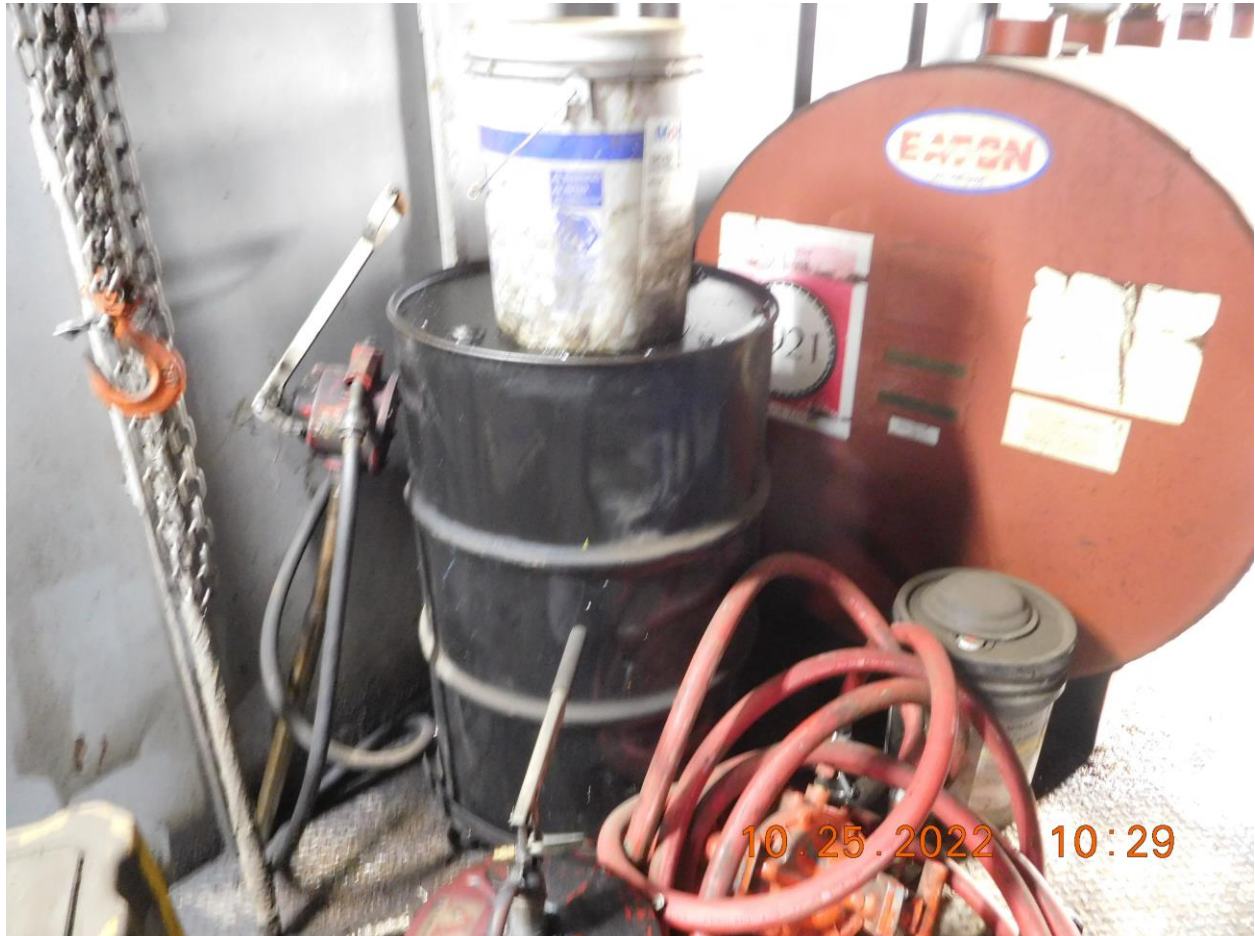
Photo 11, DSCN1630.jpg, photo of the drum shown in photos 4 and 5 after the incorrect marking had been removed from the drum.
