**U.S. ENVIRONMENTAL PROTECTION AGENCY  
REGION III WATER BRANCH, ENFORCEMENT  
AND COMPLIANCE ASSURANCE DIVISION  
CLEAN WATER ACT  
COMPLIANCE INSPECTION REPORT**

**Name of Facility:** East Manchester Township MS4  
**Facility Address:** 5080 North Sherman Street Ext, Mt. Wolf, PA 17347  
**Mailing Address:** 5080 North Sherman Street Ext, Mt. Wolf, PA 17347

| <b>Type of Inspection:</b> | MS4 Compliance Inspection |

**Unique Project Identifier (UPI):** 3E21WN021A

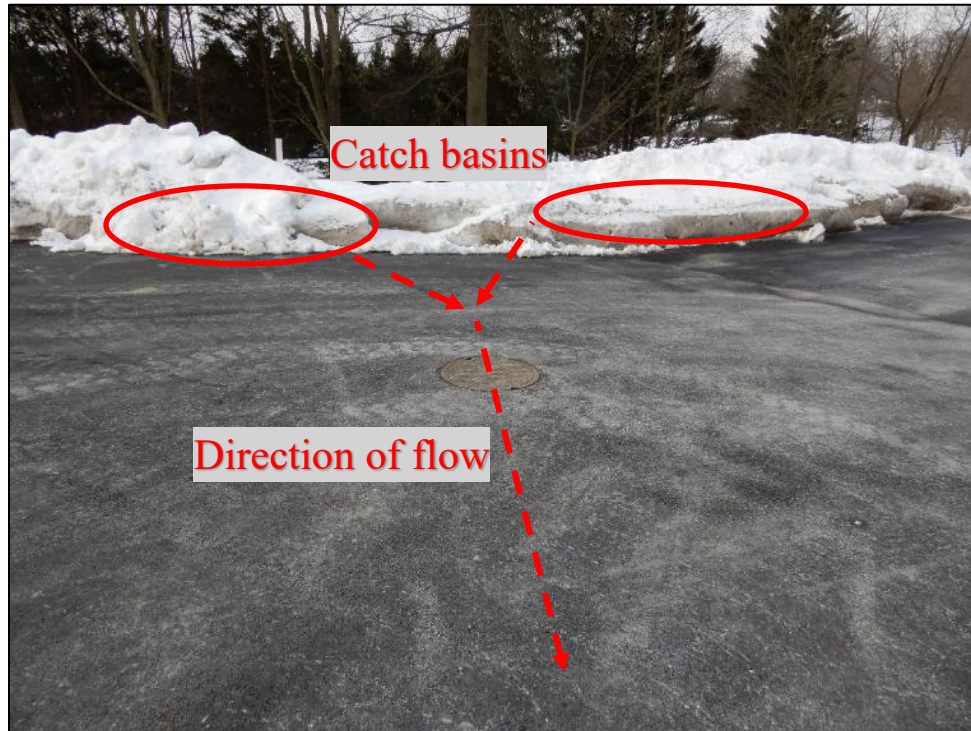
- 1) Visual observations were somewhat limited due to snowfall in excess of 3 inches covering the ground.
- 2) Township staff stated the catch basins located in the vicinity of the salt and stone storage structure and northern parking lot were routed to the new stormwater basin (refer to Photographs 1 through 4).

**Photograph 1.** View, facing west, of catch basins (covered in snow) located south of the new sand and stone storage structure.

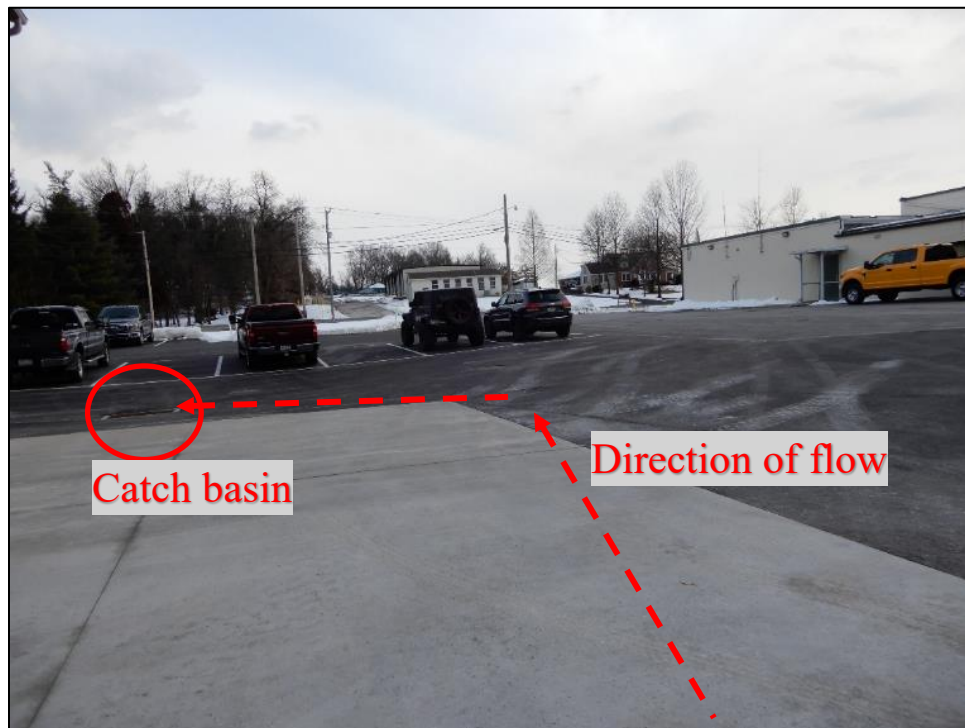
**Photograph 2.** View, facing east, of the new parking lot area north of the existing Maintenance Building.

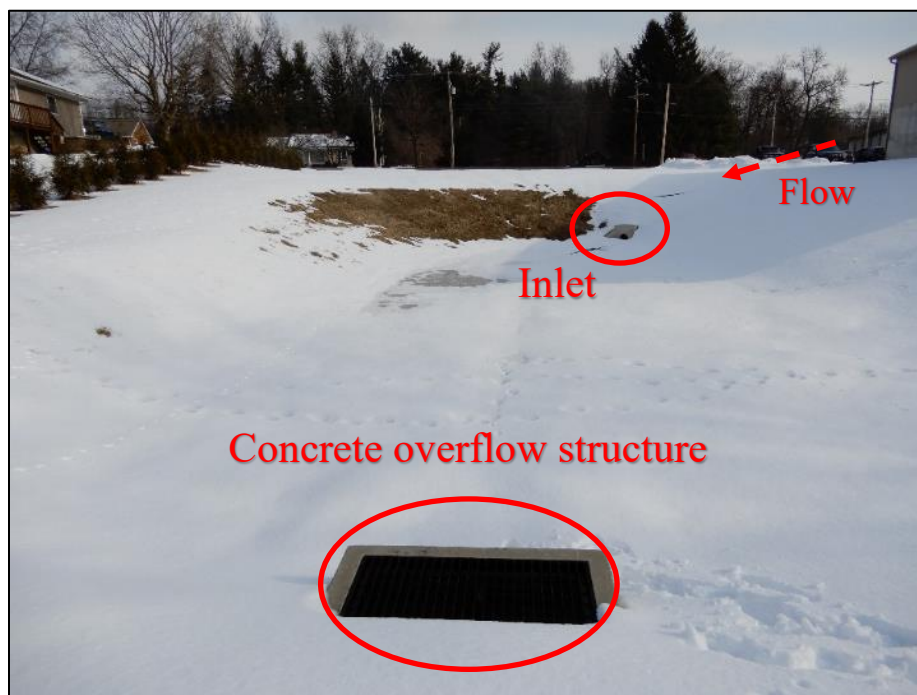
**Photograph 3.** View, facing east, of the new stormwater pond in the north portion of the property.

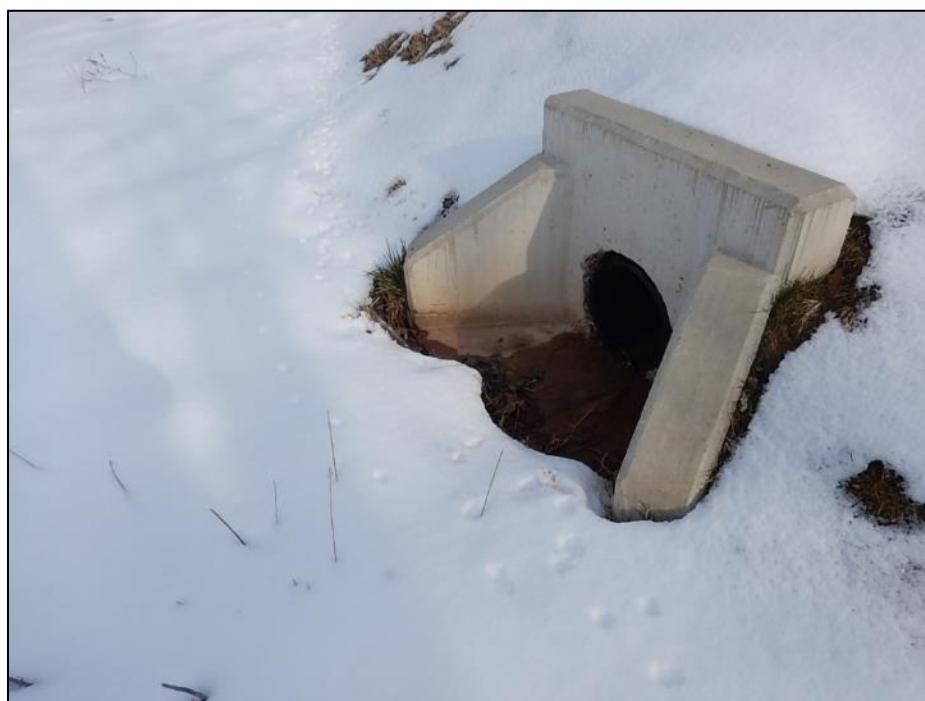
- 3) Township staff stated that during construction of the parking lot, the stormwater pond was used as a sediment trap. According to Township staff, the project has not been officially closed, and an underdrain still needs to be installed in the pond. This is shown on the new construction drainage plans (refer to Appendix B, Exhibit 1). Some sediment was observed at the outfall of the new stormwater pond during the inspection (refer to Photograph 4).

**Photograph 4.** View of the outlet for the new stormwater pond. Note that sediment was observed at the outlet.

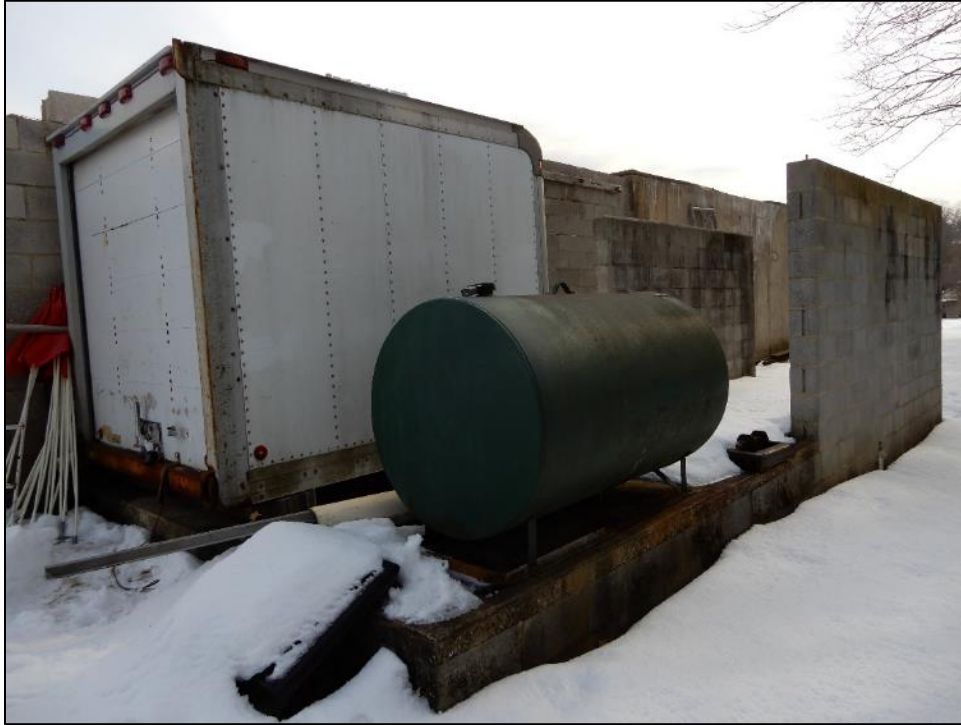
- 4) The EPA Inspection Team observed a used oil tank without secondary containment on the west side of the Maintenance Building (refer to Photograph 5). Township staff stated that the tank is single-walled and that the oil is disposed of very infrequently, every 2-3 years.

**Photograph 5.** View, facing southeast, of the used oil storage tank located on the western side of the property. The tank had a volume of approximately 150 gallons; it was not double-walled or located within secondary containment.

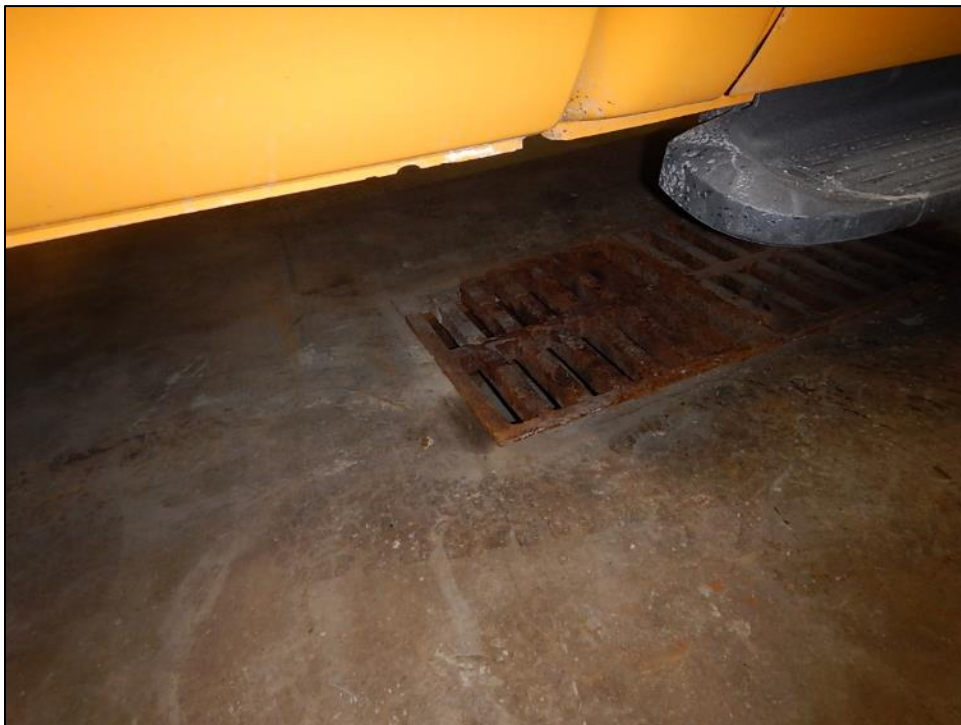
- 5) The EPA Inspection Team observed drains on the floor of the garage that collect water that drips off of vehicles (refer to Photographs 6 and 7). Township staff stated that the drains have been plugged for at least five years. Staff also stated that the drains are cleaned regularly and most water collected just evaporates. The garage is primarily used for indoor vehicle maintenance activities and provides storage for 12 trucks. The EPA Inspection Team observed spill kits inside the garage (refer to Photograph 8).

**Photograph 6.** View of a drain inside the maintenance garage. Township staff stated the drains were plugged.

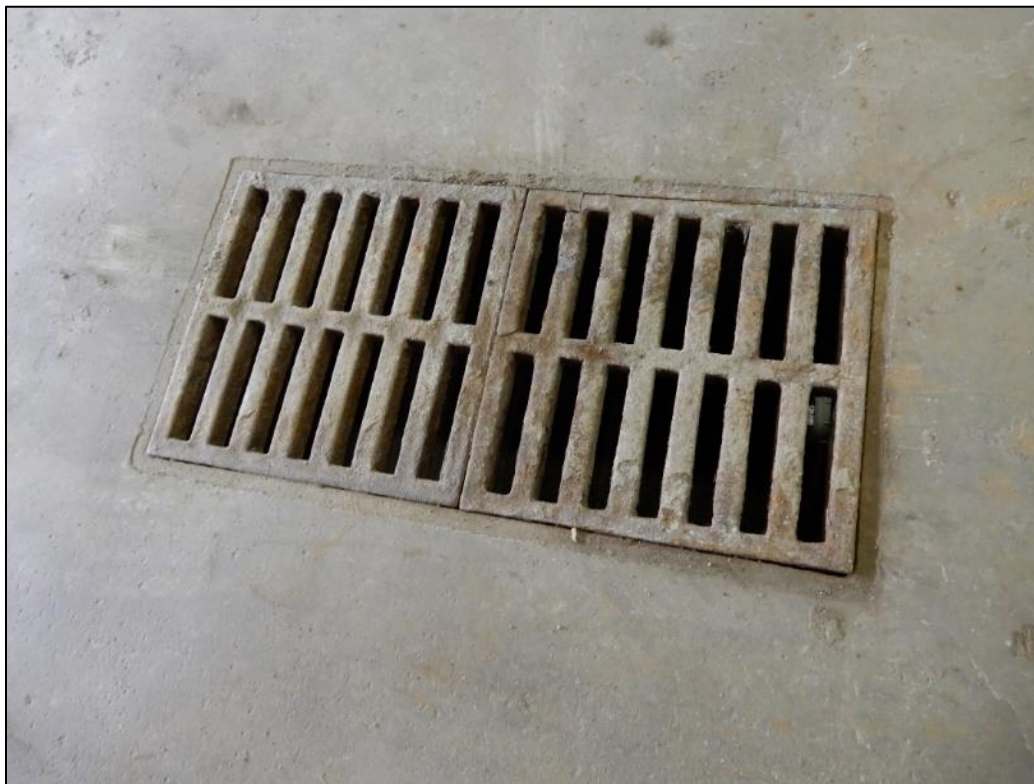
**Photograph 7.** View of another drain in the garage. Township staff stated the drains were plugged.

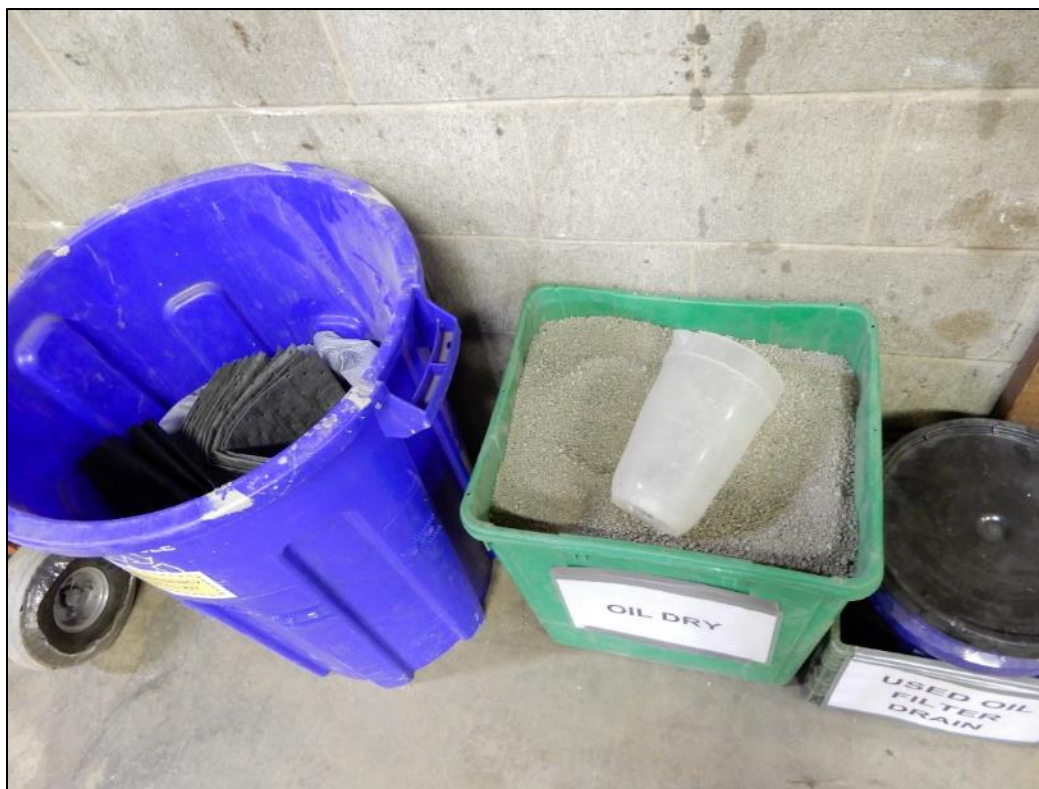
**Photograph 8.** View of a spill kit and cleanup material located in the garage.

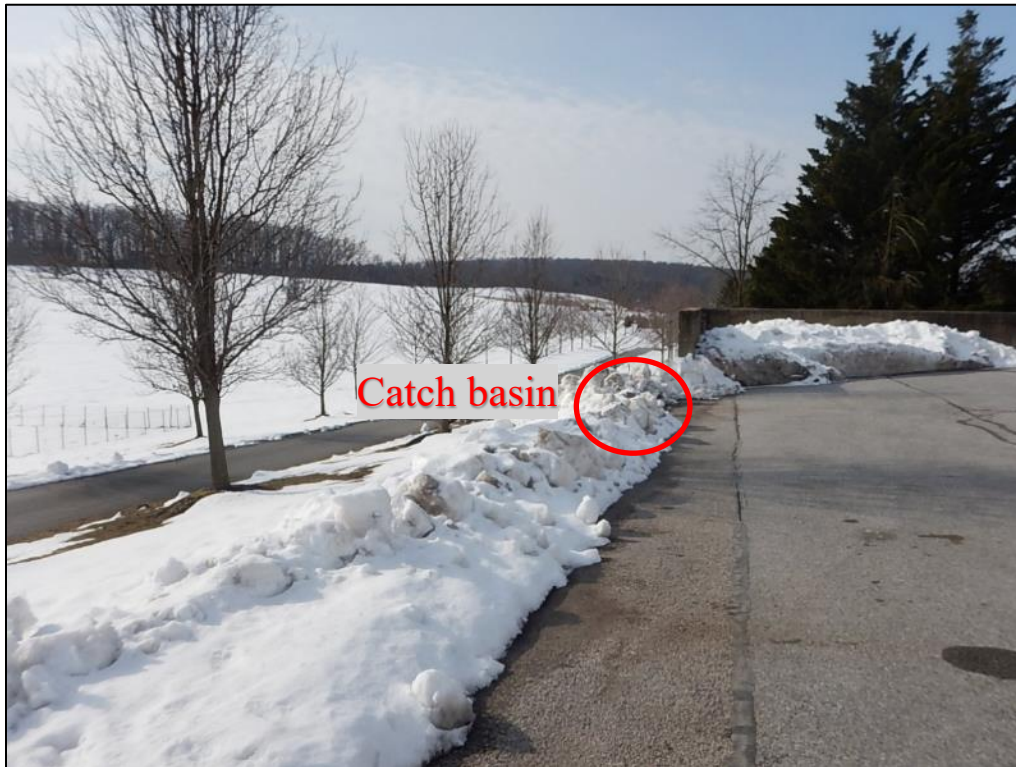
- 6) The EPA Inspection Team observed the location of catch basins outside of the garage on the southern border of the property. At the time of the inspection, the inlets were covered in snow and were not able to be viewed (refer to Photograph 9). Township staff stated that the catch basins direct stormwater to an infiltration structure located under the pavement on the southern side of the property.

**Photograph 9.** View, facing southwest, of a catch basin covered in snow on the southern border of the property. The runoff from the impervious pavement in front of the garage on the southern portion of the property drains to the basin, then to an infiltration bed on the south side of the parking lot.

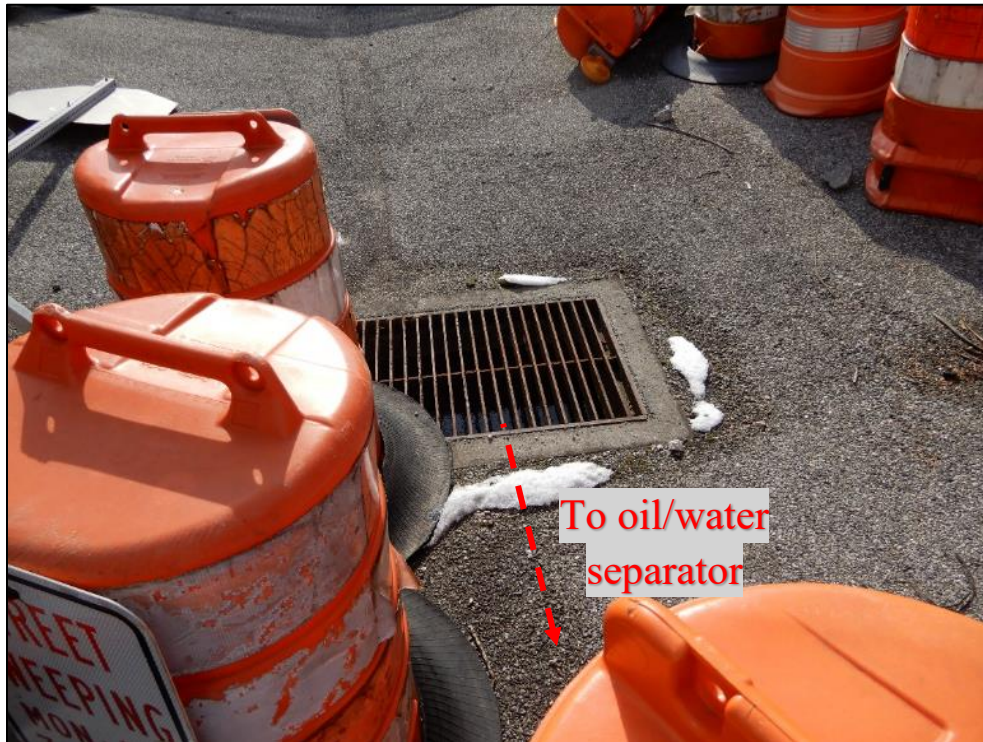
- 1) Visual observations were somewhat limited due to snowfall in excess of 3 inches covering the ground.
- 2) Township staff stated that wash water from the vehicle wash is captured in a trench drain inside the building and routed into a catch basin located between the wash building and the generator building (refer to Photograph 10). Water collected in the catch basin flows into an oil/water separator. Township staff stated that the oil/water separator discharges into an infiltration bed in the yard on the southern side of the property (refer to Photograph 11). The ground in this area was not visible at the time of the inspection due to snow. The infiltration bed location is shown on the site drainage plan in Appendix B, Exhibit 2.

**Photograph 10.** View, facing south, of the catch basin that collects vehicle wash water and routes it to the oil/water separator.

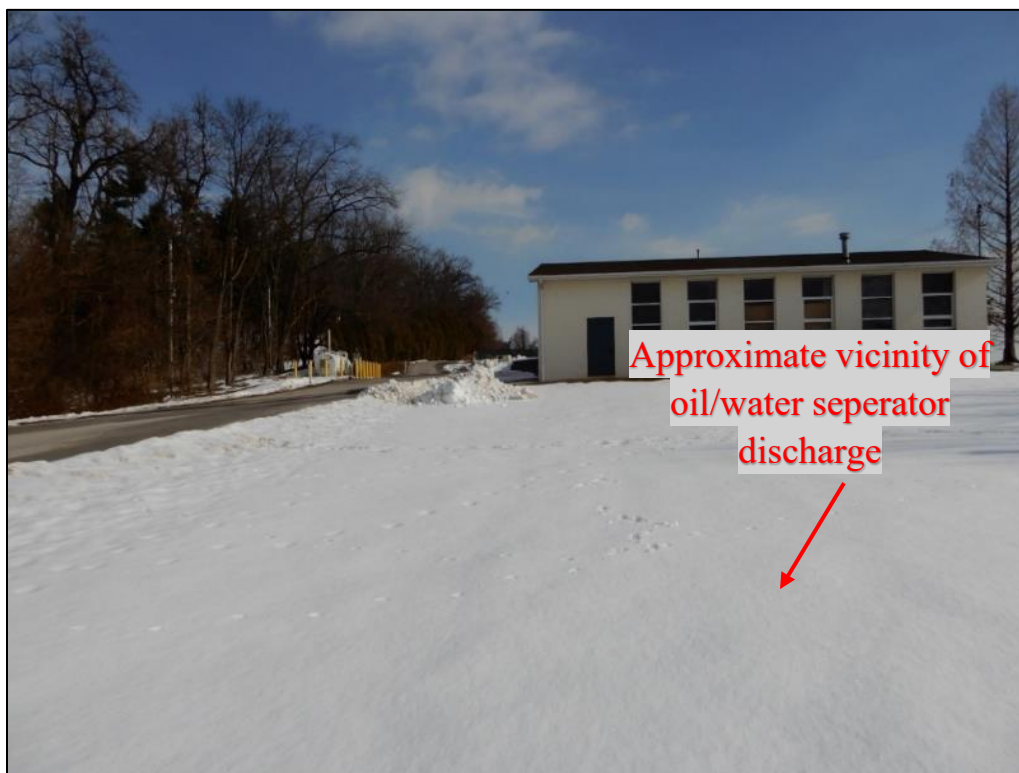
**Photograph 11.** View, facing northeast, of the vicinity of the infiltration bed where the oil/water separator discharges.

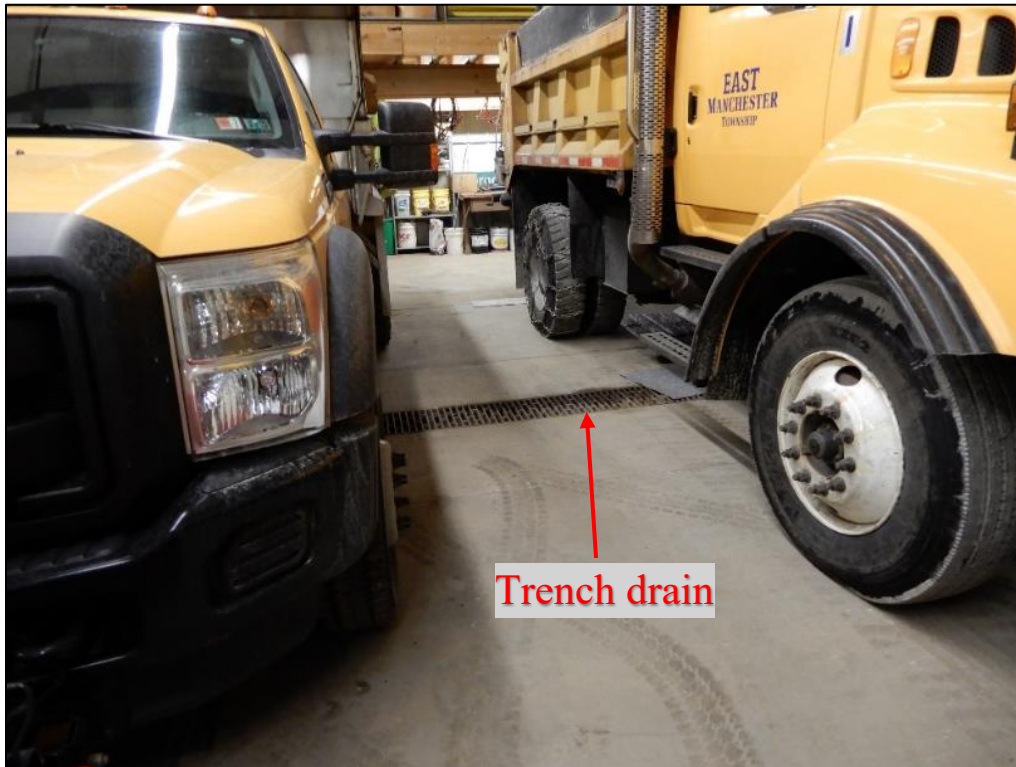
- 3) Township staff stated that vehicles are only washed inside the garage. No other maintenance is performed in the vehicle wash garage. Wash water is collected in a trench drain in the garage and directed to the oil/water separator (refer to Photographs 12 and 13).

**Photograph 12.** View inside the garage of the trench drain that stretches the length of the garage. The drain leads to an oil/water separator that drains to an infiltration bed in the yard.

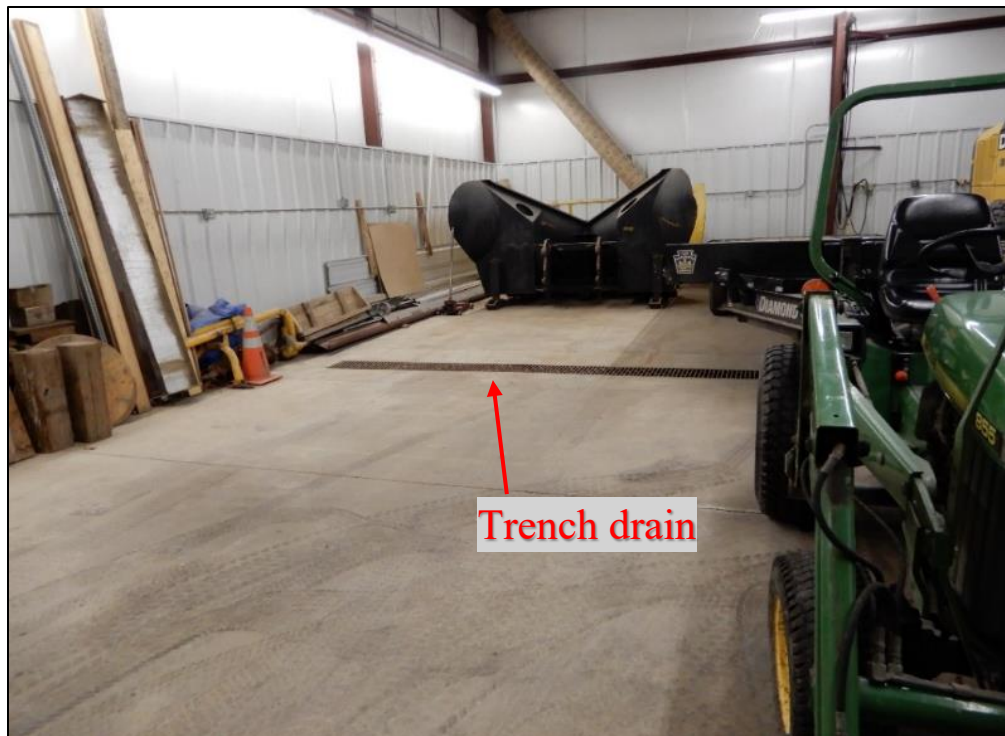
**Photograph 13.** Additional view of the trench drain that stretches the length of the garage.

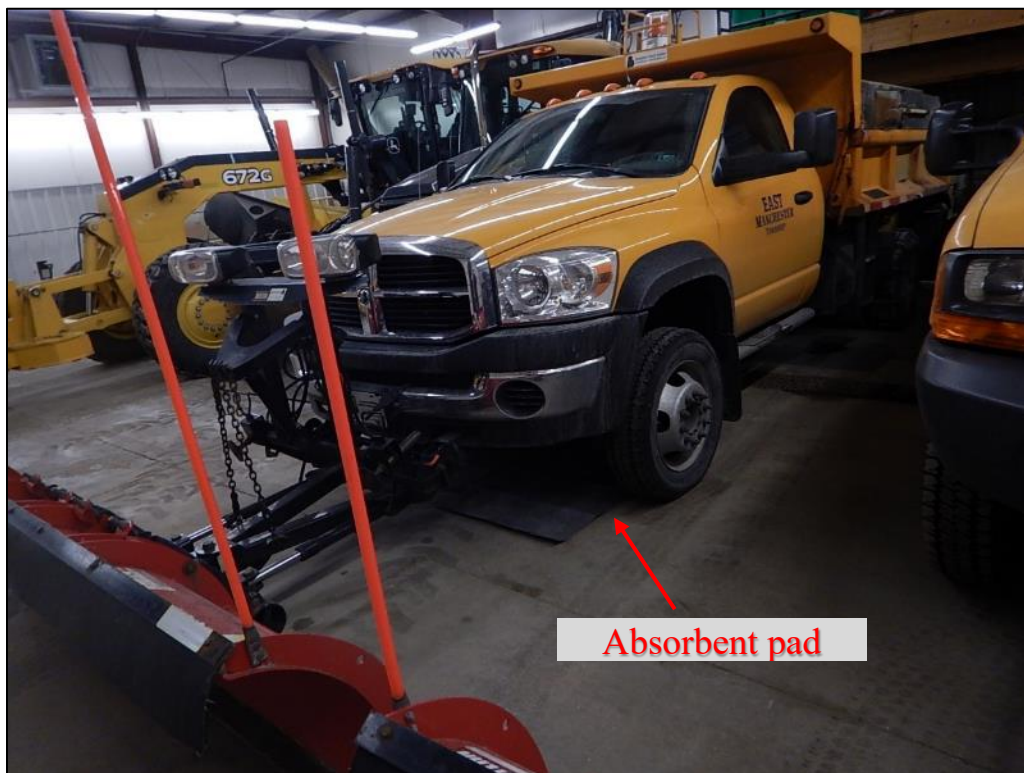
- 4) The EPA Inspection Team observed absorbent pads placed under vehicles stored in the in the wash bay (refer to Photograph 14).
- 5) The EPA Inspection Team observed a spill kit available in the garage (refer to Photograph 15).

**Photograph 14.** View of the absorbent pads under the hydraulic line on a stored vehicle in the garage.

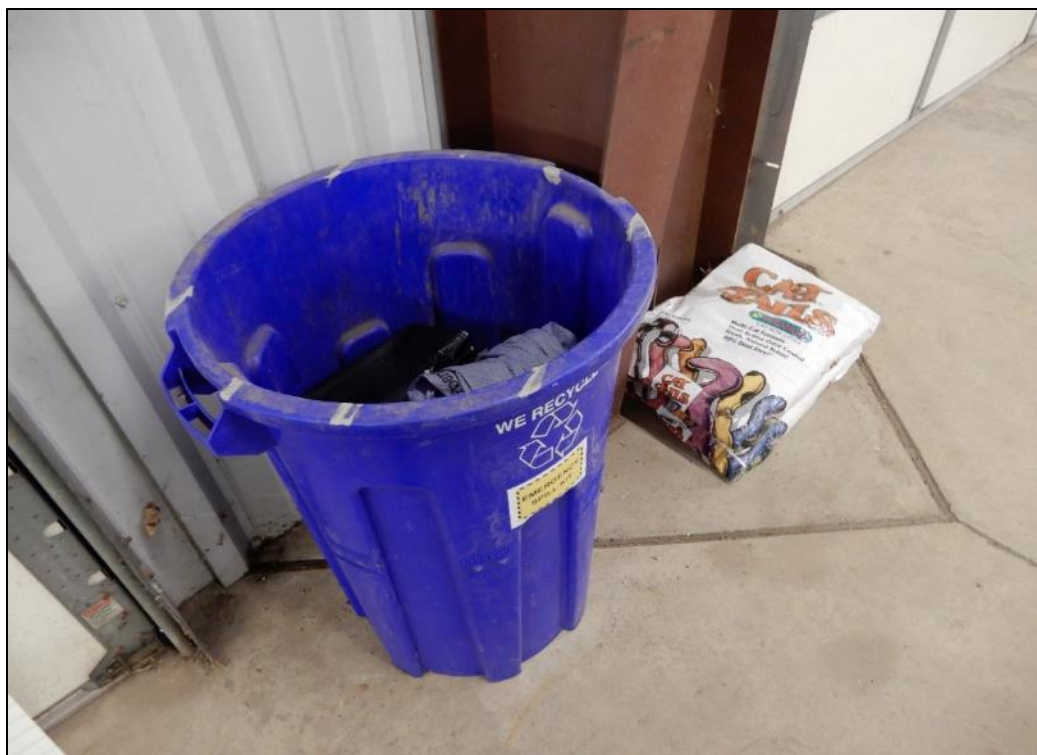
**Photograph 15.** View of a spill kit inside the garage.

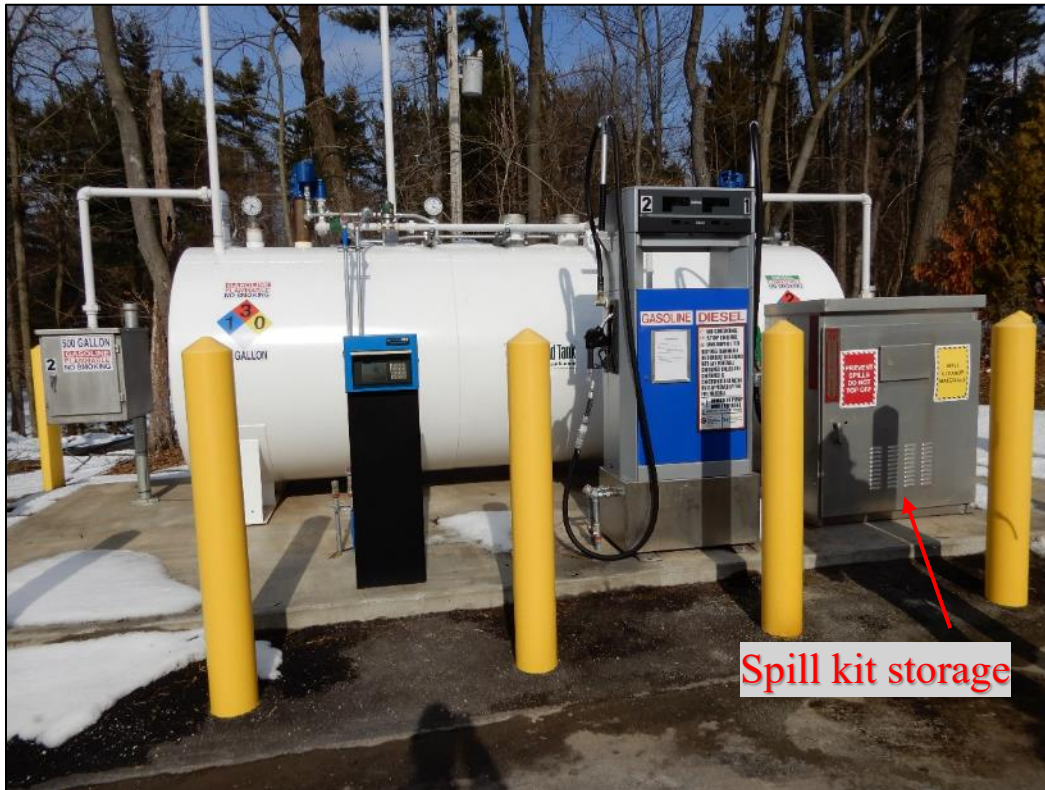
- 6) The EPA Inspection Team observed what appeared to be fresh petroleum staining in front of the fueling station (refer to Photographs 16 through 18). A spill kit was available at the location.

**Photograph 16.** View, facing north, of the fueling station. The station had a joint aboveground tank for gasoline (500 gallons) and diesel (2,000 gallons) on the northern border of the property.

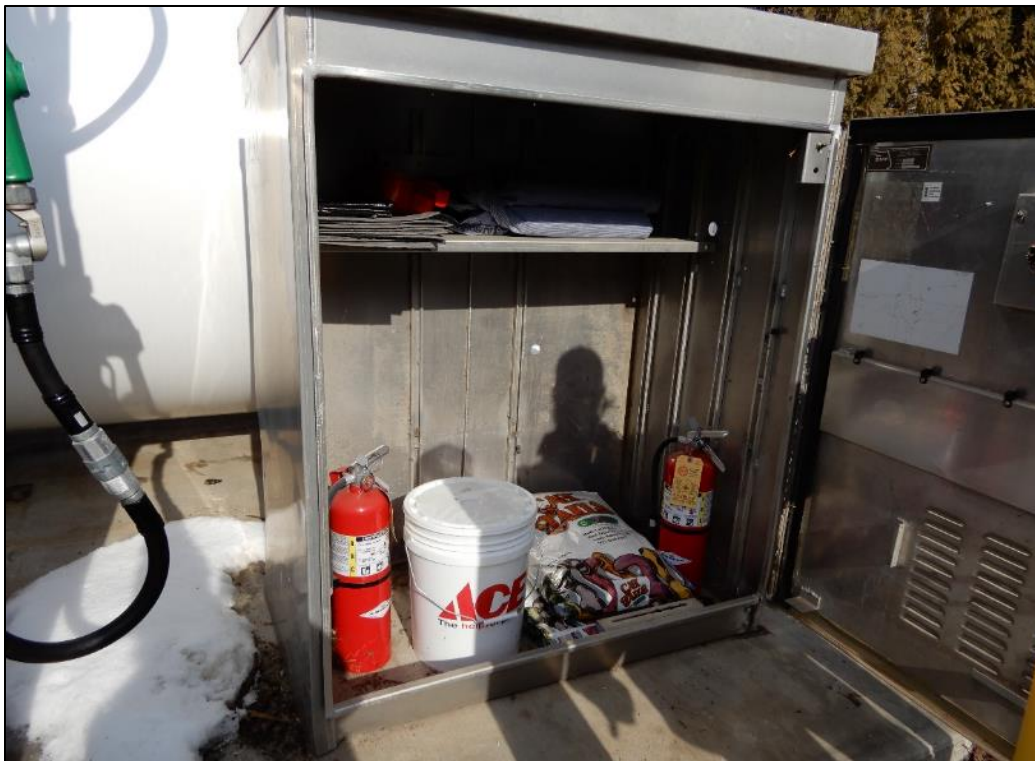
**Photograph 17.** View of the spill kit stored at the fueling station.

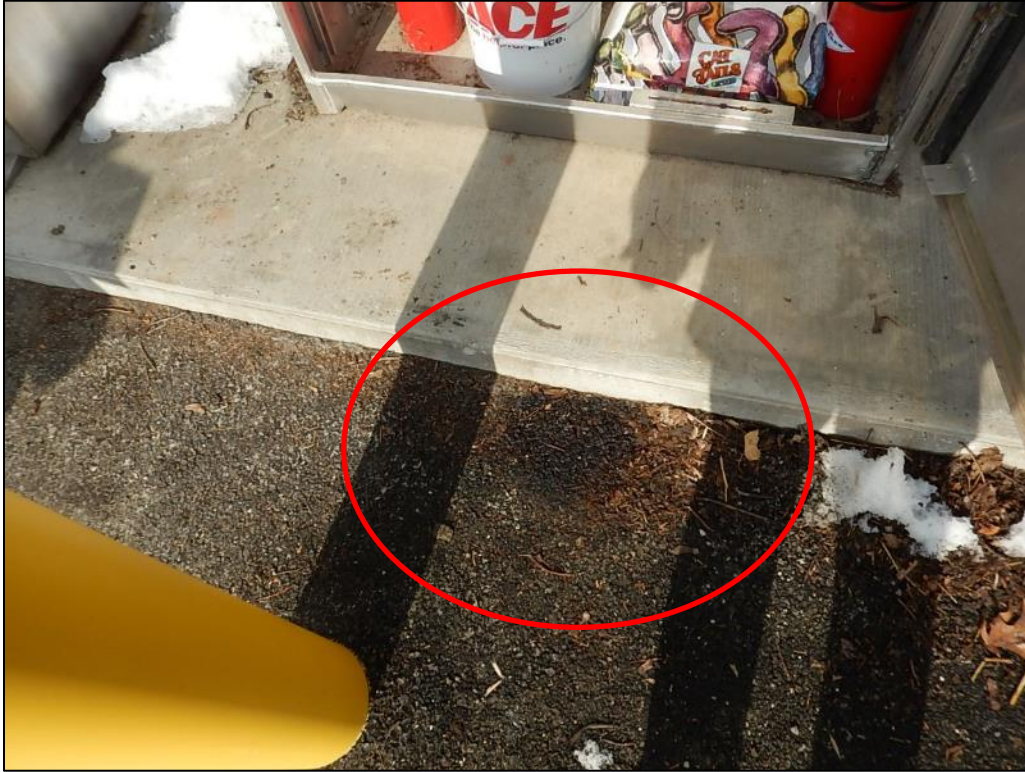
**Photograph 18.** Apparent petroleum stain in front of the spill kit storage at the fueling station.

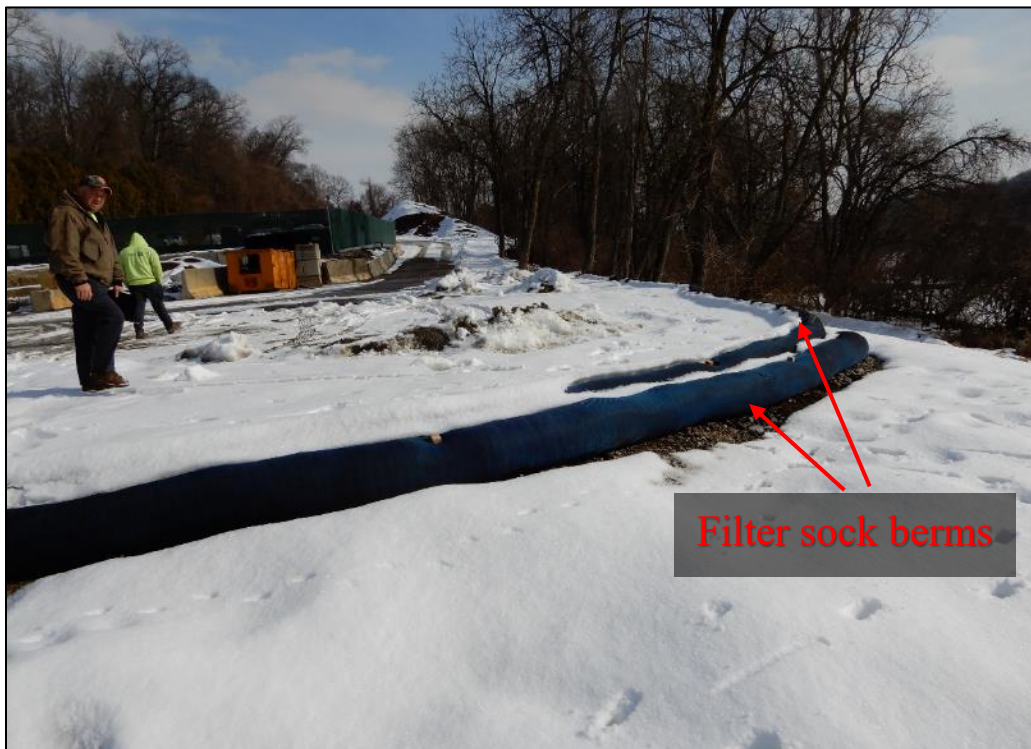
- 7) The EPA Inspection Team observed filter sock and earthen berms to control runoff on the northeastern portion of the property where stockpiles were located (refer to Photographs 19 and 20).

**Photograph 19.** View, facing northeast, of two filter sock berms used to control runoff in the the northeastern portion of the property.

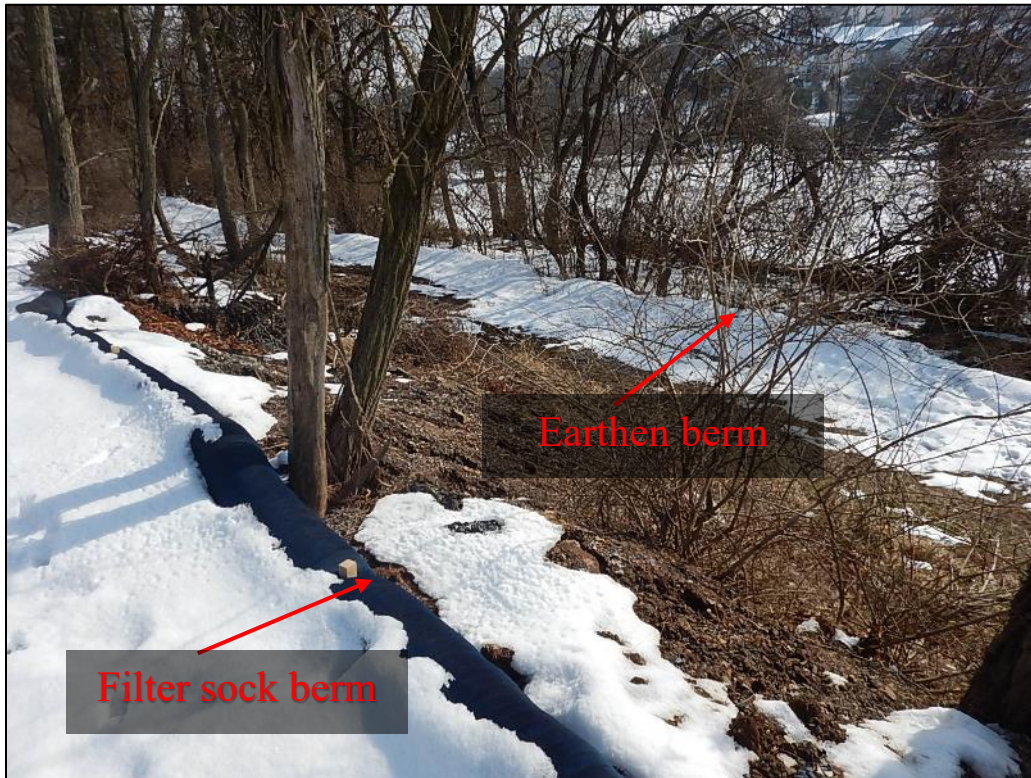
**Photograph 20.** View, facing southeast, of a filter sock berm located in the stockpile area as well as an earthen berm located down gradient along the perimeter of the property.

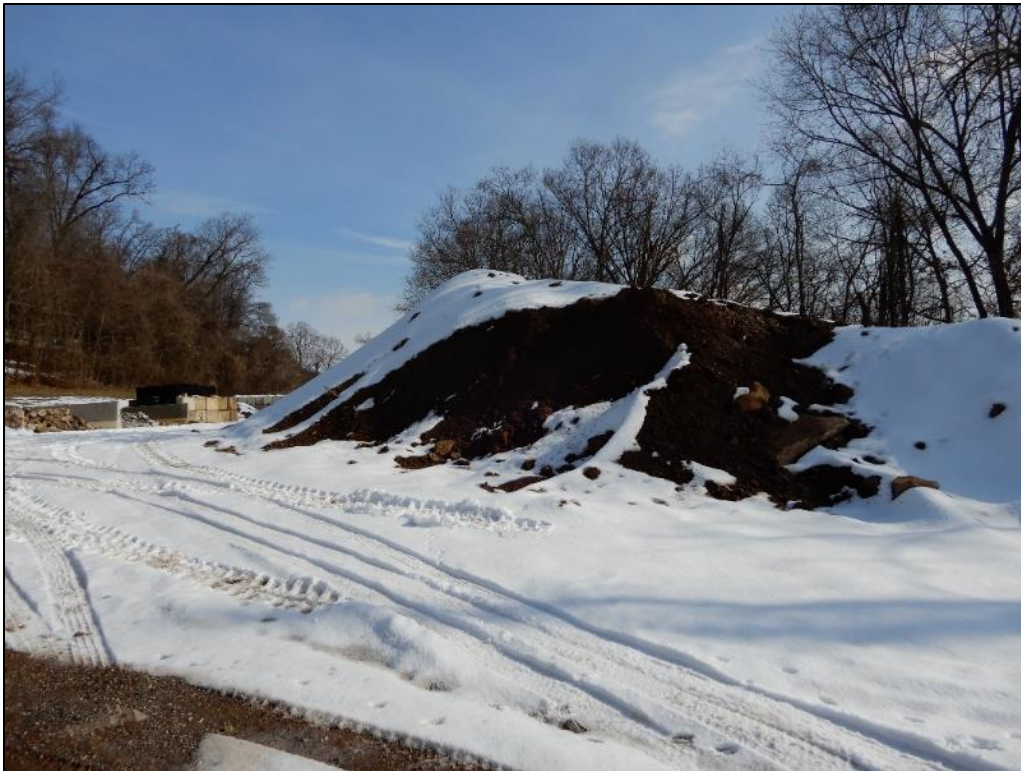
- 8) The EPA Inspection Team observed uncovered stocked materials stored on the northern portion of the property (refer to Photograph 21).

**Photograph 21.** View, facing northeast, of an uncovered dirt stockpile in the northeastern portion of the property.

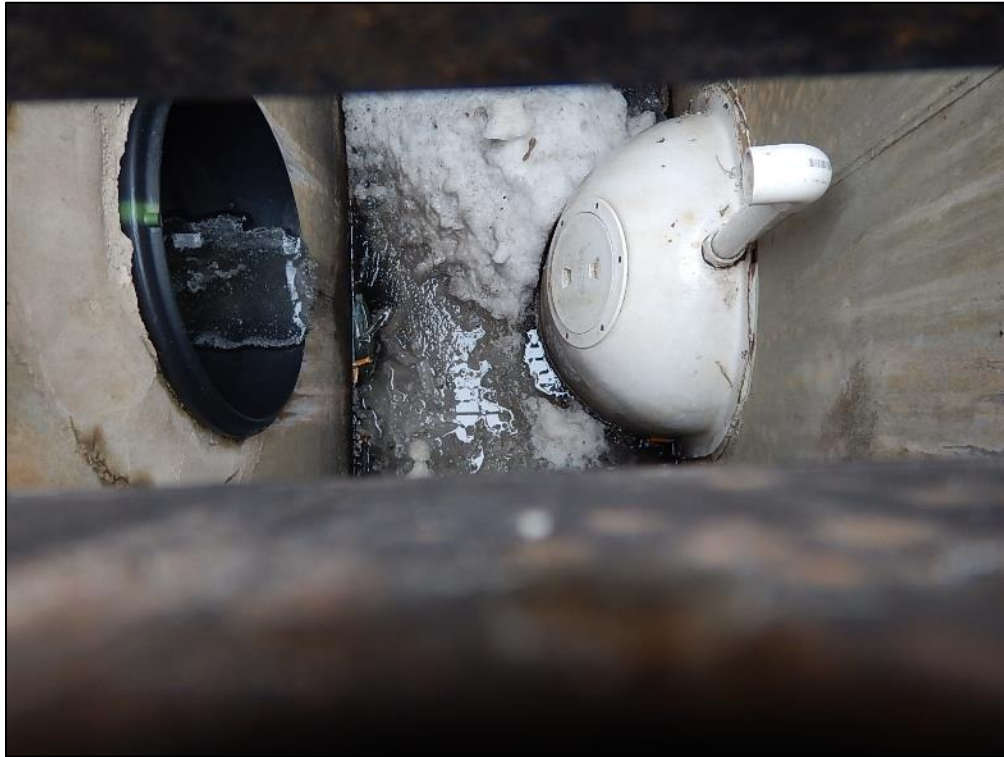
- 1) Visual observations were somewhat limited due to snowfall in excess of 3 inches covering the ground.
- 2) The EPA Inspection Team observed water quality snout device in the catch basin upstream of the stormwater basin (refer to Photograph 22).
- 3) The EPA Inspection Team observed that the concrete riser outlet structure located in the southern end of the stormwater basin apparently was not aligned properly (refer to Photographs 23 and 24).
- 4) Stormwater is discharged from the stormwater basin, through the concrete riser outlet structure, and to an intermittent tributary of the Susquehanna River (refer to Photograph 25). The EPA Inspection Team did not observe any sediment or signs of other pollution in the stream.

**Photograph 22.** View of the water quality snout device installed in the catch basin upstream of the stormwater basin.

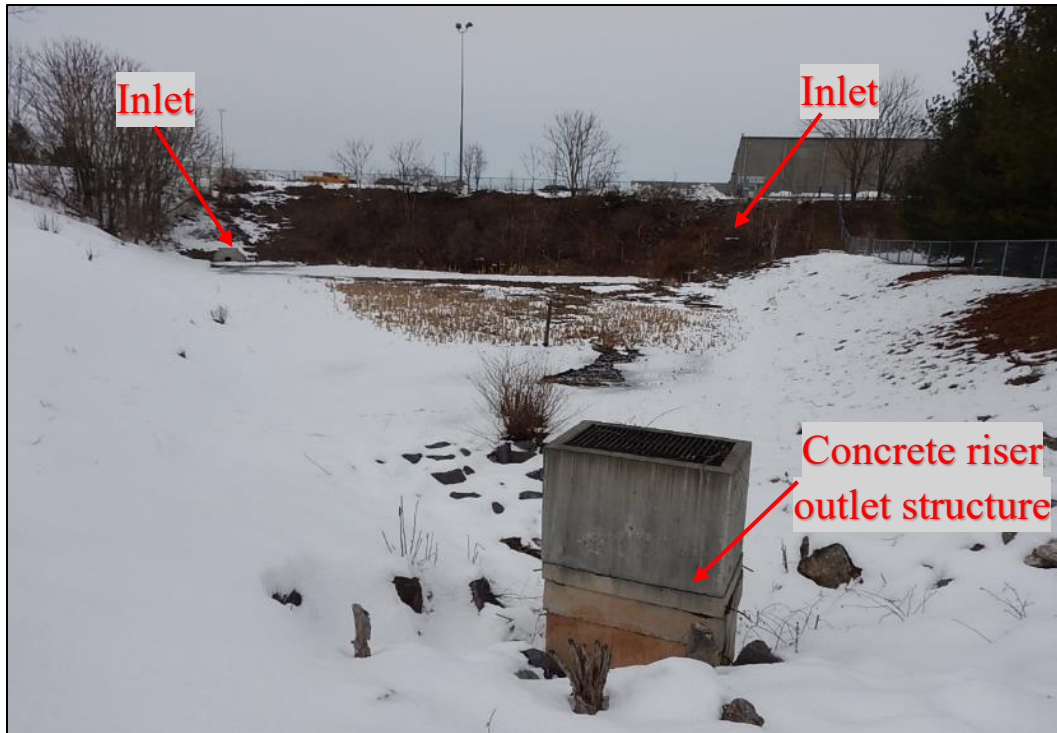
**Photograph 23.** View, facing northwest, of the stormwater basin and concrete riser outlet structure. The riser structure was not aligned.

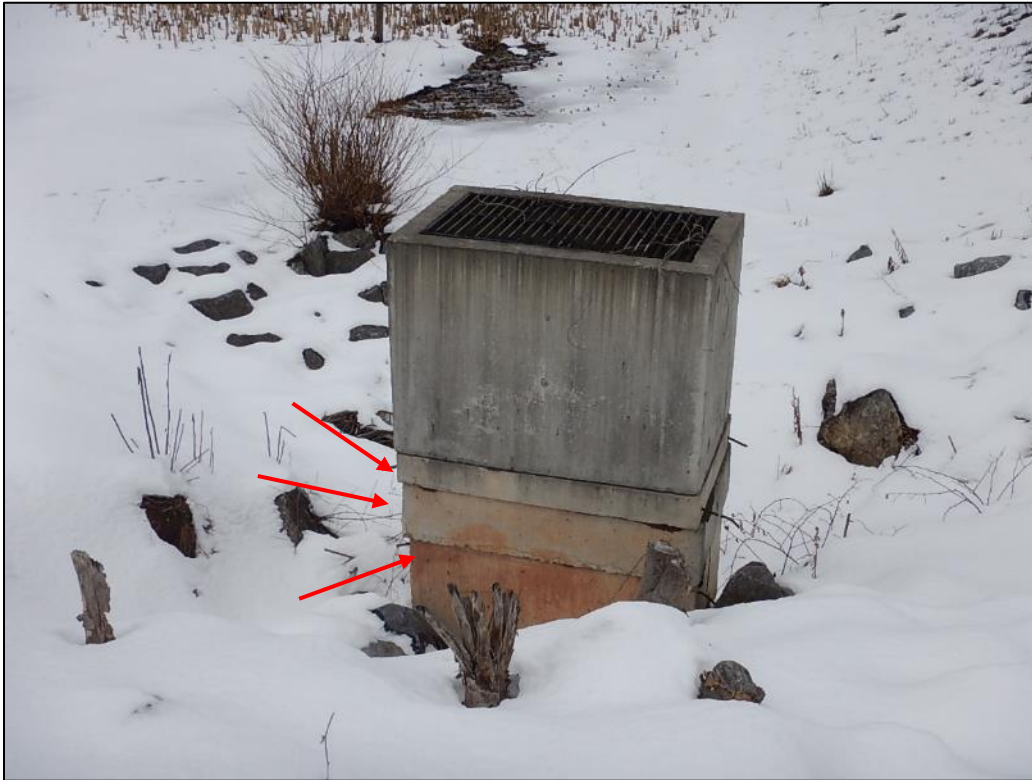
**Photograph 24.** View of the concrete riser outlet structure. The red arrows show where the riser sections were apparently not aligned.

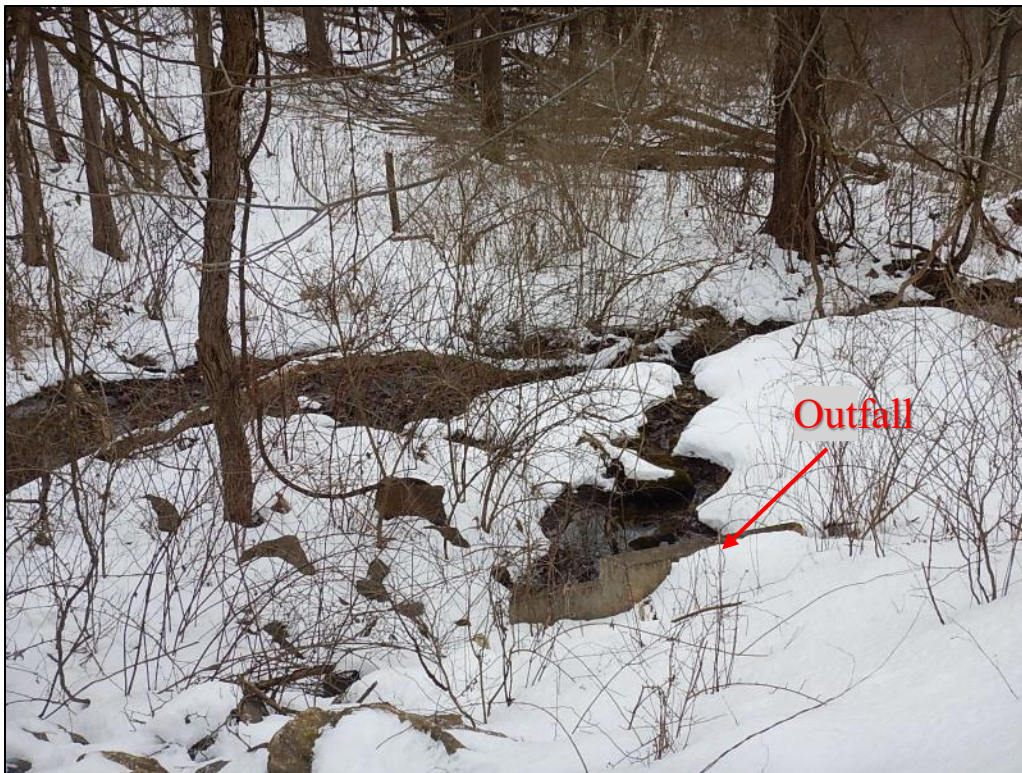
**Photograph 25.** View, facing south, of the outfall to the intermittent tributary to the Susquehanna River, south of the stormwater basin.

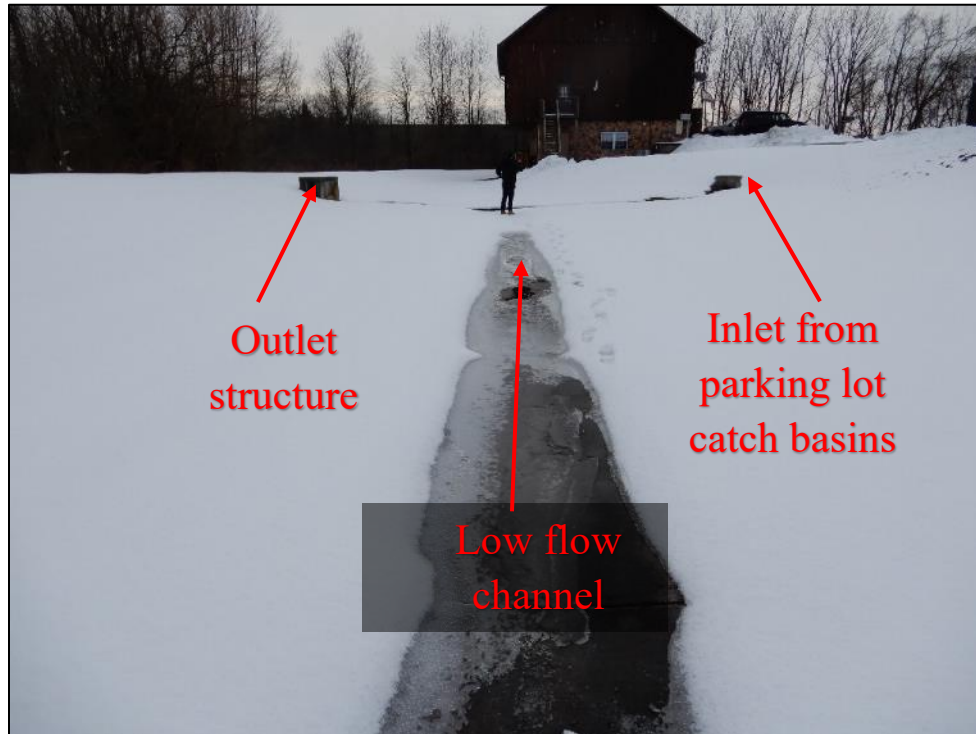
- 1) Visual observations were somewhat limited due to snowfall in excess of 3 inches covering the ground.
- 2) The EPA Inspection Team observed partially frozen pooled water in the concrete low flow channel (refer to Photograph 26). This same issue of pooled water was referenced in the May 2019 inspection report (refer to Appendix B, Exhibit 6).

**Photograph 26.** View, facing south, of the basin. Note the low flow contained partially frozen moisture.

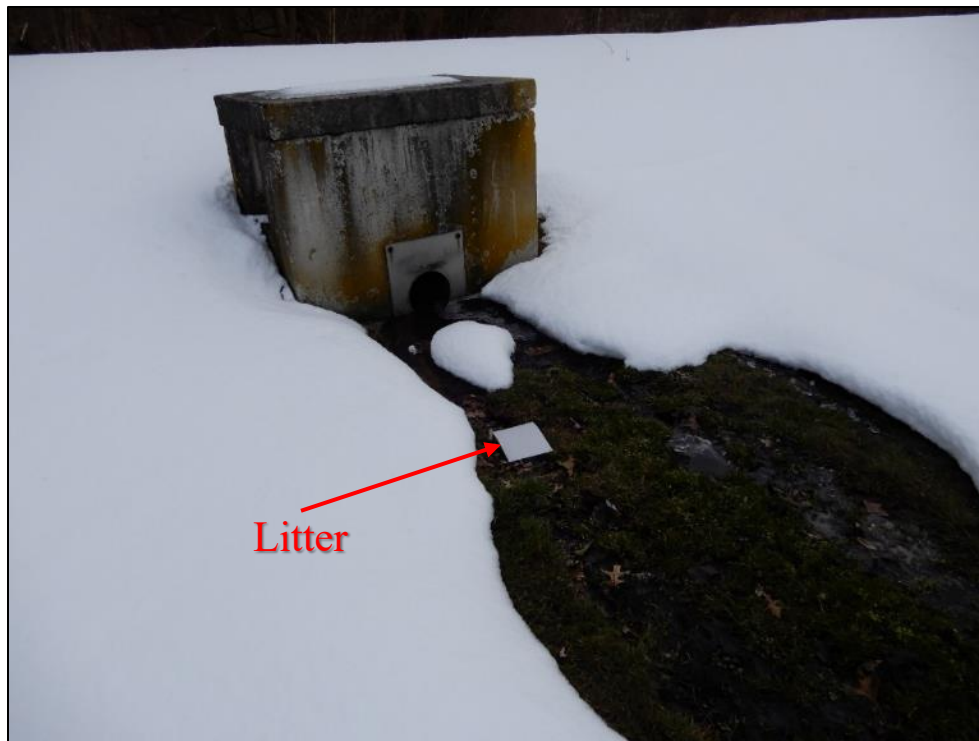
- 3) The EPA Inspection Team observed litter in front of the outlet and inlet structures as well as at the outfall into the wetland area (refer to Photographs 27 through 29). Litter in the basin was also referenced in the May 2019 inspection report (refer to Appendix B, Exhibit 6).

- 4) Mud and sediment with vegetation growing in it was observed to be accumulated in front of the outlet structure. Township staff stated that the concrete low flow channel extended to meet the outlet structure. Vegetation at the outlet was also referenced in the May 2019 inspection report (refer to Appendix B, Exhibit 6).

**Photograph 27.** View, facing west, of the outlet structure. Note that the concrete channel is not visible due to the vegetation growing in the accumulated mud and sediment in front of the structure. Litter was also present near the outlet.
