**U.S. ENVIRONMENTAL PROTECTION AGENCY  
REGION III WATER BRANCH, ENFORCEMENT  
AND COMPLIANCE ASSURANCE DIVISION  
CLEAN WATER ACT  
COMPLIANCE INSPECTION REPORT**

**Name of Facility:** East Manchester Township MS4  
**Facility Address:** 5080 North Sherman Street Ext, Mt. Wolf, PA 17347  
**Mailing Address:** 5080 North Sherman Street Ext, Mt. Wolf, PA 17347

| <b>Type of Inspection:</b> | MS4 Compliance Inspection |

**Unique Project Identifier (UPI):** 3E21WN021A

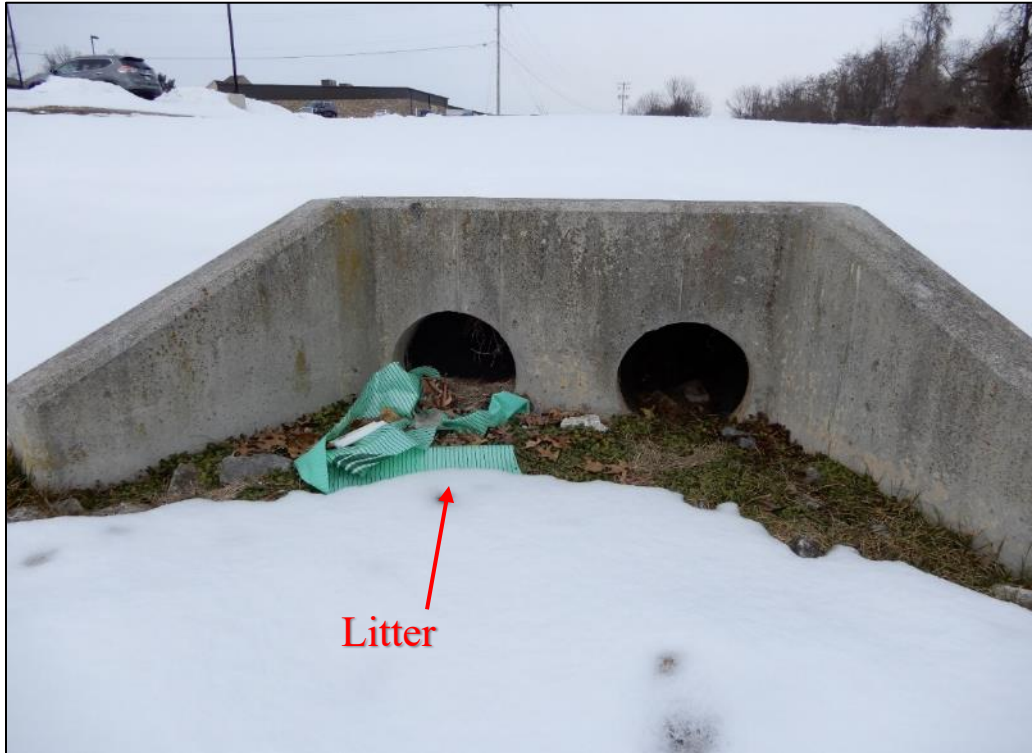
- 3) The EPA Inspection Team observed litter in front of the outlet and inlet structures as well as at the outfall into the wetland area (refer to Photographs 27 through 29). Litter in the basin was also referenced in the May 2019 inspection report (refer to Appendix B, Exhibit 6).

**Photograph 28.** View, facing north, of the stormwater basin inlets on the north side of the BMP which allow flow to enter the structure from the Advanced Auto stormwater basin. Note the trash observed at this location.

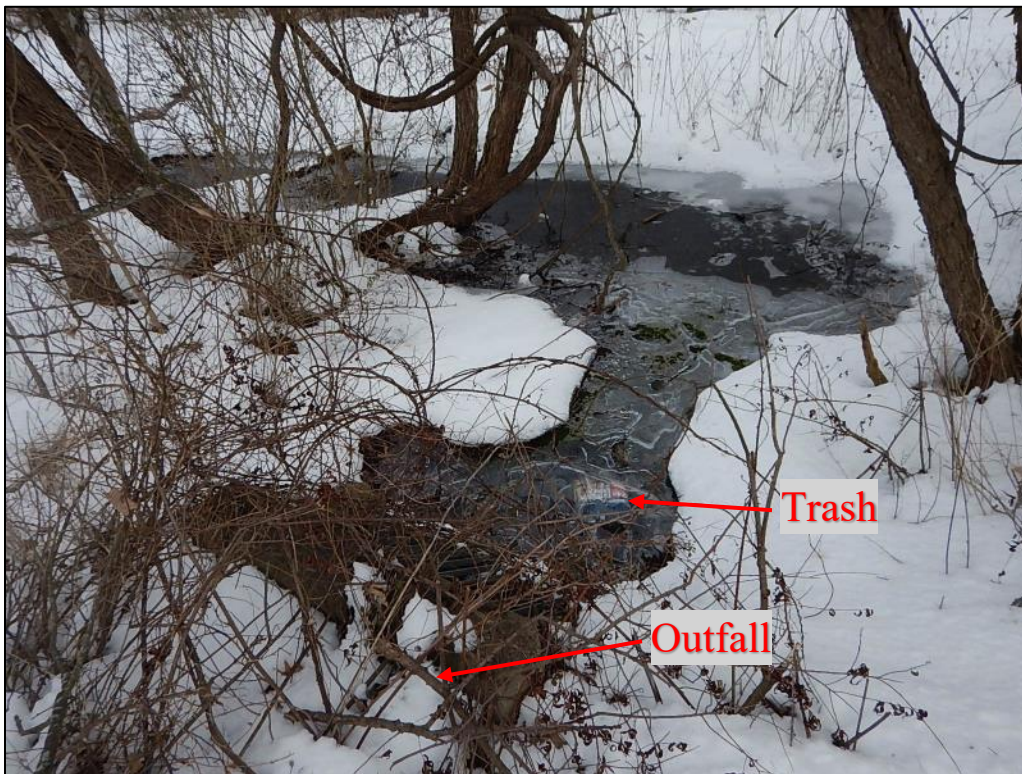
**Photograph 29.** View of partially frozen water pooled in front of the outlet from the stormwater basin into the wetland area located east of the BMP. Note trash observed near the outlet.

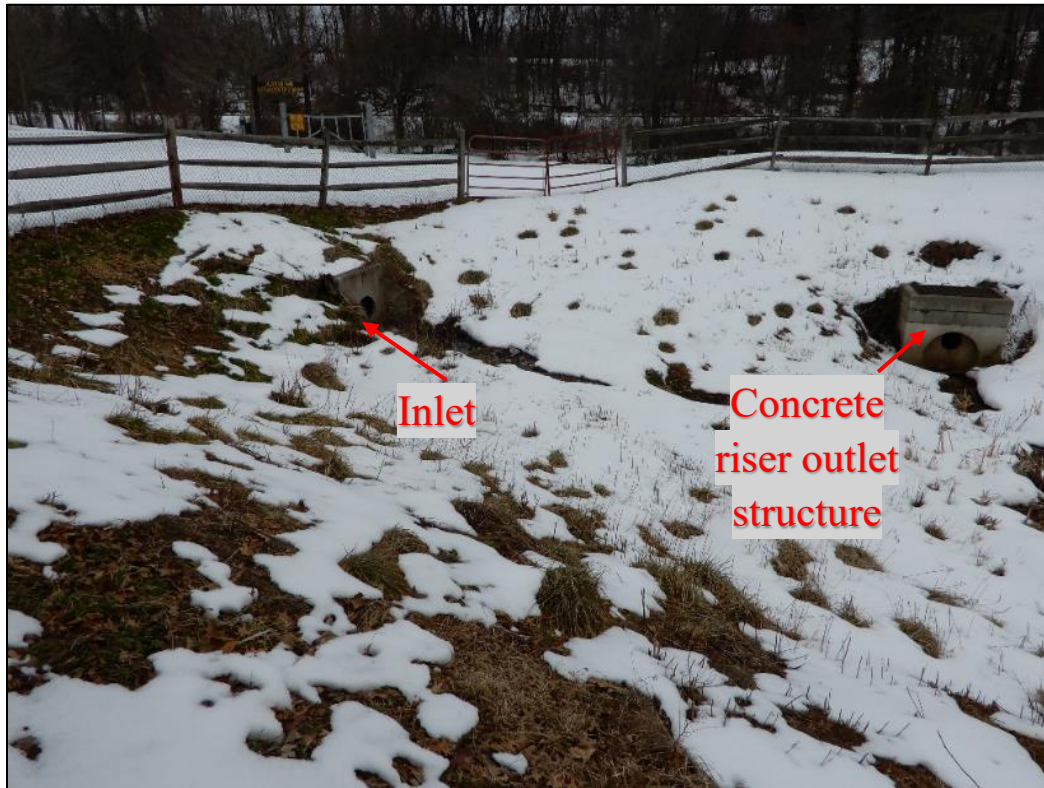
- 1) Visual observations were somewhat limited due to snowfall in excess of 3 inches covering the ground.
- 2) The EPA Inspection Team observed an inlet and a concrete riser outlet structure on the northern and northeastern end of the stormwater basin, respectively (refer to Photograph 30). The EPA Inspection Team additionally observed an inlet on the southwestern side of the basin, as well as vegetation and a willow tree growing in the middle of the stormwater basin, away from the embankment (refer to Photograph 31). The removal of vegetation was recommended in the May 2019 inspection report (refer to Appendix B, Exhibit 8). Township staff stated that a third-party contractor performs seasonal maintenance of mowing embankments and cutting cattails.

**Photograph 30.** View, facing east, of one of the basin inlets and the concrete riser outlet structure located on the north end of the stormwater basin.

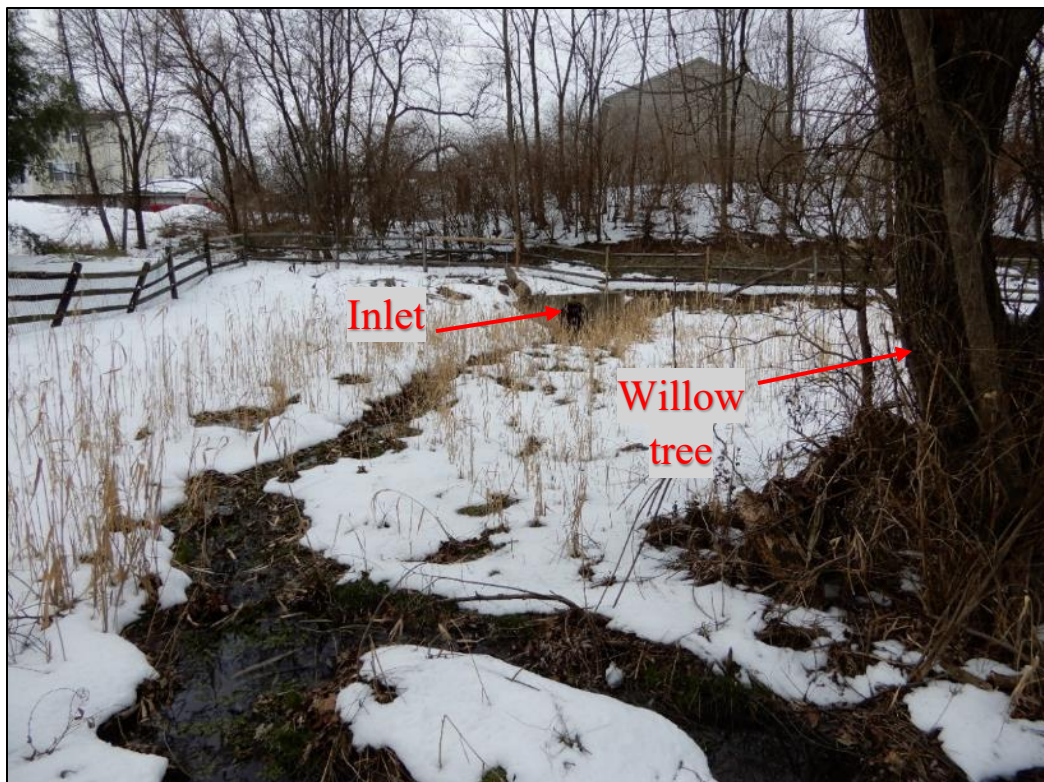
**Photograph 31.** View, facing southeast, of the inlet in the southeastern end of the stormwater basin. Also note the vegetation and willow tree.

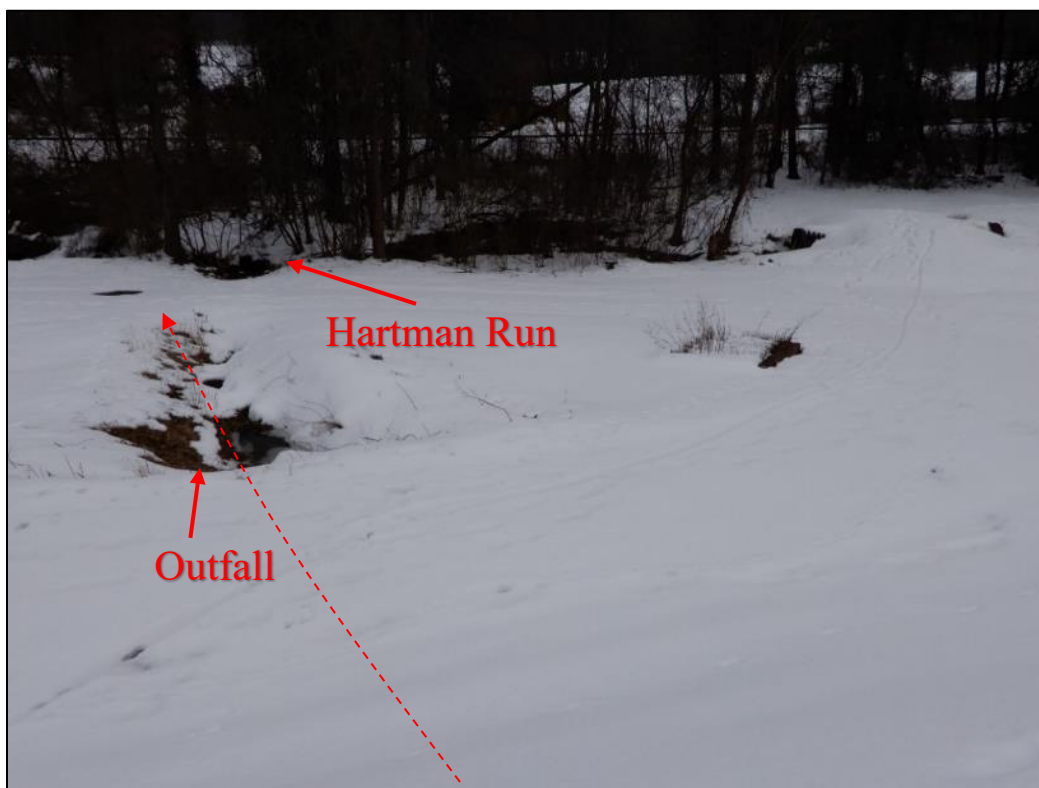
- 3) The basin discharges to the east into Hartman Run (refer to Photographs 32 and 33). No apparent signs of pollution or sediment were observed in the receiving water.

**Photograph 32.** View, facing east, of the outfall structure and Hartman Run.

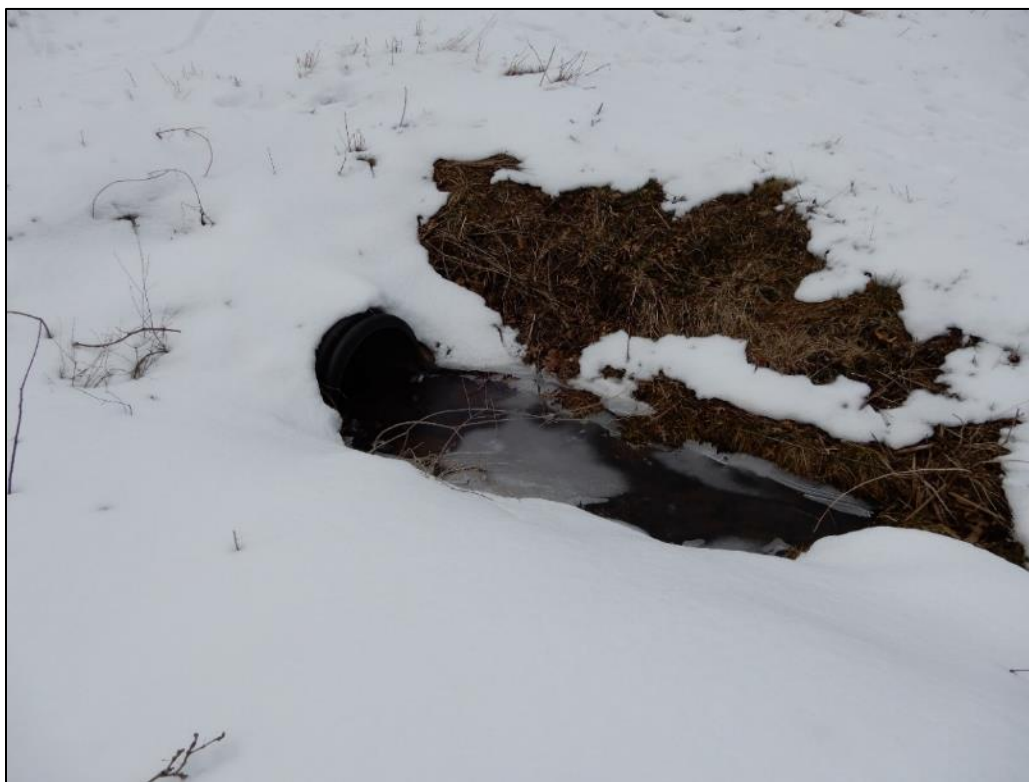
**Photograph 33.** Additional view of the outfall to Hartman Run.

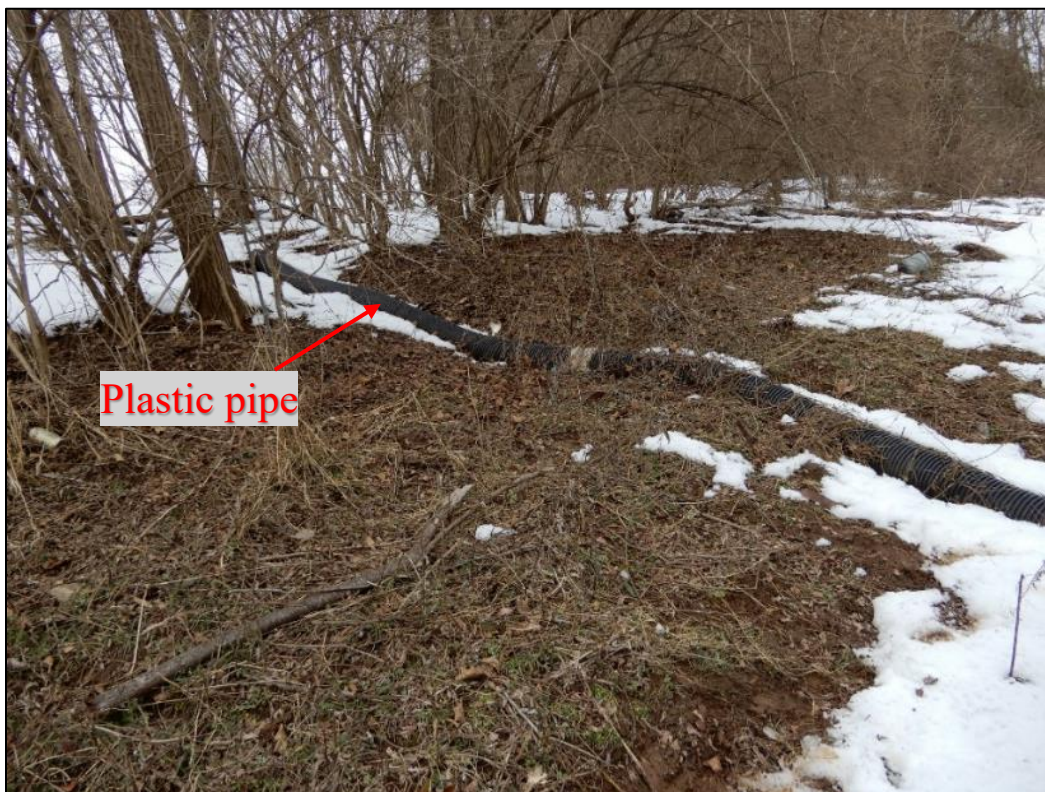
- 4) The EPA Inspection Team observed a discontinuous plastic pipe leading to the basin from the apartment complex parking lot to the west (refer to Photographs 34 and 35). Township staff stated they were not previously aware of the pipe.

**Photograph 34.** View, facing northwest, of the plastic pipe from the apartment complex parking lot leading to the stormwater basin.

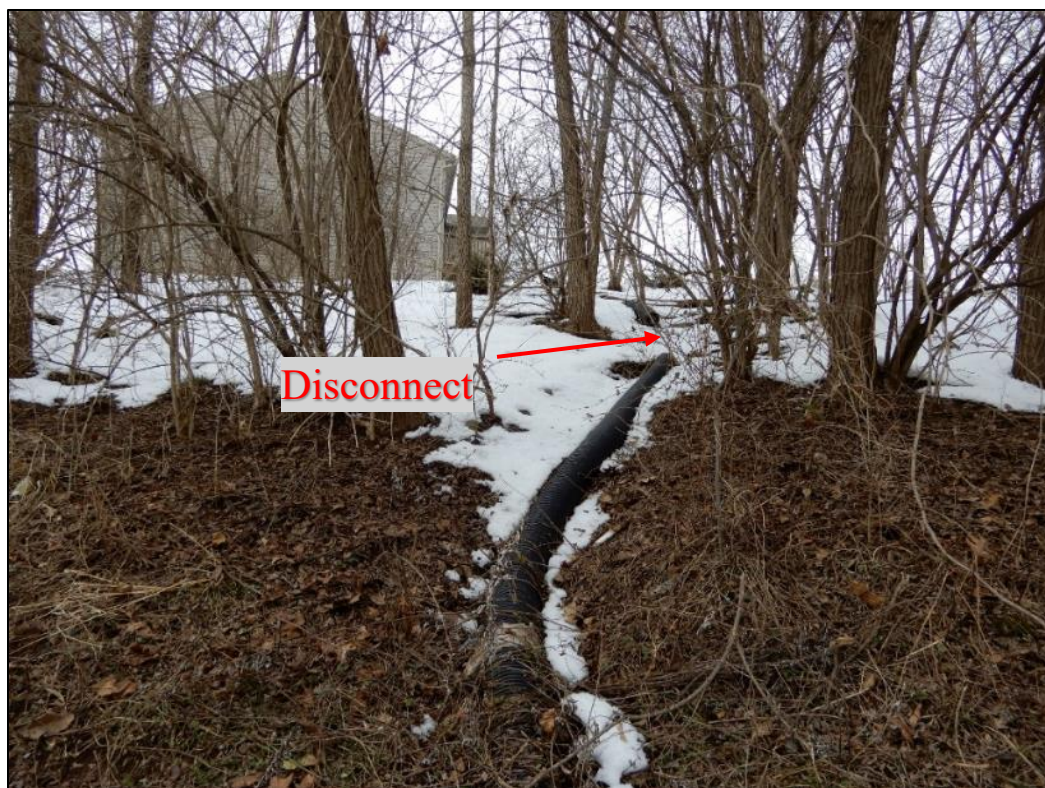
**Photograph 35.** Additional view, facing west, of the pipe shown in Photograph 34.v

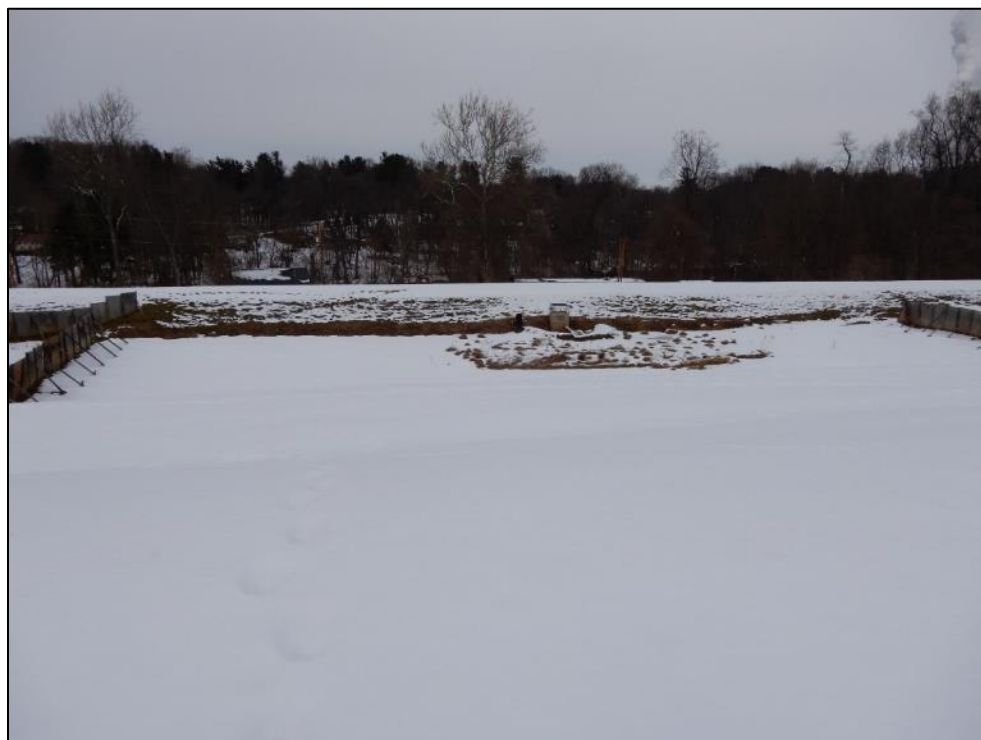
**Description:** Rentzel Subdivision Detention Basin 1 was being used as a sediment basin for subdivision construction at the time of the inspection (refer to [Photograph 36](#)). The structure will eventually be converted to a post construction stormwater basin. The EPA Inspection Team did not make observations related to post construction program implementation for this structure.

**Photograph 36.** View, facing north, of the sediment basin.

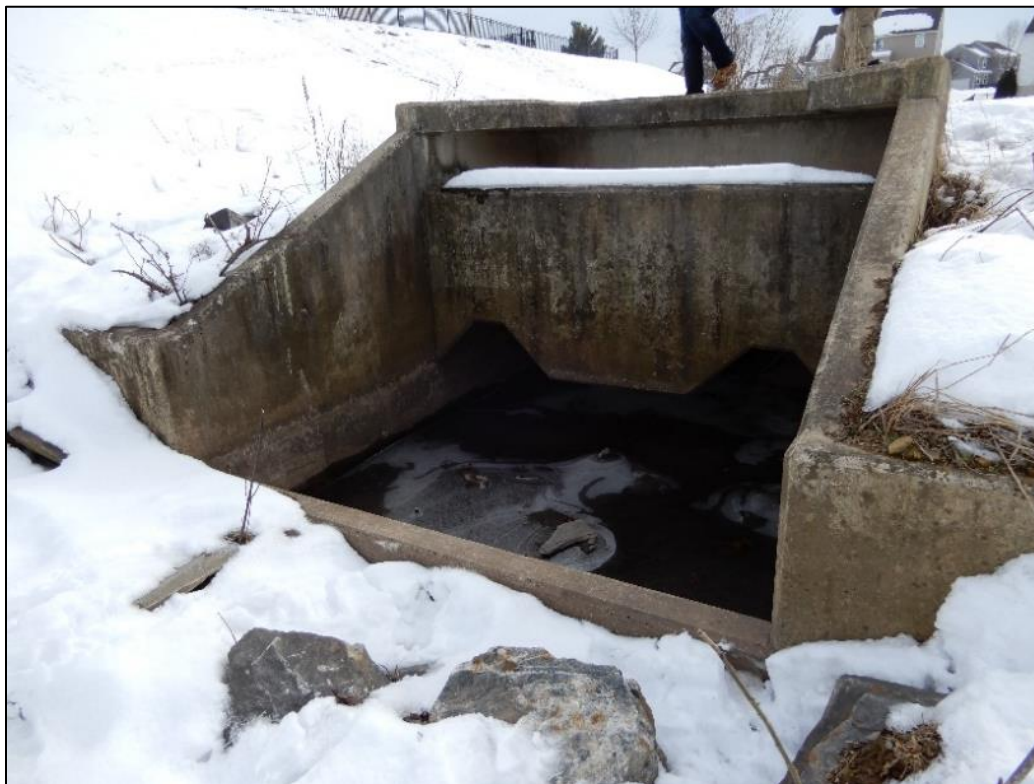
**Photograph 37.** View, facing south, of the dual inlet structure at the southern end of the basin.

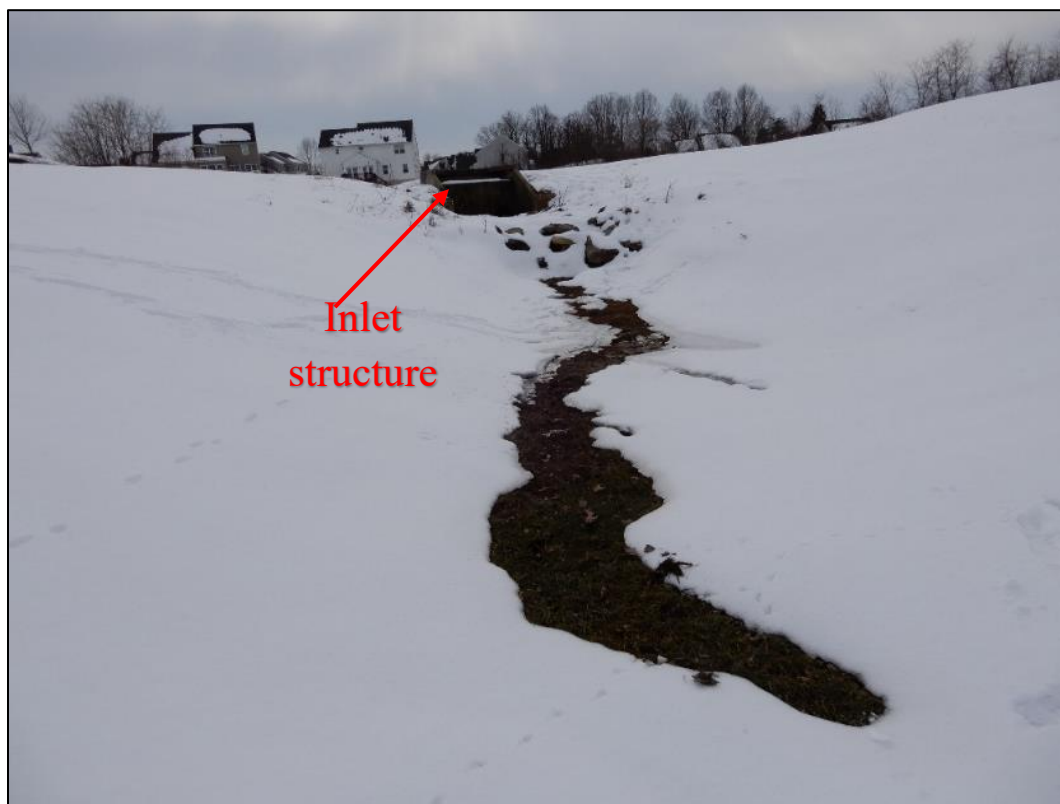
**Photograph 38.** View, facing southwest, of the dual inlet structure.

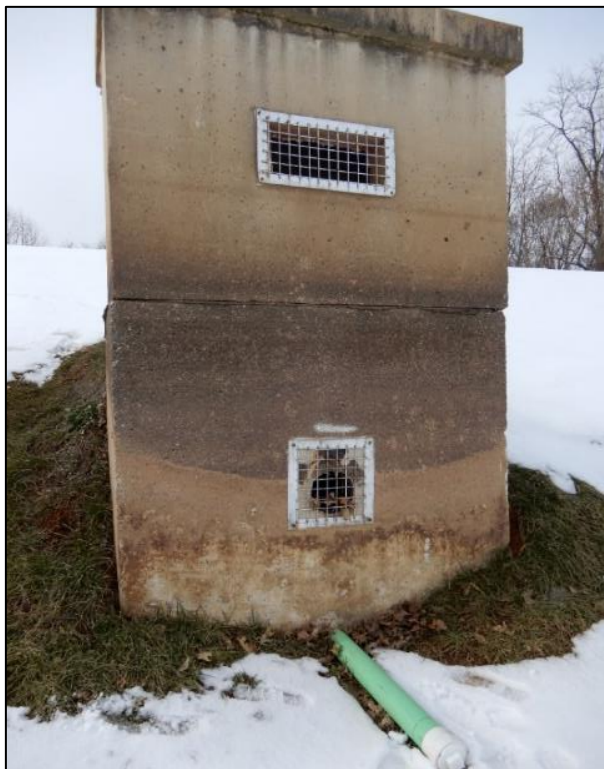
- 3) The EPA Inspection Team observed rocks and sediment inside the concrete riser outlet structure (refer to Photographs 39 and 40).
- 4) The EPA Inspection Team observed signs of erosion at the center of the stormwater basin (refer to Photographs 41 and 42).

**Photograph 39.** View, facing west, of the concrete riser outlet structure.

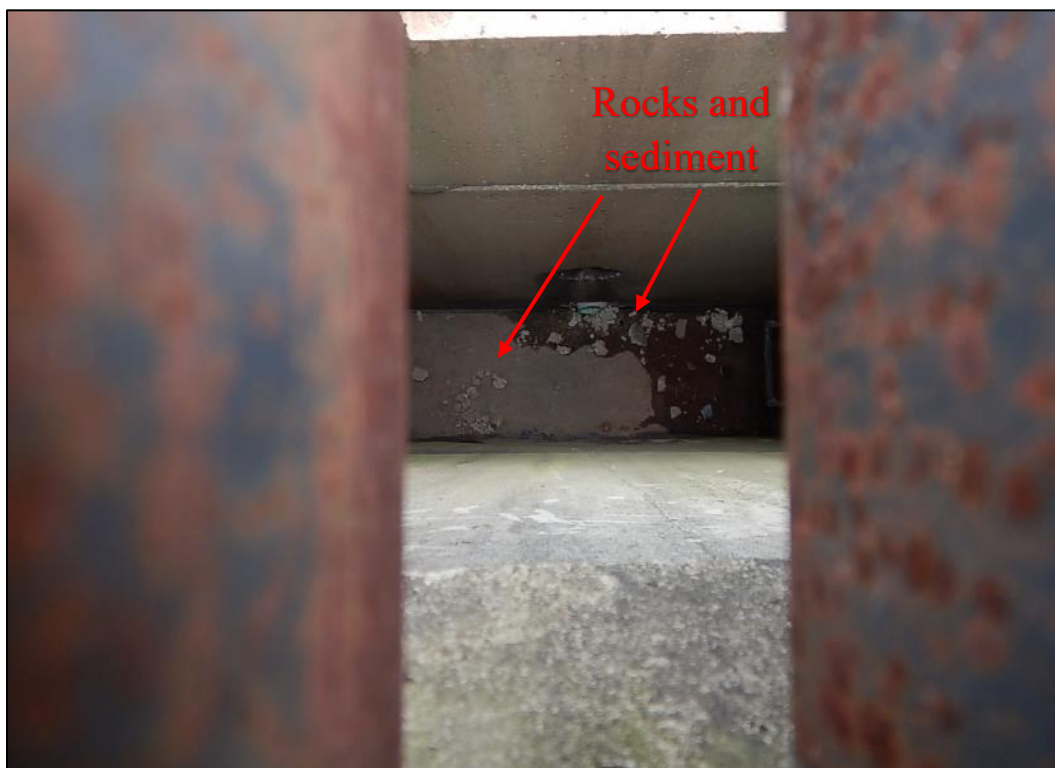
**Photograph 40.** View inside the concrete riser outlet structure. Note the rocks and sediment inside the structure.

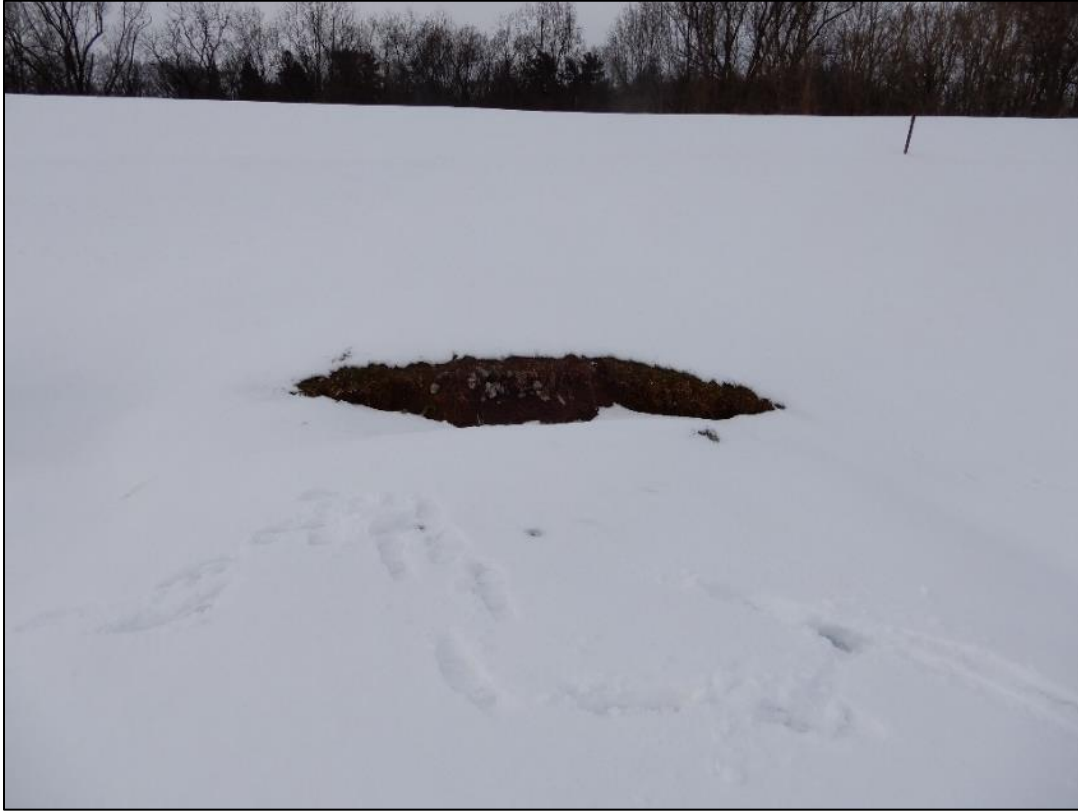
**Photograph 41.** View, facing northwest, of erosion in the center of the stormwater basin.

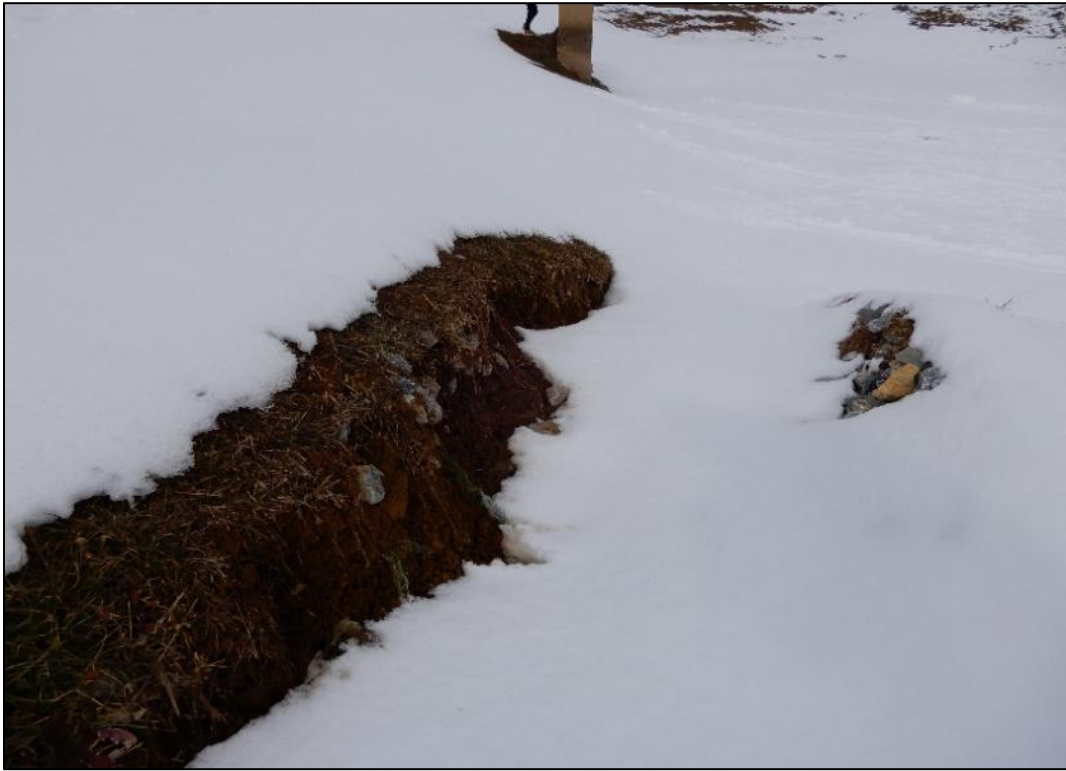
**Photograph 42.** Alternate view, facing northeast, of the erosion observed in the center of the stormwater basin.

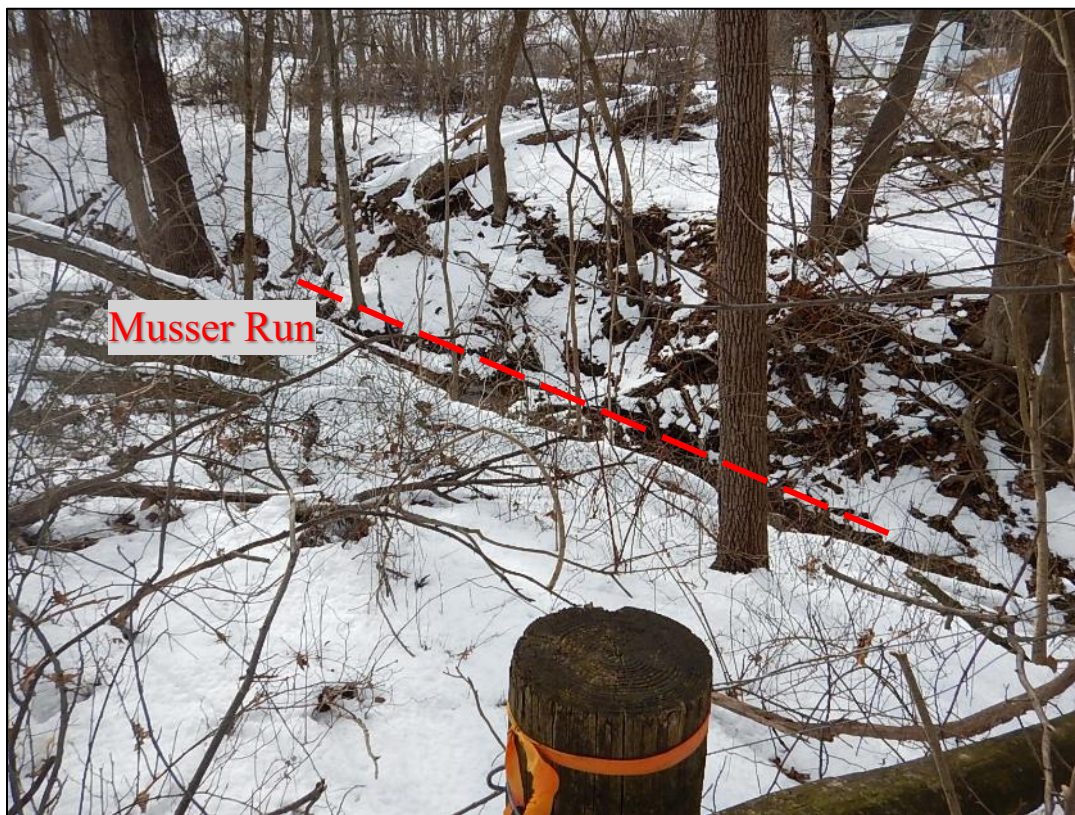
- 5) The basin discharges to Musser Run. The outfall was not able to be located at the time of the inspection due to the snow (refer to Photograph 43).

**Photograph 43.** View of Musser Run in the vicinity of the basin outfall. The outfall structure was not able to be located due to the snow.

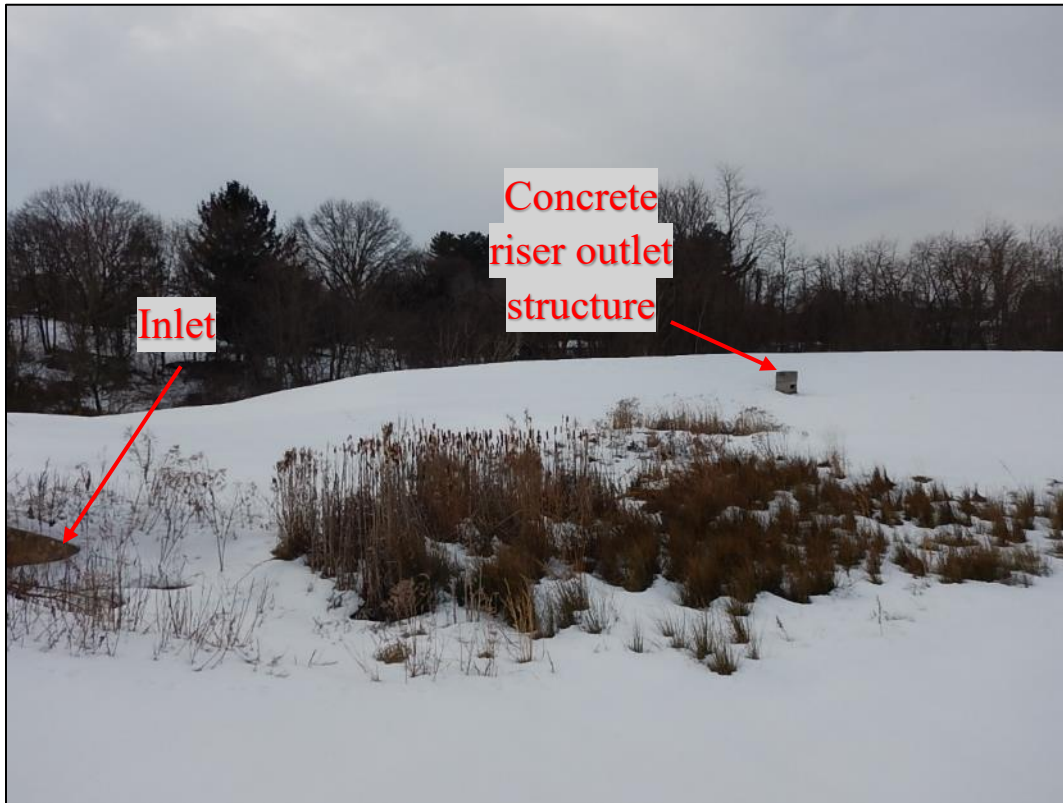
- 1) Visual observations were somewhat limited due to snowfall in excess of 3 inches covering the ground.
- 2) The EPA Inspection Team observed one inlet on the southeast end of the basin and one outlet in a concrete riser outlet structure on the southwest end of the basin. The EPA Inspection Team also observed vegetation in the basin at the time of the inspection (refer to Photographs 44 and 45). This same issue was referenced in the May 2019 Township inspection report (refer to Appendix B, Exhibit 11).
- 3) The EPA Inspection Team observed rip rap inside the outlet structure. Rip rap was also present at the outfall to the tributary to Musser Run (refer to Photographs 46 and 47). The EPA Inspection Team observed no excess sediment or additional rip rap downstream of the outfall (refer to Photograph 48).

**Photograph 44.** View, facing north, of the concrete riser outlet structure, inlet, and vegetation growing in the stormwater basin.

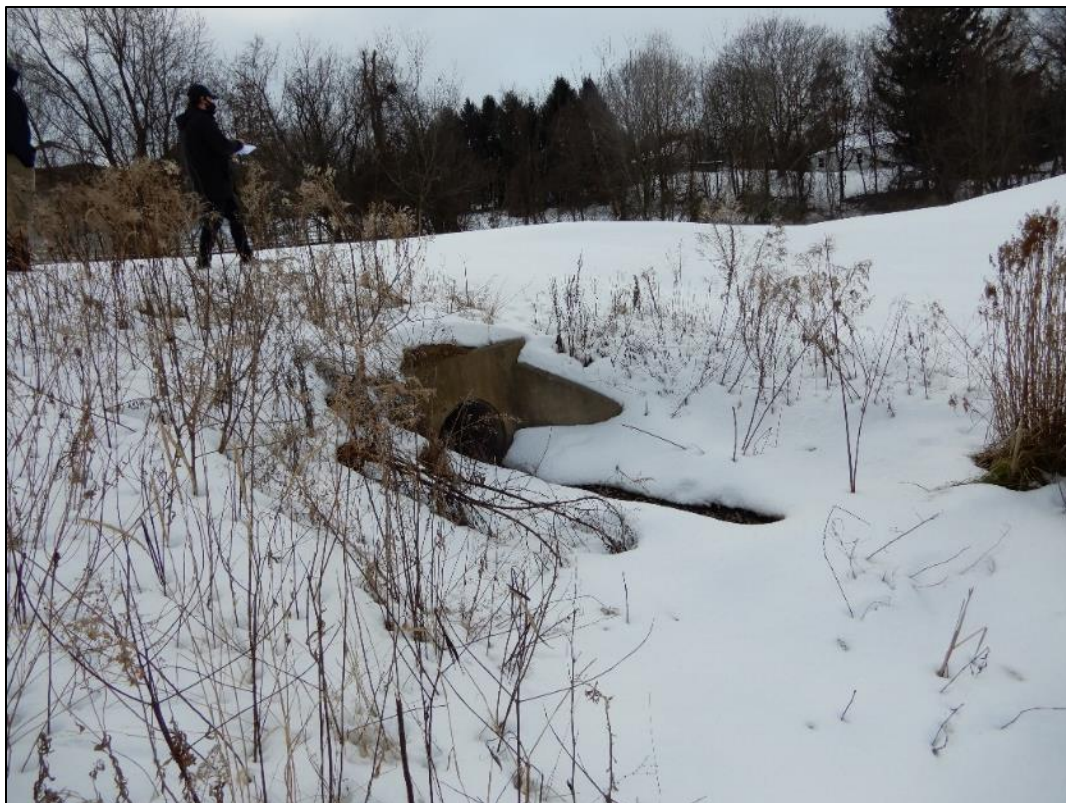
**Photograph 45.** View, facing east, of the inlet into the stormwater basin.

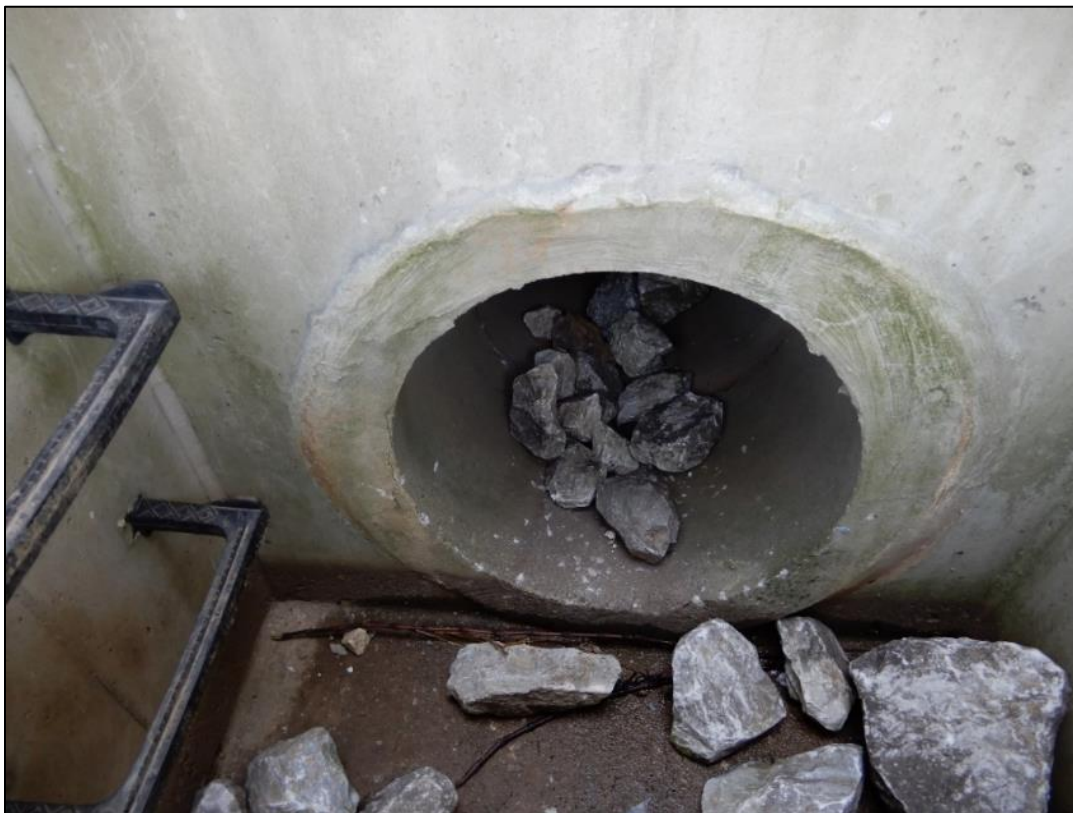
**Photograph 46.** View inside the concrete riser outlet structure. Note the rip rap inside the structure.

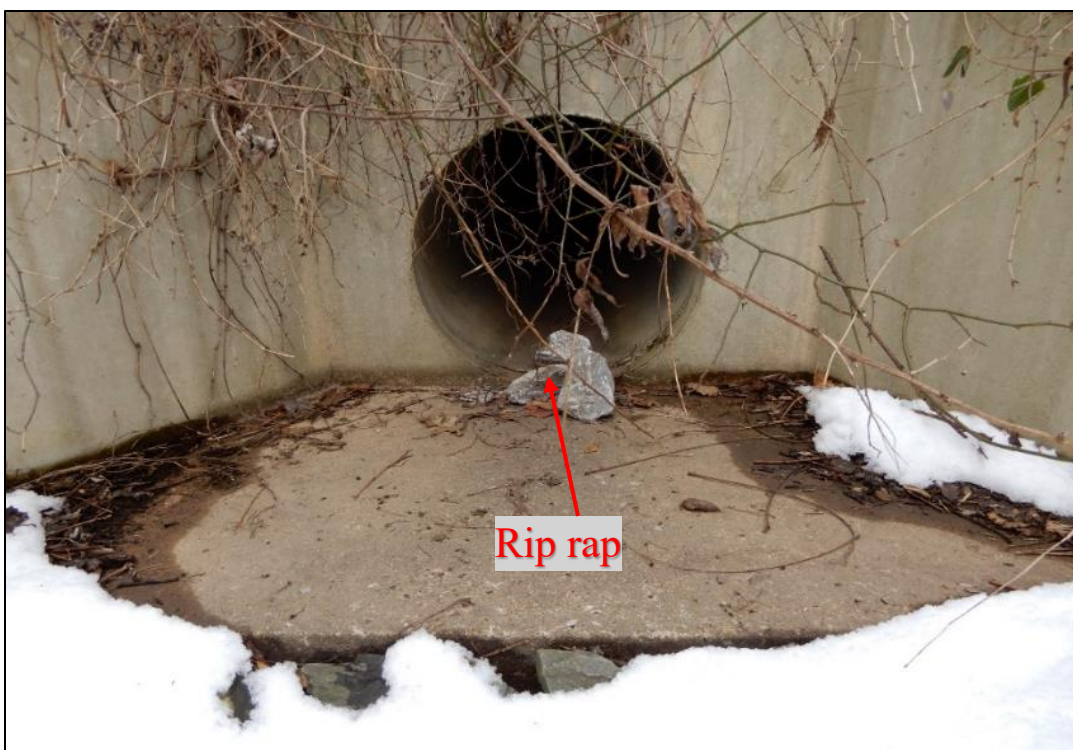
**Photograph 47.** View of the outfall to the tributary to Musser Run. Note rip rap was observed at the outfall.

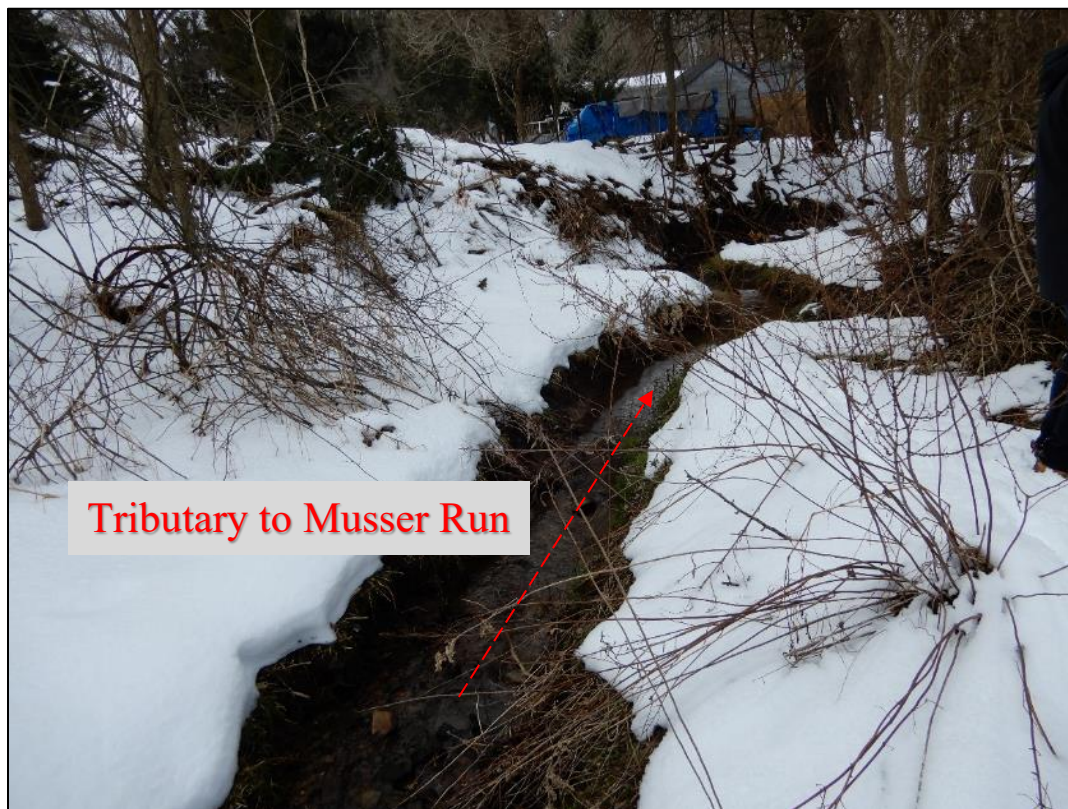
**Photograph 48.** View, facing northeast, of the tributary to Musser Run, downstream of the outfall.
