**Region 6 - Enforcement & Compliance Assurance Division**  
**INSPECTION REPORT**

| Inspection Date(s): | 06/15/2023 | |
| Regulatory Program(s) | NPDES | |
| Facility Name: | <b>Cochiti Pueblo Sewage Lagoon</b> | |

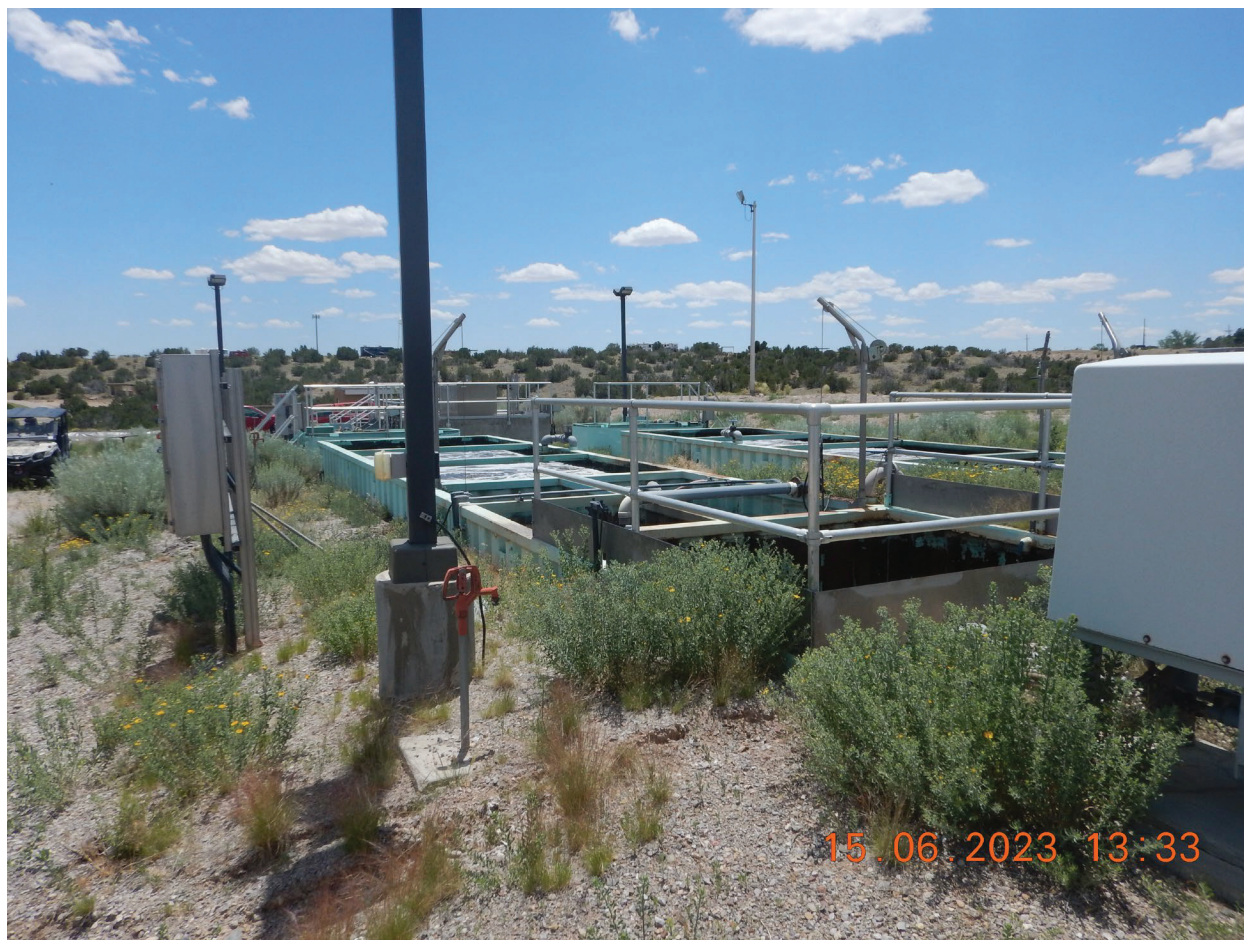
Photo No. 1

- Extensive vegetative overgrowth throughout the facility area was visible, which could potentially attract rodents and/or vermin; thus, causing undermining of the facility structures.

View looking approximately southwest towards the aeration basin treatment process equipment. The treatment structure in the foreground was offline. Note: The extensive vegetative overgrowth visible throughout the facility, which could potentially attract rodents and/or vermin; thus, causing undermining of the facility structures. (DSCN 2598). Photographed by D. Esparza.

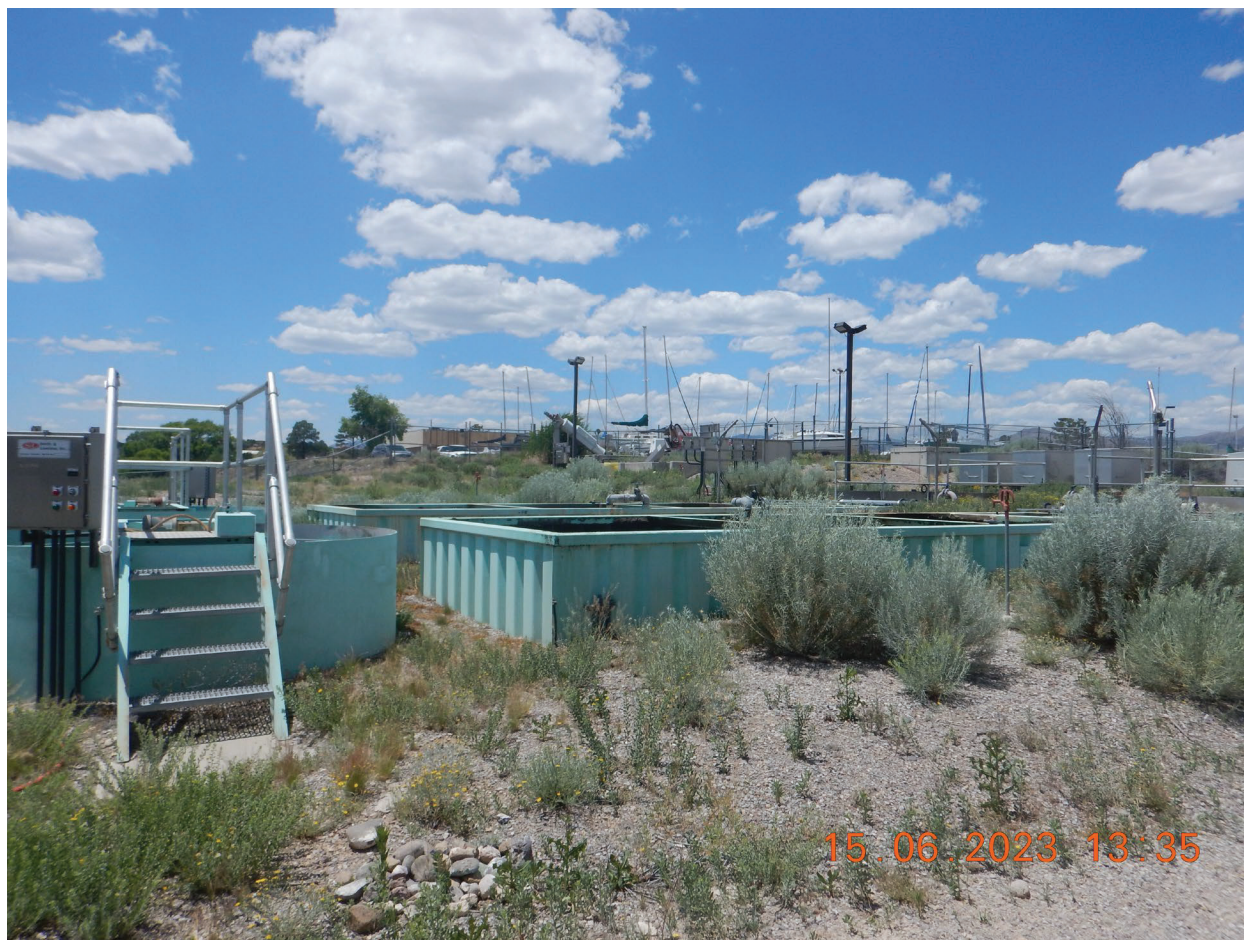
Photo No. 2

- The headworks/bar screen equipment appeared to be disconnected and non-operational. Given the fact the headworks/bar screen appear to be non-operational all inorganic material and coarse solids enter the treatment process.

View looking approximately northwest from the aeration basins on the left and an offline clarifier on the right. In the approximate upper center of the photograph is the offline headworks/bar screen. (DSCN 2600). Photographed by D. Esparza.

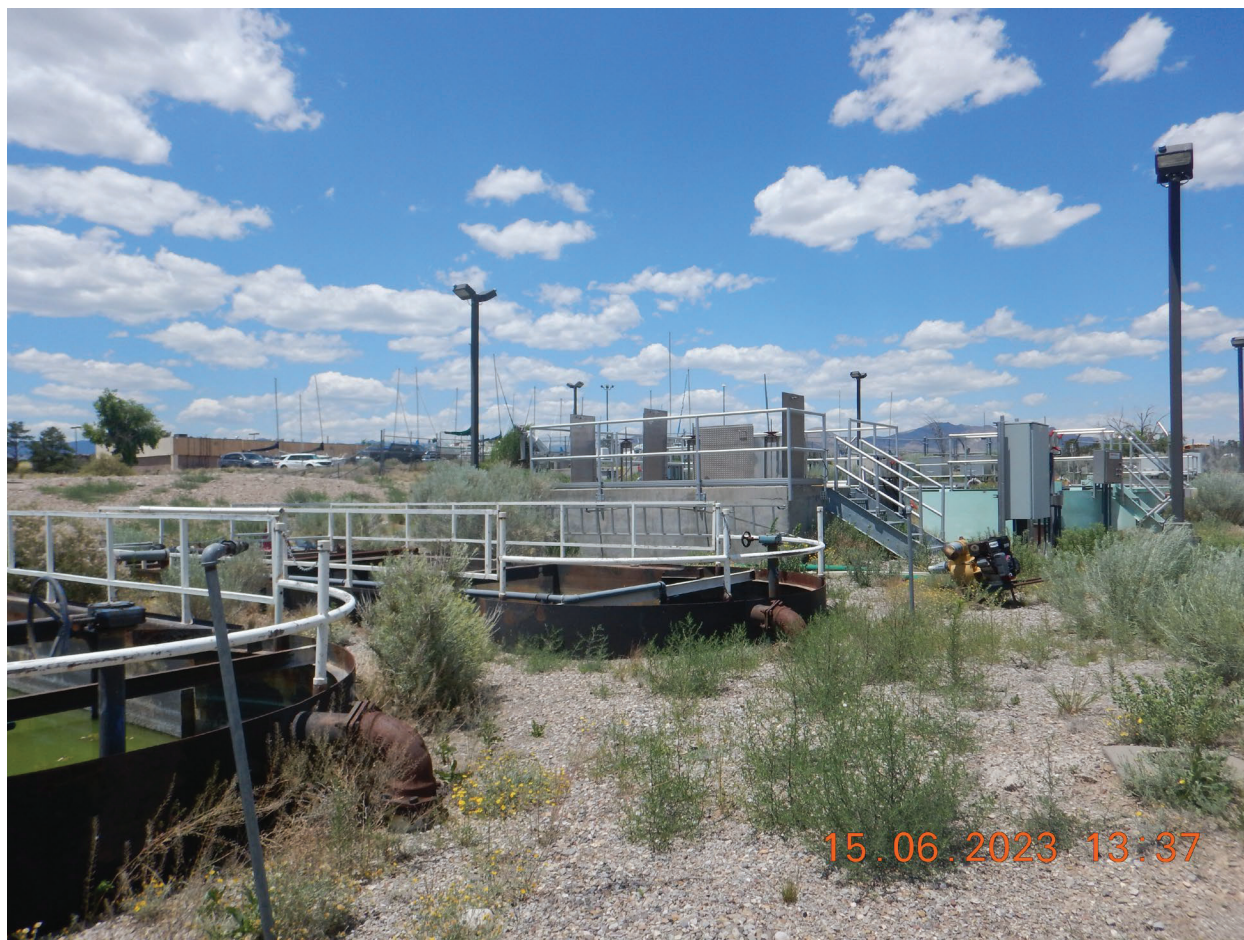
Photo No. 3

- The treatment cells exhibited limited remaining freeboard, and corrosion.
- Multiple pieces of treatment process equipment was disconnected and non-operational.

Another view looking approximately northwest of the facility. Note: the yellow sump pump at the center right of the photograph. Additionally, note the visible rust on the two (2) clarifiers. The center clarifier was almost empty and the clarifier of the left exhibited standing or stagnate aromatic water, inclusive visible algae growth. (DSCN 2601). Photographed by D. Esparza.

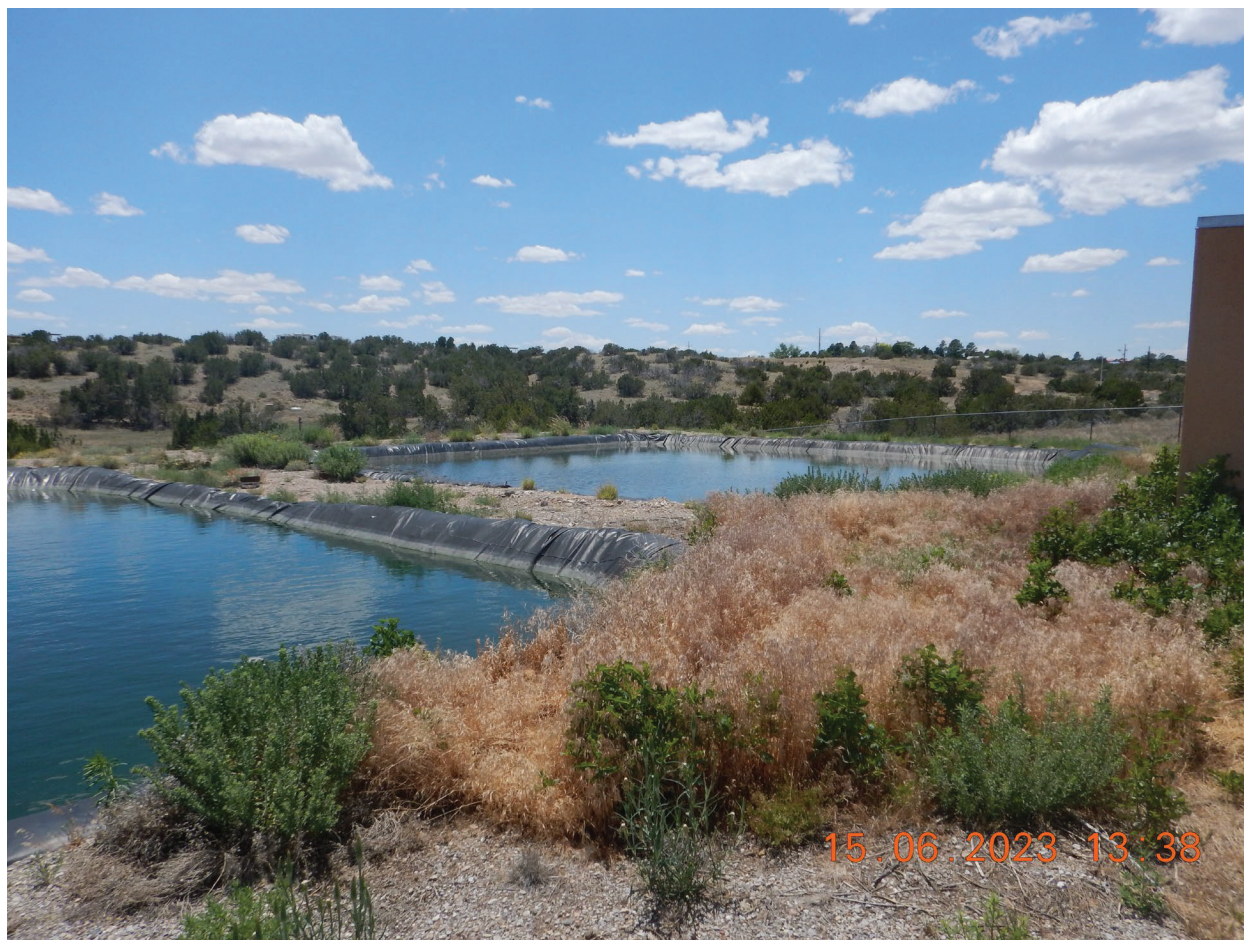
Photo No. 4

- Visual observation indicated two (2) lined lagoon cells which equate to approximately 0.06-acres (westside lagoon) and 0.10-acres (eastside lagoon), respectively in surface area. It should be noted remnants of an abandoned third lagoon located along the eastern perimeter were visible, though it was unlined.

View of both sewage evaporative lagoons. Located along the approximate southside of the facility. Note: The extensive vegetative overgrowth visible along the perimeter of the lagoons, which could potentially attract rodents and/or vermin; thus, causing undermining of the facility structures. (DSCN 2602). Photographed by D. Esparza.

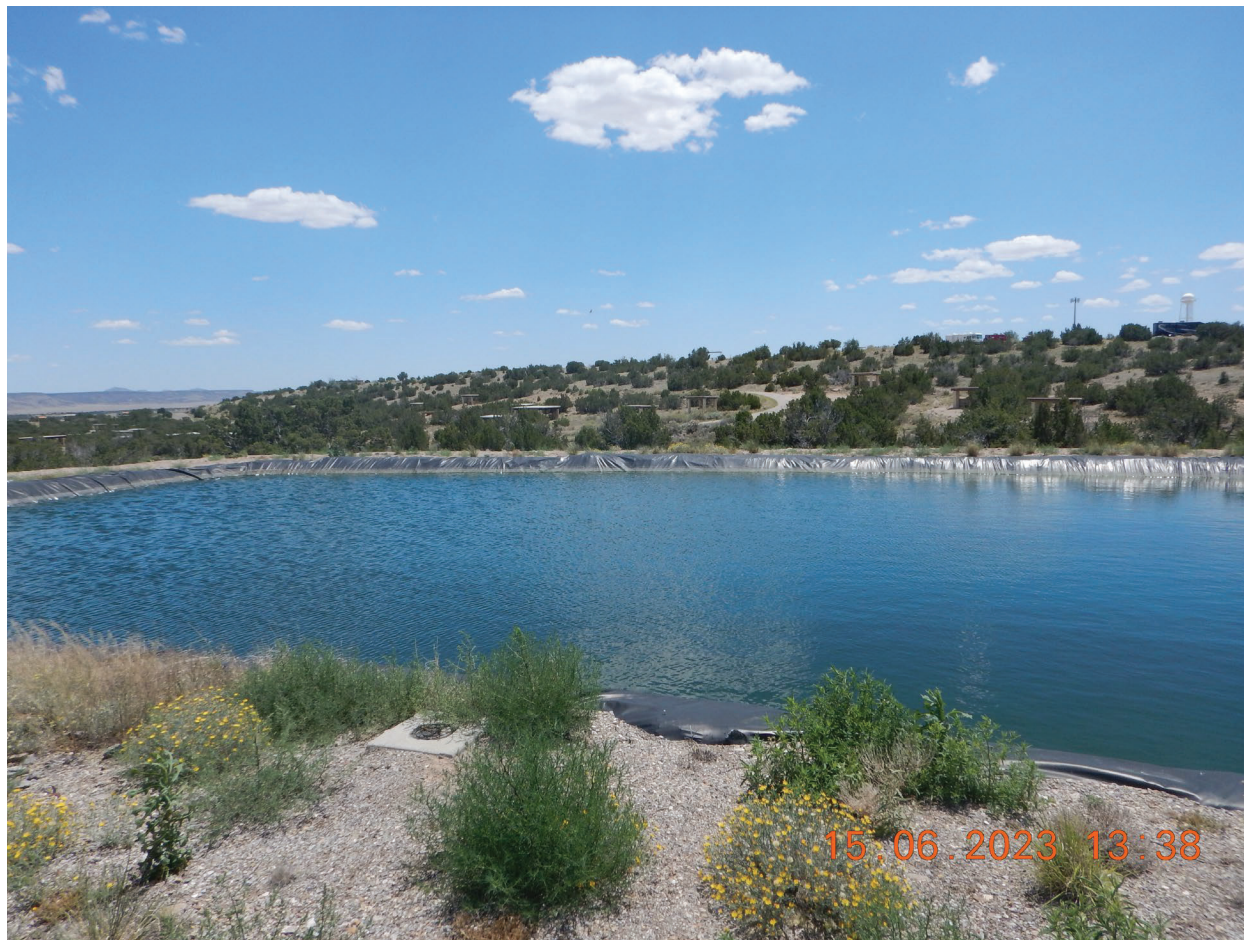
Photo No. 5

View of eastside lagoon. Note: there were visible signs of liner degradation along the containment banks in various areas. (DSCN 2603). Photographed by D. Esparza.

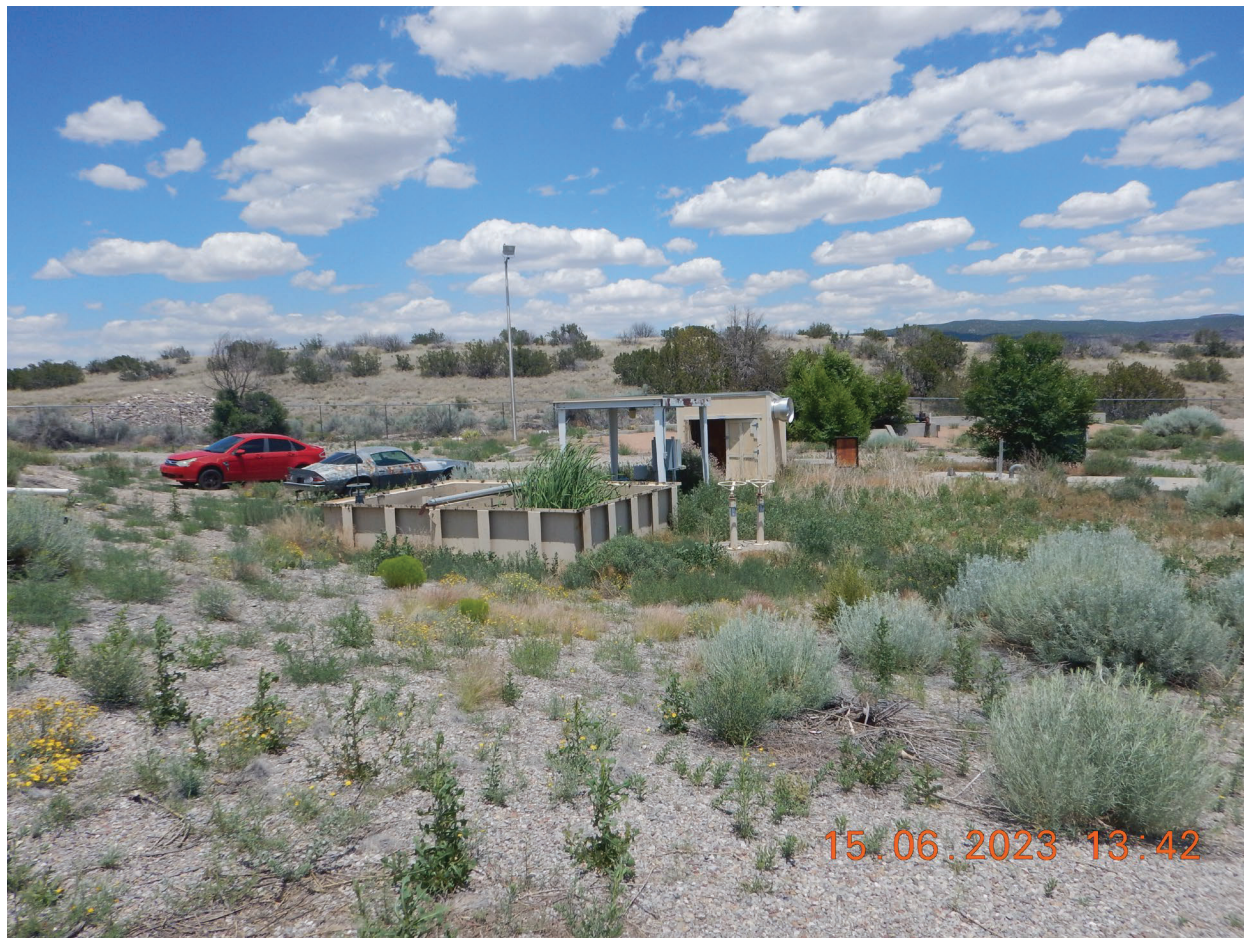
Photo No. 6

View of additional decommissioned process treatment equipment situated along the eastside of the facility. (DSCN 2604). Photographed by D. Esparza.
